<p>Alameda Point U.S. Navy NFECS Southwest, San Diego, CA</p>
<p>Figure A-2-2 SOLID WASTE MANAGEMENT UNIT INTEGRATION APPROACH RCRA Hazardous Waste Facility Permit EPA ID CA 2170023236 NAS Alameda, Alameda, CA</p>
<p>SWMU Evaluation Report for Economic Development Conveyance Parcel 5</p>

FIGURE A-3-1
SWMUs LOCATED WITHIN
EDC PARCEL 5

COMPILATION OF SOLID WASTE MANAGEMENT
UNIT EVALUATION REPORTS PREVIOUSLY
SUBMITTED WITH CERCLA DOCUMENTS
HAZARDOUS WASTE PERMIT
EPA ID NUMBER CA 2170023236

**ATTACHMENT A
SOLID WASTE MANAGEMENT UNIT
EVALUATION REPORT FOR PUBLIC
BENEFIT CONVEYANCE PARCEL 1A
Hazardous Waste Permit
EPA ID Number CA 2170023236**

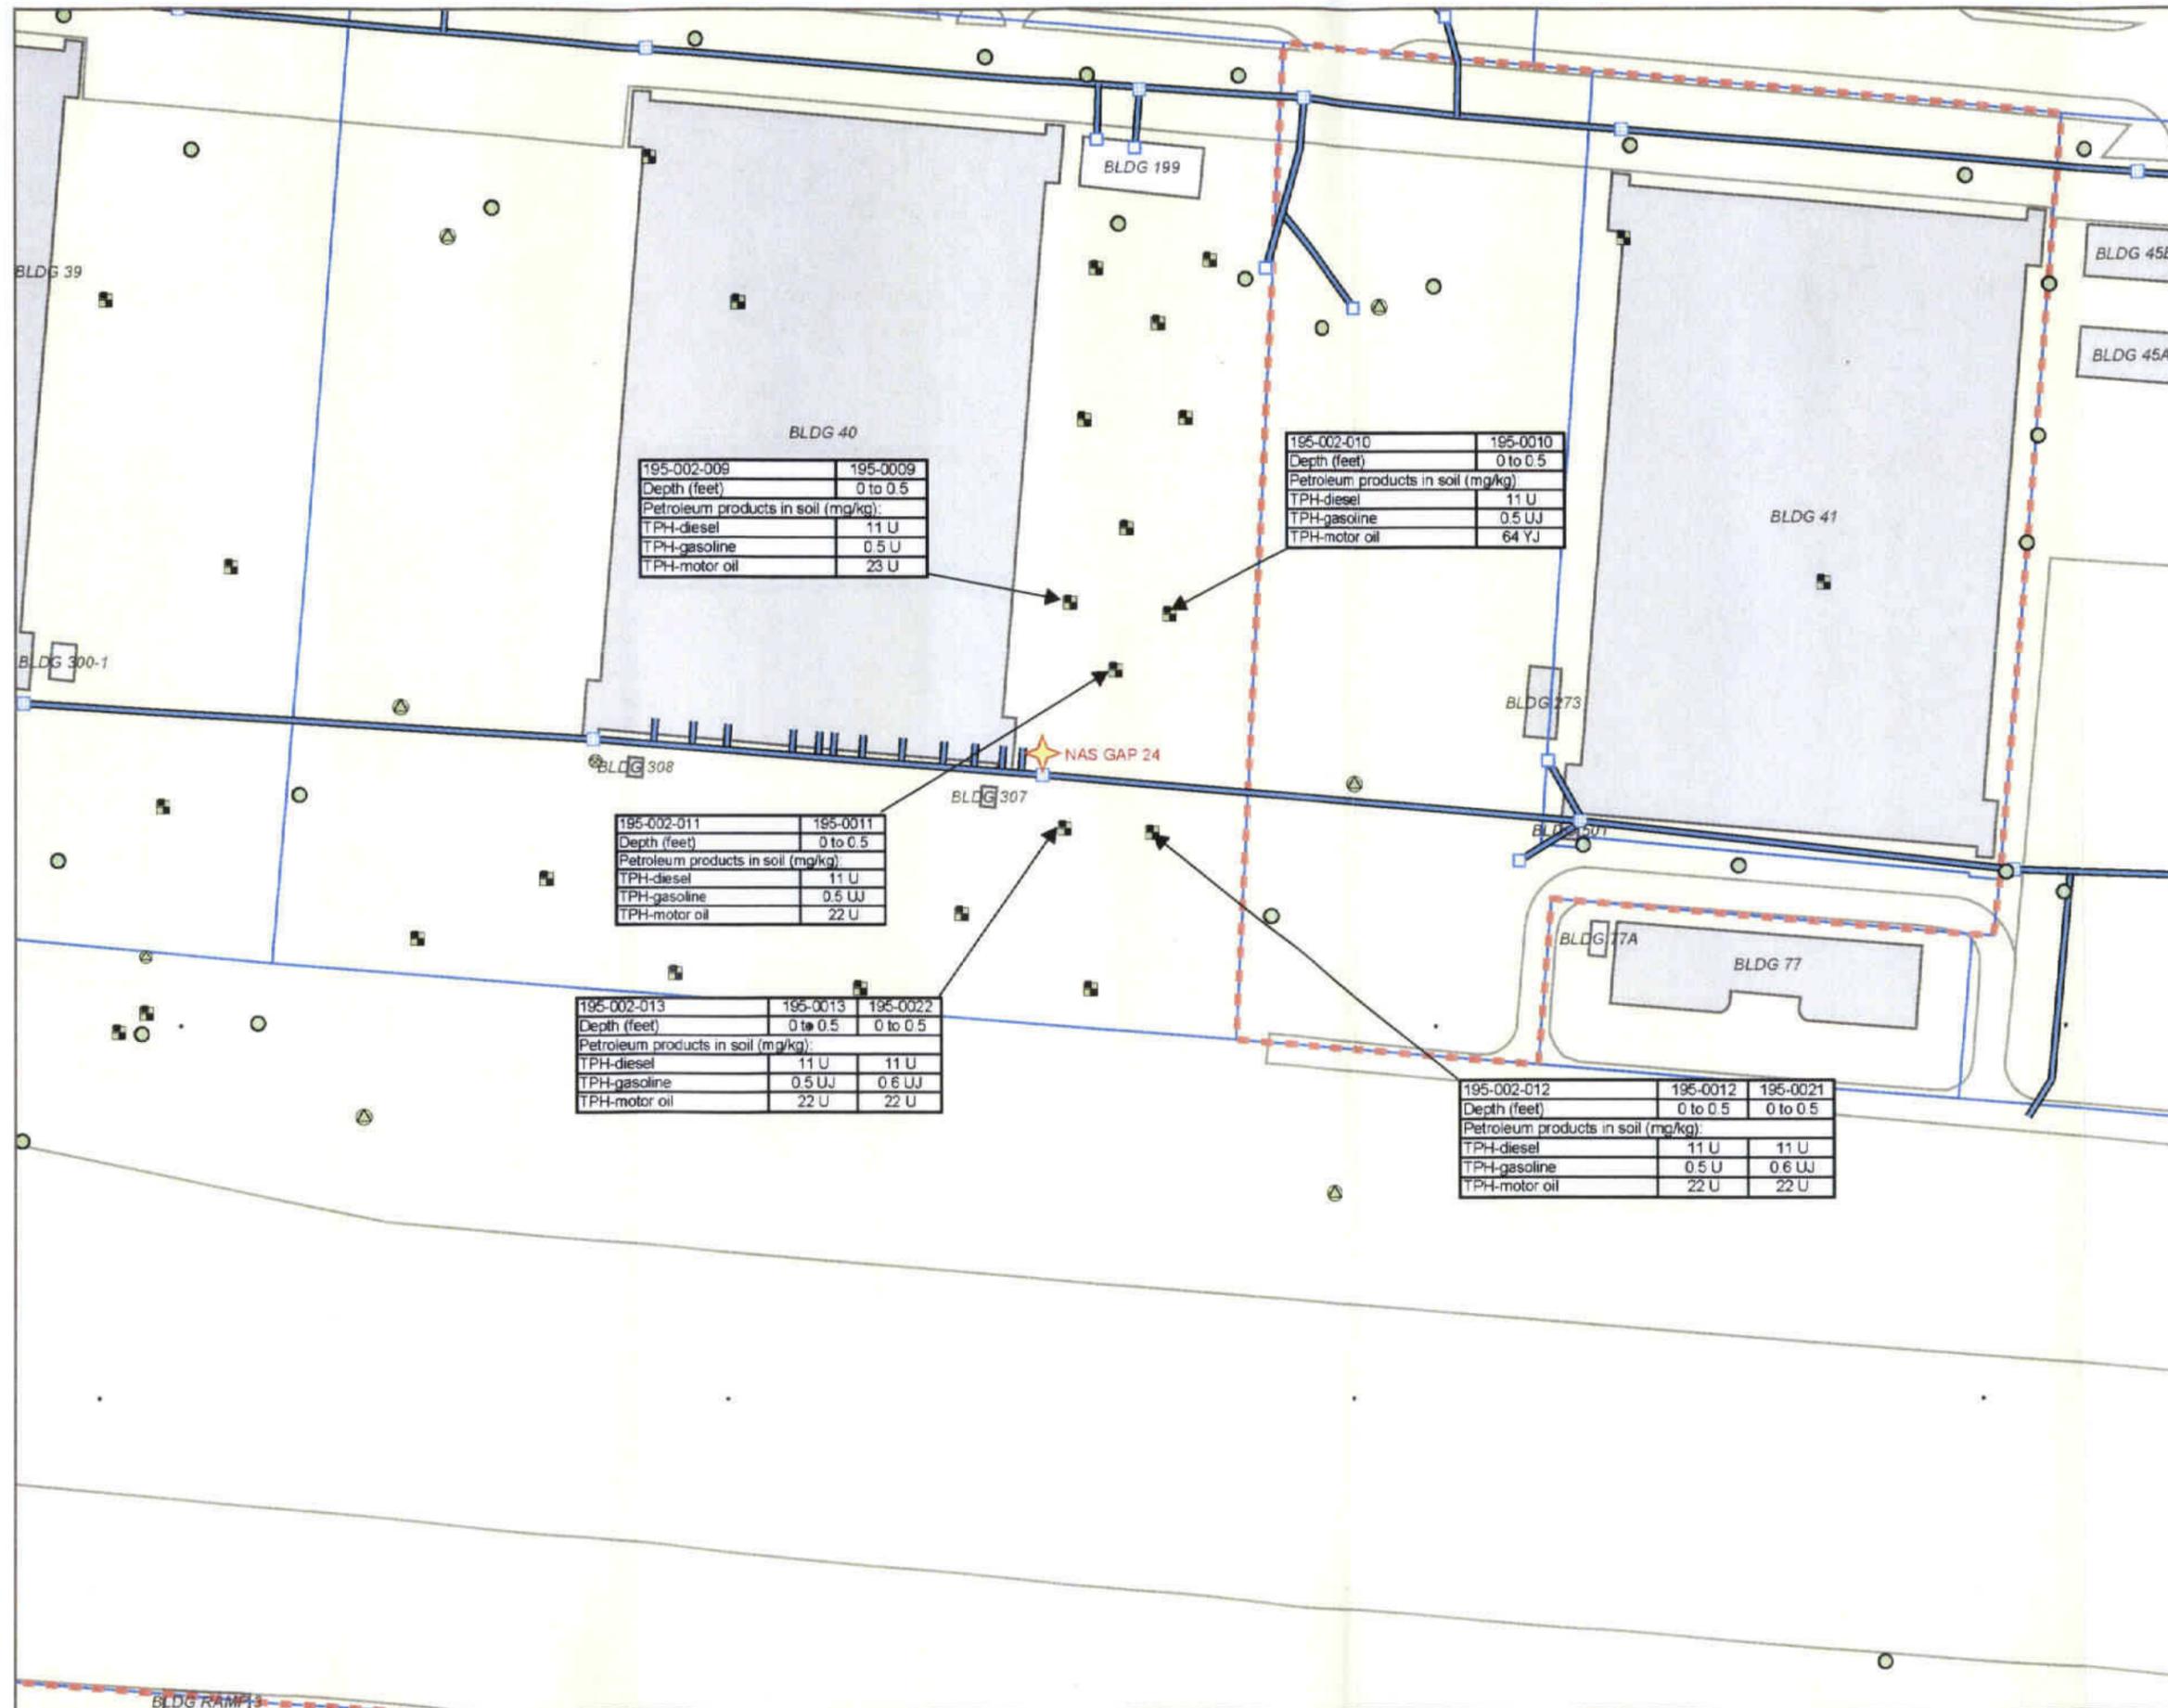
FIGURE A-3-12
EBS PARCEL 195
NAS GAP 24 SAMPLE RESULTS

- SAMPLING LOCATIONS**
- ⊙ Direct-Push
 - ⊗ Excavation
 - Soil Boring
 - Surface Location
 - ★ GENERATION ACCUMULATION POINT (GAP)
 - CATCH BASIN
 - MANHOLE
 - STORM SEWER LINE
 - - - CERCLA SITE
 - ENVIRONMENTAL BASELINE SURVEY (EBS) PARCEL
 - LAND COVER
- BUILDING**
- Present
 - Removed

SWMU Identifier **NAS GAP 24** Refer to Figure # Figure A-3-12
Navy Recommendation/Closure Status **NFA Recommended by DTSC (2004)**

NAS GAP 24 (east of Building 40) was investigated as part of Target Area 2 for parcel 195 in Zone 11 of the EBS. This SWMU consisted of metal sheds and 55-gallon drums. Localized sample results, referenced on the parcel 195 figure, show TPH concentrations below residential PRC. According to the RFA, NAS GAP 24 exhibited a low potential for releases (none known) into soil and groundwater because the GAP was located on concrete (DTSC 1992). A letter from DTSC dated November 4, 1999 recommended NFA for this SWMU (DTSC 1999). No additional samples were recommended under the EBS (IT 2001). NFA is recommended to NAS GAP 24.

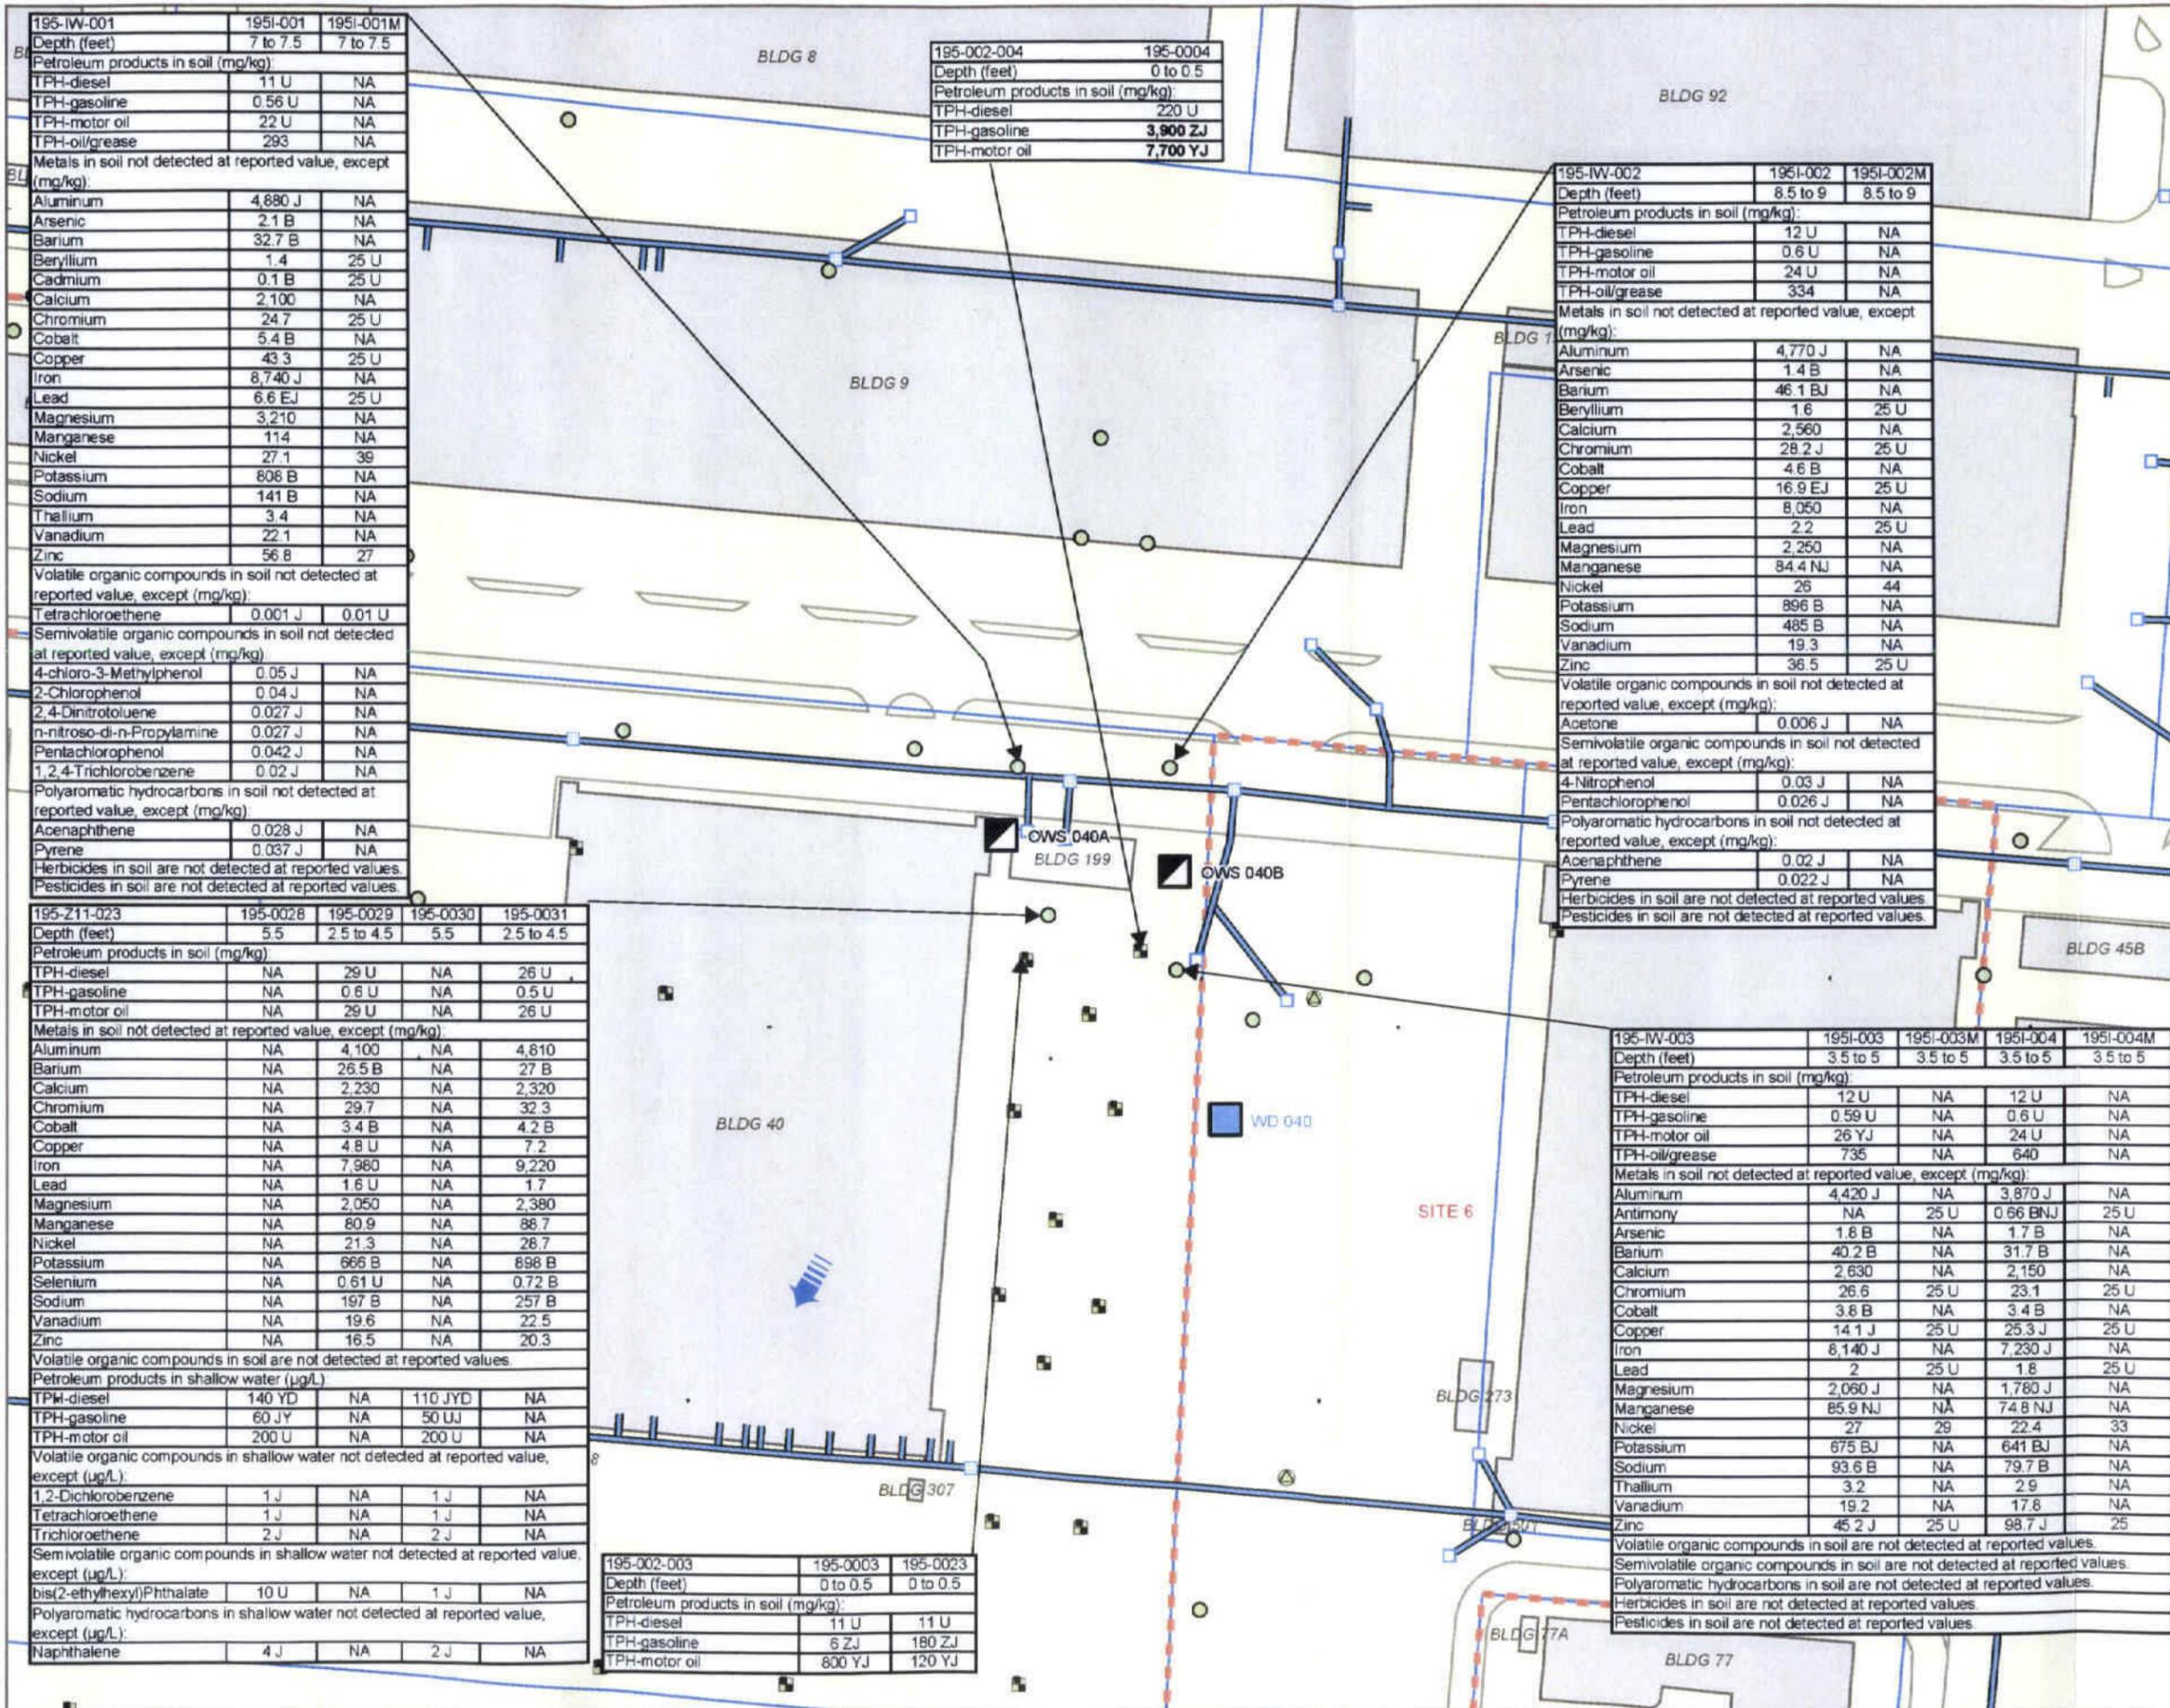
FIGURE A-3-13
EBS PARCEL 195
OWS-040A & OWS-040B SAMPLE RESULTS

- SAMPLING LOCATIONS**
- Direct-Push
 - Soil Boring
 - Surface Location
 - OIL-WATER SEPARATOR (OWS)
 - WASHDOWN (WD) AREA
 - CATCH BASIN
 - MANHOLE
 - STORM SEWER LINE

- APPROXIMATE DIRECTION OF GROUNDWATER FLOW
 - CERCLA SITE
 - ENVIRONMENTAL BASELINE SURVEY (EBS) PARCEL
 - LAND COVER
- BUILDING**
- Present
 - Removed
- Notes:**

OWS 040B is one of two OWSs located east of Building 40 in parcel 195, which is part of Zone 11 in the EBS. One sampling location (195-IW-003), located 5 feet to the north of the OWS, detected TPH as motor oil below the residential PRCs; TPH as oil and grease was also detected but there is no PRC for oil and grease. All other detected concentrations of target analytes were below residential PRCs, MCLs, EPA 2002 PRGs, and/or Alameda Point background concentrations. Note that the OWS symbol on the figure is not to scale; the soil sampling location was five feet north of the OWS. NFA is recommended for OWS 040B.

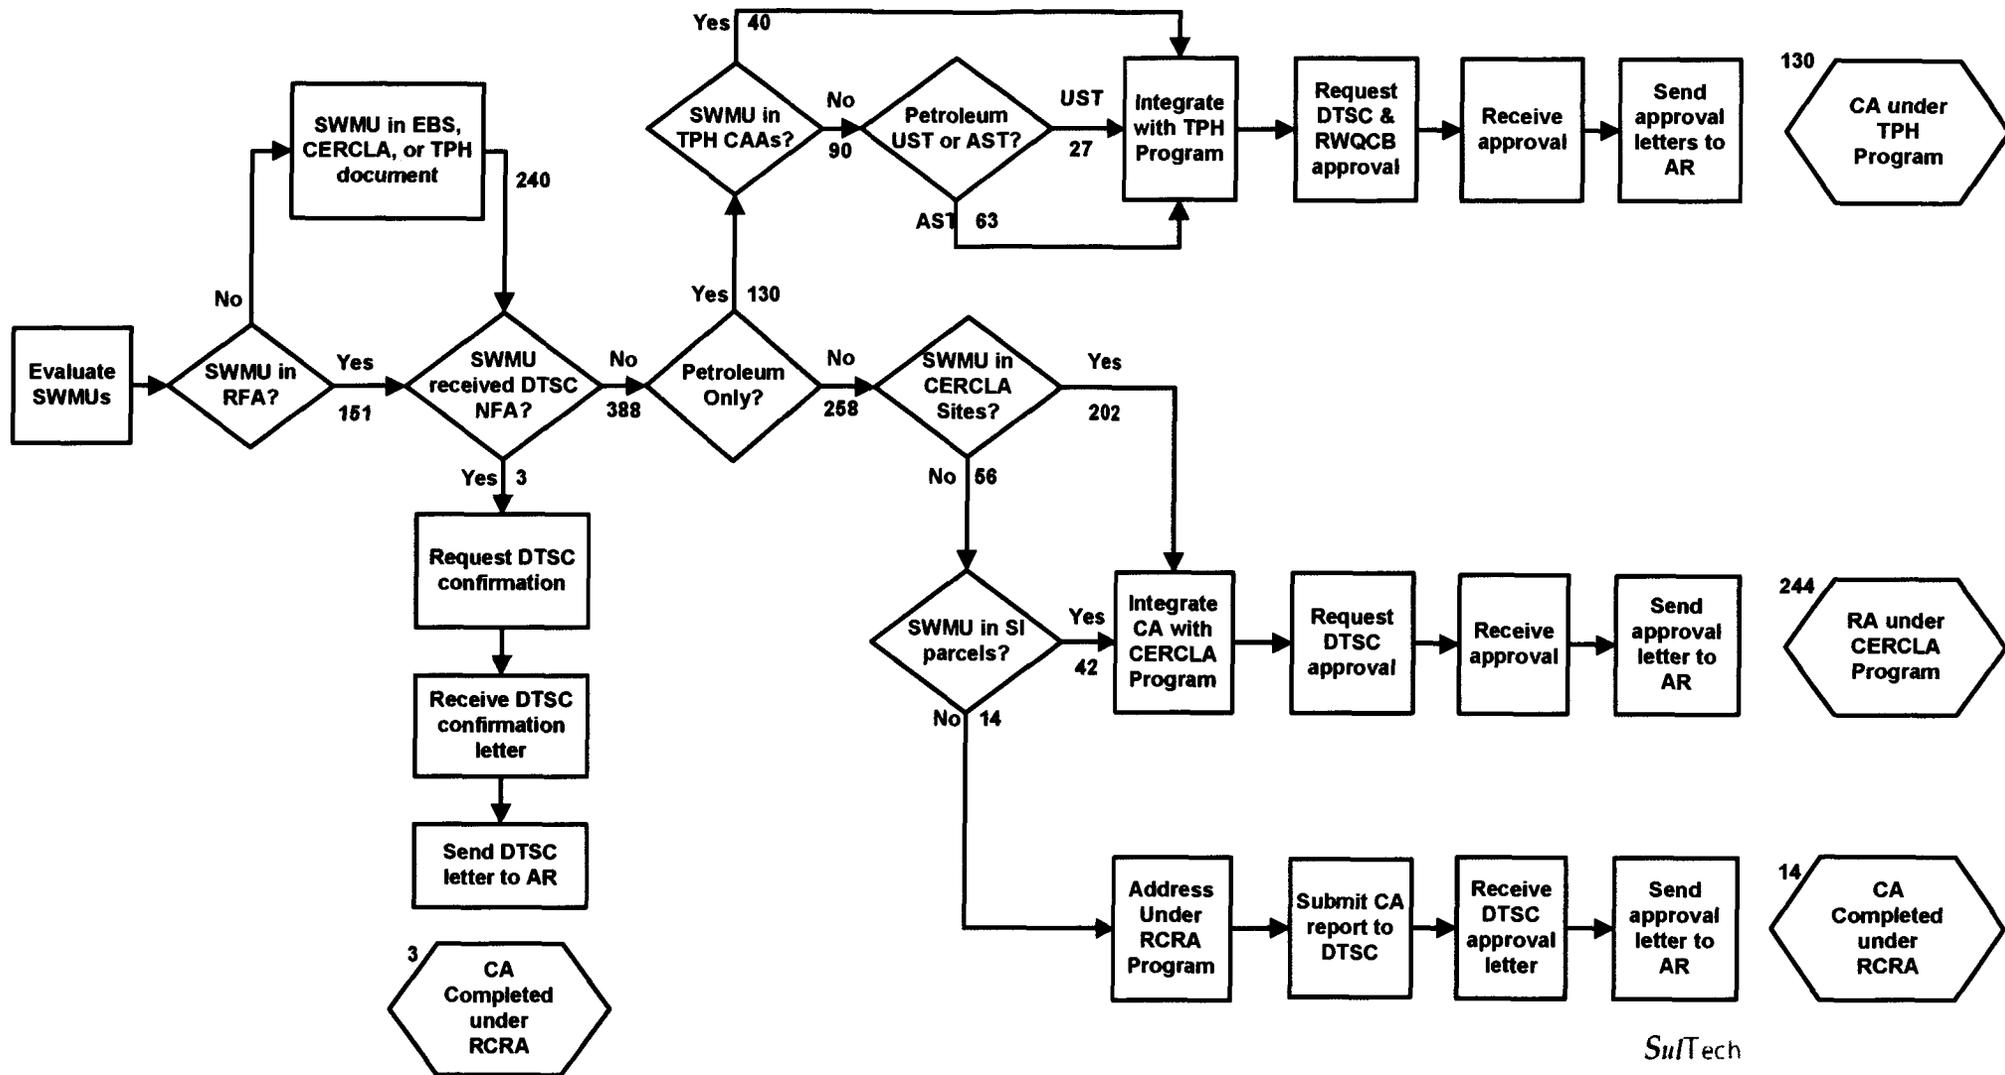
FIGURE A2-2
SOLID WASTE MANAGEMENT UNIT
INTEGRATION APPROACH
RCRA Hazardous Waste Facility Permit
EPA ID CA 2170023236
NAS Alameda, Alameda, CA

1. SWMUs include CERCLA sites, USTs, ASTs, oil-water separators, washdown areas, and underground fuel pipelines but exclude RCRA-regulated units
2. Numbers indicate number of SWMUs
