**FINAL  
SUMMARY OF FINDINGS  
EXPLORATORY TRENCHES  
Revision 1  
May 16, 2008**

**INSTALLATION RESTORATION SITE 1  
FORMER NAVAL AIR STATION ALAMEDA  
ALAMEDA POINT, ALAMEDA, CALIFORNIA**

**DCN: ECSD-2201-0015-0005.R1**

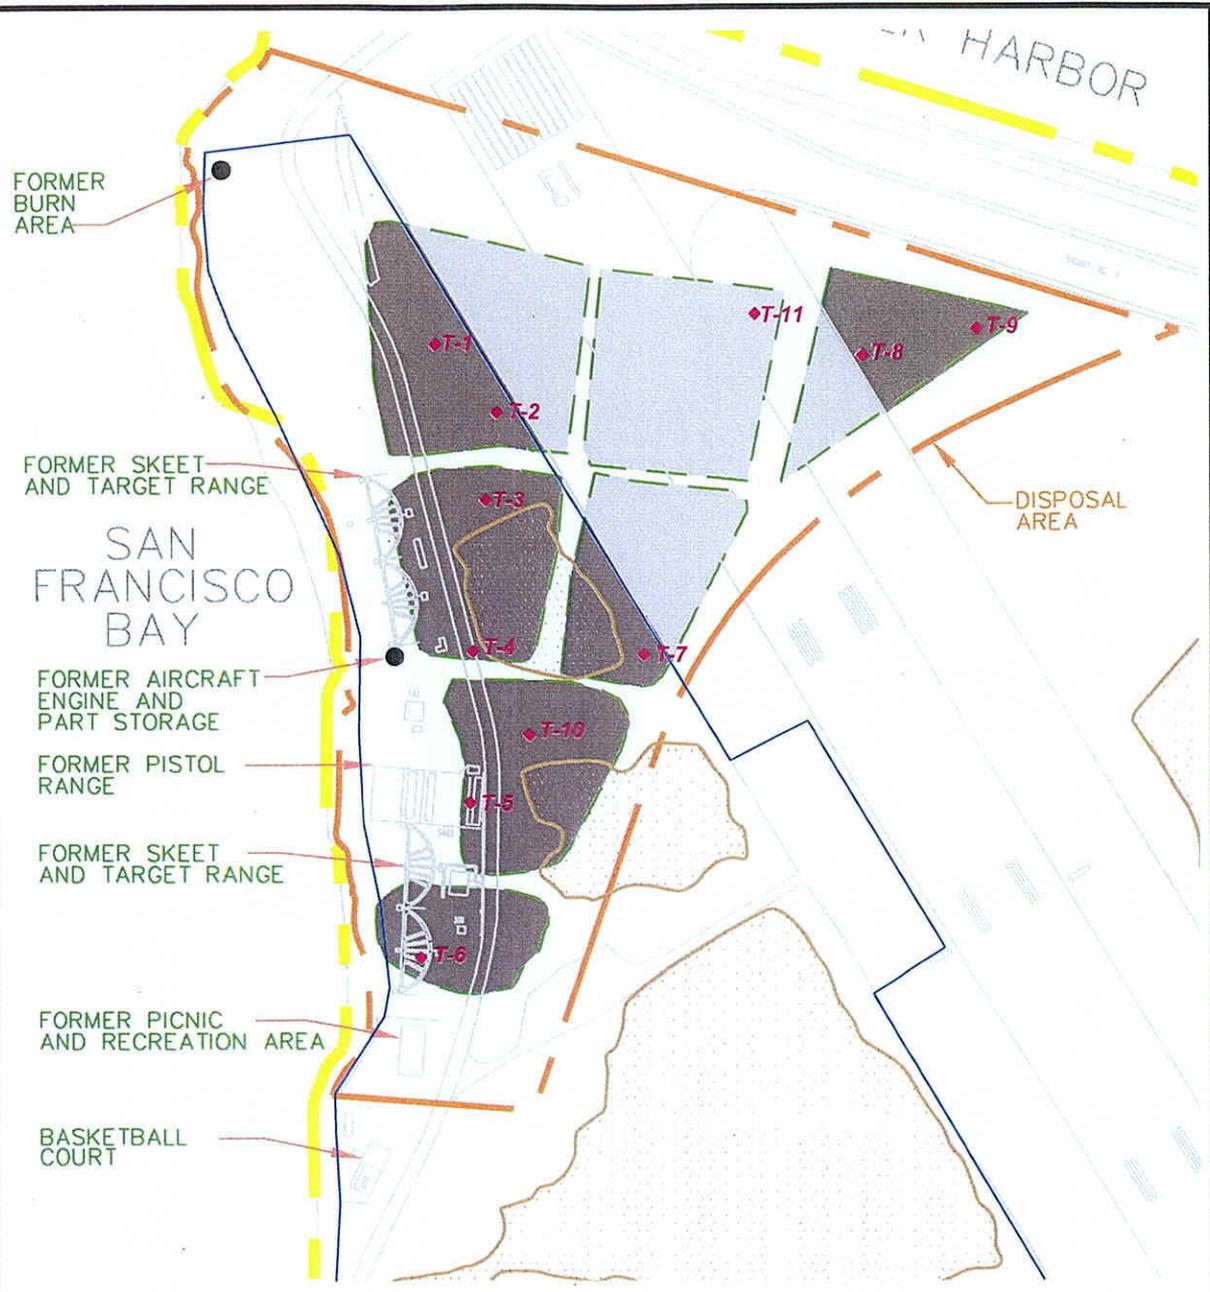
- IR SITE 1 AND 32 BOUNDARIES
- DISPOSAL AREA BOUNDARY
- SEASONAL WETLAND BOUNDARY
- RMA BOUNDARY
- TRENCH LOCATIONS
- SEASONAL WETLAND AREA
- DISPOSAL CELL

The trench locations were sited based on rough field determination utilizing the trench location figure from the Work Plan (included here as Figure 1-1). Physical site features were used to determine a rough approximation of field location in accordance with the figure.

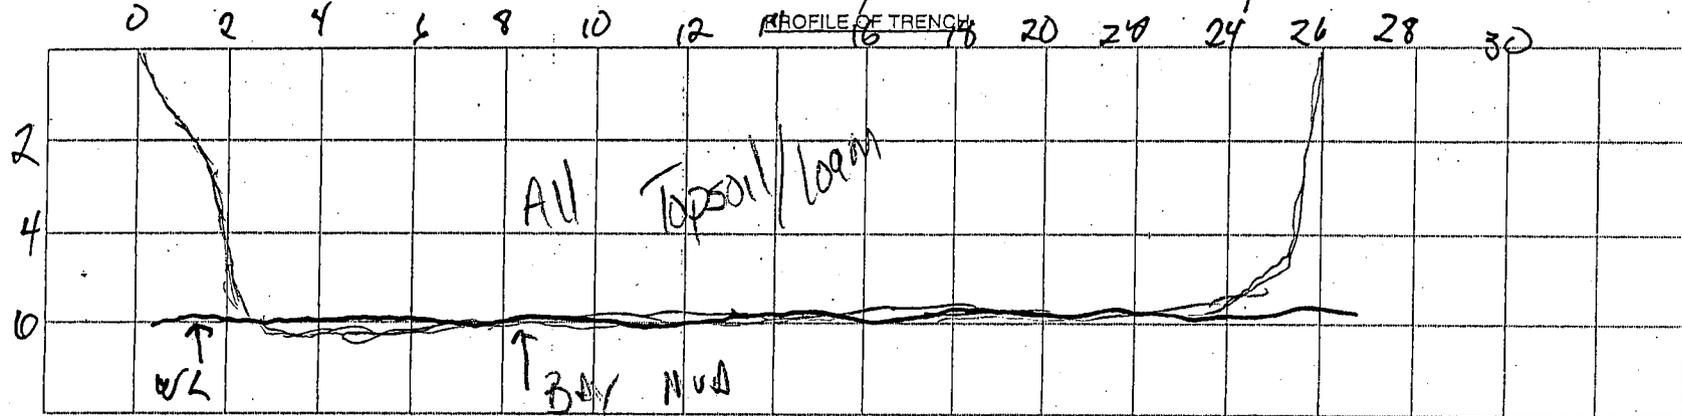
TRENCH: <u>T-15-01</u>	LENGTH: <u>25'</u>	EQUIPMENT: <u>250 excavator</u>	LOCATION: <u>Alameda</u>
	WIDTH: <u>3'</u>	BUCKET SIZE: <u>3' 2x</u>	DATE: <u>9/5/07</u>
	DEPTH: <u>6'</u> (Avg)	OPERATOR: <u>Steve</u>	LOGGED BY: <u>G. Hrybko</u>
DESCRIPTION & REMARKS: <u>START: 0915 FINISH: 1020</u> <u>0-6' Topsoil - limited debris</u> <u>6' - Bay mud &amp; water table reached</u> <u>No OXO NO DRUMS Soil w/ elevated RAD readings</u>			PLAN VIEW SKETCH OF TRENCH:

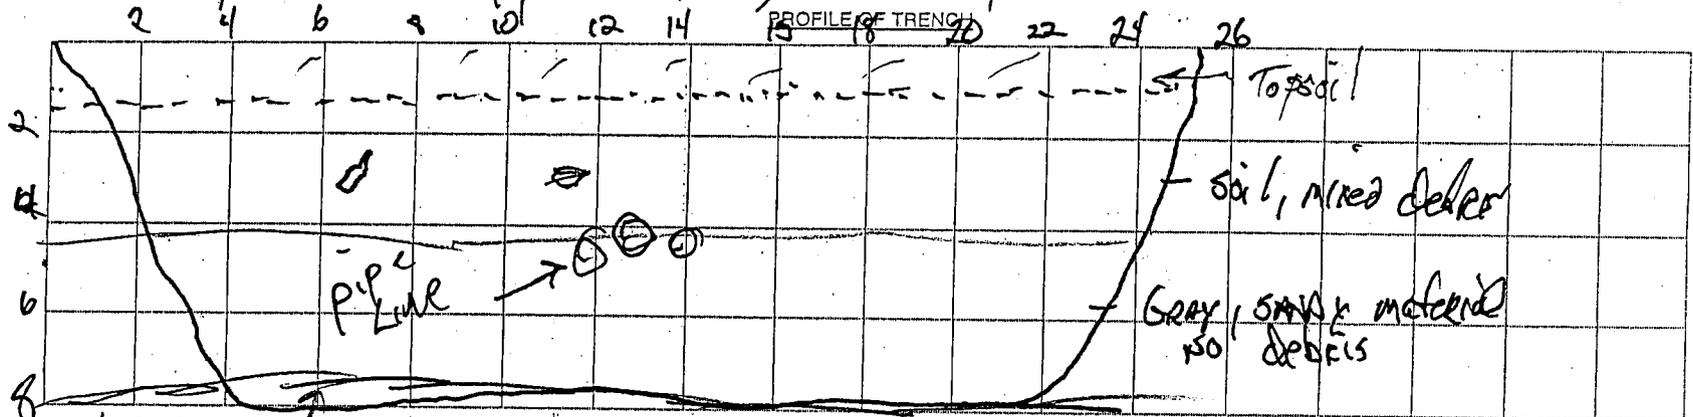
TRENCH: <u>T-015-02</u>	LENGTH: <u>25'</u>	EQUIPMENT: <u>350 Excavator</u>	LOCATION: <u>Alameda</u>
	WIDTH: <u>3'</u>	BUCKET SIZE: <u>3' 2cy</u>	DATE: <u>9/9/02</u>
	DEPTH: _____ (Avg)	OPERATOR: <u>Steve</u>	LOGGED BY: <u>L. G. [unclear]</u>
DESCRIPTION & REMARKS: <u>STARTED: 1300 Finished - WATER LEVEL - 1445</u> <u>0-1.5' Topsoil 1.5'</u> <u>1.5'-4.5' - <del>Black</del> sandy soil - MIXED debris (wood, glass, metal)</u> <u>4.5' - 8' - Gray, SANDY soil, little debris</u> <u>- Cut through abandoned pipeline APPROX 5' - SAND is probably backfill</u>			PLAN VIEW SKETCH OF TRENCH:

NO OXO, 1 DRUM CARCASS, SMALL AMT RAD impacted soil

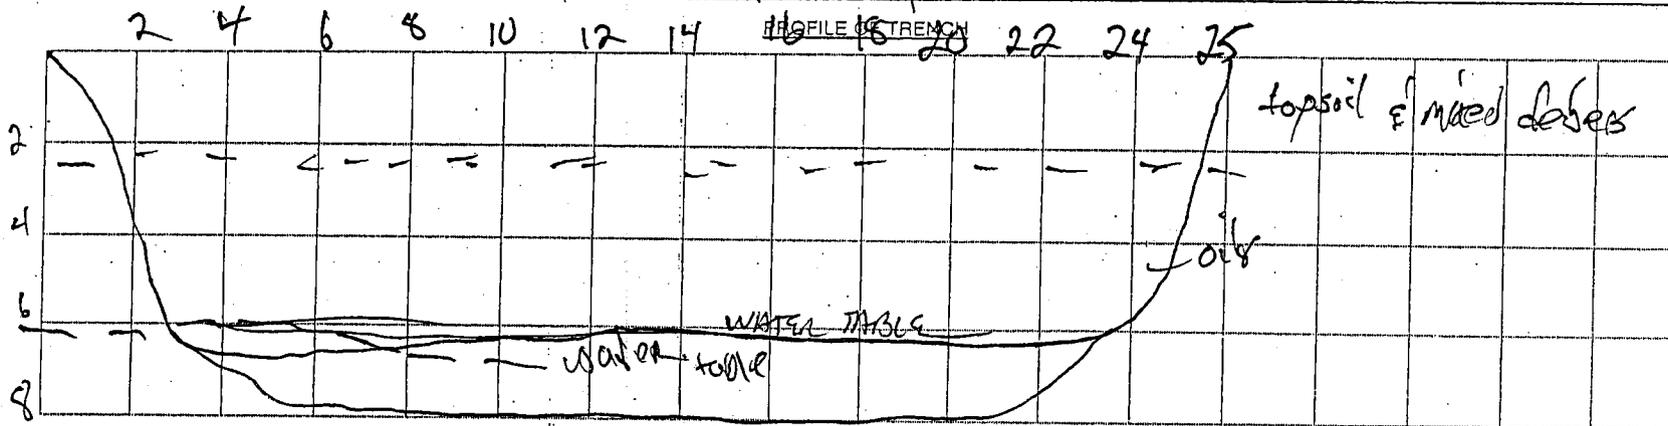
TRENCH: <u>T-015-03</u>	LENGTH: <u>25'</u>	EQUIPMENT: <u>350 excavator</u>	LOCATION: <u>Alameda</u>
	WIDTH: <u>3'</u>	BUCKET SIZE: <u>2cy</u>	DATE: <u>9/06/07 - 9/07</u>
	DEPTH: _____ (Avg)	OPERATOR: <u>Steve</u>	LOGGED BY: <u>L. Humphreys</u>
DESCRIPTION & REMARKS: <u>START: 0830 - secured 0915 9/7/07 steel 0800</u> <u>0-2 1/2' - topsoil mixed debris - wood, metal, rubber</u> <u>2 1/2-7' - oily, sandy soil and mixed debris</u> <u>water table - 7' - Dig to 8' Bgs - no change -</u> <u>No drums, No UXO, Rd unpaved soil - lots</u>			PLAN VIEW SKETCH OF TRENCH:

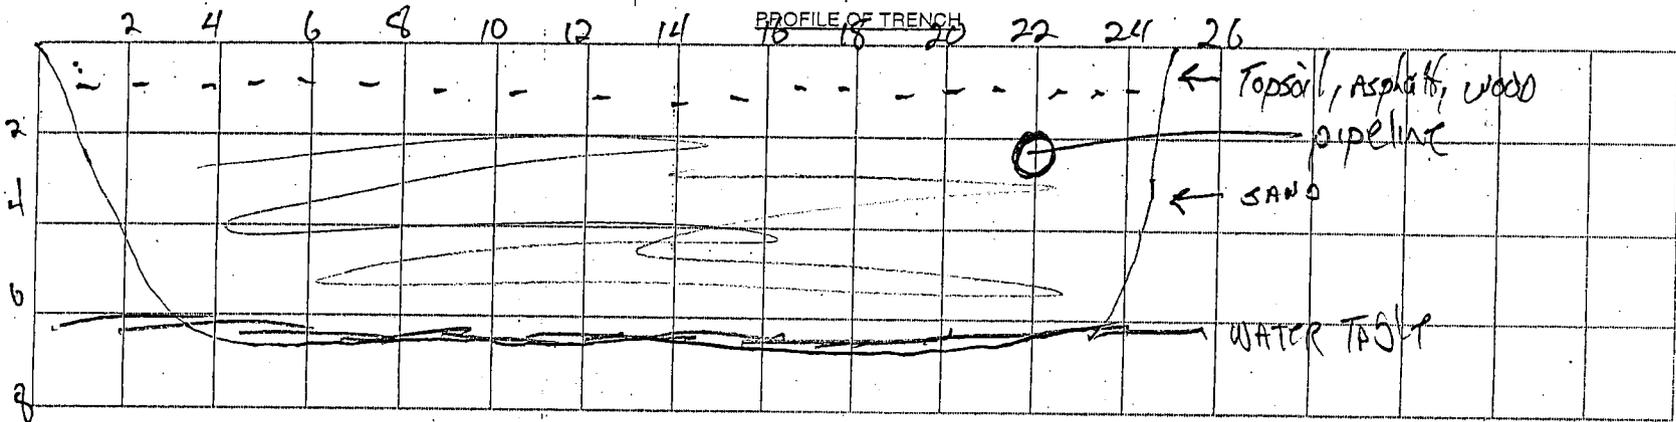
TRENCH: <u>T-015-04</u>	LENGTH: <u>25'</u>	EQUIPMENT: <u>430 Backho</u>	LOCATION: <u>30 Alameda</u>
	WIDTH: <u>2'</u>	BUCKET SIZE: <u>3'</u>	DATE: <u>9/6/07-9/10/07</u>
	DEPTH: <u>7'</u> (Avg)	OPERATOR: <u>Mike</u>	LOGGED BY: <u>L. Ny</u>
DESCRIPTION & REMARKS: <u>START: 0830 - SECURE 0915 a/7/07 - START 0800</u> <u>0-1' - topsoil &amp; asphalt debris - wood</u> <u>1'-7' - SAND - NO debris</u> <u>water table - 6 1/2'</u> <u>NO UVO, NO DEUMS, NO RAD</u> <u>Finish - 0822</u>			PLAN VIEW SKETCH OF TRENCH:

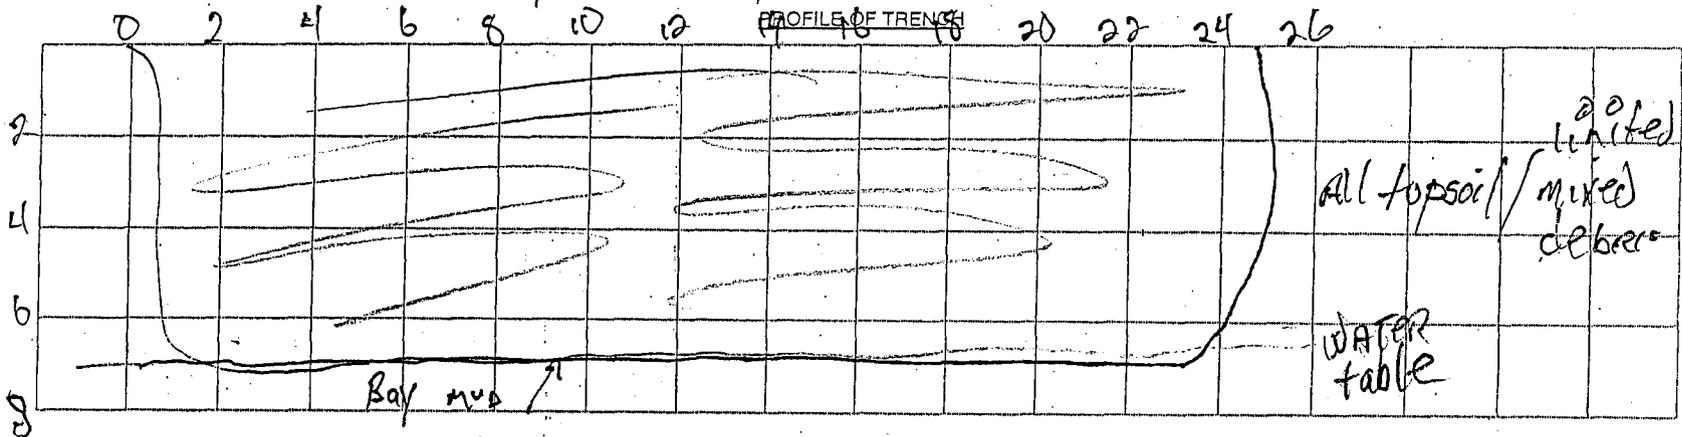
<u>NO drums, NO OXO, SOME RAD AFFECTED SOIL</u>

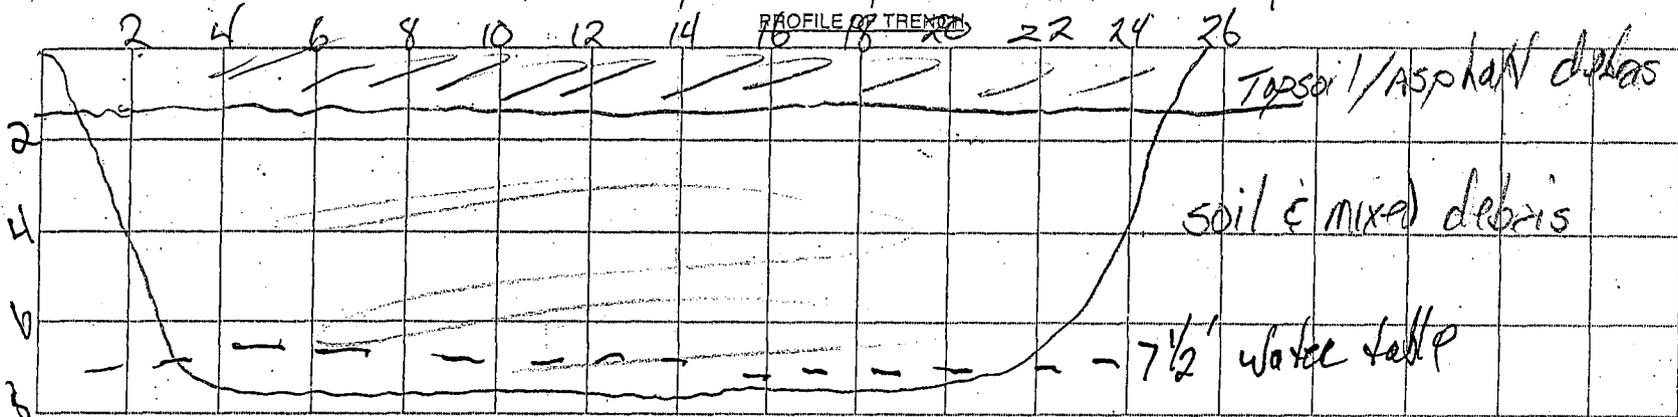
TRENCH: <u>T-016-06</u>	LENGTH: <u>25'</u>	EQUIPMENT: <u>430E Backhoe</u>	LOCATION: <u>Alameda Pt</u>
	WIDTH: <u>3'</u>	BUCKET SIZE: <u>3'</u>	DATE: <u>9/10/07</u>
	DEPTH: <u>7 1/2</u> (Avg)	OPERATOR: <u>MT Steep</u>	LOGGED BY: <u>LA</u>
DESCRIPTION & REMARKS: <u>Start: 0817</u> <u>Finish: 1510</u> <u>0 - 1 1/2' - top soil, asphalt debris - some metal</u> <u>1 1/2 - 7 1/2 soil &amp; mixed debris (metal, wood, glass, etc)</u> <u>water table: 7 1/2'</u> <u>No Dams, No UXO, All soil was RAD impacted</u>			PLAN VIEW SKETCH OF TRENCH:

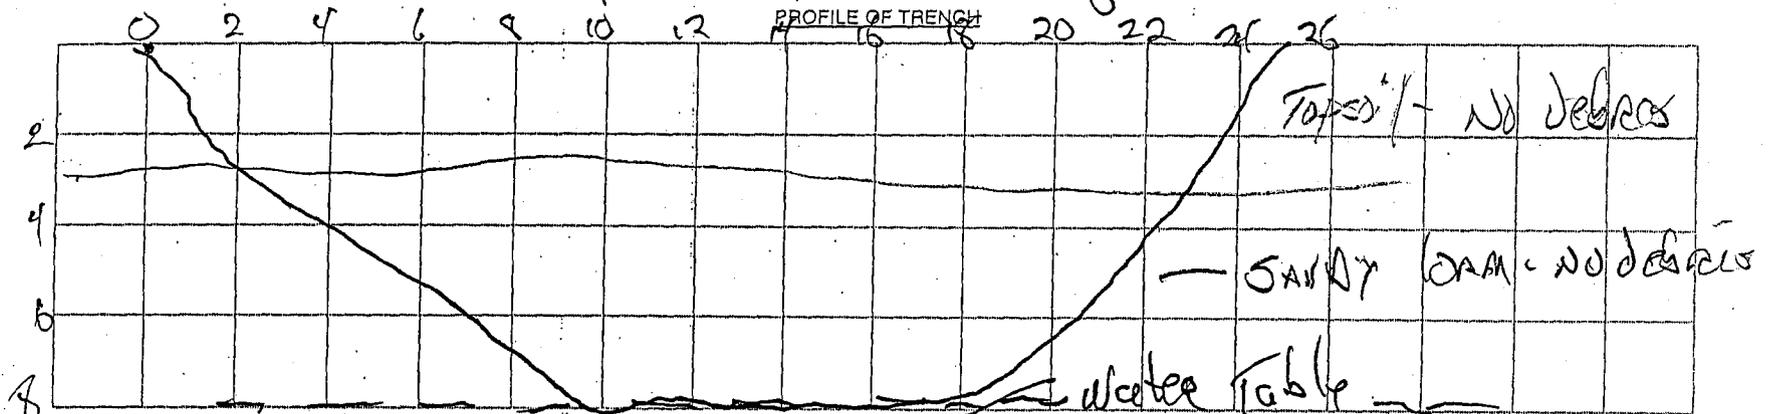
TRENCH: <u>7-015-07</u>	LENGTH: <u>25'</u>	EQUIPMENT: <u>350 Excavator</u>	LOCATION: <u>Alameda</u>
	WIDTH: <u>3'</u>	BUCKET SIZE: <u>3'</u>	DATE: <u>9/10/07</u>
	DEPTH: <u>8'</u> (Avg)	OPERATOR: <u>Mike</u>	LOGGED BY: <u>hlf</u>
DESCRIPTION & REMARKS: <u>Started: 0859</u> <u>Finished: 1010</u> <u>0-3': topsoil, NO DEBRIS</u> <u>3'-8' SANDY LOAM - NO DEBRIS</u> <u>water table - 8'</u> <u>NO TREES, NO UXO, small amount of RAO soil</u>			PLAN VIEW SKETCH OF TRENCH:

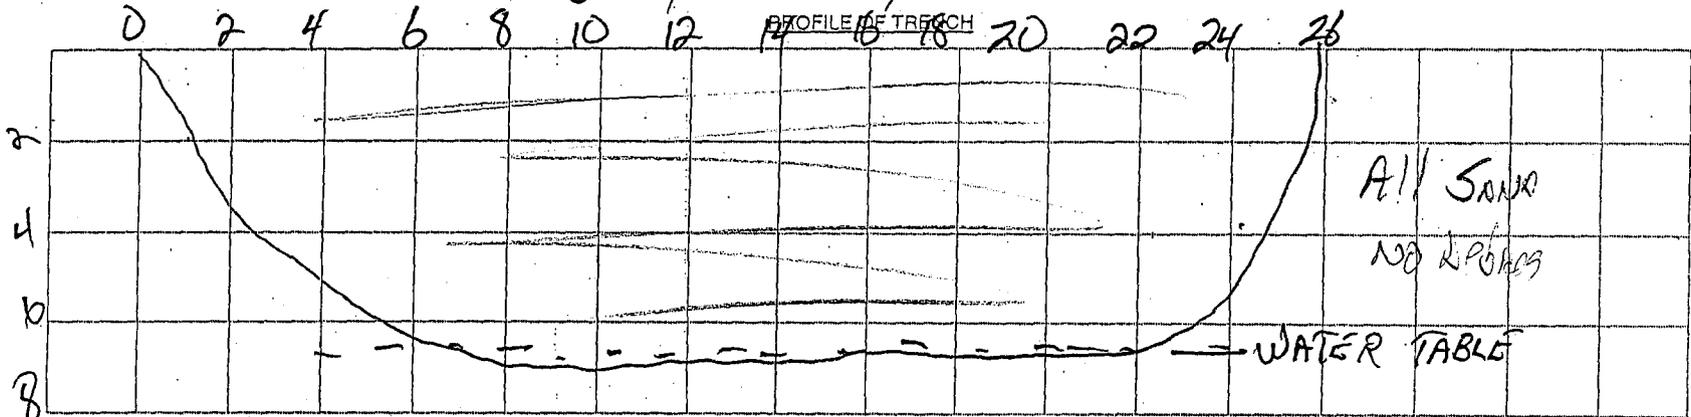
TRENCH: <u>T-015-08</u>	LENGTH: <u>25'</u>	EQUIPMENT: <u>430E Excavator</u>	LOCATION: <u>Alameda P</u>
	WIDTH: <u>3'</u>	BUCKET SIZE: <u>3'</u>	DATE: <u>9/10/07</u>
	DEPTH: <u>7'</u> (Avg)	OPERATOR: <u>Steve</u>	LOGGED BY: <u>LN</u>
DESCRIPTION & REMARKS: <u>START 1457 FINISH 1530</u> <u>0-7' All SAND, NO debris</u> <u>water table - 2'</u>  <u>No DEbris, No Rnd, No UXD</u>			PLAN VIEW SKETCH OF TRENCH:

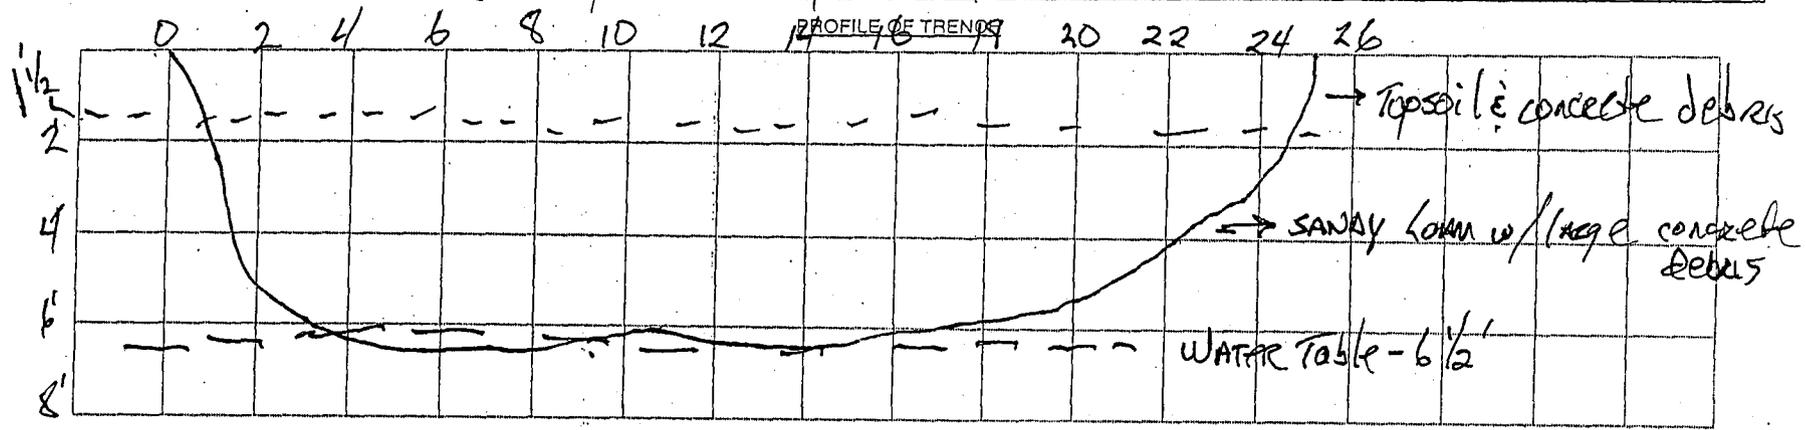
TRENCH: <u>T-015-09</u>	LENGTH: <u>25'</u>	EQUIPMENT: <u>430 Backhoe</u>	LOCATION: <u>Alameda Pk</u>
	WIDTH: <u>3'</u>	BUCKET SIZE: <u>3'</u>	DATE: <u>9/11/07</u>
	DEPTH: <u>6 1/2'</u> (Avg)	OPERATOR: <u>Steve</u>	LOGGED BY: <u>LX</u>
DESCRIPTION & REMARKS: <u>Start: 0826 Finished: 1010</u> <u>0-1 1/2' - Topsoil w/ concrete debris</u> <u>1 1/2'-6 1/2' - SANDY loam w/ large concrete debris &amp; some wood</u> <u>Water Table - 6 1/2'</u> <u>No drums, No UXO, Small amt of Rad Soil</u>			PLAN VIEW SKETCH OF TRENCH:

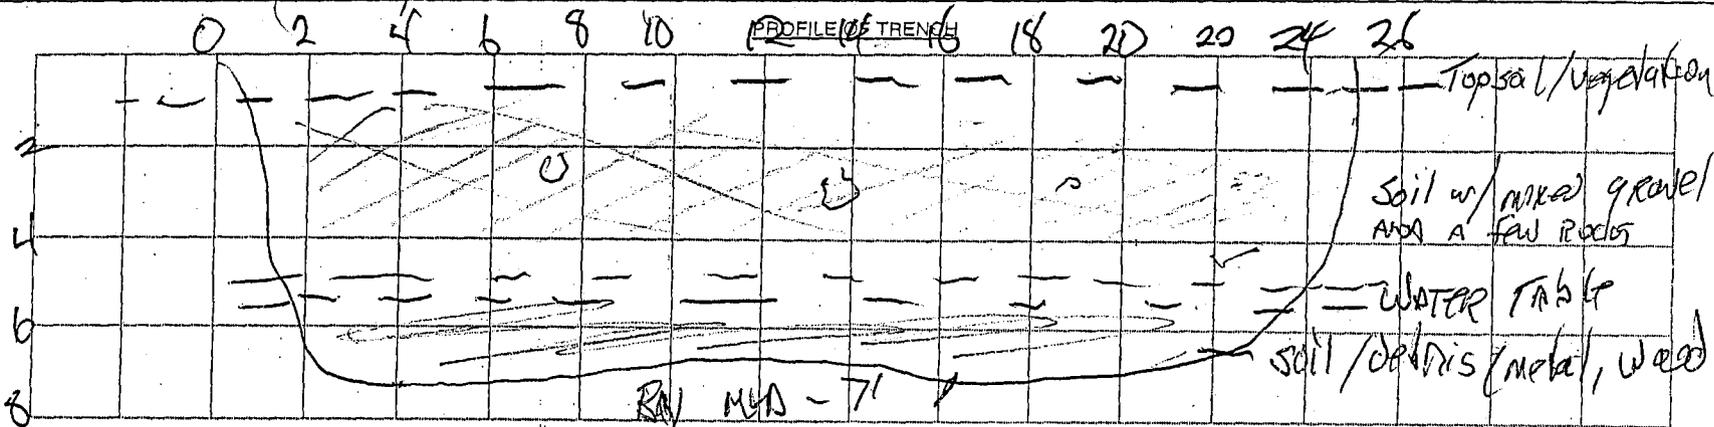
TRENCH: <u>T-015-10</u>	LENGTH: <u>25'</u>	EQUIPMENT: <u>350 EXCAVATOR</u>	LOCATION: <u>Alameda Pk</u>
	WIDTH: <u>3'</u>	BUCKET SIZE: <u>3'</u>	DATE: <u>9/1/07</u>
	DEPTH: _____ (Avg)	OPERATOR: <u>Mike</u>	LOGGED BY: <u>LV</u>
DESCRIPTION & REMARKS: <u>START: U20</u> <u>Finish 1320 - 7'</u> 0-1' - Topsoil/vegetation 1'-5' soil w/ mixed gravel & a few larger rocks 5'-6' dark soil, debris → WATER TABLE: 5 1/2' Box MUA 7' No drums, No UXO			PLAN VIEW SKETCH OF TRENCH:

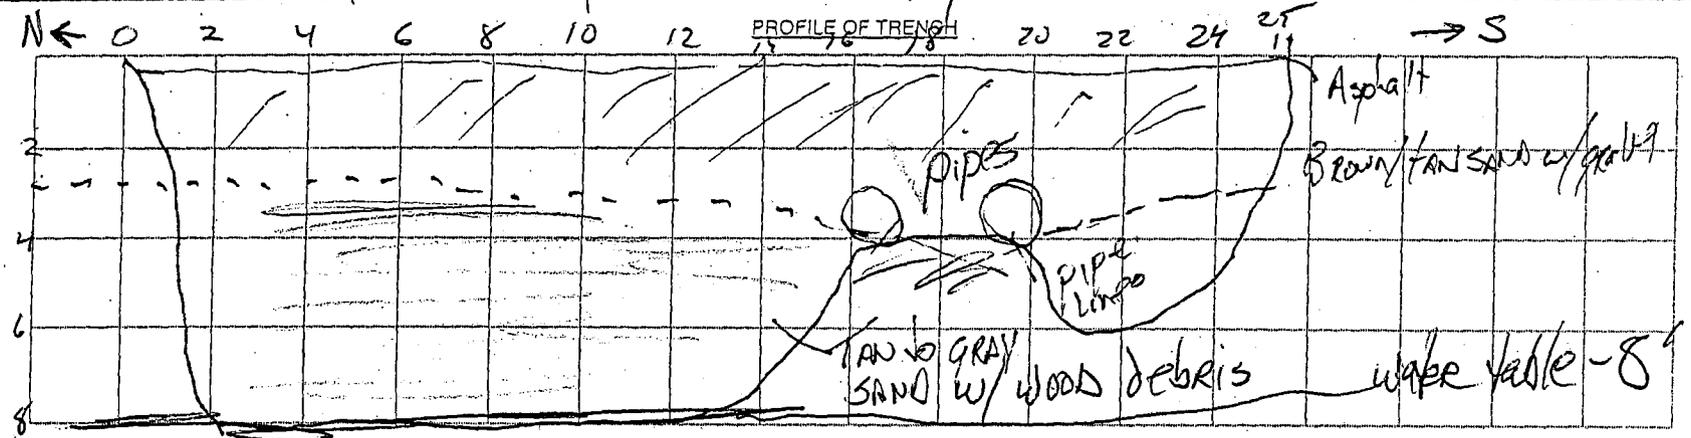
TRENCH: <u>11</u>	LENGTH: <u>25</u>	EQUIPMENT: <u>CM 430 E BACKHOE</u>	LOCATION: <u>T-14 EAST SIDE</u>
	WIDTH: <u>3'</u>	BUCKET SIZE: <u>3'</u>	DATE: <u>9/11/07</u>
	DEPTH: _____ (Avg)	OPERATOR: <u>STEVE DUGGON</u>	LOGGED BY: <u>V. R. M.</u>
DESCRIPTION & REMARKS: <u>0-3" BCS Asphalt @ 1418 ft</u> <u>@ 3' - Brown to tan fine silt w/ gravel - RAO HITS -</u> <u>3'-8' - SAND (Gill) AND GRAY SAND with some wooden debris - telephone poles</u> <u>Water table - 8'</u> <u>No drums, no WD, @ some RAO impacted soil</u>			PLAN VIEW SKETCH OF TRENCH:

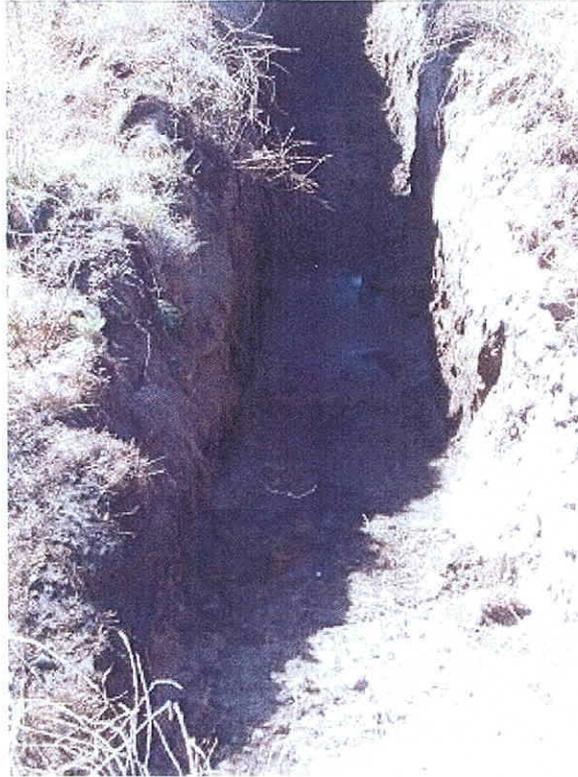
Trench 1 – Groundwater and Bay Mud at bottom of excavation. Trace debris only found in excavation.

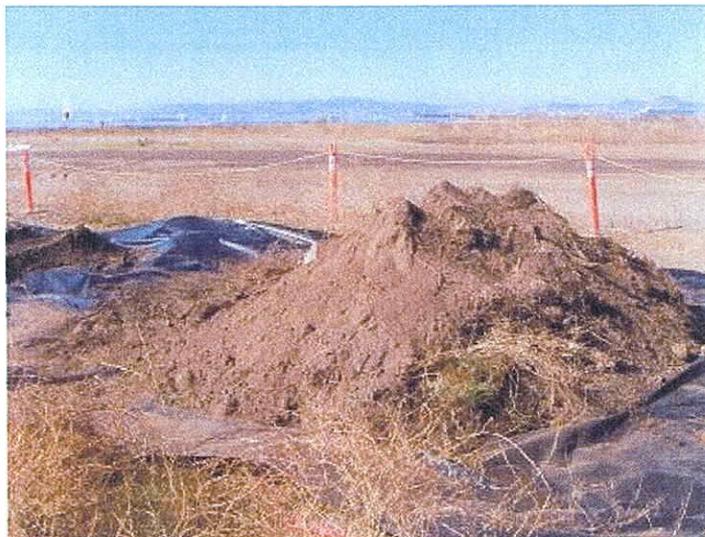
Trench 2 – Sandy Silt soil with only a trace of debris

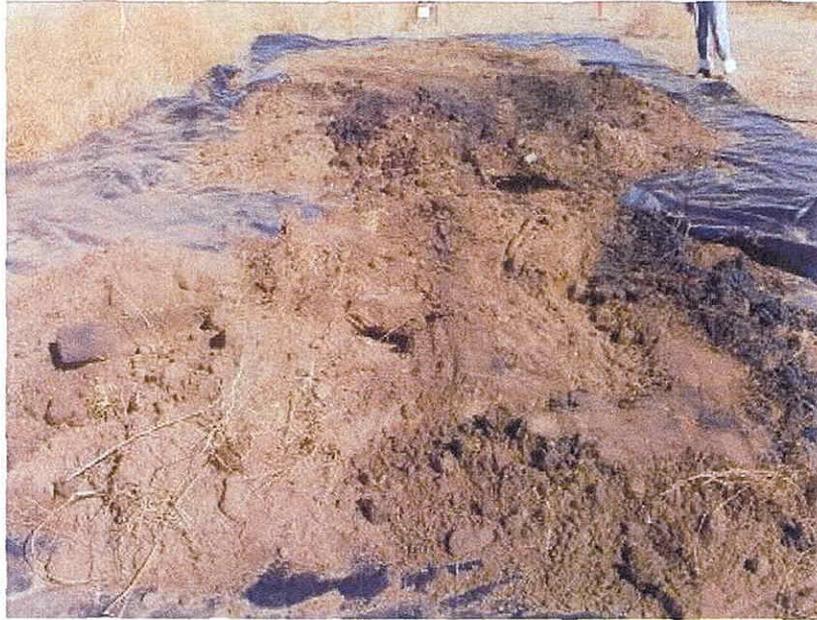
Trench 2 – Brown and dark gray soil with trace debris

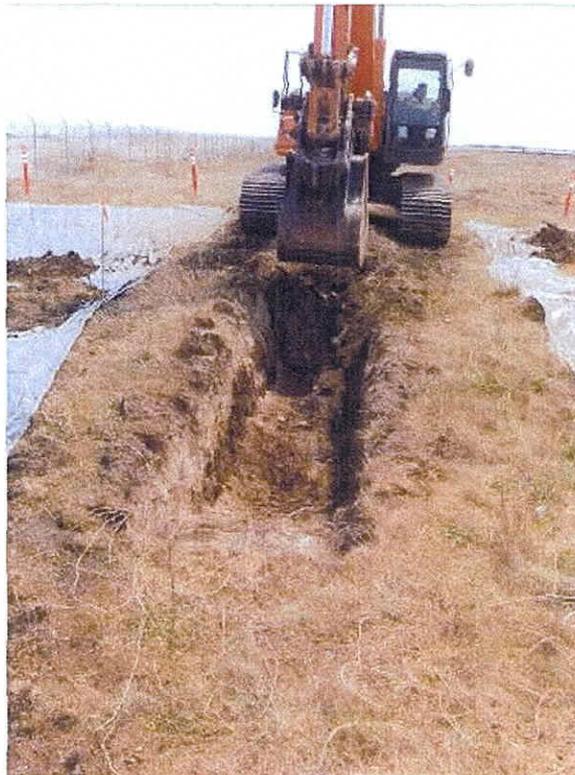
Trench 2 – Typical setup using a Cat 350 excavator with a 3-foot wide bucket. Plastic sheeting placed on both sides of trench to contain soil cuttings.

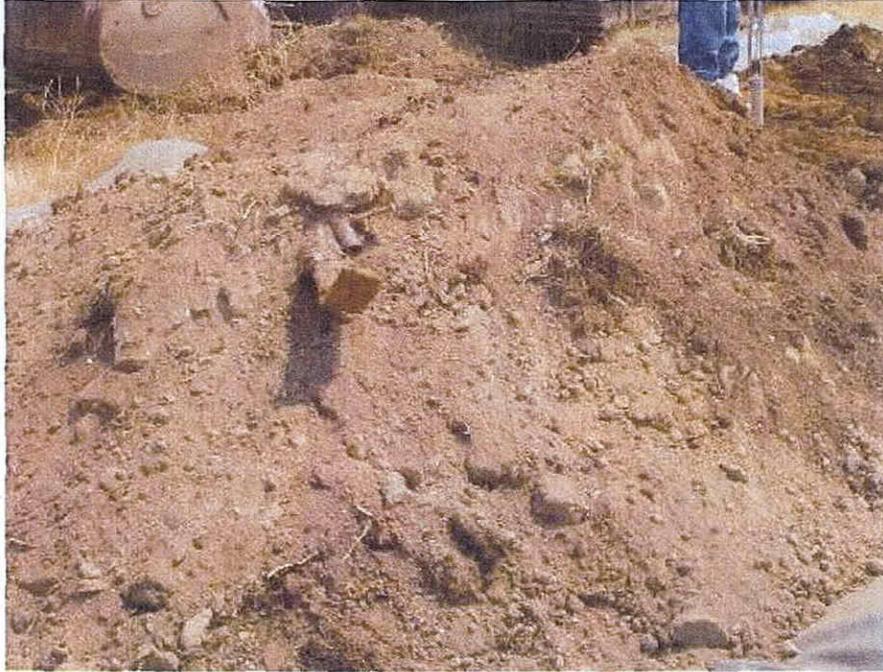
Trench 2 – Only trace debris was observed in excavation. A drum carcass was found in debris (not shown). No top or bottom third of drum body, which was highly rusted and corroded.

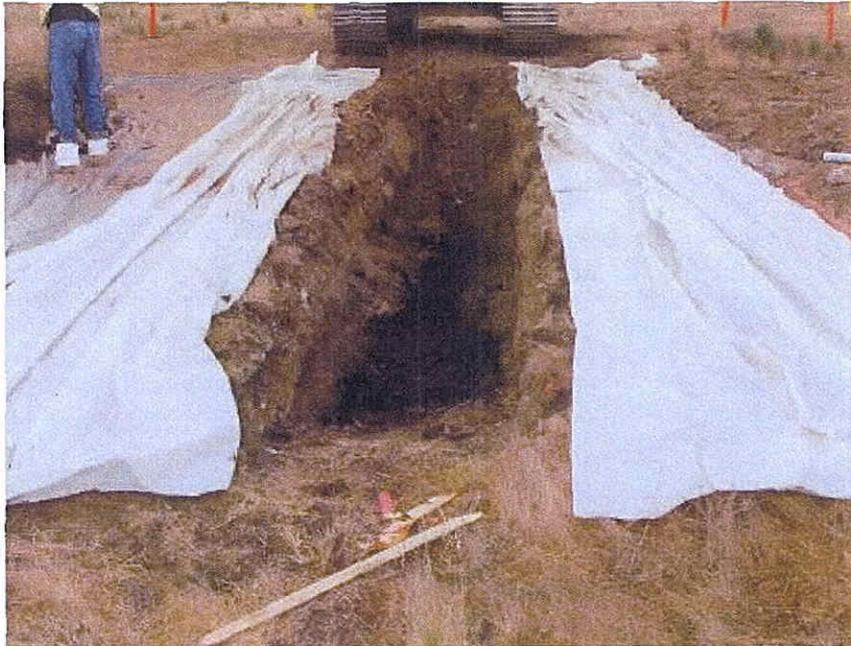
Trench 3 – Dark gray to black soil encountered with debris at 2.5 feet below ground surface

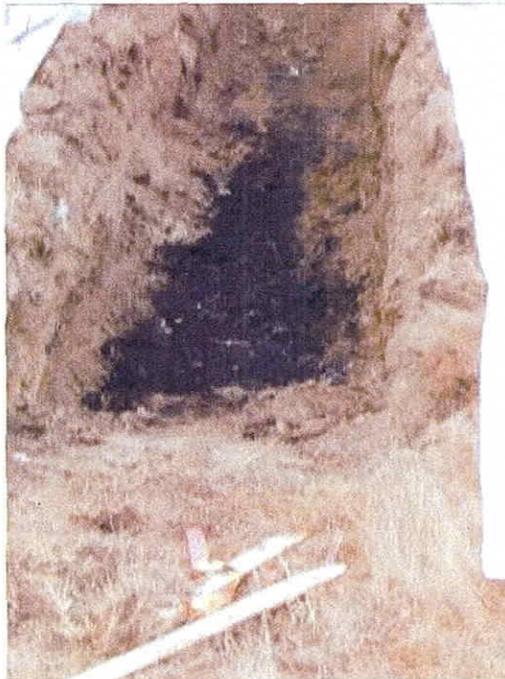
Trench 3 – Dark gray to black soil with debris

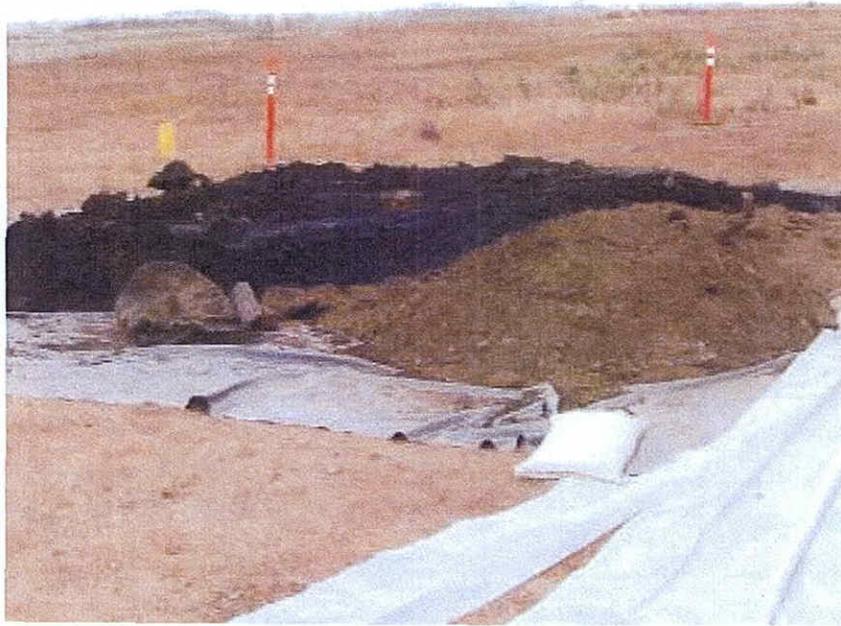
Trench 3 – An old rubber fuel cell removed from the dark gray soil zone. According to CSO, these cells were commonly used during the period the base was open.

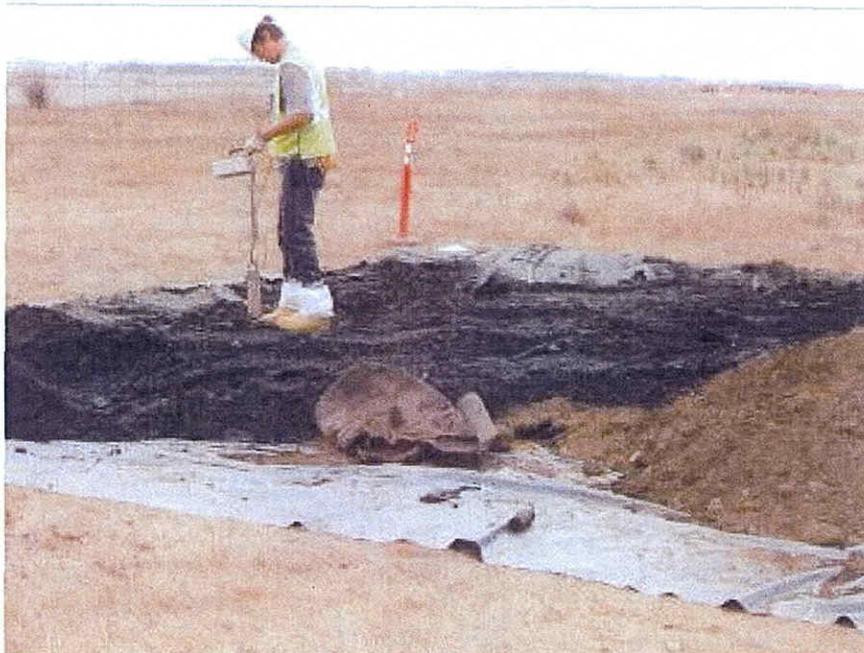
Trench 3 – Radiation Control Technician (RCT) with a sodium iodide (NaI) detector monitoring the soil for radiological contamination. Lift is less than 12 inches.

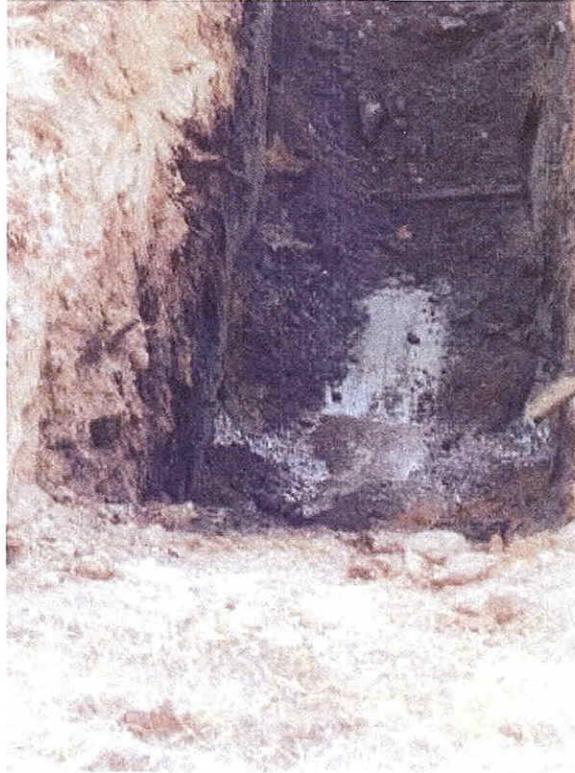
Trench 3 – Groundwater at 7 ft bgs. Dark gray soil with mixed debris from 2.5 to 7 ft bgs. Groundwater at 7 ft bgs and gray sandy soil from 7 to 8 ft bgs with no debris.

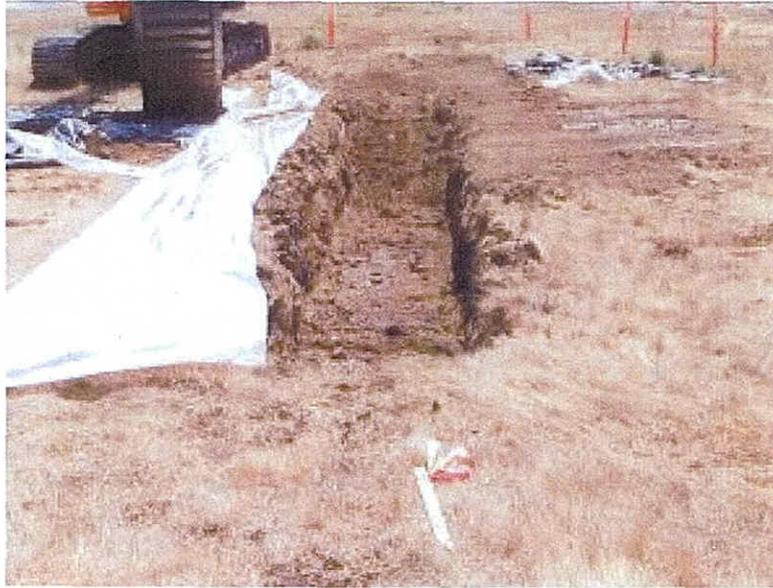
Trench 3 – Crews have completed excavation and have placed the nonimpacted soil and debris from excavation back into trench. The material was compacted using the excavator bucket. Crew is currently picking up plastic to place in an intermodal bin. One side of excavation trench has been cleaned. Note the remaining excavation is below grade due to radiologically impacted soil having been removed. The remaining portion of the trench will be backfilled with “Quarry Fines,” the approved backfill from the site. The material will be delivered in a dump truck, placed in the trench, and compacted with the excavator bucket.

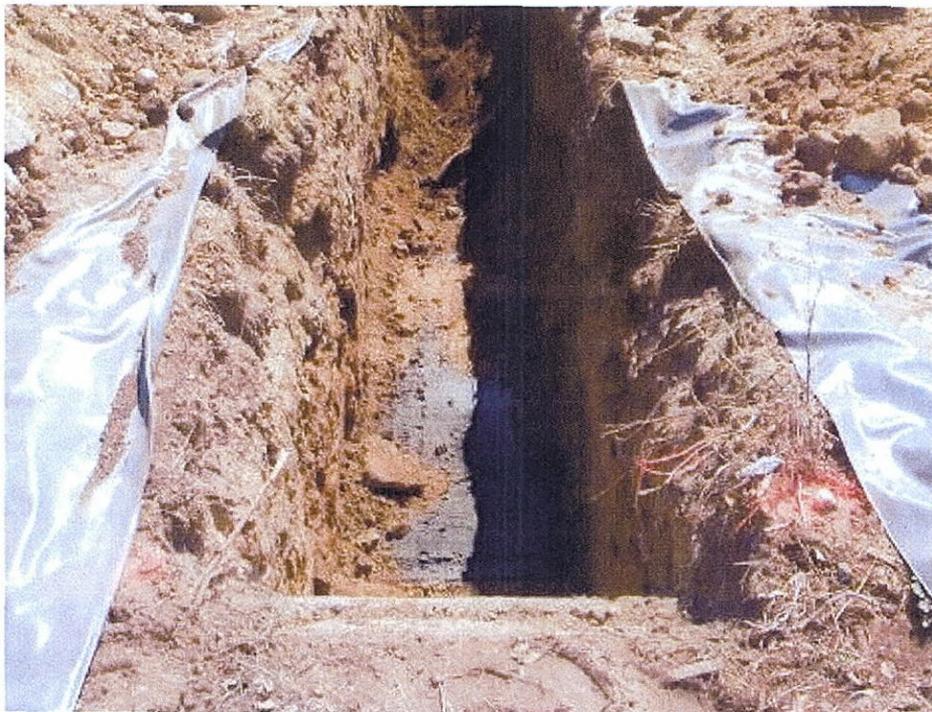
Trench 4 – Excavated trench. Trace debris. Gray sand at bottom of trench.

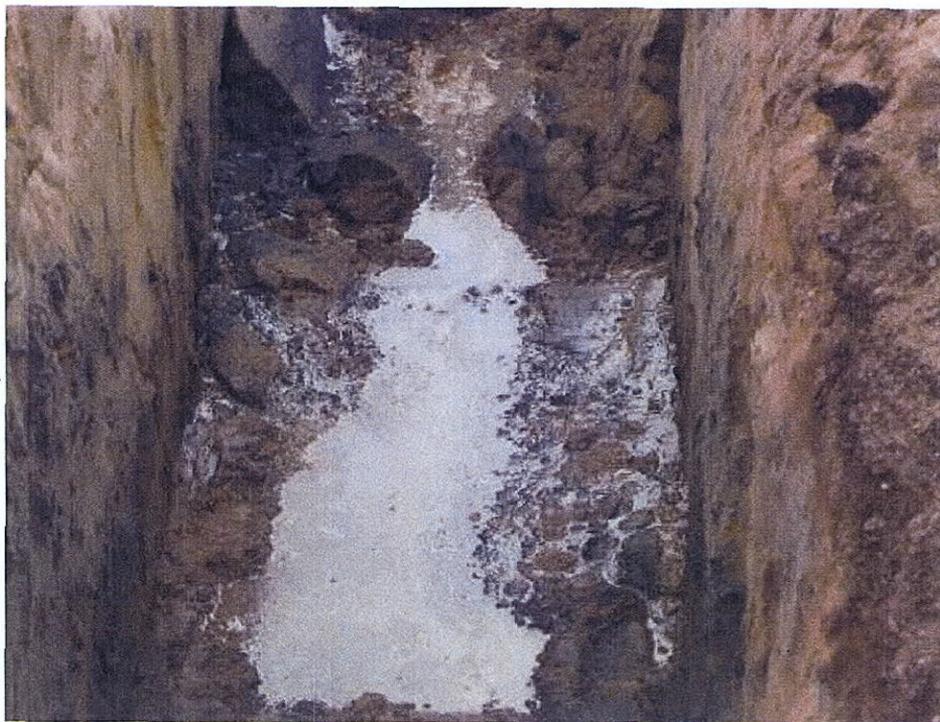
Trench 4 – Groundwater at final depth. Trace debris associated with trench.

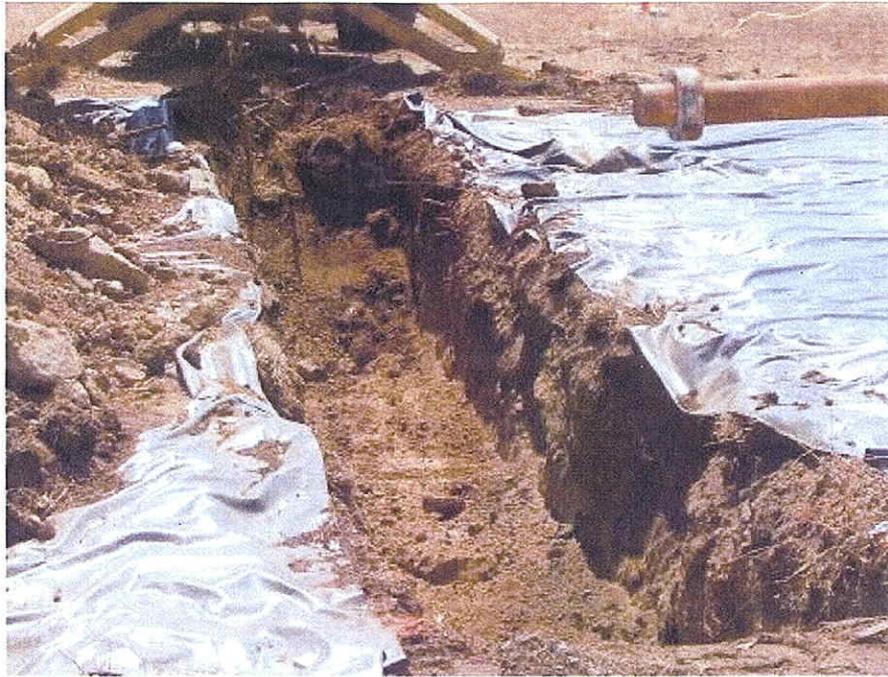
Trench 5 – The former pistol range area. Concrete near surface from former firing line.

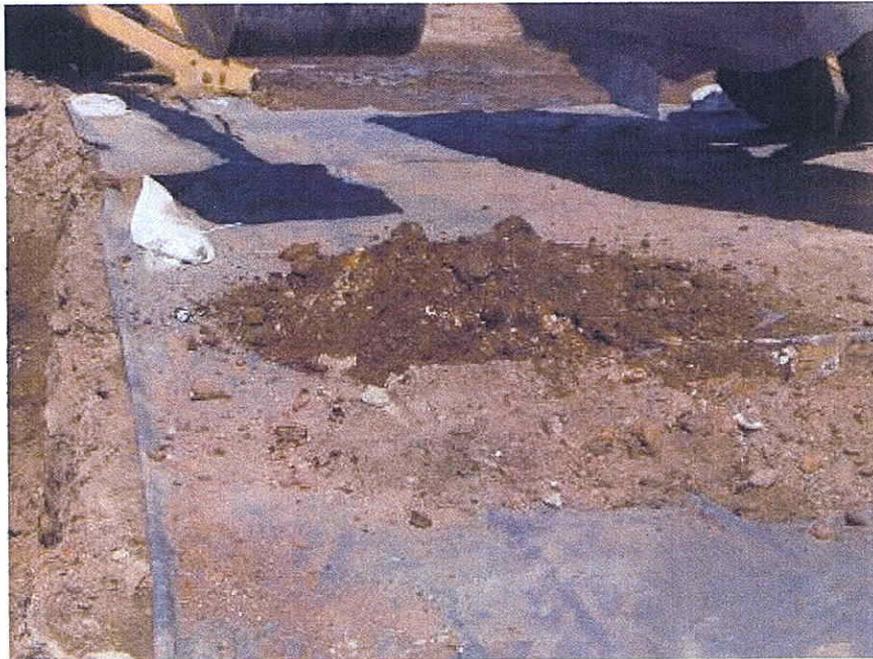
Trench 6 – Dark brown soil with rock and trace debris

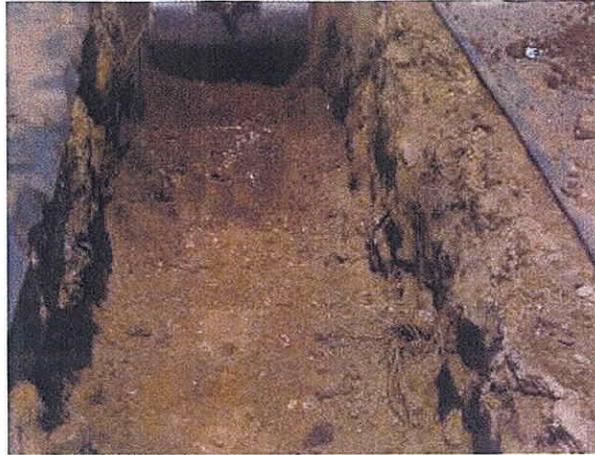
Trench 6 – Debris in trench. Note exposed wire in trench wall.

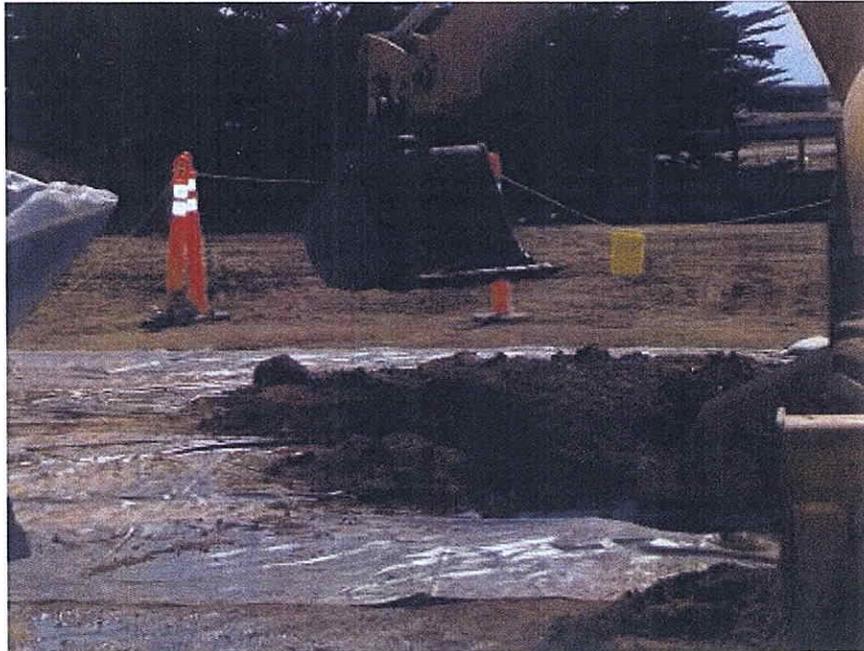
Trench 6 – A typical soil layer spread out. Once 5 scoops are spread to a layer no thicker than 12 inches, RCT and UXO technicians will survey layer.

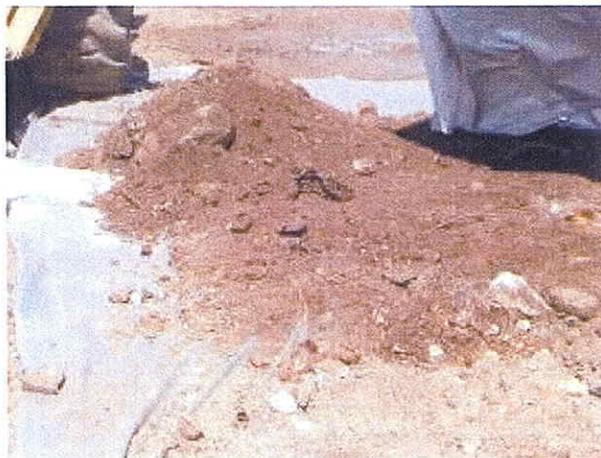
Trench 6 – Soil with trace metal debris and rock

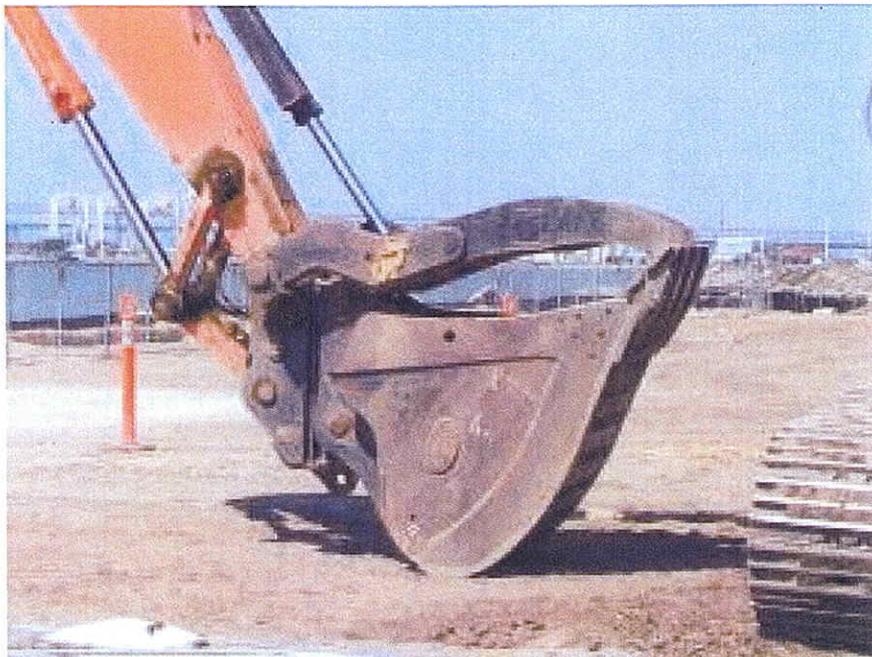
Trench 6 – The Cat 350 excavator bucket. Note numbers on side. Used by technicians to gauge depth of excavation to avoid workers standing near excavation.

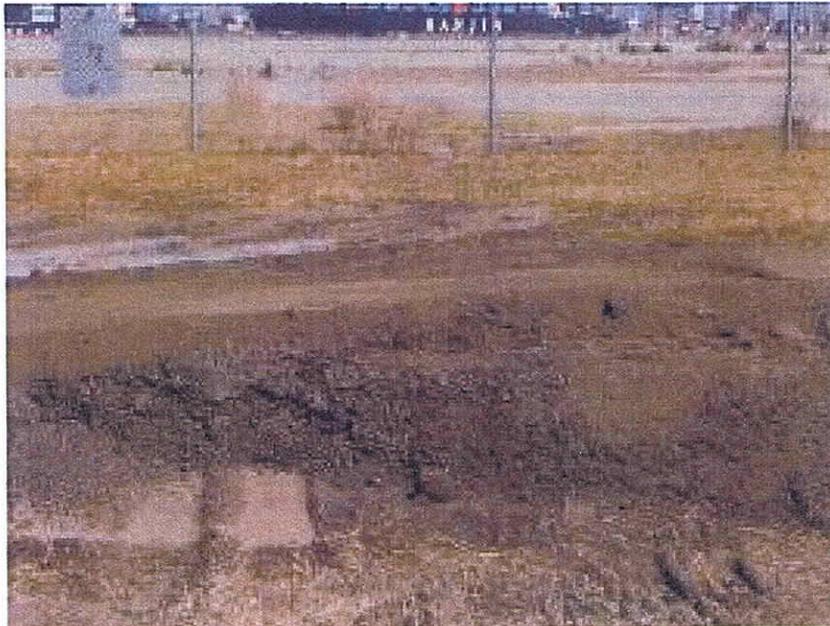
Trench 7 – Completed excavation. Import soil mounded and compacted over former excavation.

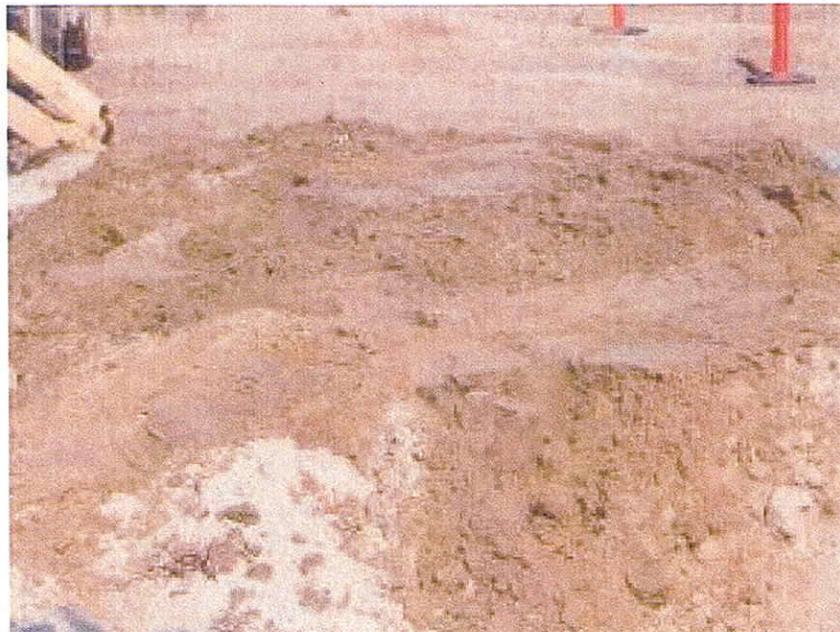
Trench 8 – Homogeneous soil throughout excavation

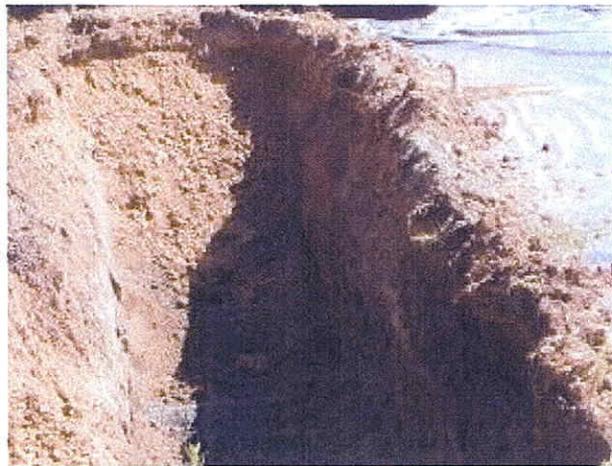
Trench 10 –An abandoned pipeline crossing the trench near excavation bottom

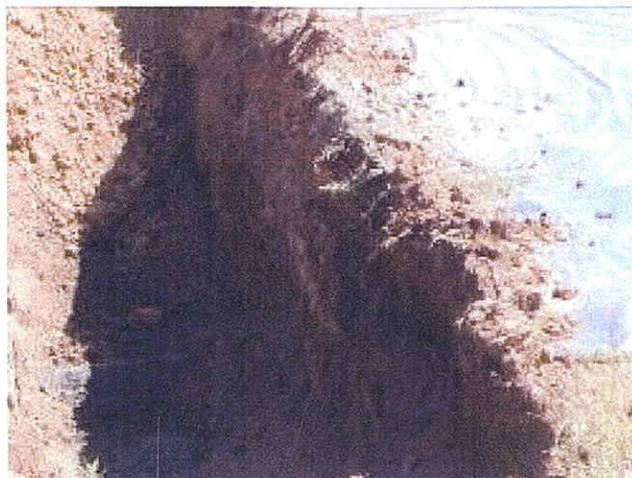
Trench 10 – Abandoned pipeline exposed across excavation
