**FINAL  
SUMMARY OF FINDINGS  
EXPLORATORY TRENCHES  
Revision 1  
May 16, 2008**

**INSTALLATION RESTORATION SITE 1  
FORMER NAVAL AIR STATION ALAMEDA  
ALAMEDA POINT, ALAMEDA, CALIFORNIA**

**DCN: ECSD-2201-0015-0005.R1**

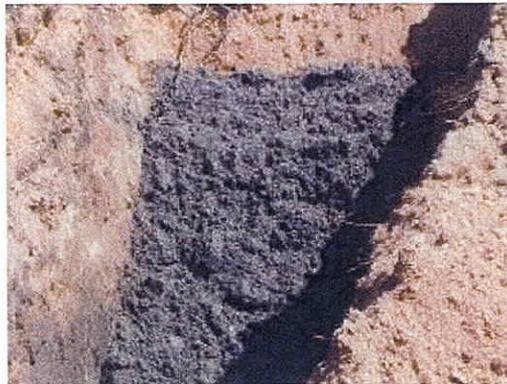
Trench 10 – Sandy gray soil that was excavated below waterline and spread on trench wall to confirm that the limited debris zone at the water level did not extend to depth. Discoloration associated with suspected anaerobic conditions at the site.

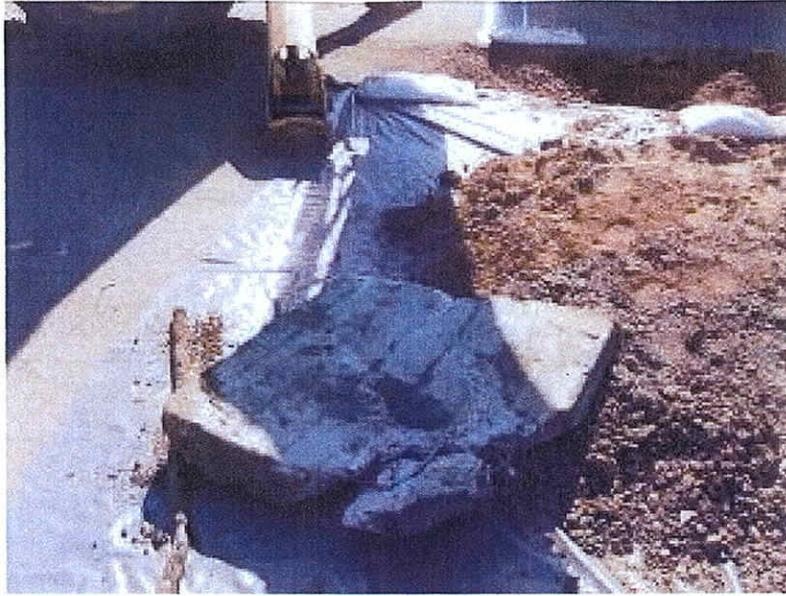
Trench 11 – The removed concrete debris with rebar.

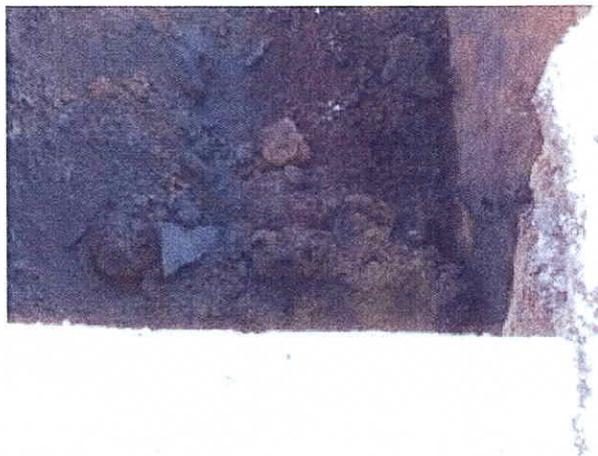
Trench 11 – Mostly silty sand material with trace rock and debris.

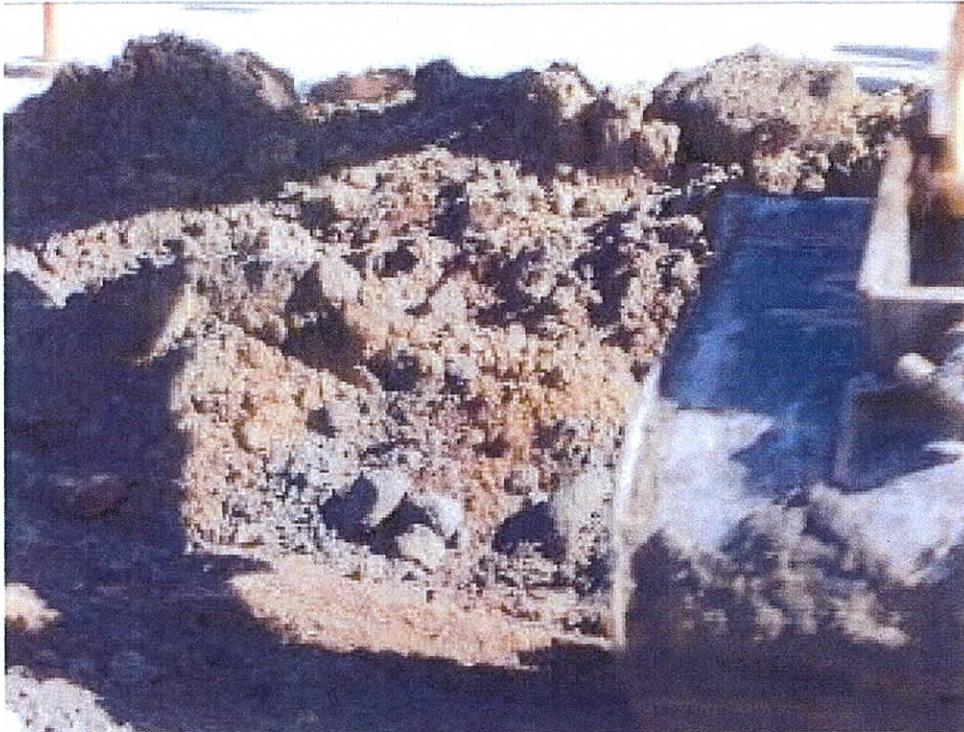
Trench 11 – Excavated soil. Trace debris only.
