# Final Wetland Delineation Installation Restoration Site 32

Alameda Point  
Alameda, California

April 2011  
Document Control No: KCH-2622-0006-0095

# Wetland Delineation Installation Restoration Site 32

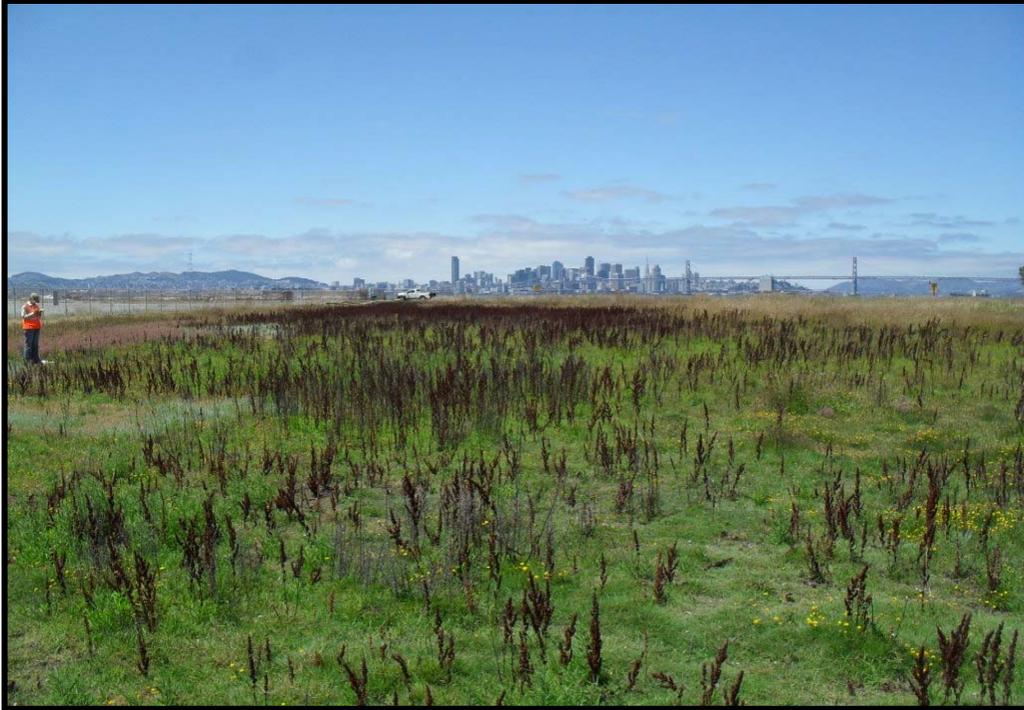
Seasonal Wetland SW-1: Low depressional basin area in the southwest corner; characterized primarily by saltgrass and curly dock with other scattered hydrophytic plant species

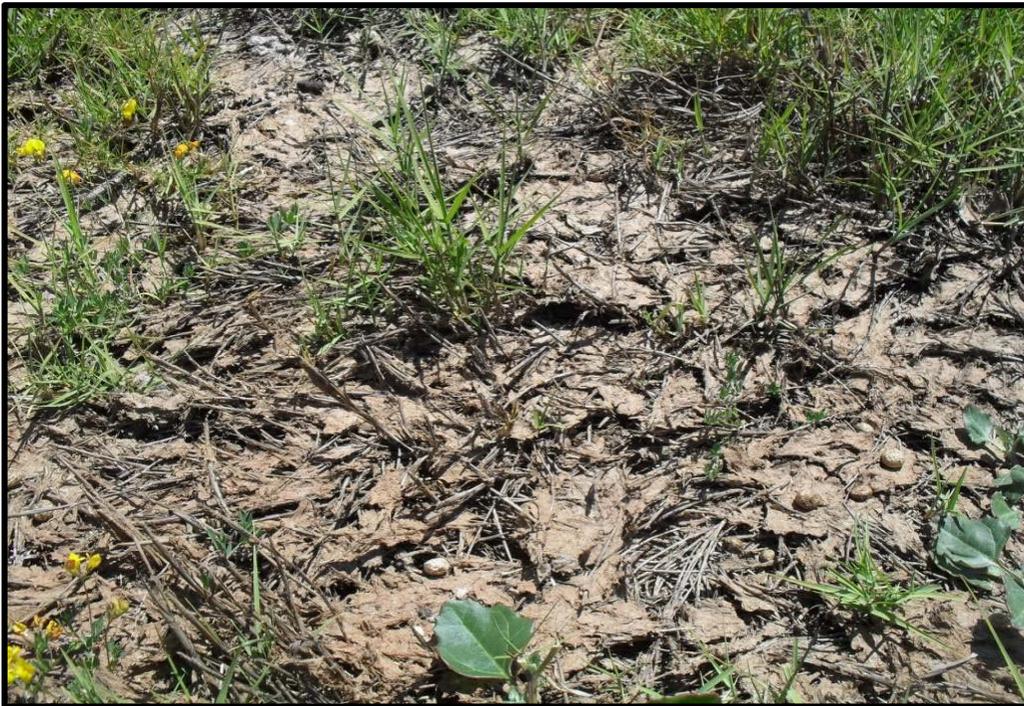
Seasonal Wetland SW-1: Biotic crust (algal matting); a primary indicator of seasonal wetland hydrology; observed in scattered locations throughout the southwest portion.

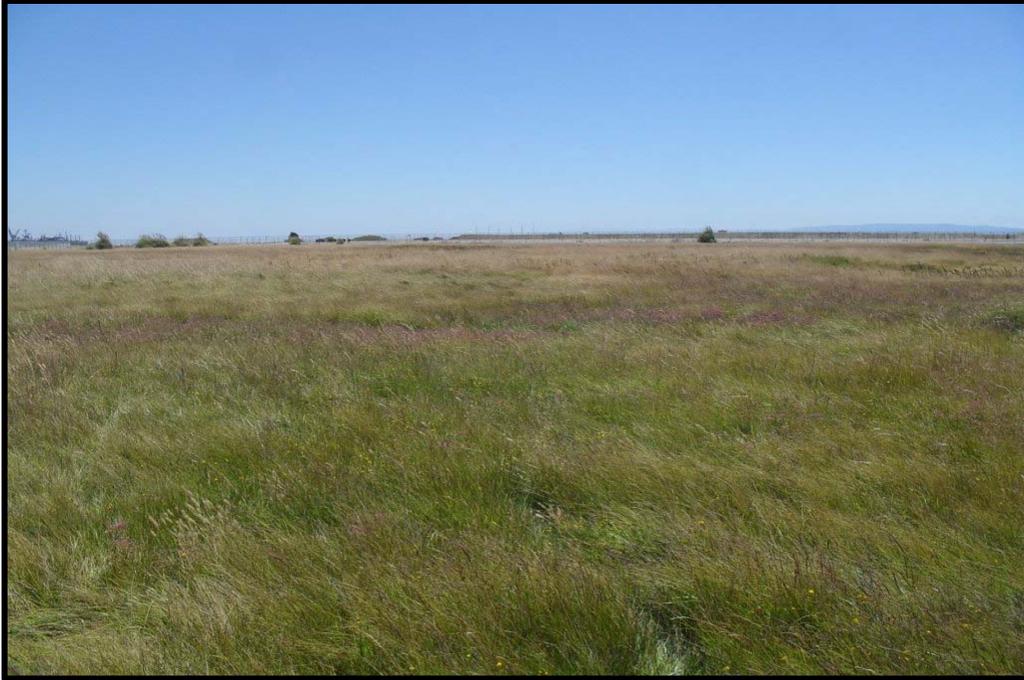
Seasonal Wetland SW-1: Mesic meadow habitat, characterized by a mixture of creeping bent grass, clustered field sedge, and tall fescue in this area. No indicators of surface hydrology were evident during the July 2010 field survey; possible seasonal saturation in the upper part of the soil.

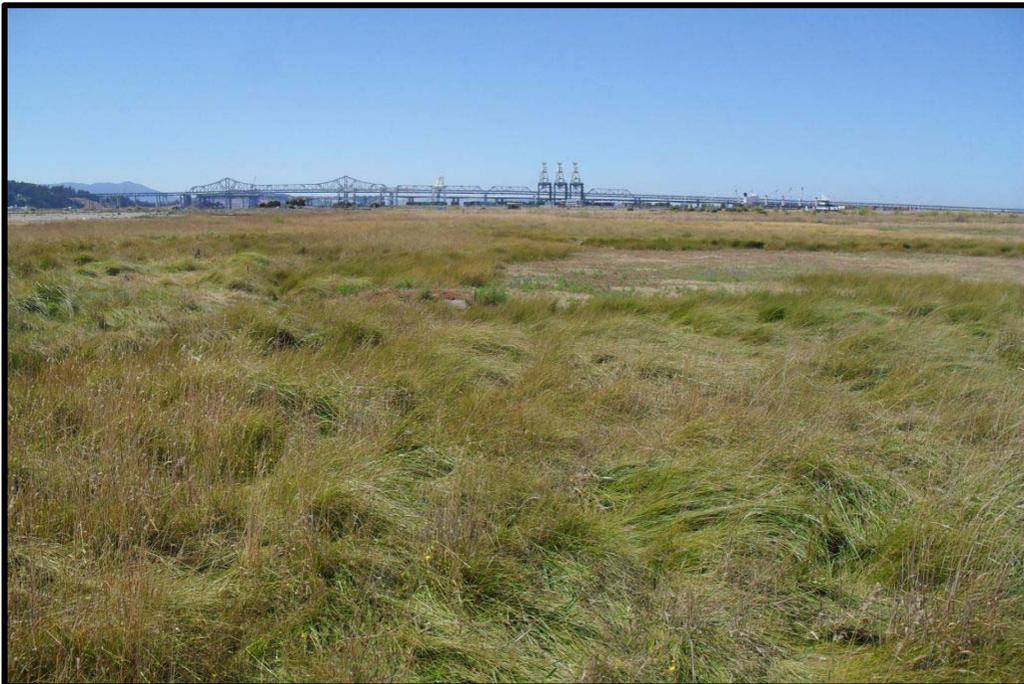
Seasonal Wetland SW-2: Dense clustered field sedge along the south and western part of low depressional area; no evidence of seasonal surface ponding in this area; possible prolonged saturated soils in the upper part during the winter and early spring months.

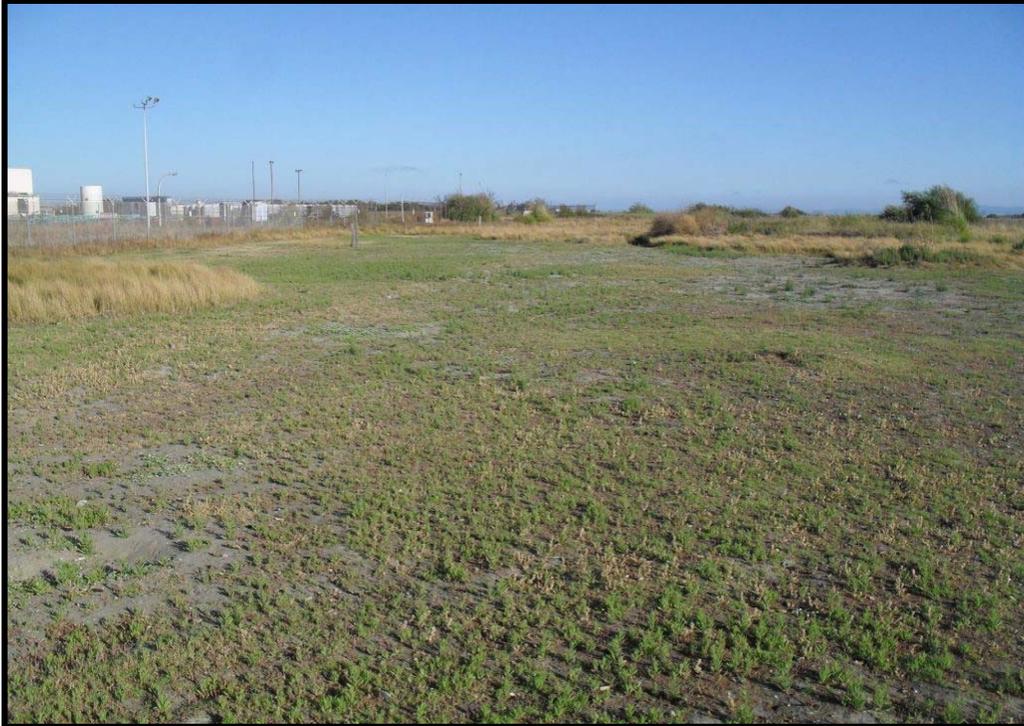
Seasonal Wetland SW-2: Low, sandy depressional area characterized by relatively dense hyssop loosestrife with young stinkwort also common.

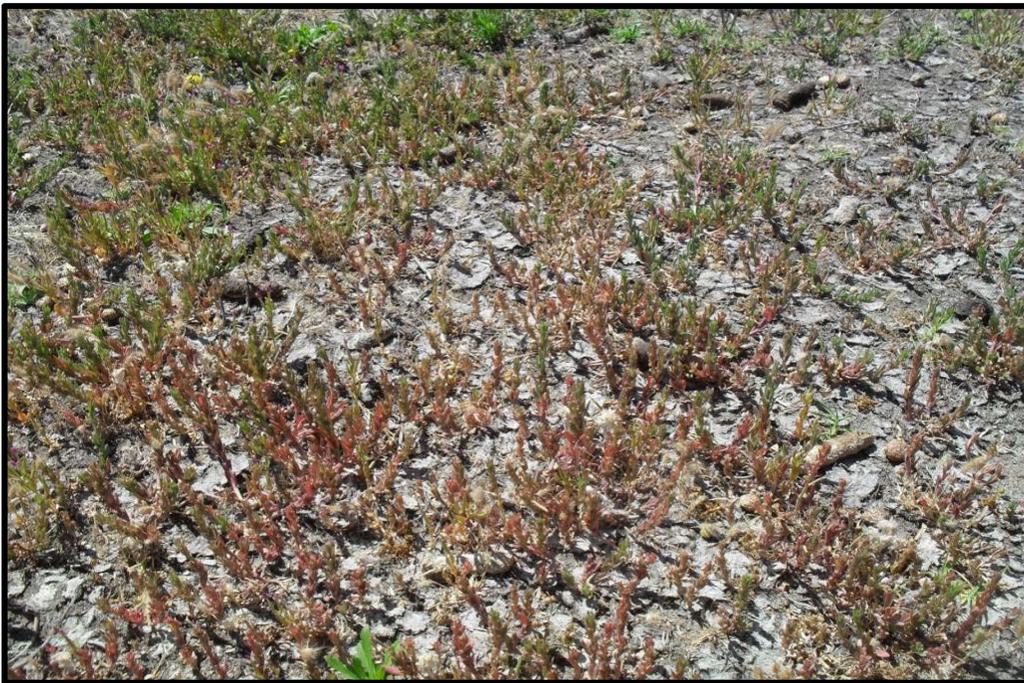
Seasonal Wetland SW-2: Hyssop loosestrife with biotic crust (dried algal matting); a primary indicator of seasonal wetland hydrology.

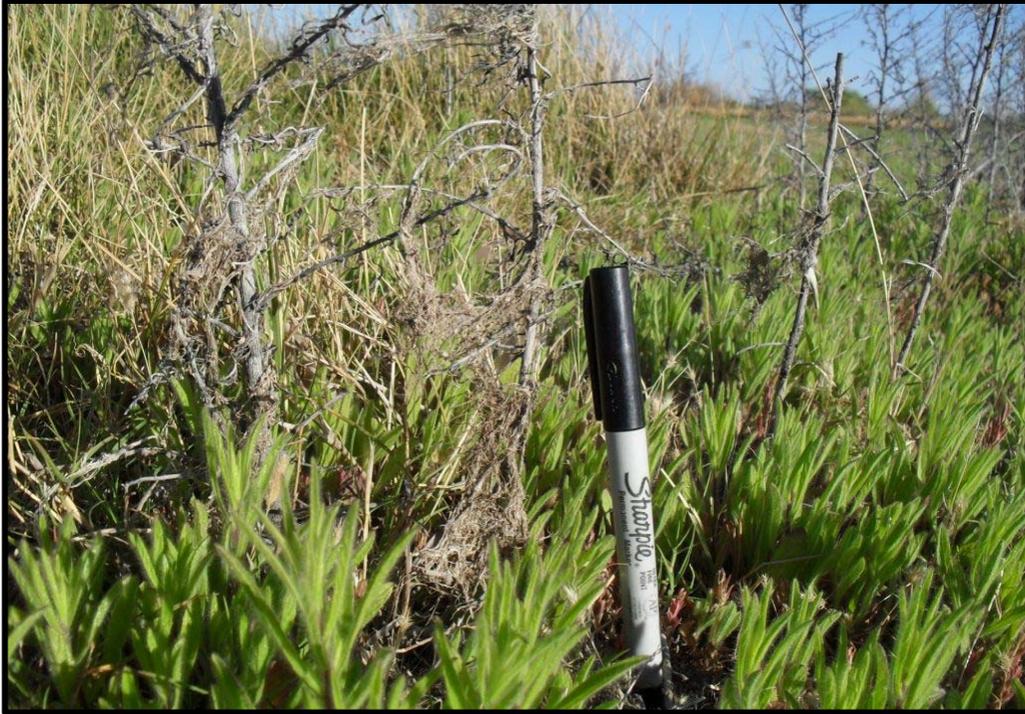
Seasonal Wetland SW-2: Drift deposits (nonriverine) observed near the northeast edge of the low depressional area, with young growth of stinkweed - a primary indicator of wetland hydrology.

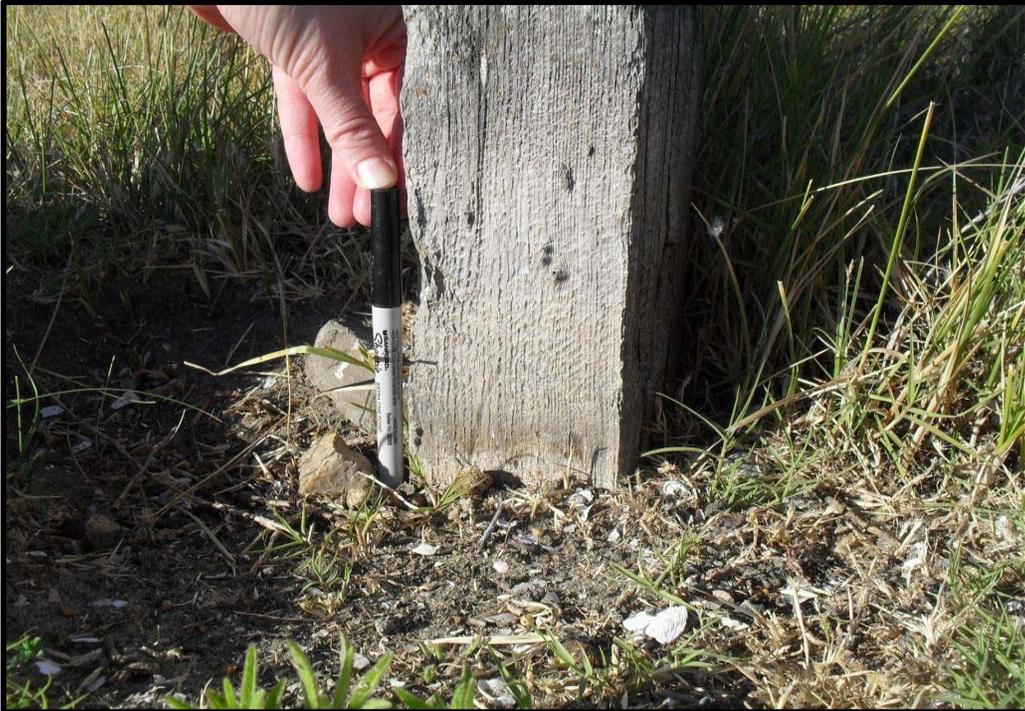
Seasonal Wetland SW-2: Water marks (nonriverine) on wooden post within the low depressional area are also primary indicators of seasonal wetland hydrology.

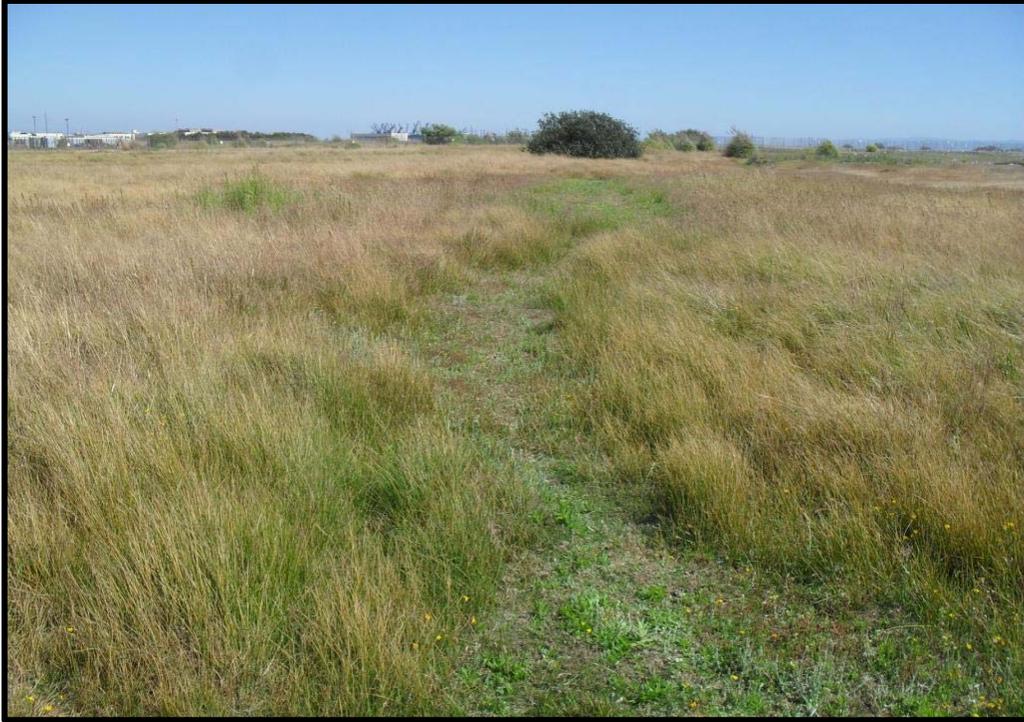
Seasonal Wetland SW-2: Drainage swale through dense clustered field sedge.

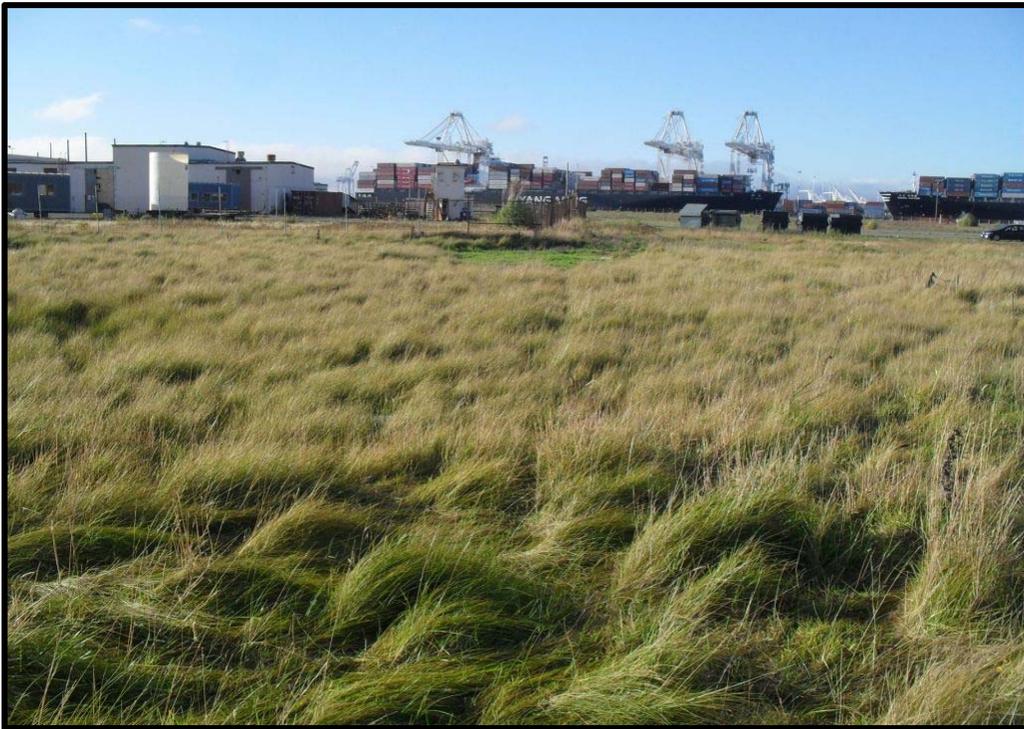
Seasonal Wetland SW-3: Dense clustered field sedge; generally no evidence of seasonal surface ponding in this area; possible prolonged saturated soils in the upper part during the winter and early spring.

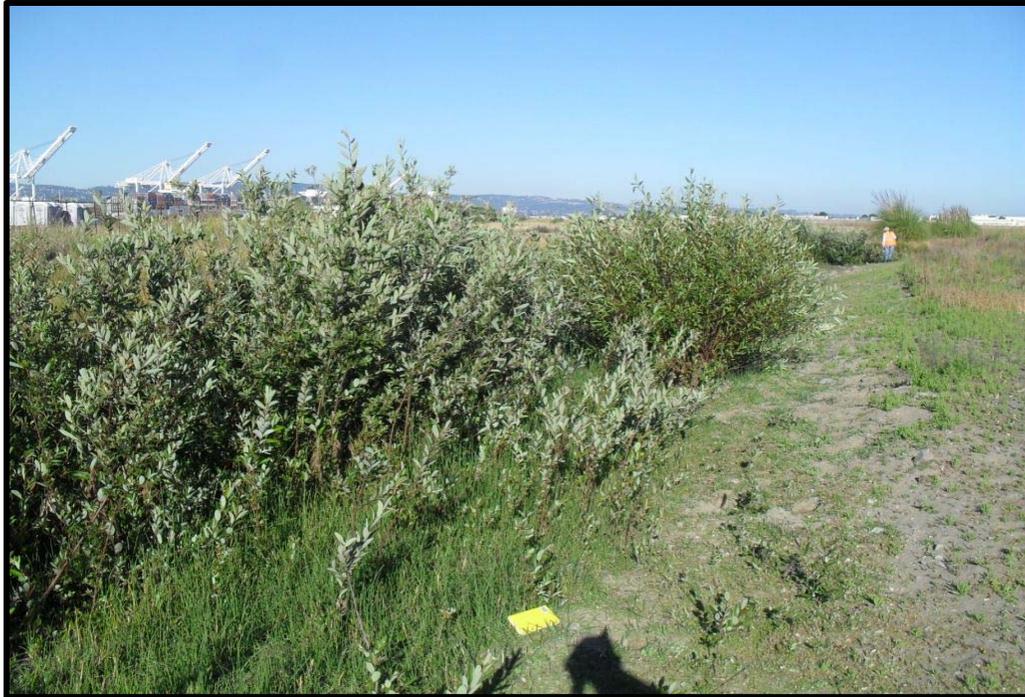
Seasonal Wetland SW-4: Linear depression area with arroyo willows, rushes, and creeping spikerush; depressional topography along with abundance of obligate wetland vegetation in this area suggested that seasonal wetland hydrology is present.

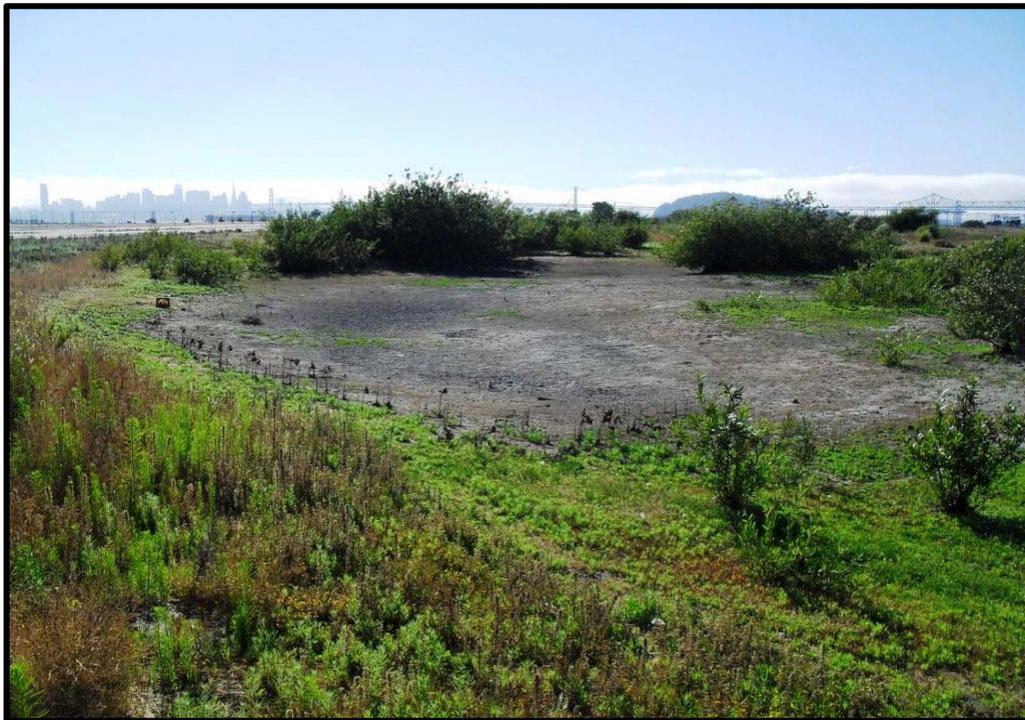
Seasonal Wetland SW-6: Appears to be an excavated area subject to seasonal inundation with wetland vegetation around the margins.

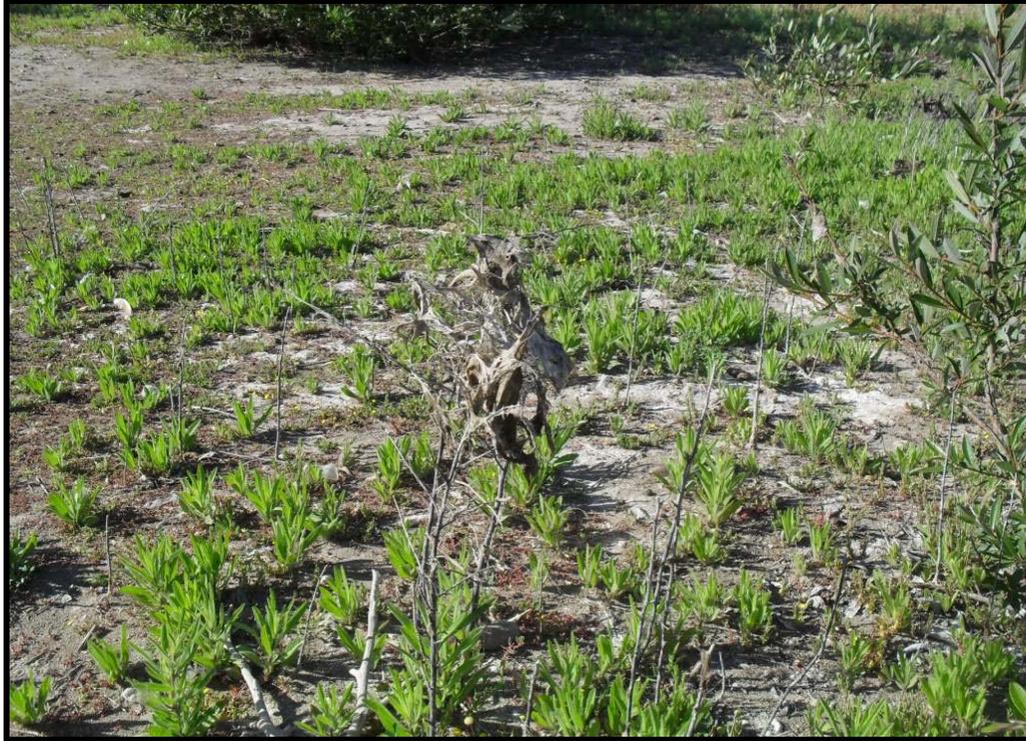
Seasonal Wetland SW-6: Drift deposits (nonriverine) observed within the basin indicate over 12 inches of seasonal ponding in this area.

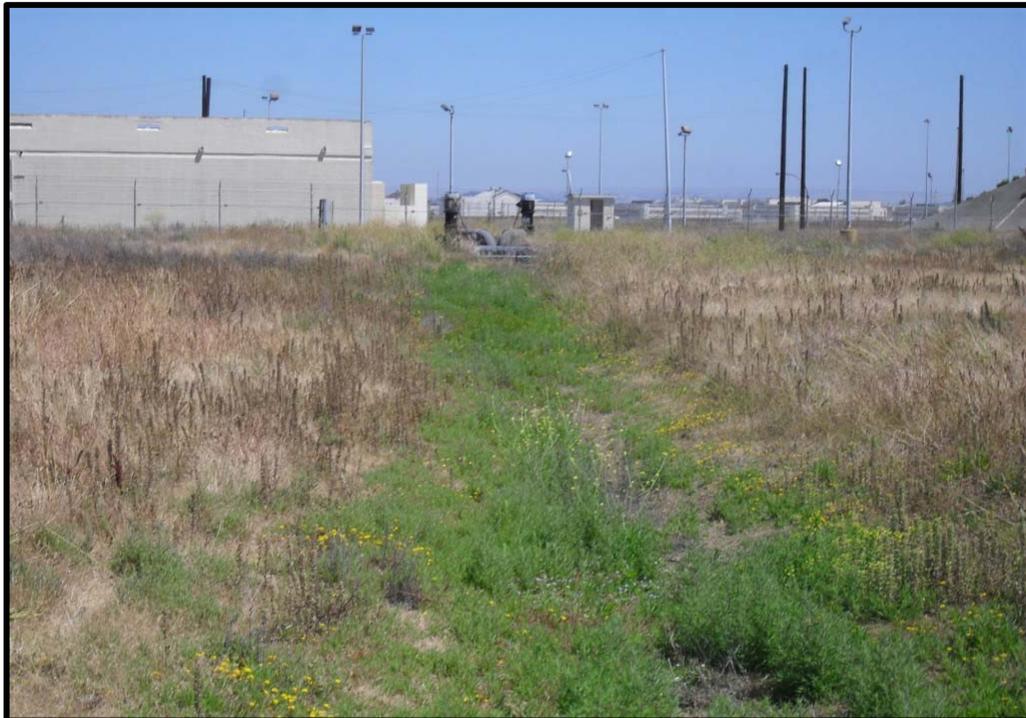
Seasonal Wetland SW-6: Excavated drainage swale and discharge pumps; dense stinkwort throughout the feature in this photograph.

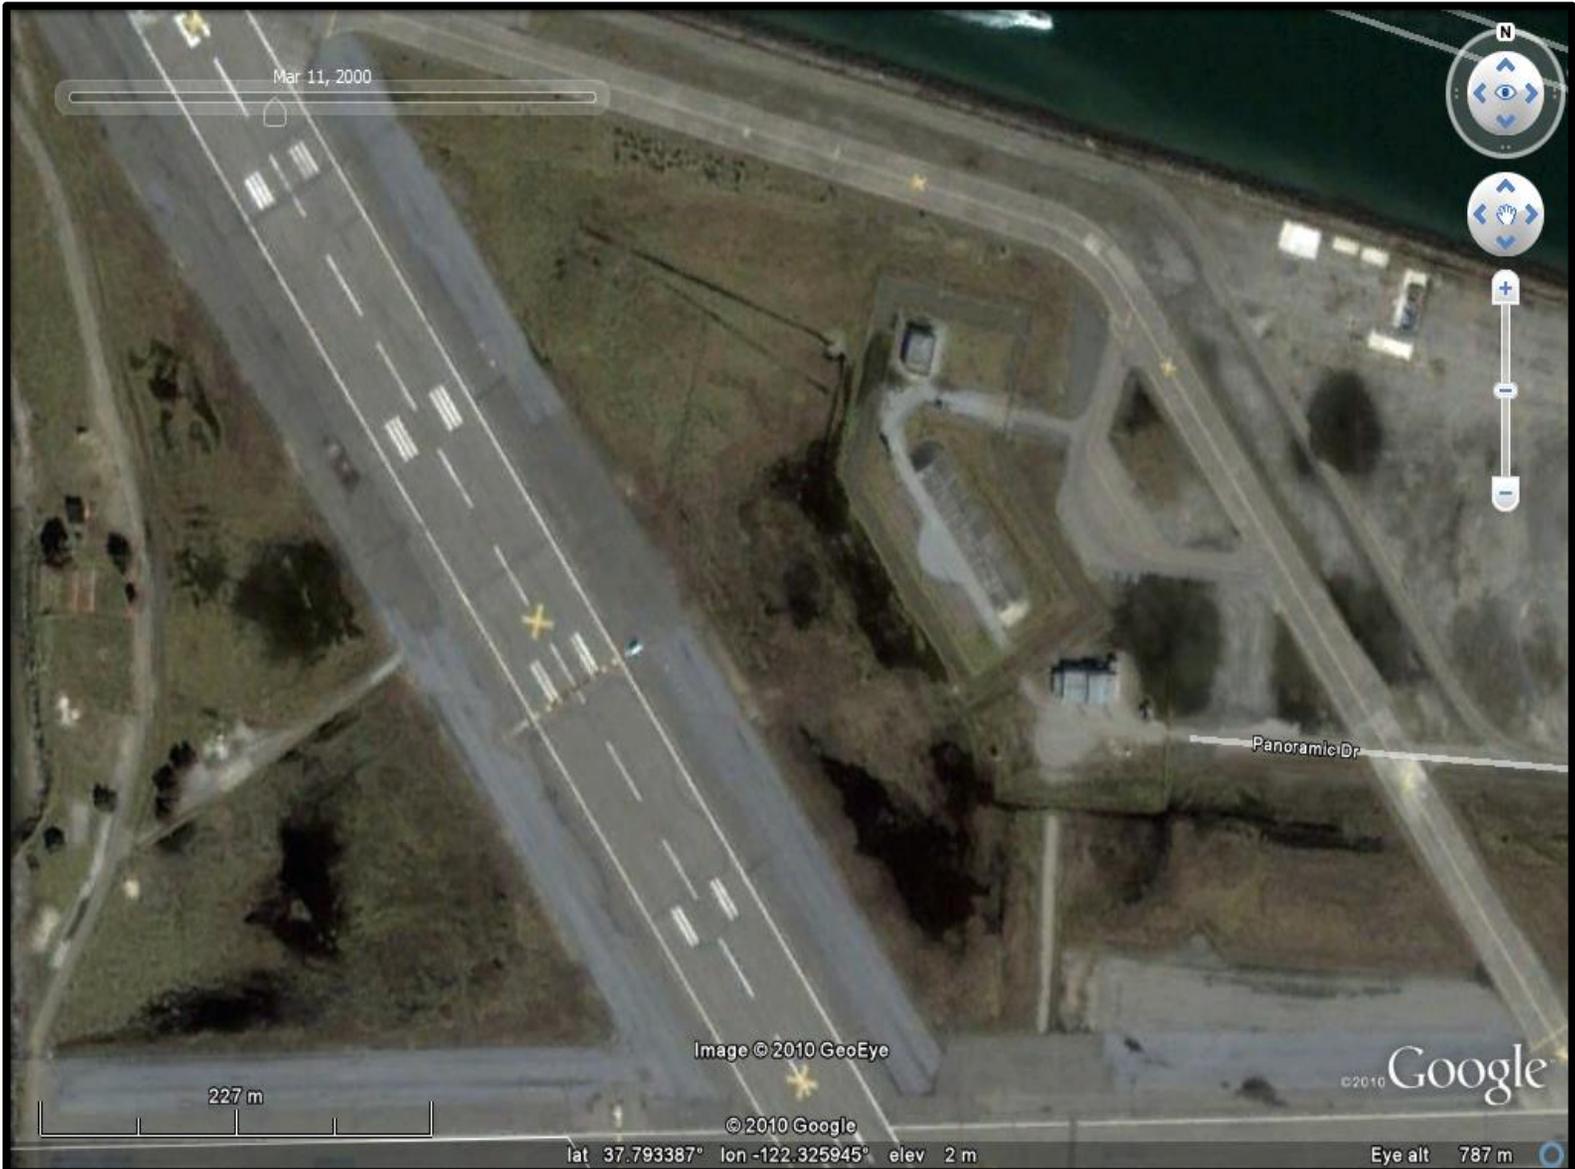
Aerial Photo from March 11, 2000. Seasonal rainfall in January and February of 2000 was 150 percent and 200 percent above the average for each month, respectively.

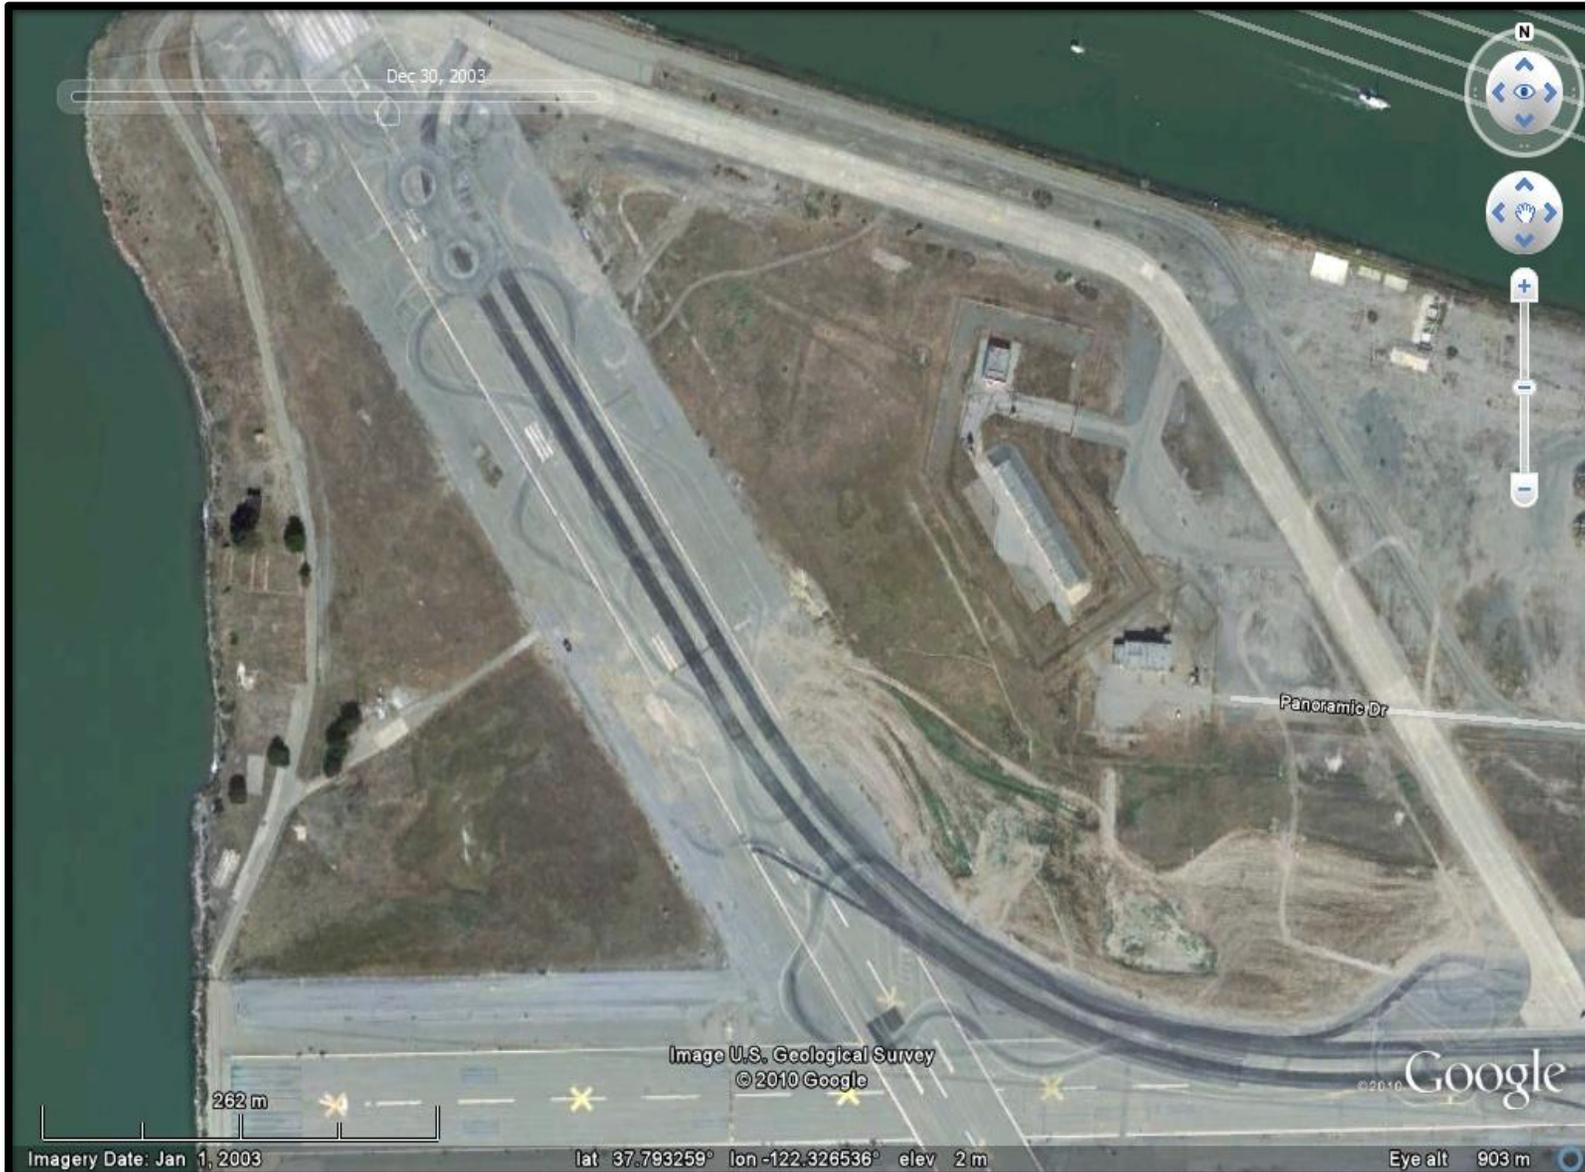
Aerial photograph from December 30, 2003. Total rainfall for the month of December was 6.77 inches, which is 160 percent above the average for this month. Total rainfall in November was approximately 86 percent of normal.

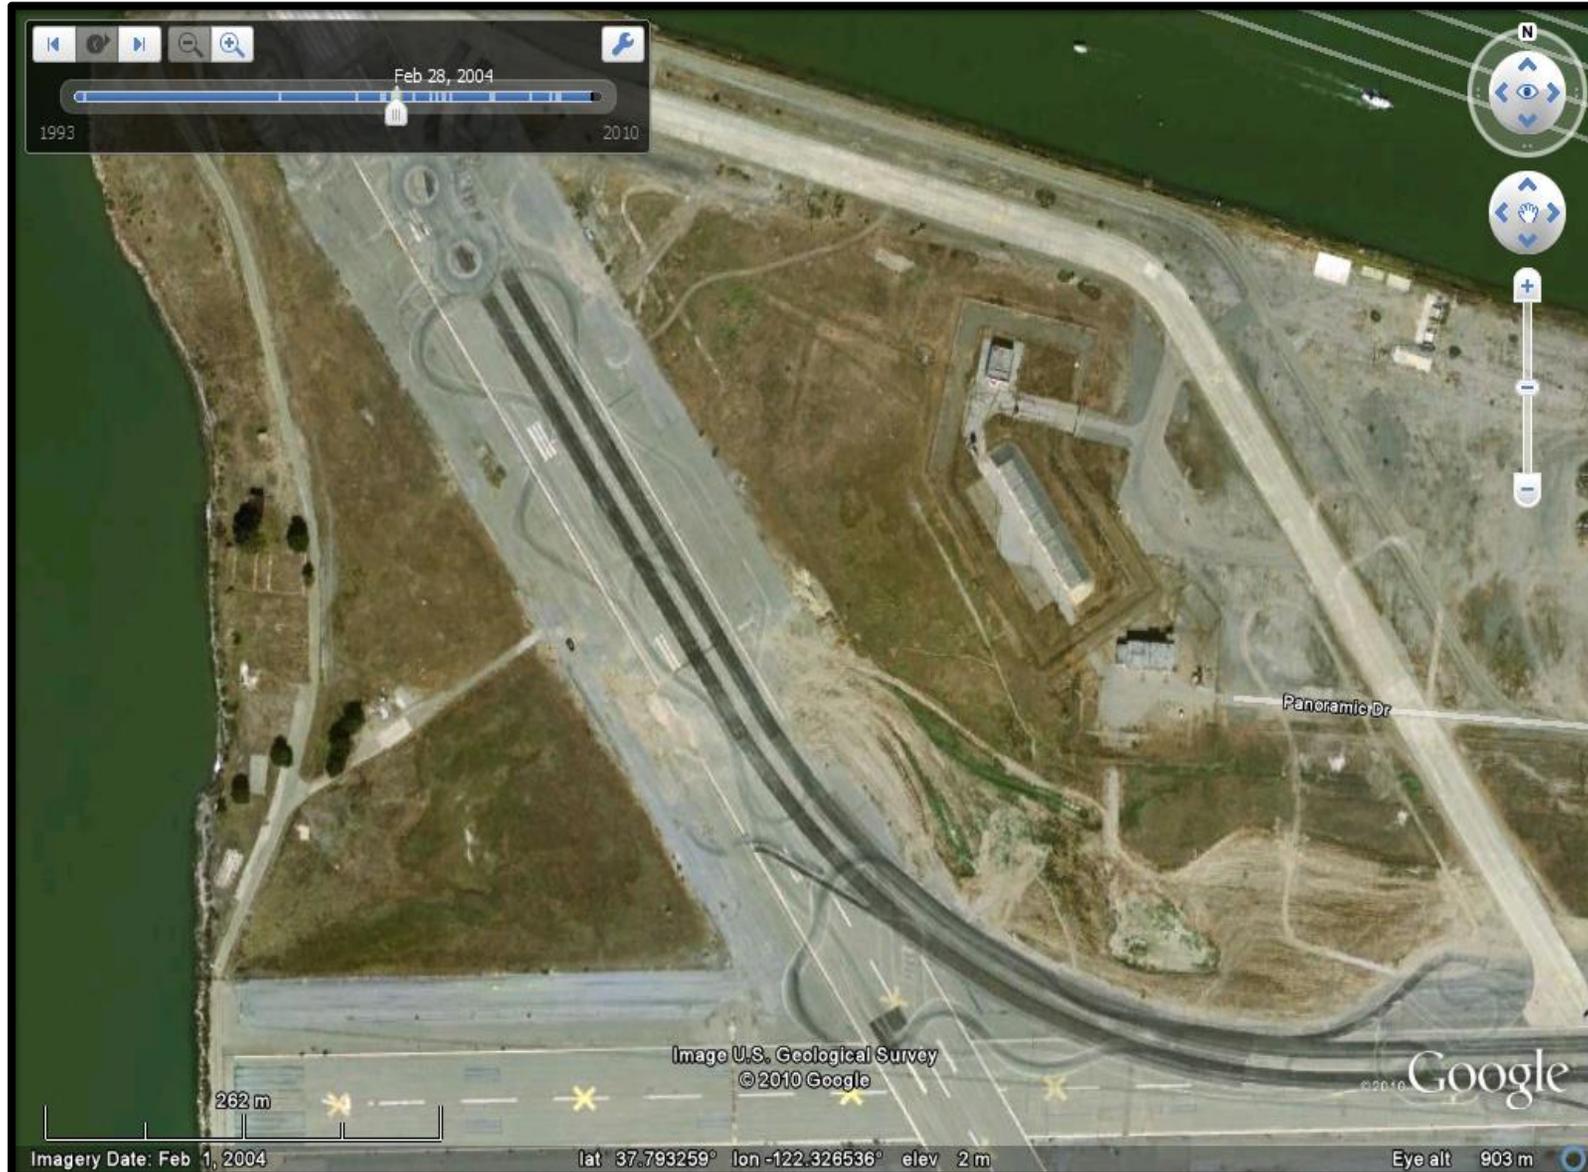
Aerial Photo from February 28, 2004. Total rainfall during February 2004 was 5.83 inches, which is approximately 135 percent of average precipitation for this month. Rainfall in January of 2004 was approximately 70 percent of the average.

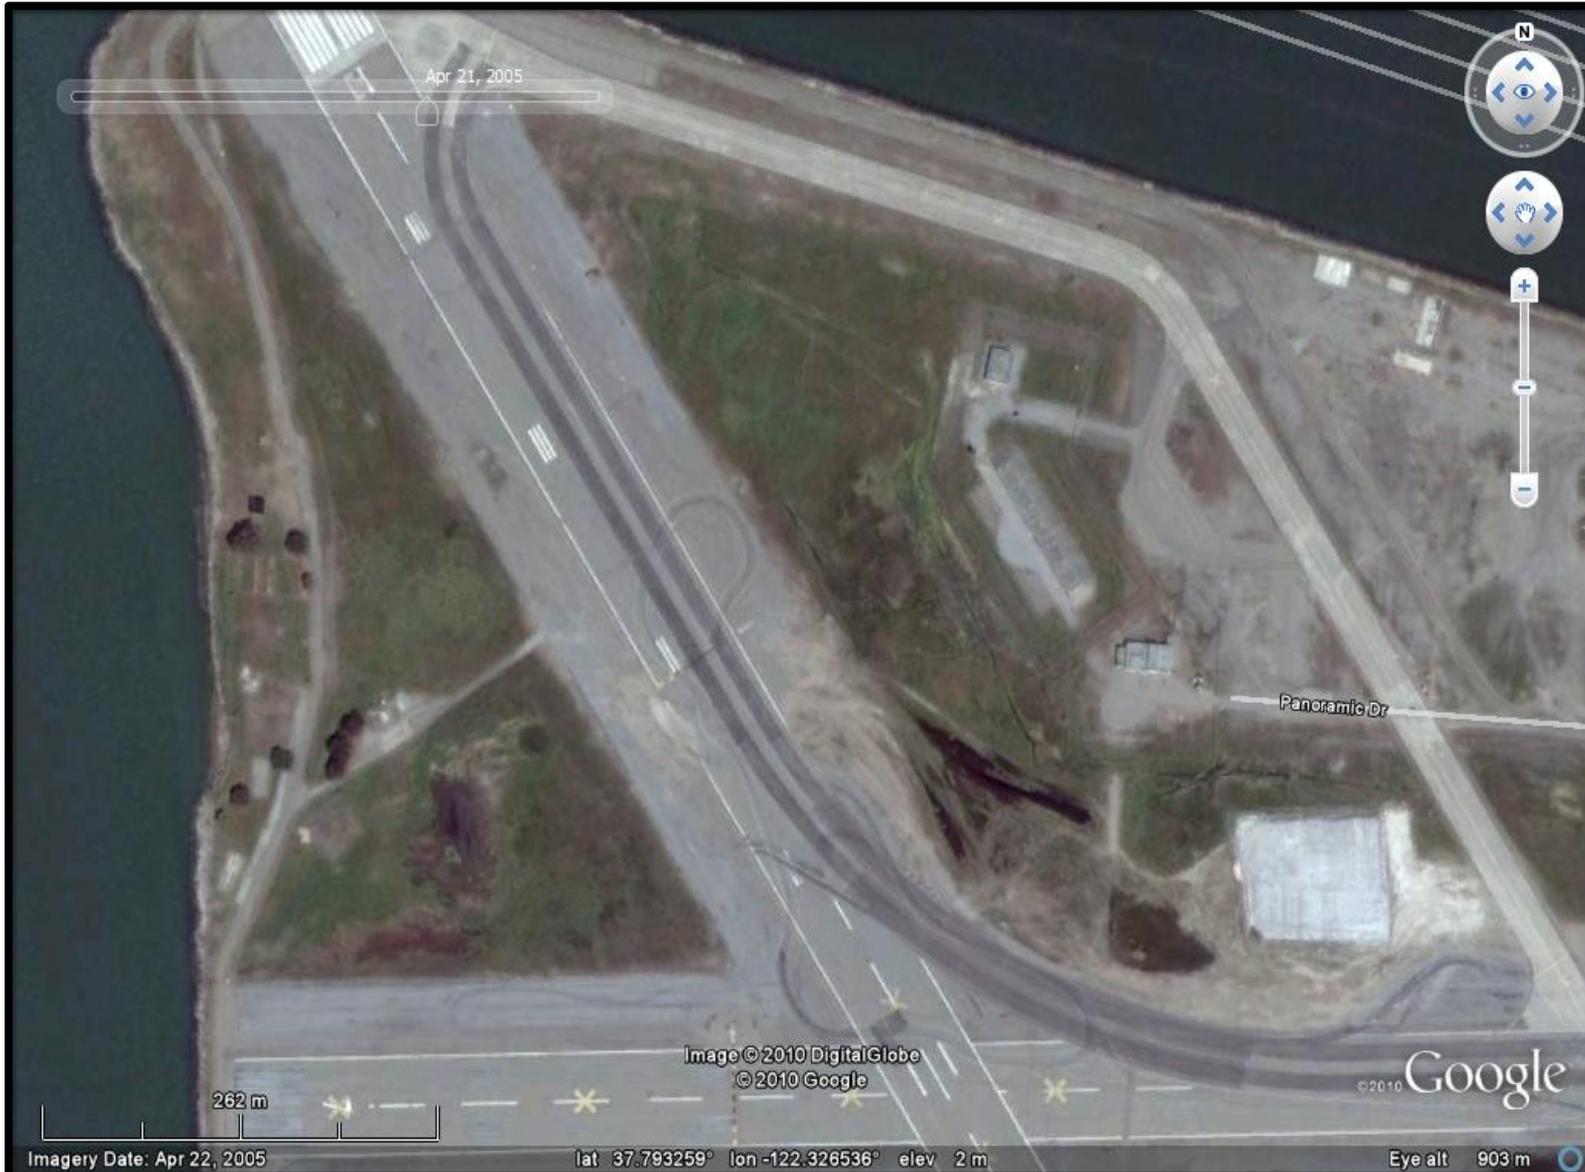
Aerial Photo from April 21, 2005. Total rainfall between March 1 and April 21 was 6.68 inches, which is approximately 140 percent the average for this time of year.

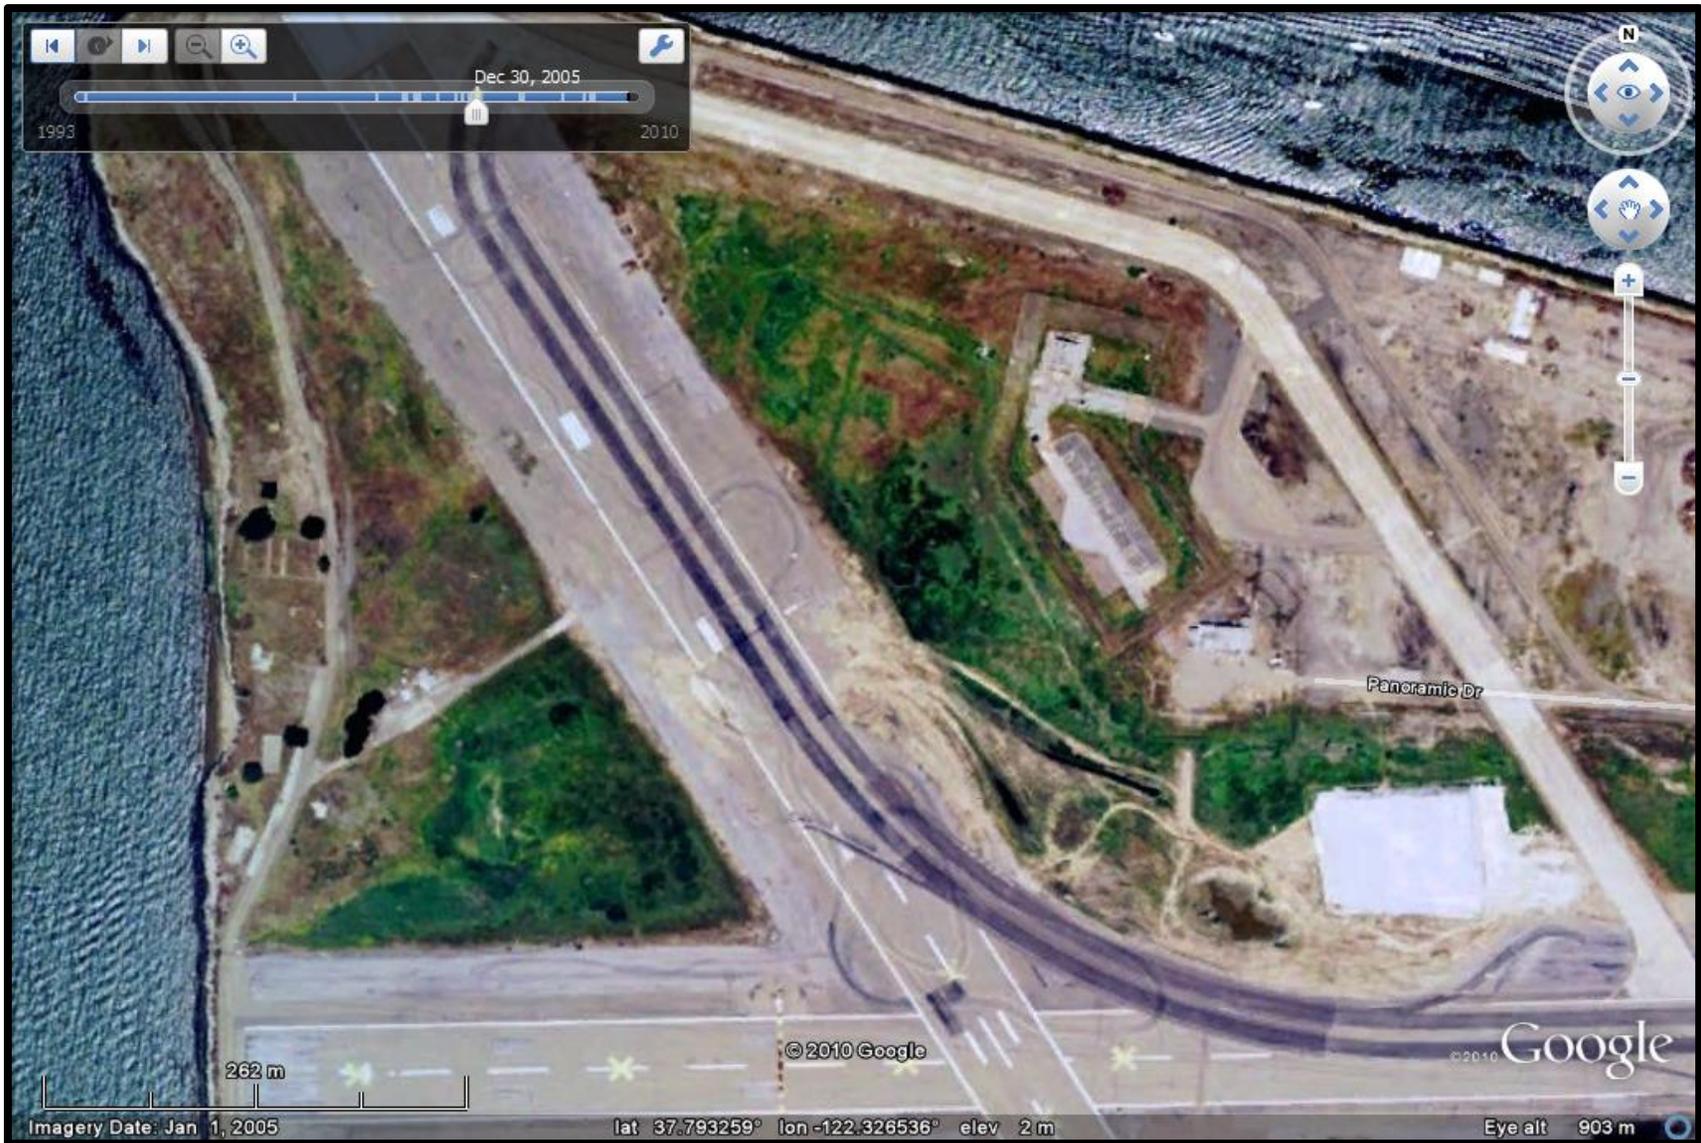
Aerial photograph from December 30, 2005. Total rainfall during December 2005 was 8.98 inches, or 214 percent of the average for this month. Rainfall in November was approximately 80 percent of normal.

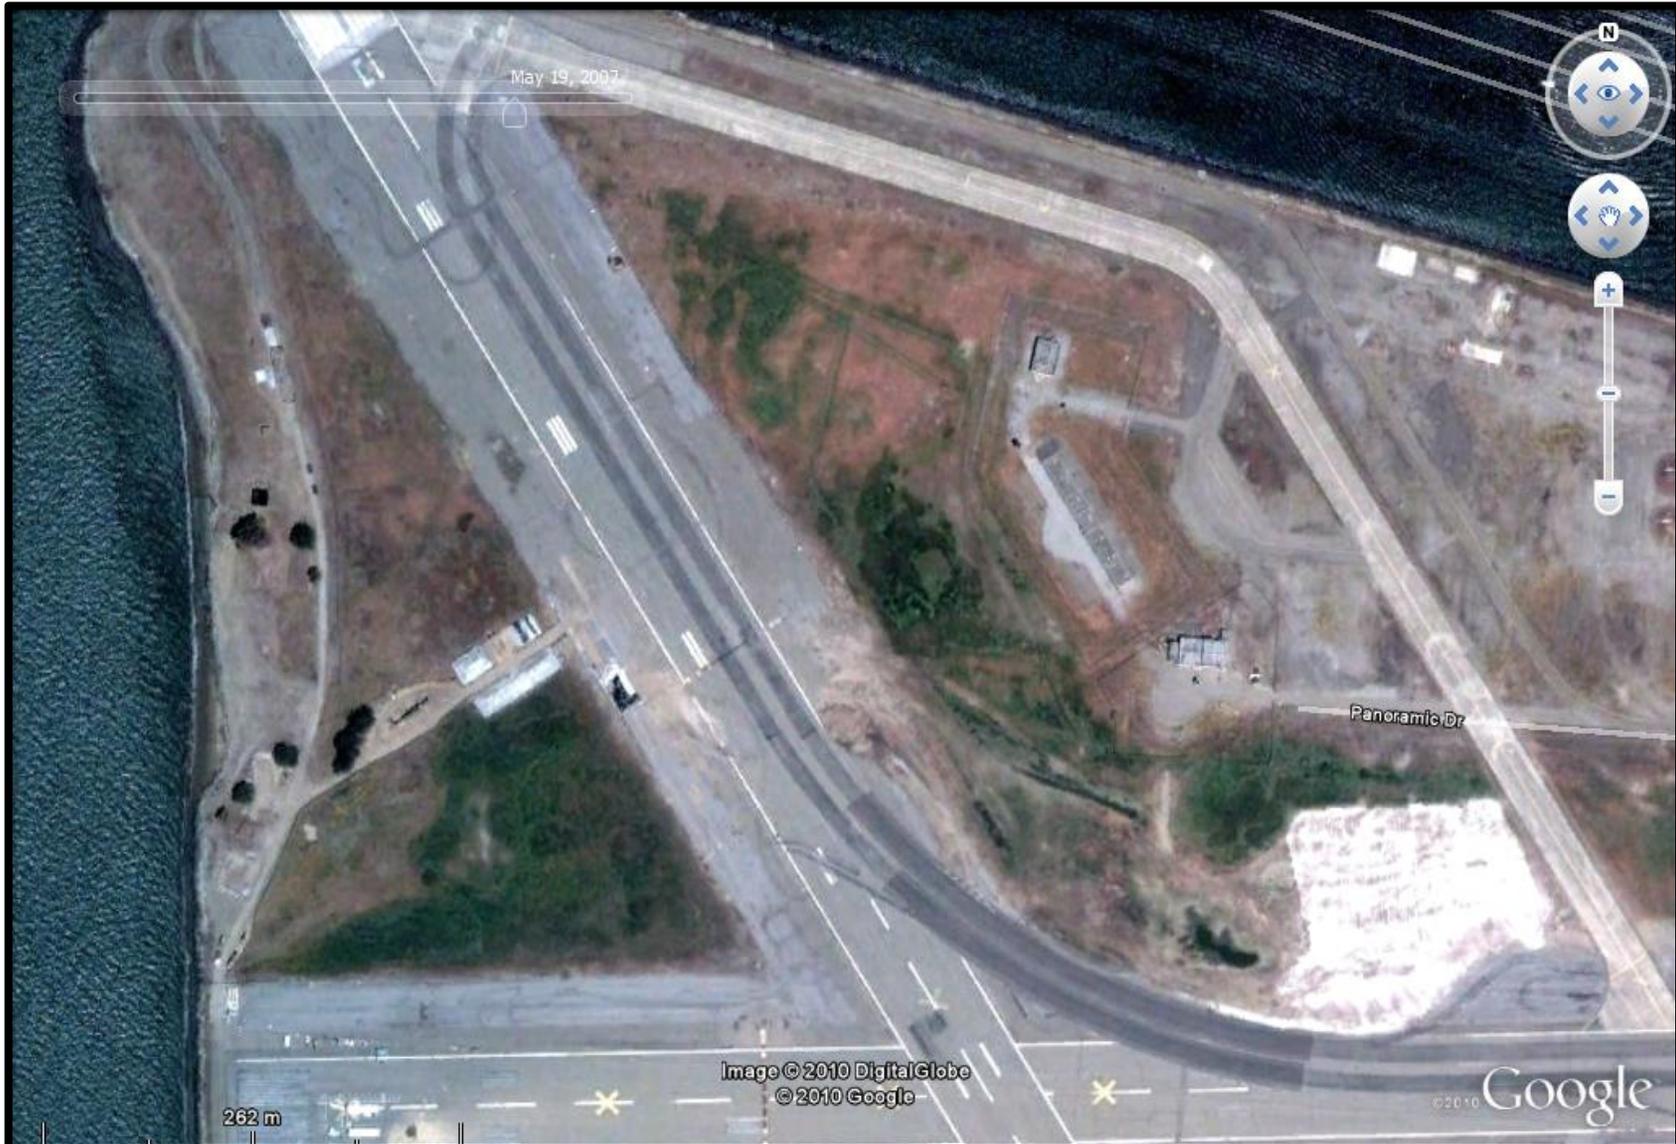
Aerial photograph from May 19, 2007. Overall, 2007 was a drought year; total rainfall between January and May was only 66 percent of normal. Rainfall between April 1 and May 18, 2007 was 2.59 inches, which is slightly above (116 percent) average for this time of year.
