Summary Report

Aerial Photograph Anomaly APHO 4
Probable Soil Stains
(Also known as SAIC Anomaly 22)
Marine Corps Air Station, El Toro, California

28 July 1999

Prepared by
Southwest Division, Naval Facilities Engineering Command
BRAC Program Office
1420 Kettner Boulevard, Suite 501
San Diego, CA 92101-2404

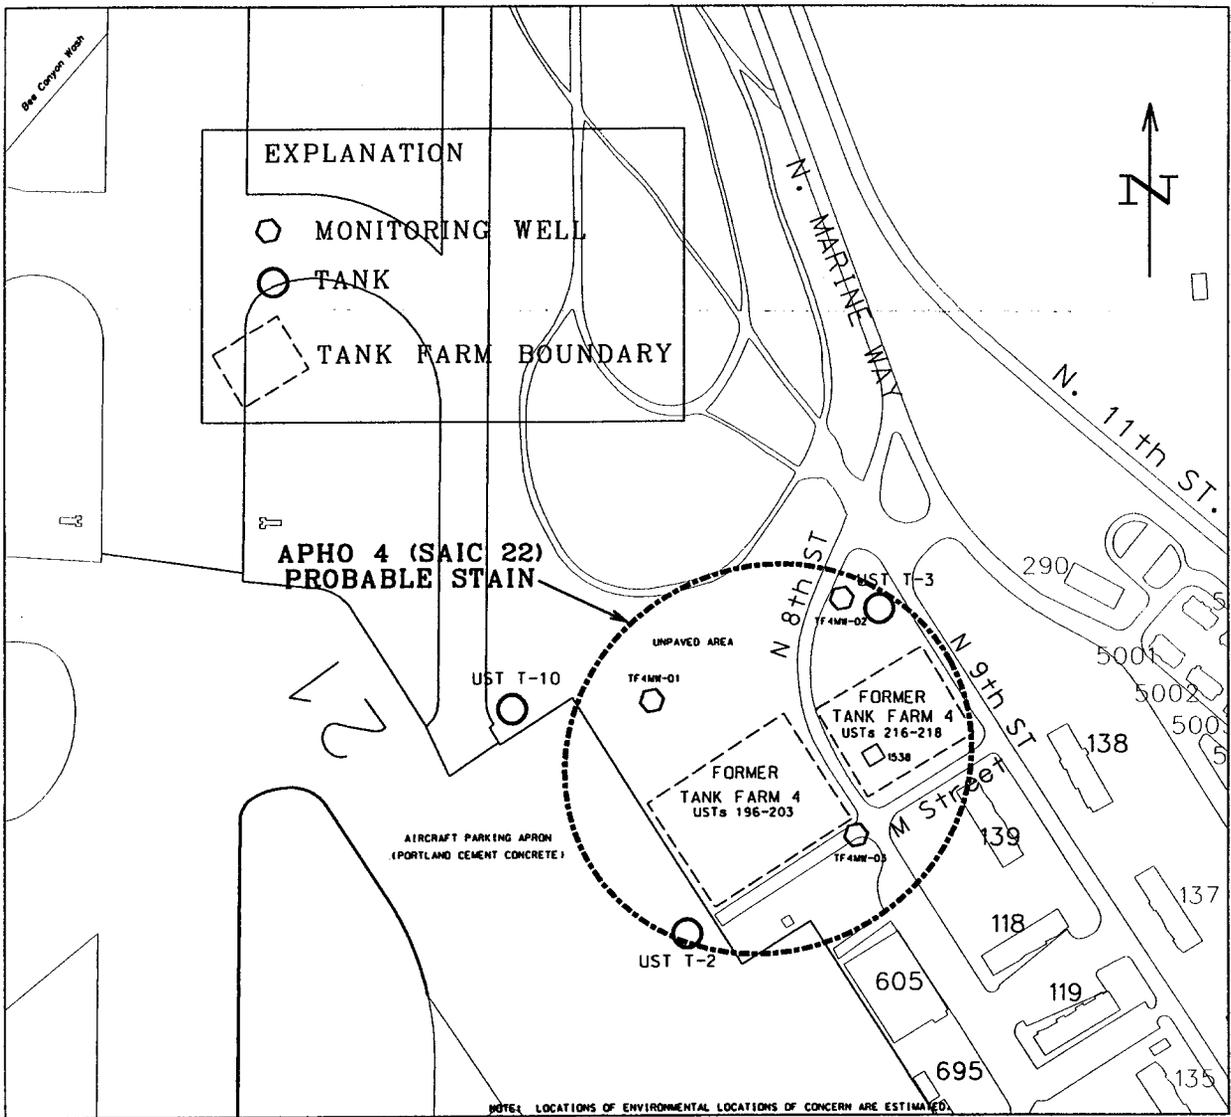
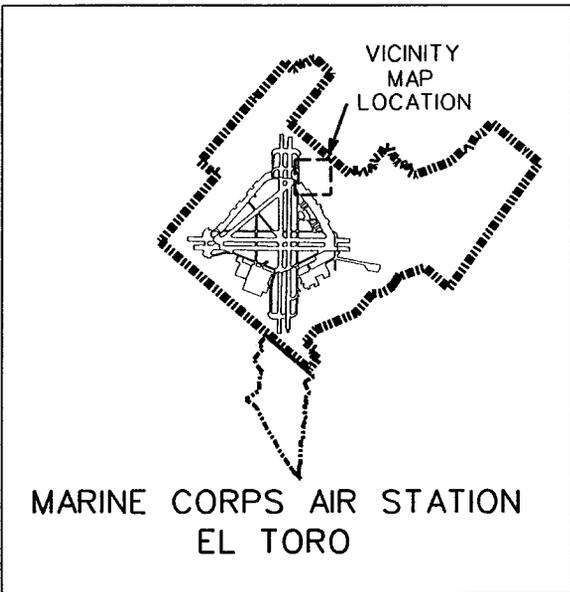
Figure 1.
AERIAL PHOTOGRAPH ANOMALY PROGRAM
APHO 4 VICINITY MAP
MARINE CORPS AIR STATION, EL TORO

APPROXIMATE SCALE:
1 inch = 350 feet

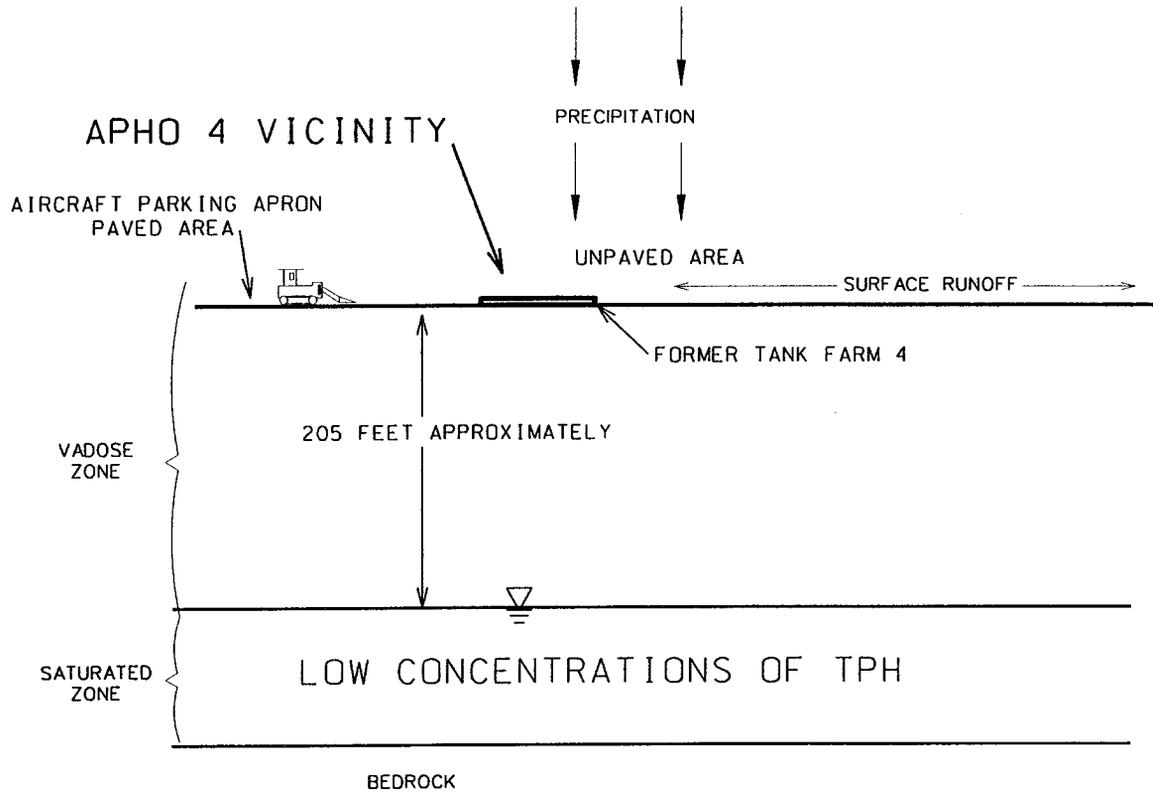
PETROLEUM IMPACTED SOILS

GROUND WATER

APHO 4 CONCEPTUAL SITE MODEL

Ground water conditions have been investigated in the vicinity of APHO 4 during the Remedial Investigation of the groundwater as Installation Restoration Program (IRP) Site 18 and during the verification of conditions at former Tank Farm 4. The wells that were constructed around the perimeter of Tank Farm 4 also encircle the anomaly APHO 4. Ground water is located approximately 205 feet below ground surface based upon measurements from these wells. Low concentrations of petroleum hydrocarbons, including benzene, have been detected in the wells adjacent to Tank Farm 4. Selected information pertaining to the wells at Tank Farm 4 is presented in the Appendix, and a conceptual site model is shown on Figure 2.

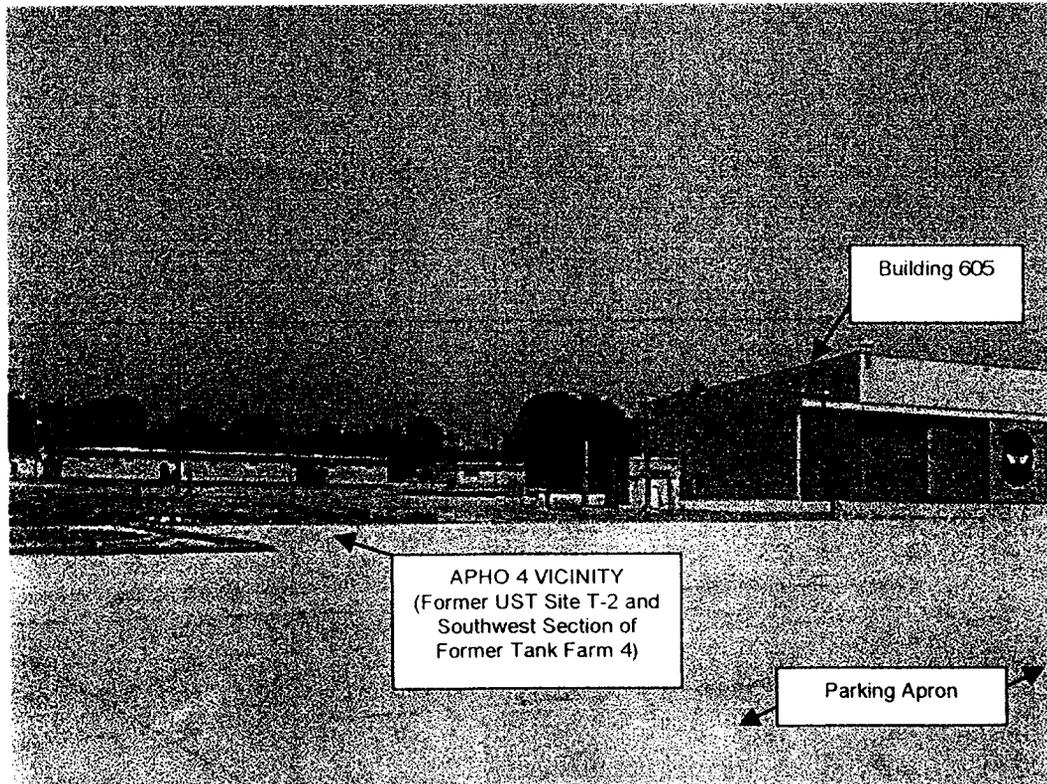
Photograph 1. APHO 4 (SAIC 22) Vicinity
View from Parking Apron Looking Northeast
Aerial Photograph Anomaly Program
Marine Corps Air Station, El Toro
Date of Photograph: July 1999

Photographs of the vicinity of APHO 4 and former Tank Farm 4 are presented in the Appendix. No soil stains or discolored areas were observed on the unpaved or paved surfaces surrounding the tank farm during the inspections of July 1999.

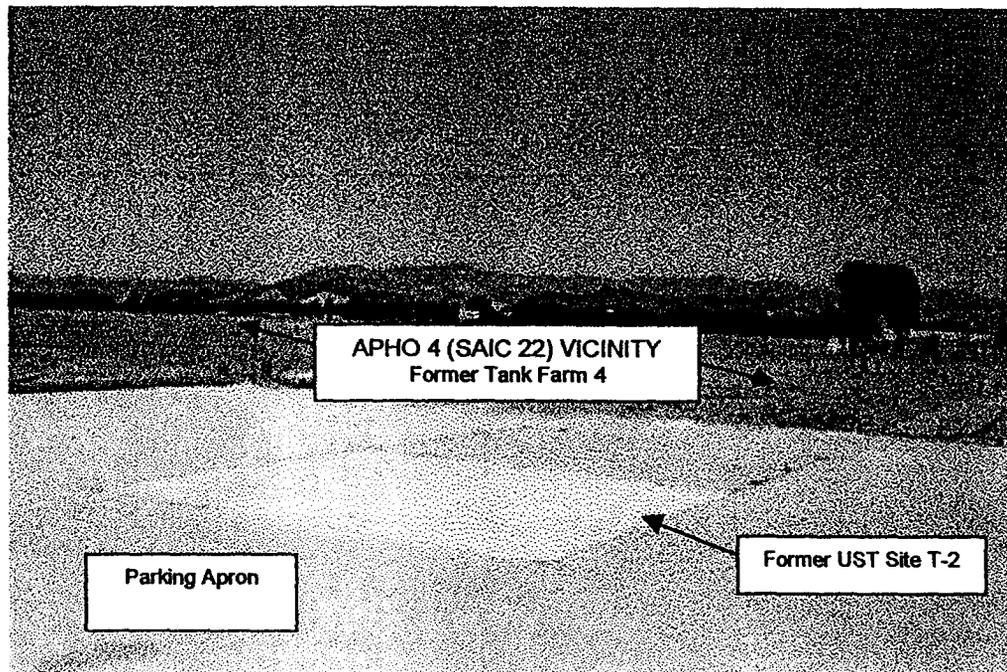
Photograph 4. APHO 4 (SAIC 22) Vicinity
View from Southwest Section of Tank Farm 4 Looking North
Aerial Photograph Anomaly Program
Marine Corps Air Station, El Toro
Date of Photograph: July 1999

Current Site Conditions: *The APHO 4 vicinity is generally unpaved and includes the former Tank Farm 4 site. Tank Farm 4 included two groups of tanks, one group located adjacent to the aircraft parking apron and one group located to the northeast. All tanks have been removed from the former Tank Farm 4 facility, and UST T-10 was removed from the area northwest of Tank Farm 4. The former Tank Farm 4 facility and most of the adjacent areas, except for the aircraft parking apron and access roads, are covered with grasses. There is a paved parking lot located northeast of the northeast section of Tank Farm 4. There is a surface drainage channel northwest of APHO 4, and the surface runoff is eventually conveyed to Bee Canyon Wash. No stains were observed on the paved area of the parking apron, and no areas of wet soils or soil stains were observed on the unpaved areas of APHO 4.*

Recommendation: No Further Action Status

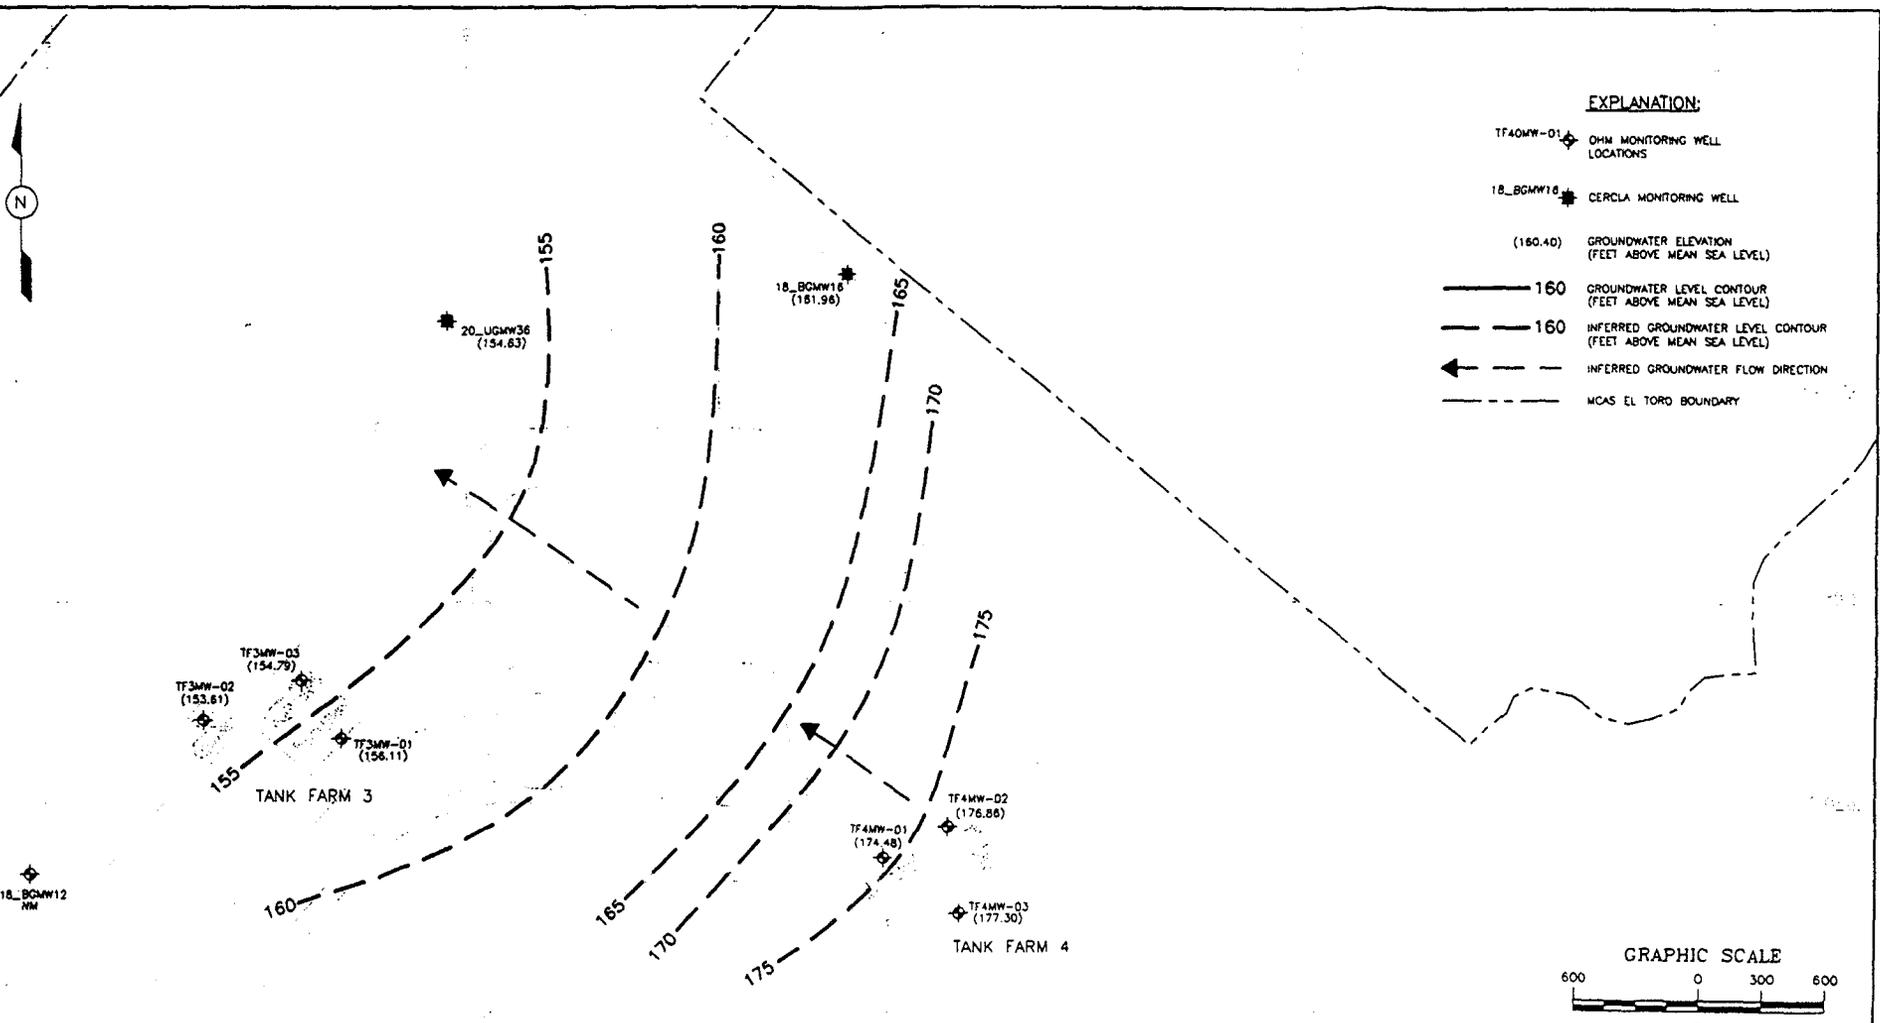
TANK FARMS 3 AND 4 SURVEY DATA

- TF40MW-01 OHM MONITORING WELL LOCATIONS
- 18_BGMW18 CERCLA MONITORING WELL
- (160.40) GROUNDWATER ELEVATION (FEET ABOVE MEAN SEA LEVEL)
- 160 GROUNDWATER LEVEL CONTOUR (FEET ABOVE MEAN SEA LEVEL)
- 160 INFERRED GROUNDWATER LEVEL CONTOUR (FEET ABOVE MEAN SEA LEVEL)
- INFERRED GROUNDWATER FLOW DIRECTION
- MCAS EL TORO BOUNDARY
