Historical Radiological Assessment
(HRA)

Marine Corps Air Station, El Toro

Prepared by:
Roy F. Weston, Inc. - Mare Island Office
Vallejo, California

May 2000

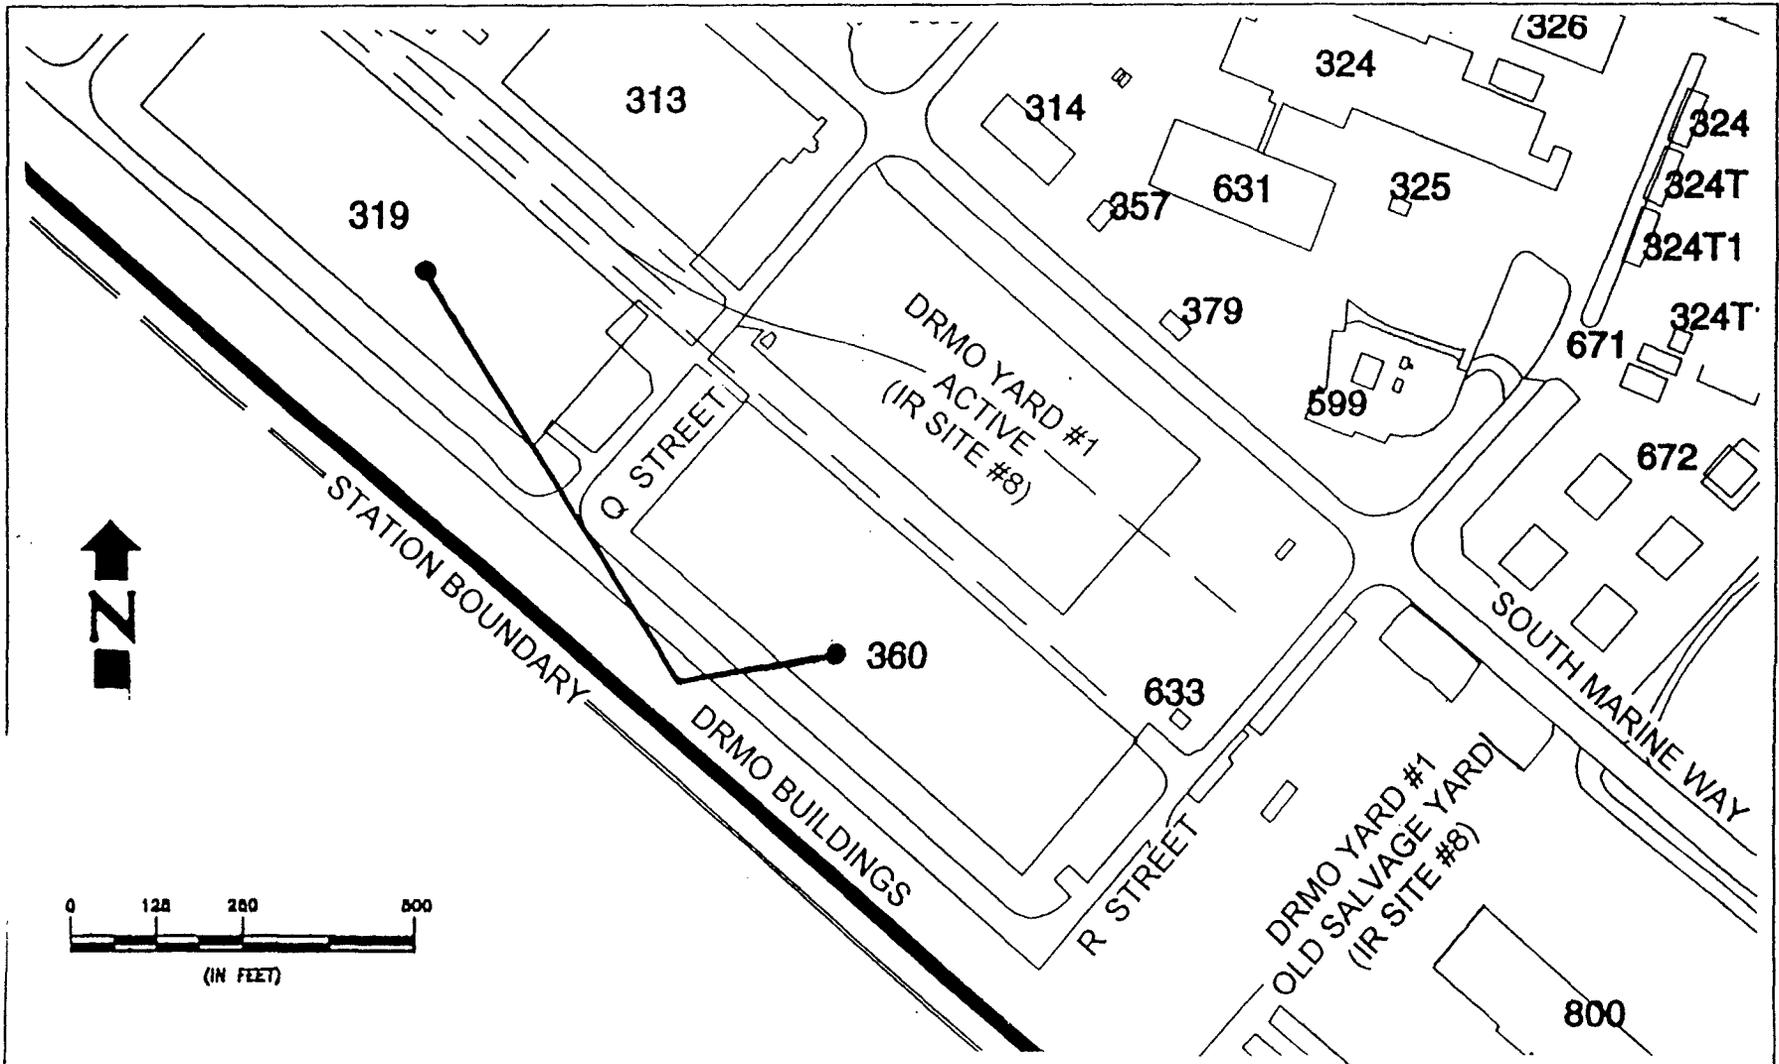
Figure A-3

DRMO Buildings 319 and 360 and DRMO Yard #1 (IR Site #8)

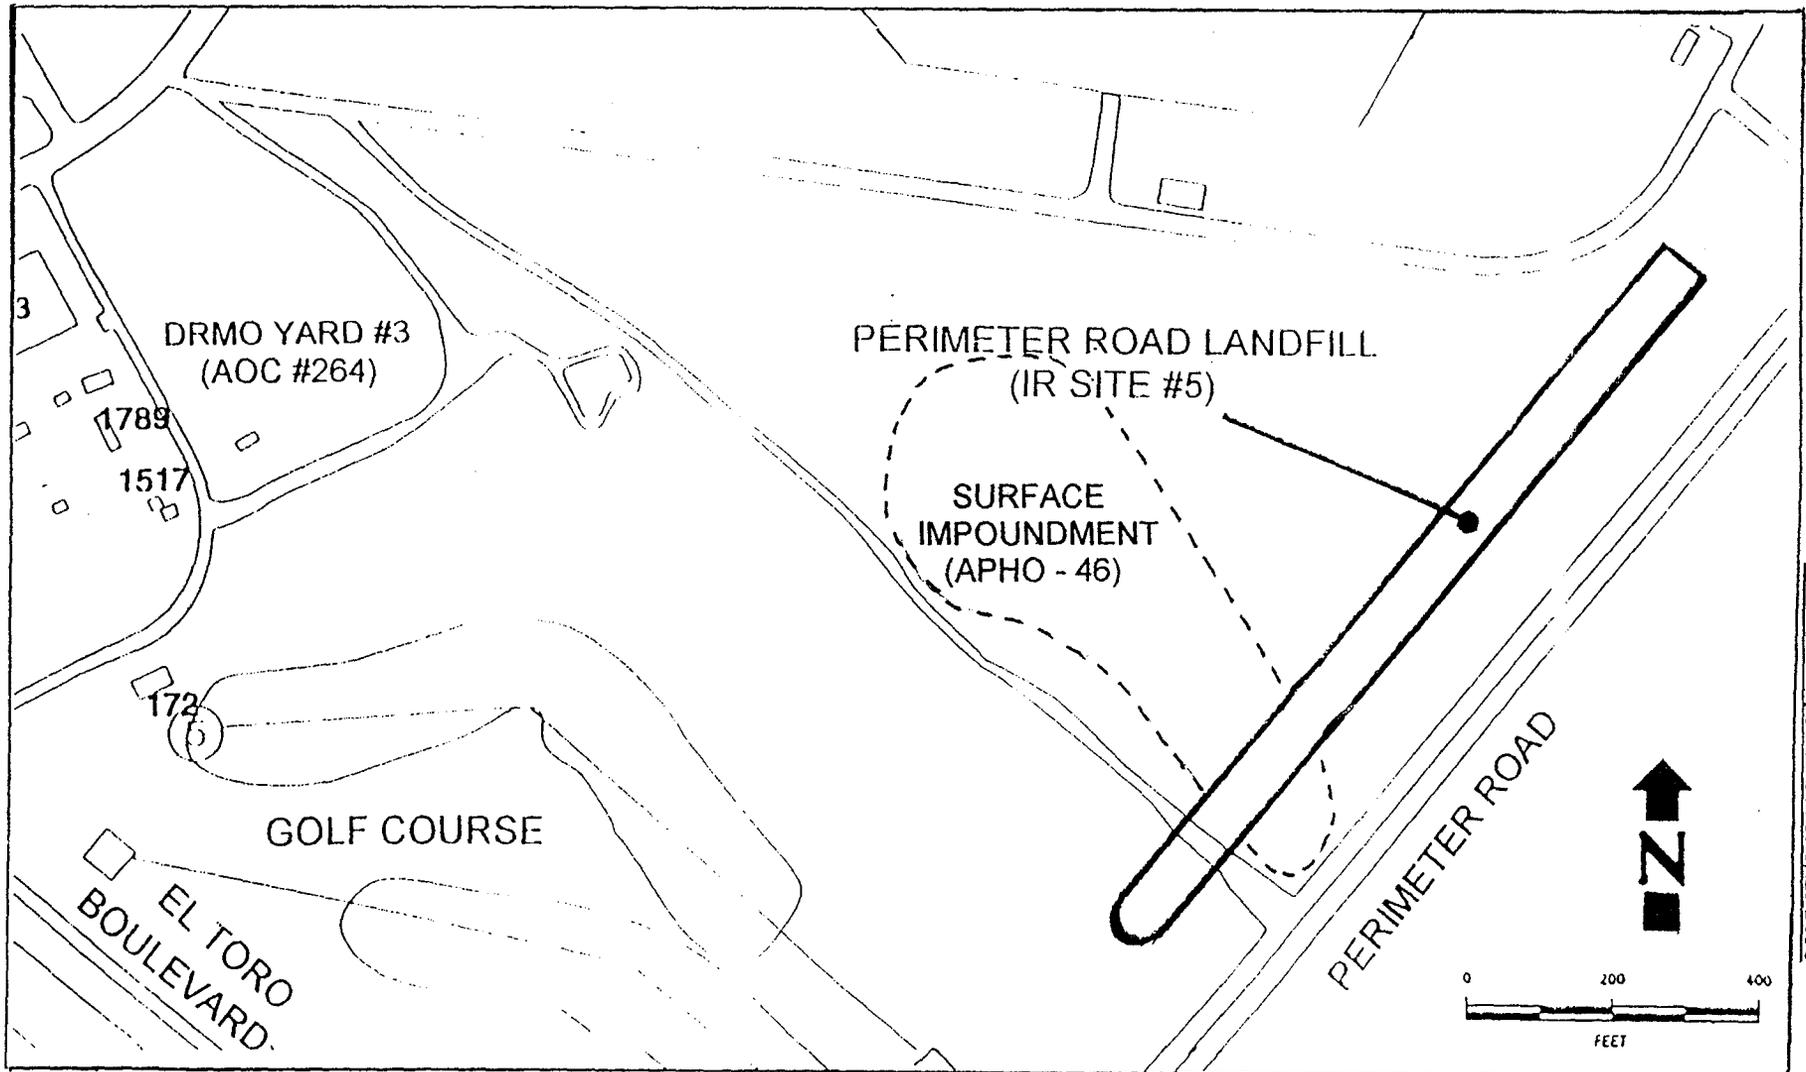
Figure A-4

The Perimeter Landfill was in operation from 1955 to the late 1960s. Adjacent to IR Site #5 is a large impoundment, APHO-46 (from an aerial photograph dated 1979). To date, no evidence has been found indicating the disposal of components containing radioactive material. However, comments from MCAS El Toro employees indicate that G-RAM may have been inadvertently disposed in the landfill. APHO-46 is considered potentially impacted, based on its close proximity to IR Site #5.

DRMO Yard #3 (AOC #264) and Perimeter Road Landfill (IR Site #5) Including Surface Impoundment (APHO-46)

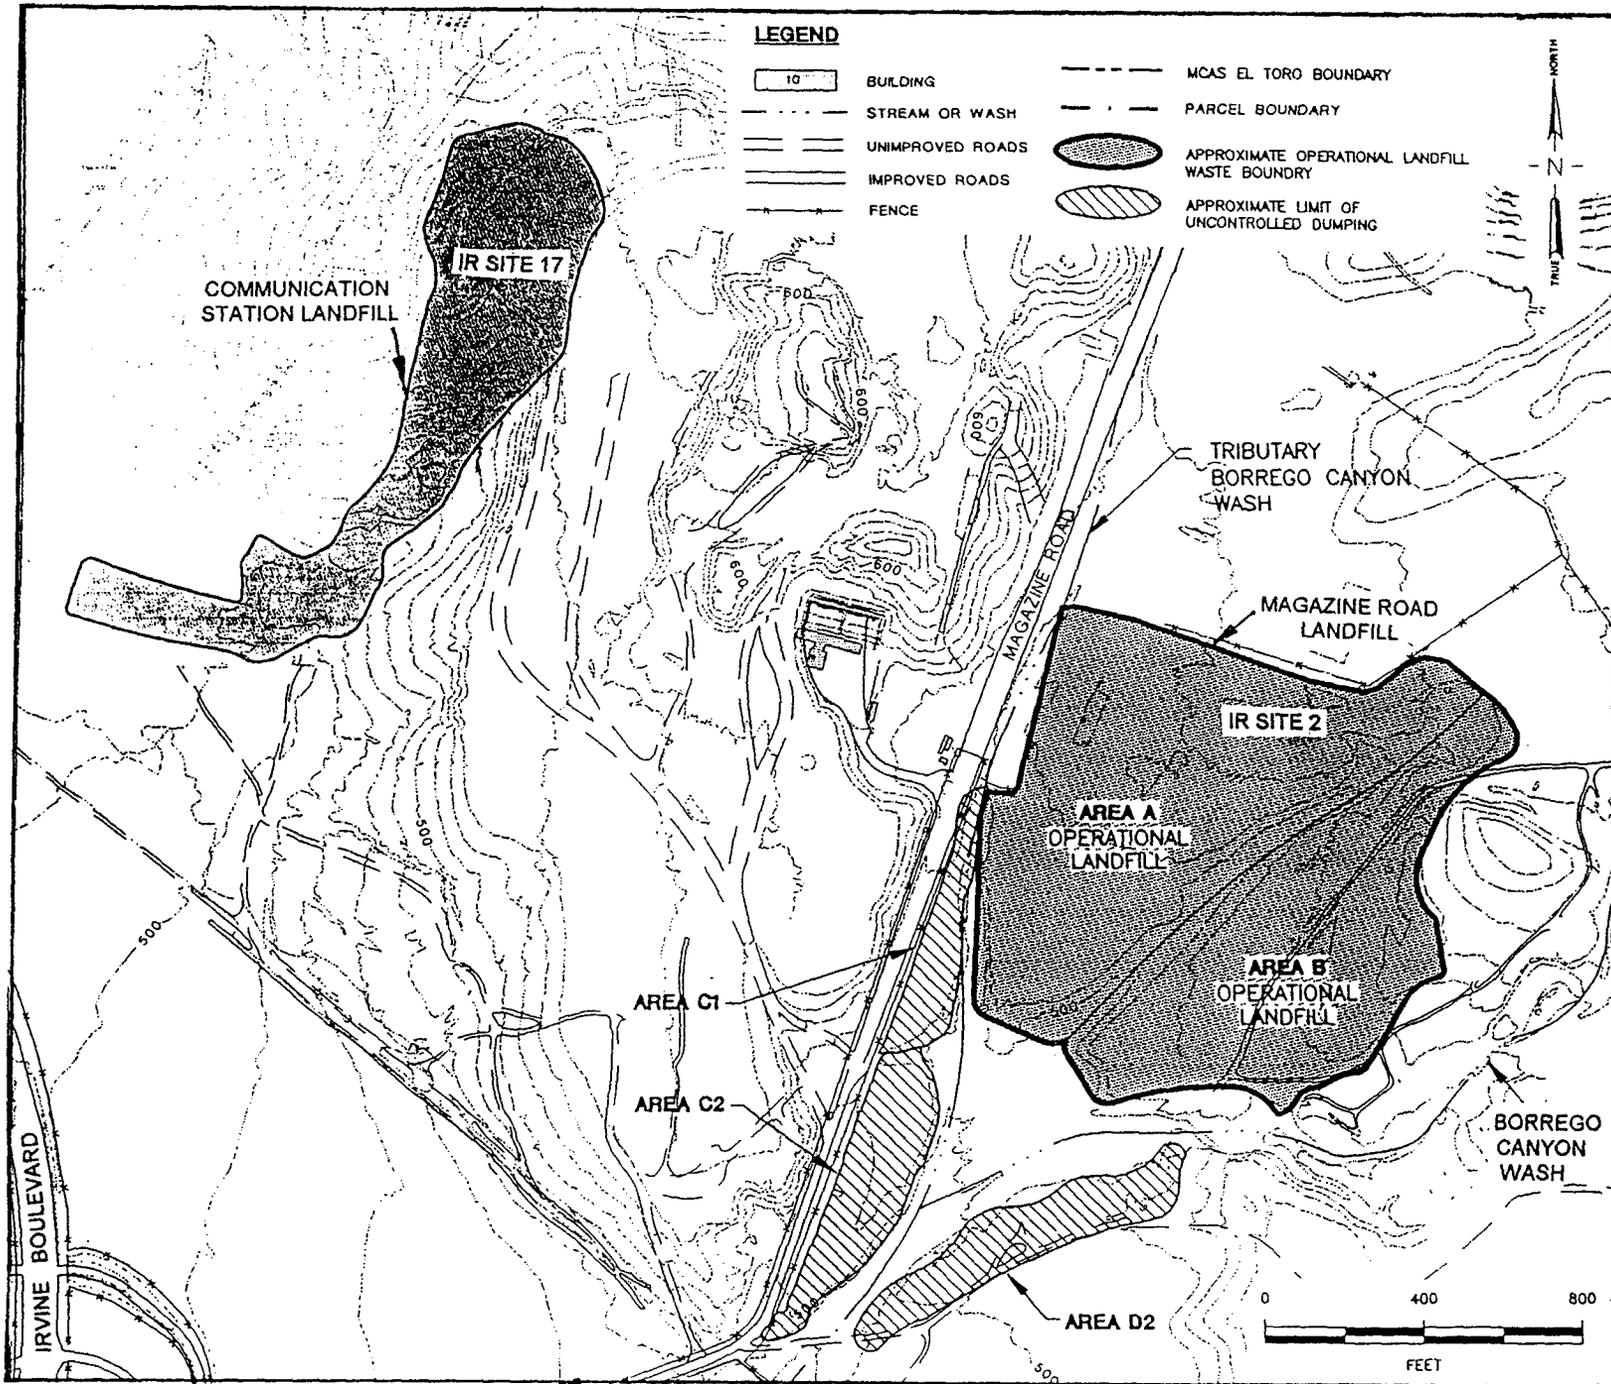
Figure A-6
Magazine Road (IR Site #2) and Communication Station (IR Site #17) Landfills

The Magazine Road Landfill operated between the late 1960s and 1980. Employee statements indicate that G-RAM may have been inadvertently disposed in the Station landfills and, in July 1999, a gauge with a radium painted dial was reported to have been found in the vicinity of Landfill Site #2.

The Communication Station Landfill operated between 1981 and 1983. Adjacent to the southern end of IR Site #17 is a large impoundment, APHO-44 (from an aerial photograph dated 1974). To date, no evidence has been found indicating the disposal of components containing radioactive material. However, comments from MCAS employees indicate that G-RAM may have been inadvertently disposed in the landfills. APHO-44 is considered potentially impacted, based on its close proximity to IR Site #17.

Surface water and seep water analyses performed in 1998 indicated that samples taken in the vicinity of the Magazine Road Landfill (IR Site #2) contained gross alpha (estimated) and gross beta in excess of the MCL for drinking water. No analyses were performed to determine the radionuclide(s) present in the surface water and seep water samples. Radionuclide analyses should be performed when elevated levels are found. When such analyses were performed on area groundwater samples exhibiting elevated gross alpha levels, it was determined that natural uranium was the cause. A program is now in place to monitor surface water and seep water. If elevated gross alpha levels are detected, the samples will be analyzed for specific radionuclides.

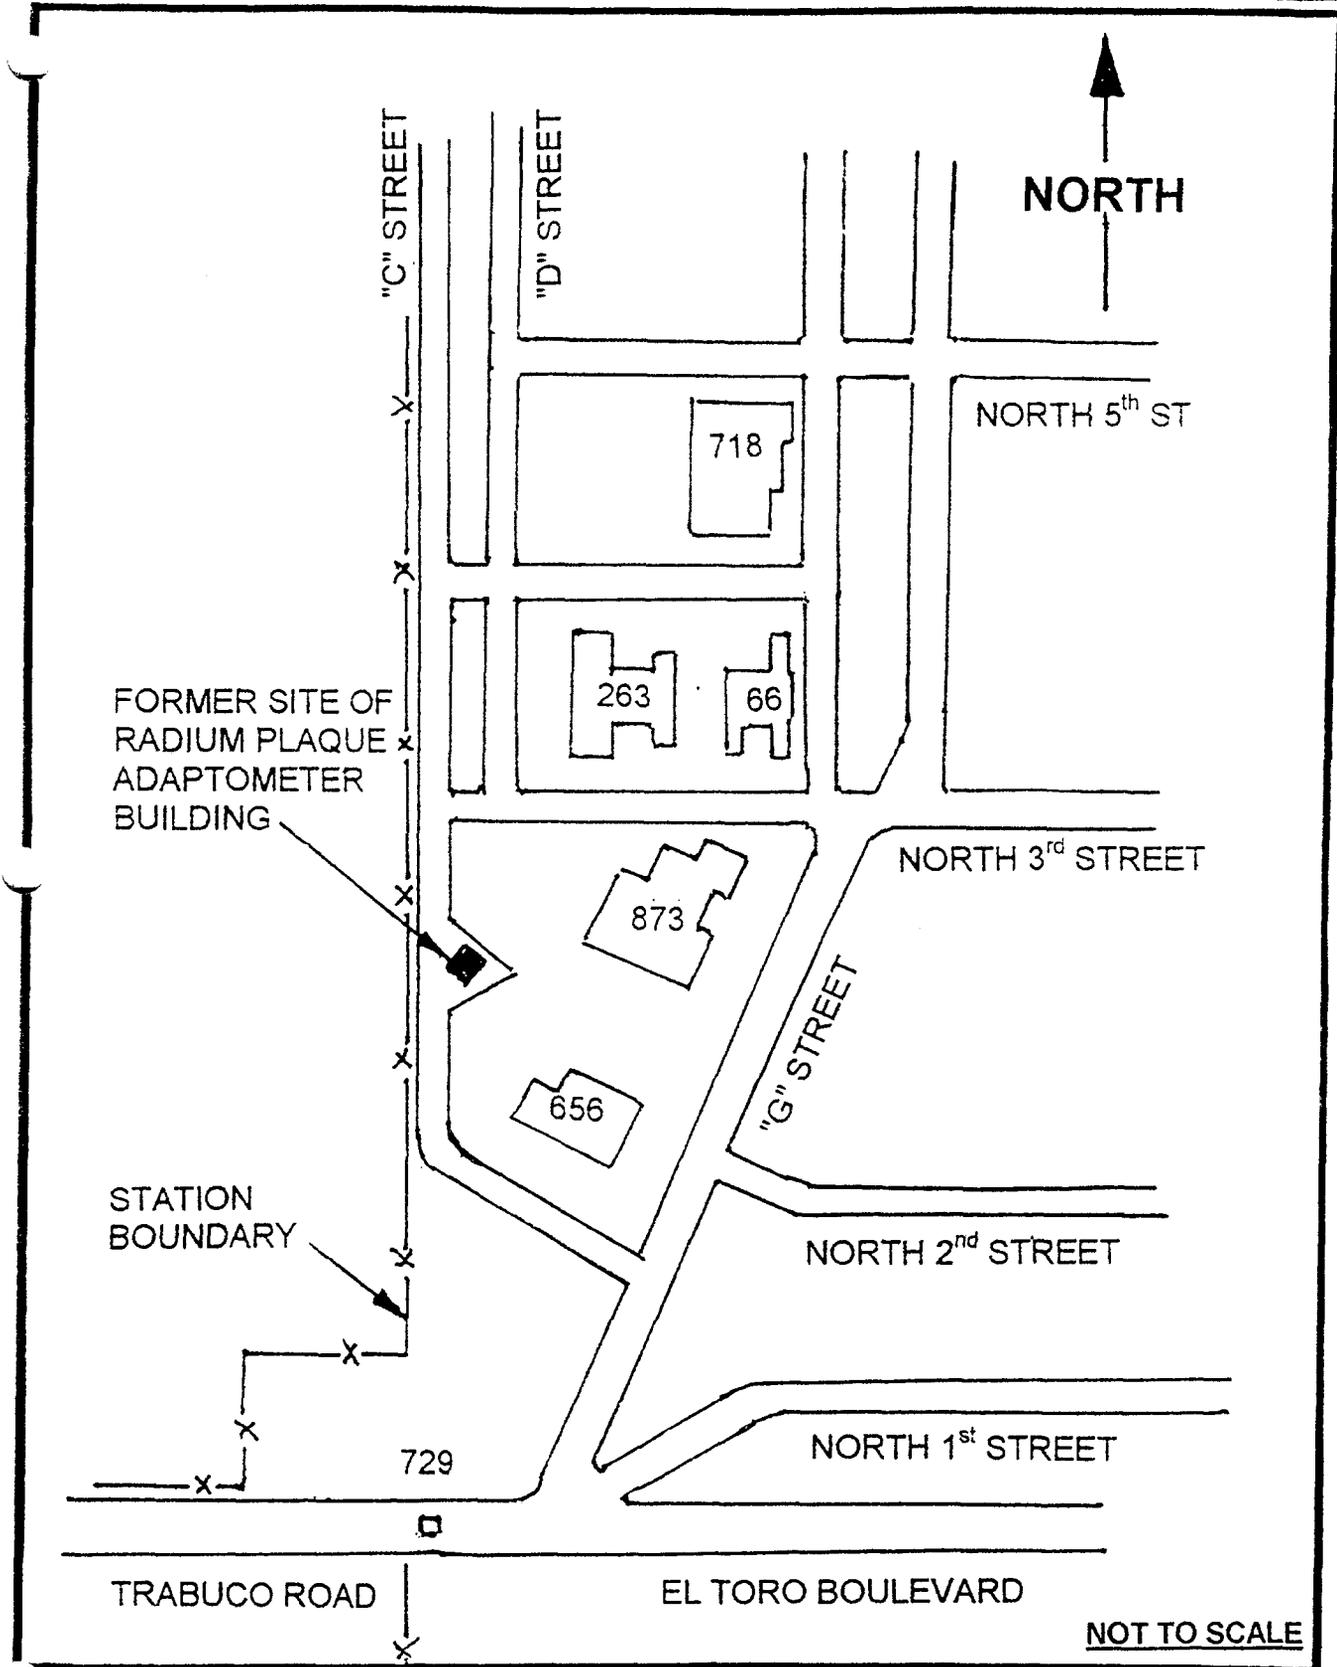
Figure A-10
Former Site of Radium Plaque Adaptometer Building

It cannot be determined whether the RPA building was actually constructed at El Toro, since there was no building number assigned, no construction drawings and no evidence of a building (foundation, disturbed soil, etc.) in the location where an unnumbered sketch shows the footprint of such a building.

However, since records do show a facility footprint, it is recommended that radiation surveys be performed at the footprint of the site to ensure that no residual radioactivity remains.
