# Summary Report

*Aerial Photograph Anomaly Area 5*

*Marine Corps Air Station*

*El Toro, California*

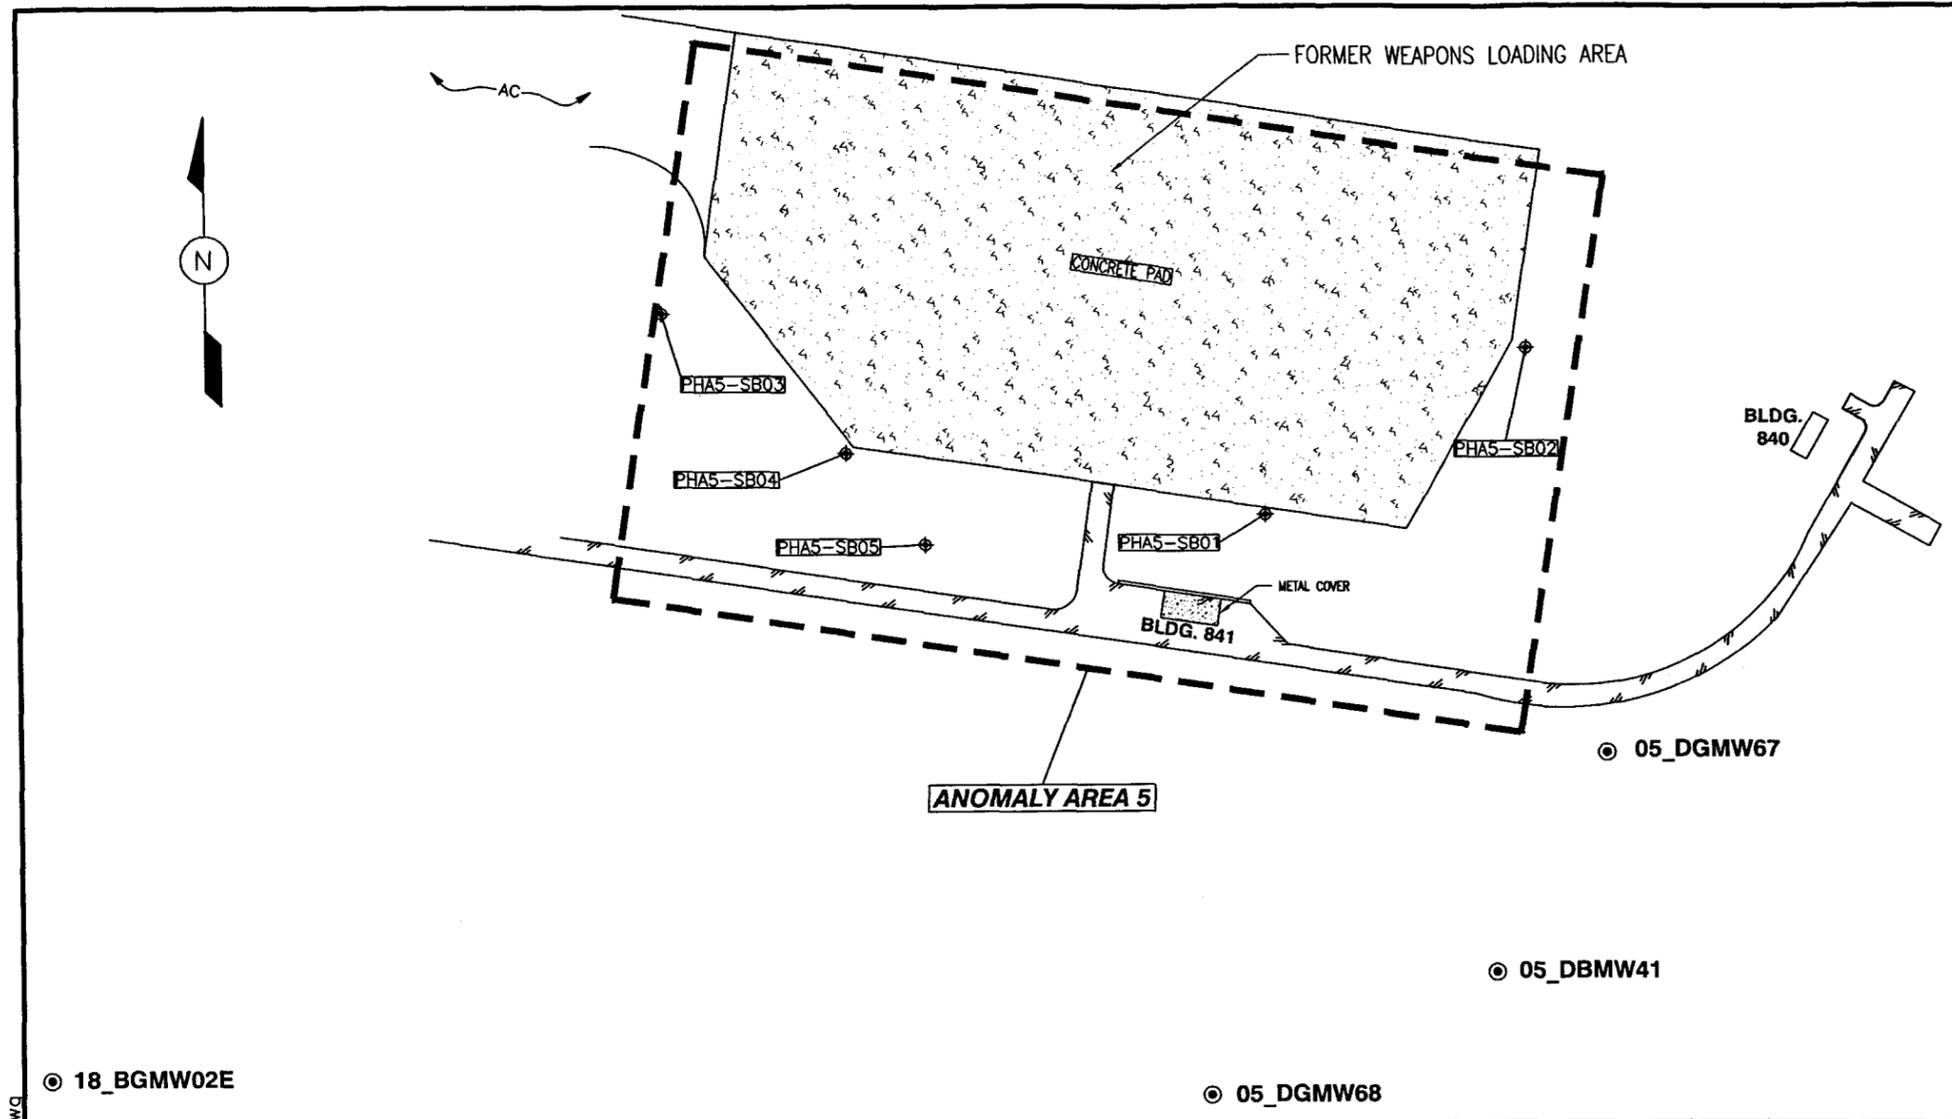
On December 10, 1999, OHM conducted verification drilling and sampling activities at Anomaly Area 5 to evaluate the sub surface conditions. A total of 5 soil borings were advanced (PHA5 SB-01 through PHA5 SB-05) to approximate total depths of 15 feet below ground surface. These boring locations were selected based on field visit. The soil boring locations are shown in Figure 4-1.

- EXPLANATION:**
- PHAS-SB01 ◊ SOIL BORING
  - 18\_BGMW02A ● MONITORING WELL
  - /// EDGE OF PAVEMENT
  - APPROXIMATE SITE BOUNDARY OF ANOMALY AREA 5

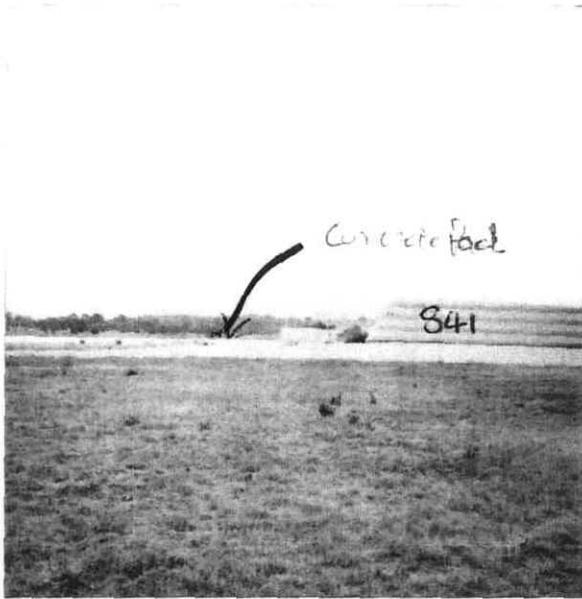
APHO 5, Unpaved Area  
w. Concrete Pad

**Current Site Conditions:** Anomaly Area 5 is relatively flat. Building 840/841, former LOX/Explosive Safety office, with concrete pad is within Anomaly Area 5. More than half of Anomaly Area 5 is former weapons loading area concrete pad. Anomaly Area 5 is surrounded by grass-covered area to the south, the edges of the runways to the north, and IRP Site 5 to the southeast. MSC-D1 remains southwest of Anomaly Area 5. No evidence of recent excavations or trenches was observed during the inspection. Also, no stains or discolored areas were observed on the unpaved and concrete pad area of Anomaly Area 5. [Comment: APHO 31, 43, 66,67 and 68 are grouped together]

Based on results of the field verification sampling data at Anomaly Area 5, the results of the record search activities, and the results of the visual inspection, it is recommended *that no further action (NFA)* status be designated for Anomaly Area 5 (APHO 66, APHO 31, APHO 43, APHO 67, and APHO 68) and that *NFA* status be documented in the next BRAC Business Plan update.

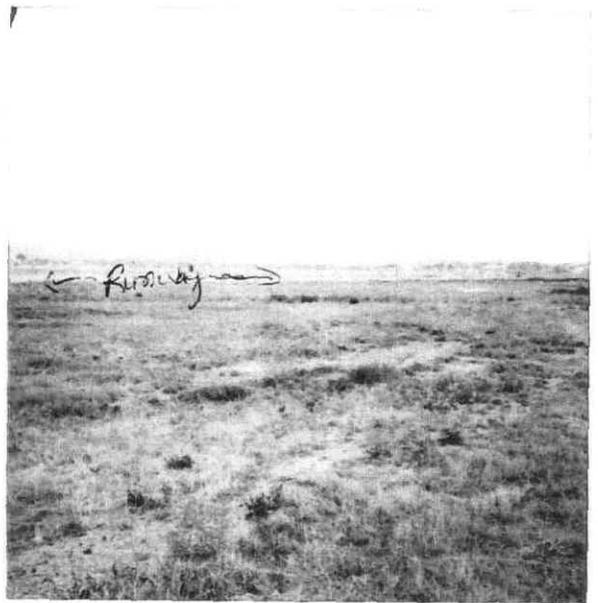
APHO 5, Part of Runway  
Unpaved Area

Is there visual evidence of the anomaly identified in the photograph present at the site? *None, No construction debris, materials, trenches were observed and no waste items were being stored at the site.*
