# Summary Report

*Former Temporary Accumulation Area (TAA) 672  
Solid Waste Management Unit (SWMU) 177  
Former Marine Corps Air Station, El Toro, California*

5 July 2002

*Prepared by:*  
Southwest Division, Naval Facilities Engineering Command  
BRAC Programs Office  
San Diego, CA 92101-2404

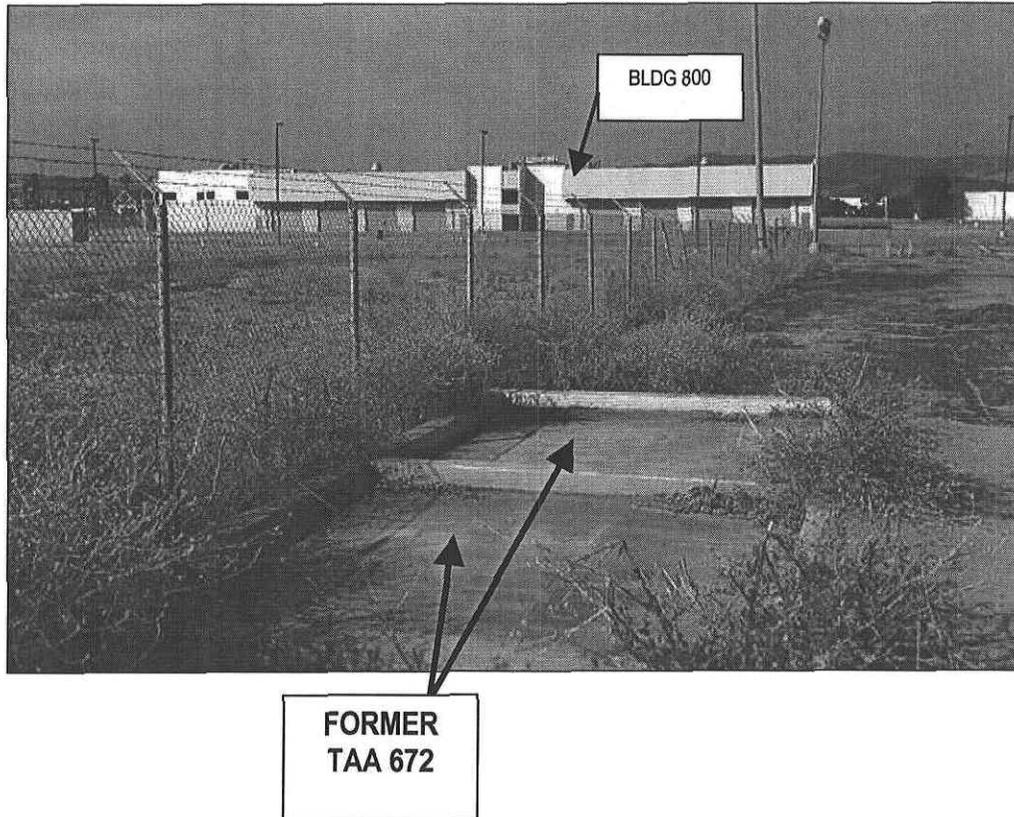
**Photograph 1. Former Temporary Accumulation Area (TAA) 672**  
**[Solid Waste Management Unit (SWMU) 177]**  
**Looking Approximately South Toward Building 800**  
**Former Marine Corps Air Station, El Toro**  
**Date of Photograph: 28 June 2002**

TAA 672 (SWMU 177) was visually inspected on 28 June 2002. No stains or significant cracks were observed on the concrete surfaces of the slab or the berm. The TAA does not have a sump or a roof. No stains or significant cracks were observed on the surface of the asphalt-paved ramp on the west side of TAA 672. No stains or significant cracks were observed on the on the asphalt-paved parking area and road located adjacent to TAA 672. Based upon the review of the historical facility records and the results of the visual inspection of 28 June 2002, it is estimated that the concrete slab and berm (the structural components of TAA 672) were constructed in the late 1980's.

Based upon the review of historical documentation, the low levels of residual contaminants in the vicinity, and the results of visual inspections, it is recommended that no further action status be designated for former TAA 672 (SWMU 177). It is also recommended that environmental condition of property (ECP) category 2 (former storage or release of petroleum products) be designated for former TAA 672 in the next Business Plan Update.

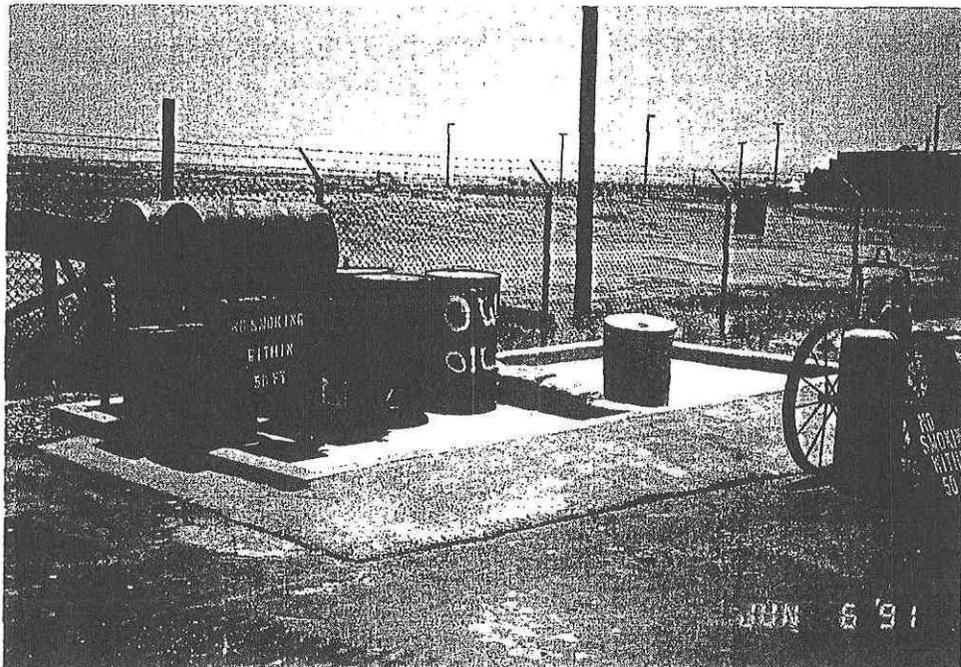
The DSA is used to store product materials such as motor oil, hydraulic fluid, and grease. The storage area appeared relatively new. There are no significant stains or cracks in the concrete storage surface or the berm surrounding the storage area.

No further action is recommended for this DSA.

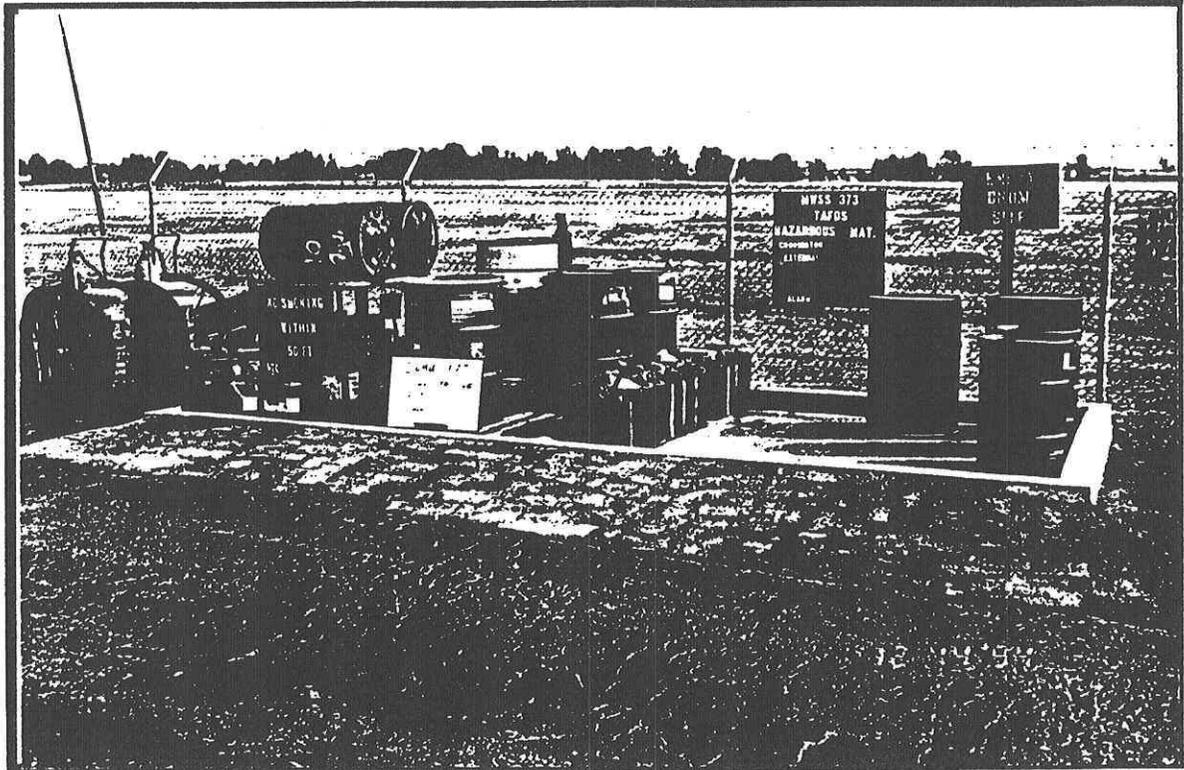
**SWMU #: 177**

TAA 672 (SWMU 177) was visually inspected on 2 December 1994 and 10 November 1995 during the preparation of the Addendum to the RFA (Bechtel, 1996). Minor stains were observed during the 1994 and 1995 inspections, and a photograph was taken of TAA 672 during the 1994 inspection. Sampling or decontamination activities were not recommended based upon the results of the 1994 and 1995 inspections.
