Summary Report

Aerial Photograph Anomaly APHO 42
Aerial Photograph Anomaly Program
Marine Corps Air Station, El Toro, California

15 December 1999

Prepared by
Southwest Division, Naval Facilities Engineering Command
BRAC Program Office
1420 Kettner Boulevard, Suite 501
San Diego, CA 92101-2404

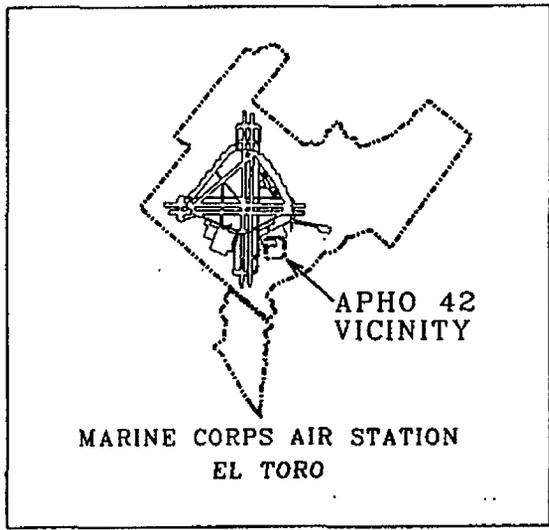
Figure 1.
AERIAL PHOTOGRAPH ANOMALY PROGRAM
APHO 42 VICINITY MAP
MARINE CORPS AIR STATION, EL TORO

The Marine Corps Air Station, El Toro, also known as the Station, comprises approximately 4,700 acres and is located in eastern Orange County approximately 45 miles southeast of Los Angeles, California. The APHO 42 vicinity is located northwest of Z Street and northwest of the Golf Course as shown on Figure 1.

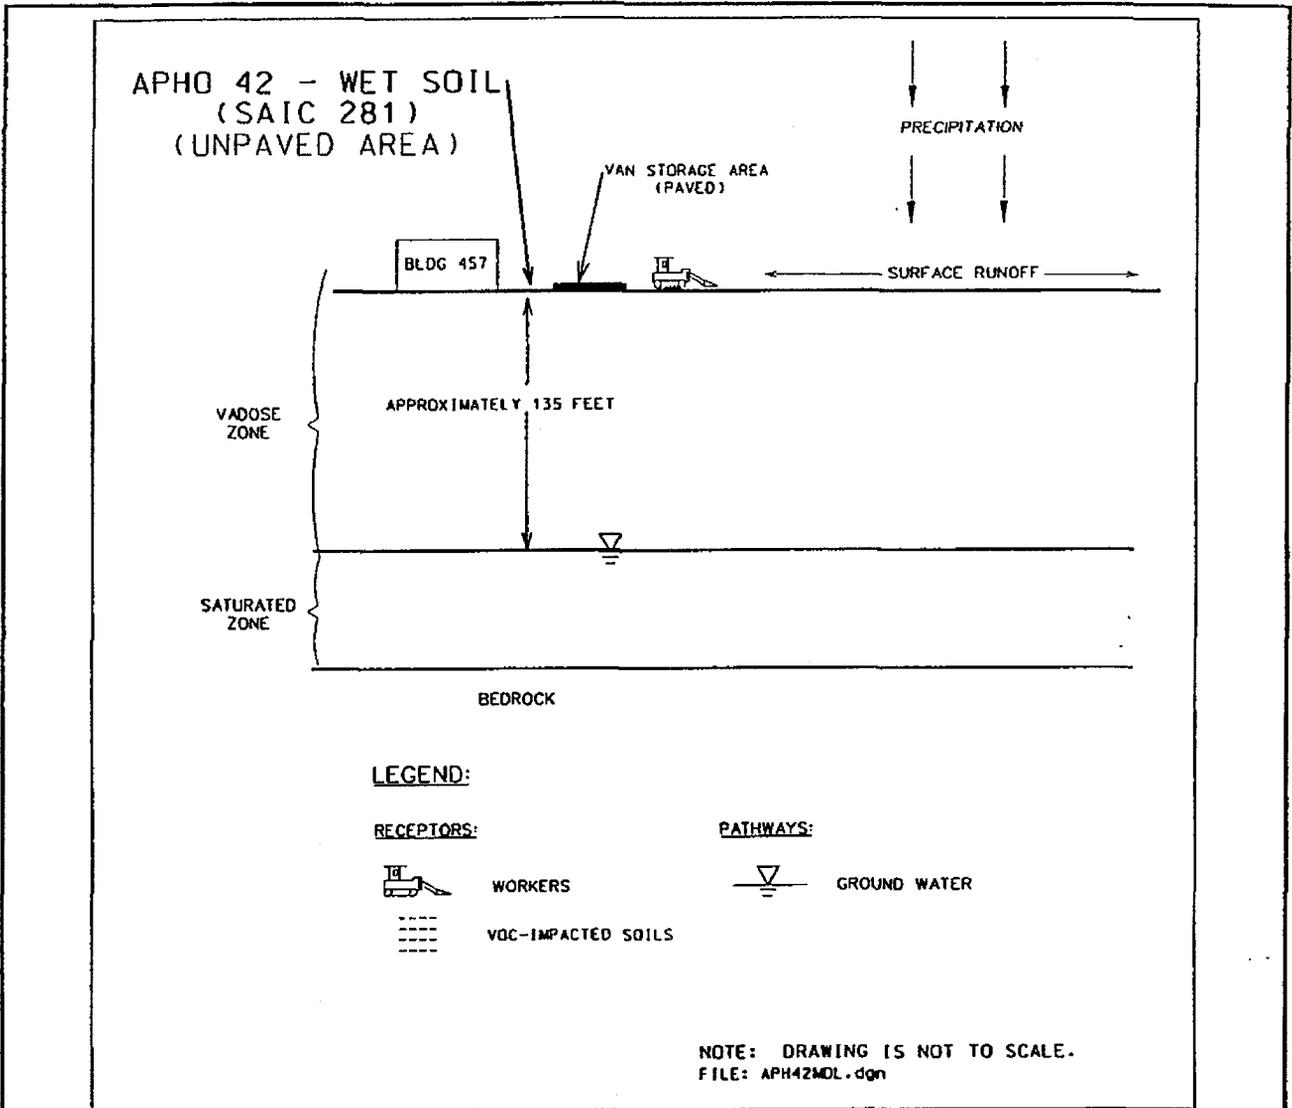
Ground water conditions have been investigated in the APHO 42 vicinity during the investigation of Installation Restoration Program (IRP) Site 6 – the Drop Tank Drainage Area Number 1. IRP Site 6 is located more than 1,000 feet west of APHO 42. Ground water is located approximately 135 feet below ground surface based upon measurements from well 06_UGMW28, and the gradient is approximately west-northwest. Selected ground water information is presented in the Appendix, and a conceptual site model is shown on Figure 2.

Water Level Measurements at Nearby Well 06_UGMW28

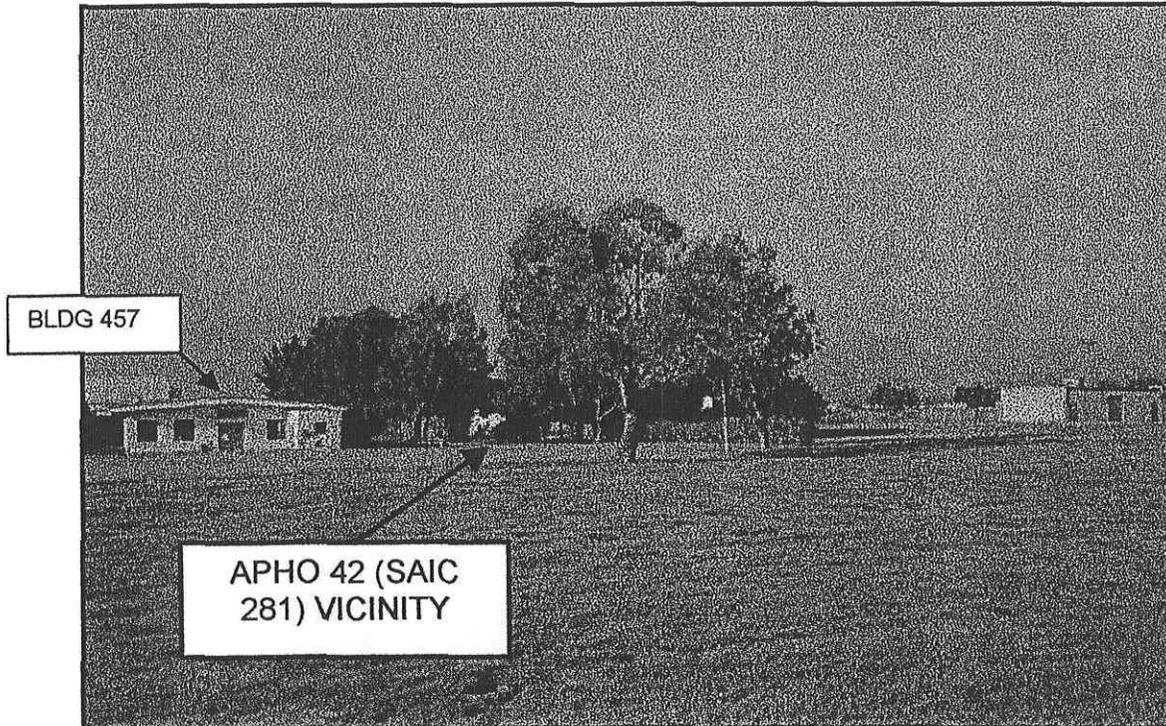
Photograph 1. APHO 42 (SAIC 281) Vicinity.
Looking Approximately North.
Aerial Photograph Anomaly Program
Marine Corps Air Station, El Toro

The APHO 42 vicinity was visually inspected by the Navy in December 1999. The APHO 42 vicinity encompasses an abandoned picnic area located east of Building 457. The area is relatively level, unpaved, and landscaped with grasses, shrubs, and large trees. Playground equipment and horseshoe pits were observed during the visual inspection. No wet soils, stains, or burned areas were observed during the inspection.

- The APHO 42 vicinity was visually inspected by Navy representatives in December 1999, and no wet soils or burned areas were observed. APHO 42 encompasses an abandoned picnic area. It is possible that routine irrigation of the trees and shrubs or that storm water runoff accumulated at APHO 42 and caused the appearance of wet soils or burned areas on the 1974 photograph.

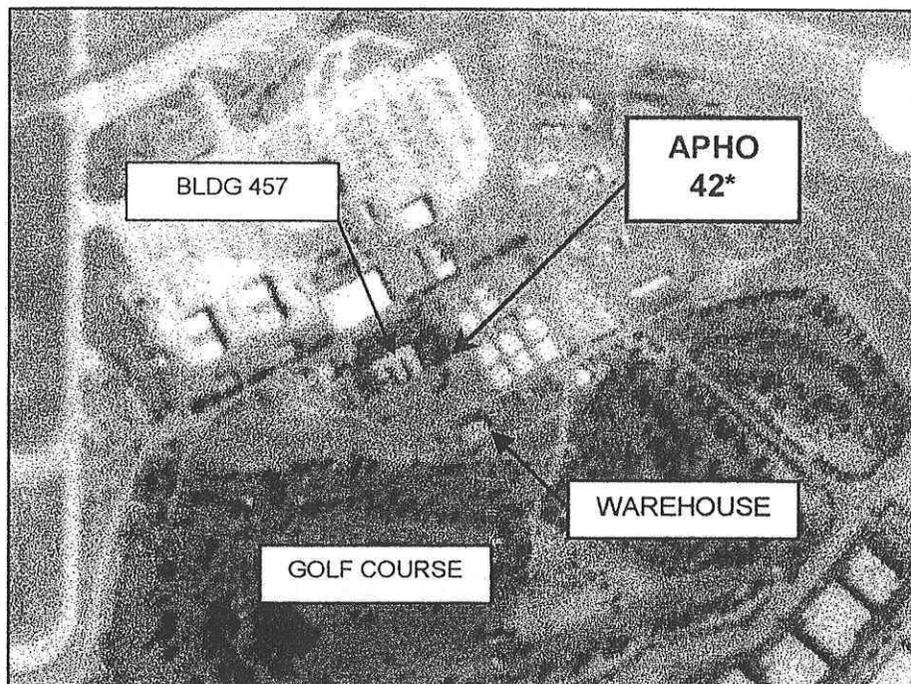
Photograph 3. APHO 42 (SAIC 281) Vicinity.
Aerial Photograph Anomaly Program
Marine Corps Air Station, El Toro

APHO 42 (SAIC 281)
VICINITY

BLDG 457
ACCESS ROAD

*NOTE: The APHO 42 Vicinity consists of a park with playground equipment and several large trees and shrubs.
