MINUTES FROM 14 APRIL 2011 RESTORATION ADVISORY BOARD MEETING WITH
TRANSMITTAL LETTER NSWC INDIAN HEAD MD
04/14/2011
NAVAL SUPPORT ACTIVITY SOUTH POTOMAC

RESTORATION ADVISORY BOARD (RAB) MEETING

**NAVAL SUPPORT FACILITY INDIAN HEAD
INSTALLATION RESTORATION (IR) PROGRAM
RESTORATION ADVISORY BOARD (RAB) MEETING AGENDA**

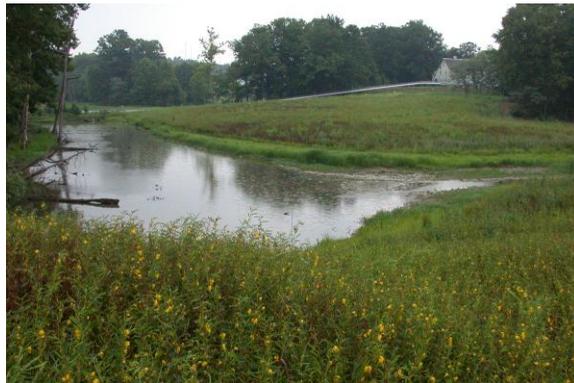
Site 12-Town Gut Landfill

- 4.8 Acre site containing 3 areas of waste
- 3 waste areas are divided by 2 ponds and Atkins Road Extension
- Landfill composed of construction rubble and landscaping debris

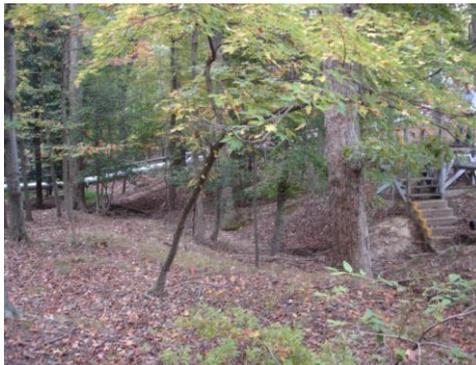
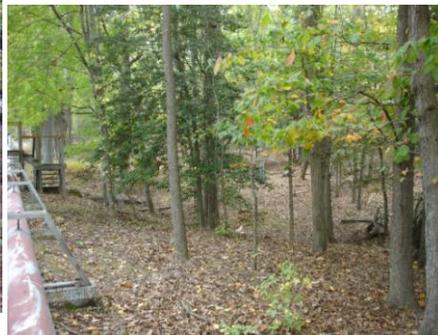
Site 19 – Pre-Excavation

- *Site 19 – Catch Basins at Chip Collection Houses*
 - Consists of drainage areas leading from two chip collection houses, Buildings 785 and 1051
 - Releases from catch pad outfalls may have contaminated stream sediments
 - Only Building 785 remains in operation
 - Wastewater is now recycled rather than discharged to swales
 - SSP Report completed in June 2009
 - Contaminants of concern are lead and nitroglycerin in the surface and subsurface soil
 - Recommended IRA for surface and subsurface soil (groundwater will be looked at separately)

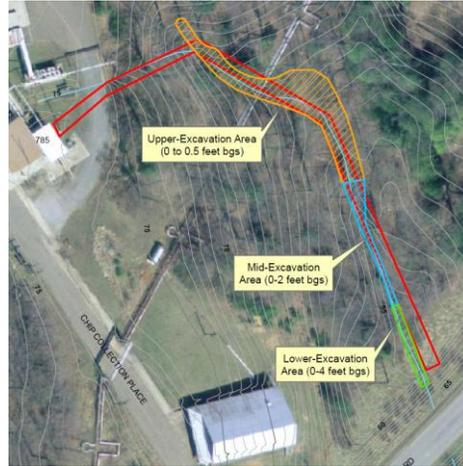
- EE/CA completed in September 2010
 - Recommends soil removal and offsite disposal
 - 0-6 inches in orange section
 - 0-2 feet in blue section
 - 0-4 feet in green section
 - Approx. 216 cubic yards to be removed
 - Post excavation sampling not needed
 - Backfill with clean soil
- Action Memorandum completed in September 2010

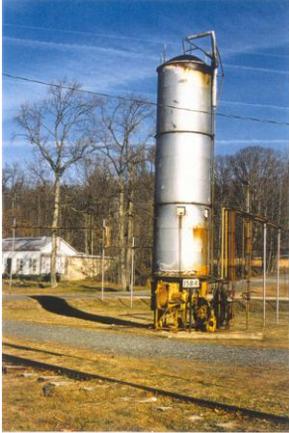
Site 27 – Pre-Excavation

- Recommends surface soil removal (0-6 inches) and offsite disposal
- Approx. 299 cubic yards to be removed
- Post excavation sampling not needed
- Backfill with clean soil

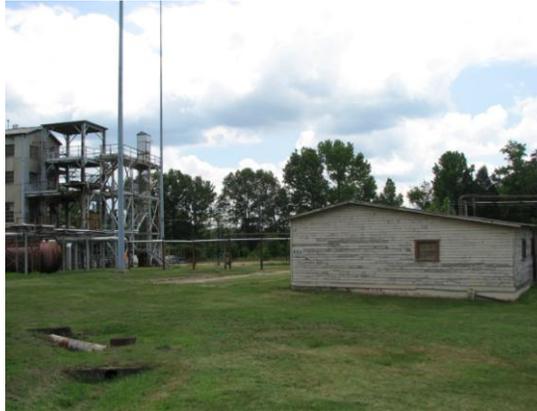
- Site is located north of Hershey Road and 400' from the Mattawoman Creek
- Former destructor was located on concrete pad (Building 1584)
- The incinerator operated from 1976-1979 and burned hydrazine-containing fuel and UDMH-contaminated wastewater
- Potential spills from operations may have contaminated soils surrounding concrete pad
- SSP Report was completed in June 2009
 - Contaminant of concern is Arsenic and Chromium
 - Recommended IRA for surface soil

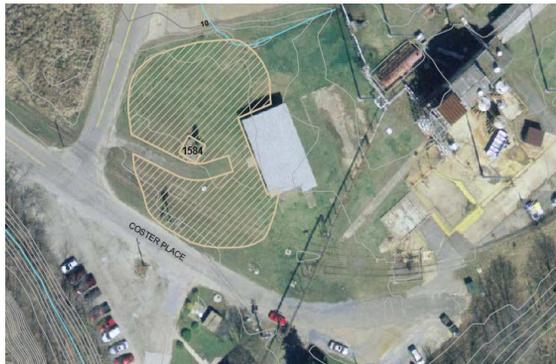
• EE/CA completed in September 2010

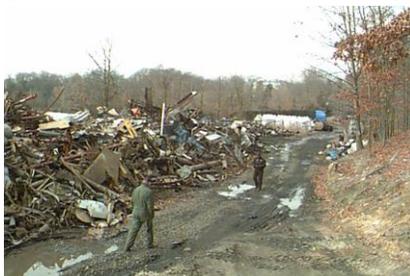
- Used as scrap metal storage yard by the installation from 1960s-1980s
- PCBs from transformers leaked and contaminated soil
- Waste, lead-acid batteries also suspected of leaking and contaminating soil
- Originally designated as Site 41 in the IR Program

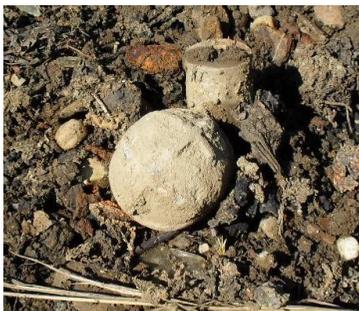
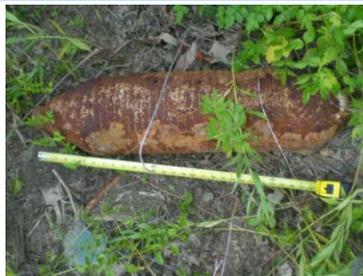
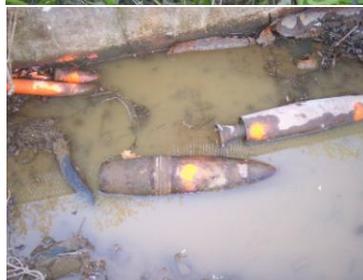
**220 LB Frag Bomb
8" Projectile
BLU 36 Submunition**

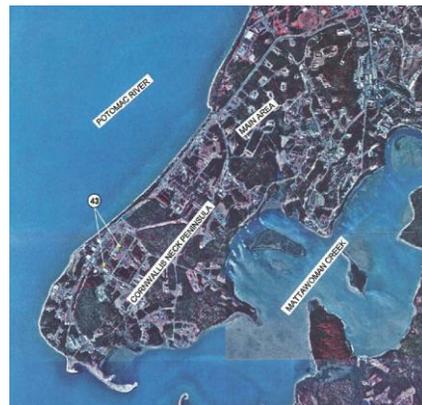
- *Site 43 includes two areas separated by 700 ft along Gallery Rd*
 1. *Area near northern corner of Building 1040*
 2. *Utility pole across Gallery Rd from Building 1041*

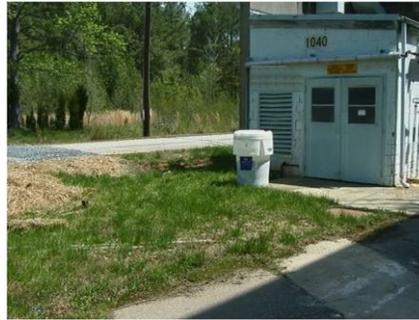
- *Parts cleaning operations occurred from 1960 to 1989.*
- *Historical disposal of acetone used for propellant removal in drainage ditch over ~2 yrs.*

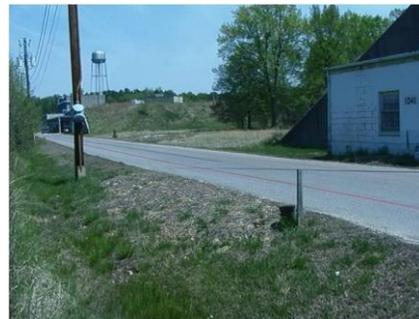
- *Parts cleaning operations occurred from the late 1950s to 1989.*
- *Historical disposal of acetone and toluene used for propellant removal at base of pole over ~2 yrs*

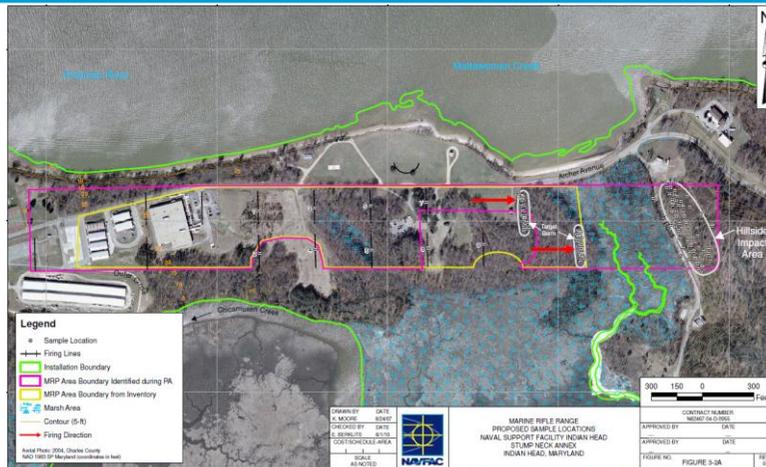
Marine Rifle Range (UXO 14)

- Used for rifle (.30-cal) training from 1911 to 1918
- Multiple firing lines, two target berms, hillside impact area

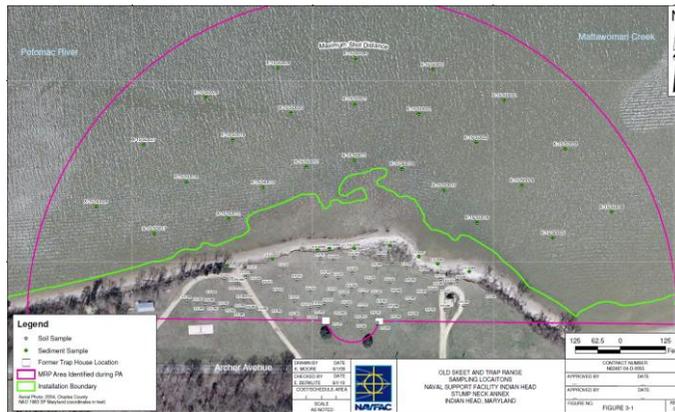
Old Skeet and Trap Range (UXO 15)

- Used for small arms recreation from ~1967 to 1991
- Flat, fan-shaped area with accumulations of lead shot and clay target fragments on ground surface

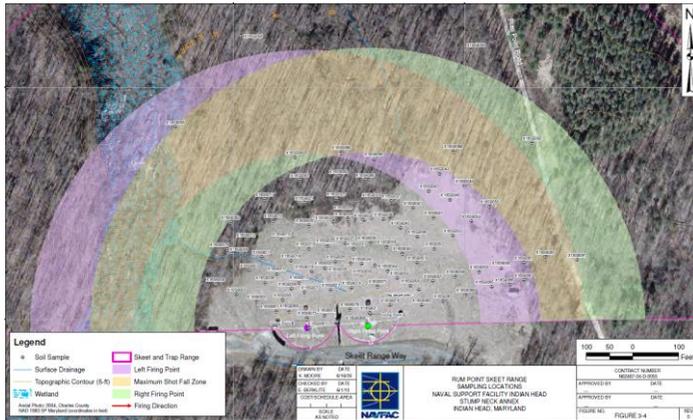
Rum Point Skeet Range (UXO 16)

- Used for shotgun recreation from 1991 to 2001
- Flat fan-shaped area with accumulations of lead shot and clay target fragments on ground surface

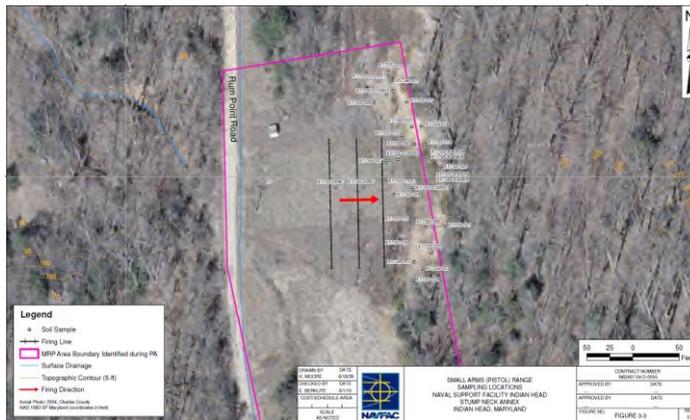
Small Arms (Pistol) Range (UXO 17)

- Used for small arms (.22-, .45-, .50-cal; 9-mm) training from mid-1980s to 1991
- Three firing lines, target/hillside impact area

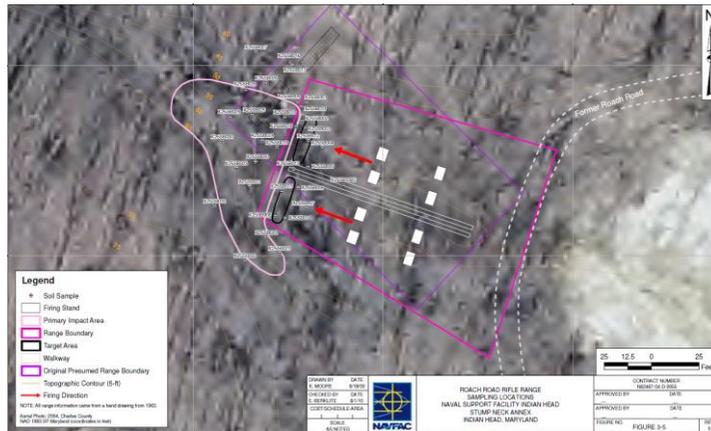
Roach Road Rifle Range (UXO 25)

- Used for small arms (rifle and pistol) training from 1967 to 1986
- Two firing lines, target/hillside impact area

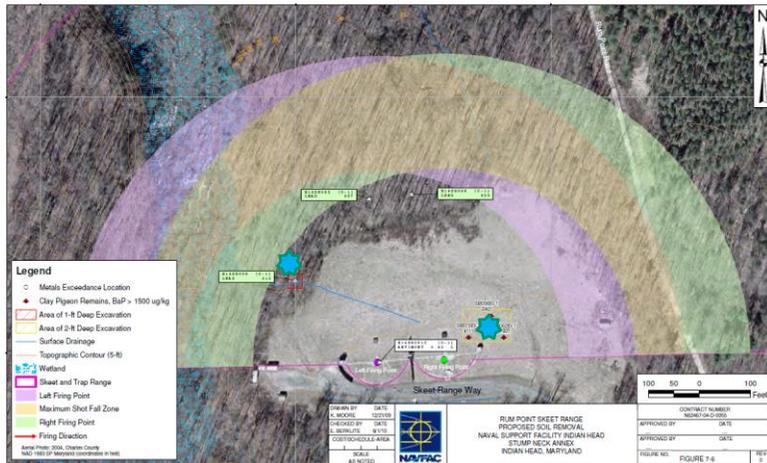
Rum Point Skeet Range (UXO 16)

- 2 wells – 1 each at firing point and NW target area
- Sample firing point for PAHs; target for antimony, lead

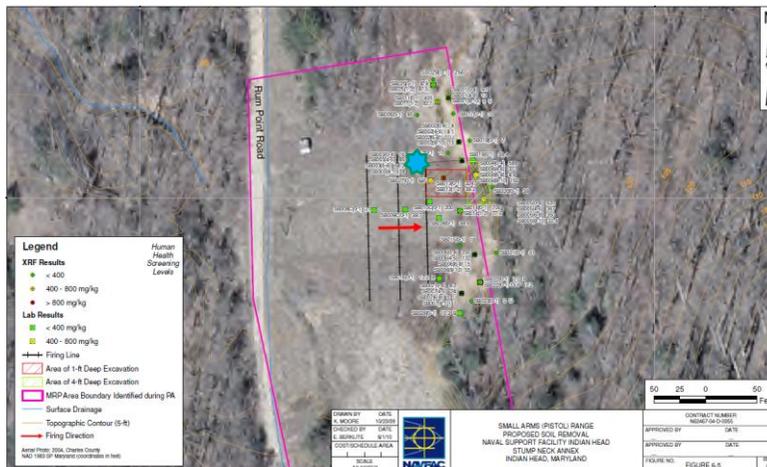
Small Arms (Pistol) Range (UXO 17)

- 1 well – at hillside target area
- Sample for NG, antimony, lead

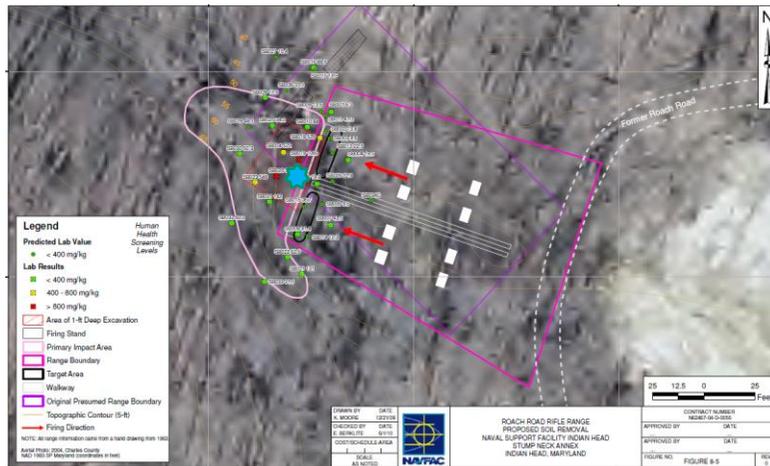
Roach Road Rifle Range (UXO 25)

- 1 well – at hillside target area
- Sample for antimony, copper, lead
