SUBJECT: PERMIT YEAR 2 ANNUAL REPORT FOR NAVY CONSOLIDATED MS4 PERMIT (VAR040114)

REGIONAL MS4 STORMWATER PROGRAM ANNUAL REPORT

Naval Station Dam Neck, Virginia Beach, VA
Storm Water Discharge Investigation 9-25-14

Dam Neck Storm Manhole Connecting Pipe Inspections

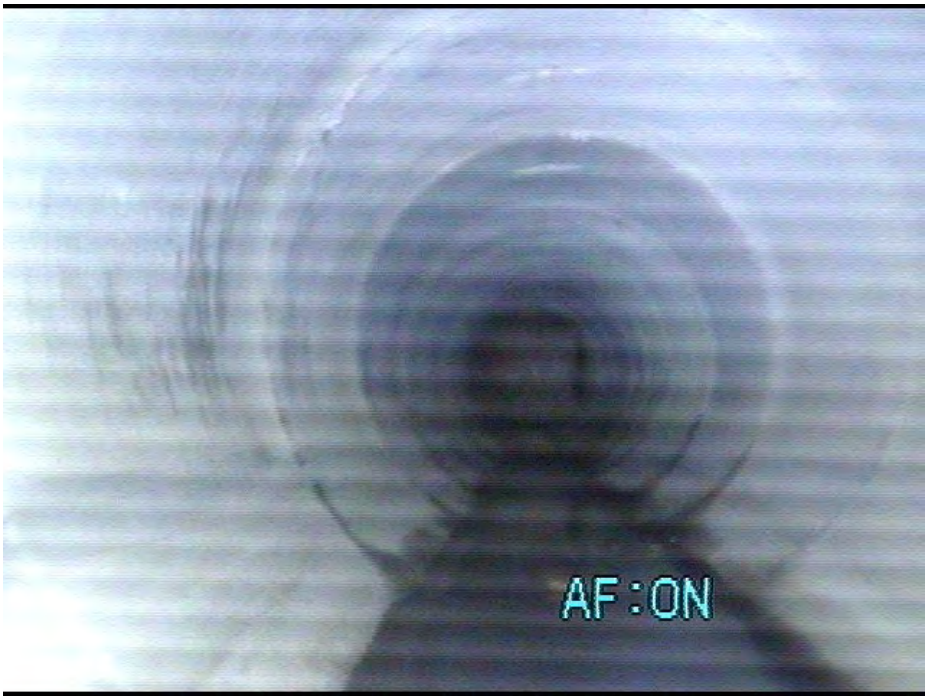
Stormwater Manhole 003

MH 003 Outgoing 30-inch line penetrated by steel bar 15-feet downstream.

MH 003 Incoming 30-inch line in good condition.

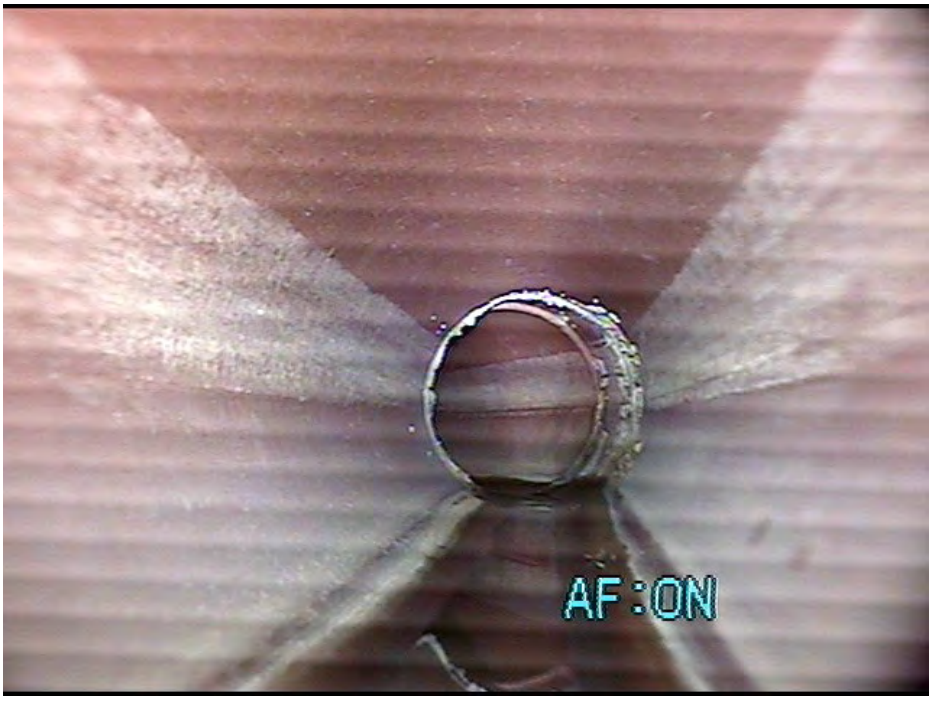
Stormwater Manhole 003

MH 003 Incoming 8-inch line abandoned line into manhole.

MH 003 Incoming 12-inch line originates in Building 127 (no flow observed).

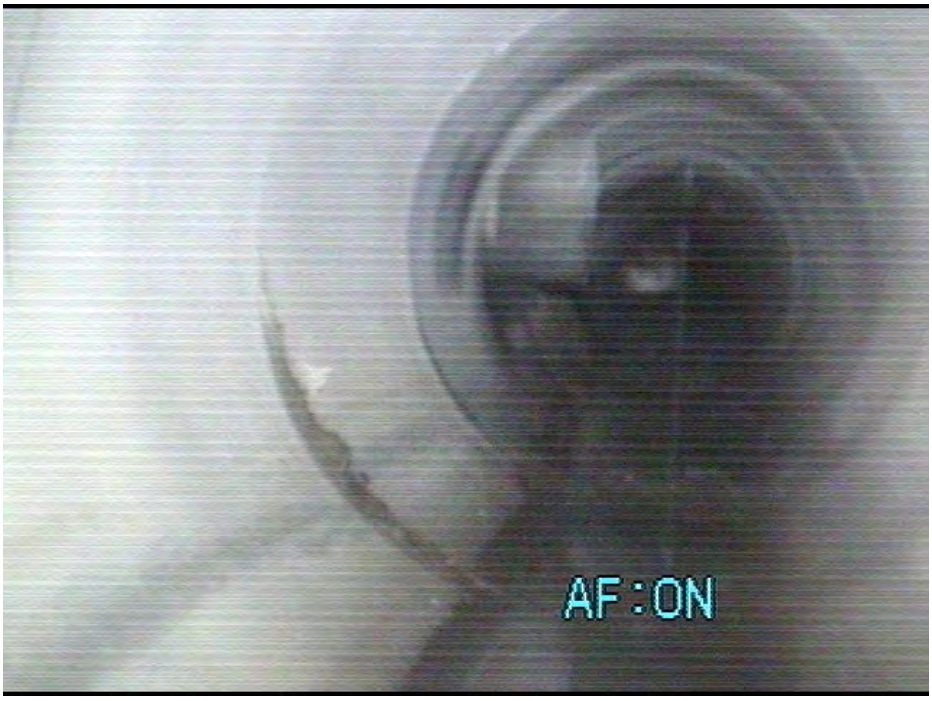
Stormwater Manhole 004

MH 004 Outgoing 30-inch line with minor longitudinal cracks.

MH 004 Incoming 30-inch line with catch basin connection 9 0’clock and discharge from 2-inch pipe 57.5 feet upstream from 12 o’clock position.

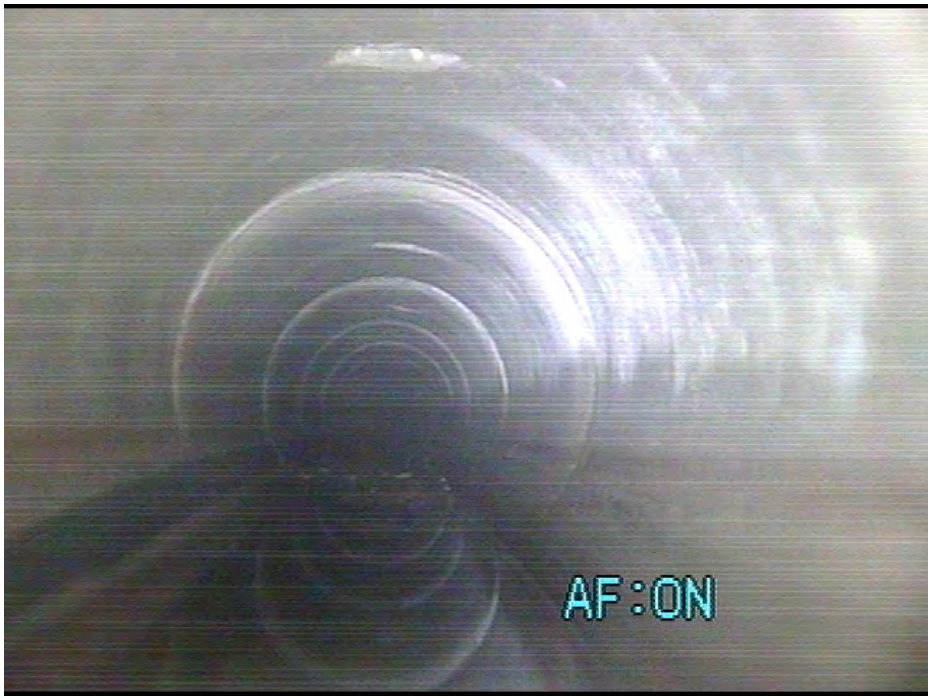
Stormwater Manhole 006

MH 006 Outgoing 30-inch line with minor debris casing water to pond.

MH 006 incoming 15-inch line with debris.

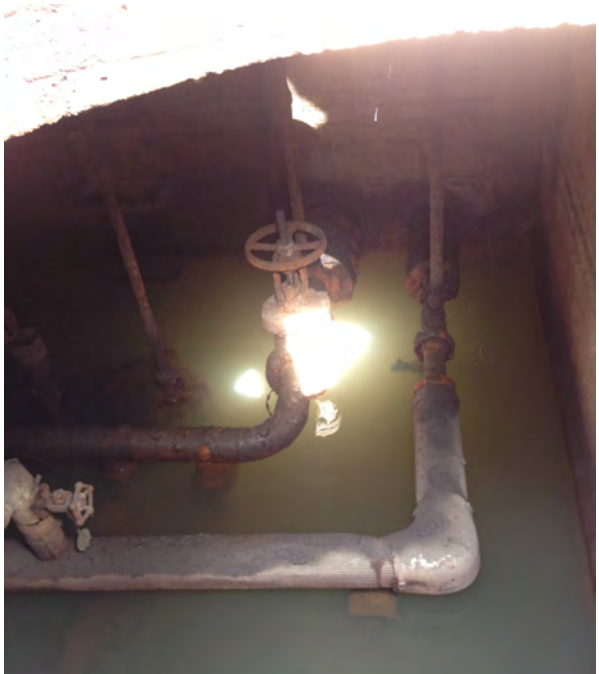
Not clear what these pipes are inside manhole by physical fitness center, (BLDG 276). Any storm drainage pipes here are fully submerged, if present.

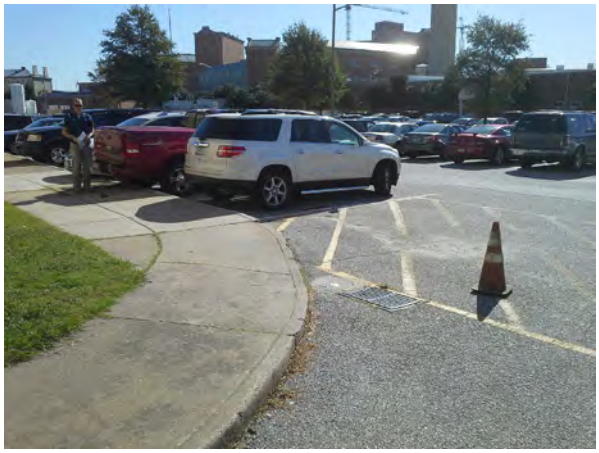
Outlet pipe not visible.

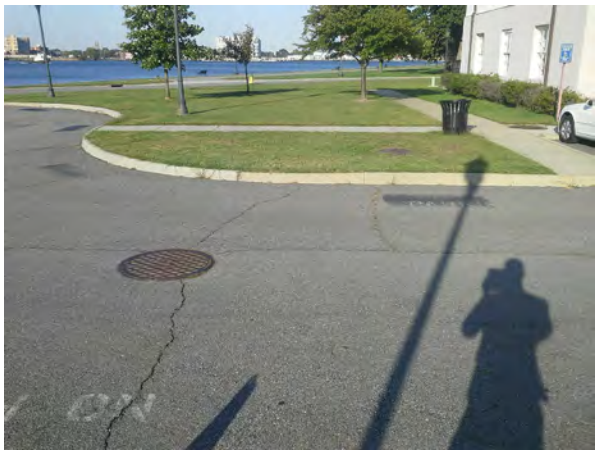
NSA Portsmouth-12-324 Grid ID: C8

Pipe dimensions determined from downstream invert.

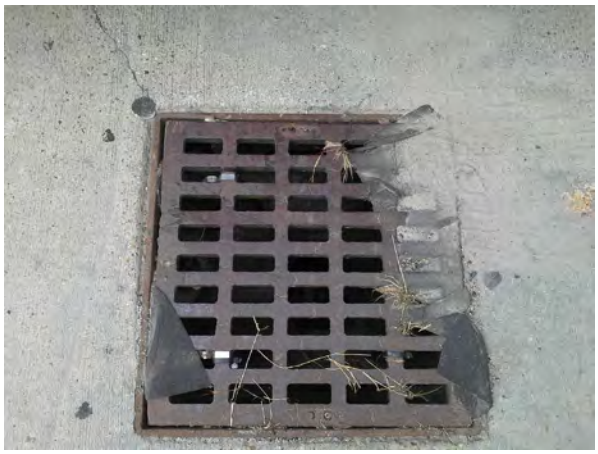
Sediment bag

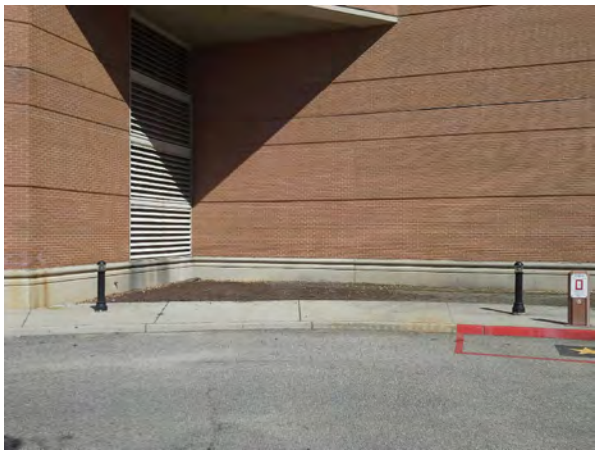
A temporary air handling unit was located near this curb inlet during initial inspection. At a follow-up visit, that unit was removed and curb inlet was dry.

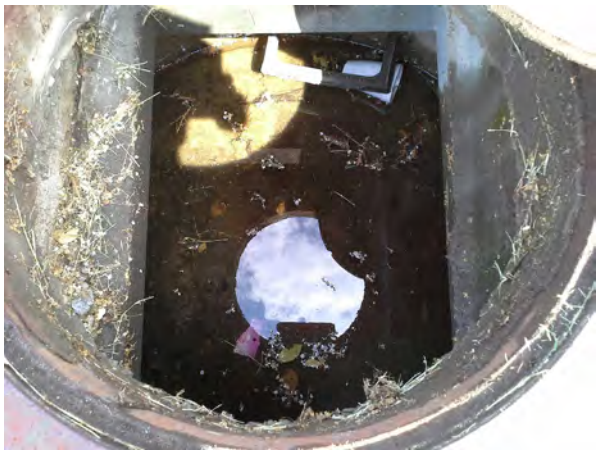
Standing water.

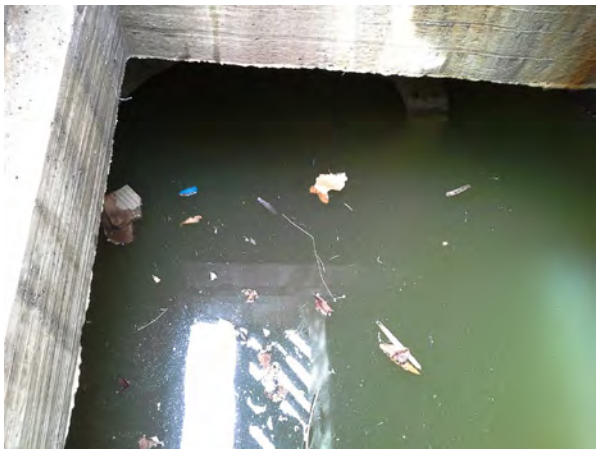
Standing water

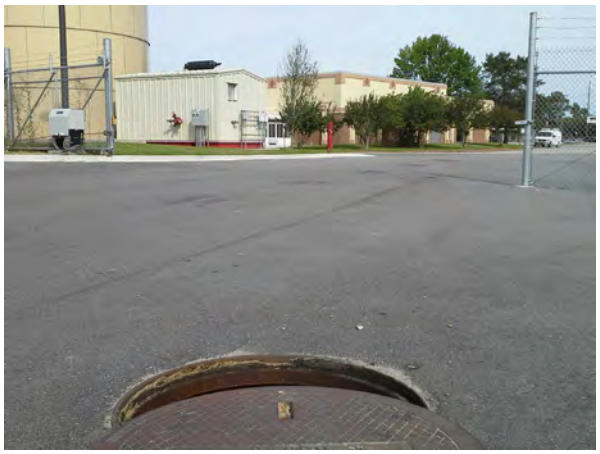
Clear trickle. Nearest source of flow appears to be fire supply line. This can be seen in the distance in the photo on the right.
