Revision 0 – February 5, 2007

Corrective Action Area 6
Alameda Point, Alameda, California

Final Field Activity Summary Report

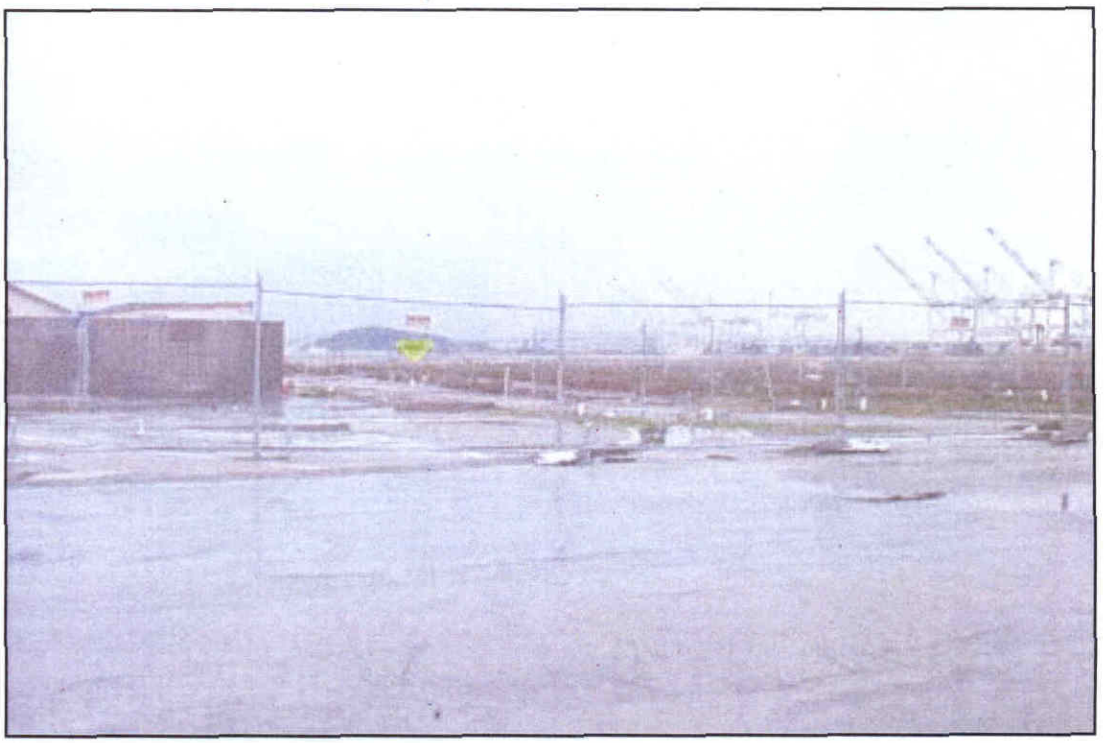
Photo No. 1: CAA-6 area north of Building 377, looking west-northwest (2006).

Photo No. 2: Sparge well wellhead assembly showing pressure gauge and sample port.

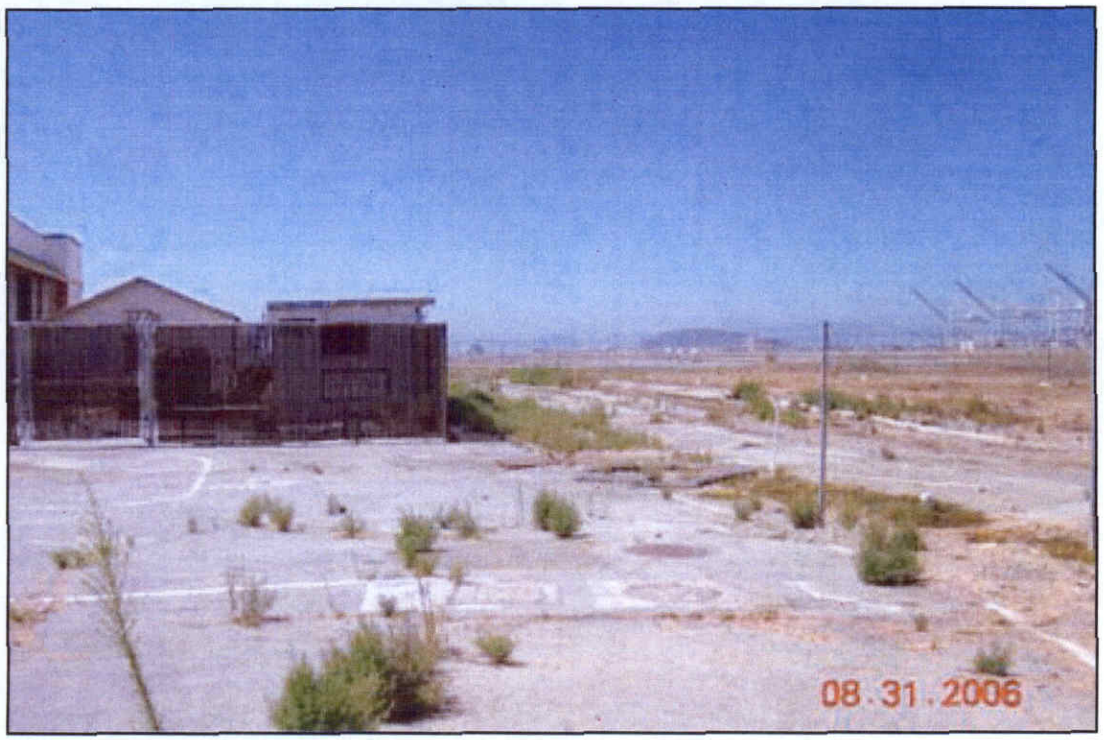
Photo No. 3: Site inside fence looking west with Building 377 inside fenced compound (left center - August 2006)

Photo No. 4: Site inside fence looking southwest toward Building 20, Building 377 in center (August 2006).
