June 2, 1999

Re: Tank Closure Report
Above-ground Storage Tank (AST) 155 at
Marine Corps Air Station El Toro, California
SWDIV Contract No. N68711-93-D-1459
DCN SW 6816, Delivery Order No. 70

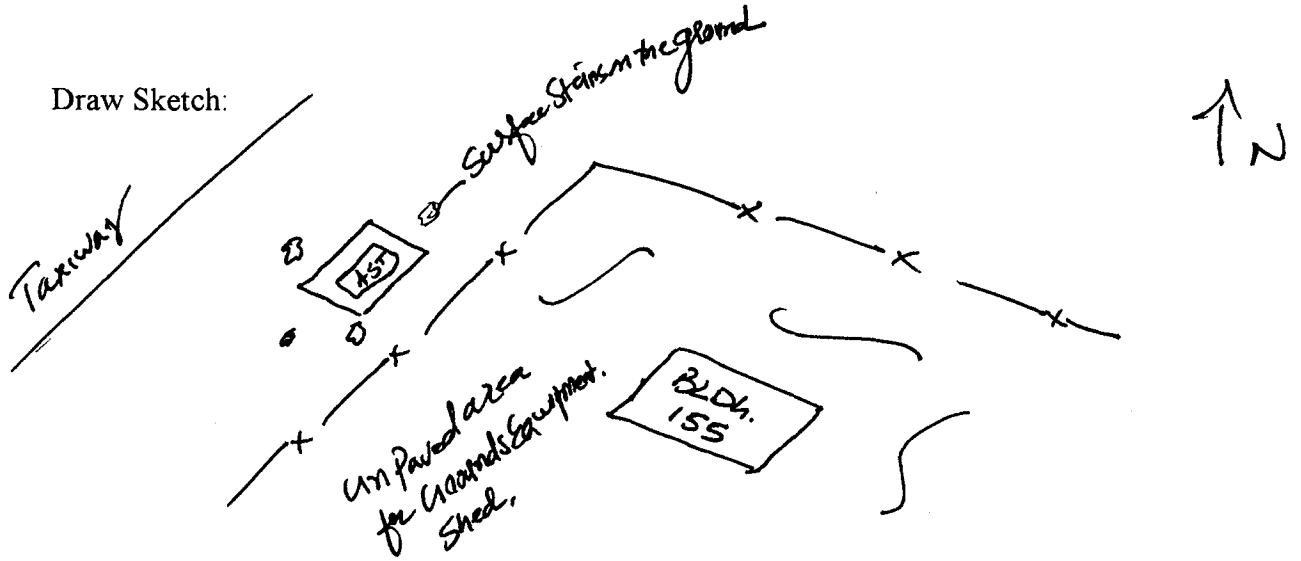
Draw Sketch:

Additional Field Notes: Some surface stains around the Concrete berm area. Probably from AST 155 use, No recent spill observed. AST Seems to be empty and not in active use from long time.

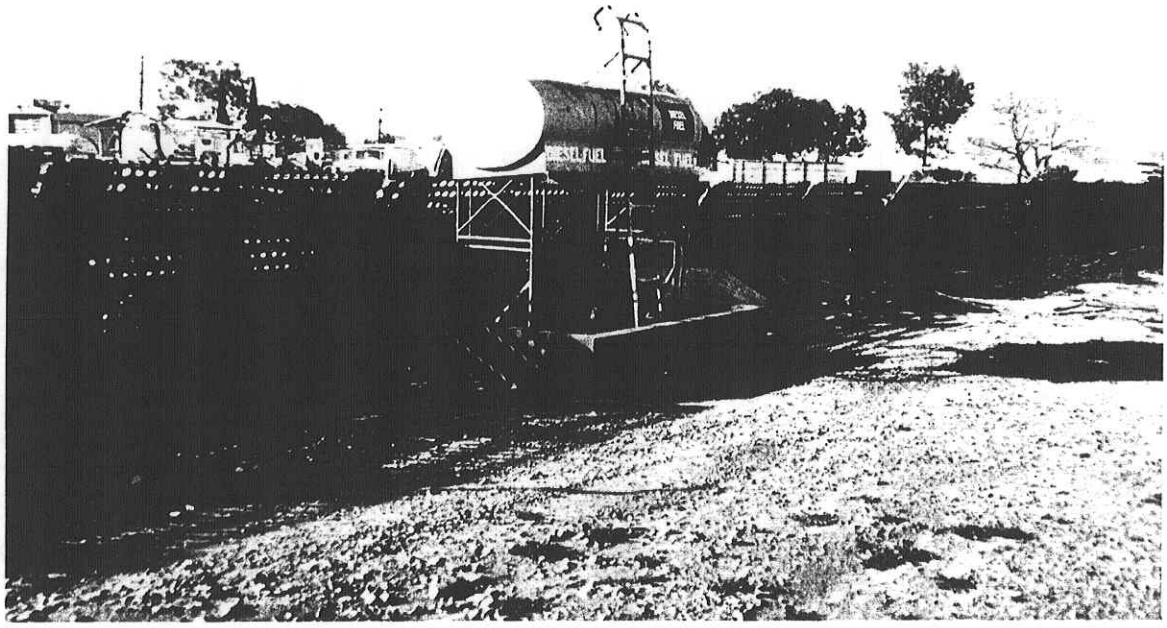
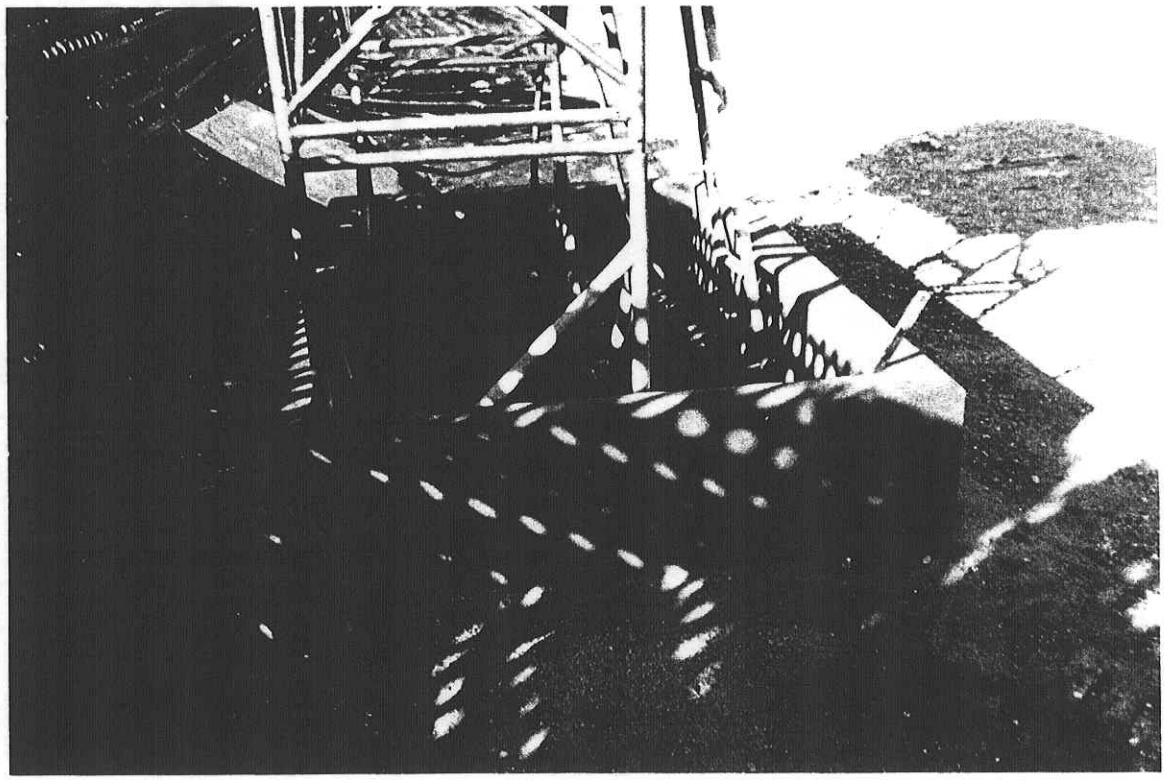
Photograph No. 1 and 2: AST 155 Site Condition Prior to Removal

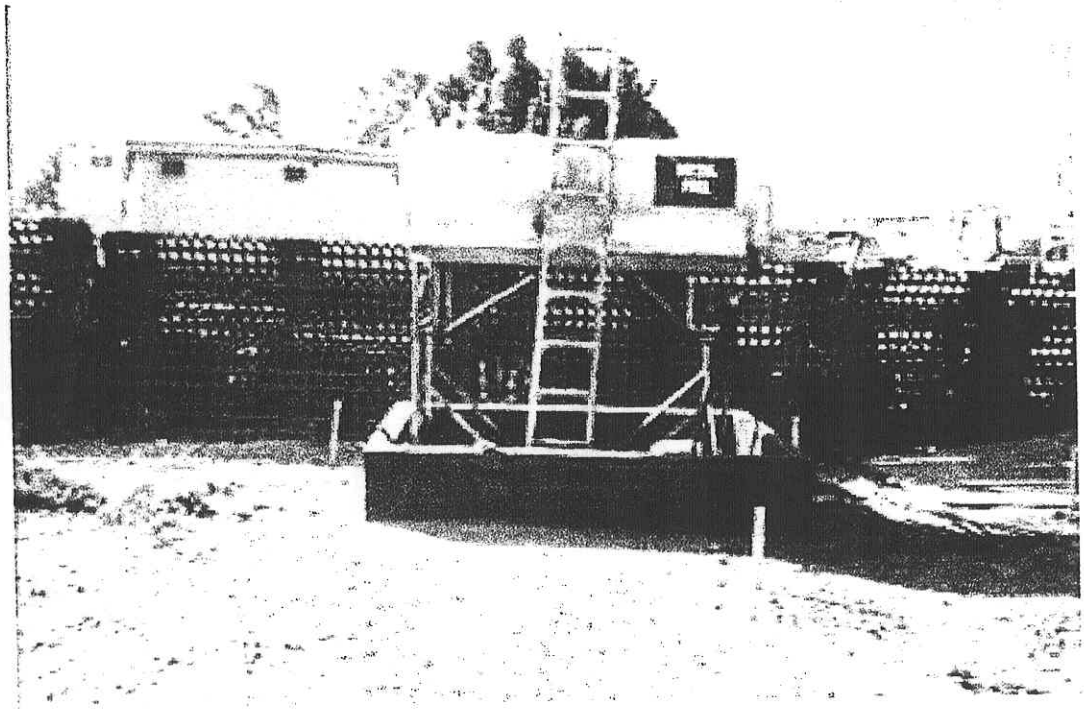
During the visual inspection of the AST 155 area, OHM observed some evidence of surface stains at four locations on the unpaved dirt area surrounding the concrete berm. OHM determined the general hand auger sampling locations at the stained areas. A copy of the Site Inspection Log is included in Appendix B, Site Inspection Log.

Photograph No. 3: AST 155 Surrounding Unpaved Dirt Area

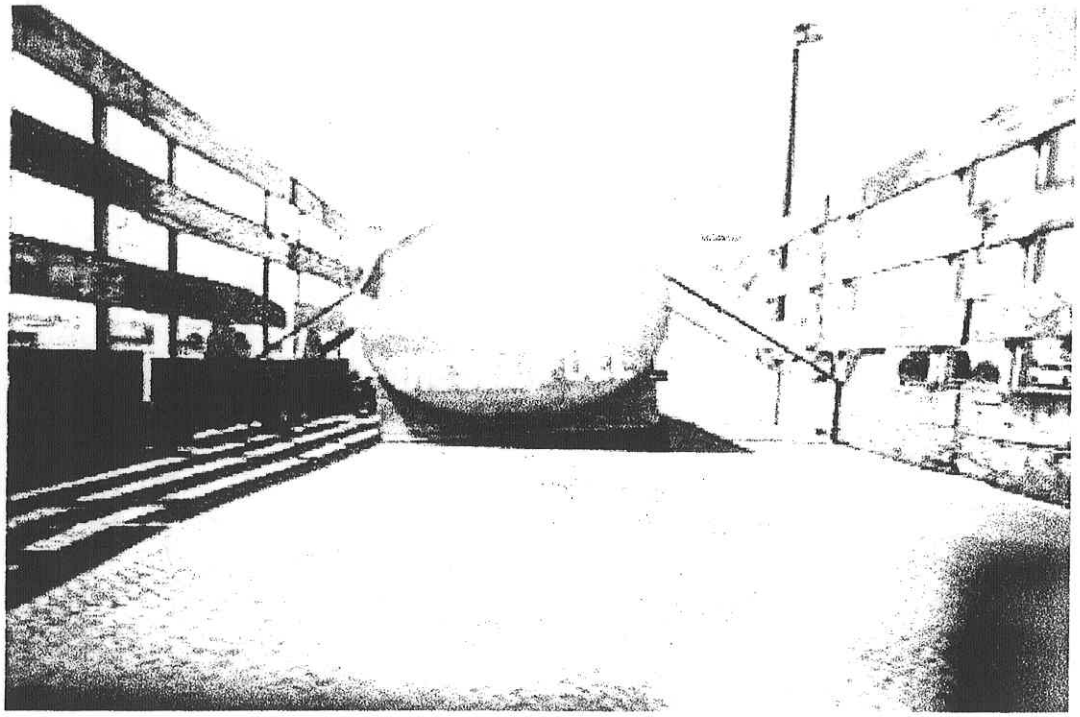
Photograph No. 4: AST 155 confirmation soil samples locations with staked
