Closure Report

Solid Waste Management Unit Number 88 (SWMU 88)
Marine Corps Air Station
El Toro, California

SWDIV Contract No. N68711-93-D-1459, Delivery Order No. 0070
OHM Project No. 18609
Document Control No. SW9703
Revision 0
May 21, 2001

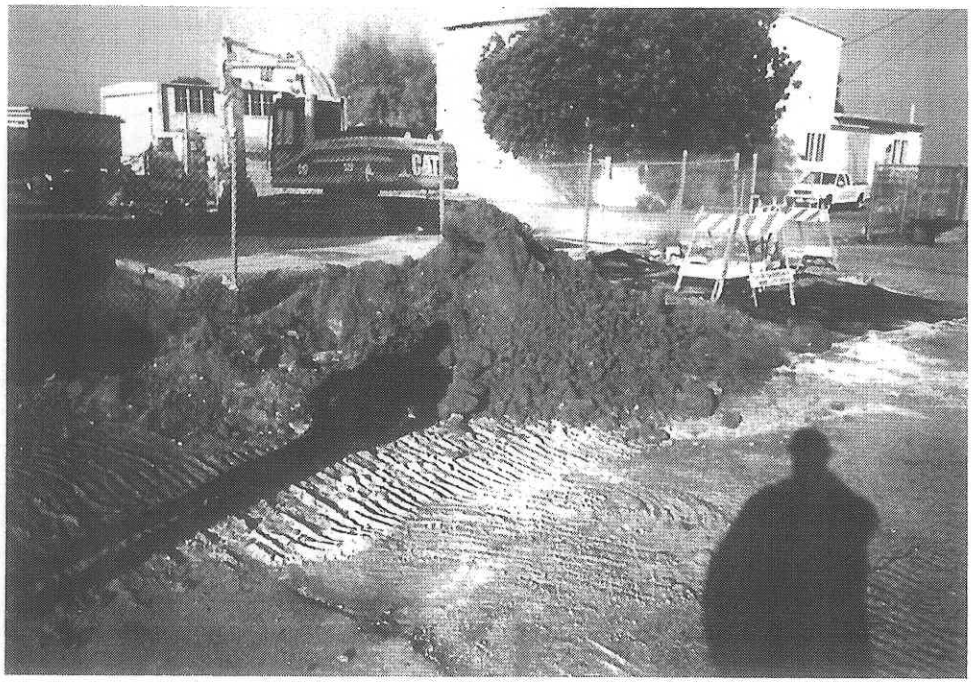
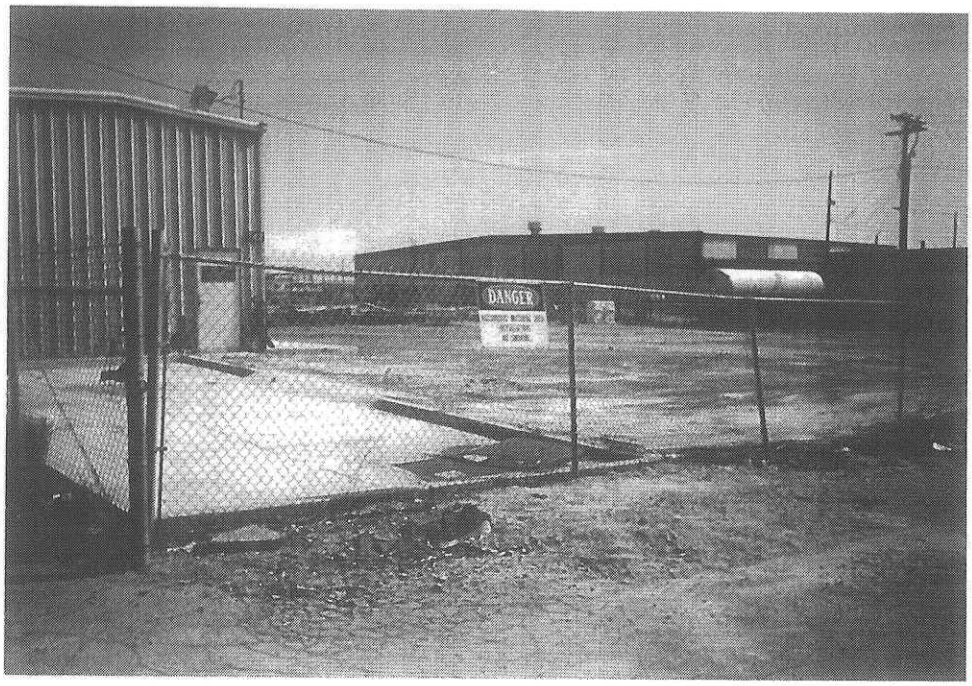
Excavation of PCB-contaminated soil at SWMU 88.

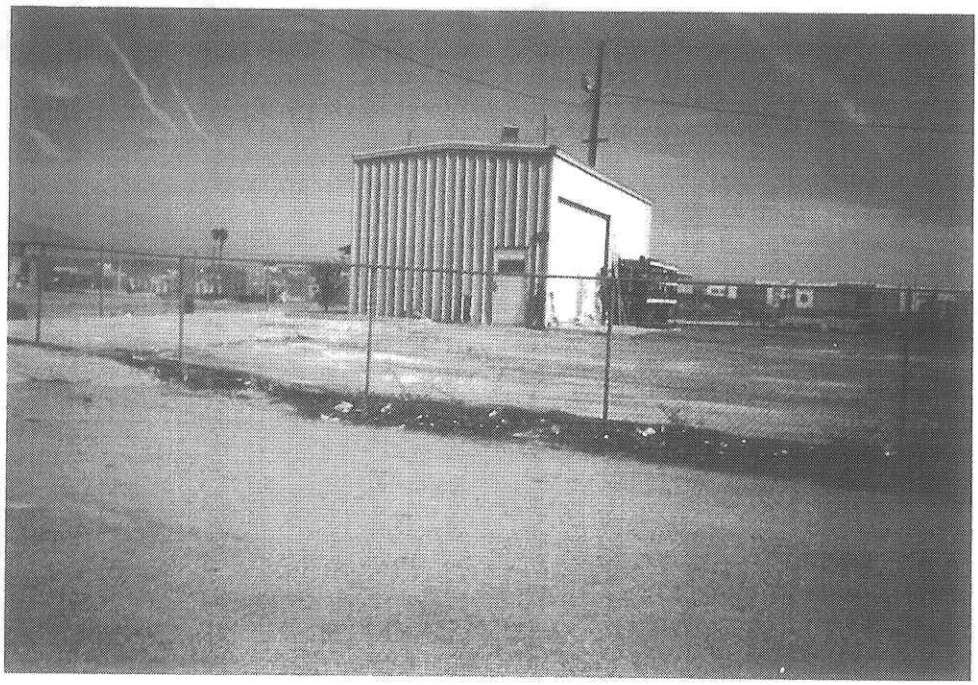
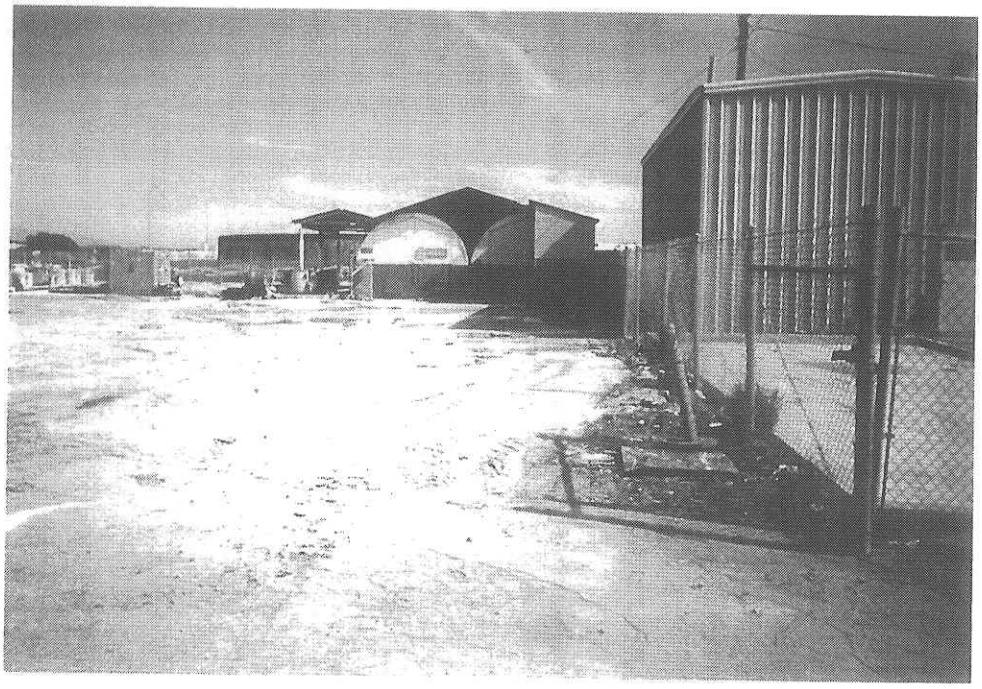
Post-excavation at SWMU 88.
