INFORMATION PACKAGE

Aerial Photograph Anomaly APHO 122 (SAIC 570)
Former Open Storage Area
Former Marine Corps Air Station, El Toro

12 March 2004

APHO 122 (SAIC 570)
Former Open Storage Area
Former Marine Corps Air Station (MCAS), El Toro
Dates of Visual Inspections: May 2003, 24 February 2004, and 10 March 2004

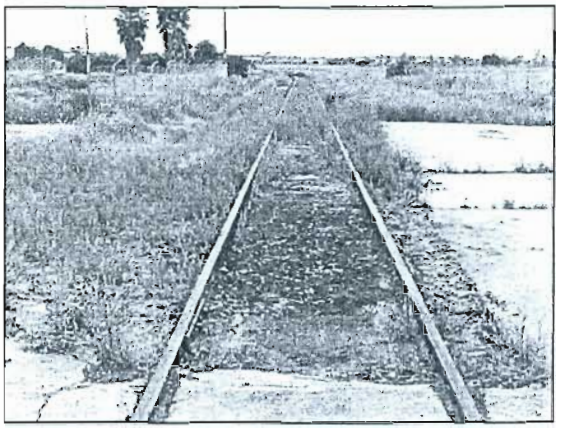
Stained soils were observed between the railroad tracks near the southeastern boundary of the investigation area. The 1950 drawing of the petroleum storage area at APHO 122 shows a feature identified as an "unloading dock" at or near the stained soils. Photograph 1 shows the stained area and Photograph 7 shows the location of the stained area relative to the locations of the open storage areas.

Photograph 1. Railroad Spur at APHO 122 (SAIC 570).
Former MCAS El Toro. Date of Photograph: 8 May 2003.

Boring Identifier	Location	Comments
APHO122 HA1 (also known as HA1)	Between the railroad tracks, near former unloading dock, at the stained area. (See Photographs 1 and 7 in the Appendix) The railroad tracks are located between the southwestern and northeastern fenced storage areas. The railroad spurs within the southwestern section of the facility are also being addressed as Potential Release Location (PRL) Railroads. The sample HA1 is proposed because it is between the two fenced open storage areas of APHO 122 and the stain may be attributable to former operations at the open storage areas.	Sample will be analyzed for the following chemicals: Total Petroleum Hydrocarbons (EPA Method 8015-Diesel, EPA Method 8015-Gasoline) Volatile Organic Compounds (EPA Method 8260B) Semivolatile Organic Compounds (EPA Method 8270) Chlorinated Acid Pesticides (EPA Method 8151A) Organochlorine Pesticides (EPA Method 8081A) Organophosphorus Compounds (EPA Method 8141A) Metals (EPA Methods 6010B and 7174A)

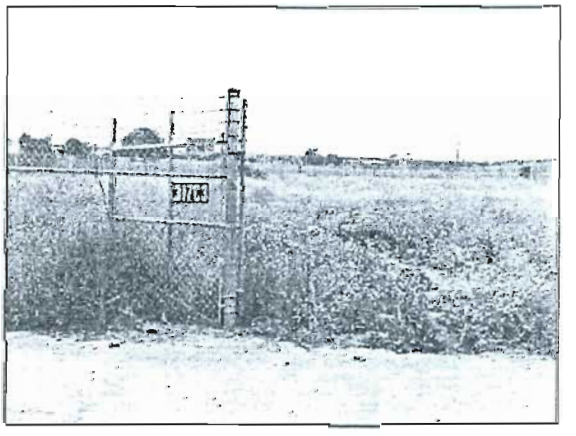
Photograph 2. Gated Fence at APHO 122 (SAIC 570).
Former MCAS El Toro. Date of Photograph: 8 May 2003.

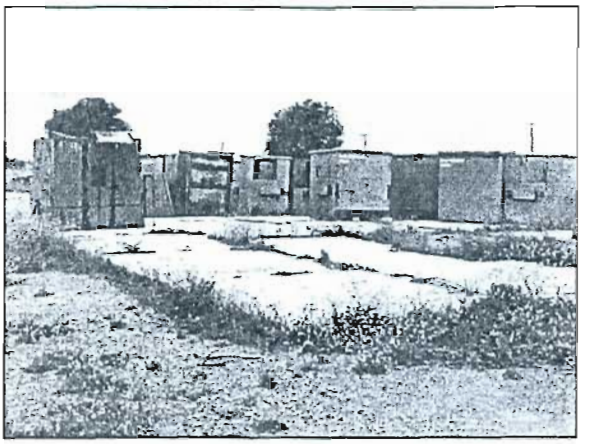
Empty garbage dumpsters were observed in storage in the northwestern end of APHO 122 during the visual inspections. No stains were observed on the ground surface in the dumpster storage area.

Photograph 4. Concrete Slab with Empty Dumpsters at APHO 122 (SAIC 570).
Former MCAS El Toro. Date of Photograph: 8 May 2003.

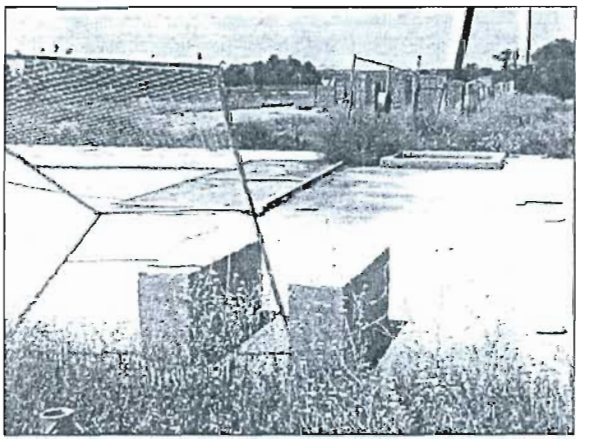
Photograph 5. Concrete Slab at APHO 122 (SAIC 570).
Former MCAS El Toro. Date of Photograph: 12 May 2003.

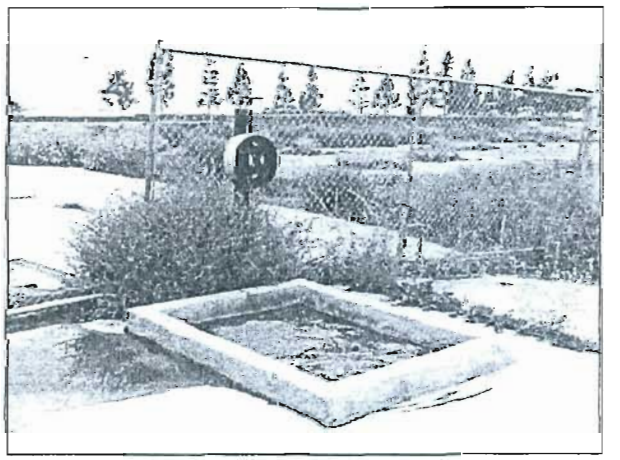
Photograph 6. Concrete Slab with Bermed Area at APHO 122 (SAIC 570).
Former MCAS El Toro. Date of Photograph: 12 May 2003.

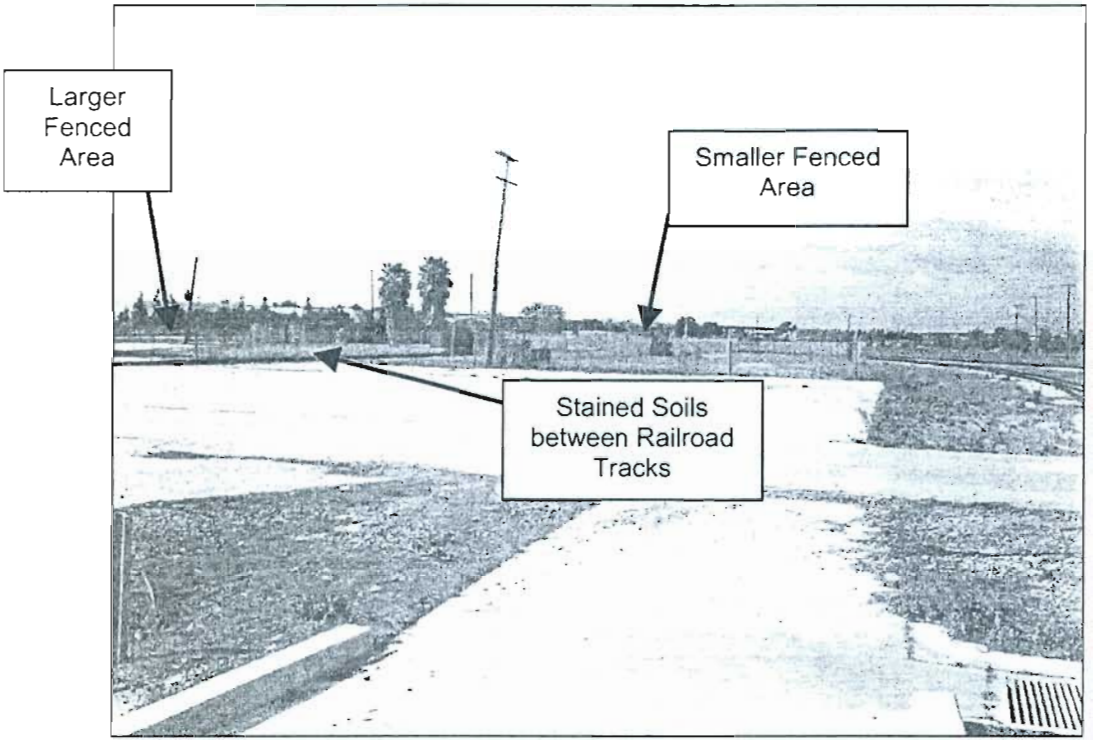
Photograph 7. View of APHO 122 (SAIC 570) from Building 317, Looking Approximately Northwest.
Former MCAS El Toro. Date of Photograph: 24 February 2004
