N96095.AR.000440
NWIRP CALVERTON NY
5090.3a

SUBJECT: ENVIRONMENTAL INVESTIGATIONS AT THE SOUTHERN AREA AND PECONIC RIVER SPORTSMAN'S CLUB PROPERTY; NWIRP CALVERTON, NEW YORK

Enclosure: 1. Analytical Data for Southern Area Investigation

STUDY AREA
SITES 6A, 10B, SA
PHASE 2 – RCRA FACILITY INVESTIGATION
NWIRP, CALVERTON, NY

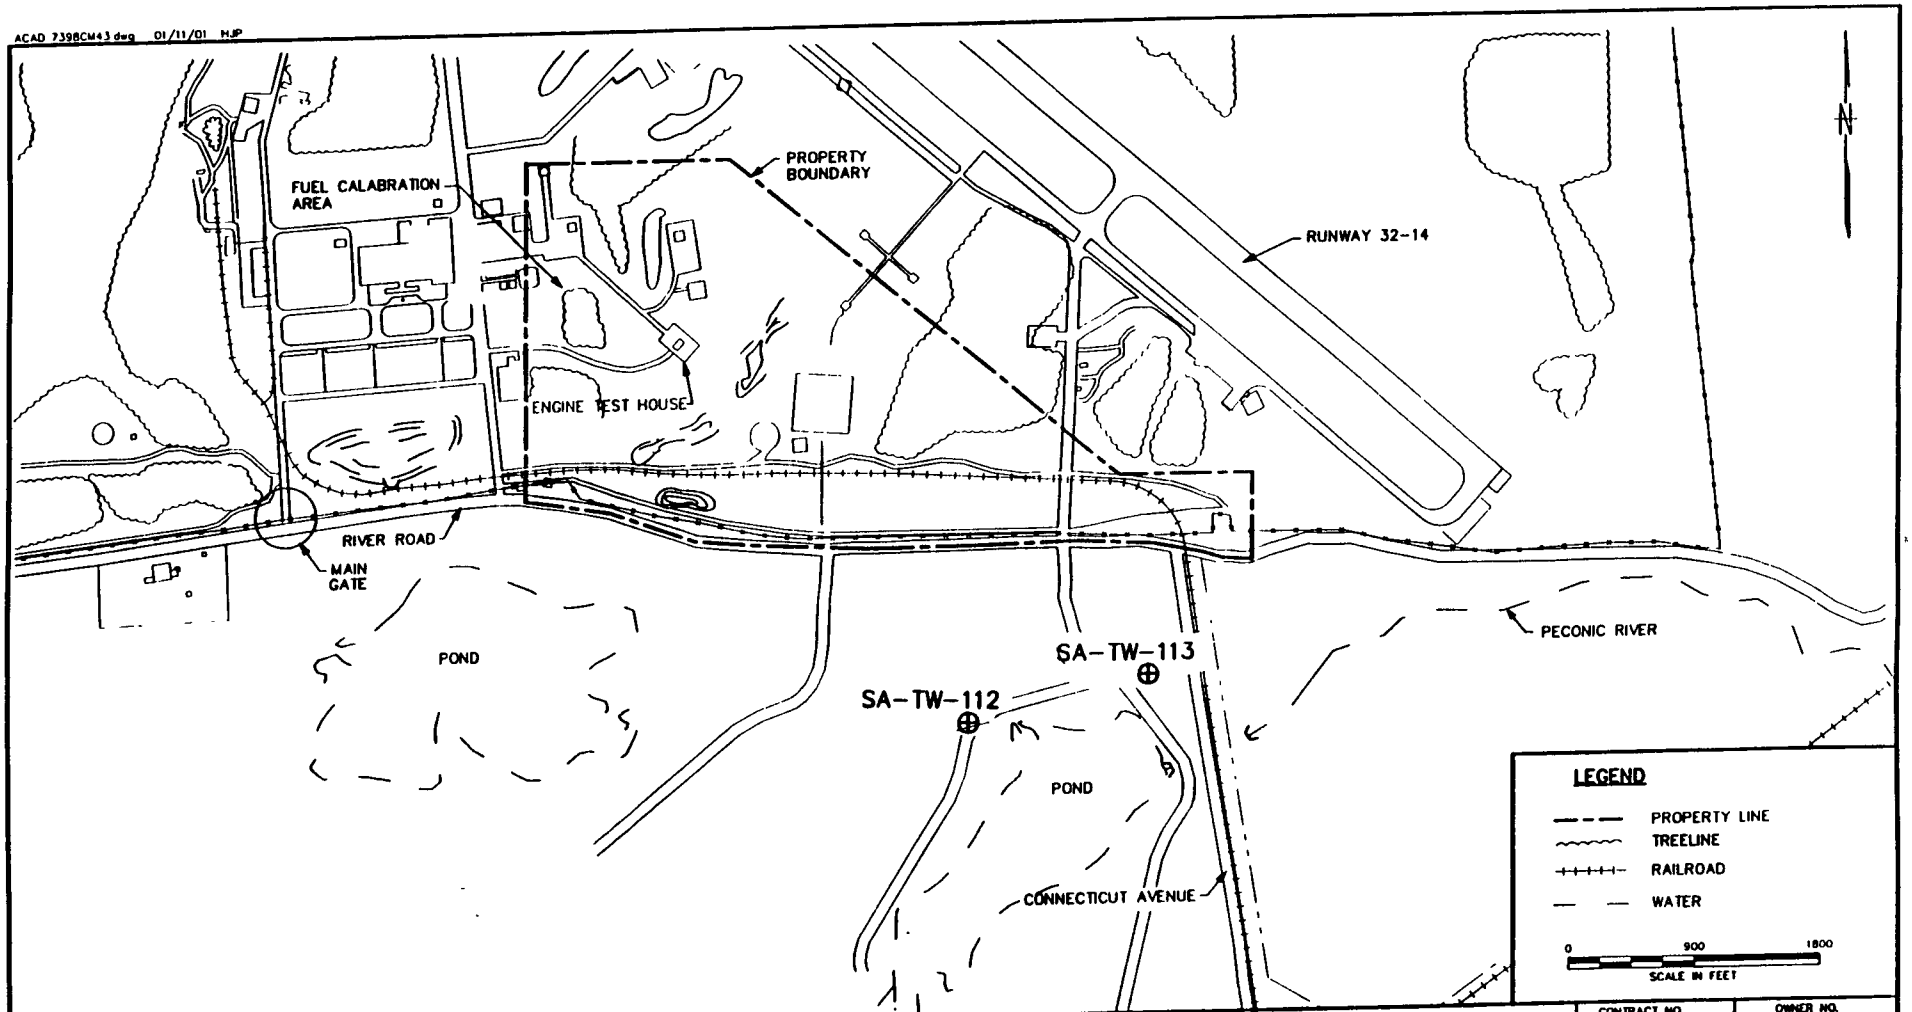
Temporary monitoring well SA-TW113, which was located on gun club property, was found to be contaminated in the deepest sample collected from 95 feet below ground surface (bgs). For all other locations sampled within this part of the Southern Area, the maximum depth for which VOC contamination was detected was less than 60 feet bgs and groundwater flows upward near the Peconic River. One possible concern with finding contamination at this depth is the presence of a groundwater extraction well that has been reported to be located in the general vicinity of SA-TW113. If this well does exist, the Navy would like to request information regarding this well including date of installation, groundwater pumping rate, screened interval, well construction material, method of installation, and analytical data that may have been collected from this well. This information will aid in the determination of whether or not contamination found at this depth is from natural migration from the Navy's property or from relatively shallower contamination that was pulled down to this depth by virtue of the operation of this extraction well.
