INITIAL ASSESSMENT STUDY OF MARINE CORPS BASE CAMP LEJEUNE NORTH CAROLINA

NEESA 13-011

INITIAL ASSESSMENT STUDY

OF MARINE CORPS BASE CAMP LEJEUNE, NORTH CAROLINA

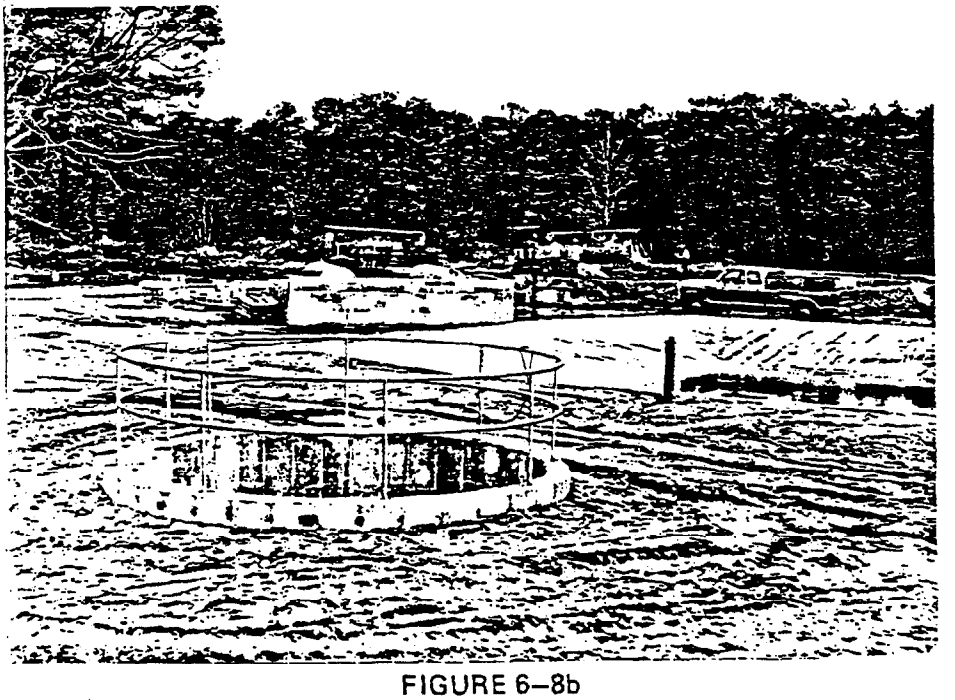
FIGURE 6–8b
Site No. 9 – Fire Fighting Training Pit near Piney Green Road.
Oil Water Separation Pit in Foreground

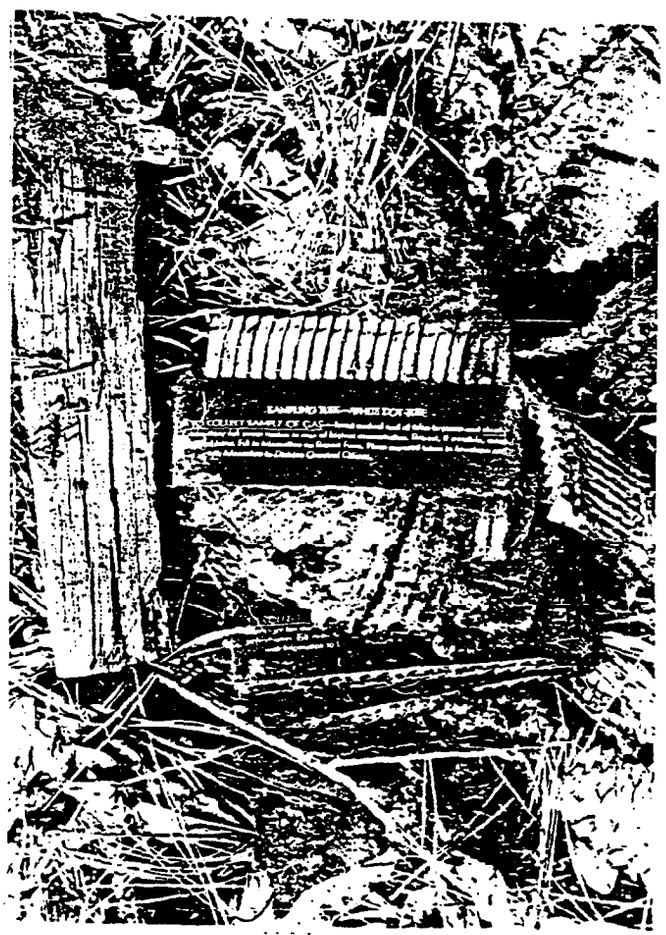
FIGURE 6–33
Site No. 69 – Rifle Range Chemical Dump
Showing Discarded Gas Detection Kits
