Contractor's Closeout Report

Underground Storage Tank Removals at Building 25 MCB Camp Lejeune Jacksonville, North Carolina

Contract No. N62470-93-D-3032
Delivery Order 0078

OHM Project No. 17418

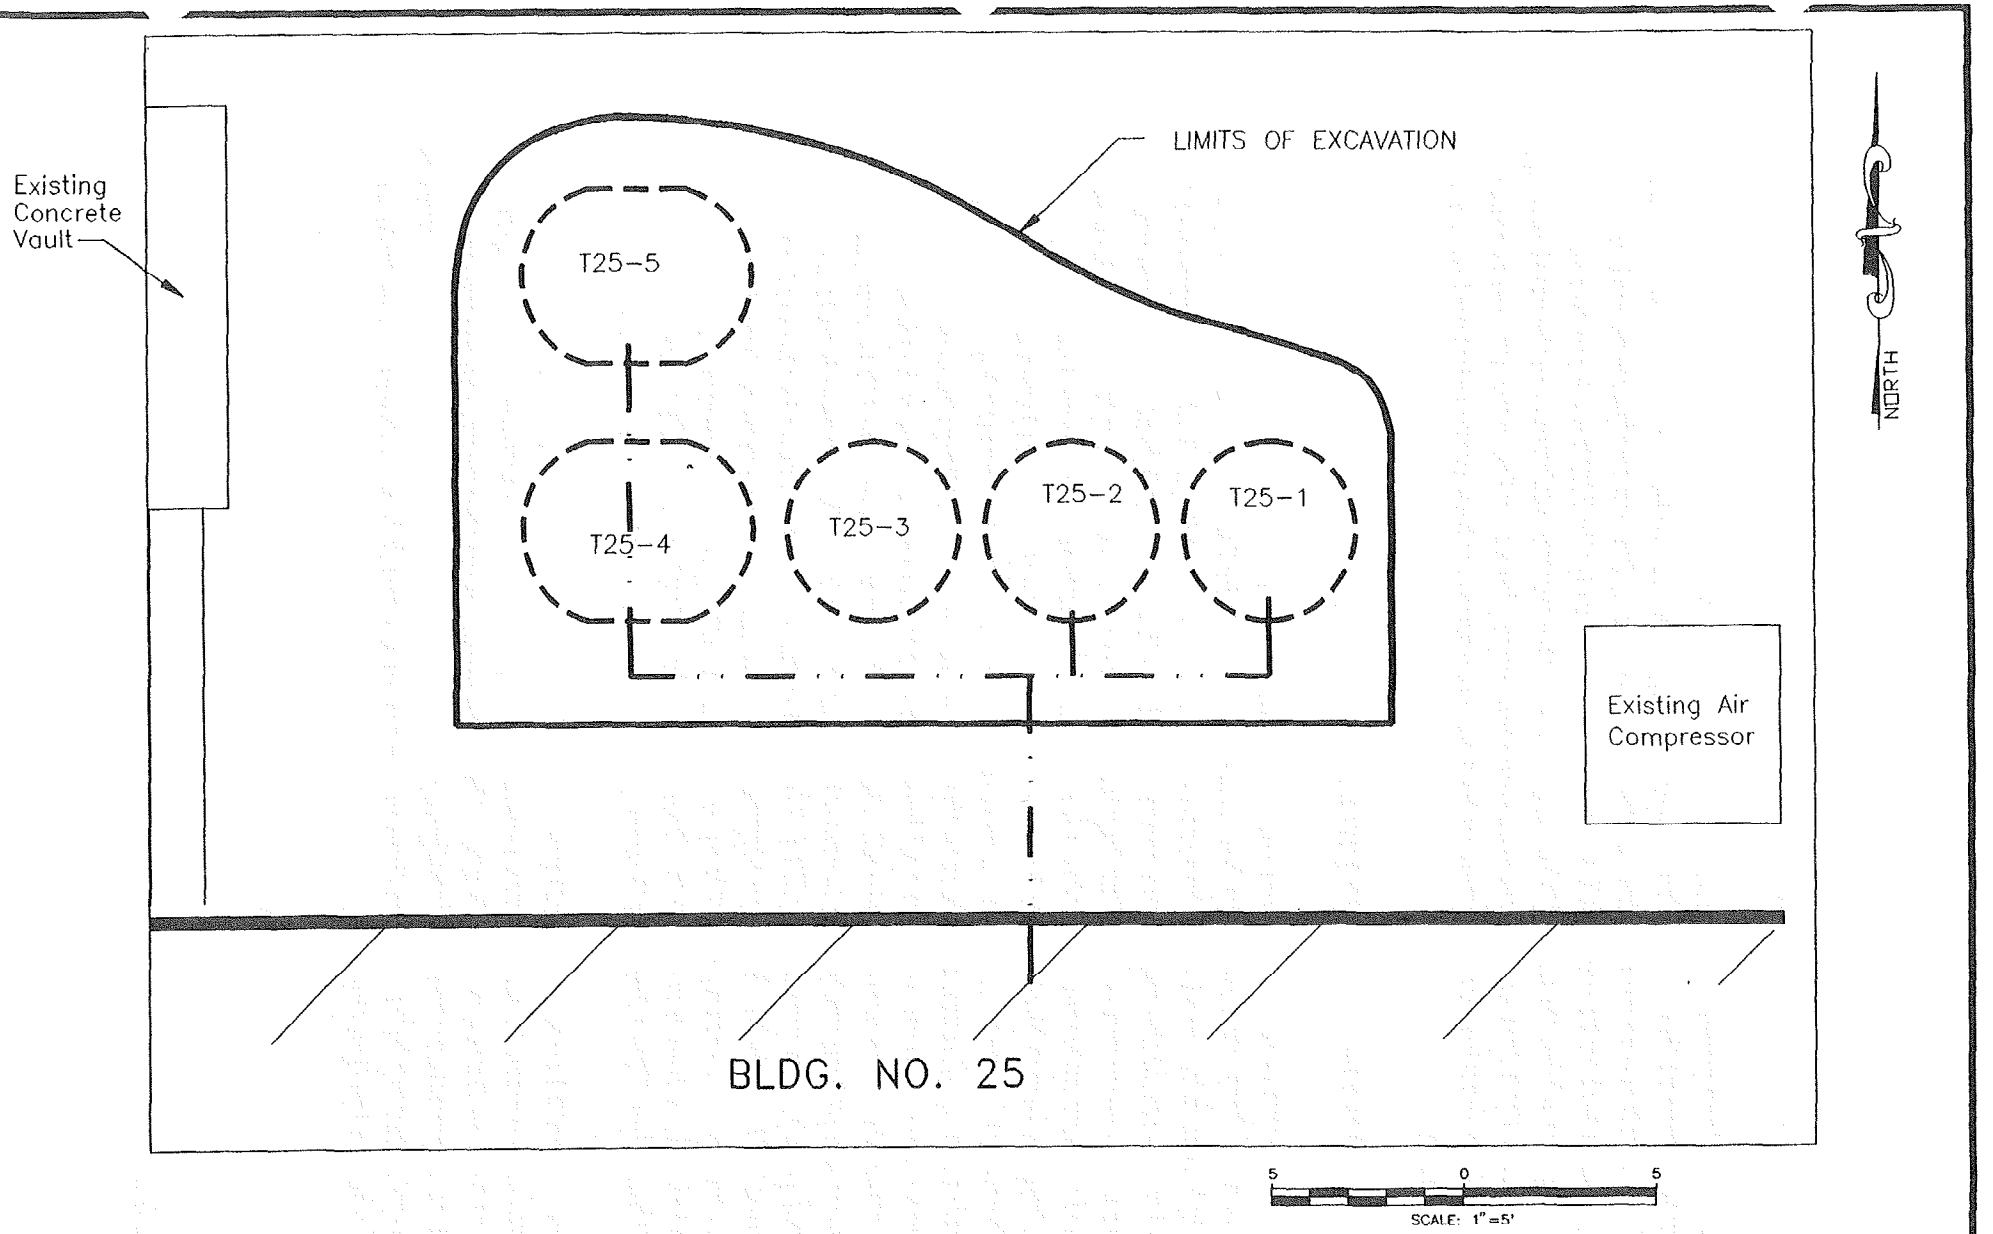
FIGURE 2.1

To minimize the potential impact on the Building 25 strip spread footing (approximately 1 foot 6 inches deep by 1 foot 9 inches wide) located 10 feet from the center line of the tanks, each tank was excavated from the side away from the building. Soil was excavated 2 feet around the sides of the tanks, the contents of the USTs were emptied using a vacuum truck, and the tanks were removed. The liquids were transported by the vacuum truck to the disposal facility operated by Clean Harbors of Baltimore in Baltimore, Maryland. Following the removal of the tank liquid contents, the tank was rendered inert in accordance with Standard Operating Procedures outline in the Health and Safety Plan. This was accomplished by placing dry ice into the tank, and then monitoring the tank atmosphere until less than 8 percent oxygen and less than 10 percent of the Lower Explosion Limit (LEL) concentrations were obtained. All piping associated with the USTs was removed, except for the piping under the foundation of Building 25. Concrete tank hold down blocks were not present on these five USTs. Groundwater was not present in the UST pit following UST removal. Refer to Figure 2.1 for the limits of excavation. The five 750-gallon USTs were approximately 6 feet long by 4.5 feet in diameter and were buried approximately 1 foot 6 inches bls. Tank Nos. T25-1, T25-2, and T25-3 were set vertically while Tank Nos. T25-4 and T24-5 were set horizontally as shown in Figure 2.1.

LIMITS OF EXCAVATION

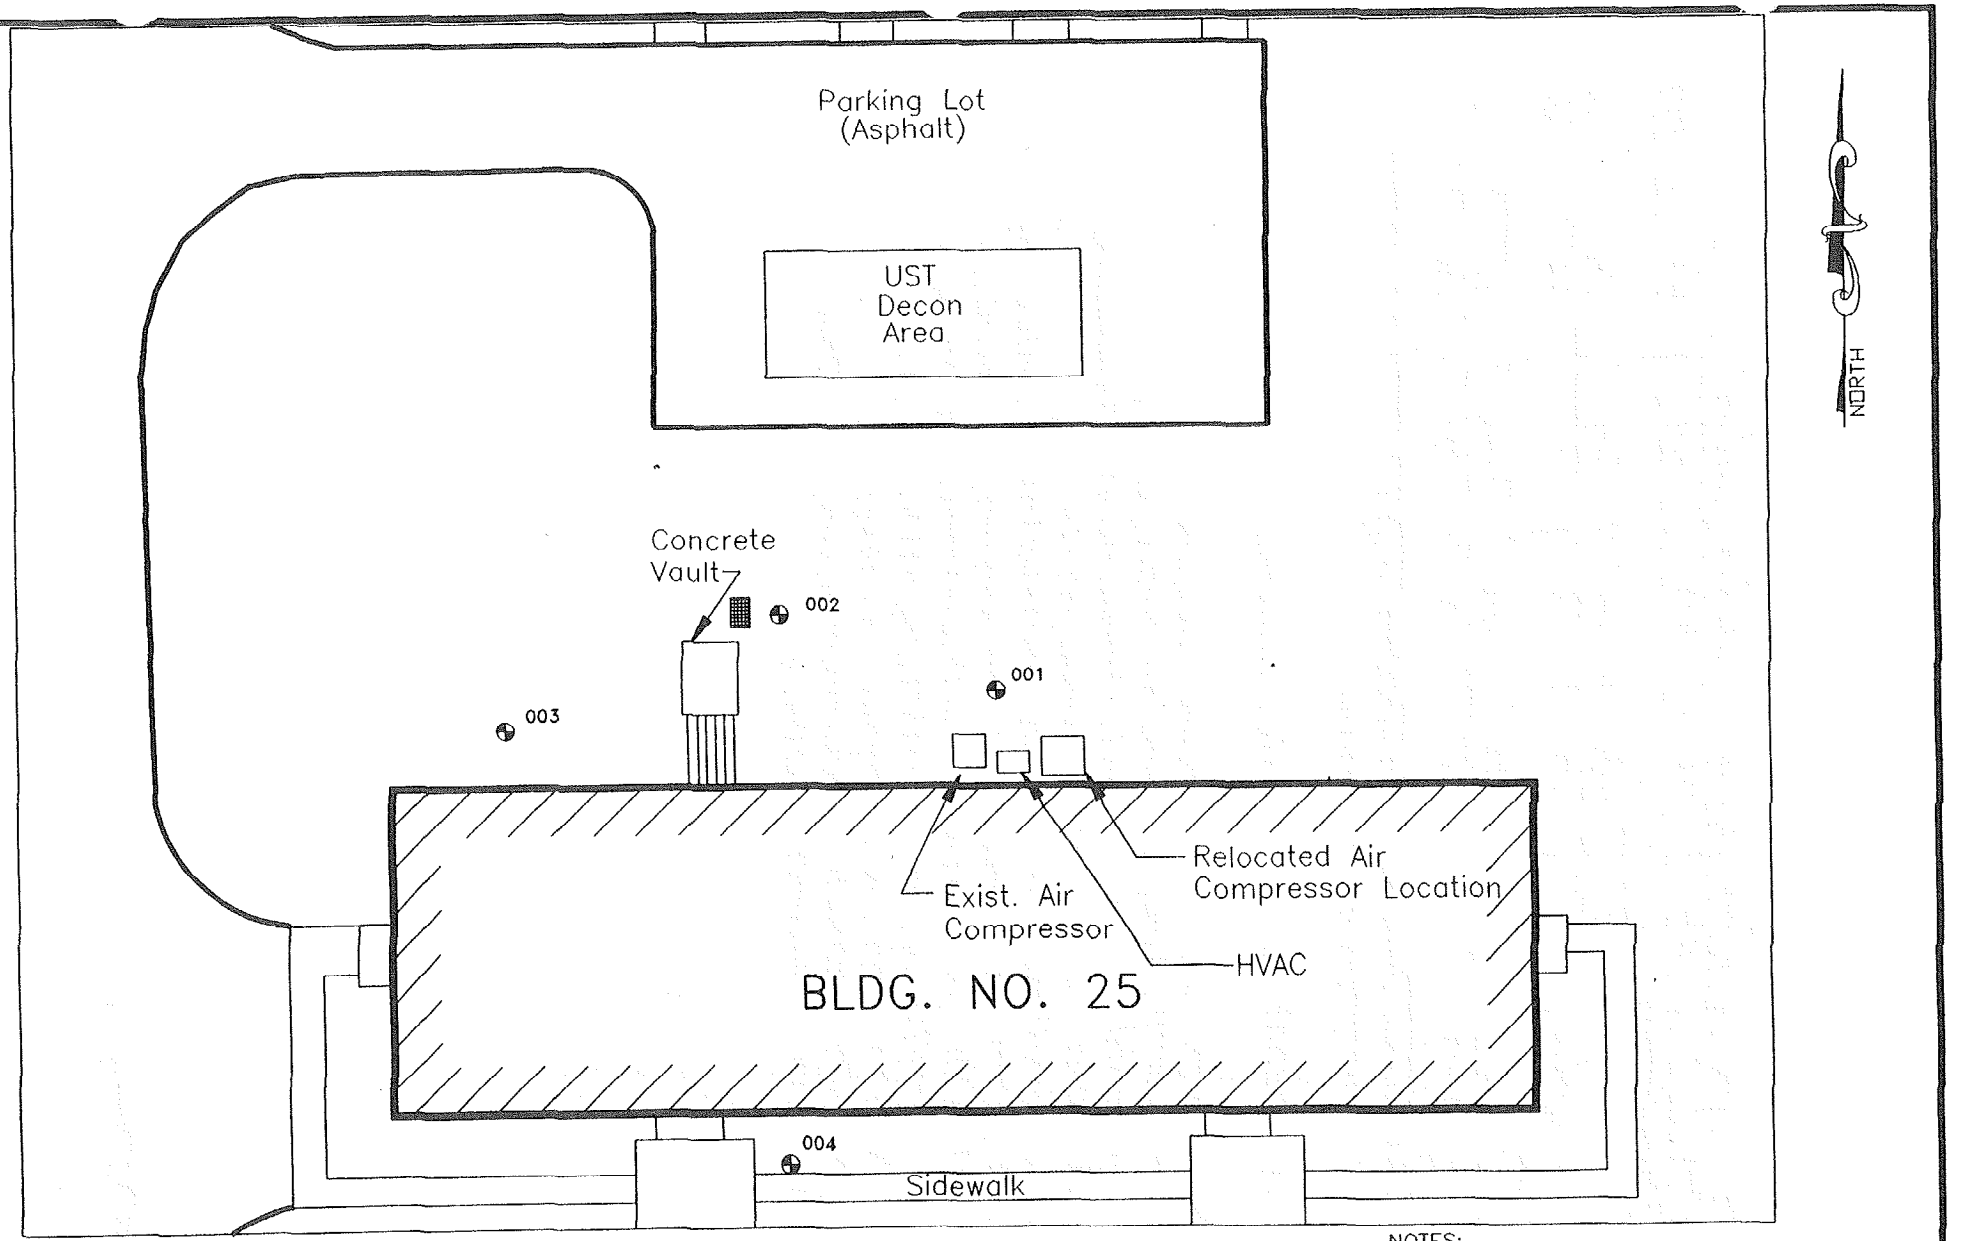
FIGURE 6.1
TEMPORARY MONITORING WELL LOCATIONS

Four temporary groundwater monitoring wells were installed on November 12, 1995 to assist in evaluation of soil and groundwater in the Building 25 UST area. The location of these temporary wells is shown in Figure 6.1. Groundwater and soil samples collected at these well locations were analyzed for the contaminants of concern. A summary of the groundwater data, a summary of the soil data, and the field note generated during well installation are presented in Appendix I. The laboratory data sheets are included in Appendix H of this report. Laboratory results from soil samples collected during well installation detected the presence of PCE at 55 µg/kg, which is below the action level of 12,000 µg/kg and above the EPA soil screening level of 40 µg/kg. Groundwater remediation is being addressed in a separate report being prepared by Baker Environmental, Inc. for the Department of the Navy.

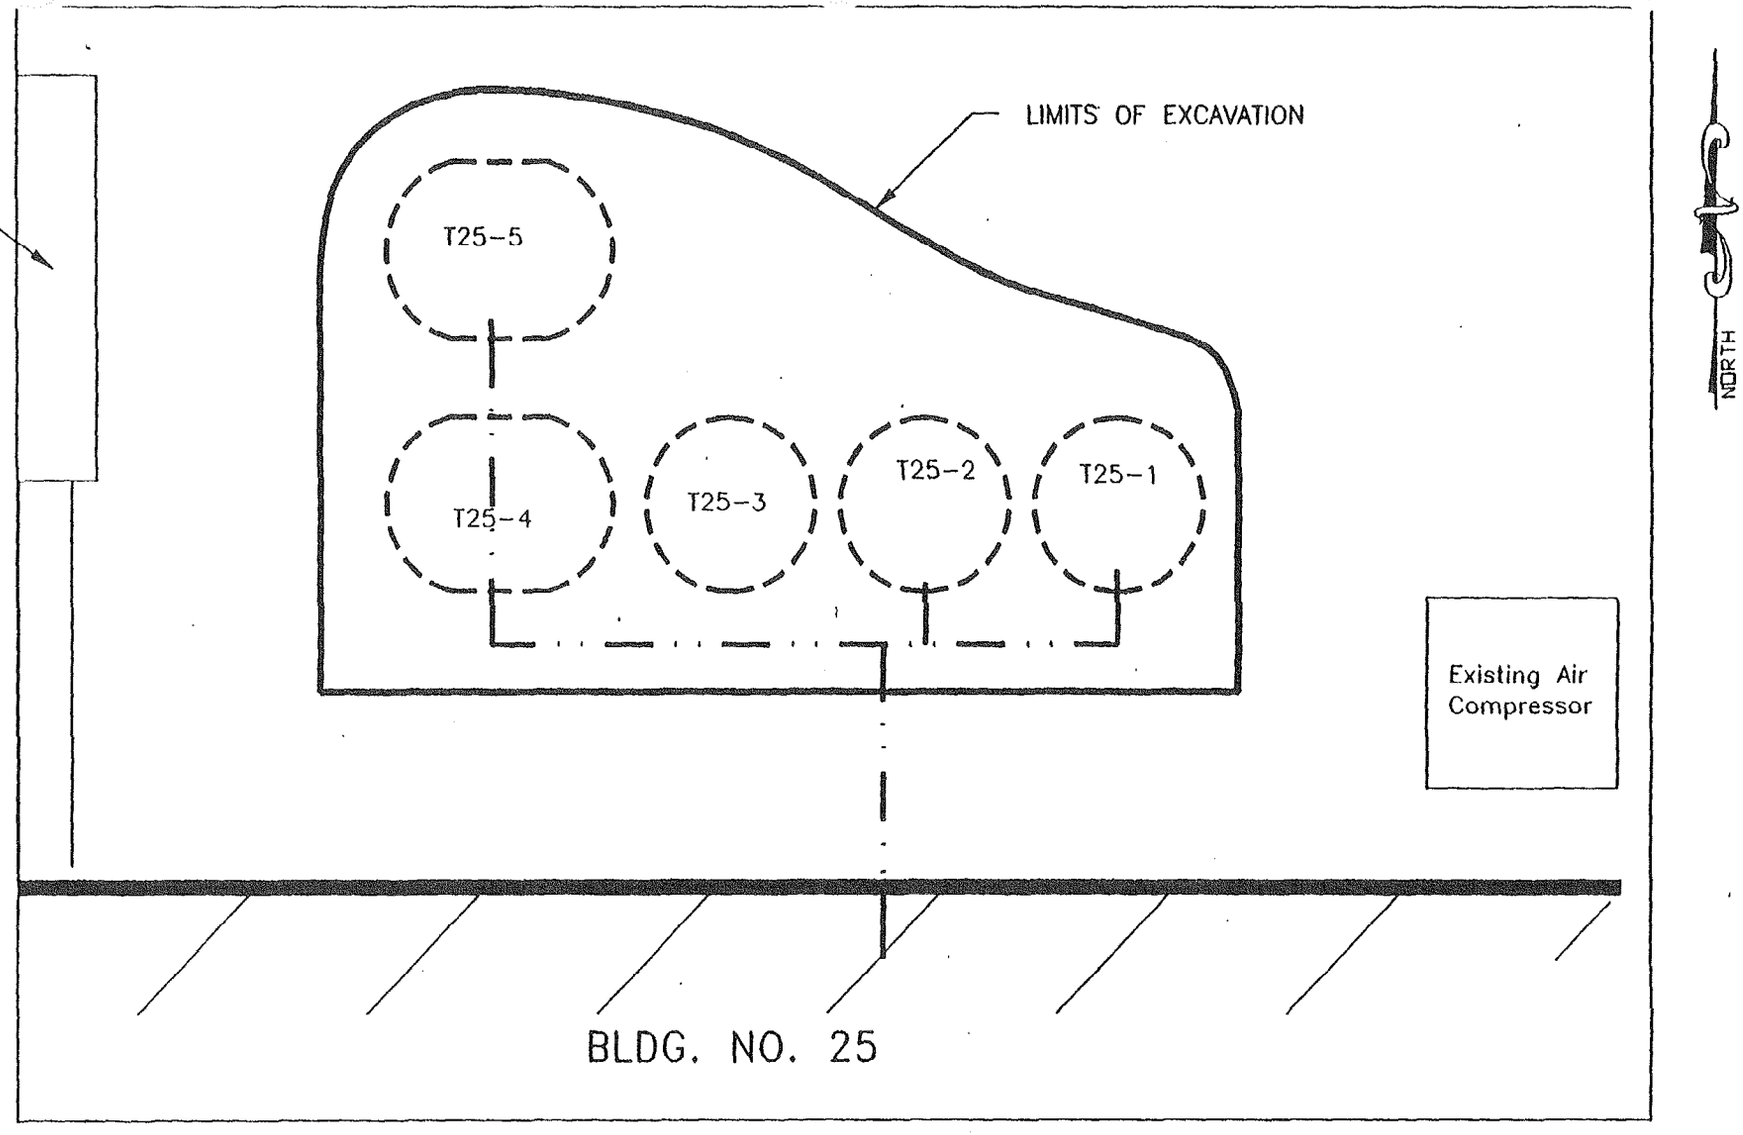
FIGURE 2.1

Upon completion of field construction activities, excavated areas were backfilled with soils from the Base borrow area. The backfill was compacted utilizing the heavy equipment on-site. Once the areas were brought to the approximate original grade, the area was prepared for planting grass. The disturbed areas were fertilized and seeded. An as-built drawing of the site which depicts the excavation area is presented in Figure 2.1.

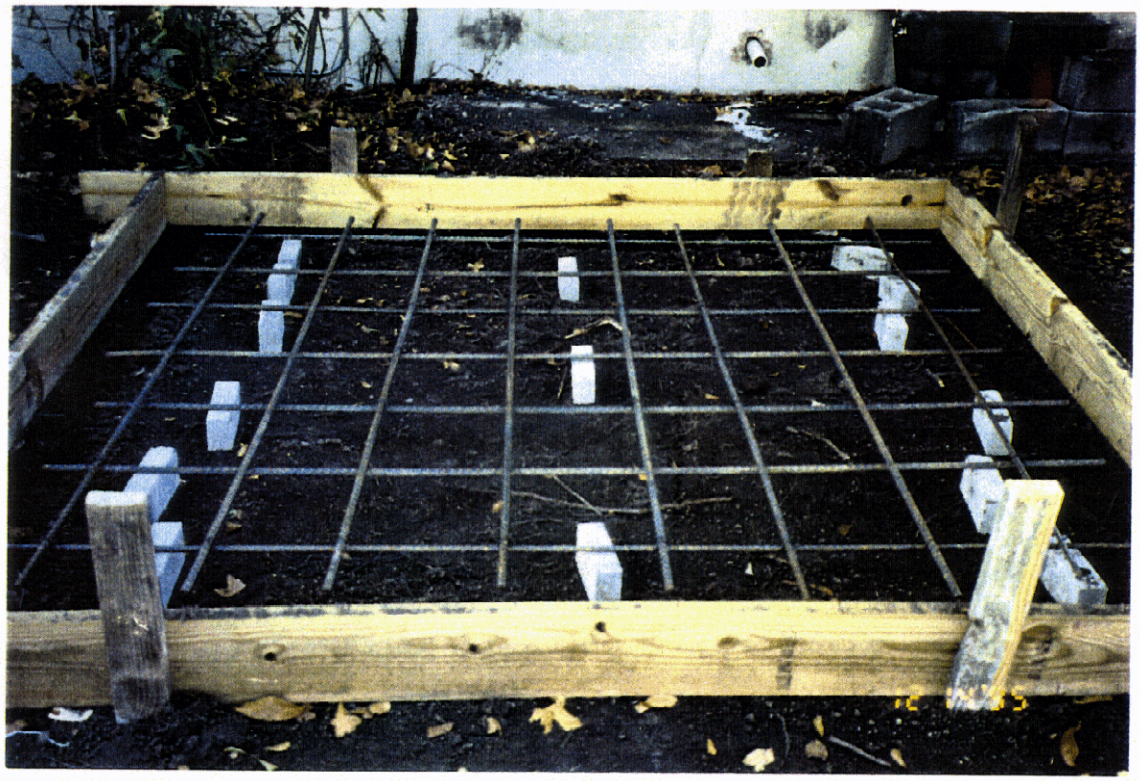
Project No. 17418 Date: 12/14/95
Contract No. N62470-93-D-3032
Delivery Order: 78
Location: Building 25
Description: Form and rebar for air compressor pad

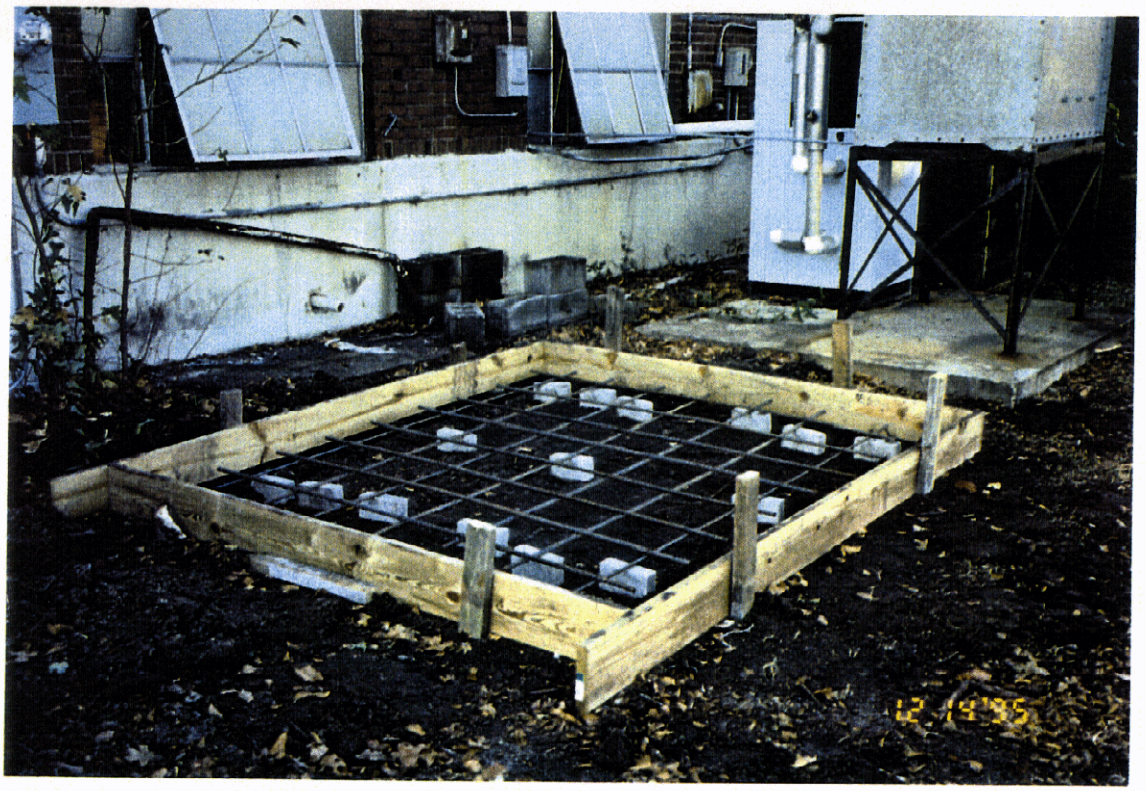
Project No. 17418 Date: 12/14/95
Contract No. N62470-93-D-3032
Delivery Order: 78
Location: Building 25
Description: Form and rebar for air compressor pad

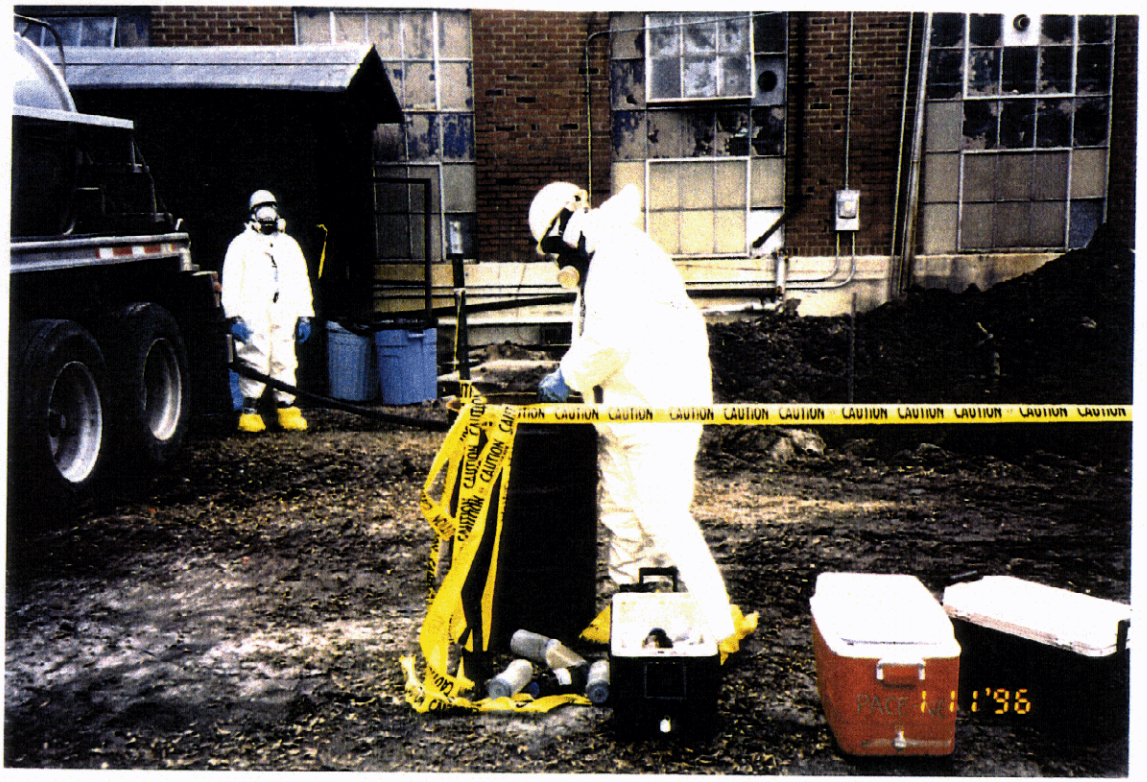
Project No. 17418 Date: 1/11/96
Contract No. N62470-93-D-3032
Delivery Order: 78
Location: Building 25
Description: Removal of tank contents into a tanker truck

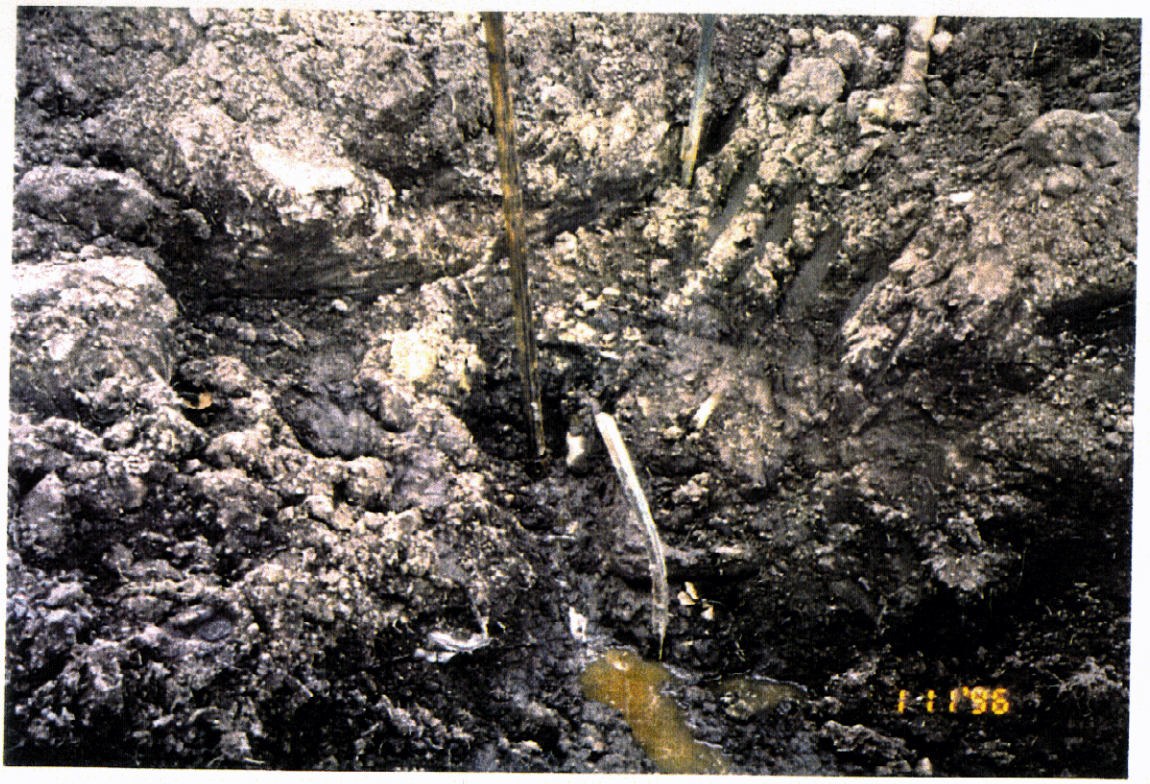
Project No. 17418 Date: 1/11/96
Contract No. N62470-93-D-3032
Delivery Order: 78
Location: Building 25
Description: Tank thief used to remove tank contents

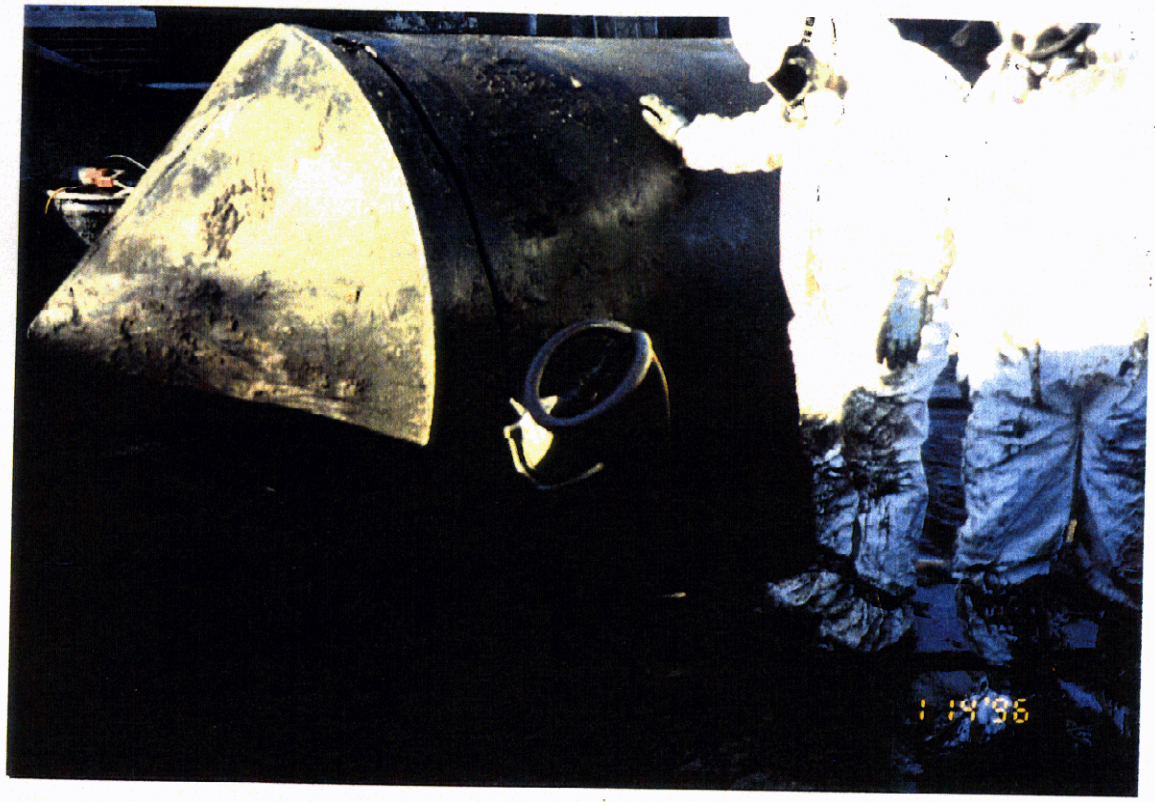
Project No. 17418 Date: 1/14/96
Contract No. N62470-93-D-3032
Delivery Order: 78
Location: Building 25
Description: Cutting of UST with pneumatic nibbler

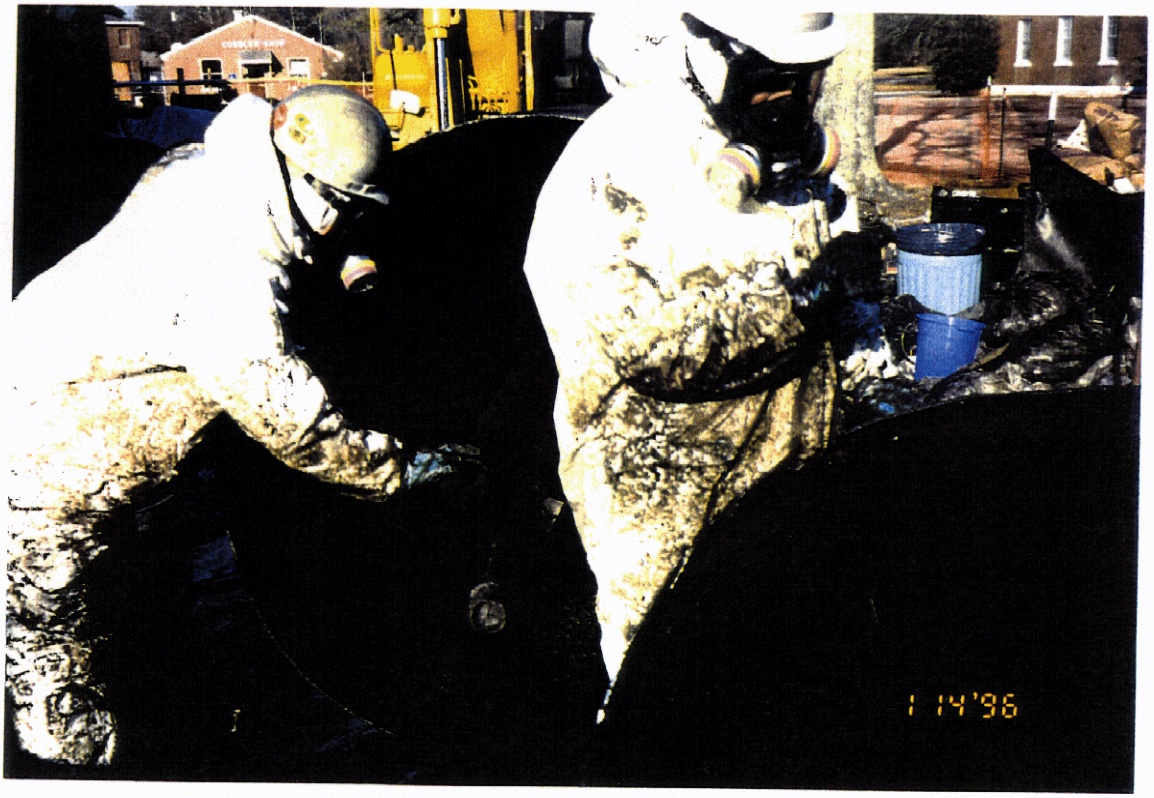
Project No. 17418 Date: 1/14/96
Contract No. N62470-93-D-3032
Delivery Order: 78
Location: Building 25
Description: Demolition of USTs

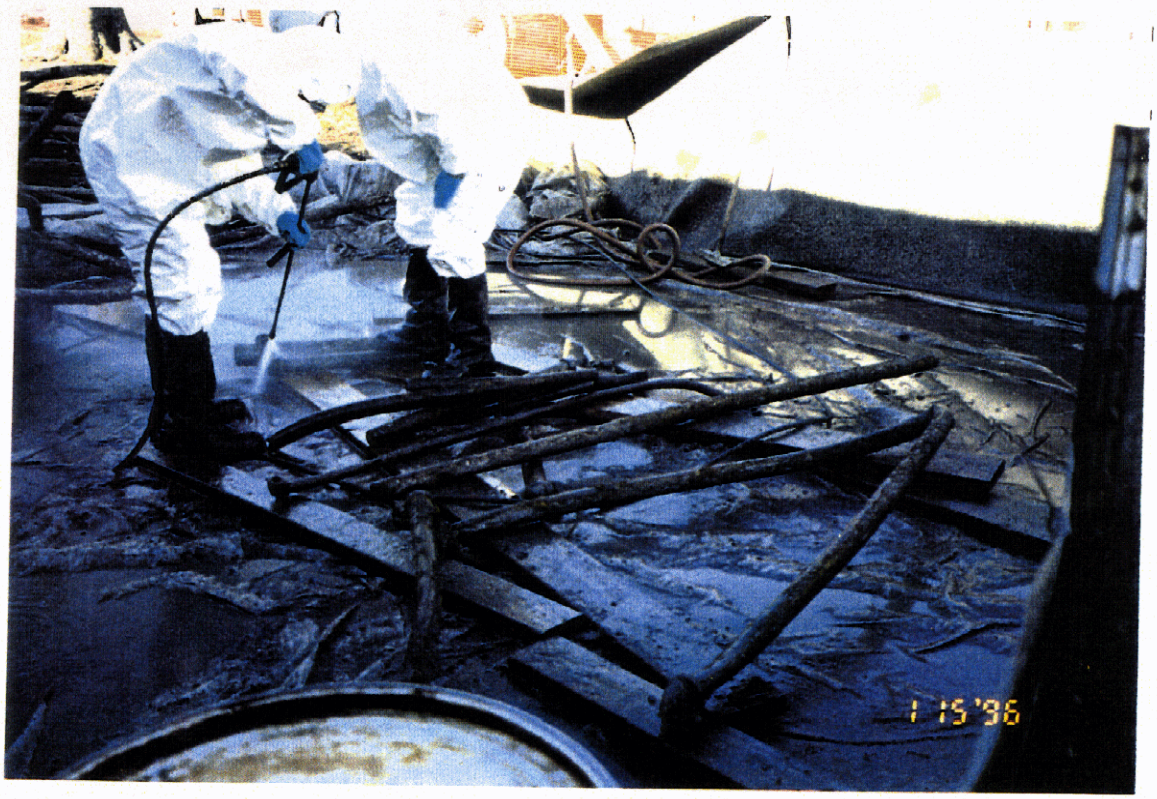
Project No. 17418 Date: 1/15/96
Contract No. N62470-93-D-3032
Delivery Order: 78
Location: Building 25
Description: Decon of piping

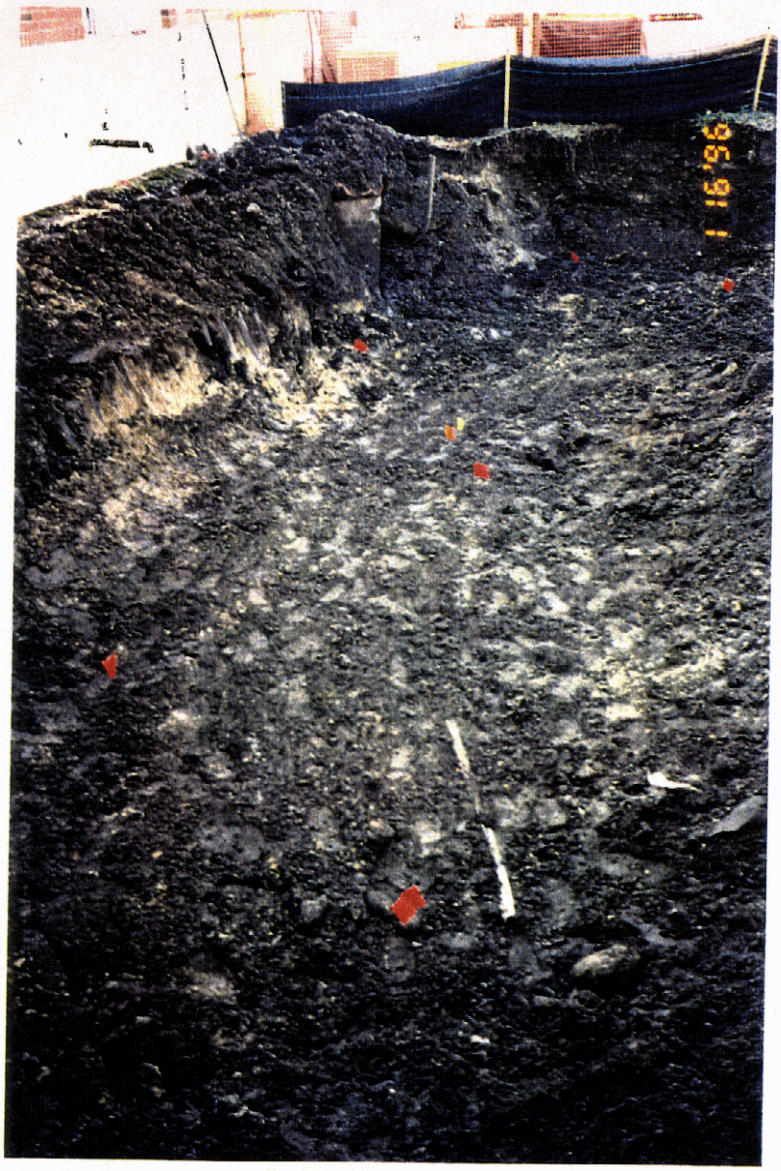
Project No. 17418 **Date: 1/16/96**
Contract No. N62470-93-D-3032
Delivery Order: 78
Location: Building 25
Description:Location of sample points for composite sample
