SAMPLING AND ANALYSIS REPORT FOR SITE 12 BAY B CONCRETE FLOOR PCB ANALYSES

NAVAL CONSTRUCTION BATTALION CENTER (NCBC)
DAVISVILLE, RHODE ISLAND

May 1997

Foster Wheeler Environmental Corporation
470 Atlantic Avenue
Boston, MA 02210

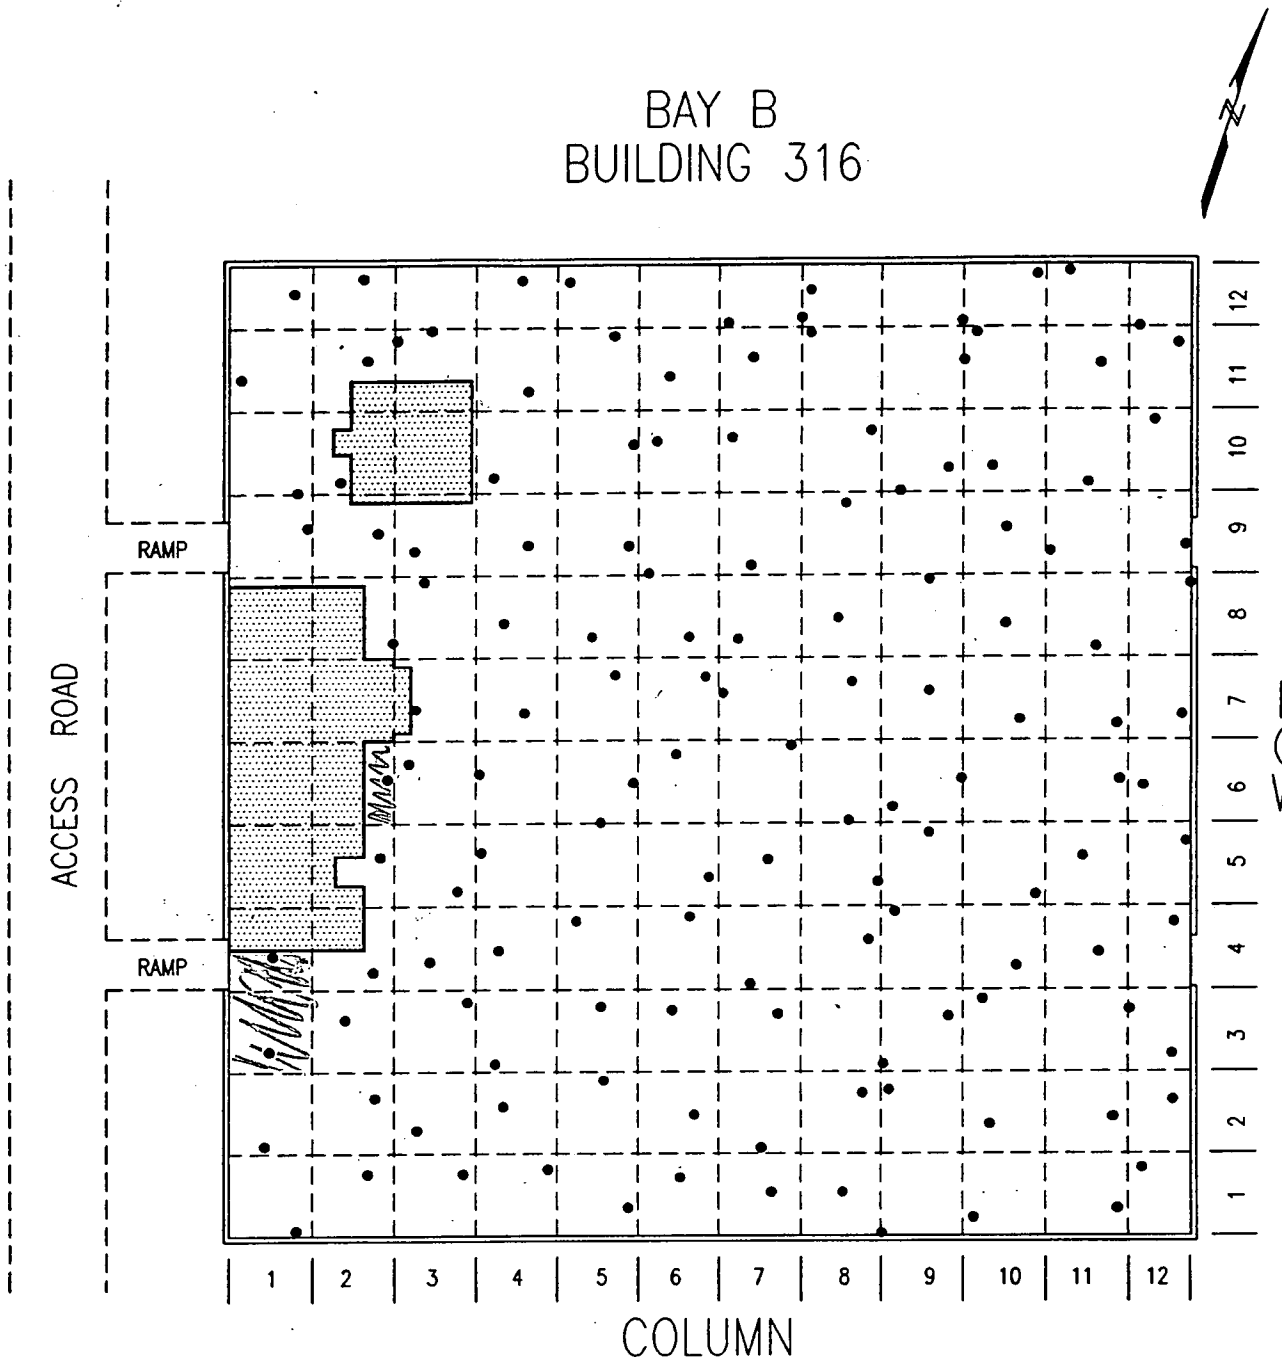
FIGURE 1

A total of 139 sampling points were proposed in the SAP; however, following completion of the SAP, the concrete floor was removed from the grid cell located in column 2, row 7 and could not be sampled. None of the other sampling locations proposed in the SAP needed to be eliminated or relocated. Sampling locations are shown on Figure 1 and the randomly generated sampling coordinates are presented in Table 1.

SITE 12 GRID OVERLAY WITH RANDOM SAMPLING POINTS
