REPORT OF SOIL/DEBRIS REMOVAL ACTIVITY

OFF-SITE WEAPONS STORAGE AREA

CARSWELL AFB, TEXAS

November 1993

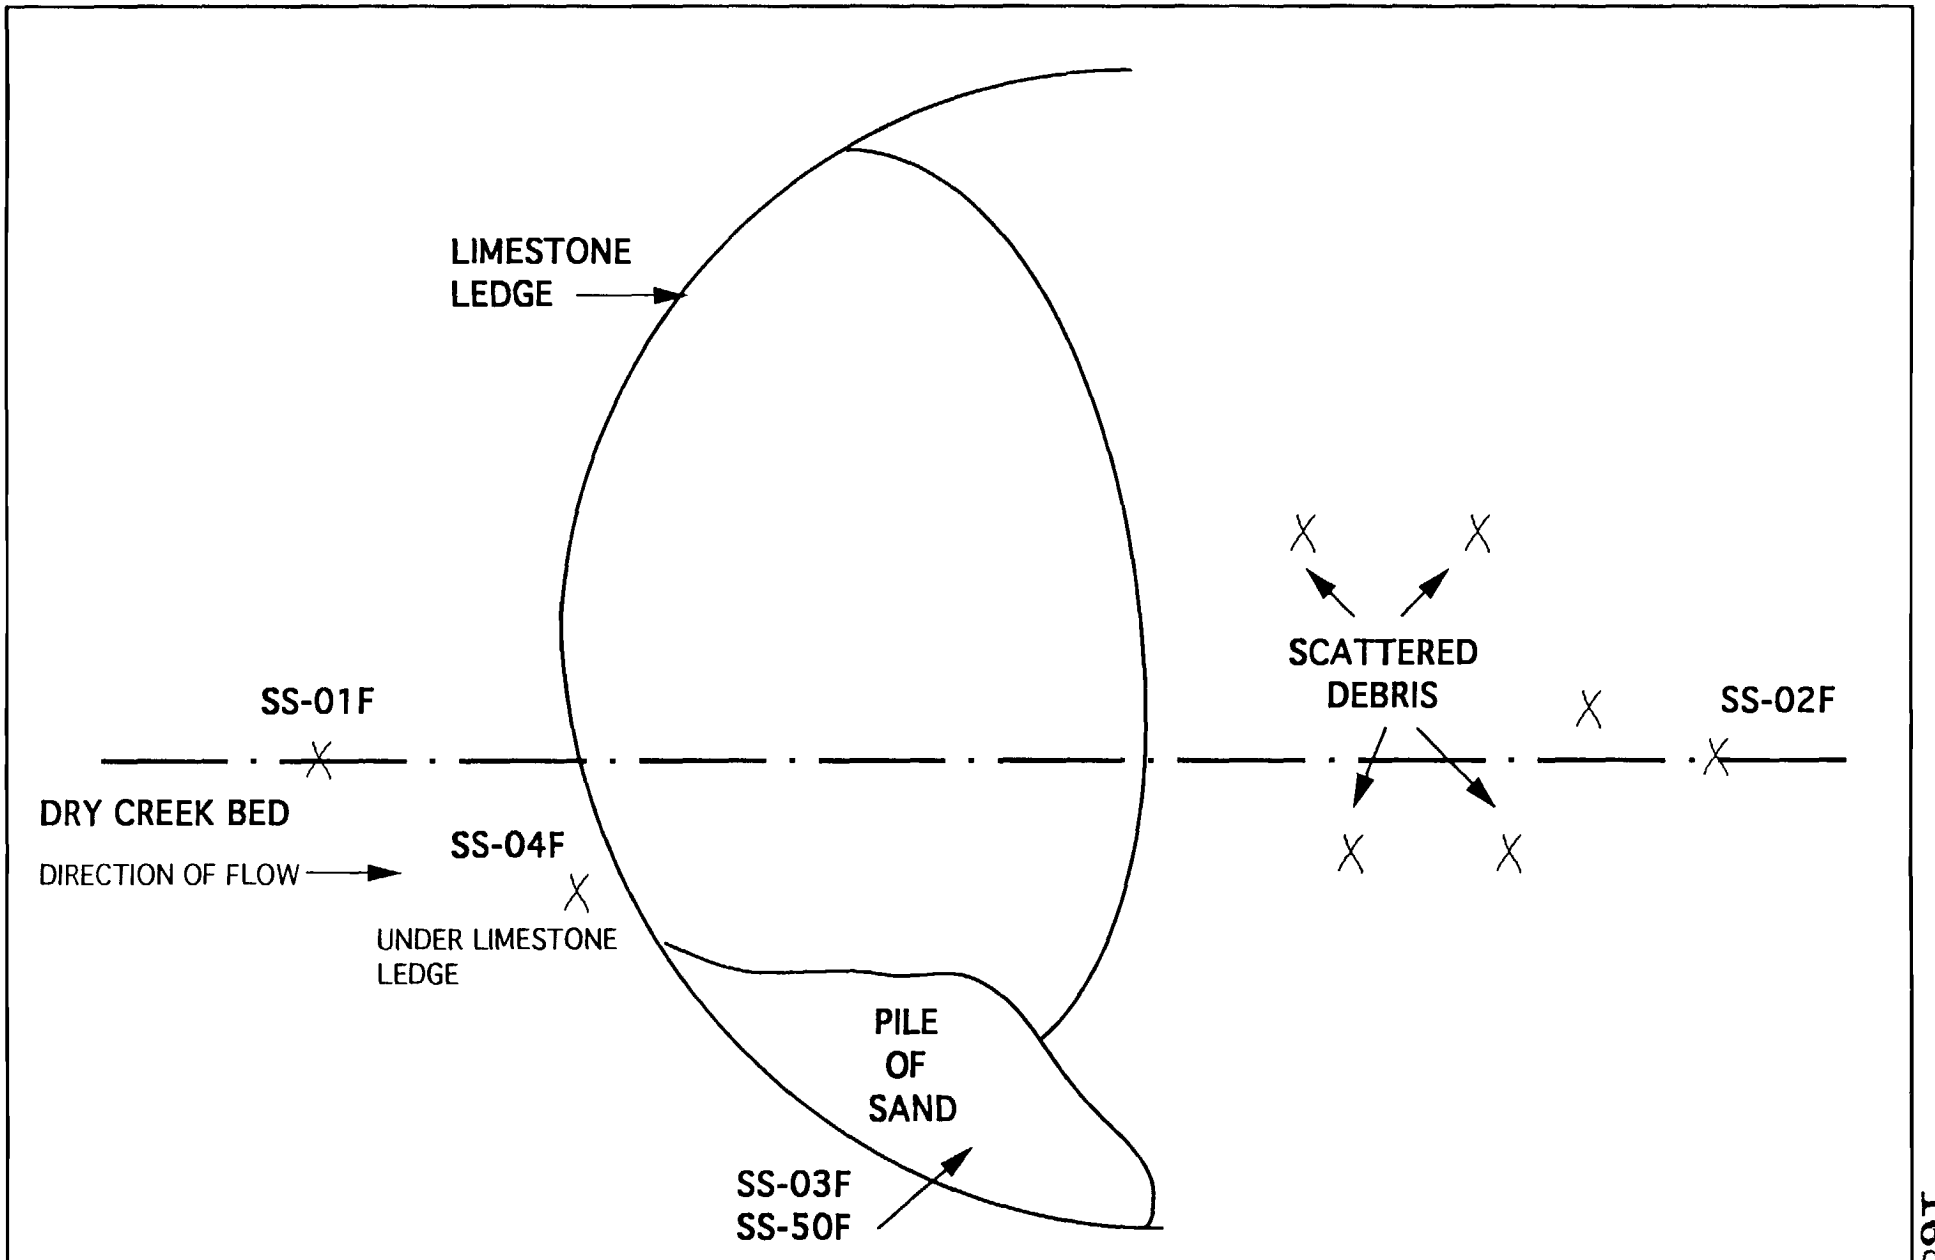
SITE LAYOUT AND SAMPLING LOCATIONS

As a screening procedure, four soil samples were taken from three locations at the debris disposal area. The samples were taken from the dry creek bed up- and downgradient of the disposal area and from a sand pile within the disposal area (SS-01F, 02F, 03F, and 50F). These locations are depicted on Figure 5.1. The analytical results for these samples are listed in Tables 5-1 and 5-2. A review of Table 5-1 shows that there were no compounds detected above method detection limits for any sample for volatile organic compounds, semi-volatile compounds, or total petroleum hydrocarbons.

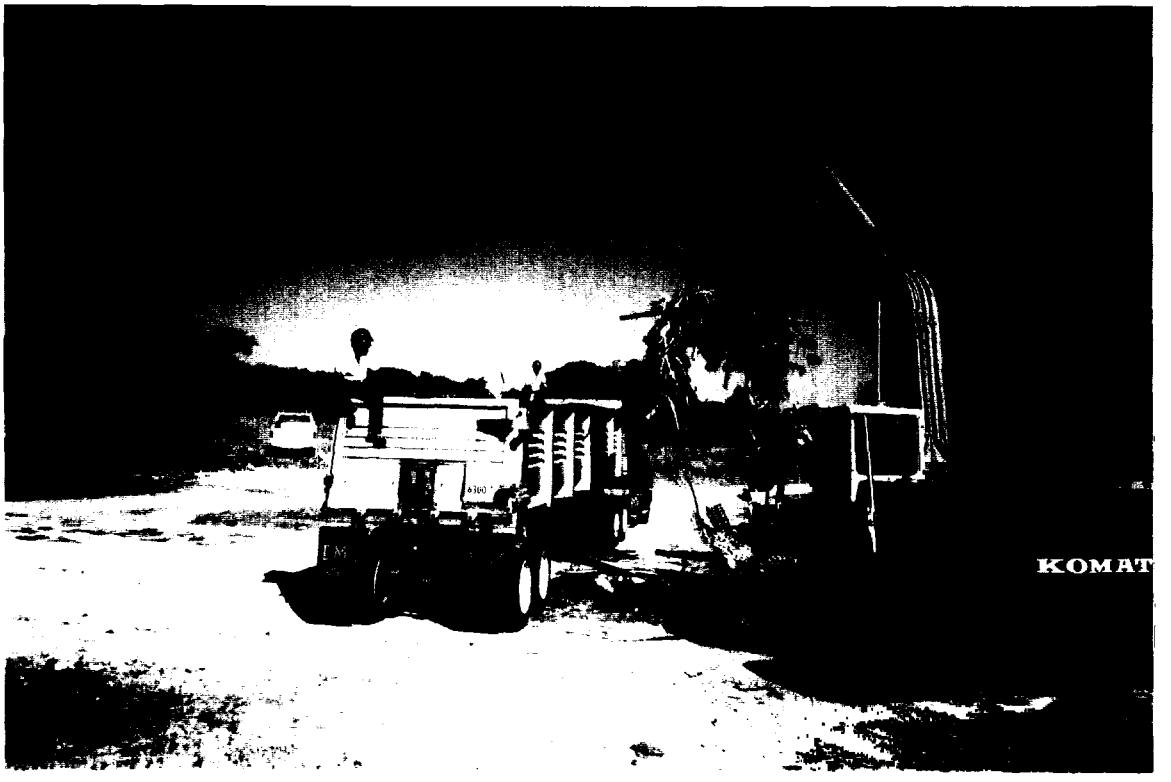
PHOTOGRAPH 3 Loading Debris into the Dump Trucks

PHOTOGRAPH 4 Excavation under the Limestone Ledge
