QUARTERLY GROUNDWATER MONITORING REPORT OCTOBER - DECEMBER 1999 AT SITE 11 NSB KINGS BAY GA

QUARTERLY GROUNDWATER MONITORING REPORT
October–December 1999

SITE 11, OLD CAMDEN COUNTY LANDFILL
NAVAL SUBMARINE BASE KINGS BAY, GEORGIA

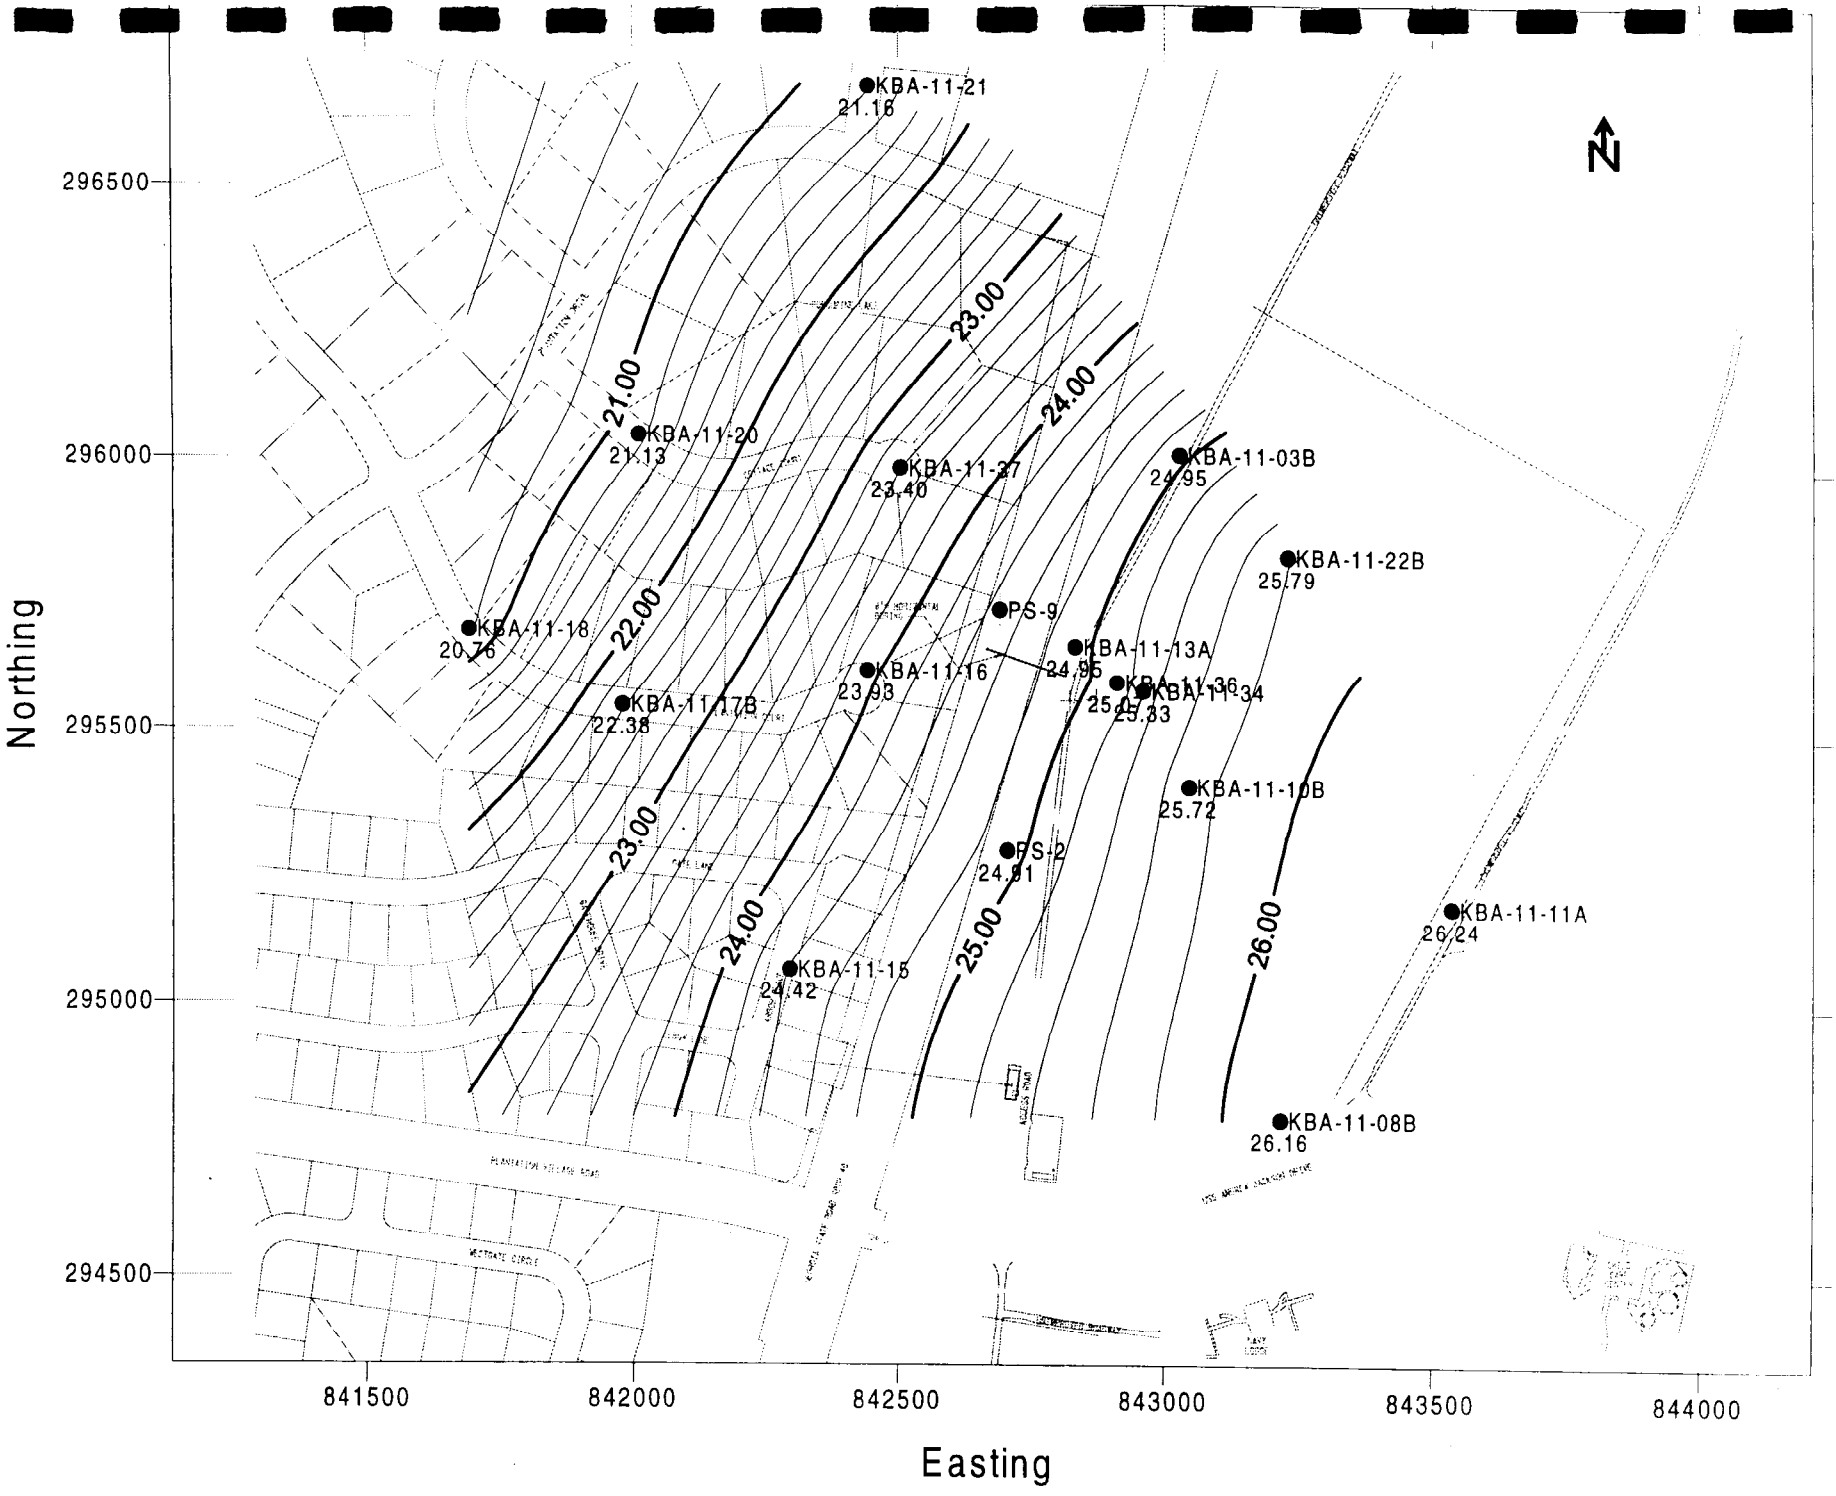
Water level and well depth measurements were collected using an electronic meter level meter. Table 2 provides a summary of the well measurements. All measurements were made from a surveyed reference point located at the top of the well casing. Depth to water ranged from approximately 12 ft below the top of the well casing (26 ft MSL) at the source area to approximately 2 ft below the top of the casing (21 ft MSL) offsite at the Crooked River Plantation subdivision. Apparent groundwater flow is to the northwest. Figures 2 and 3 show the groundwater elevations for November 8, and August 2, 1999.

Figure 2 - Groundwater Elevation Map, No\ ber 8, 1999 Contour Interval = 0.2 ft

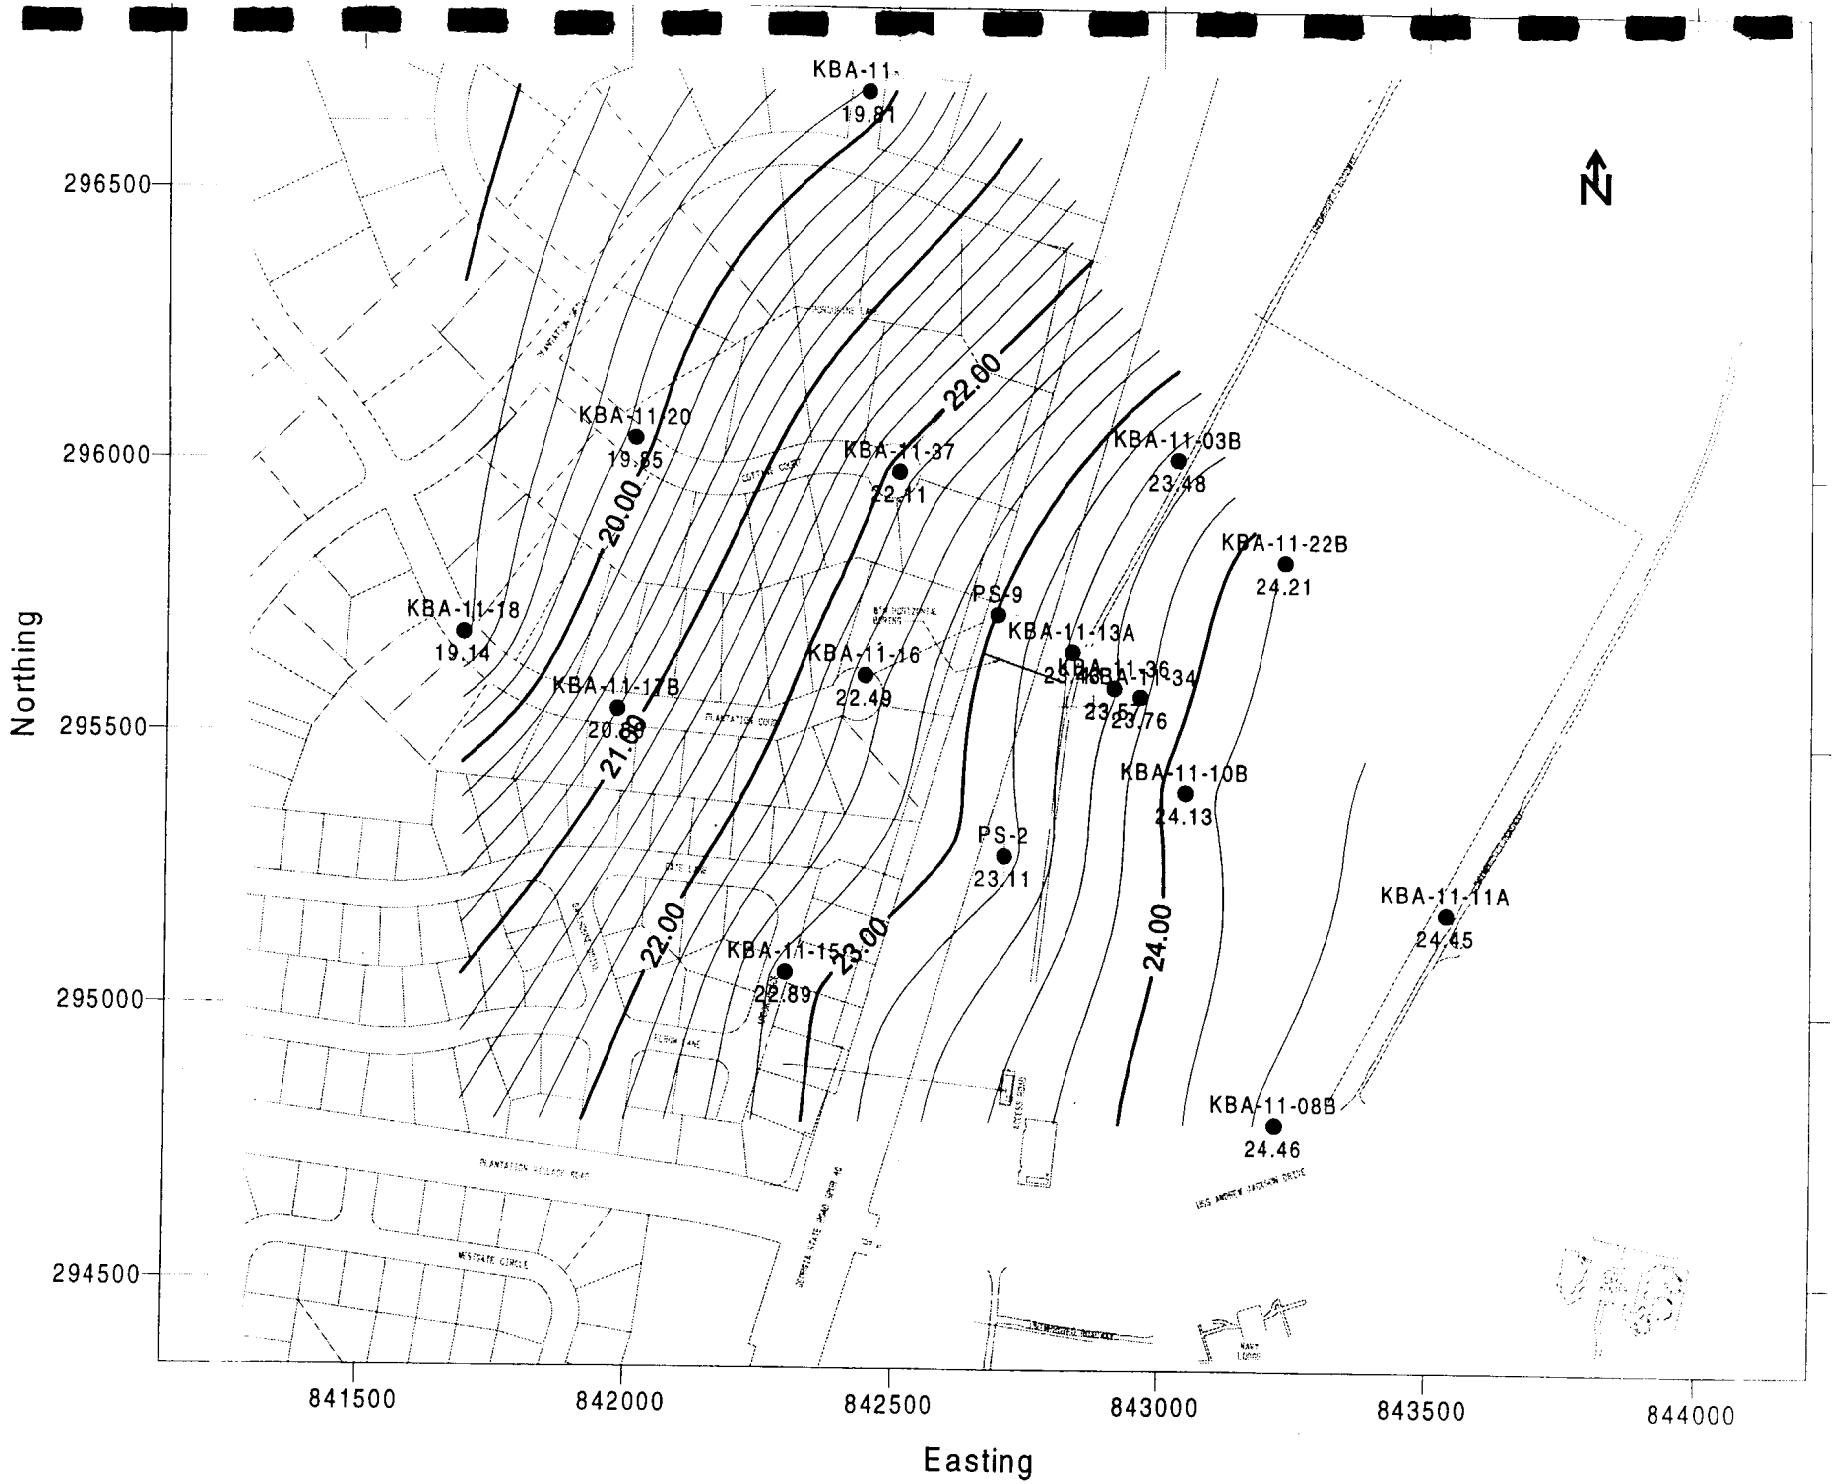
Figure 3 - Groundwater Elevation Map, August 2, 1999

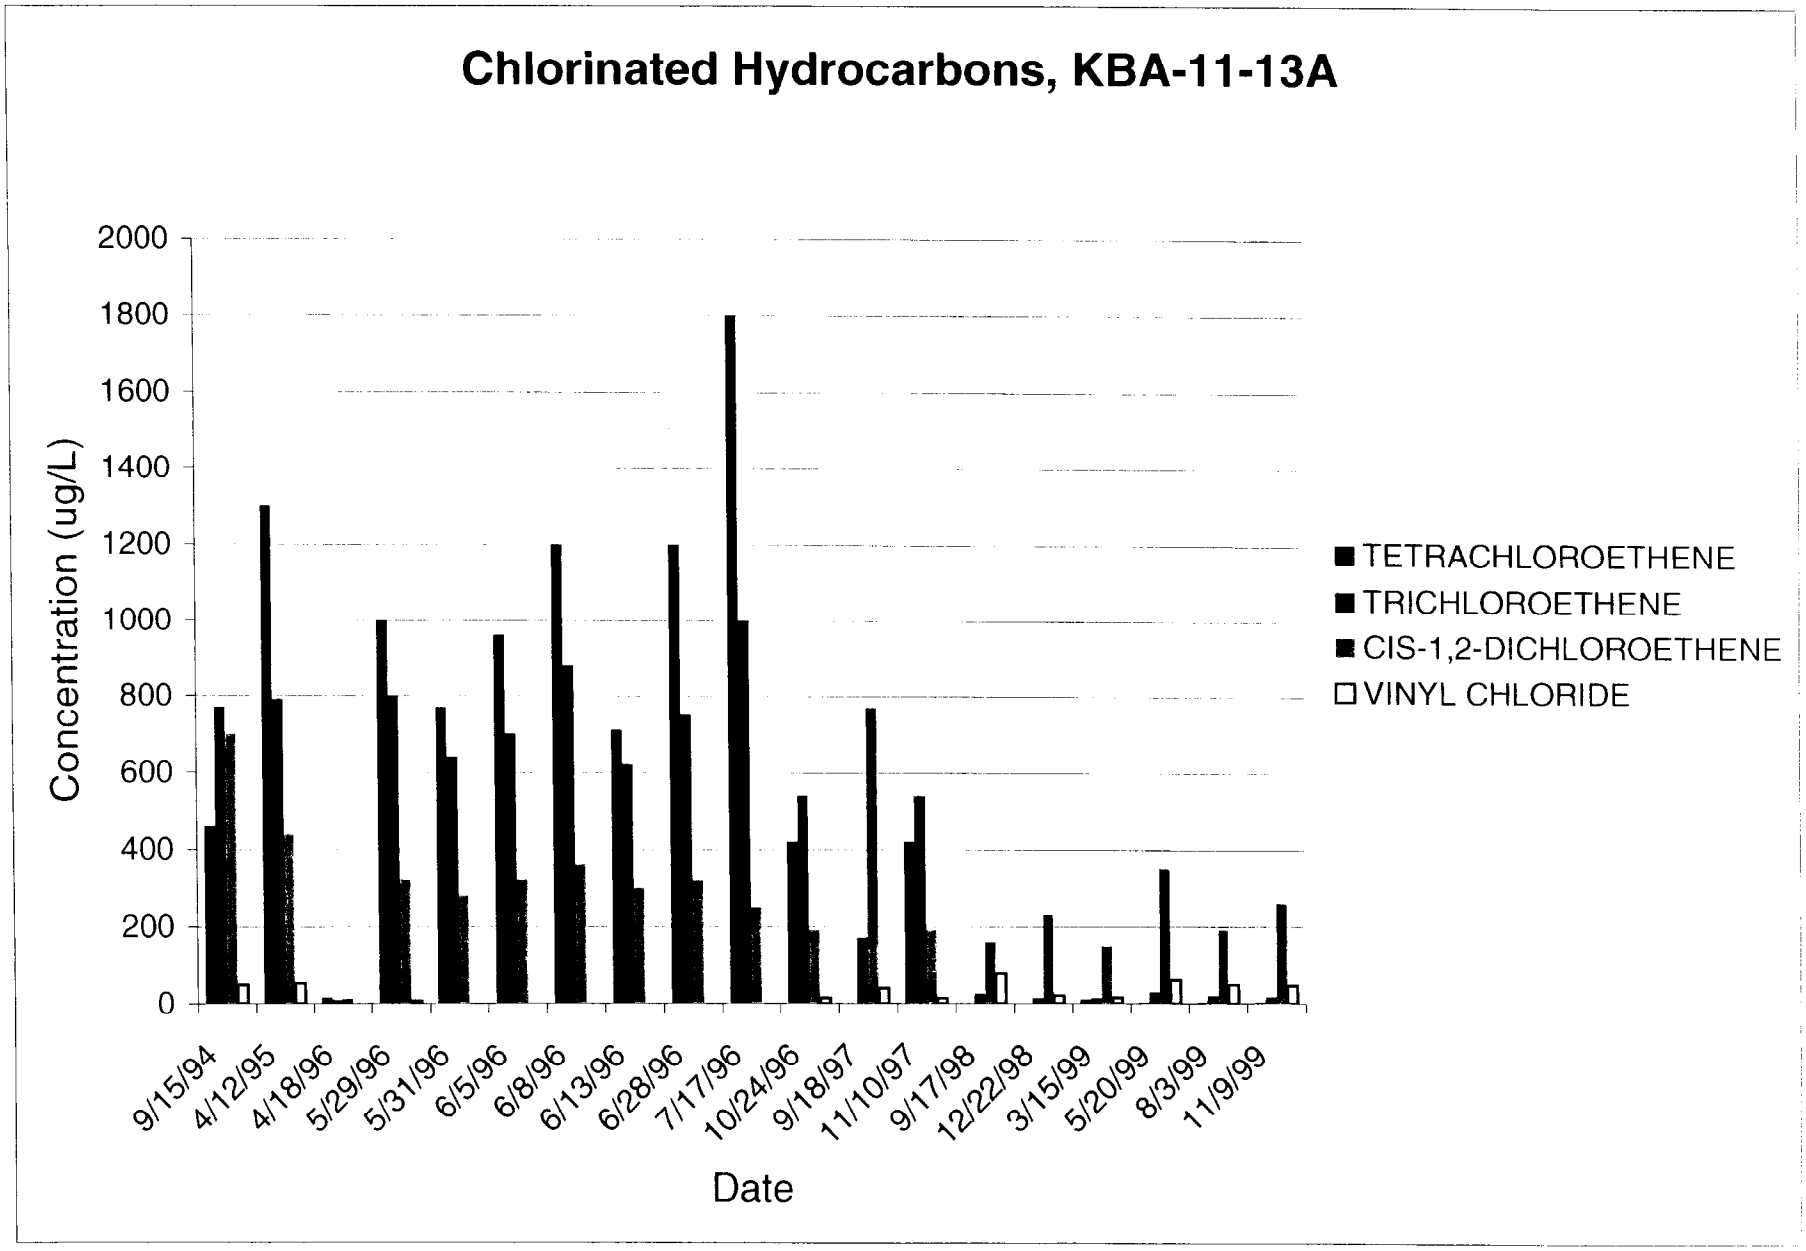
FIGURE 4 - CHLORINATED HYDROCARBONS, KBA-11-13A

Immediately downgradient to the source area at well KBA-11-13A, tetrachloroethene and trichloroethene have decreased below the standard and cis-1,2-dichloroethene and vinyl chloride remain above the

standard (Figures 4 and 5). There is a slight increase in cis-1,2-dichloroethene and vinyl chloride at KBA-11-13A; however, the concentrations should decrease as treated groundwater from the source area moves through the vicinity of KBA-11-13A. Chlorobenzene in KBA-11-13A also exceeds the Groundwater Protection Standard.
