QUARTERLY GROUNDWATER MONITORING REPORT AT SITE 11 SEPTEMBER - NOVEMBER 2000 NSB KINGS BAY GA

Quarterly Groundwater Monitoring Report

September - November 2000
FINAL

Site 11, Old Camden County Landfill
Naval Submarine Base Kings Bay, Georgia

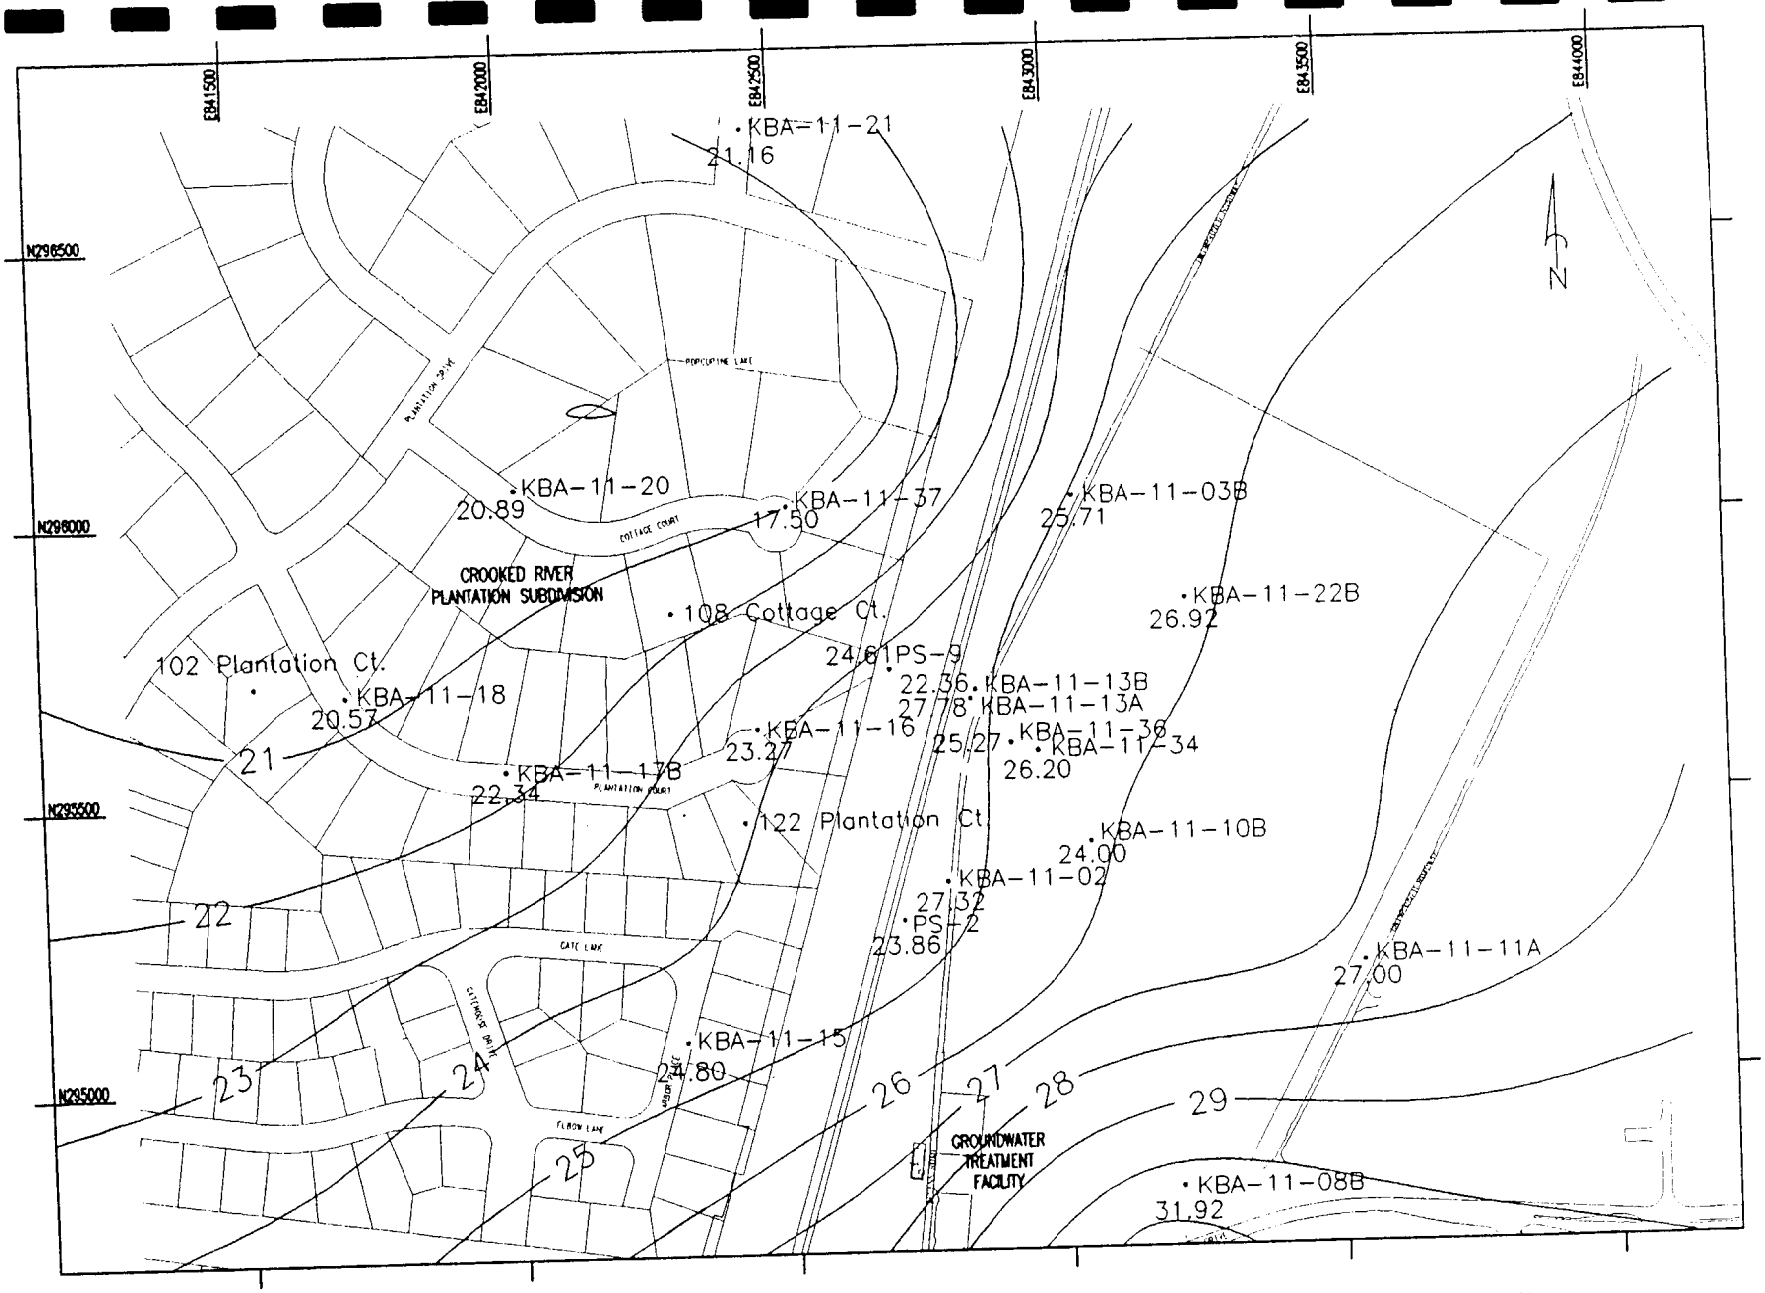
FIGURE 2: Groundwater Elevation Map–November 2000

Water level and well depth measurements were collected using an electronic meter level meter. Table 2 provides a summary of the well measurements. All measurements were made from a surveyed reference point located at the top of the well casing. Depth to water ranged from approximately 14.3 ft below the top of the well casing (24.00 ft MSL) at the source area to approximately 2.76 ft below the top of the casing (17.50 ft MSL). Apparent groundwater flow is to the northwest.

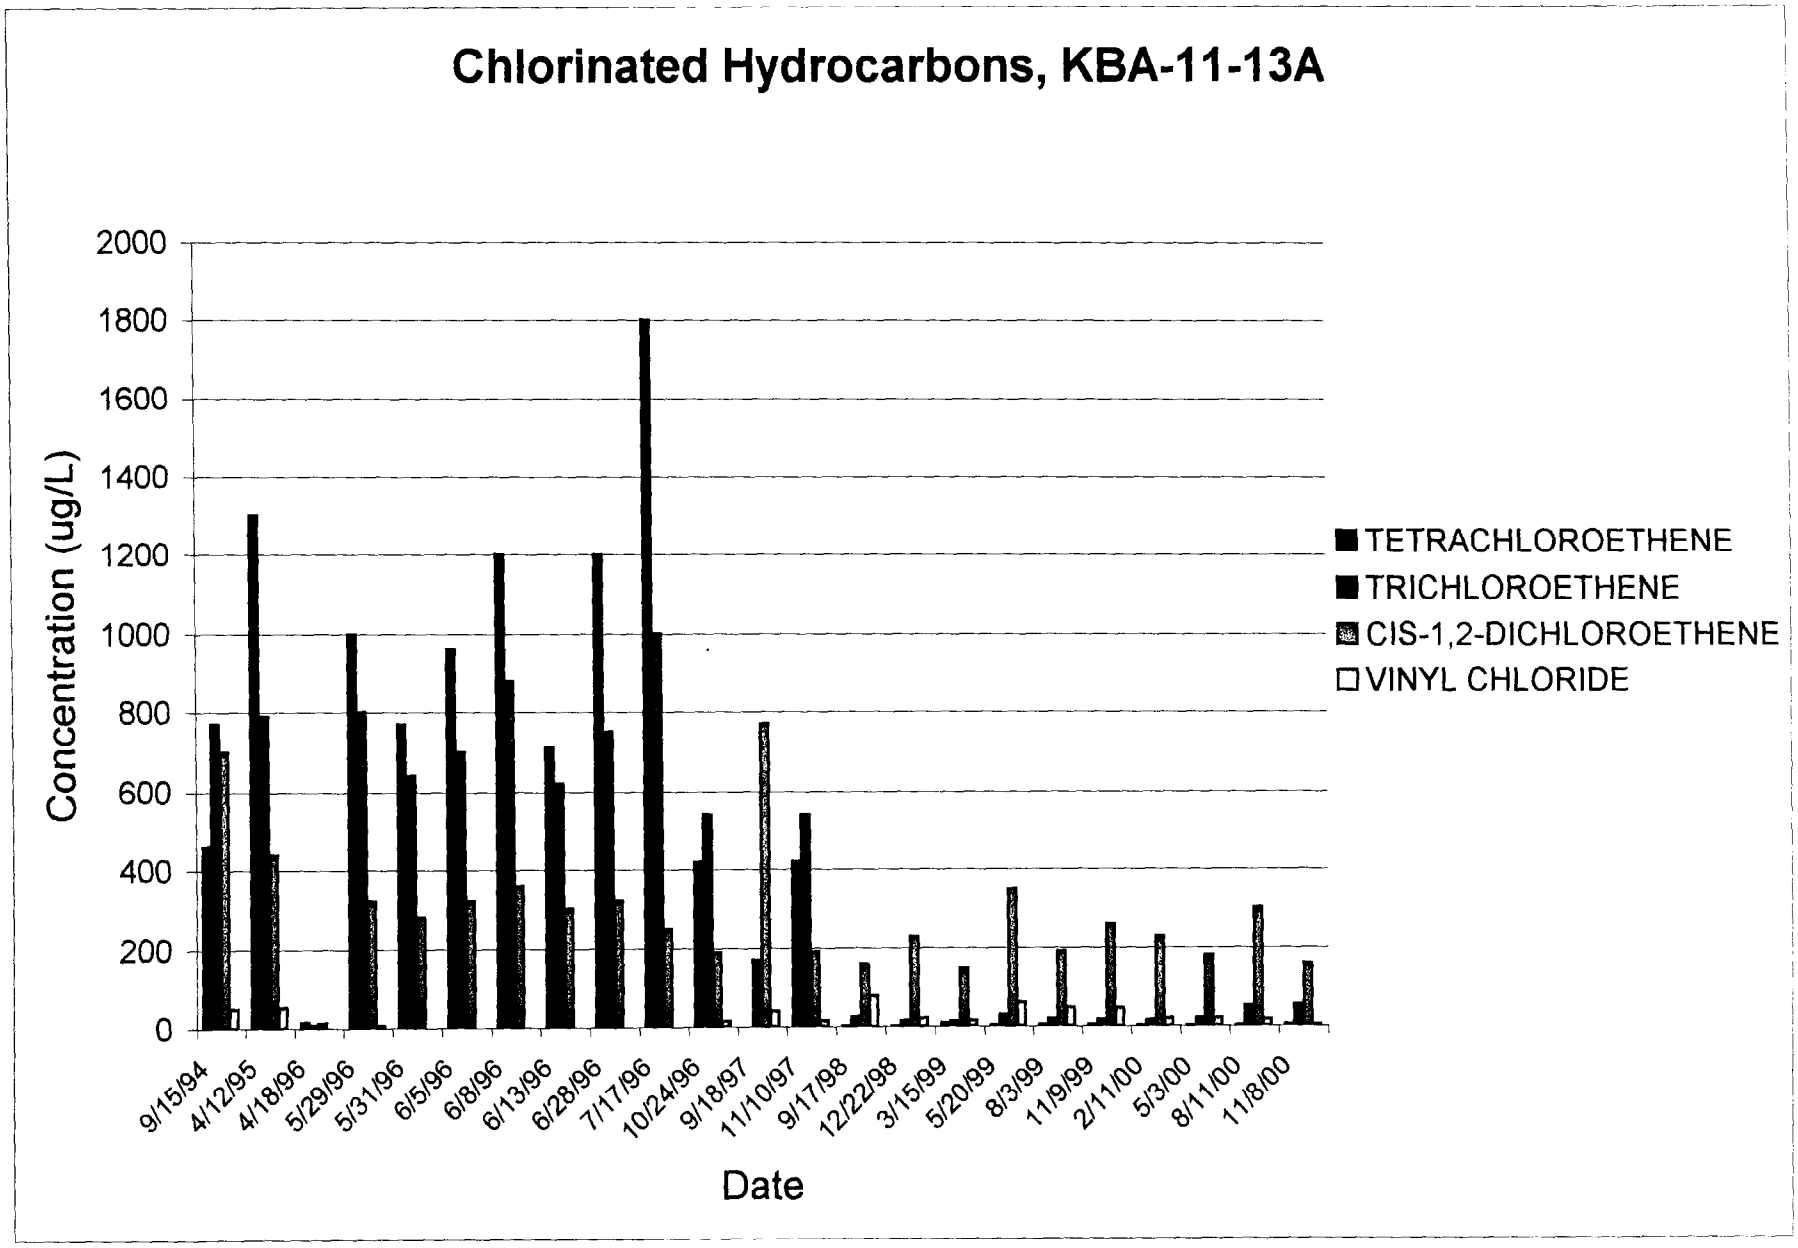
FIGURE 3 - CHLORINATED HYDROCARBONS, KBA-11-13A

Immediately downgradient to the source area at well KBA-11-13A, tetrachloroethene remains below the standard and cis-1,2-dichloroethene, trichloroethene, chlorobenzene and vinyl chloride remain above the standard (Figures 3 and 4). There was an increase in trichloroethene, tetrachloroethene and a decrease of cis-1, 2-dichloroethene and vinyl chloride concentrations at KBA-11-13A from the last quarter, while the chlorobenzene concentrations stayed constant.
