ENVIRONMENTAL ASSESSMENT REPORT ORLANDO EXECUTIVE AIRPORT NTC ORLANDO FL

ENVIRONMENTAL SITE ASSESSMENT

ORLANDO EXECUTIVE AIRPORT
ORLANDO, FLORIDA

ISSUE DATE: JULY 15, 1996

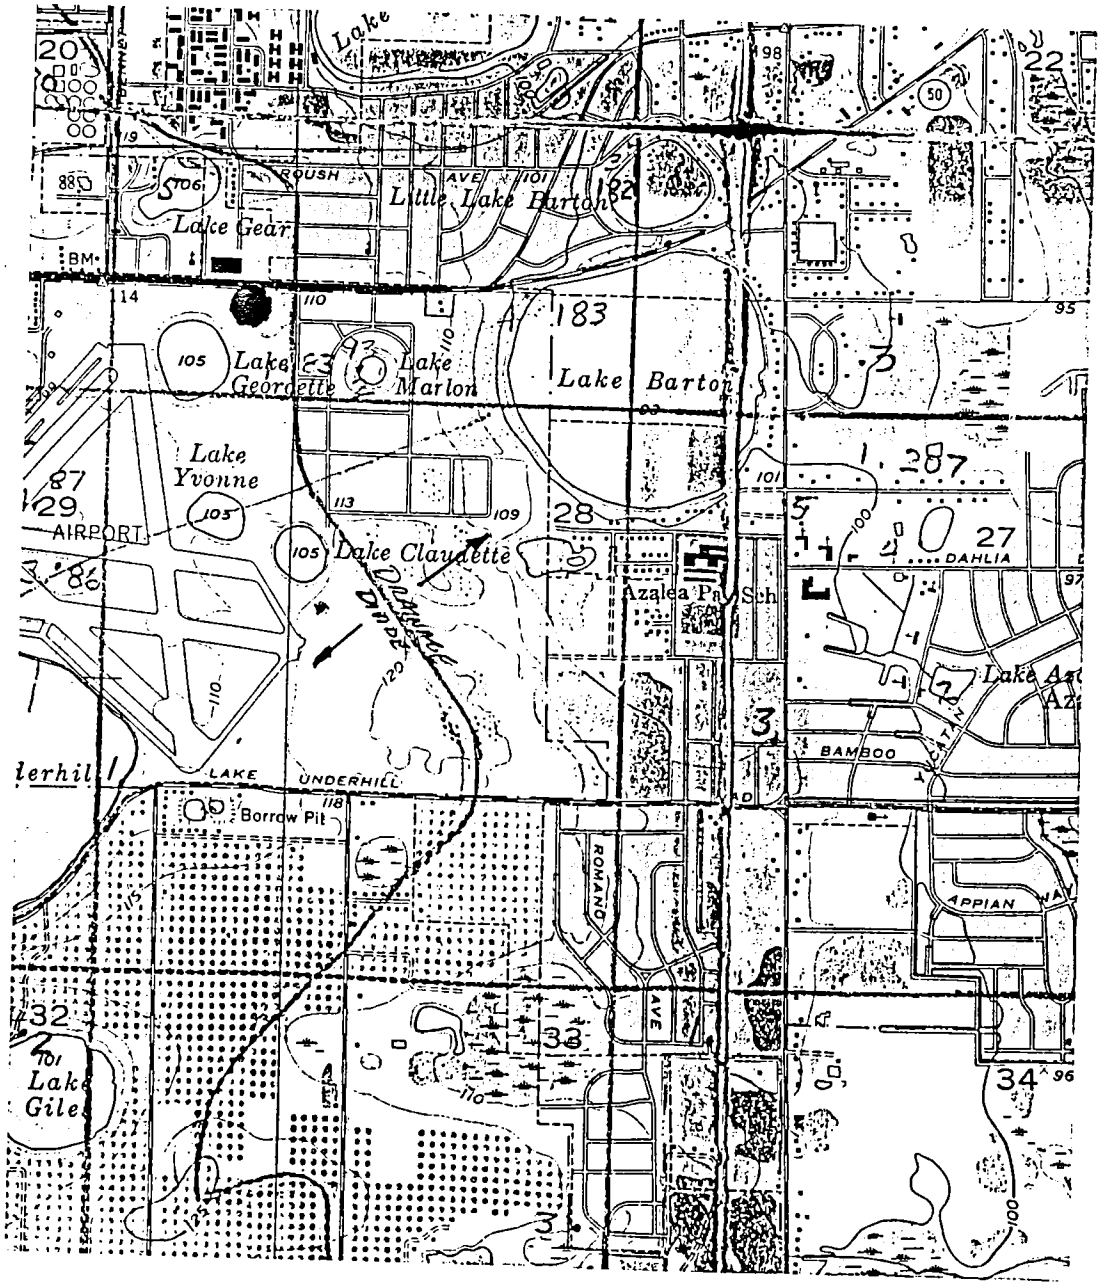
Figure 3

drainage measures to collect the runoff once it leaves the site. The site occupies a topographic drainage divide. The northeastern sections of the site will drain into Lake Barton to the northeast. The southwestern sections of the site will drain into Lake Underhill to the west and southwest (figure 3).

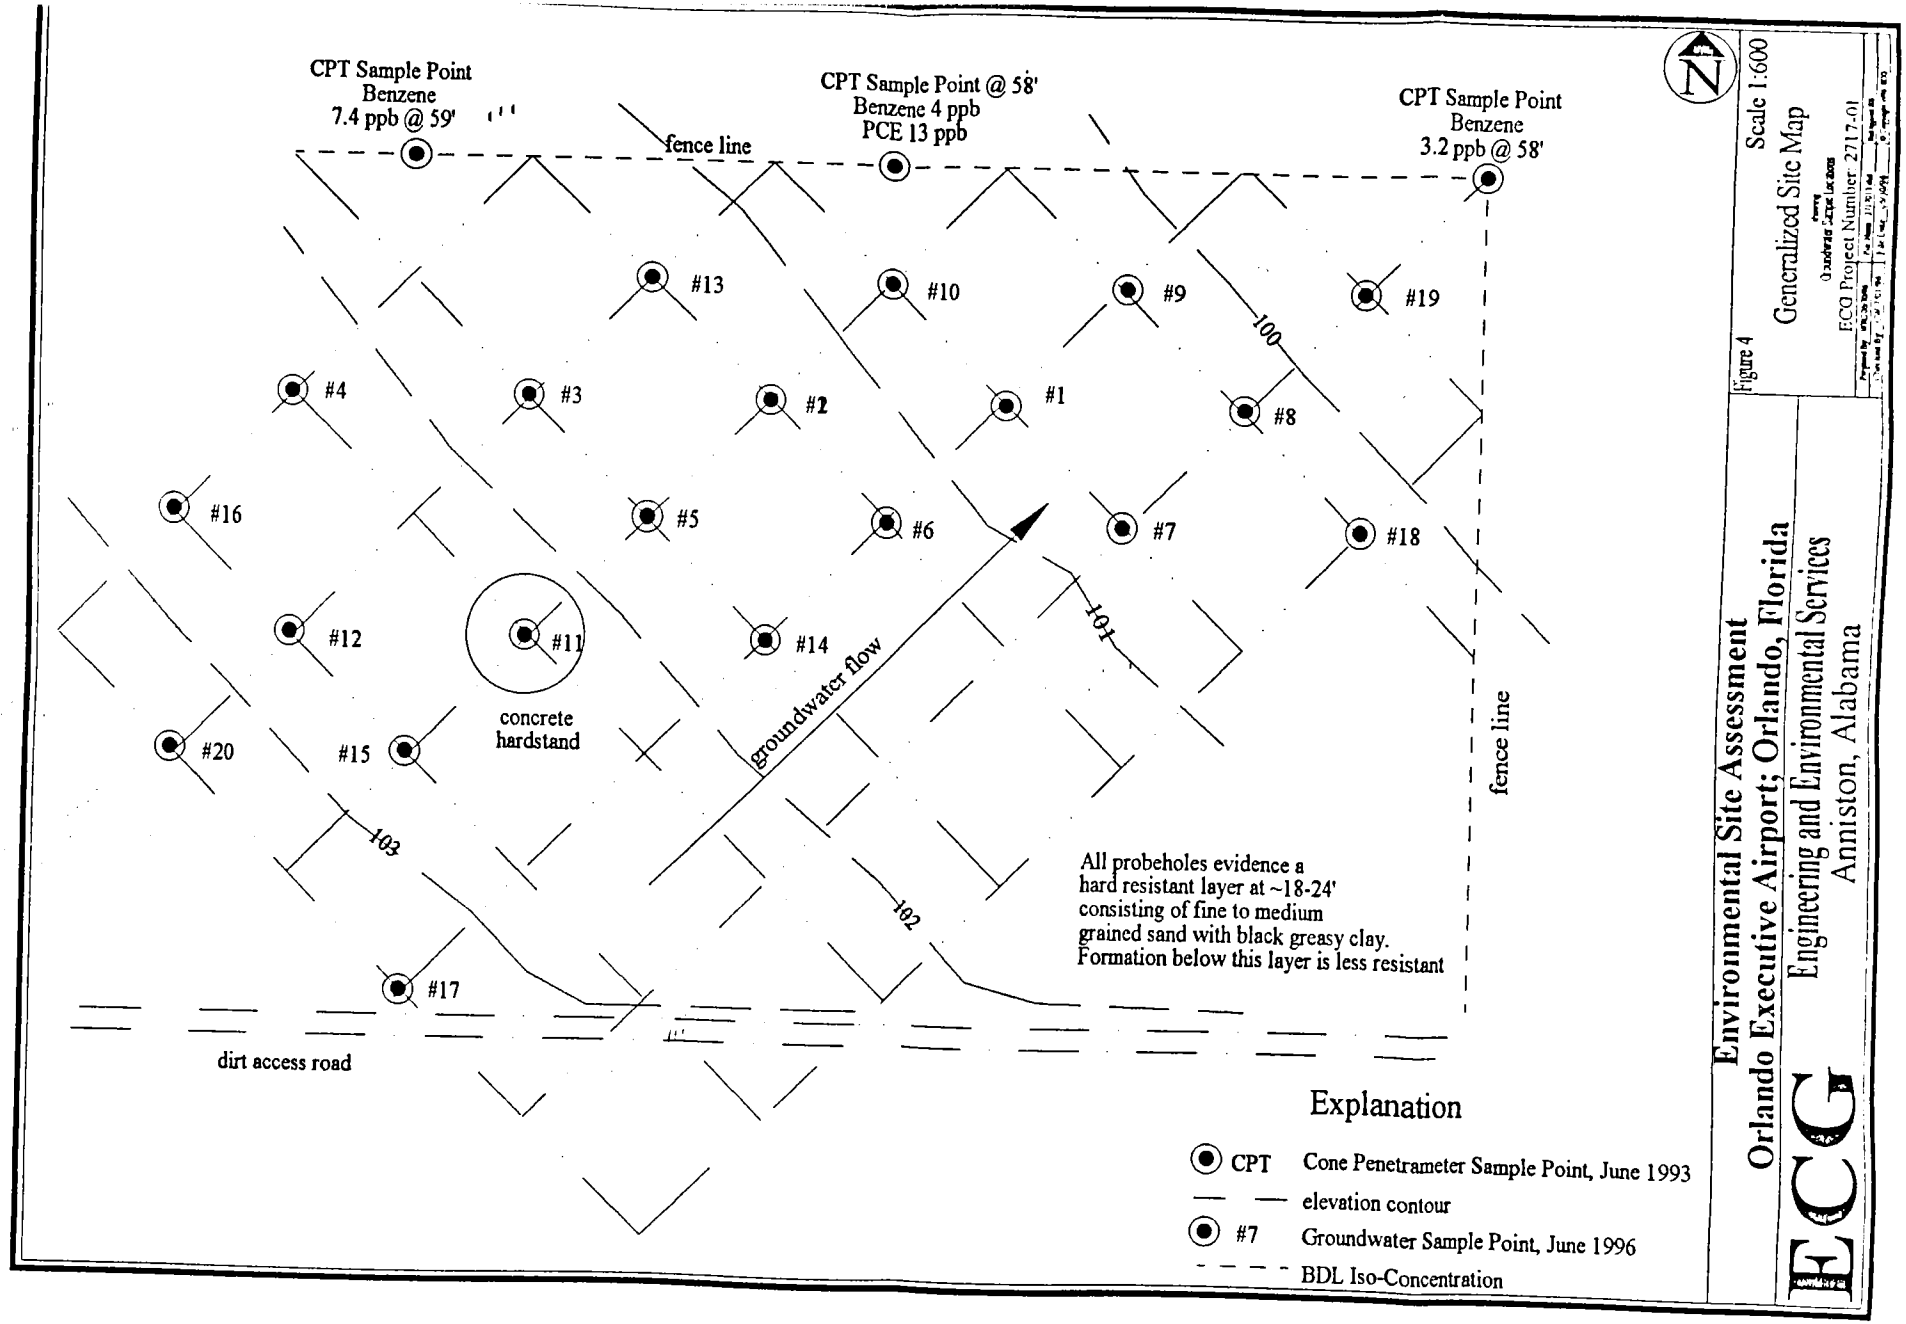
Those points on figure 4, labeled as cone penetrameter (CPT) sample points, are from the previous investigation on the adjacent property to the north and are used as indicators and markers. That investigation was conducted in June 1993.

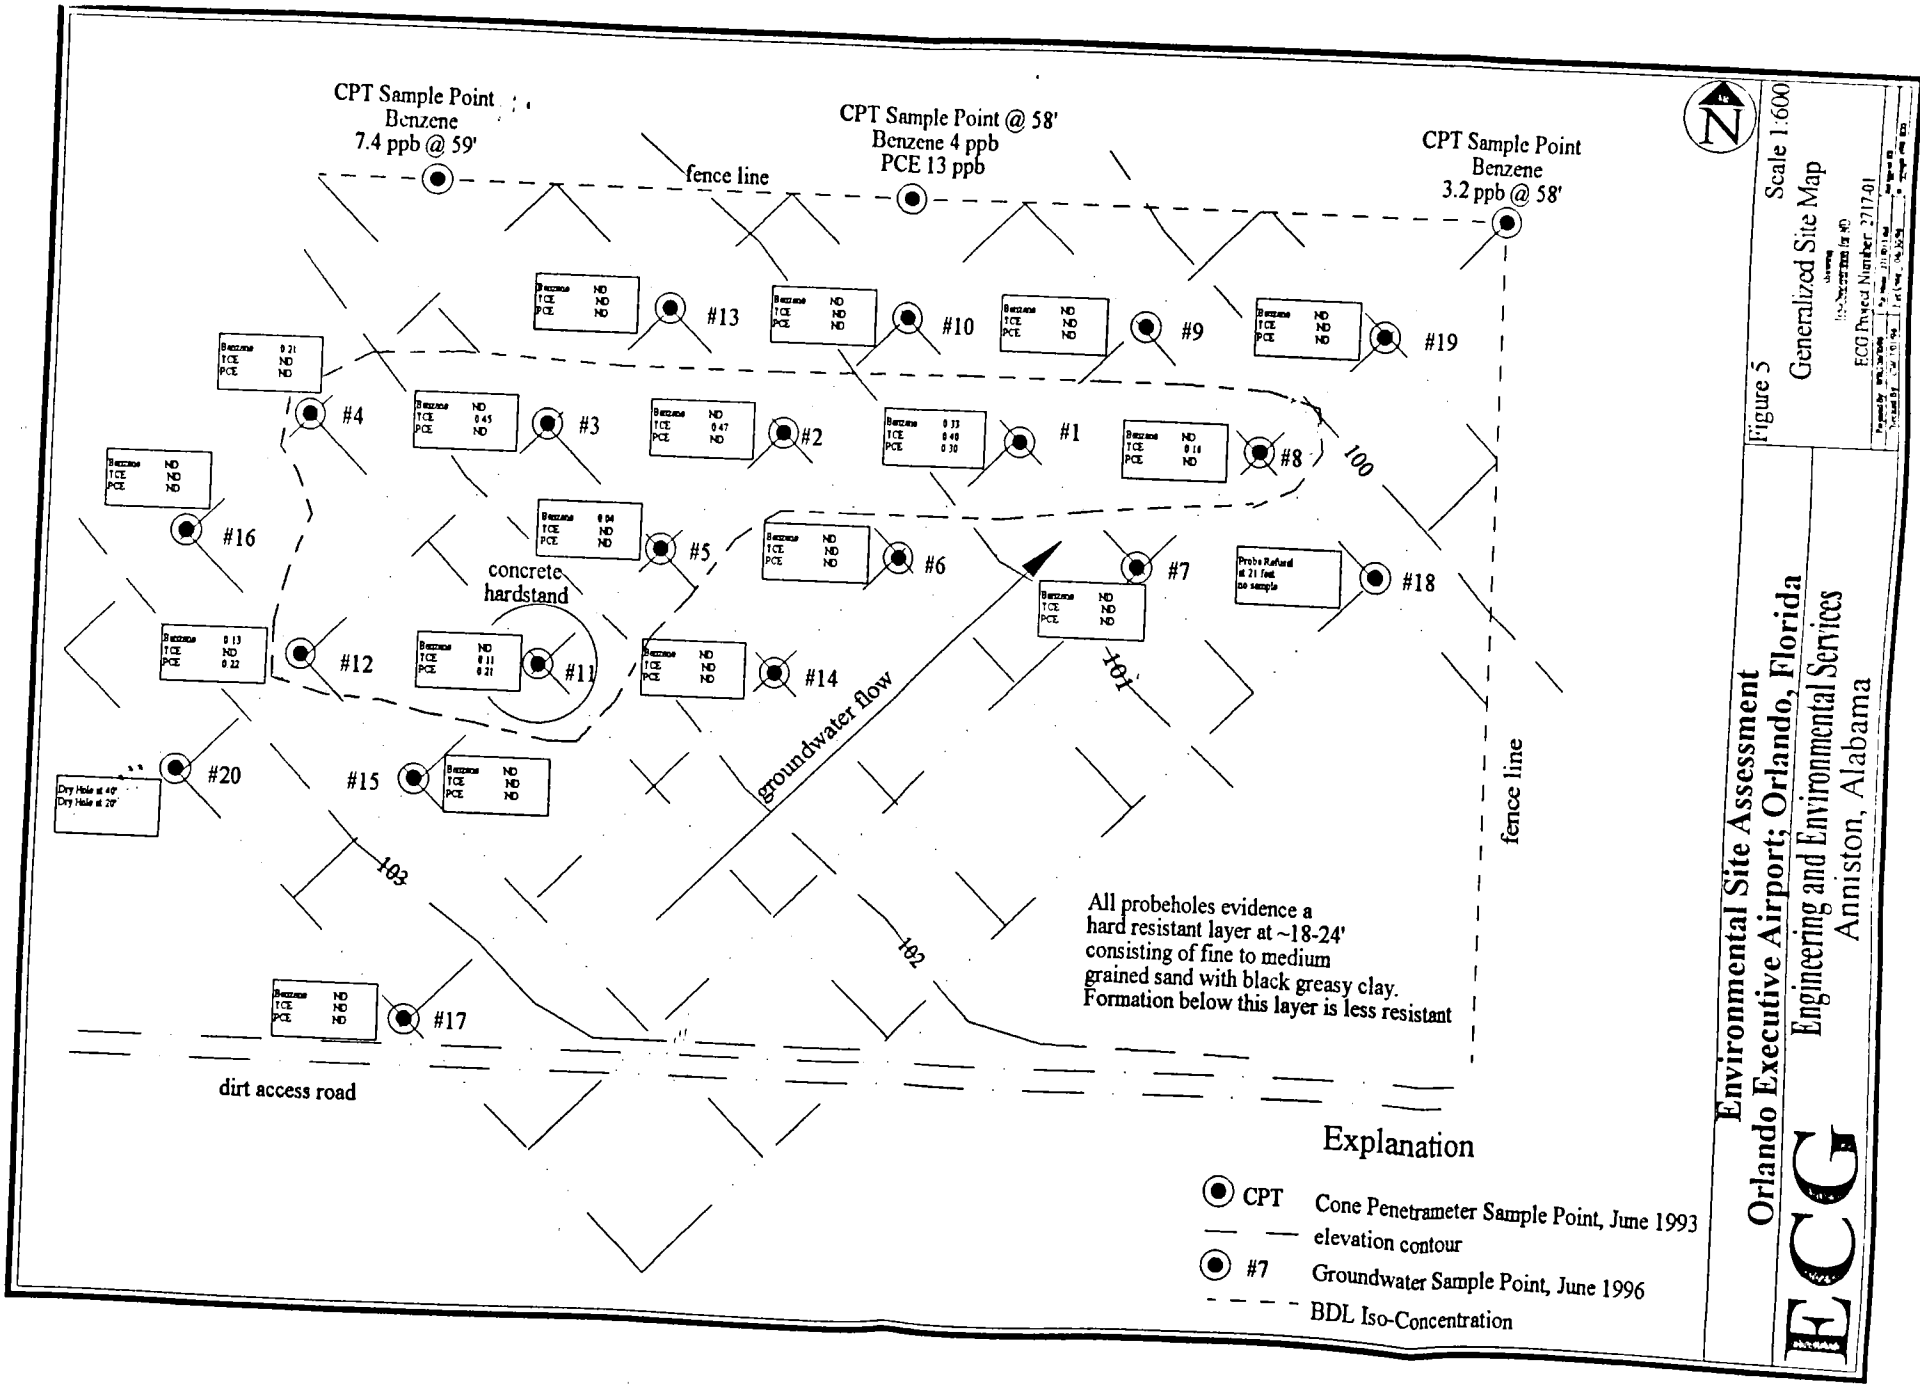
Since the data indicated a plume with the hardstand as a source, the second sample from point P11 at forty (40) feet and two (2) others immediately upgradient, P15 and P17, were sent to an independent laboratory for confirmation. No contaminants were detected.

Results of these analyses are plotted and displayed graphically in figure 5. Sample results for TCE, PCE, and benzene are displayed on Tables 3 below. GC strip charts and laboratory originals can be found in Appendix B of this report.
