N00204.AR.000053
NAS PENSACOLA
5090.3a

QUARTERLY REPORT
CORRECTIVE ACTION PROGRAM WWTP
2/87 TO 4/87
NAS PENSACOLA, FLORIDA

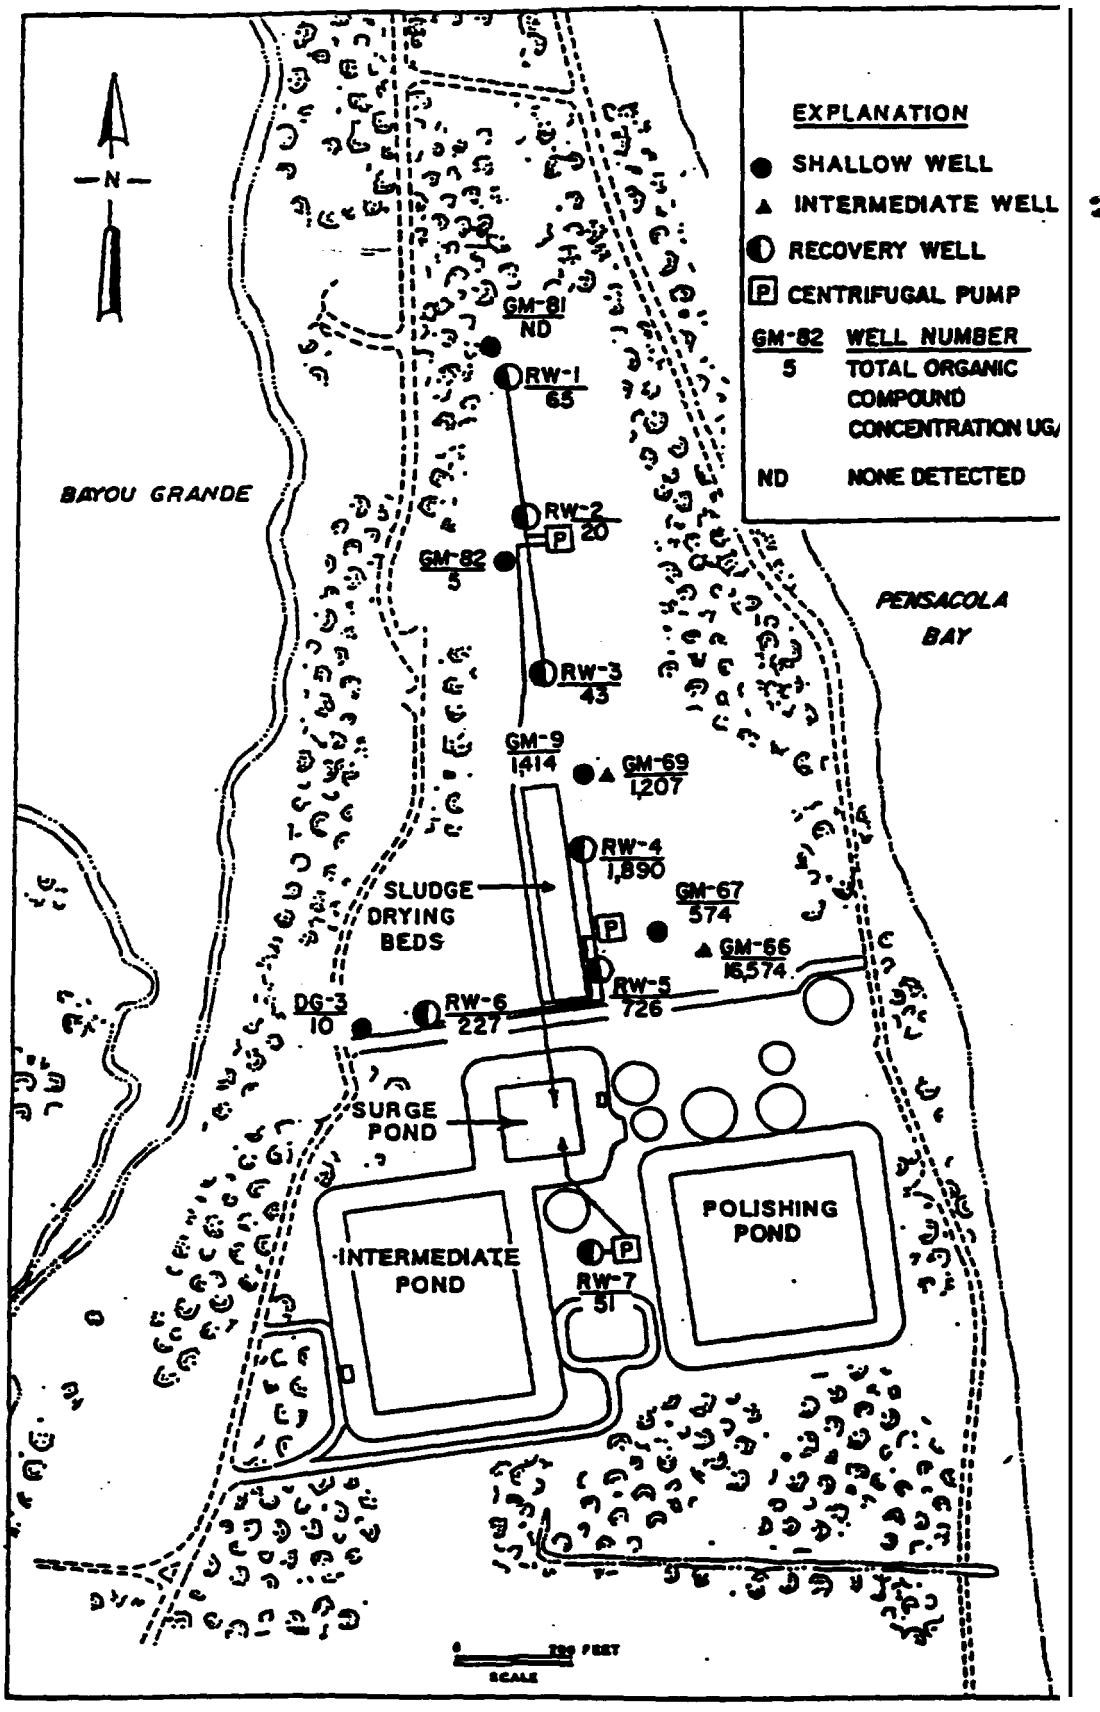
Figure 7. Areal Distribution of Total Organic Compound Concentrations in the Monitor and Recovery Wells.

The data basically document existing conditions prior to long-term operation of the system and will be useful in developing trends in the water-quality constituents as the ground-water system is gradually purged of contaminants. The areal distribution of total organic concentrations detected in the monitor and recovery wells during start-up are shown in Figure 7.

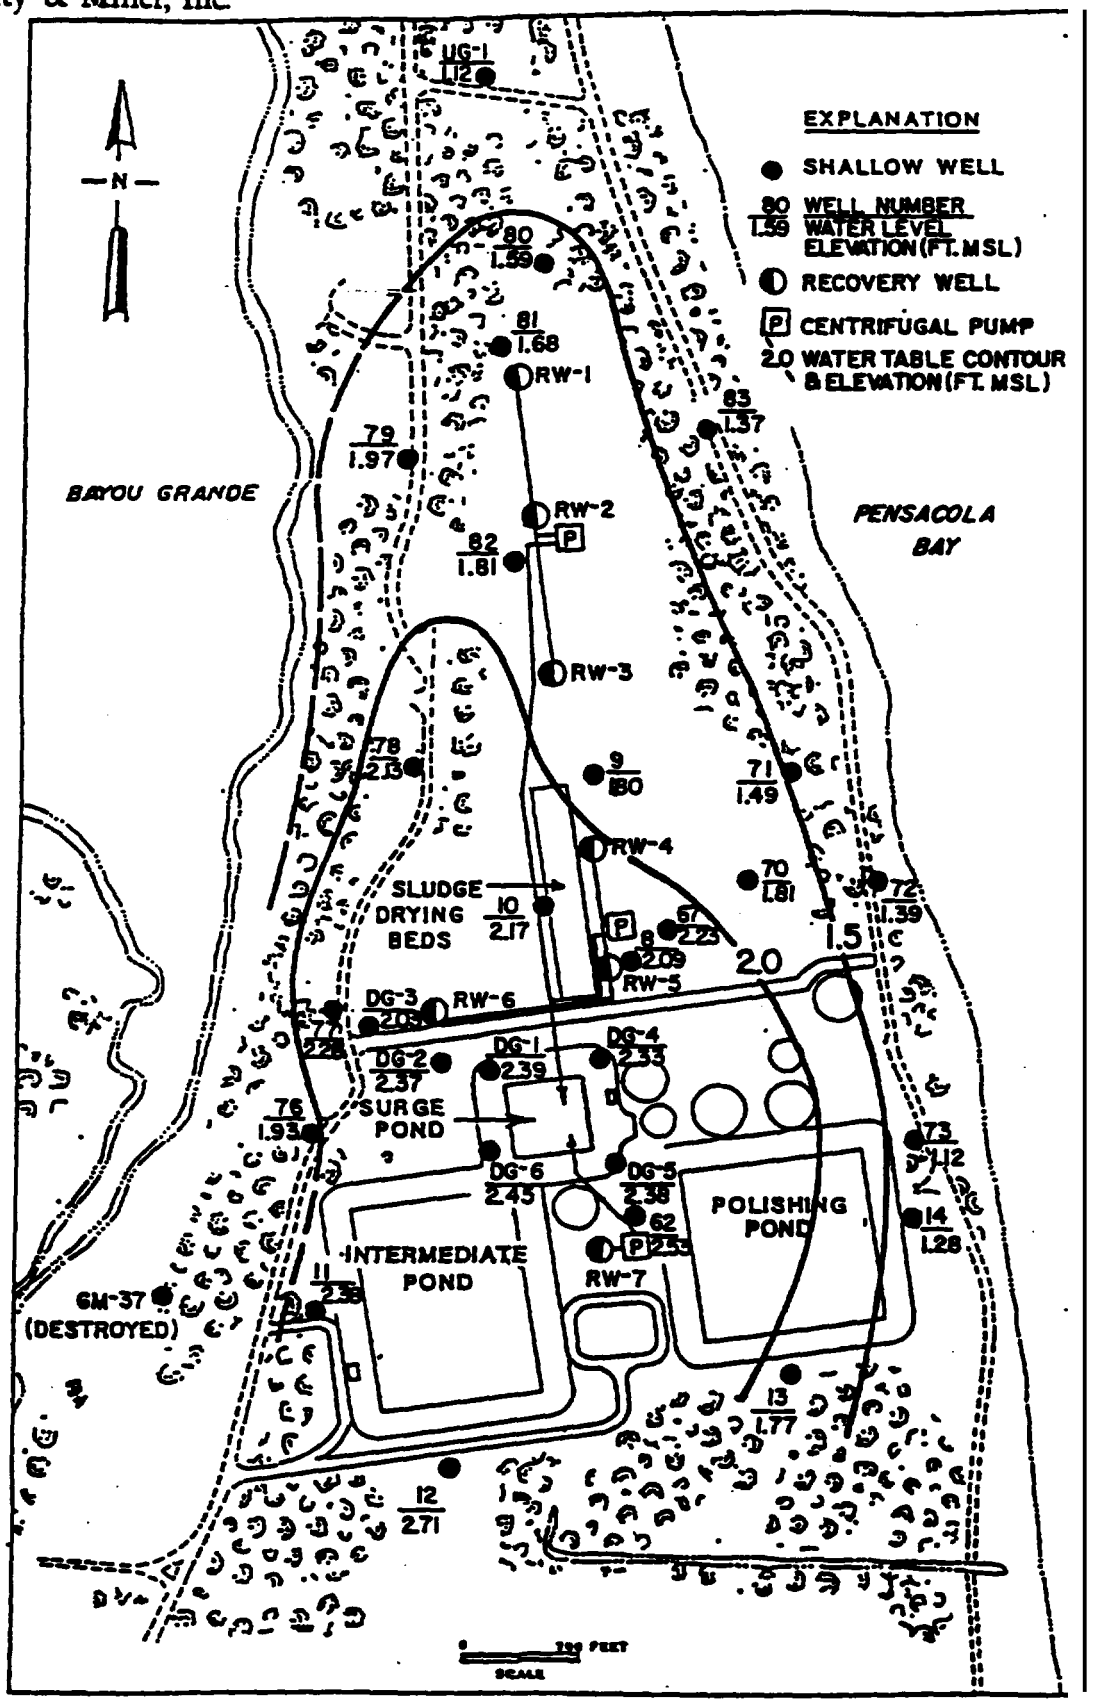
Figure 8. Water-Table Contour Map on February 3 and 4, 1987 (pre-pumping).

The configuration of the static (pre-pumping) water-level elevations as determined from measurements in the shallow monitor wells taken on February 3 and 4, 1987, are shown in Figure 8. Water-level elevations ranged from 1.12 to 2.96 ft above mean sea level (msl) (Table 6). As determined in previous investigations, a ground-water divide extends along the axis of the peninsula and the direction of flow is north, northeast, and northwest toward Pensacola Bay and Bayou Grande.

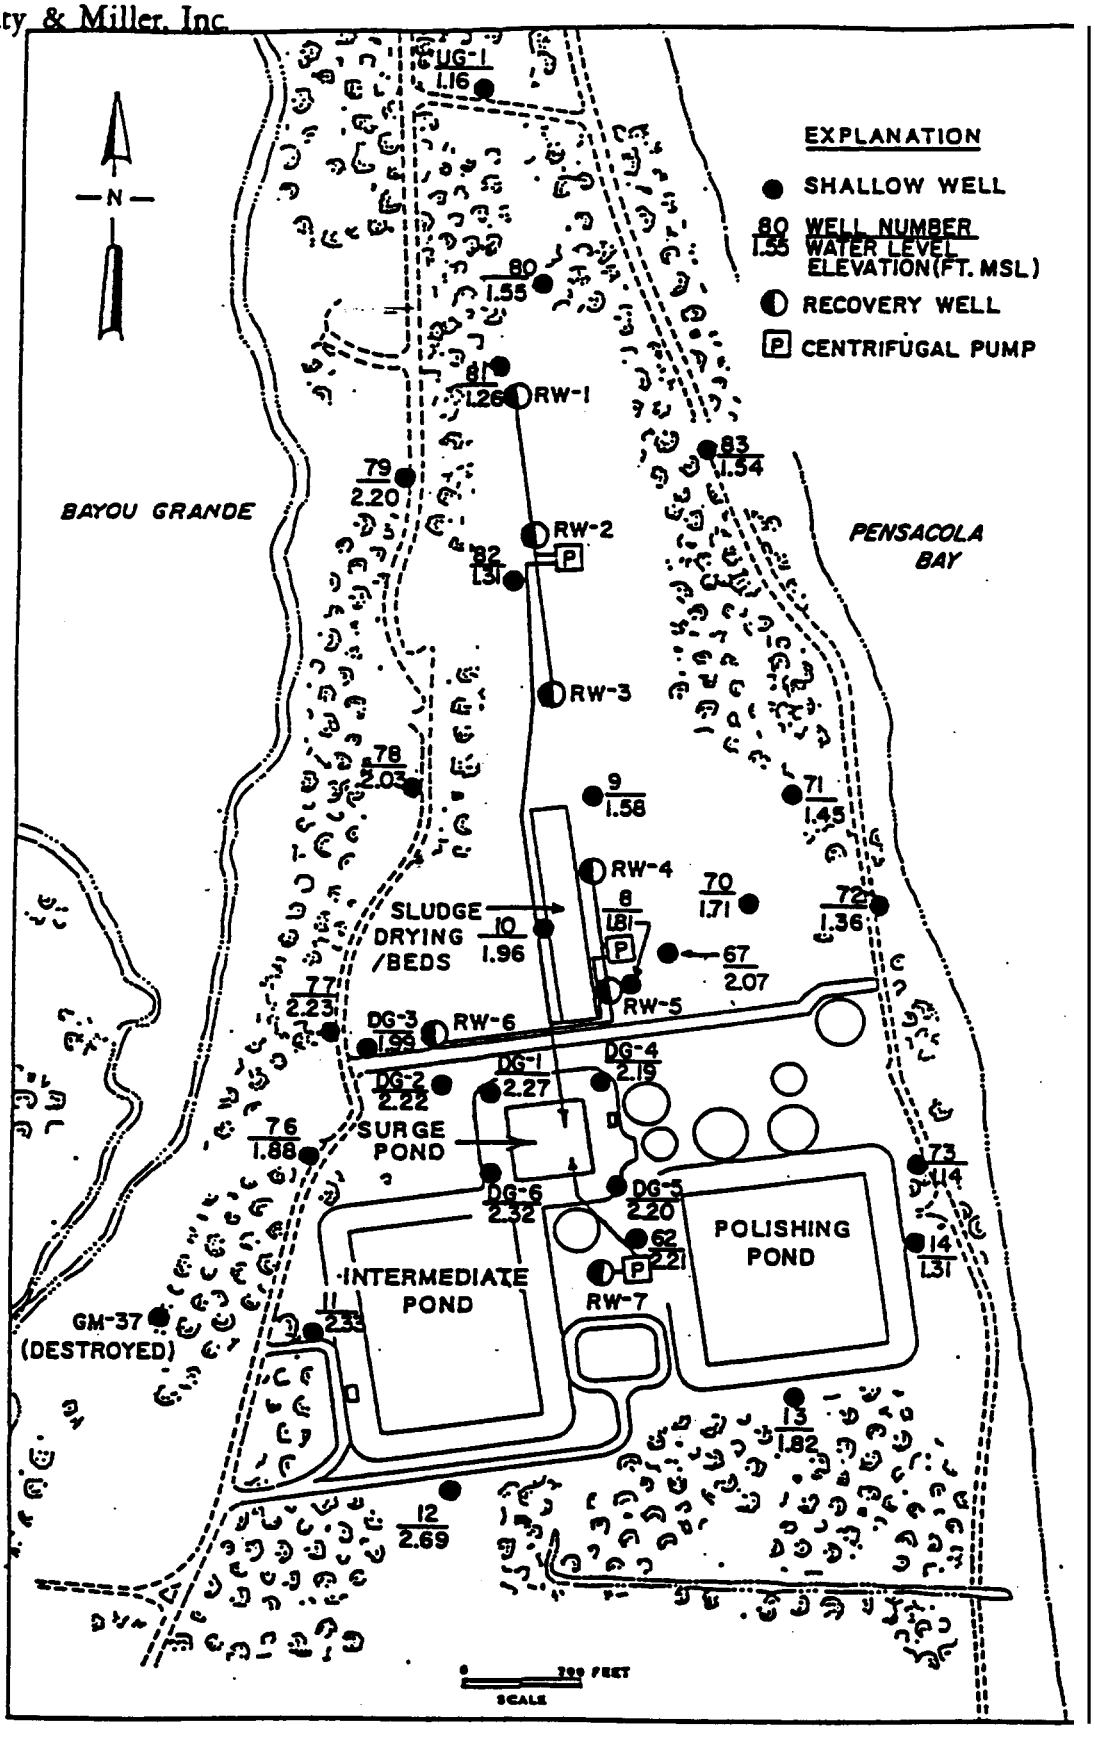
Figure 9. Water-Level Elevations on February 6, 1987 (Recovery-Well System Pumping for Two Days).

Ground-water levels measured on March 10, 1987 (approximately 30 days of pumping) generally were higher than pre-pumping values, which is sttributed to heavy rains in the area prior to and during this time period, Therefore, the water-level data collected on February 6, 1987 (two days of pumping were used to illustrate the cone of depression surrounding the recovery wells. Figure 9 shows the start of a depression forming in the water-table surface. Water-level drawdown will become more obvious and significant with continued pumping and lesser rainfall. The data show that the cone has developed within the confines of the peninsula and suggest that the system can be operated at the existing withdrawal rates without causing significant salt-water intrusion into the shallow ground-water system. The cone of depression will increase and decrease in size in response to rainfall events; future monitoring of water levels and water
