ASBESTOS AND LEAD-BASED PAINT REMEDIATION PLAN
STOP 7 ½ NAVAL RESERVATION

ROOSEVELT ROADS REAL ESTATE
SAN JUAN, PUERTO RICO

CONTRACT TASK ORDER 0401

AUGUST 2002

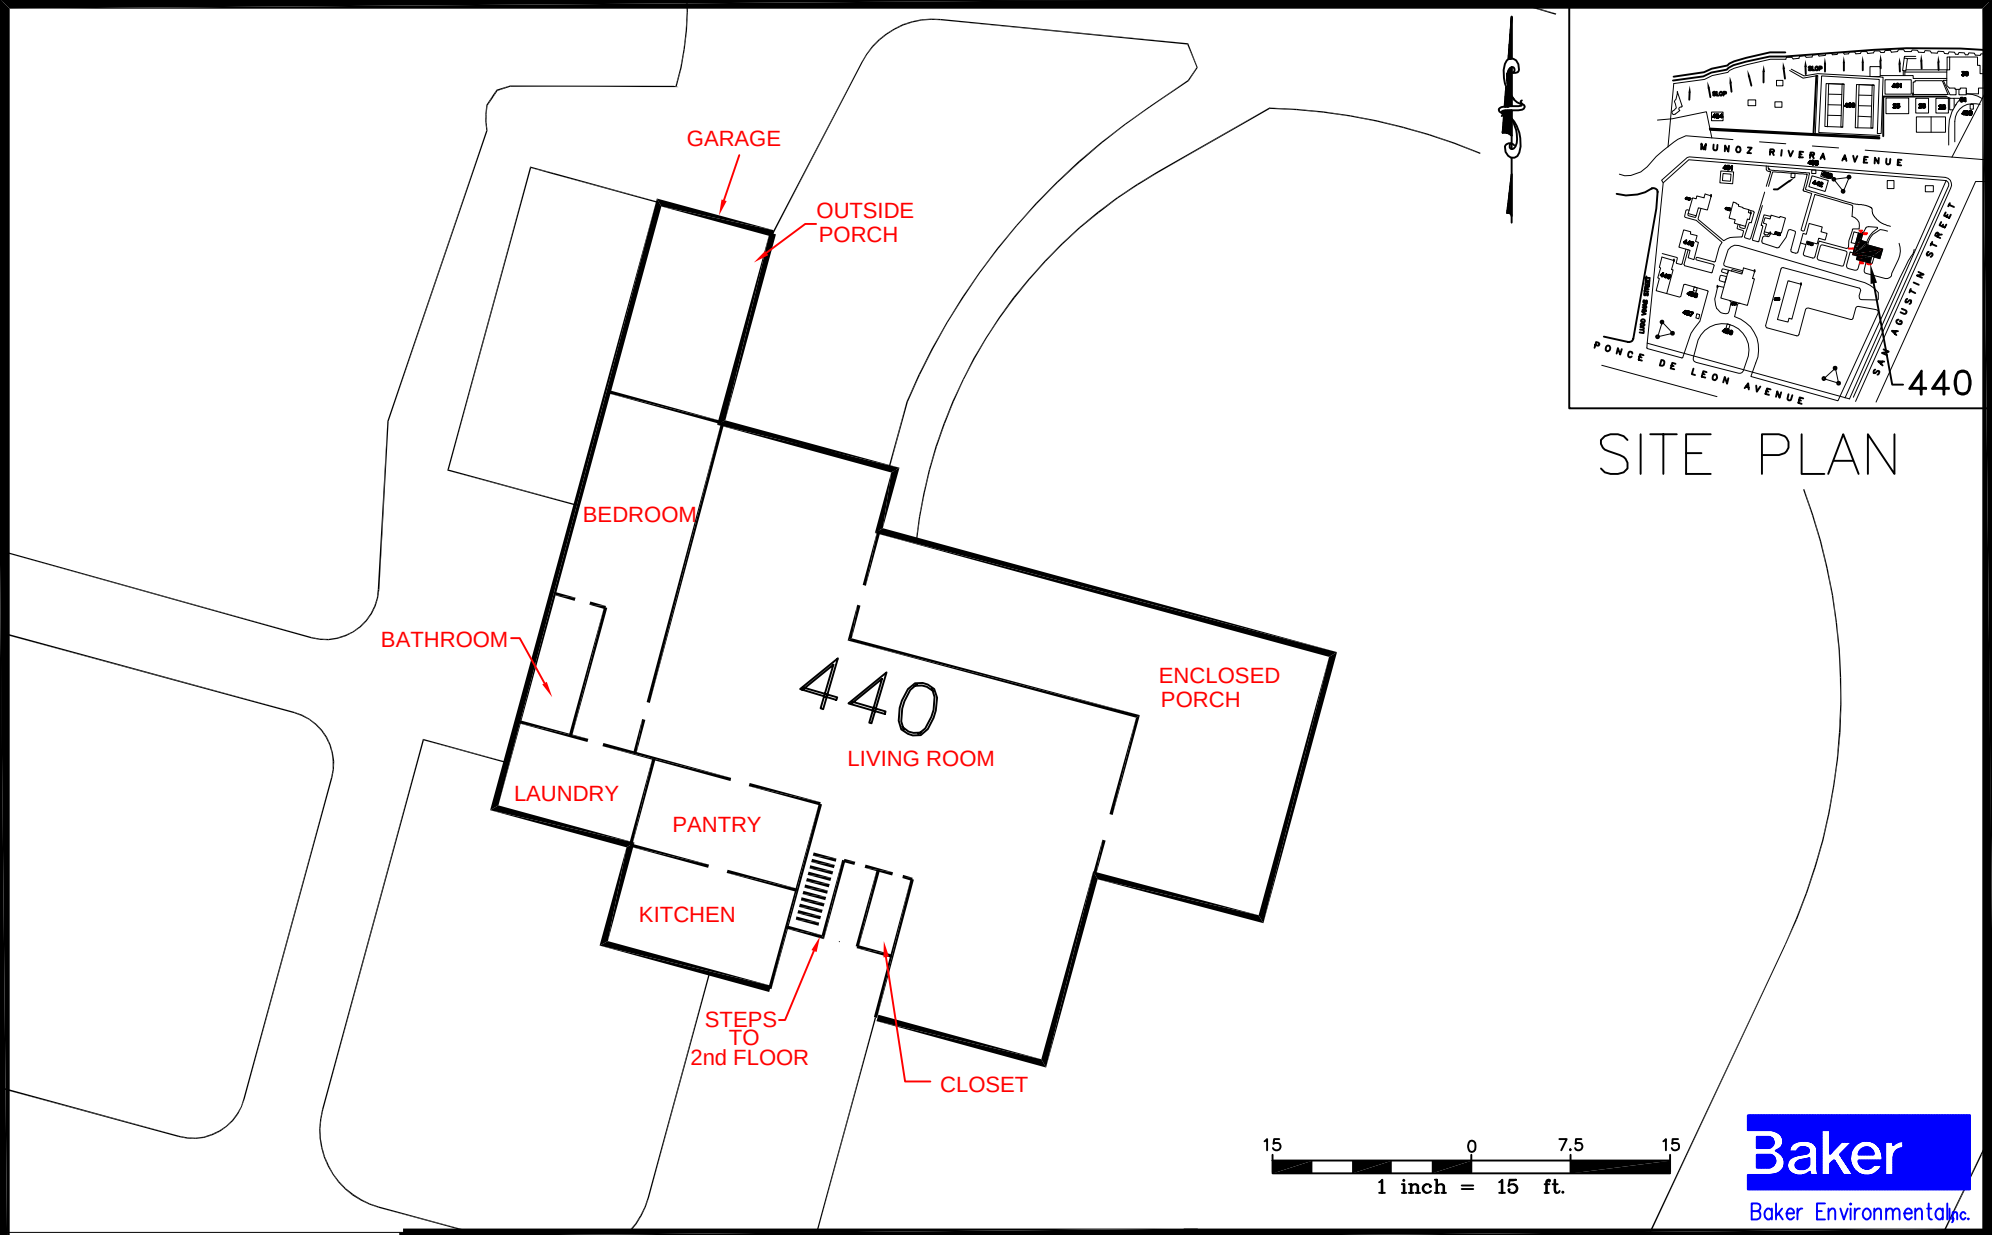
The vinyl floor tile, adhesive, and sink coating were all in good condition at the time of the field investigation. Refer to Photograph Layout 3-3 to view various photographs of Building 440. Figures 3-4 and 3-5 depict the first floor and second floor, floor plans for Building 440, respectively.

1. VINYL FLOOR TILE LAUNDRY ROOM
2. FLOOR TILE ADHESIVE LAUNDRY ROOM
3. COATING ON BOTTOM OF KITCHEN SINK

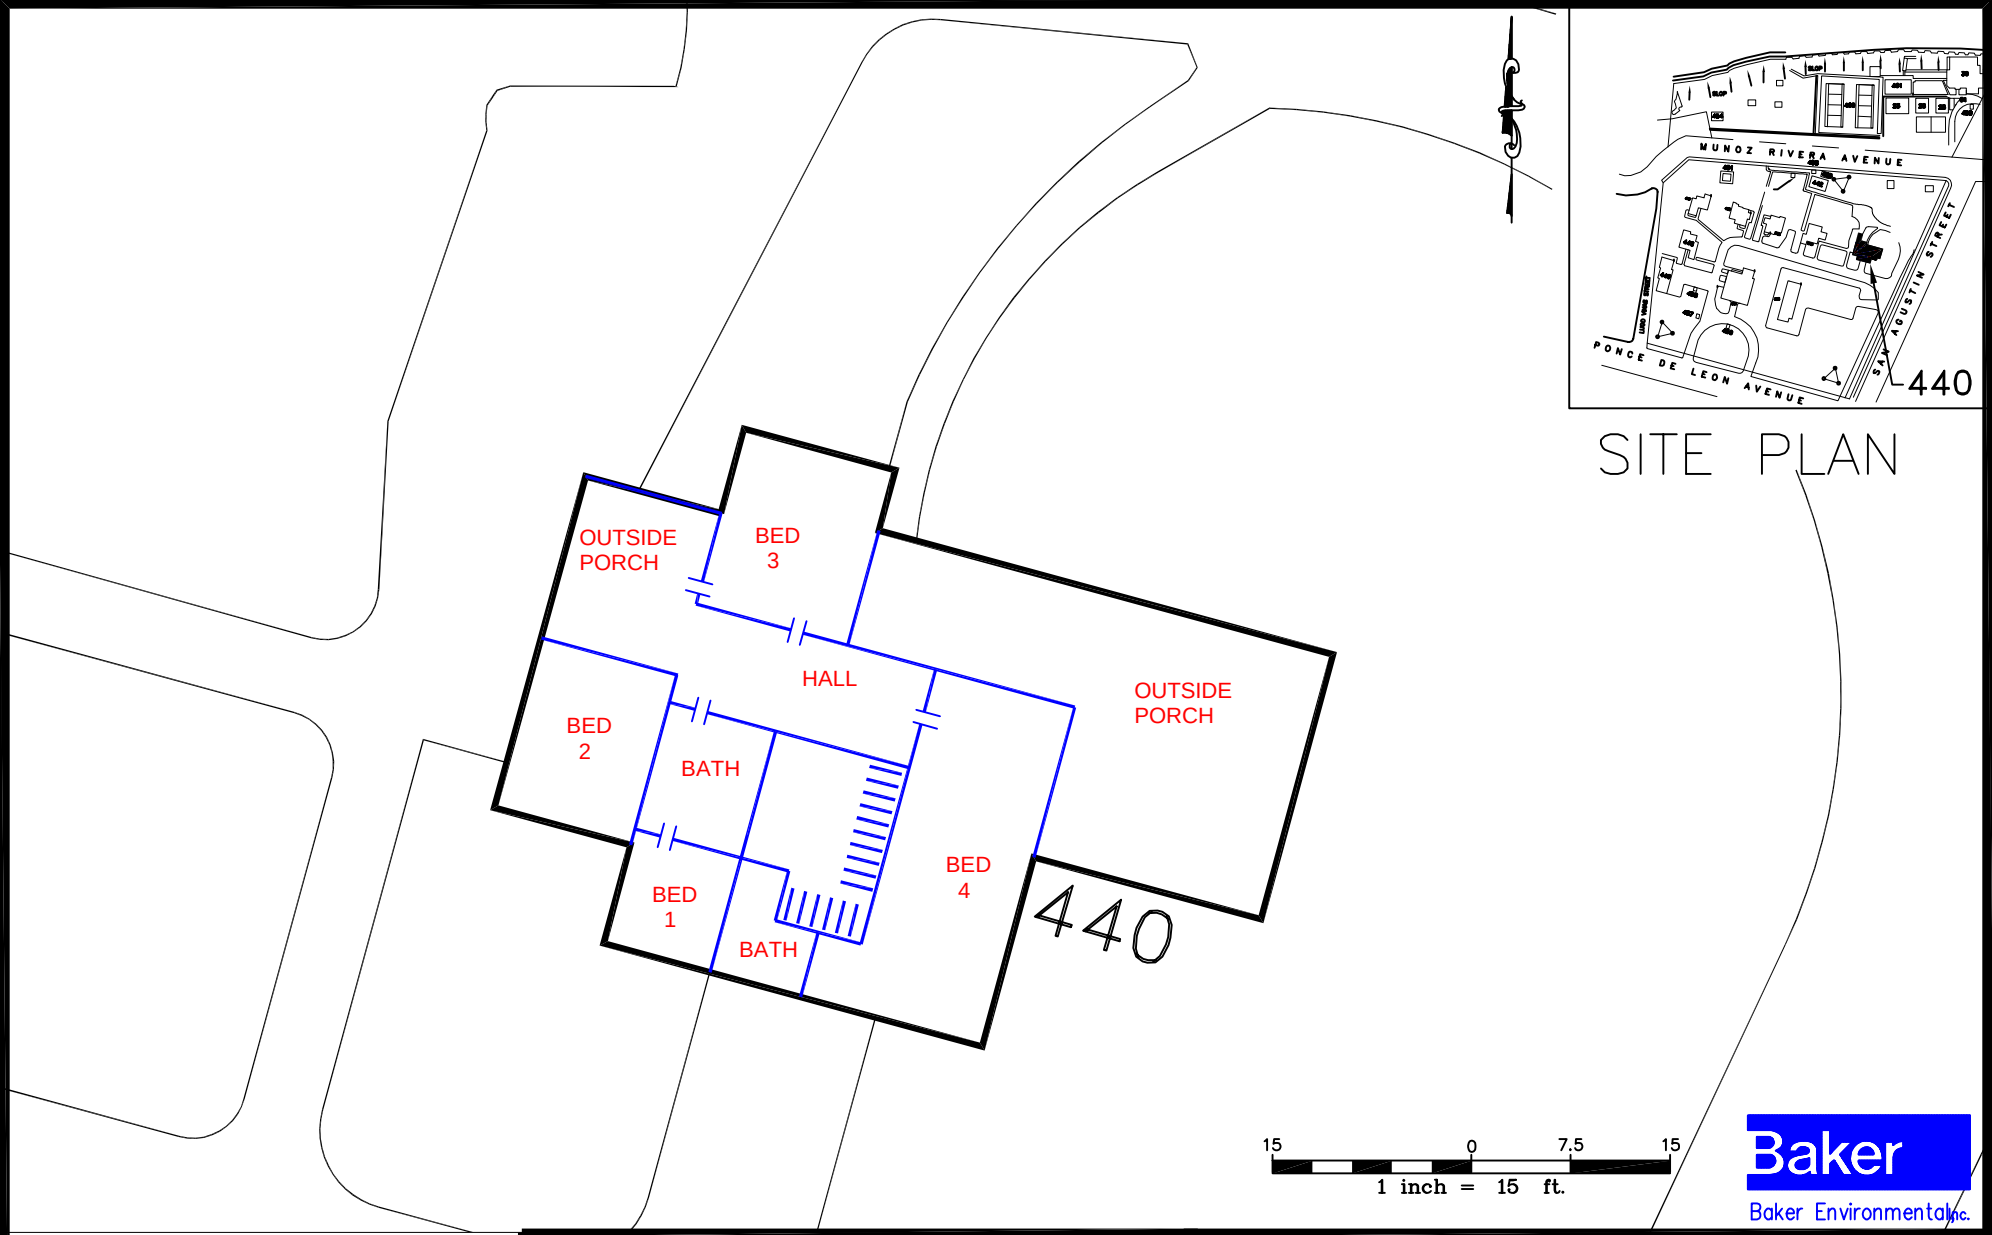
FIGURE 3–5
STOP 7–1/2 BUILDING 440B
UNOCCUPIED RESIDENT BUILDING
SECOND FLOOR

NO ASBESTOS DETECTED

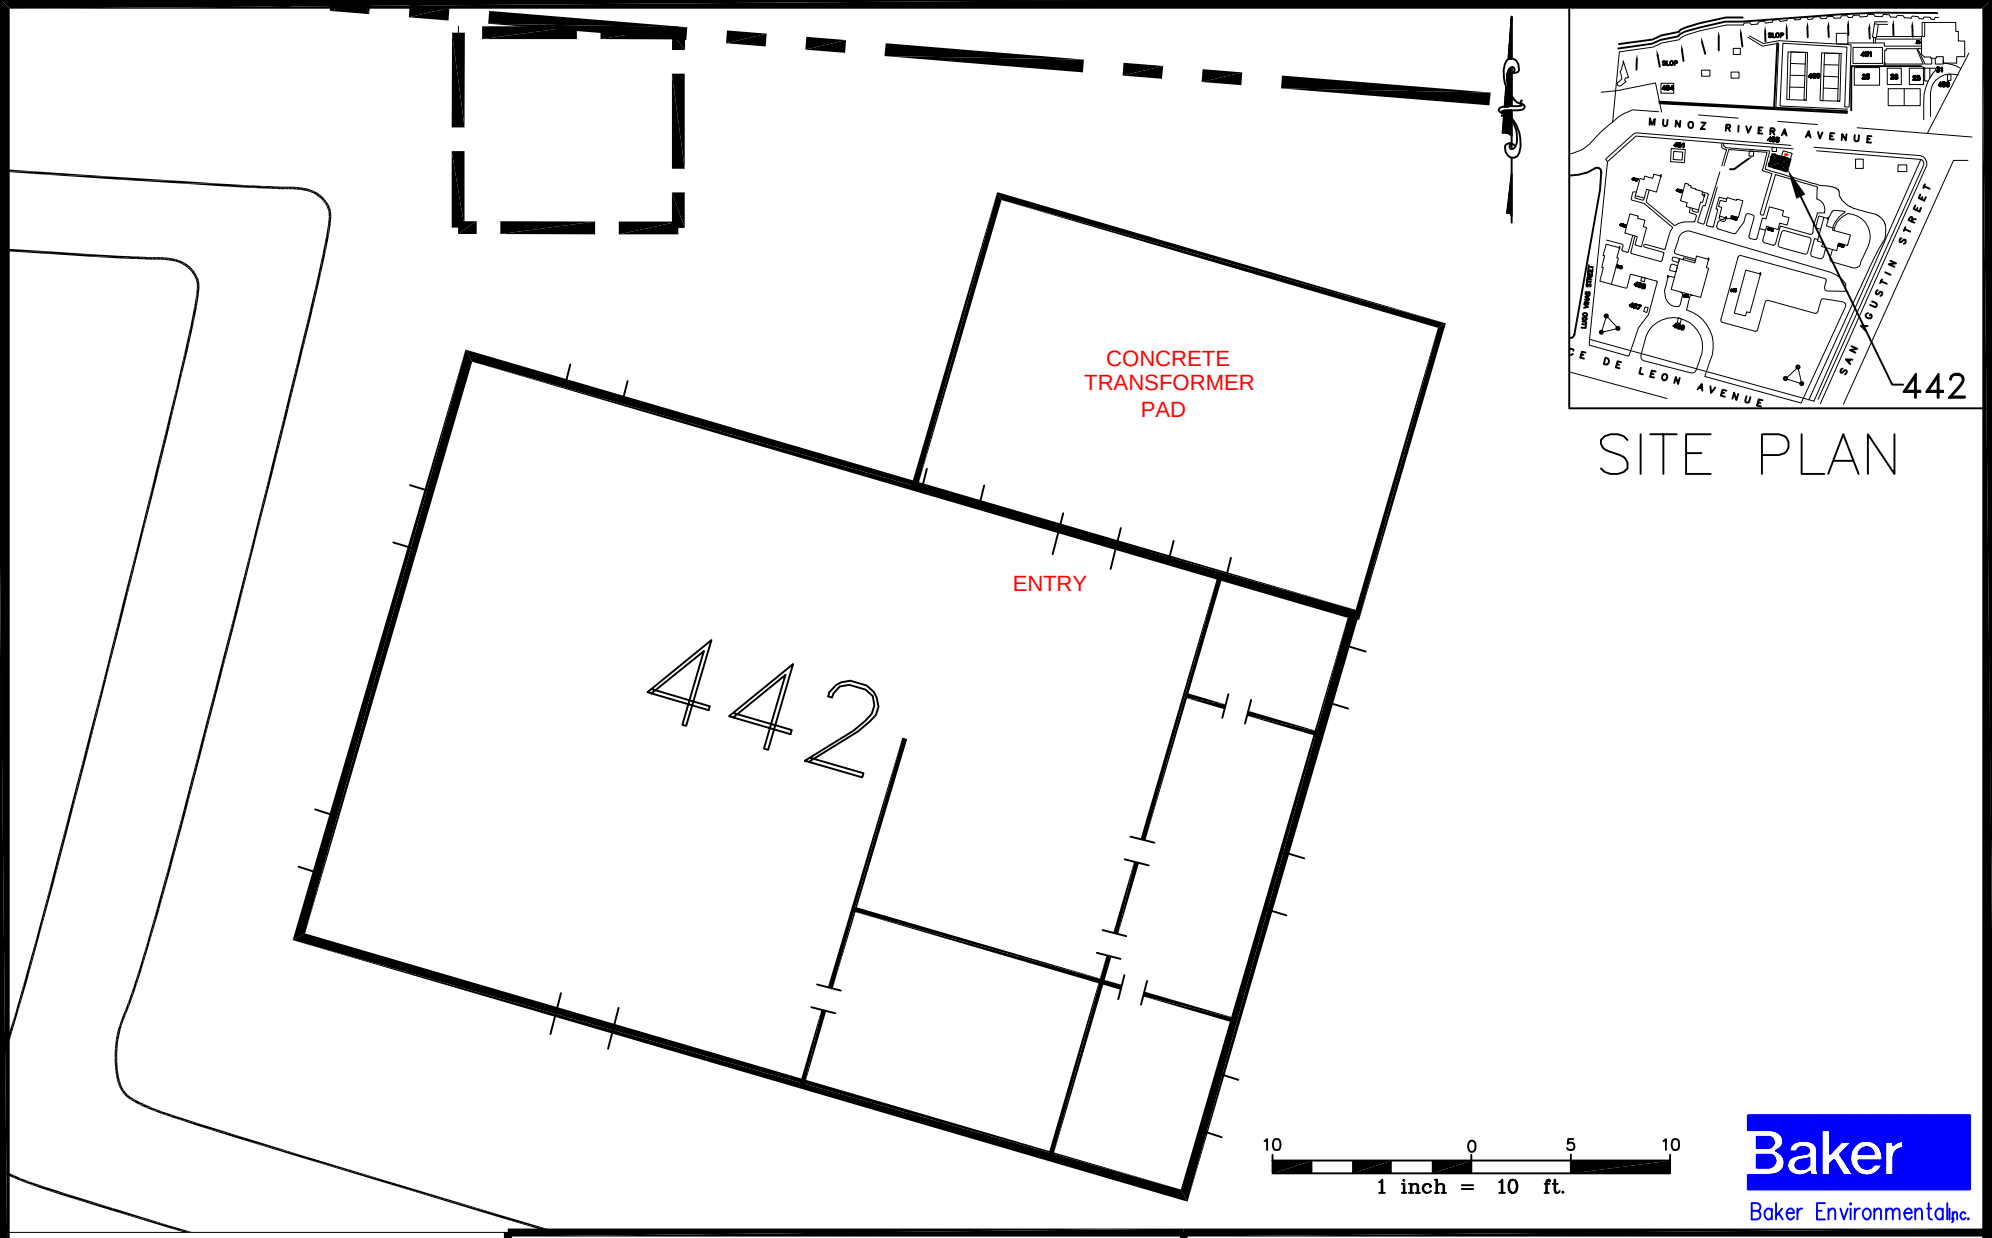
FIGURE 3–8
STOP 7–1/2 BUILDING 442
FORMER RADIO STATION POWER HOUSE

NO ASBESTOS DETECTED

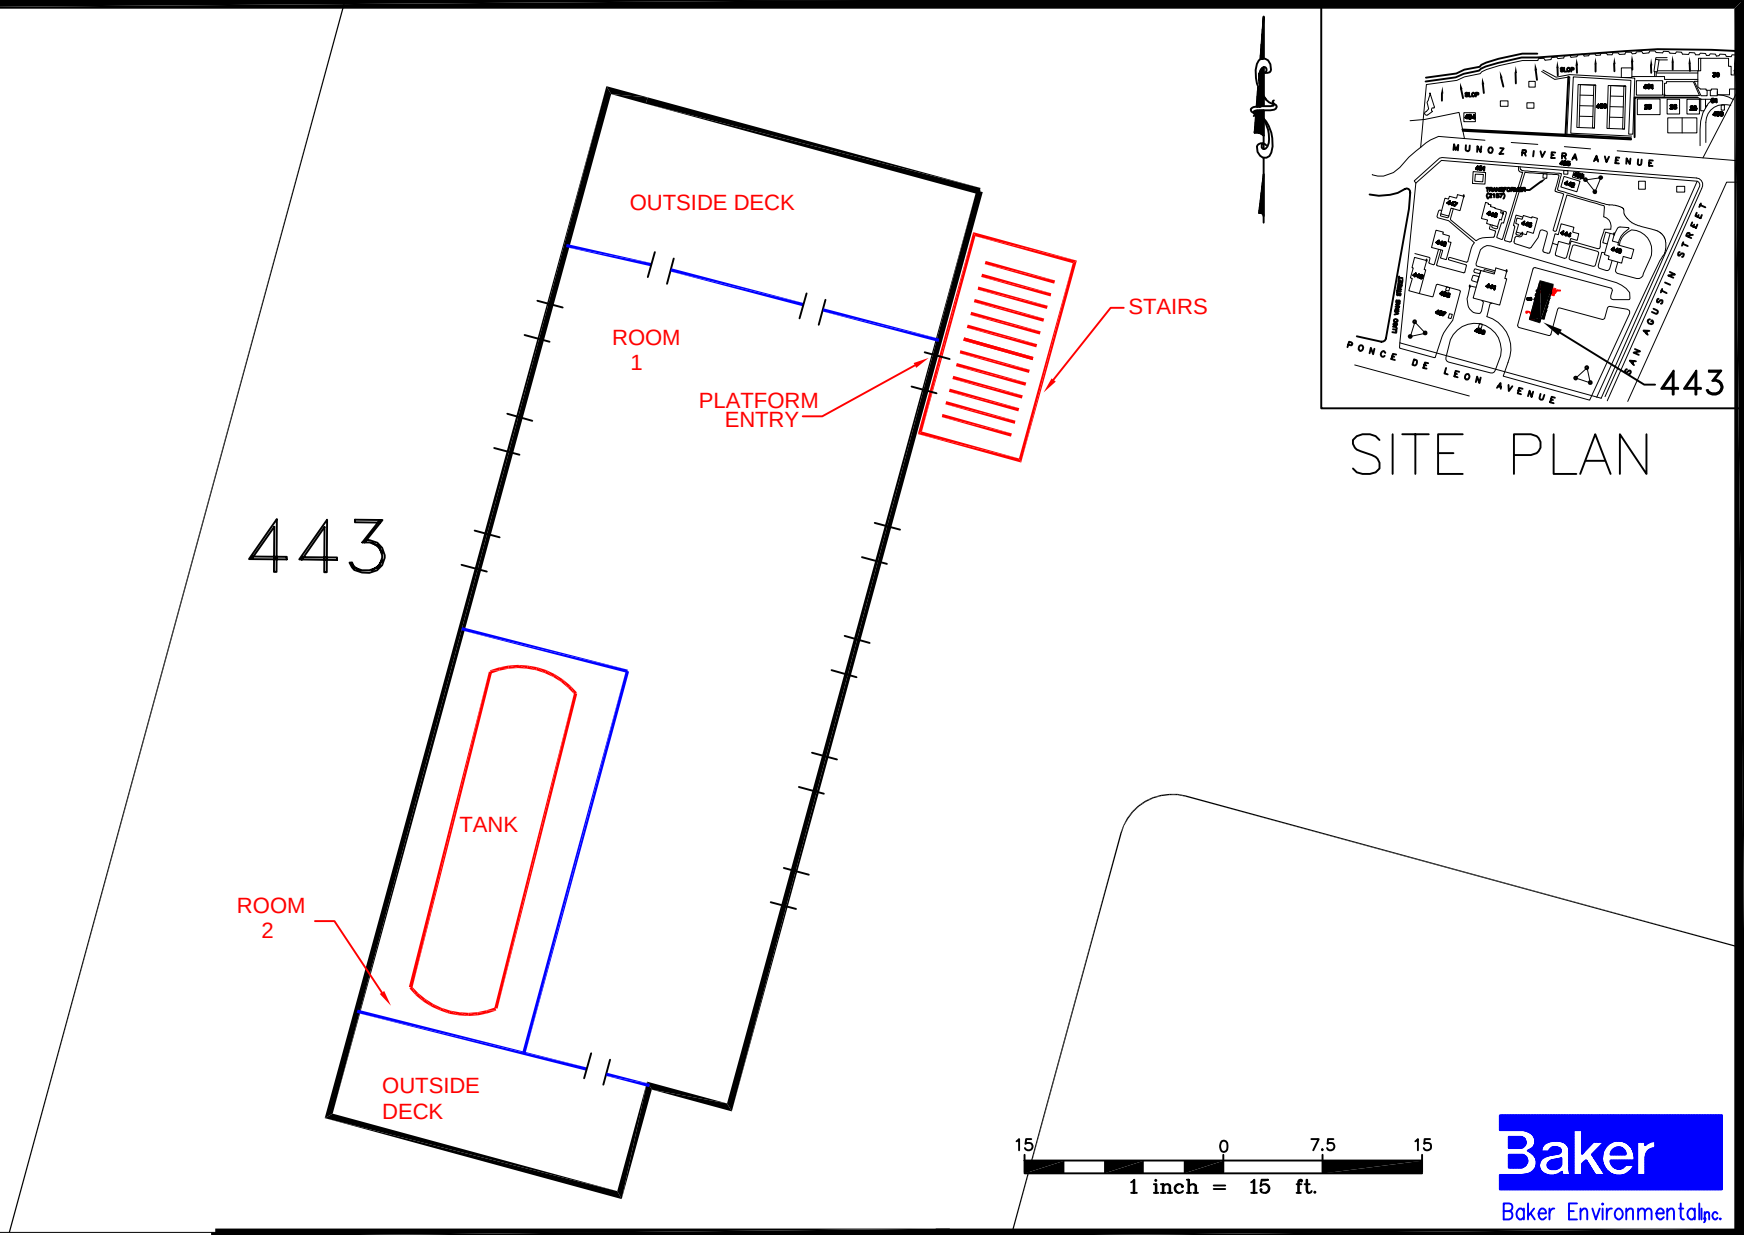
1.VINYL FLOOR TILE AND ADHESIVE IN ROOM 1

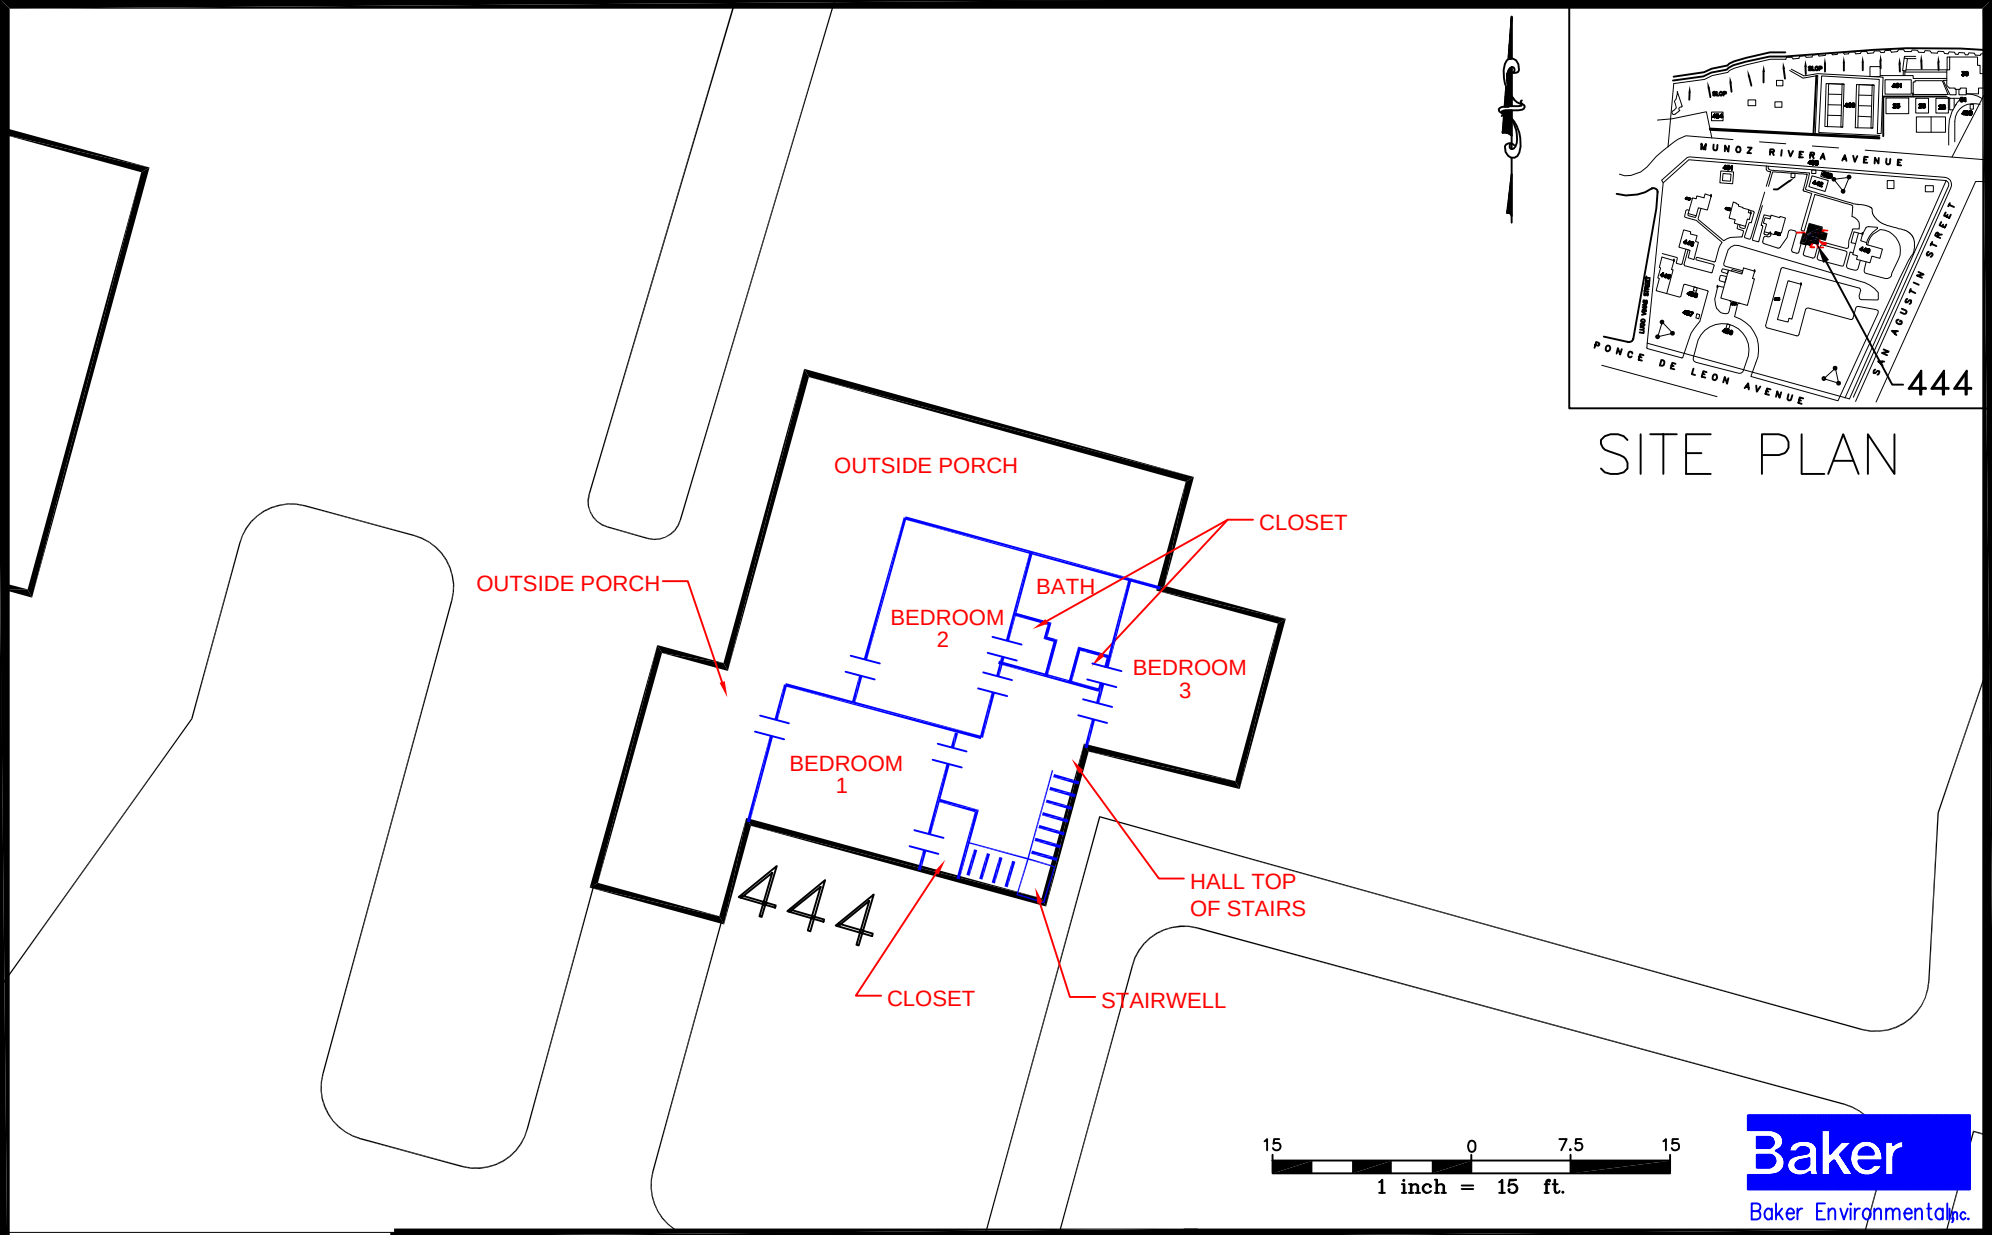
FIGURE 3–12
STOP 7–1/2 BUILDING 444B
UNOCCUPIED RESIDENT BUILDING
SECOND FLOOR

ASBESTOS DETECTED:

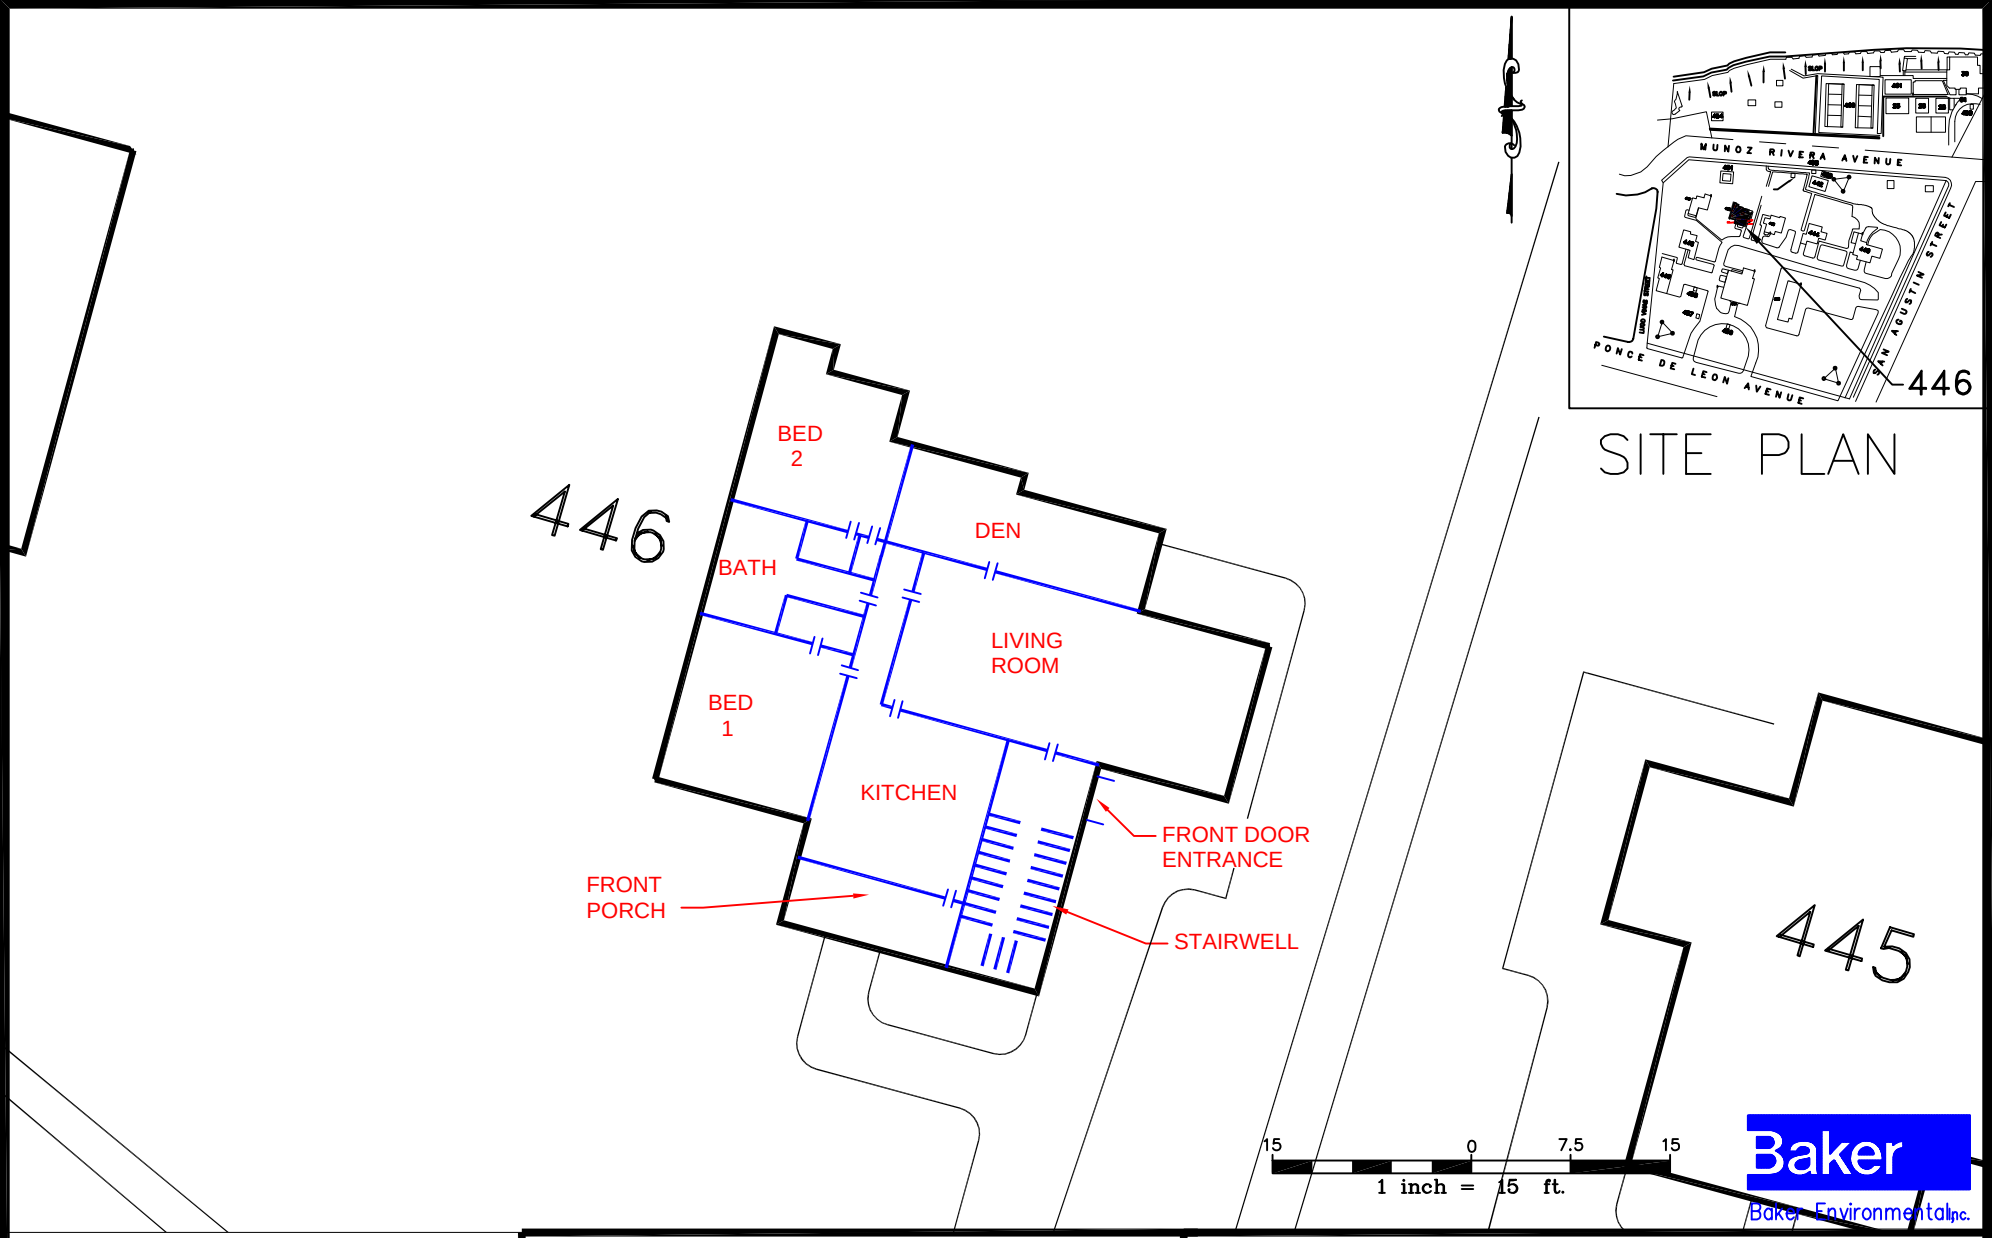
FIGURE 3–16
STOP 7–1/2 BUILDING 446B
OCCUPIED RESIDENT BUILDING
SECOND FLOOR

NO ASBESTOS DETECTED

1.ROOFING MATERIAL NOT SAMPLED

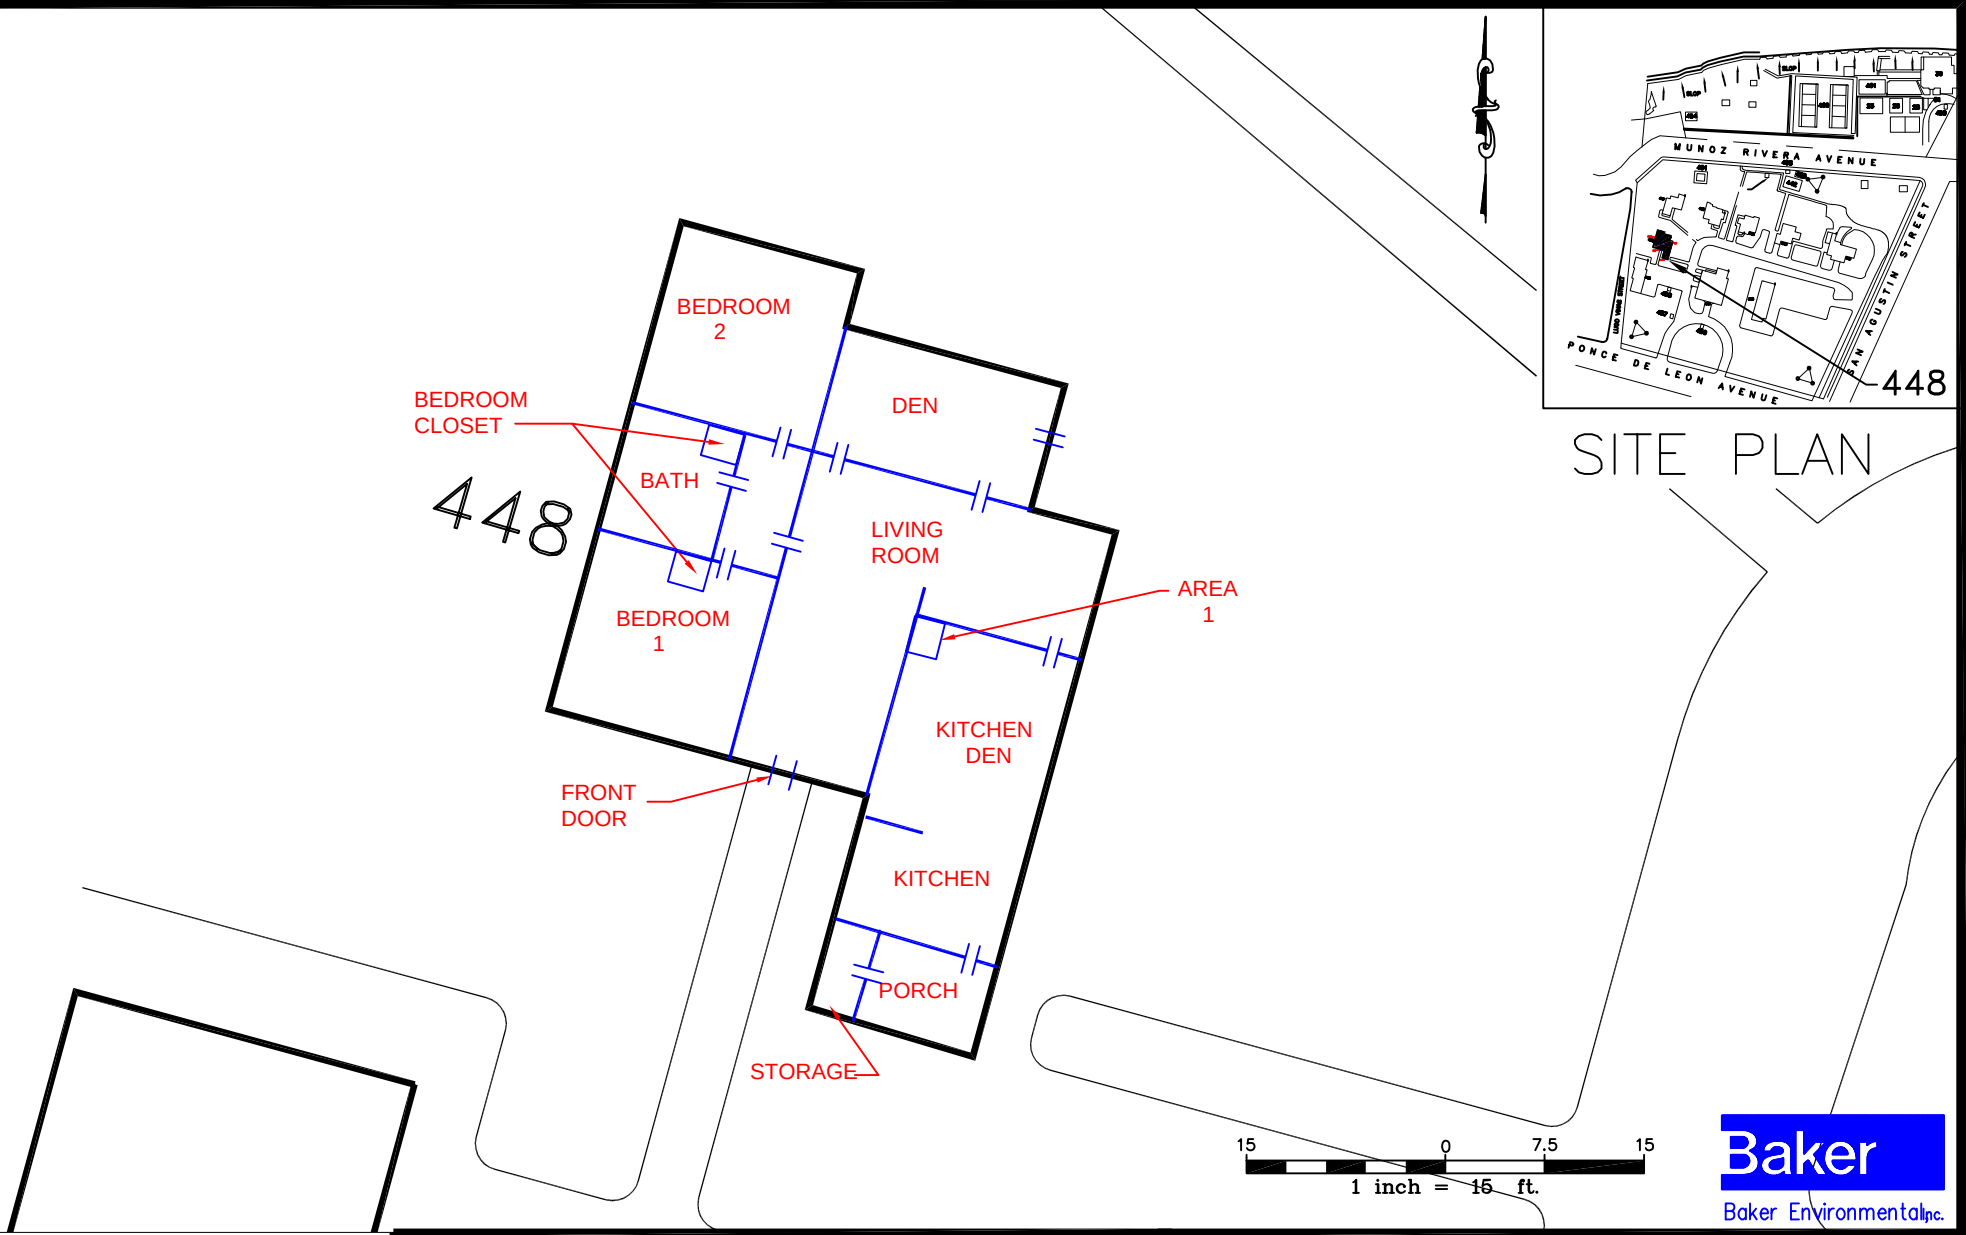
FIGURE 3-19
STOP 7-1/2 BUILDING 448A
OCCUPIED RESIDENT BUILDING
FIRST FLOOR

The thermal pipe insulation was located in the kitchen, den, and both bedroom closets on the first floor. This friable material was wrapped in a jacket and painted. A small amount of damage was noted at the ends of the pipelines. Painted wooden pipe chases traverse through the living room, hallway, and bathroom. These pipe chases could not be accessed without causing damage to the

ASBESTOS DETECTED:
1.THERMAL PIPE INSULATION IN KITCHEN DEN AREA AND BEDROOM CLOSETS, VARIOUS ENCLOSED PIPE CHASES IN IN LIVING ROOM, HALLWAY, AND BATHROOM
SOURCE: ICF KAISER.

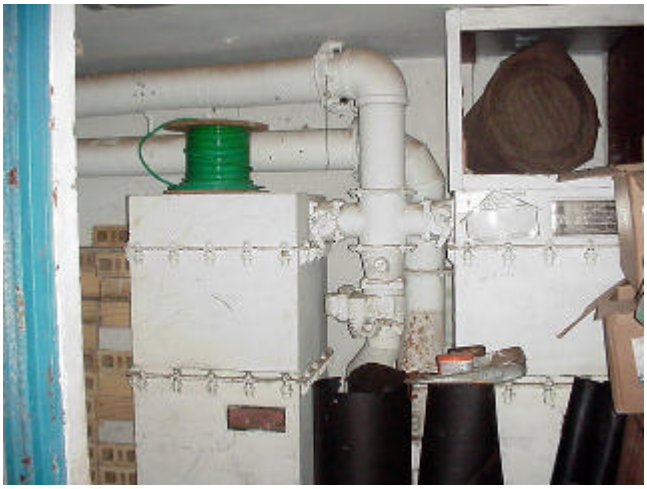
This equipment is on the first floor of Building 443. The gasket material tested negative for asbestos.

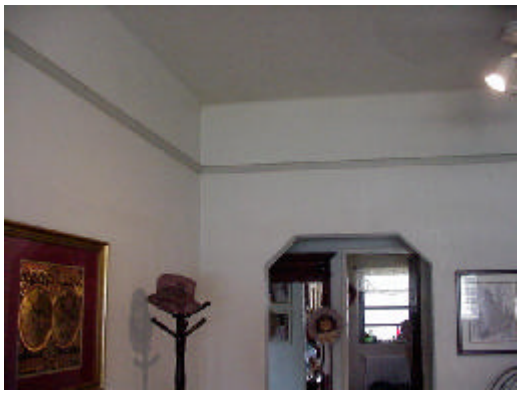
The photograph on the left depicts the living room on the first floor of Building 445. The photograph on the right is one of the first floor bedrooms. As noted previously this building was remodeled in 1997 and is in good condition. The asbestos samples were negative for asbestos in Building 445.

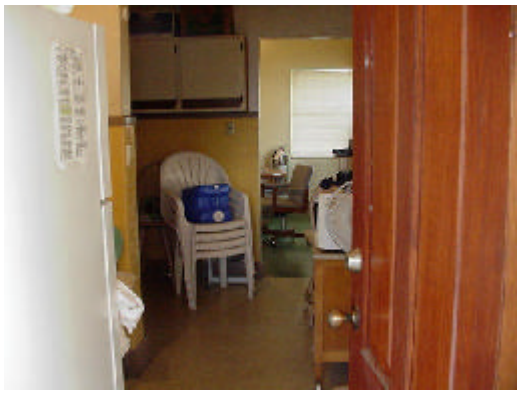
The photograph on the left shows the view from the kitchen to the living room. The vinyl floor tile and adhesive in the kitchen and kitchen den tested negative for asbestos. The photograph on the right is the east entrance to the first floor of Building 448.

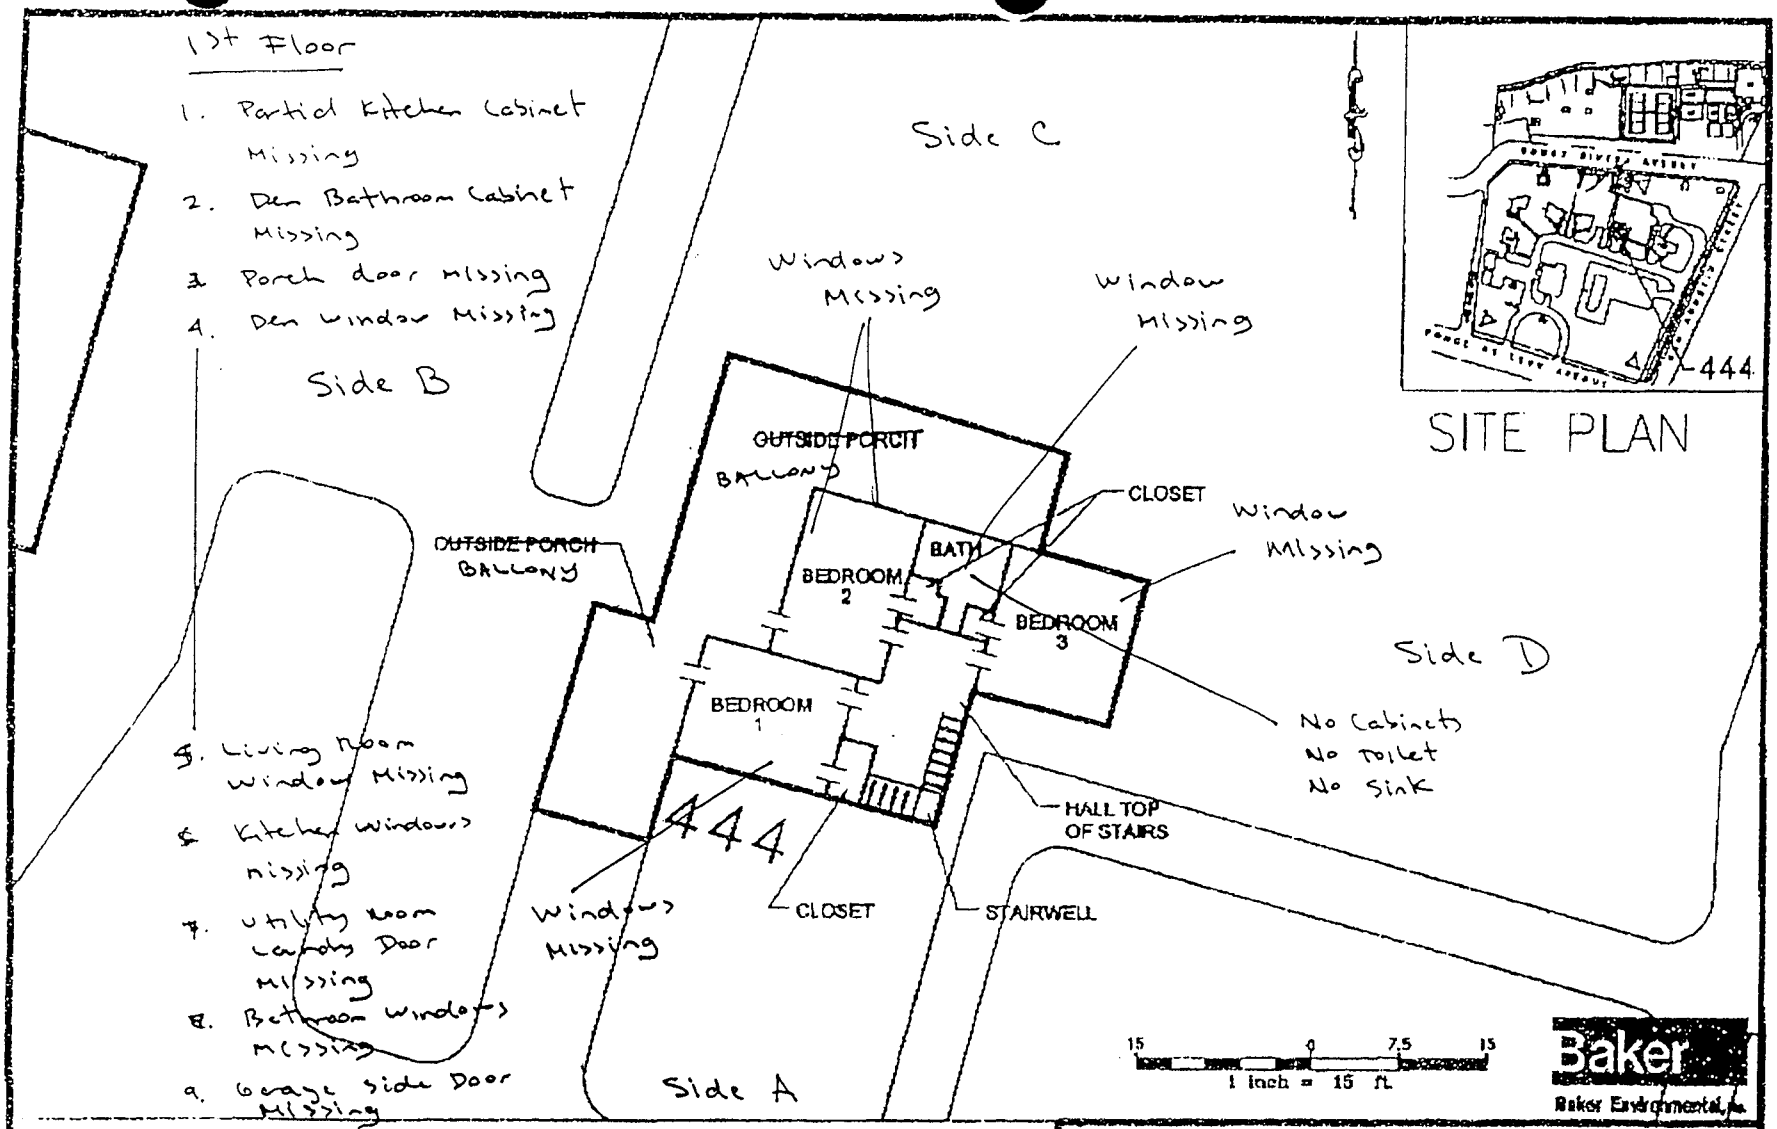
SITE PLAN

1. Partial Kitchen Cabinet Missing
2. Den Bathroom Cabinet Missing
3. Porch door Missing
4. Den Window Missing
5. Living Room Window Missing
6. Kitchen windows missing
7. Utility Room Laundry Door Missing
8. Bathroom windows Missing
9. Garage side Door Missing

Missing Building Components
April 2000
Miguel A Oliveras

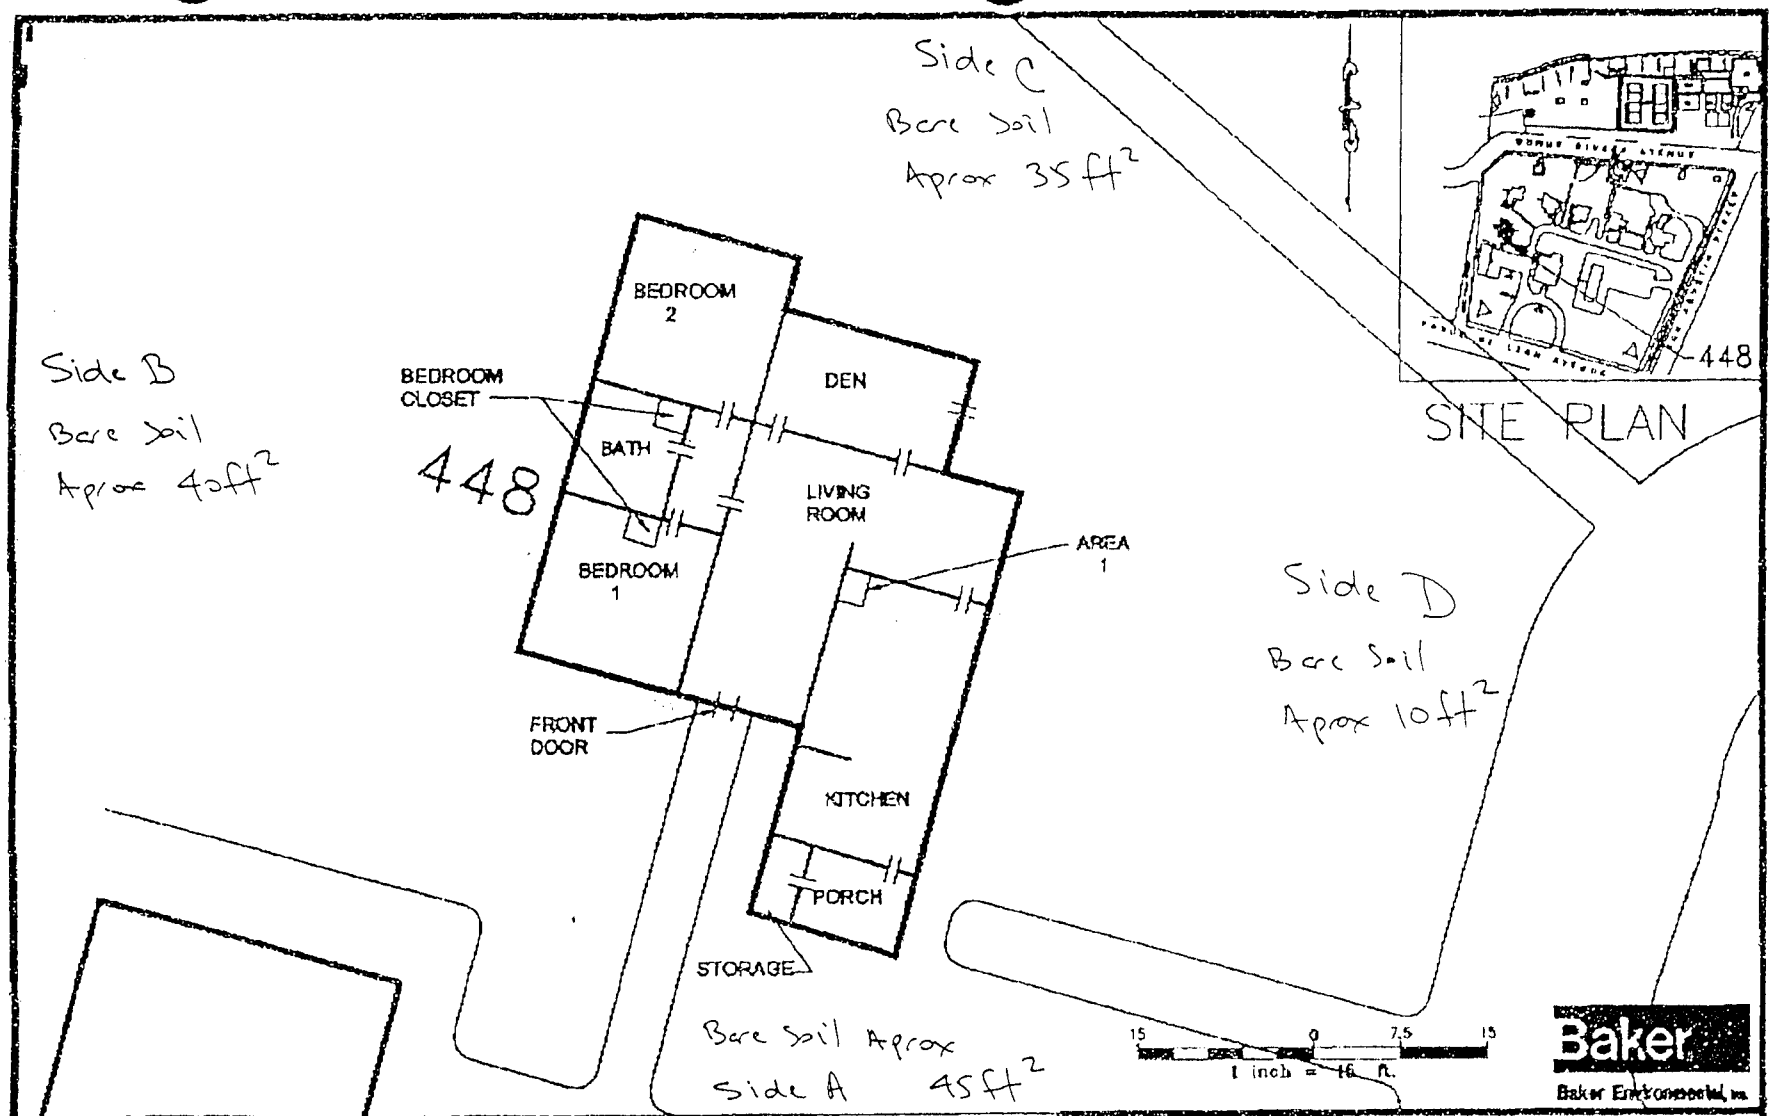
Bare Soil Quantities and Location ☐

Composite Soil Sampling Locations ☒

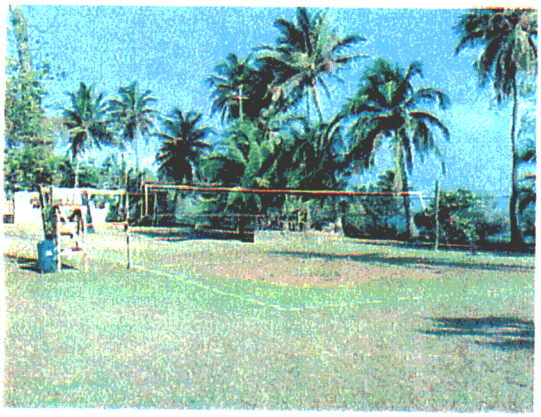
Photograph #1

Swing Set and Volleyball Court

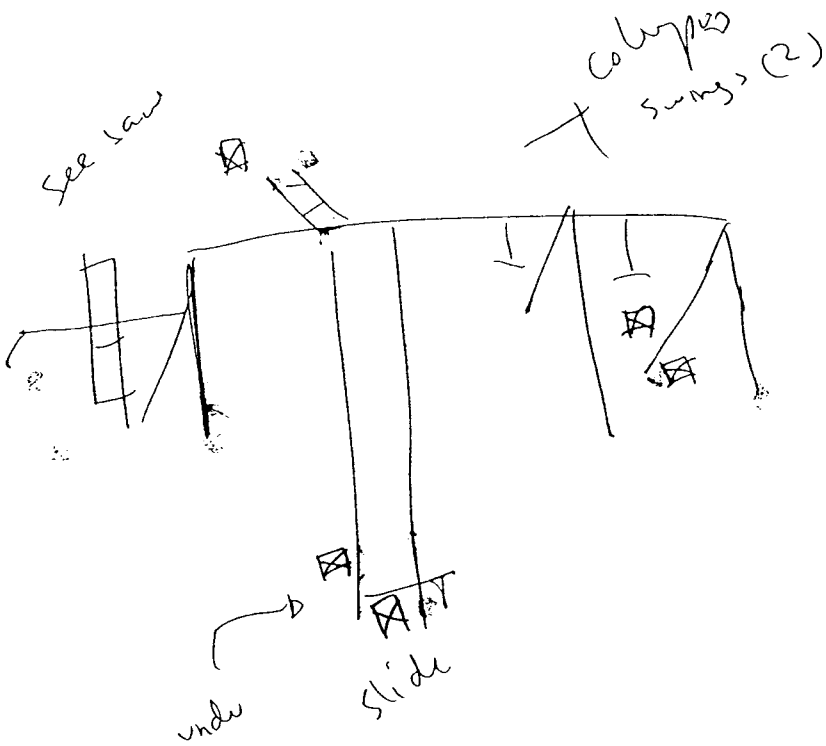
Swing set

less than 9 ft^2
