ASBESTOS AND LEAD-BASED PAINT REMEDIATION PLAN
STOP 7 ½ NAVAL RESERVATION

ROOSEVELT ROADS REAL ESTATE
SAN JUAN, PUERTO RICO

CONTRACT TASK ORDER 0401

AUGUST 2002

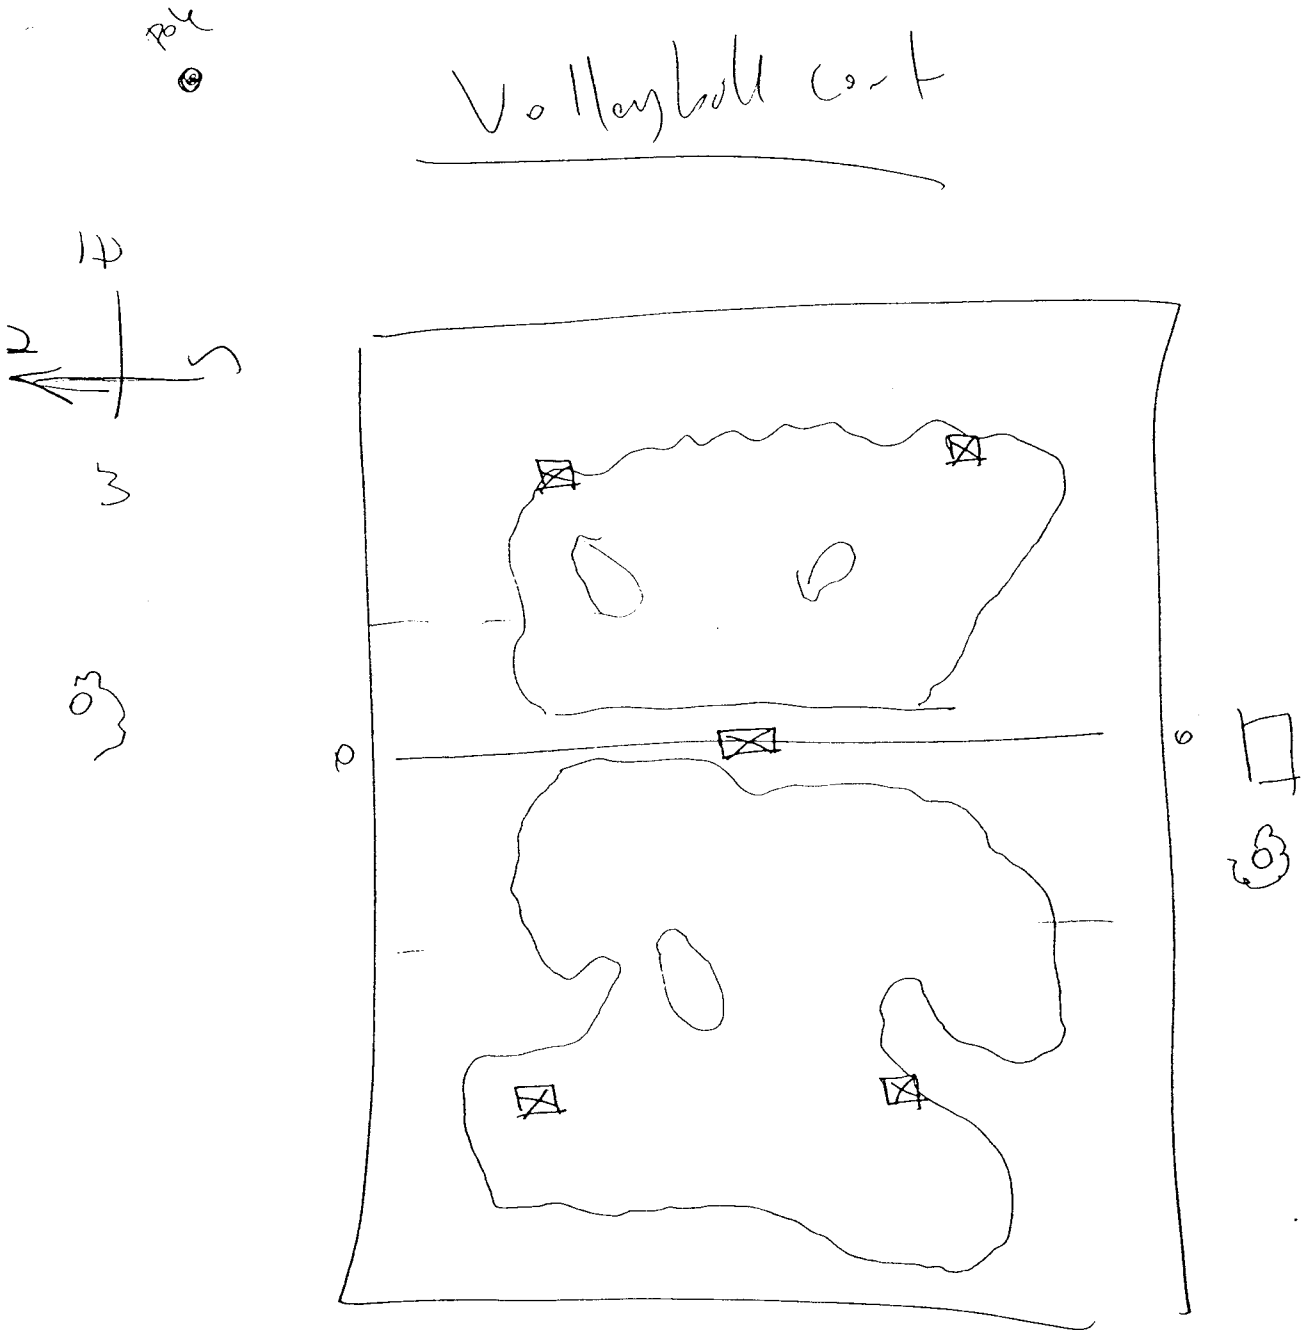
Volleyball Court

+/- 75% is Exposed Soil or Bare
