AR_N00217_000885
HUNTERS POINT
SSIC NO. 5090.3.A

TETRA TECH EC, INC.

March 20, 2006

Subject: BUILDING 115 WASTE CONSOLIDATION FINAL STATUS REPORT

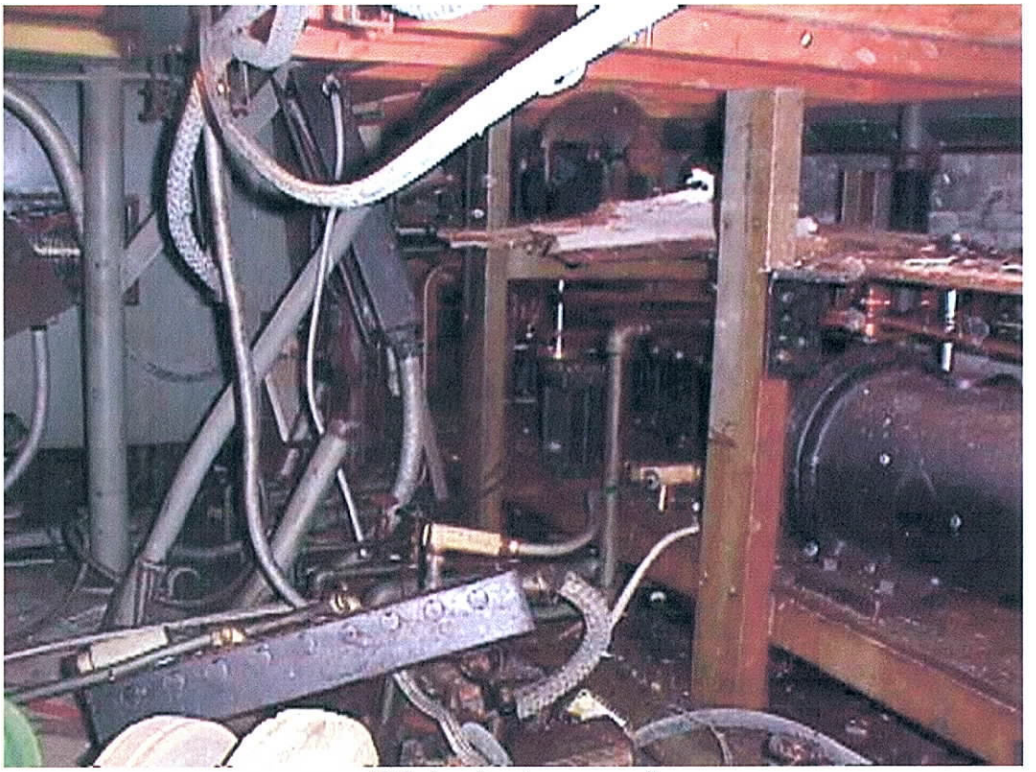
IPE-1 prior to removal

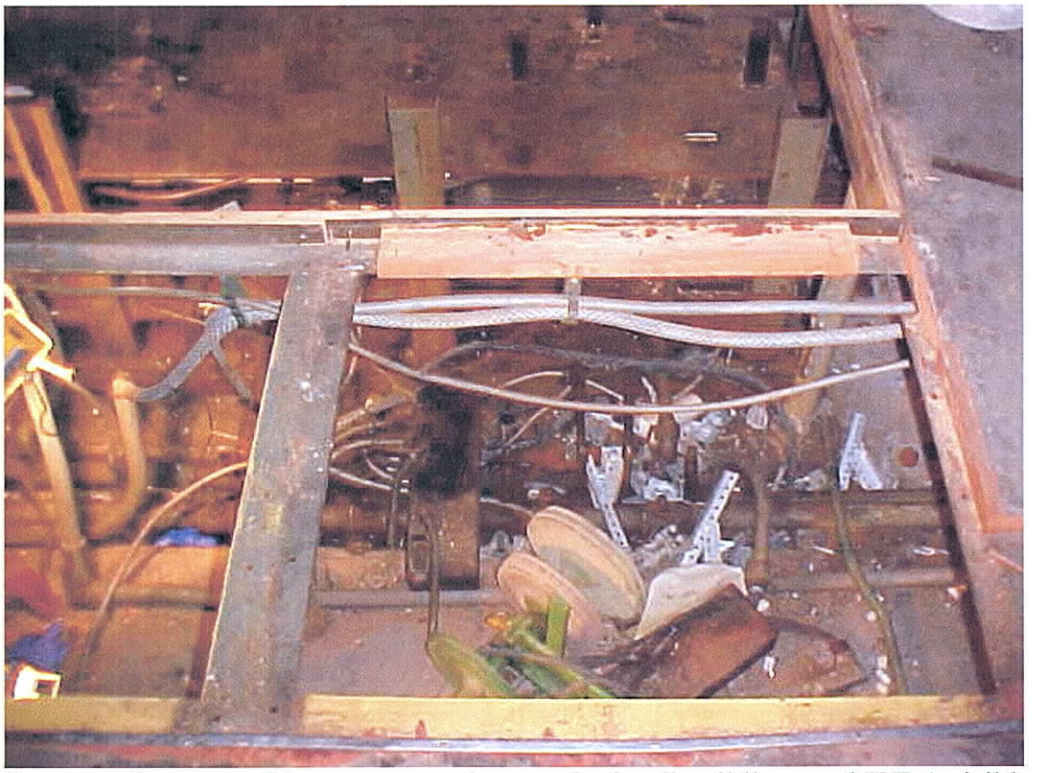
Floor panels removed to access crawl space; hydraulic oil lines and IPE-1 visible

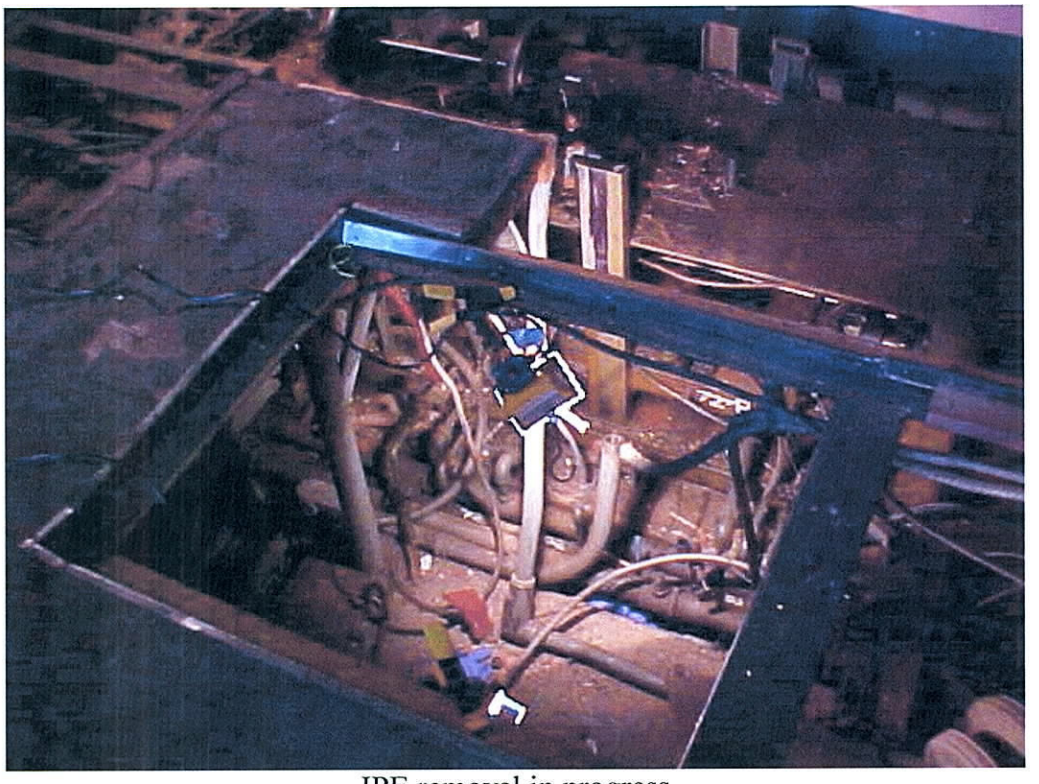
IPE removal in progress

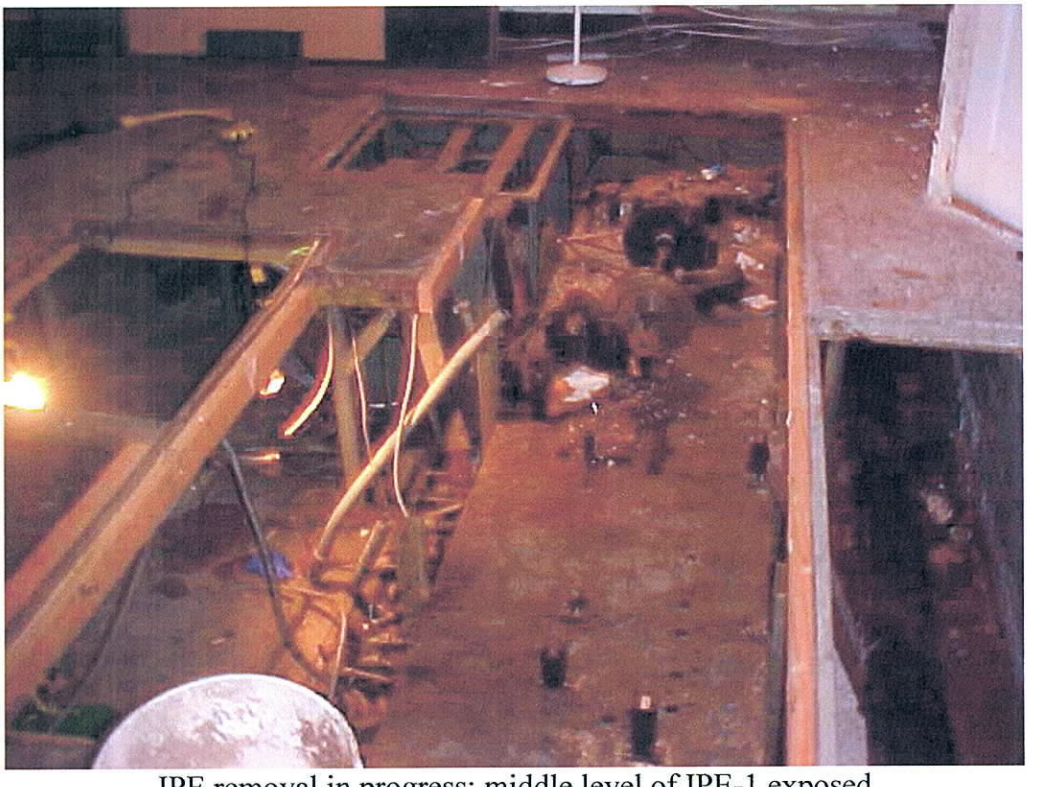
IPE removal in progress; middle level of IPE-1 exposed

IPE removed by hand as tenant had covered the previously existing bridge crane with drywall and soundproofing material

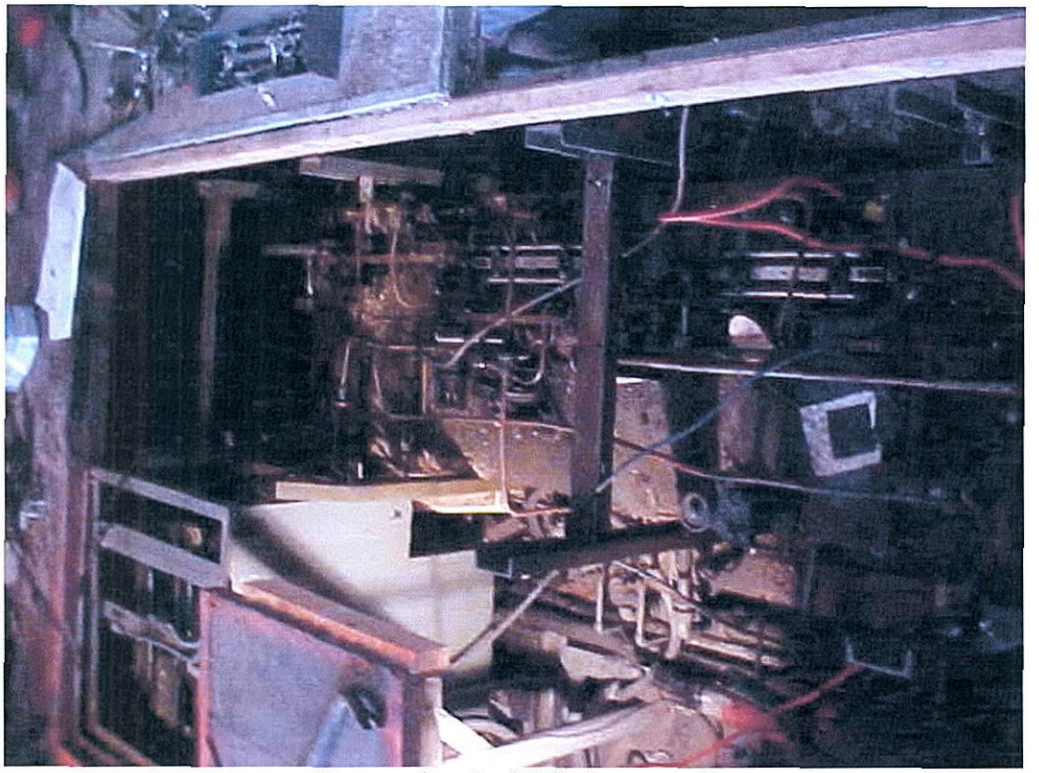
Bottom level of IPE-1 exposed

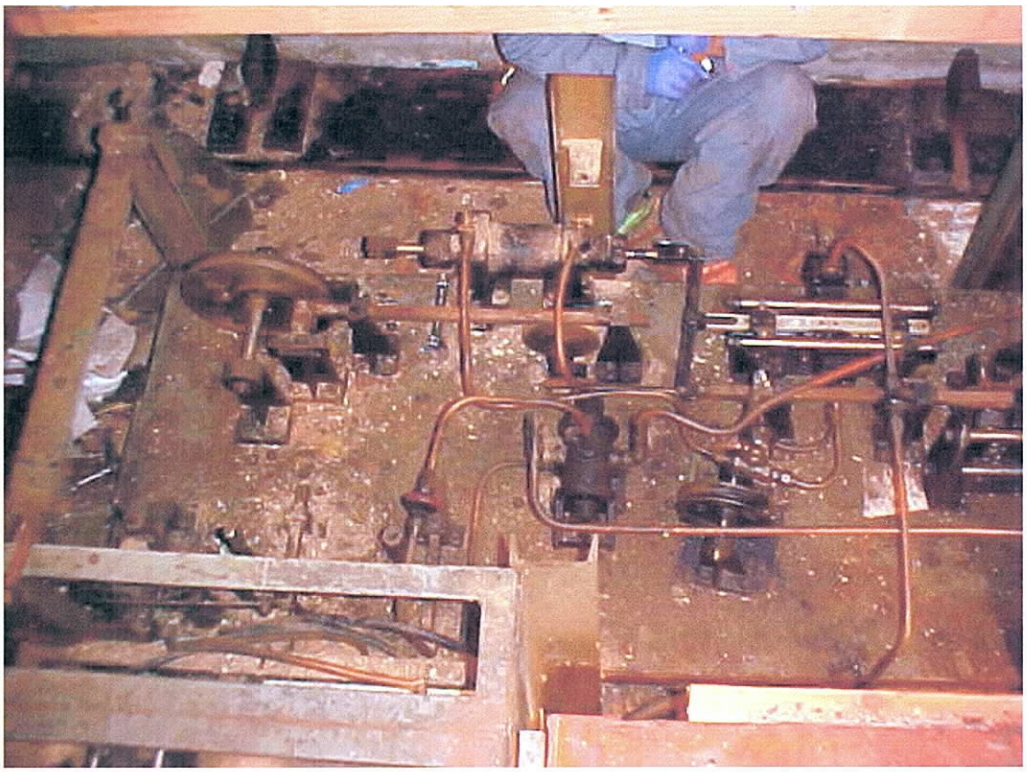
Typical equipment- components of IPE-1
