# Steel Erection Contractor Fatality

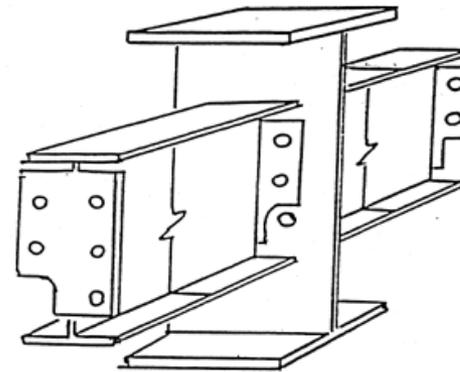
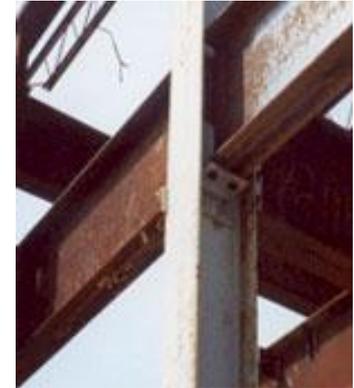
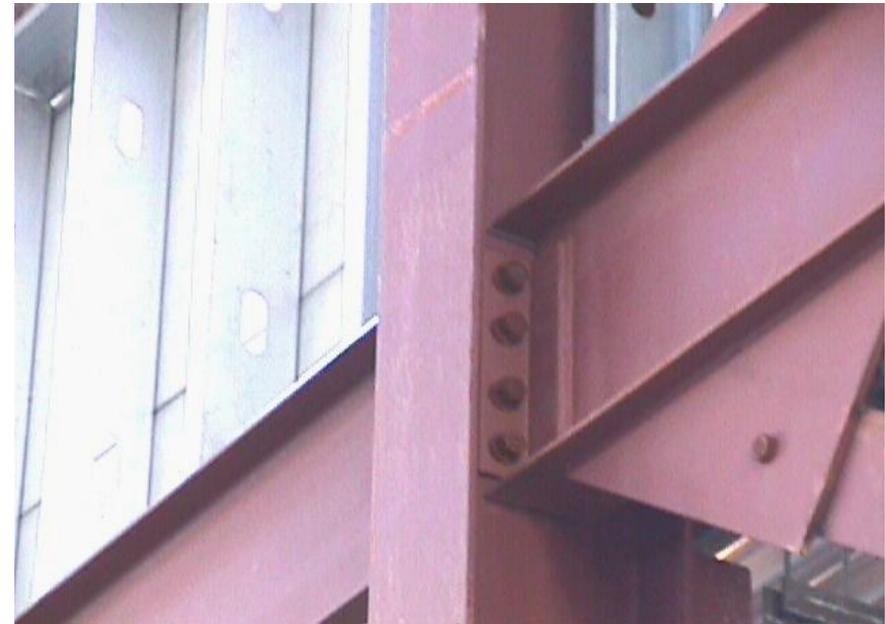
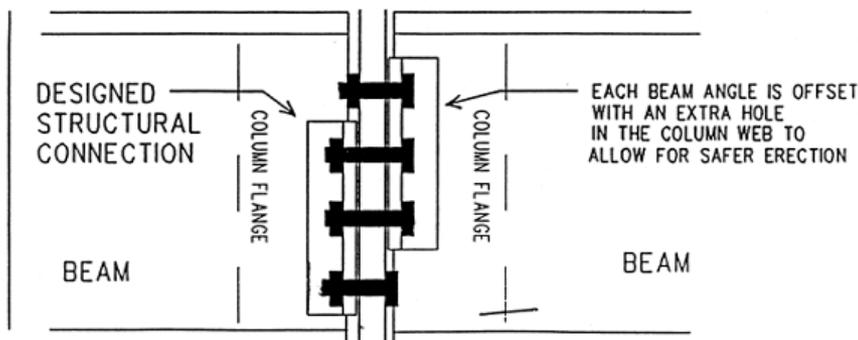
- 38 year old Iron Worker
- Second Tier Sub
- Cause: Unsecured load above
- Root Cause(s): Beam released from material handling equipment without being fastened, bolted, or without seat support during double connection process.
- Initial Lessons Learned:
  - Ensure there is a fastened bolt or seat for double connections during erection.
  - Ensure no one is under a live load.

When two structural members on opposite sides of a column web or beam web over a column are connected sharing common connection holes, at least one bolt with its wrench-tight nut shall remain connected to the first member unless a shop-attached or field-attached seat or equivalent connection device is supplied with the member to secure the first member and prevent the column from being displaced. If seta or equivalent device is used the seat shall be designed to support the load during double connection process.
