FINAL RESOURCE CONSERVATION AND RECOVERY ACT PARTIAL CLOSURE REPORT  
FOR BUILDING 44 WITH TRANSMITTAL LETTER NAS BRUNSWICK ME  
3/14/2011  
NAS BRUNSWICK

**RCRA PARTIAL CLOSURE REPORT**  
**for**  
**BUILDING 44 – FITCH AVENUE MAGAZINE PARCEL**  
**NAVAL AIR STATION BRUNSWICK, MAINE**  
**USEPA IDENTIFICATION NUMBER ME8170022018**  
**MARCH 2011**

**HWSA INSPECTION REPORT  
HAZARDOUS WASTE STORAGE AREAS CLOSURE  
NAS BRUNSWICK  
BRUNSWICK, MAINE  
CTO WE22**

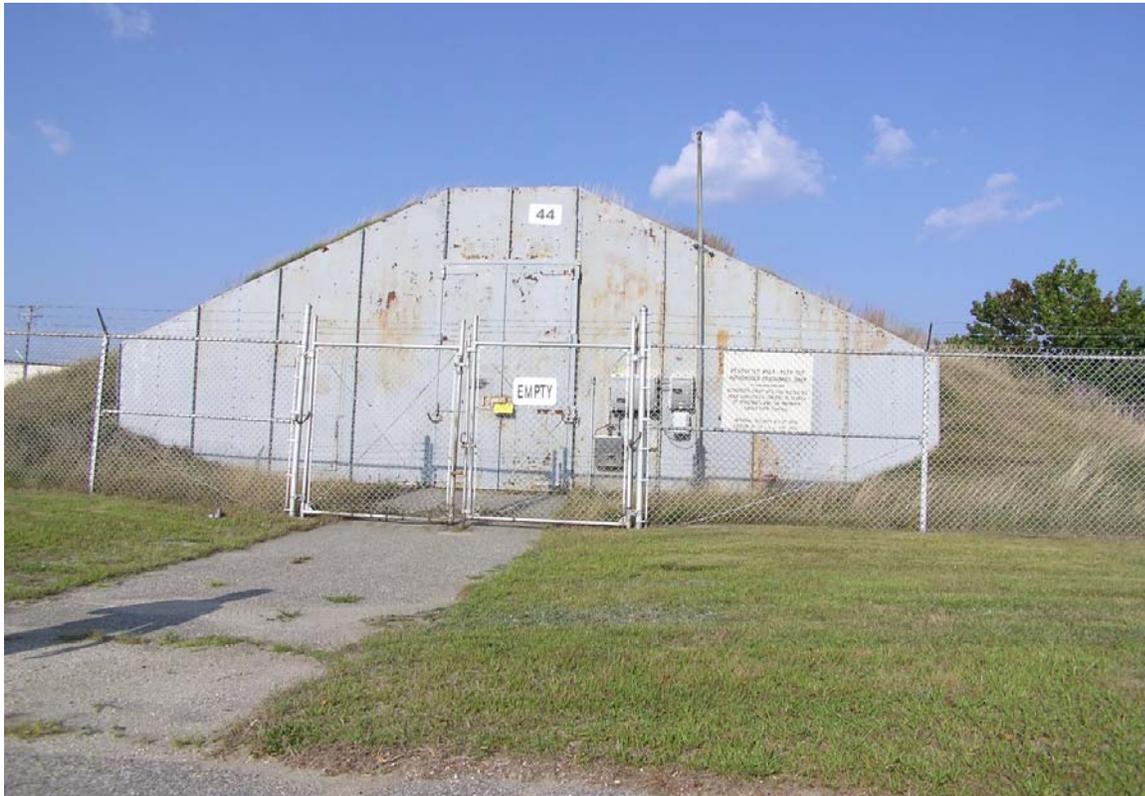
No. 1 Building 44 – Fitch Avenue Magazine, NAS Brunswick August 31, 2010  
Fitch Avenue Magazine (Building 44) west elevation, with facility entrance

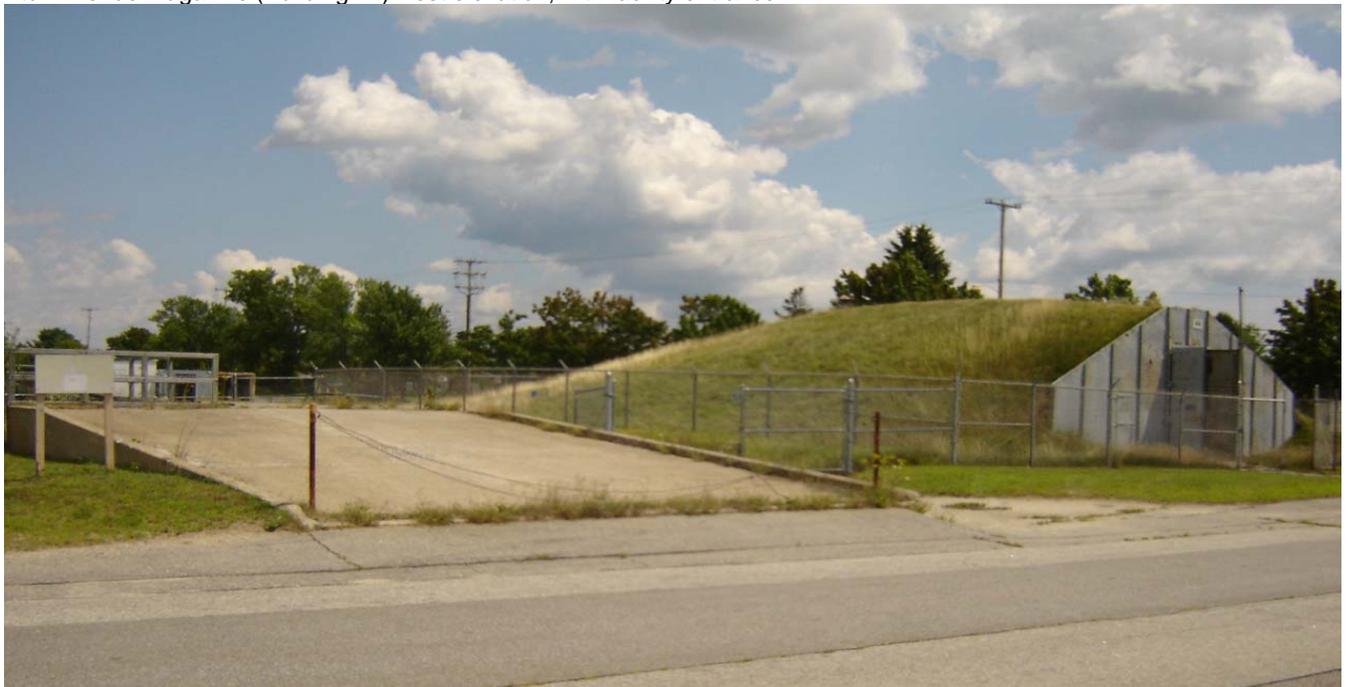
No. 2 Building 44 – Fitch Avenue Magazine, NAS Brunswick July 29, 2010  
West elevations of Loading Dock (Building 556) at left of frame and Building 44 in right background
