REVISED FINAL RESOURCE CONSERVATION AND RECOVERY ACT PARTIAL CLOSURE
REPORT FOR BUILDING 538 WITH TRANSMITTAL LETTER NAS BRUNSWICK ME
3/14/2011
NAS BRUNSWICK

Subj: Final RCRA Partial Closure Report for Building 538 (Revised)

**RCRA PARTIAL CLOSURE REPORT
for
BUILDING 538 – NEX SERVICE STATION PARCEL
BUILDING 605 – ENVIRONMENTAL SHED
NAVAL AIR STATION BRUNSWICK, MAINE
USEPA IDENTIFICATION NUMBER ME8170022018
FEBRUARY 2011**

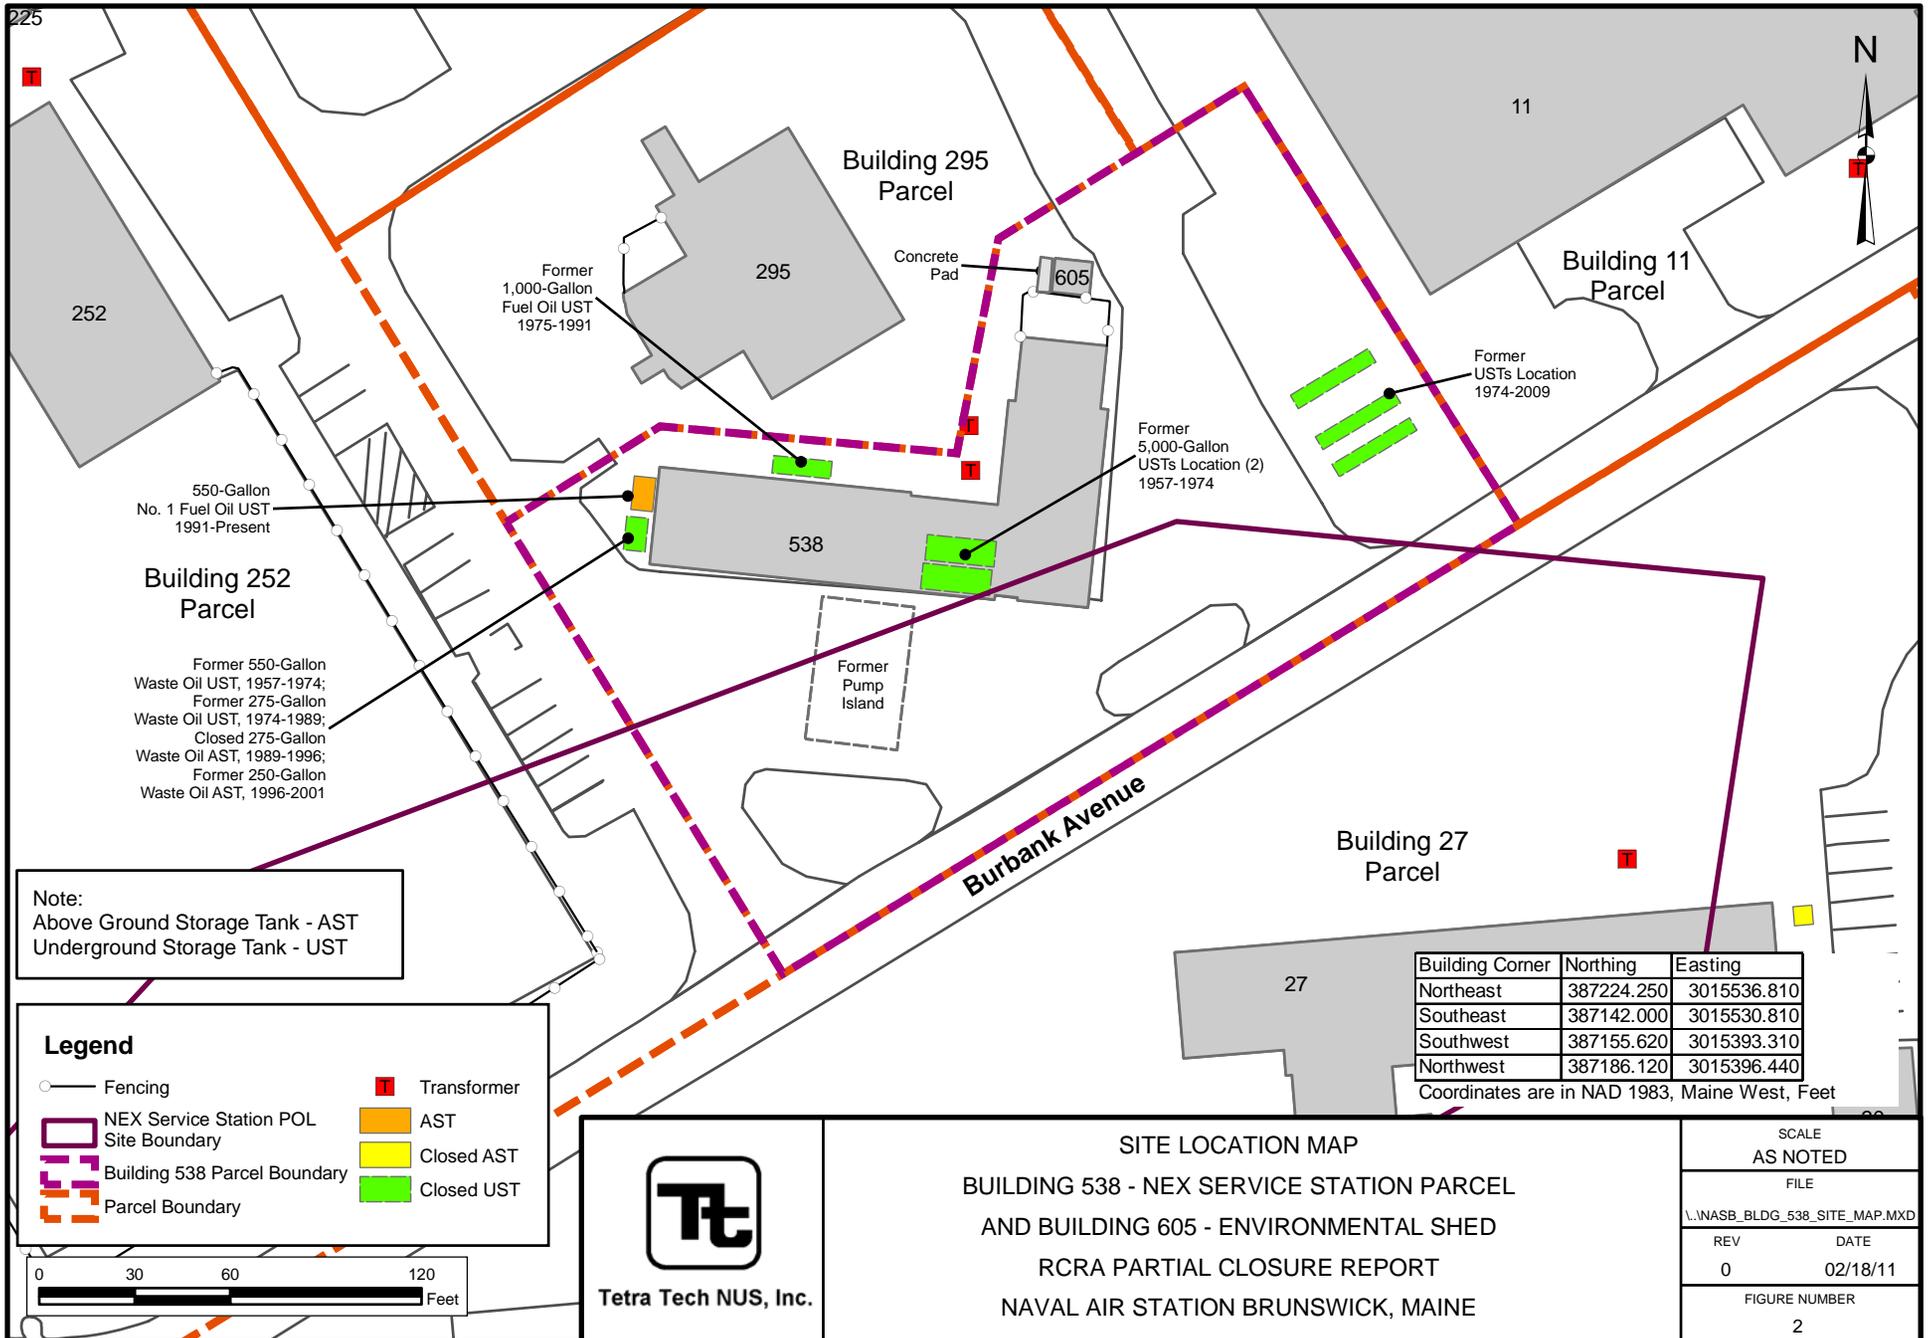
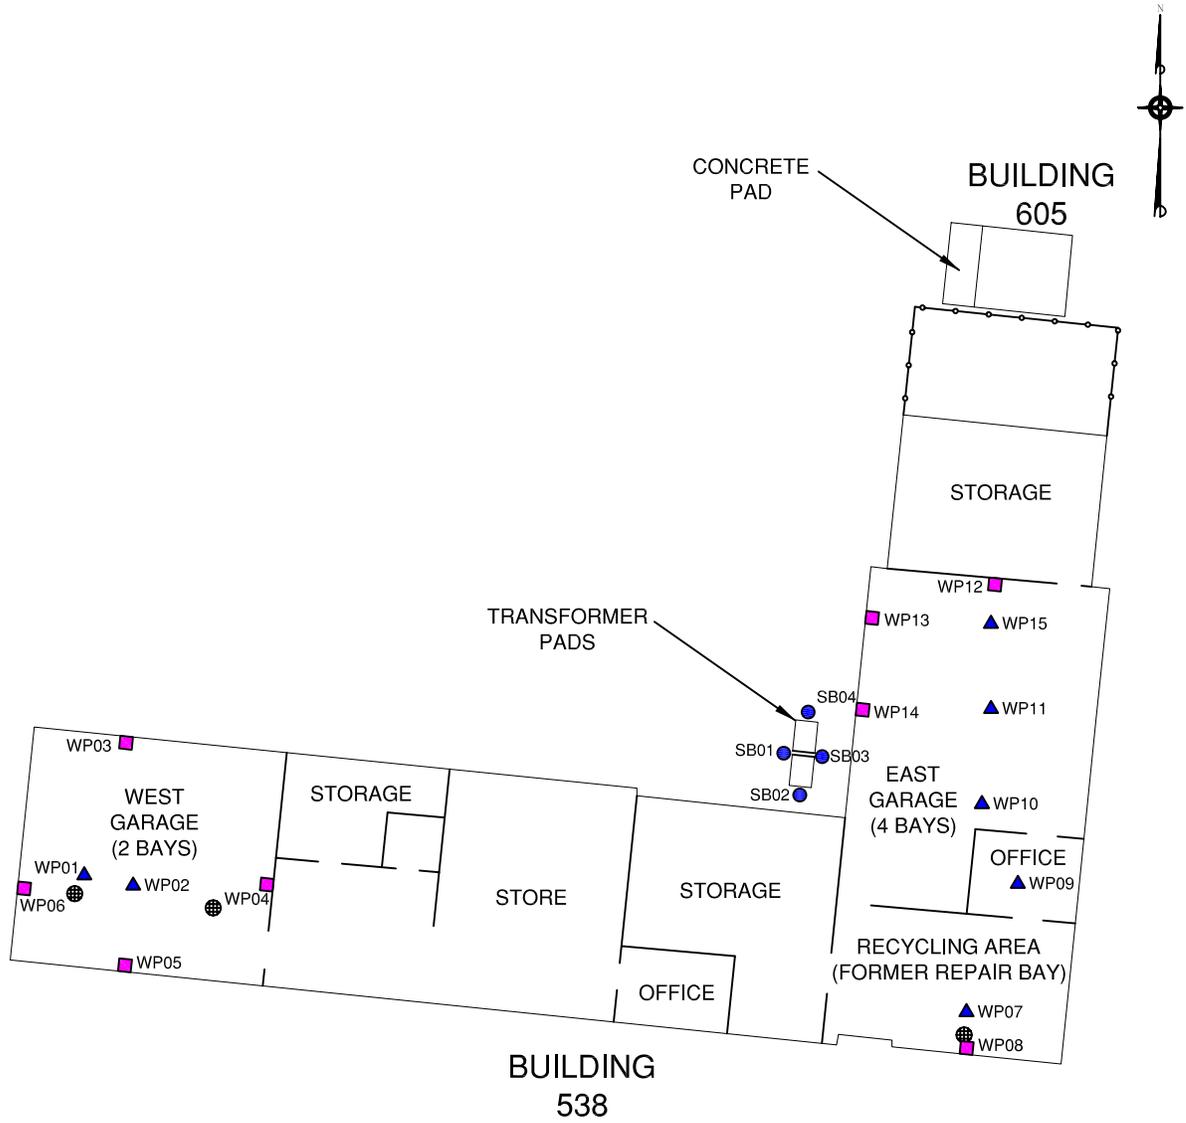
On July 29, 2010, wipe samples were collected from 15 locations in Building 538, including seven floor and eight wall locations, as shown on Figure 3. The wipe samples were submitted for RCRA metals, and a subset was submitted for semi-volatile organic compounds (SVOCs) analysis by Tetra Tech's subcontracted analytical laboratory, Analytics Environmental Laboratory (Analytics), of Portsmouth, New Hampshire. The resulting analytical data underwent limited data validation consisting of field duplicate evaluation, laboratory blank contamination evaluation, and completeness evaluation.
