FINAL RESOURCE CONSERVATION AND RECOVERY ACT PARTIAL CLOSURE REPORT
FOR BUILDINGS 22 AND 39 WITH TRANSMITTAL LETTER NAS BRUNSWICK ME
3/31/2011
NAS BRUNSWICK

Subj: Final RCRA Partial Closure Report for Buildings 22 and 39

RCRA PARTIAL CLOSURE REPORT
for
BUILDING 22 – GOLF MAINTENANCE BUILDING AWNING
BUILDING 39 – GOLF MAINTENANCE BUILDING
NAVAL AIR STATION BRUNSWICK, MAINE
USEPA IDENTIFICATION NUMBER ME8170022018
MARCH 2011

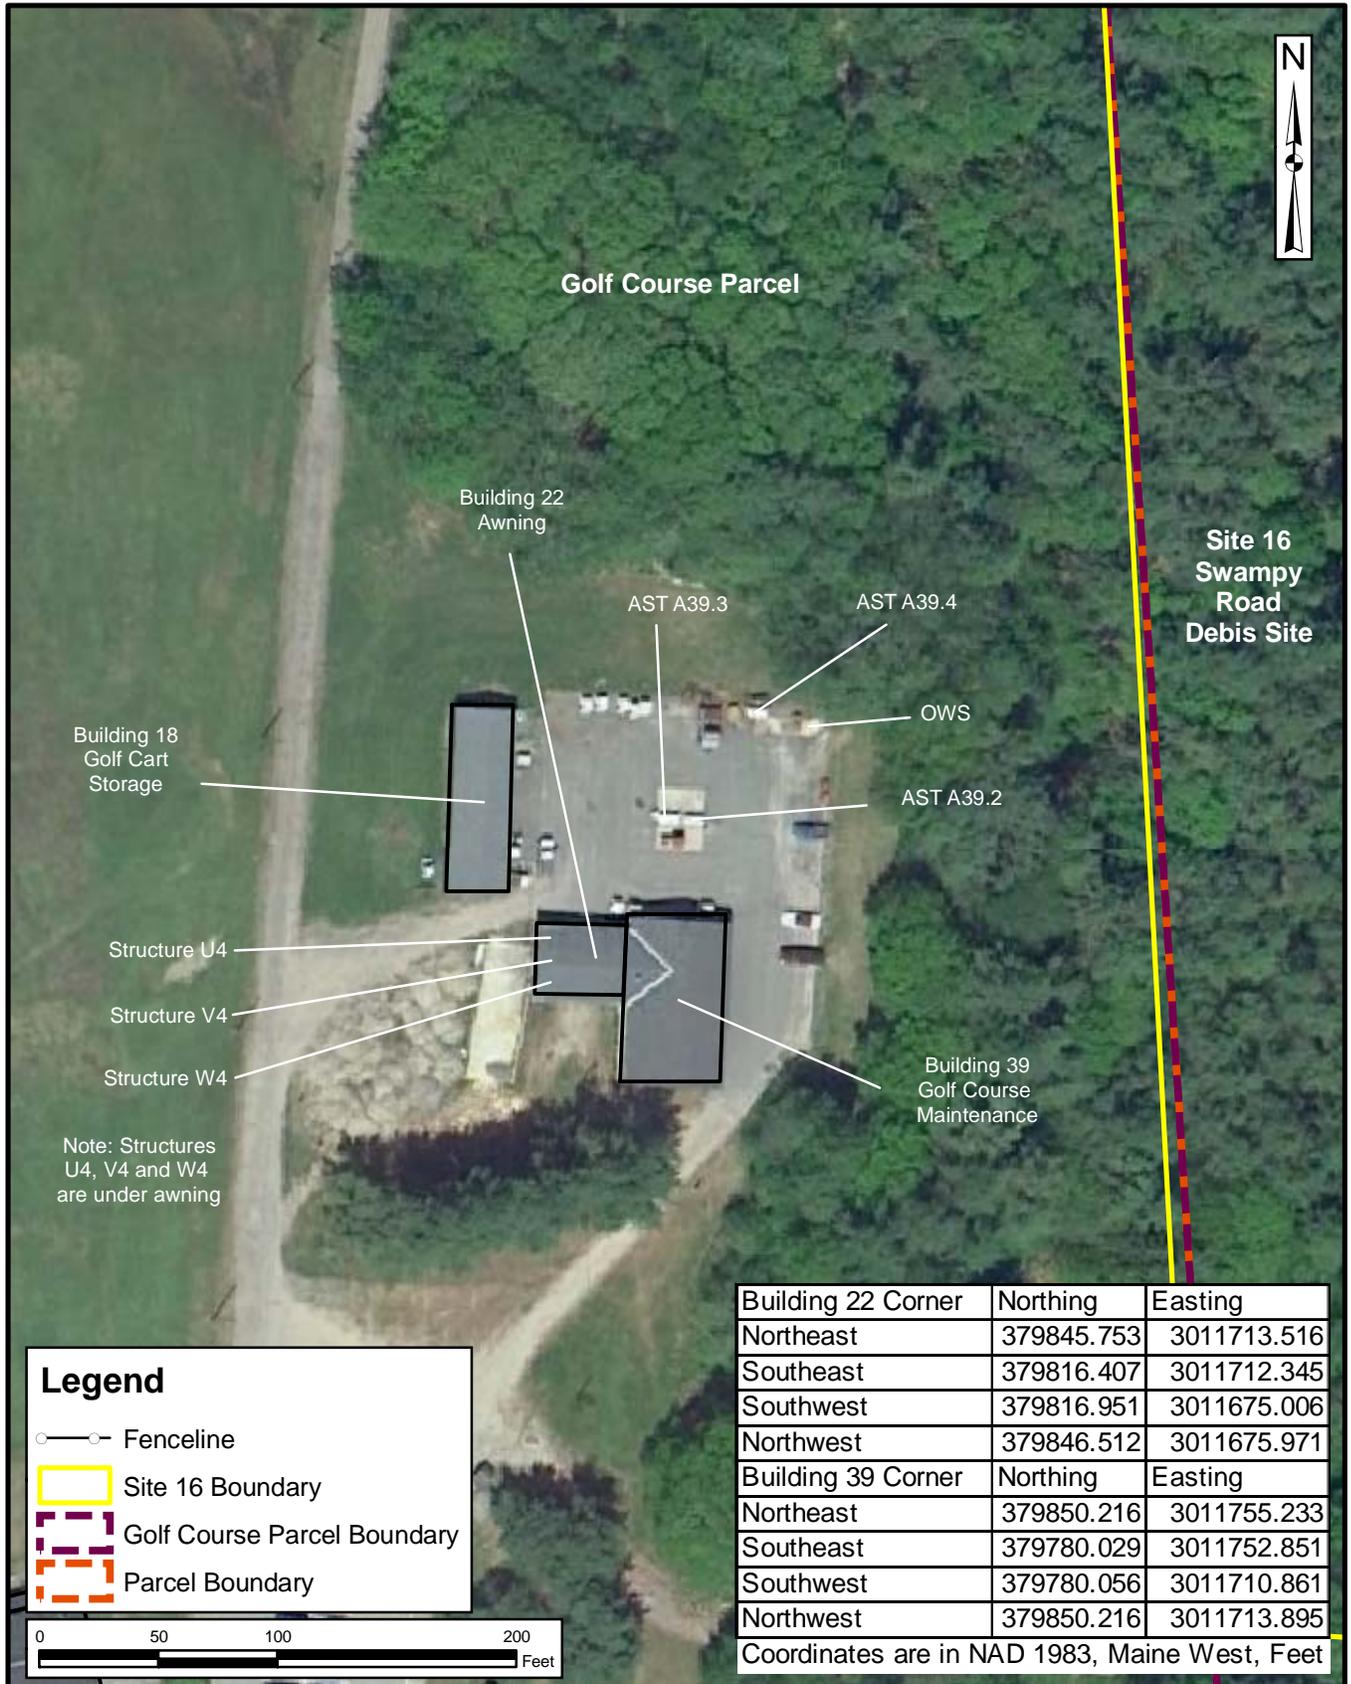
Tetra Tech NUS, Inc.	SITE PLAN BUILDING 22 - GOLF COURSE MAINTENANCE BUILDING AWNING BUILDING 39 - GOLF COURSE MAINTENANCE BUILDING RCRA PARTIAL CLOSURE REPORT NAVAL AIR STATION BRUNSWICK, MAINE	SCALE AS NOTED
		FILE \\NASB_BLDG_22and39_SITE_MAP.MXD
		REV DATE 0 03/18/11
		FIGURE NUMBER 2

This investigation of the hazardous waste closure requirement applies to the footprints of Buildings 22 and 39 (as shown on Figure 2), only. It does not apply to the land surrounding or the groundwater underlying Buildings 22 and 39.
