FINAL RESOURCE CONSERVATION AND RECOVERY ACT PARTIAL CLOSURE REPORT
FOR GOLF COURSE AREA PARCEL WITH TRANSMITTAL LETTER NAS BRUNSWICK ME
4/6/2011
NAS BRUNSWICK

Subj: Final RCRA Partial Closure Report for Golf Course Area Parcel

RCRA PARTIAL CLOSURE REPORT
for
GOLF COURSE AREA
NAVAL AIR STATION BRUNSWICK, MAINE
USEPA IDENTIFICATION NUMBER ME8170022018
APRIL 2011

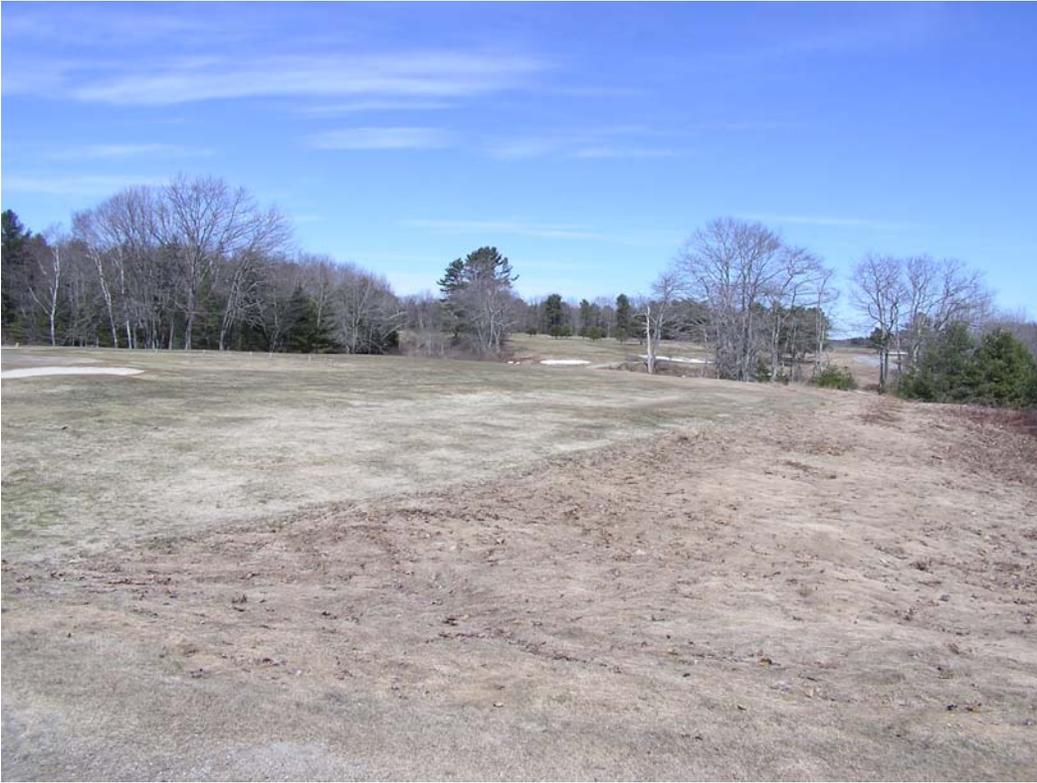
No. 1 Golf Course Area, NAS Brunswick March 29, 2011
Mere Creek Golf Course – view looking west from south side of Middle Bay Road

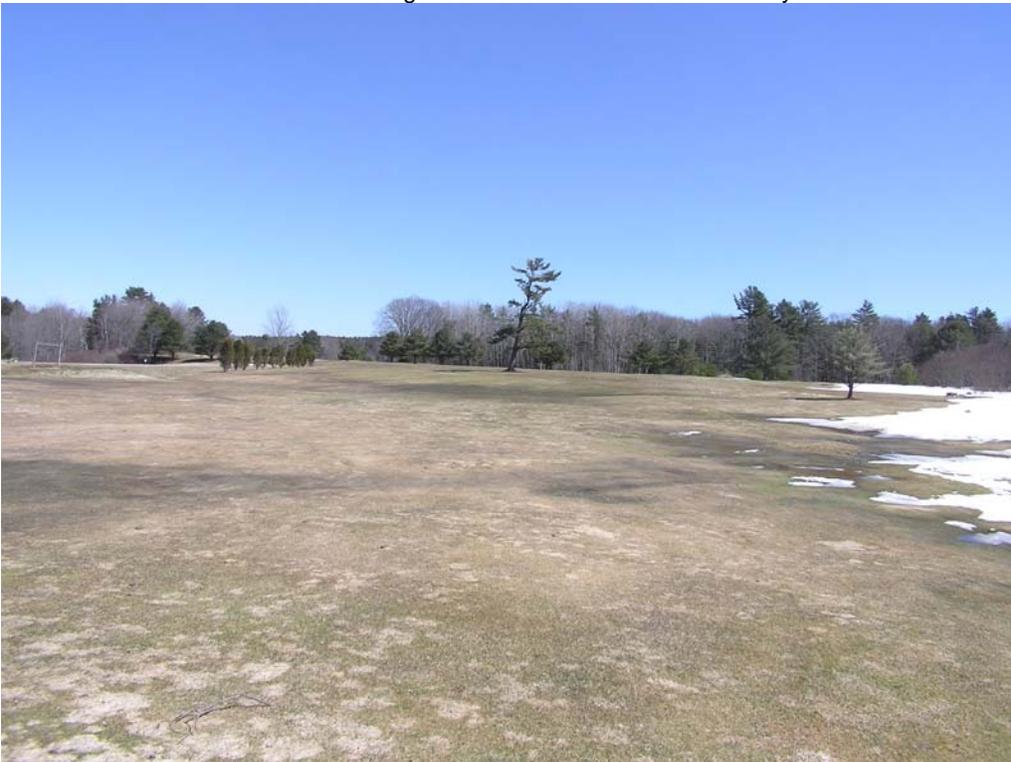
No. 2 Golf Course Area, NAS Brunswick March 29, 2011
Mere Creek Golf Course from south of Middle Bay Road – view looking east west
