LEAD BASE PAINT SURVEY OF 12 DUPLEX FAMILY UNITS SECTION 4 CNC
CHARLESTON SC
4/1/2001
PRECISION ENVIRONMENTAL MANAGEMENT, INC.

**LEAD BASE PAINT SURVEY OF
12 DUPLEX FAMILY UNITS AT
CHARLESTON NAVAL COMPLEX
CHARLESTON, SC**

April 5, 2001

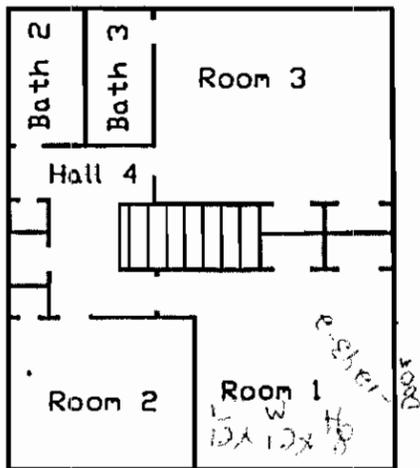
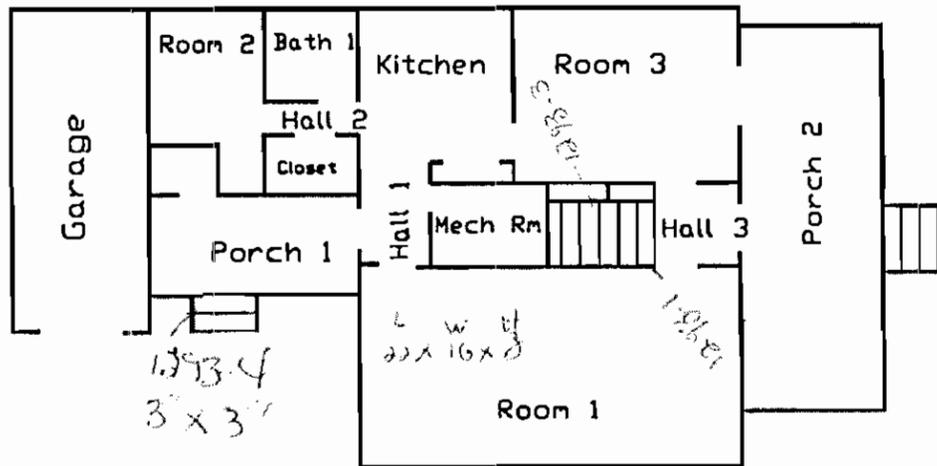
SPORTENVDETHASN 1899 North Hobson Ave. North Charleston, SC 29405-2106 Ph. (803) 743-8777	Floor Plan (Type HD-23) 1288 AVE. "H" QUARTERS (FF) Charleston Naval Complex Charleston, SC	
	DWG DATE: 14 Apr 98	DWG NAME: Qtrs-FF

Kitchen - wallpaper @ except doors and ceilings
 Homygenis white paint throughout the house
 Bathroom - wallpaper - except ceiling and doors
 Overall - very good condition

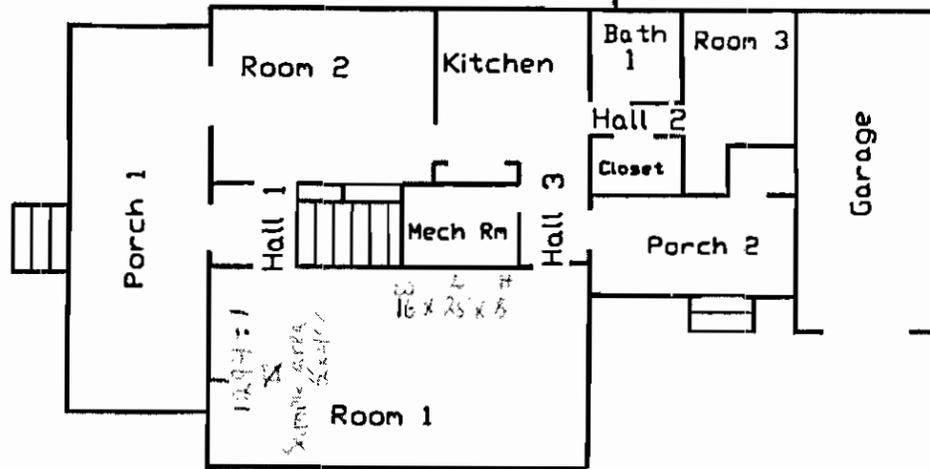
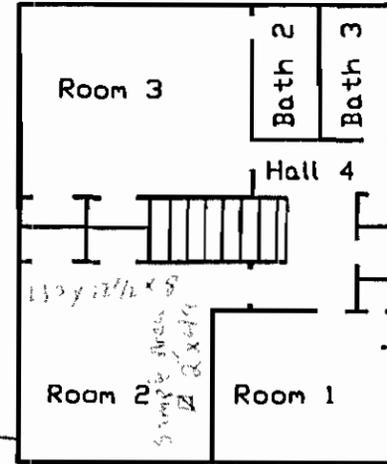
SPORTEVDETCHASN 1899 North Hobson Ave. North Charleston, SC 29405-2108 Ph. (803) 743-8777	Floor Plan (Type HD-23) 1294 AVE. "H" QUARTERS (GG) Charleston Naval Complex Charleston, SC	
	DWG DATE: 14 Apr 98	DWG NAME: Qtrs-GG

Sample near 2' x 4"
 1294-2 Ceiling

Substrate - wood Living Room
 Mergolens - white paint throughout the house
 Kitchen wallpaper except on ceiling and doors
 Bathroom wallpaper except ceiling throughout the house
 Substrate - Sheetrock Bathroom
 Substrate - Sheetrock Room #2
 Overall - New Paint Job / Very Good Condition

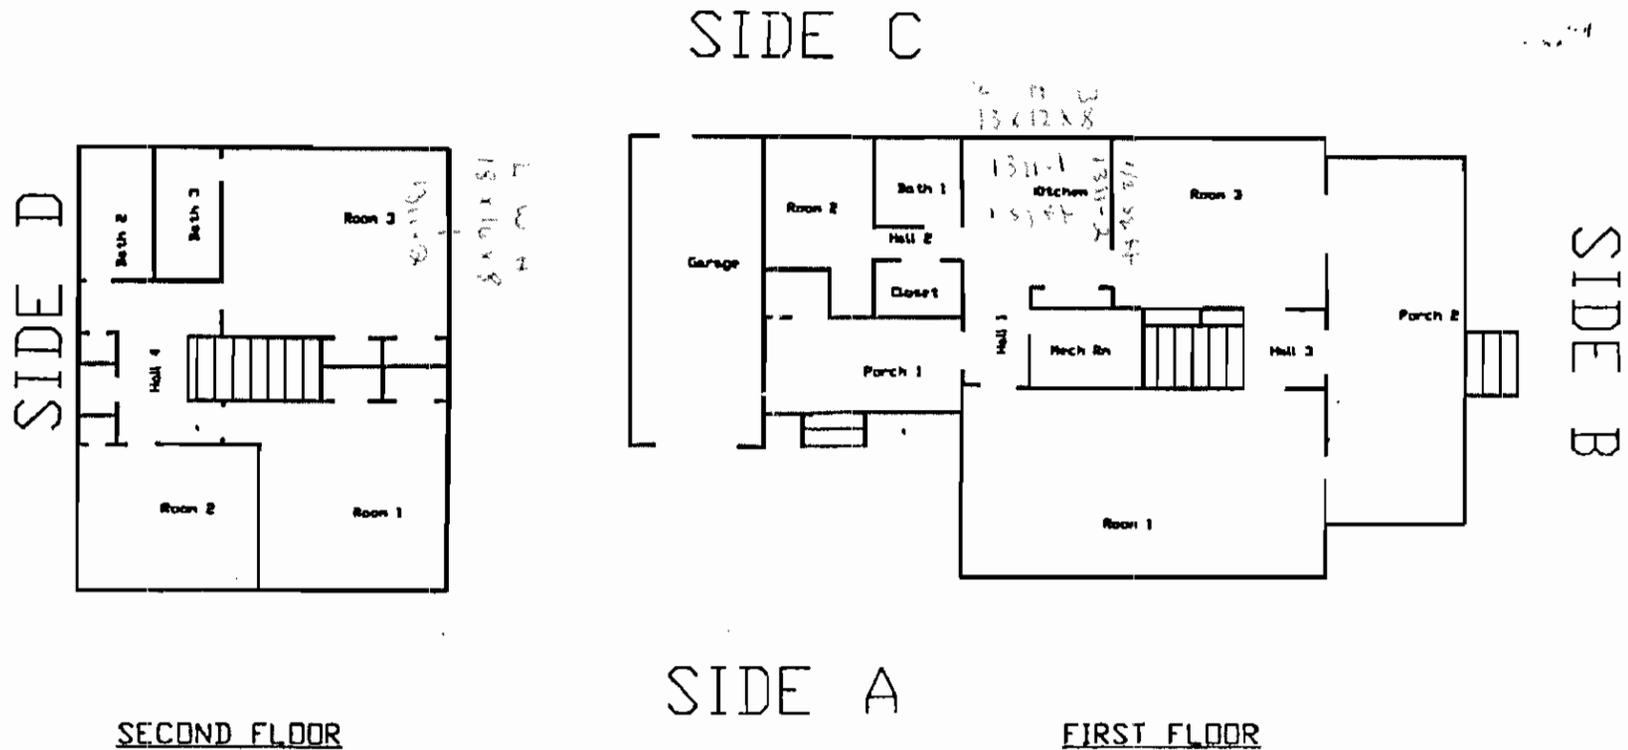
Figure 29-a, Quarters II, Floorplan 689

- 1311-1 Kitchen Ceiling - substrate sheetrock - cause by water damage 1 sq ft
- 1311-2 Bedroom #3 Baseboard - (B wall) substrate - wood - 1/2 sq ft
- 1311-3 Kitchen (A wall) Vent substrate - metal - 1/2 sq ft.

Wallpaper in Bathroom and Kitchen except for ceiling & doors, + Meloding
 Hermigenis white paint throughout the house
 Overall New paint job and very good condition

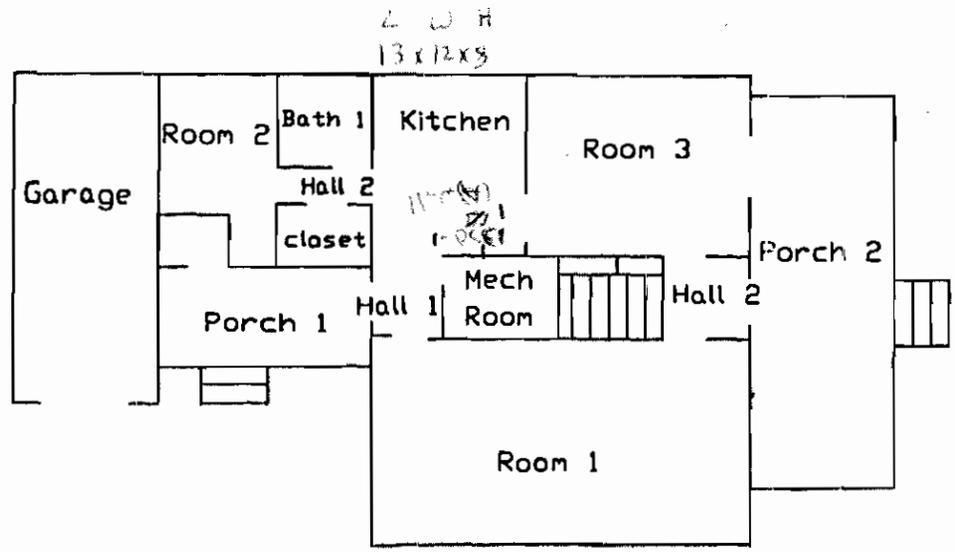
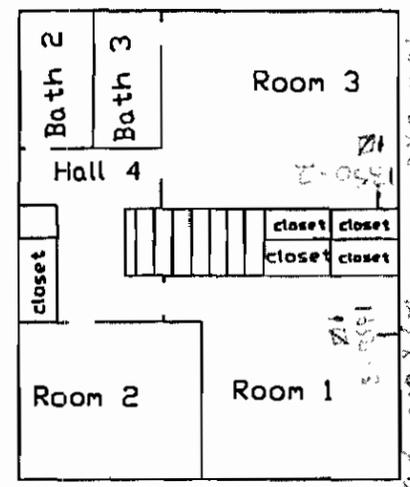
Figure 21-a, Quarters AA, Floorplan

Kitchen to cover with wallpaper / the molding and closet doors are painted.
 Bathroom walls cover with wallpaper (B) + 3
 Substrate wood kitchen
 Hemigenis paint white throughout the house
 wall (kitchen) wall (Room 3)
 1350-1 (A) Second closet door / 1350-2 (C) First closet door side edge / 1350-3 (B) Baseboard
 CAUSE AS TRAILING
