**Environmental Baseline Survey
Water and Wastewater Utility System
Privatization
Naval Station Mayport
Mayport, Florida**

March 2005

**Southern Division
Naval Facilities Engineering Command
North Charleston, South Carolina**

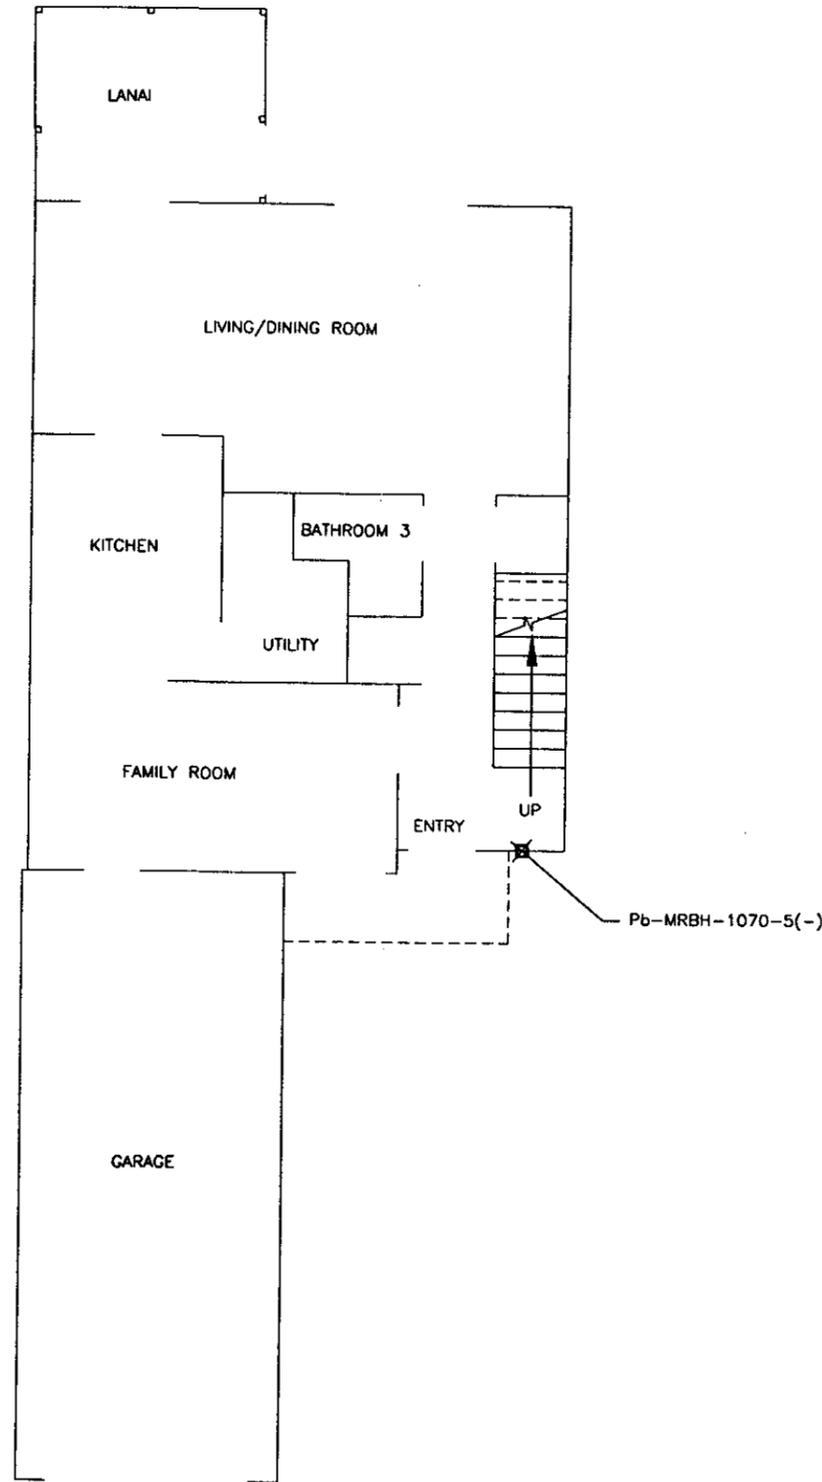
NOTE
NO LEAD-BASED PAINT WAS IDENTIFIED IN THIS UNIT TYPE.
