# Bechtel

## Interoffice Memorandum

Subject Historical Aerial Photograph Review of Landfill Sites, MCAS El Toro Date May 12, 1997

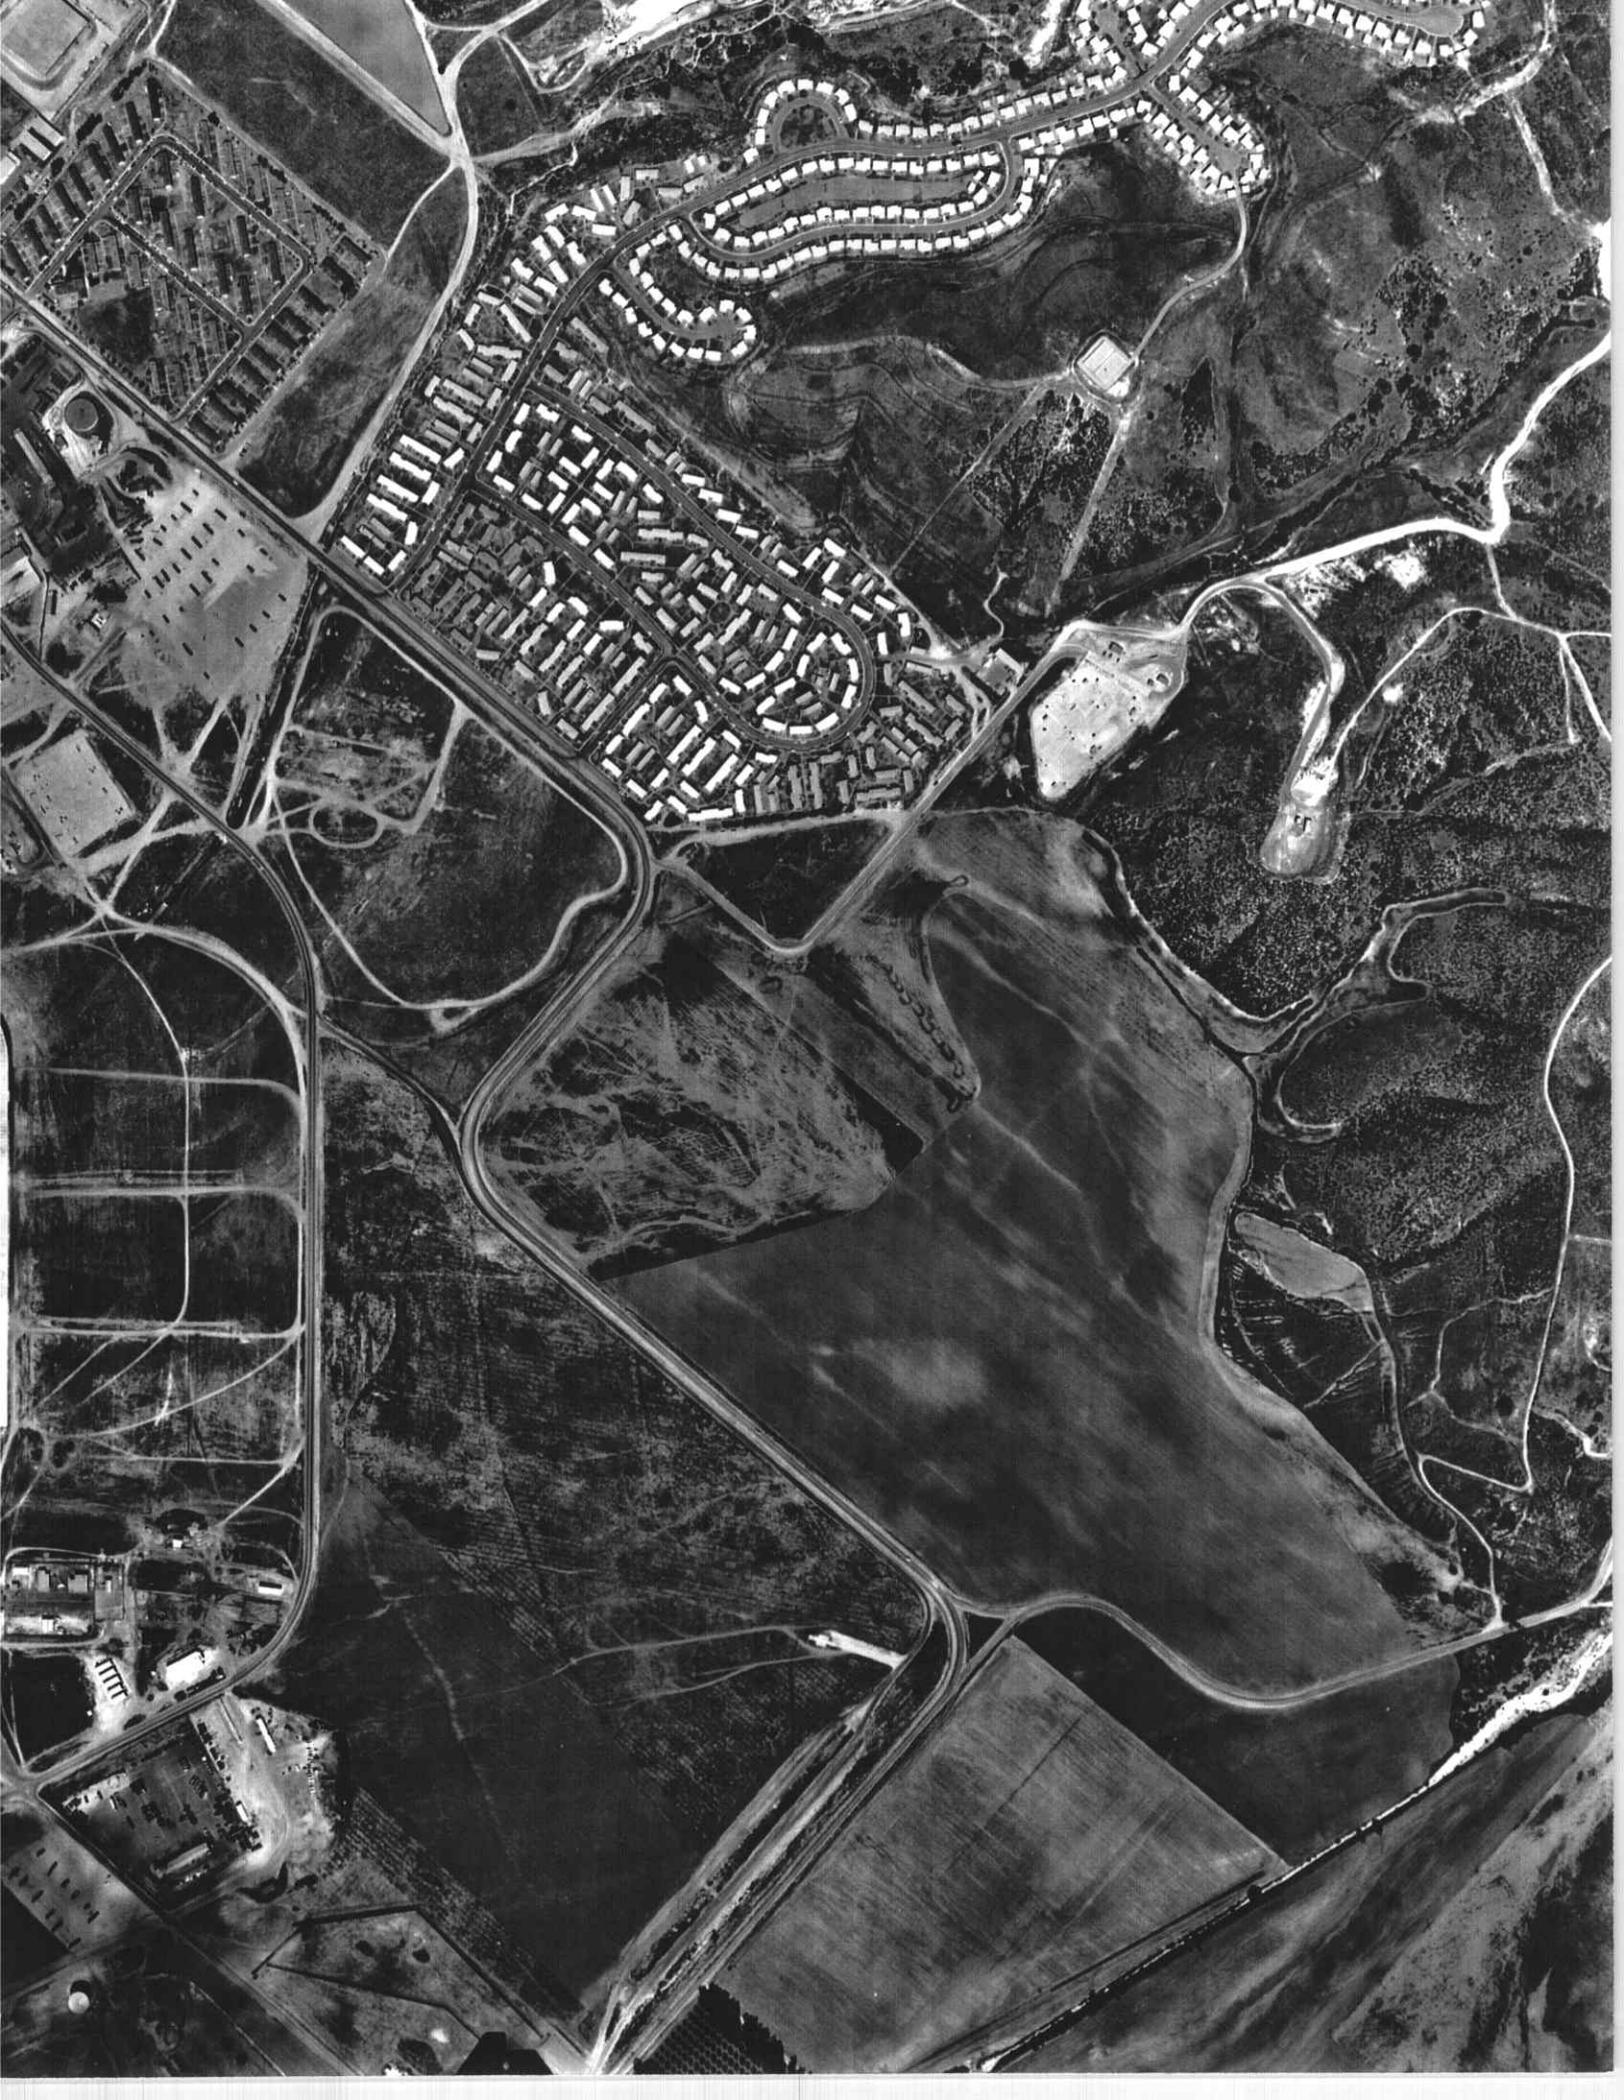
**NEGATIVE NO.:** 3K-36

Site 2 - Areas A and B appear as open fields with short (grass vegetation). Area C1 and C2 are not disturbed and appear adjacent to the washes. Area D1 is located at the end of an open field and Area D2 is an open field.

Site 5 - no activities present; possible native habitat.

Site 3 - possible piles in the west half; large disturbance in east half.

Site 17 - no wastes or activities present.
