Summary Report

Former Temporary Accumulation Area (TAA) 779
Solid Waste Management Unit (SWMU) 227
Former Marine Corps Air Station, El Toro, California

25 March 2002

Prepared by:
Southwest Division, Naval Facilities Engineering Command
BRAC Programs Office
San Diego, CA 92101-2404

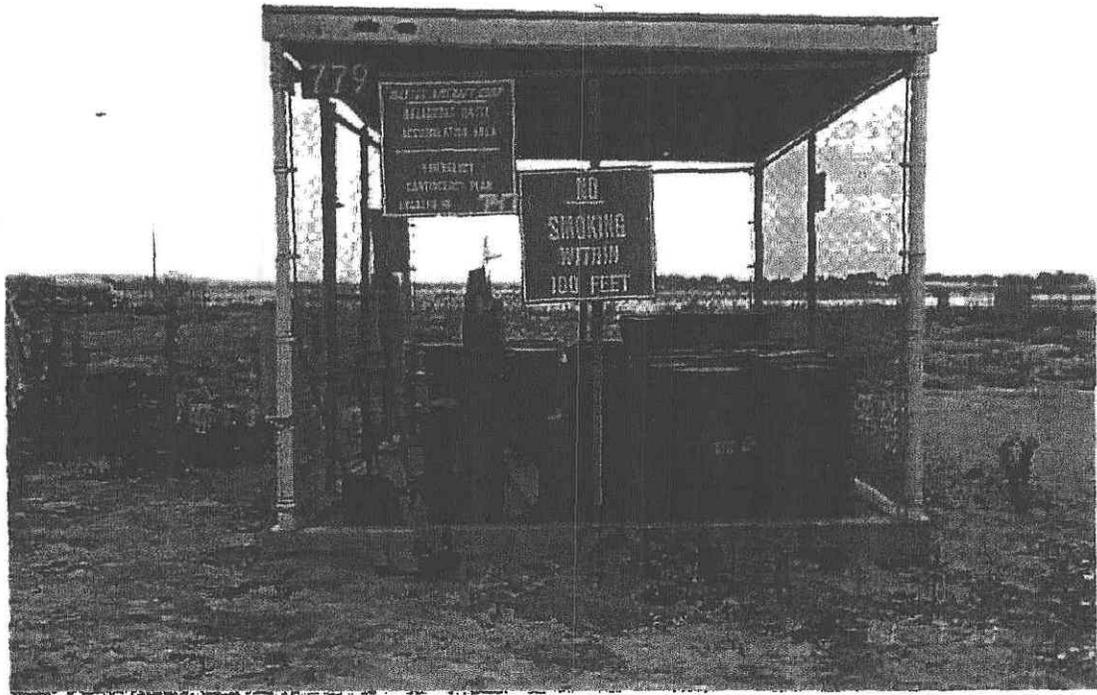
PHOTOGRAPHS OF TAA 779 TAKEN ON 7 OCTOBER 1993

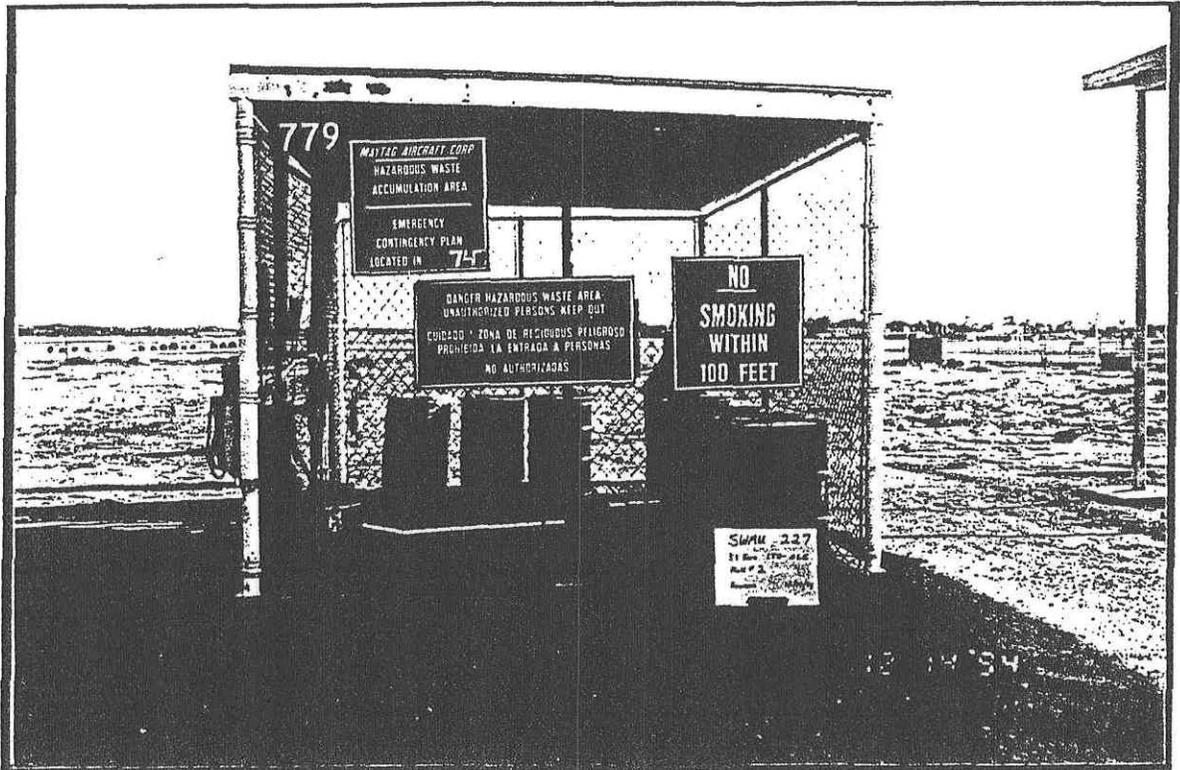
SWMU #: 227

AA/SWMU: 15x10 ft.
"Stain(s)": None.
Any Restrictions To Access?: Fence, roof and poles.
