Subj: Aerial Photograph Anomalies APHO 93 (SAIC 121) and APHO 97 (SAIC 135)  
Former Marine Corps Air Station, El Toro

Aerial Photograph Anomalies APHO 93 (SAIC 121) and APHO 97 (SAIC 135)  
Former Marine Corps Air Station, El Toro

28 January 2004

*Prepared by:*  
Naval Facilities Engineering Command  
Southwest Division  
BRAC Operations  
San Diego, California

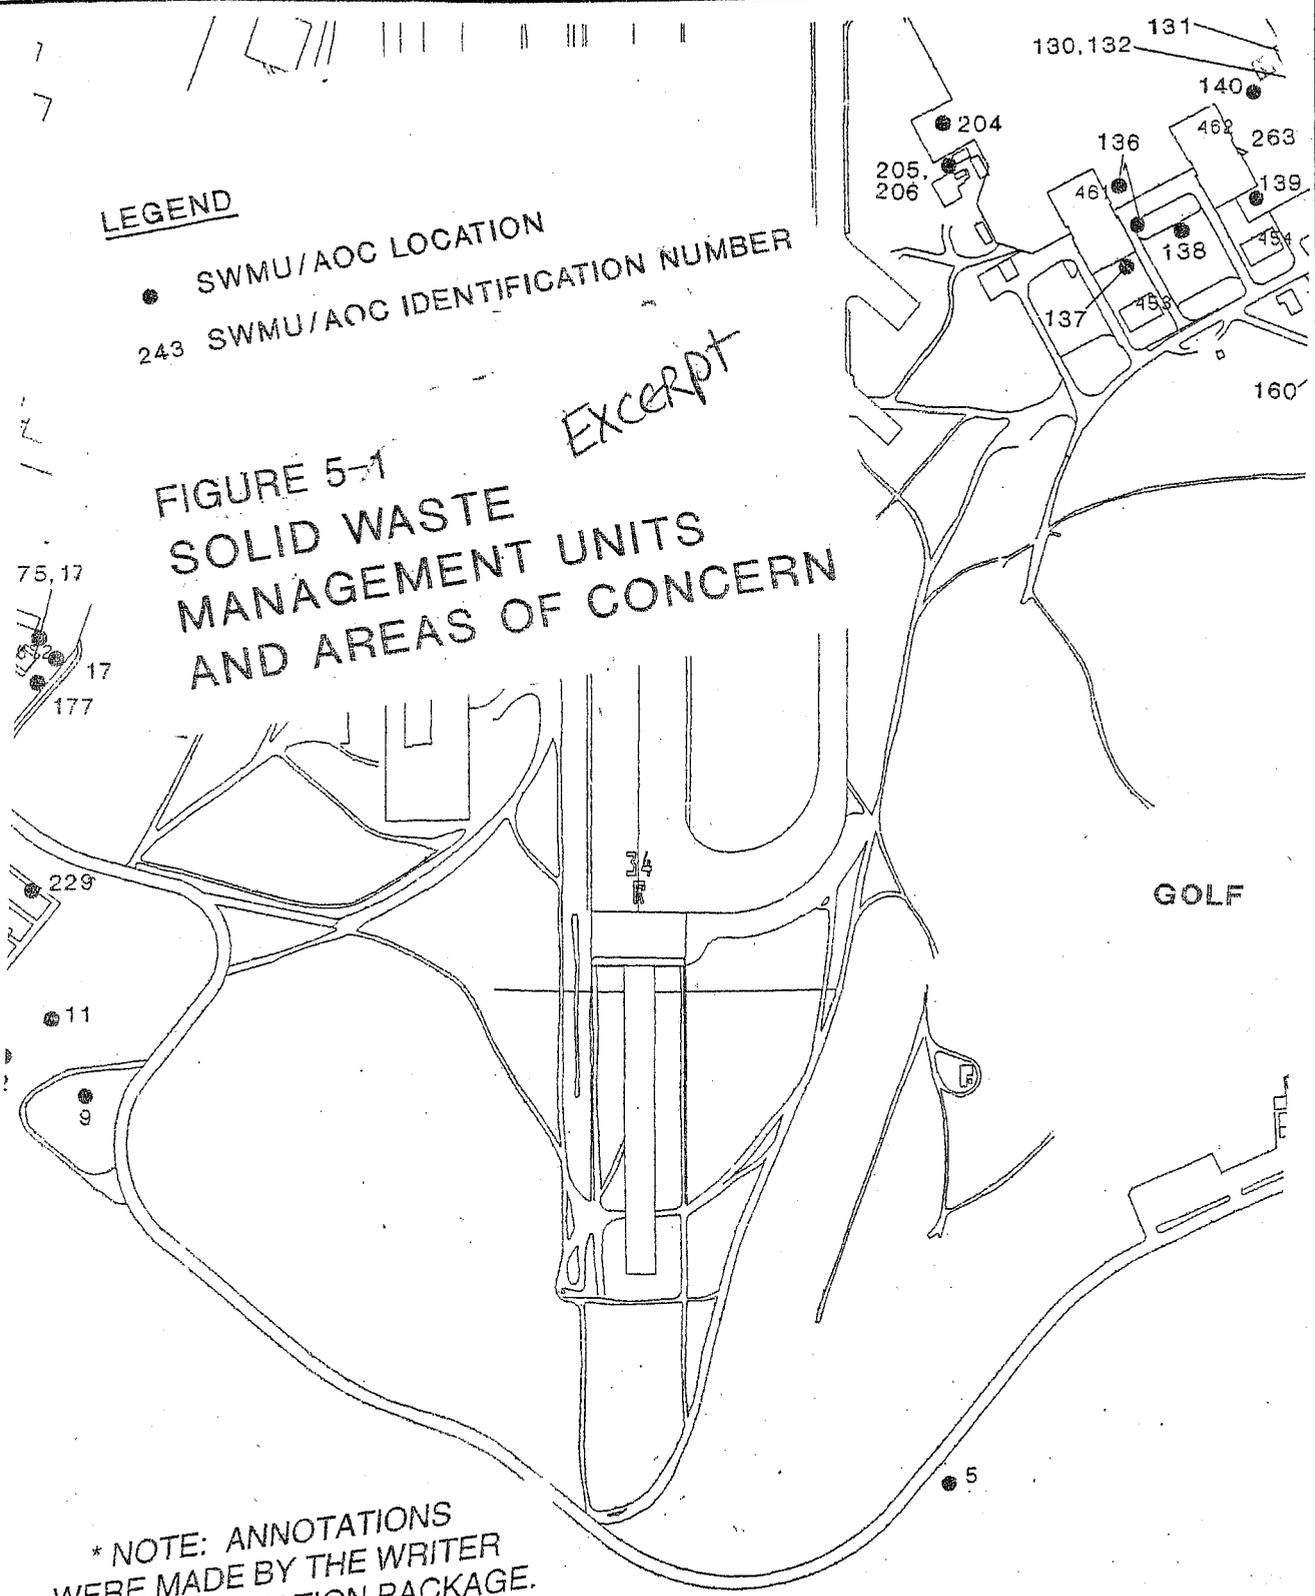
**FIGURE 5-1  
SOLID WASTE  
MANAGEMENT UNITS  
AND AREAS OF CONCERN**

NOTES: (1) The excerpt from the RFA map (Figure 5-1) is annotated with an open circle symbol to show the approximate location of APHO 93/APHO 97. (2) The RFA map also shows the location of SWMU 5 (Borrego Canyon Wash), and SWMU 5 sampling visit information is presented.

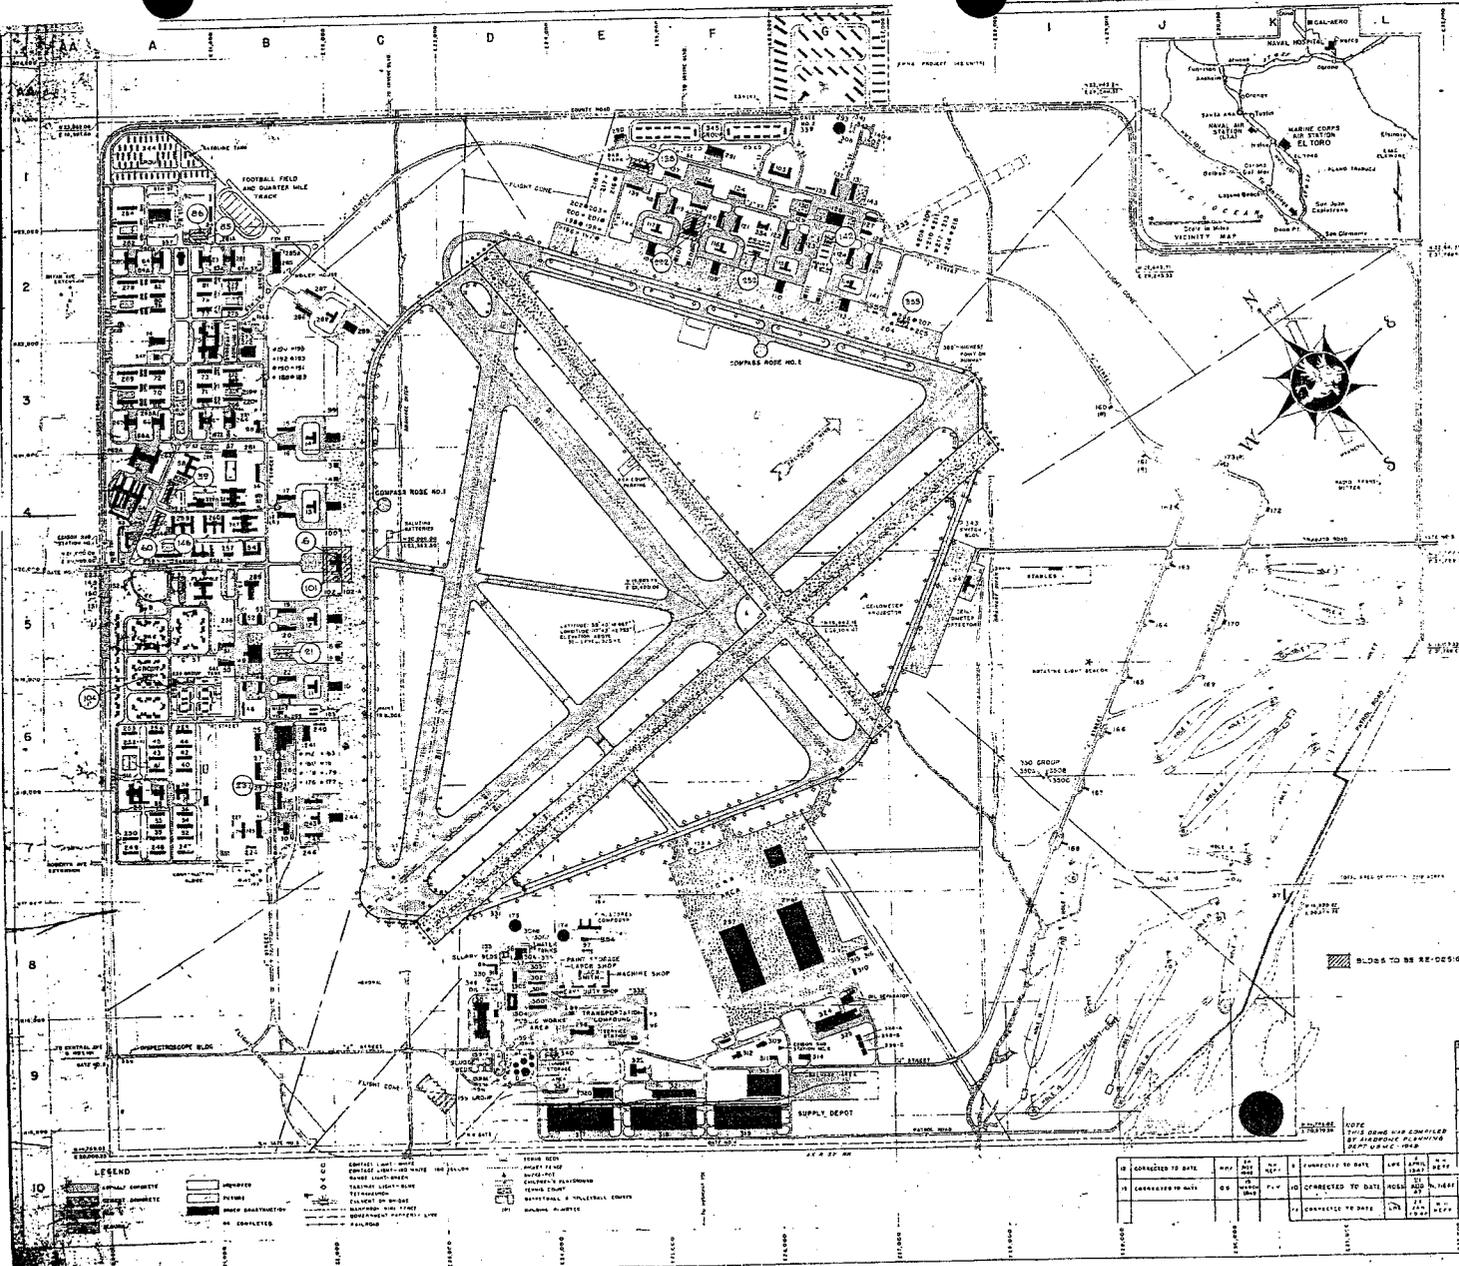
## Historical Master Plot Plan dated 17 January 1950

NOTE: The 1950 plan is annotated with a solid circle symbol to show the approximate location of APHO 93/APHO 97.

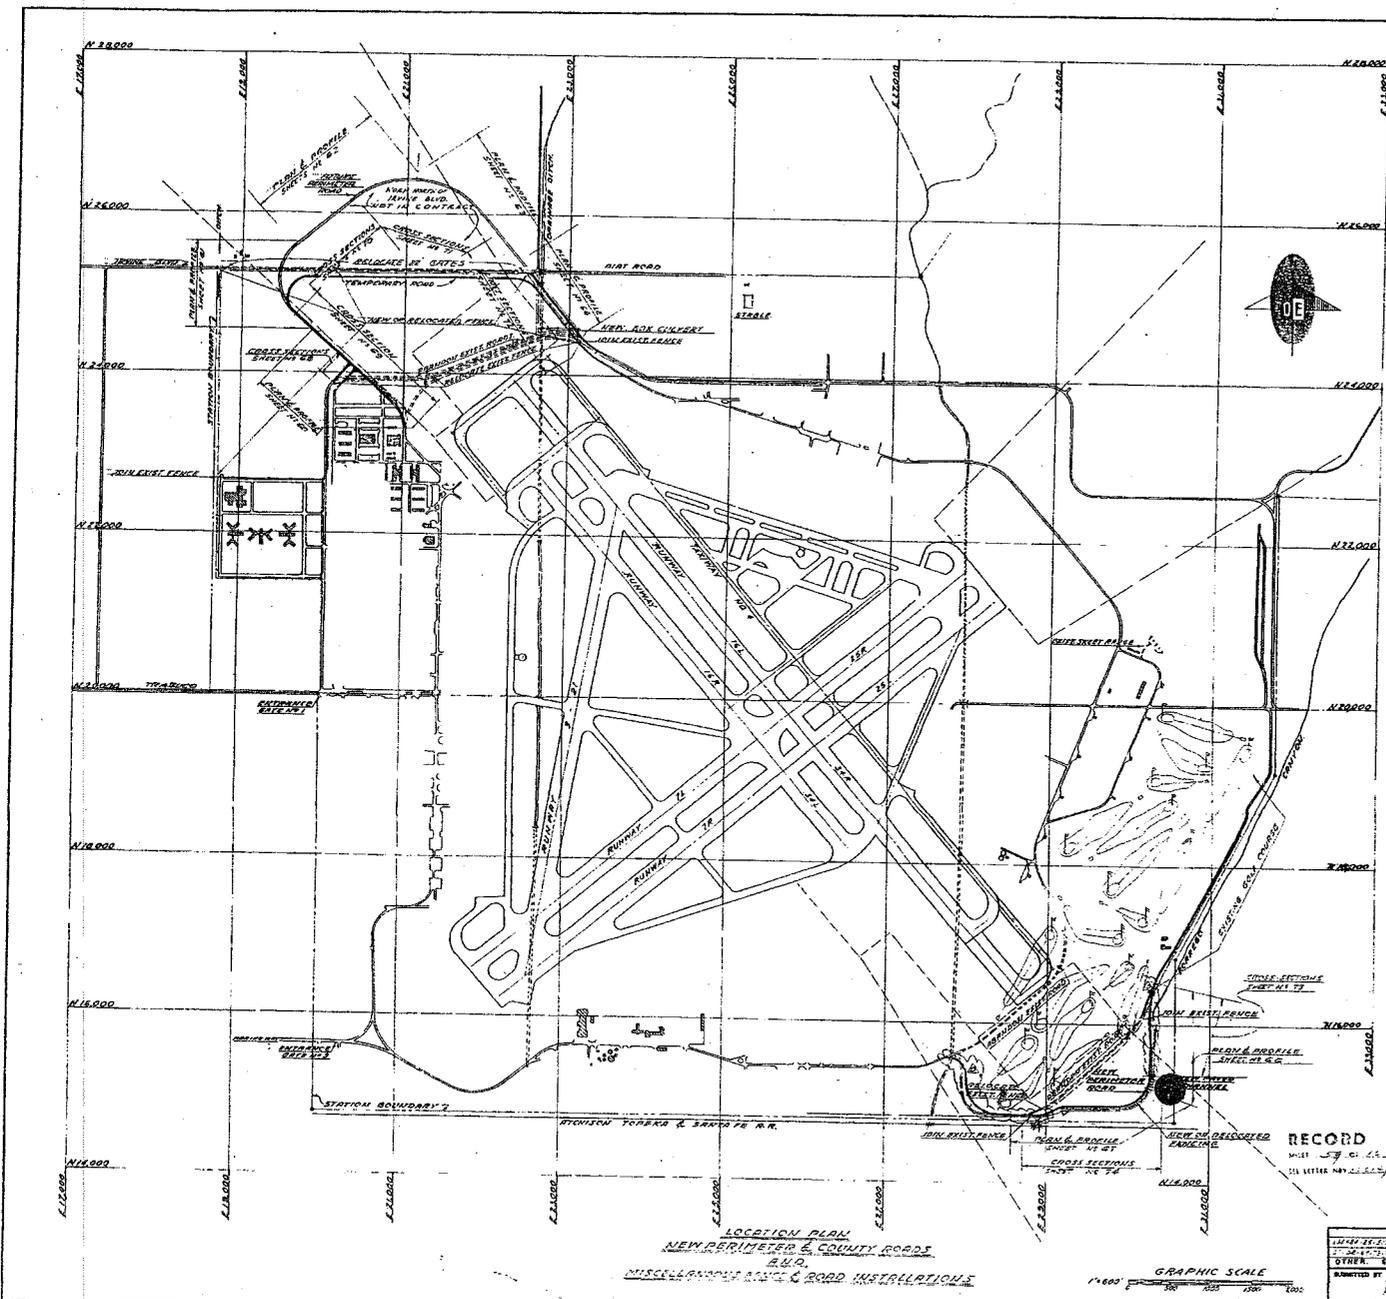
Excerpt from Location Plan, New Perimeter Roads, Extension to Runway 16L –  
34R & Installation of Approach Lighting (Yards and Docks Drawing 817790,  
Sheet 59 of 75, dated 1958)

NOTE: The excerpt from the plan shows the new alignment for the perimeter road in the  
vicinity of APHO 93/APHO 97 and the paved channel for Borrego Canyon Wash near  
APHO 93/APHO 97.

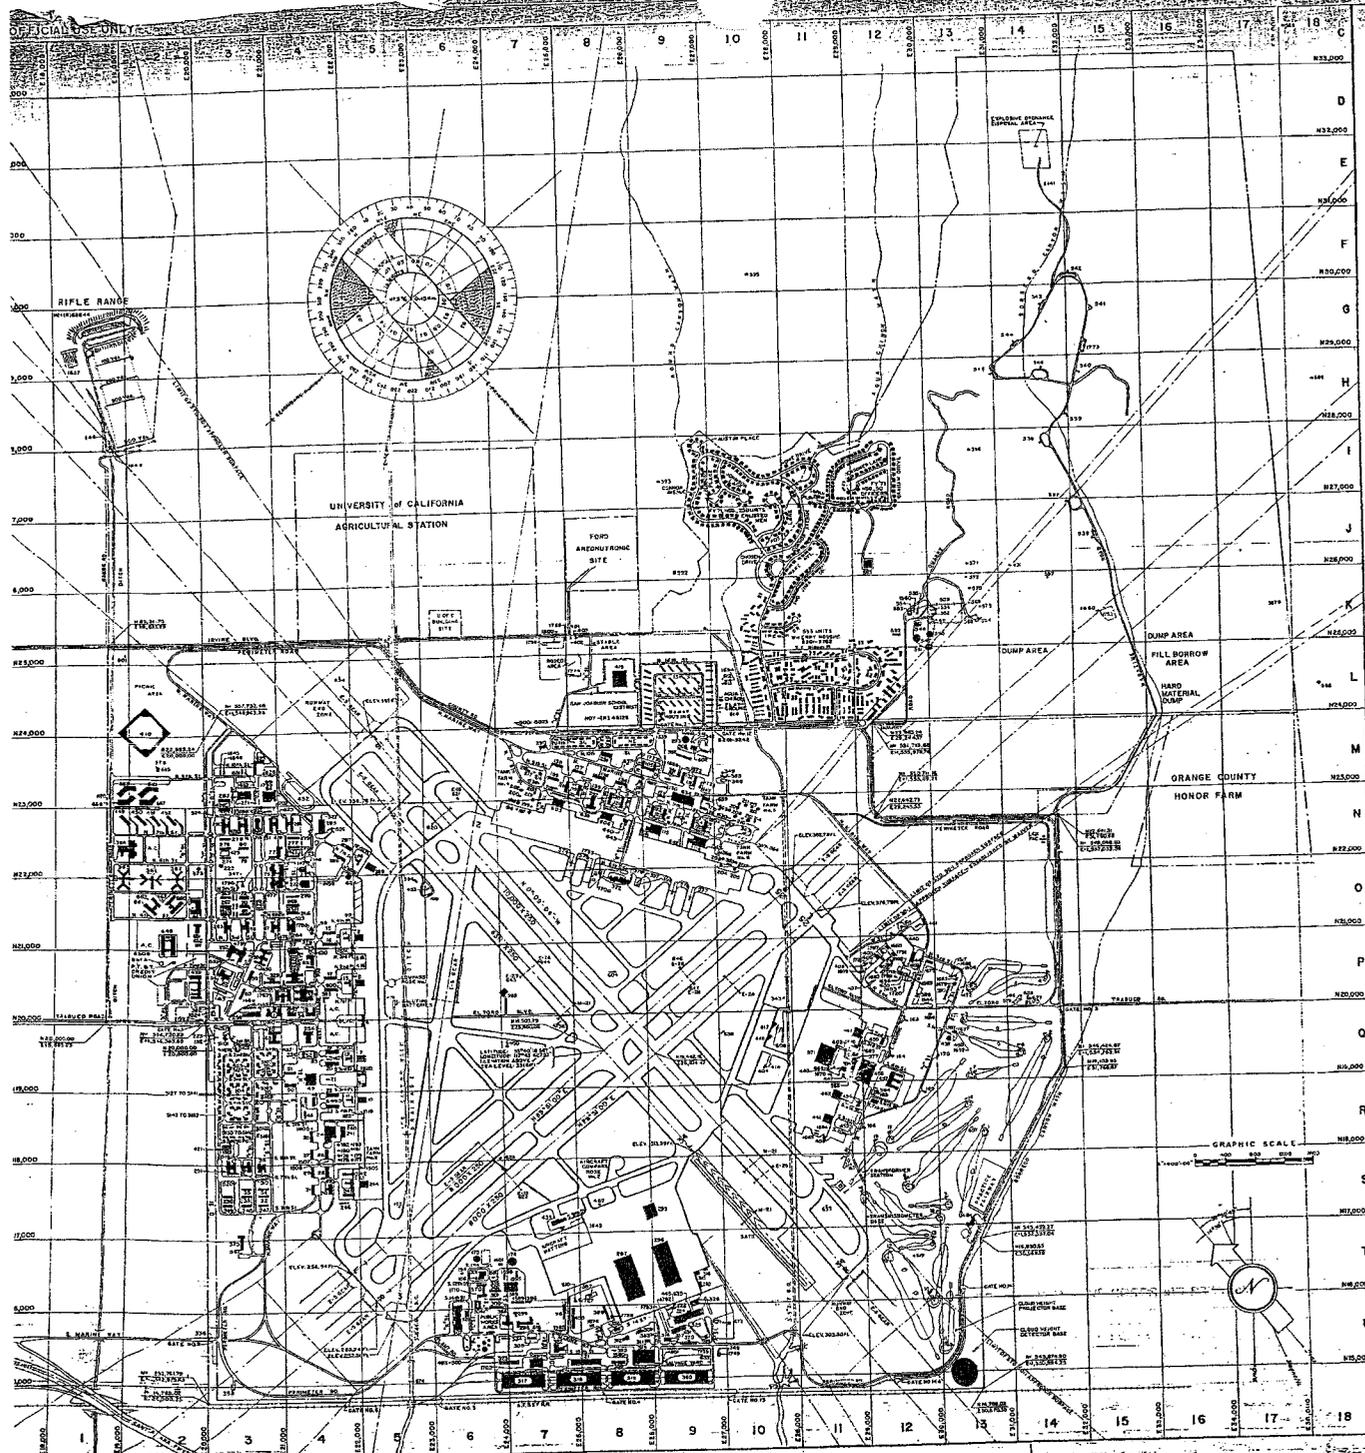
### Excerpt from 1973 Station Map (Public Works Drawing S-2010)

NOTE: The excerpt from the Station Map shows the locations of Gate 14, Gate 14A, Borrego Canyon Wash, Perimeter Road, and the approximate location of APHO 93/APHO 97 (denoted by a solid circle symbol).

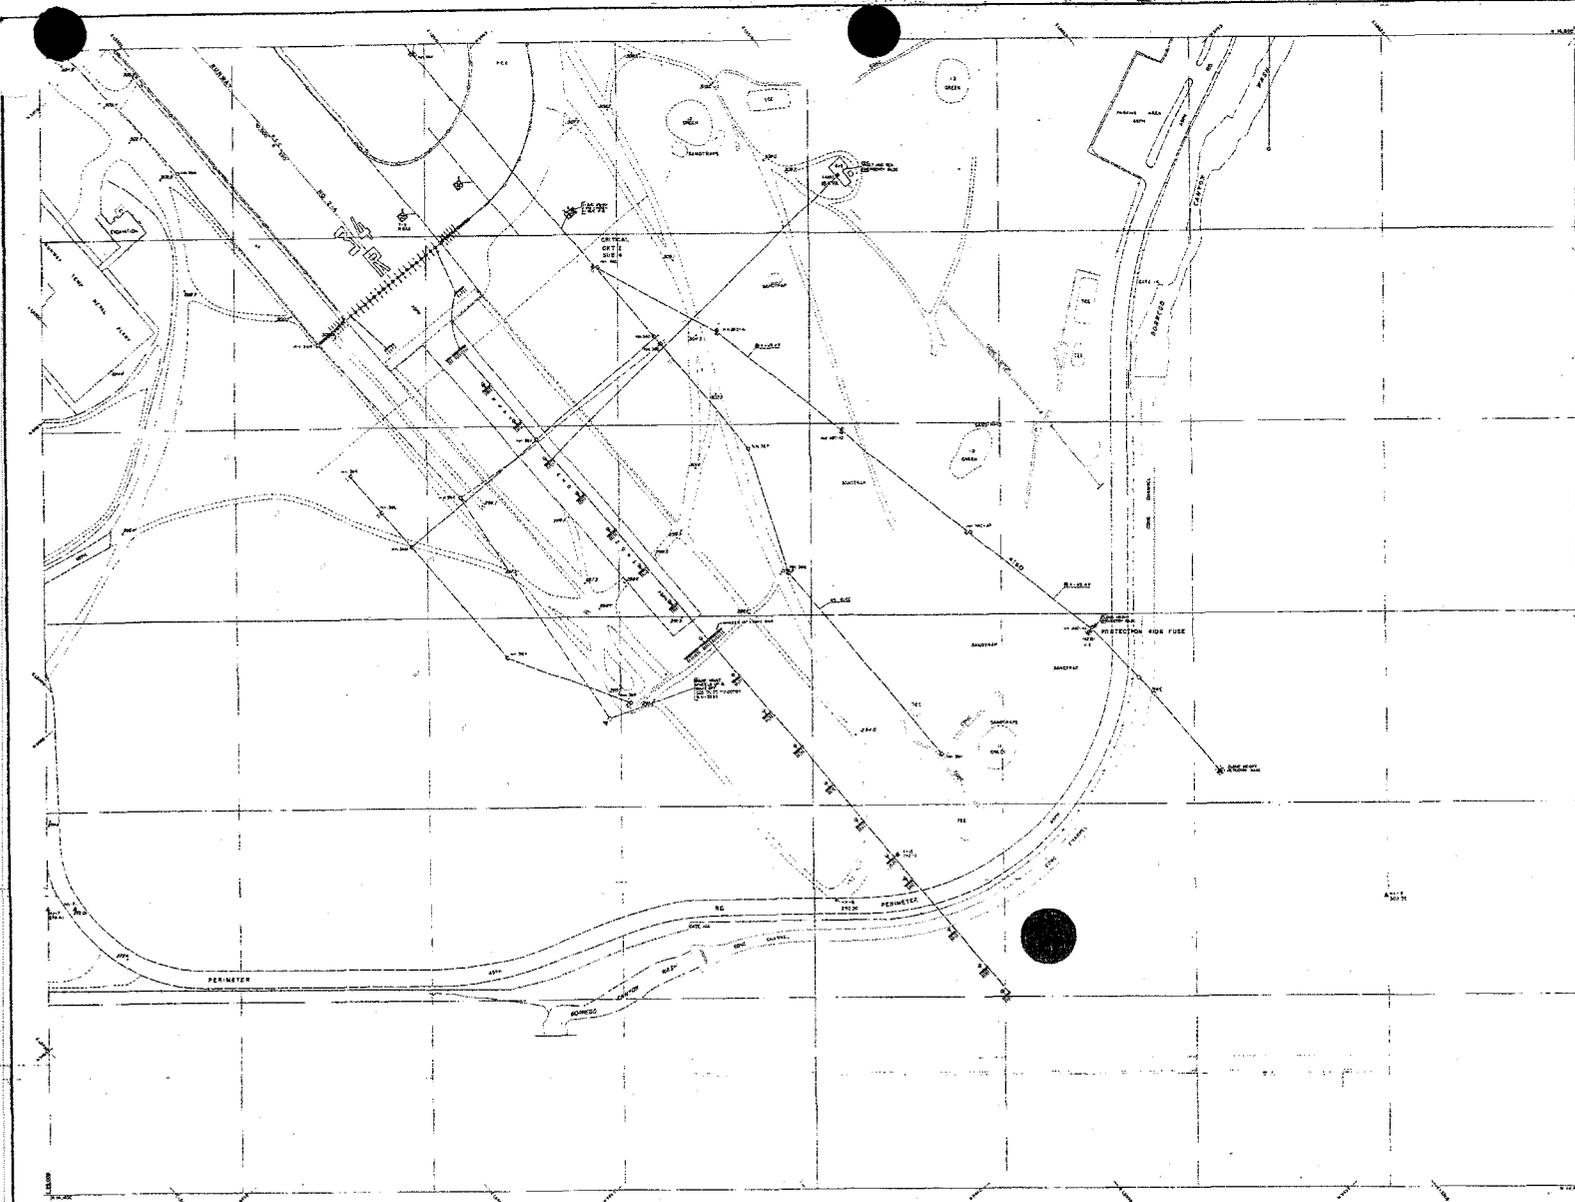
Excerpt from Area 29, Electrical Distribution Plan (U.S. Marine Corps Air Station,  
El Toro, Public Works Department, Revised 14 April 1988)

APHO 93/APHO 97 is located adjacent to and approximately east of the approach lighting structures for Runway 34R. Runway approach lighting structures are shown on historical plans dated 1958 and on the electrical system utility maps dated 1988. It is possible that construction of or repairs to the underground electrical lines for the lighting structures caused the appearance of an excavation, trench, or area of disturbed ground.

NOTE: The excerpt from the electrical distribution plan has been annotated with a solid circle symbol for the approximate location of APHO 93/APHO 97 near the approach lighting structures for Runway 34R.
