# Memorandum

To: Brian Murray, NAVFAC MIDLANT  
From: David Brayack, Tetra Tech  
Date: January 28, 2021  
Re: Annual LUC Inspection and Operation Summary Report: Sites 1, 2, 3, and 4 – NWIRP Bethpage  
Revision 1  
Contract/CTO Number: N6247016D9008/WE13

## 1.0 Introduction

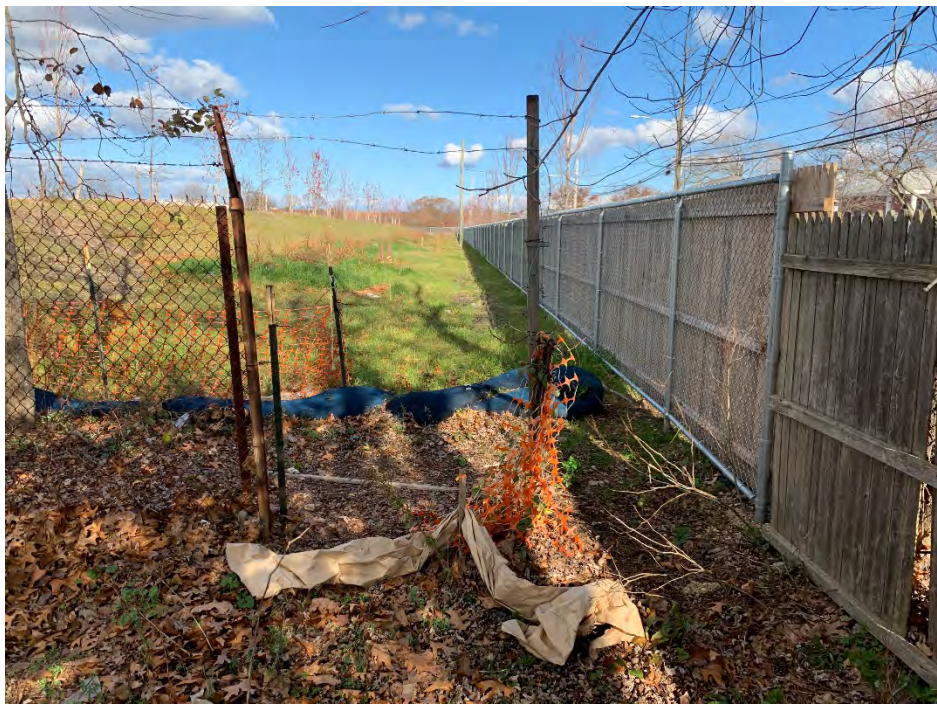
Photo 1B – Site 1 eastern boundary looking north towards SVE wells and earthen berm with new tree plantings

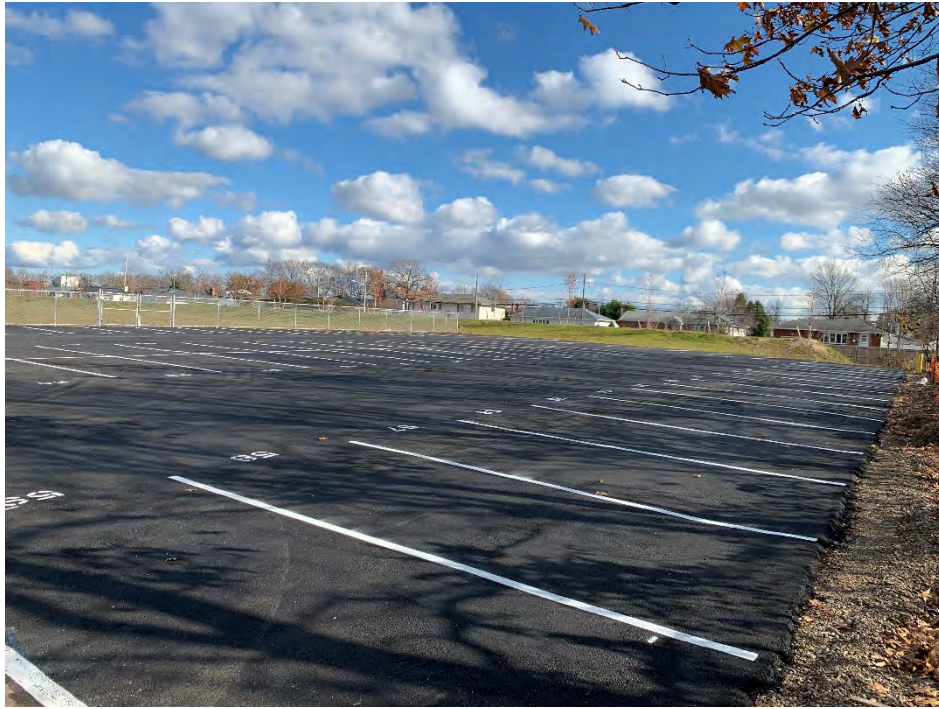
Photo 1C – Southwest corner of Site 1 looking east-northeast at new paving and discontinuous fence

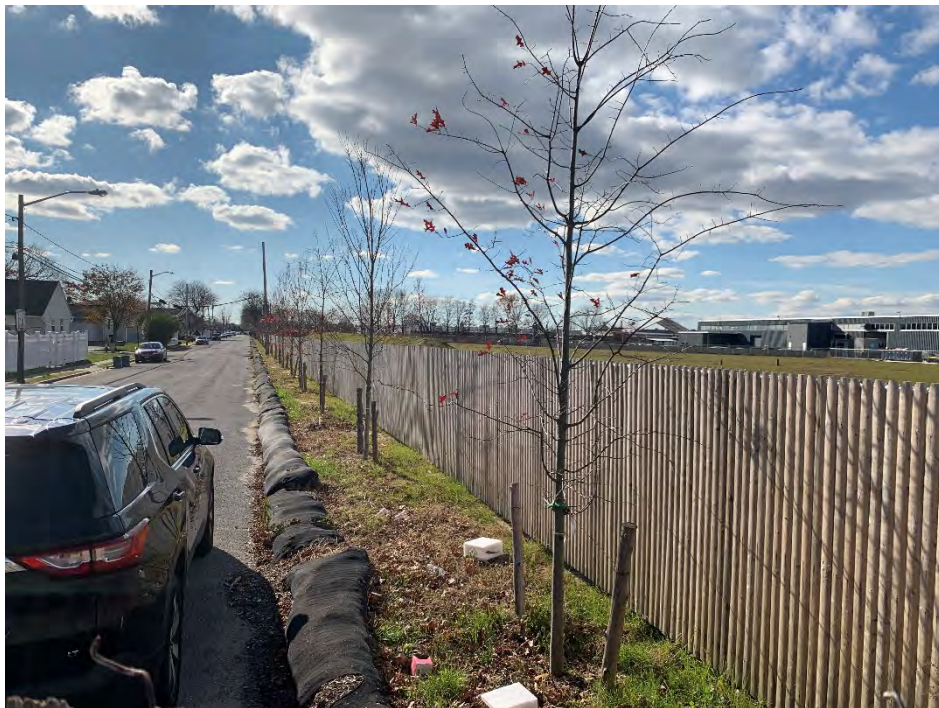
Photo 1D – Site 1 eastern boundary on 11<sup>th</sup> St looking south at new stockade fence and new tree plantings

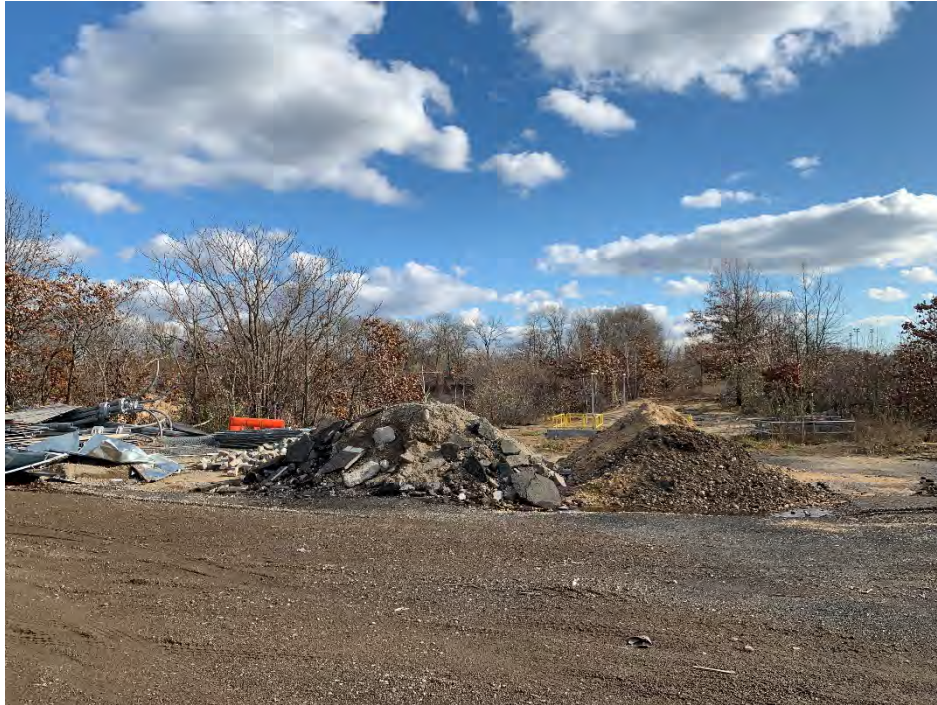
Photo 2C –Center of Site 2 looking east between the north and south basins at Steel Equities laydown/storage area

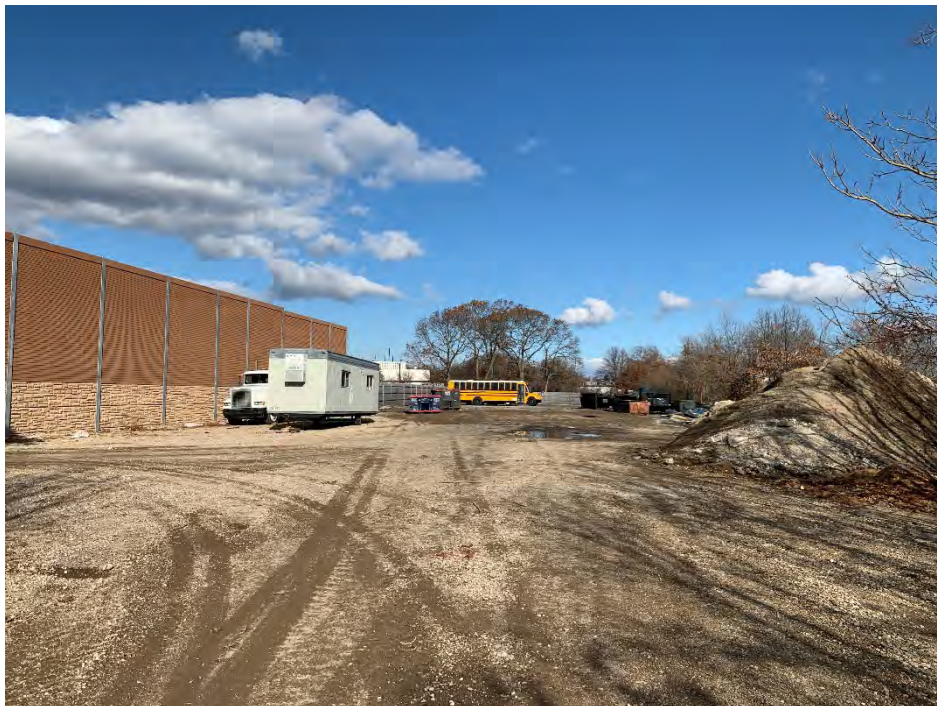
Photo 2D –Center of Site 2 looking north at Steel Equities laydown/storage area between the FEDEX hub terminal and north basin

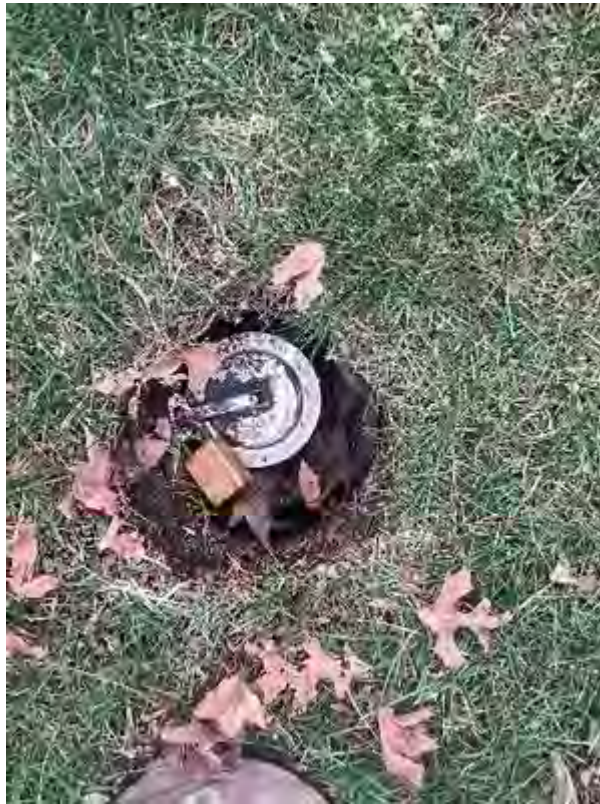
| <b>Notes (Explain if answered No to any of the above)</b><br>Missing two bolts | |

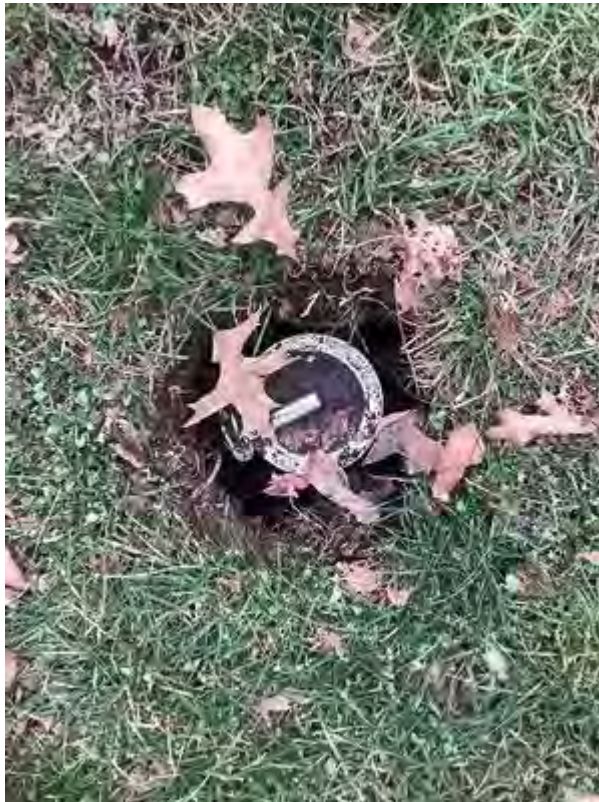
| <b>Notes (Explain if answered No to any of the above)</b><br>Missing one bolt | |

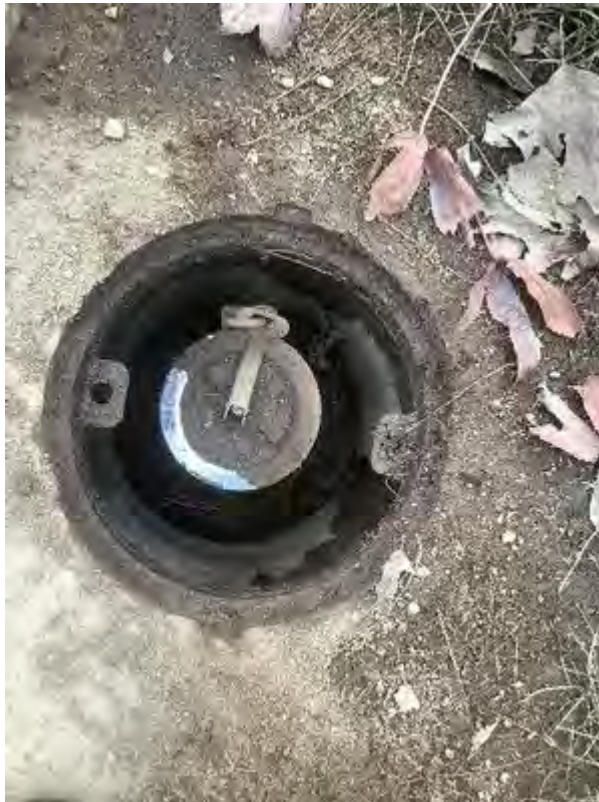
| <b>OVERALL CONDITION:</b> | FAIR |
| <b>Notes (Explain if answered No to any of the above)</b><br>Missing one bolt | |

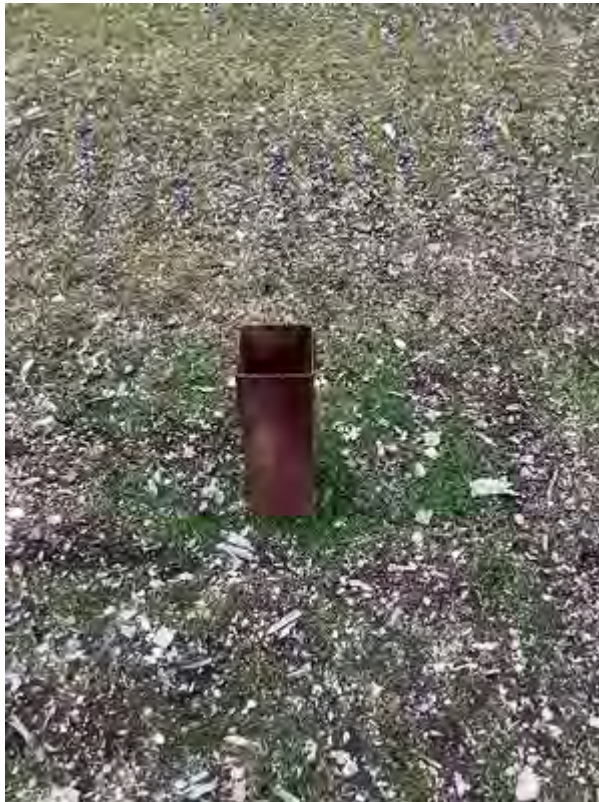
| <b>Manhole cover present and in working condition?</b> | NO |
| <b>OVERALL CONDITION:</b> | FAIR |
| <b>Notes (Explain if answered No to any of the above)</b><br>Stick up casing missing top | |

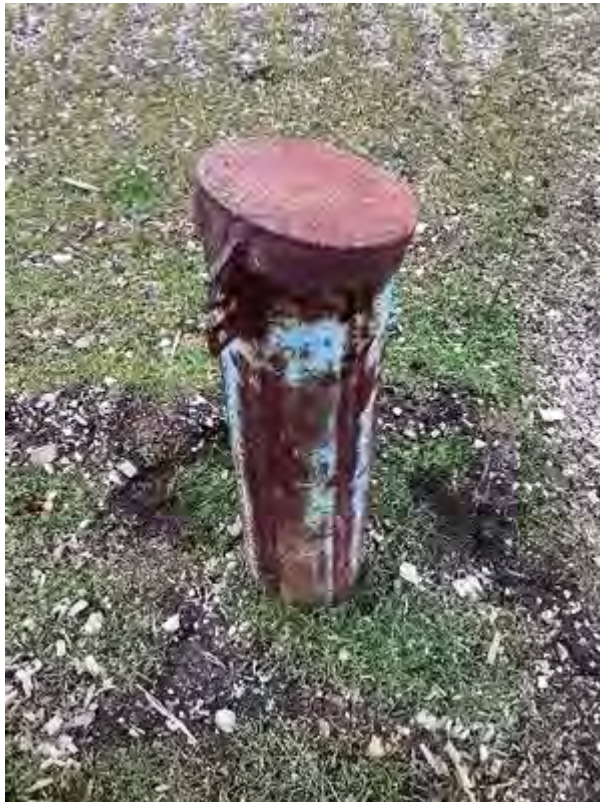
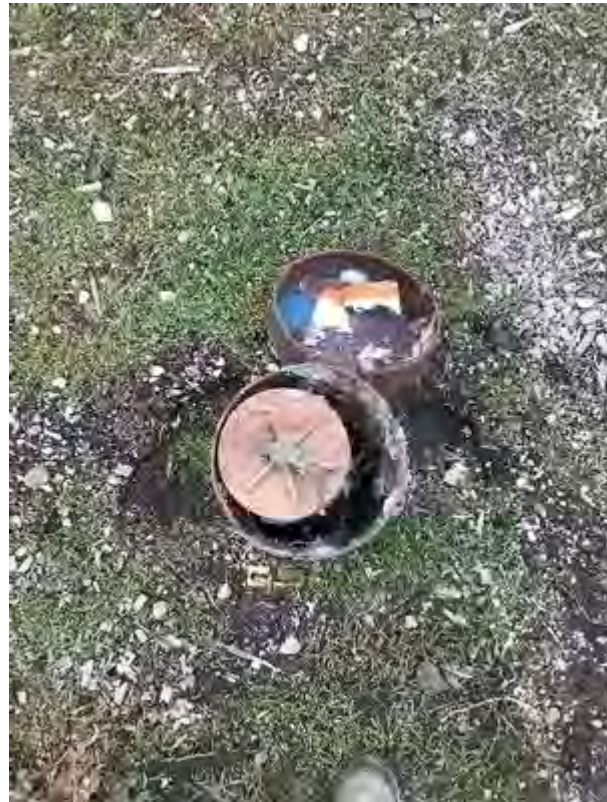
| <b>Manhole cover present and in working condition?</b> | NO |
| <b>Notes (Explain if answered No to any of the above)</b><br>Stick up well, casing top will not close. | |

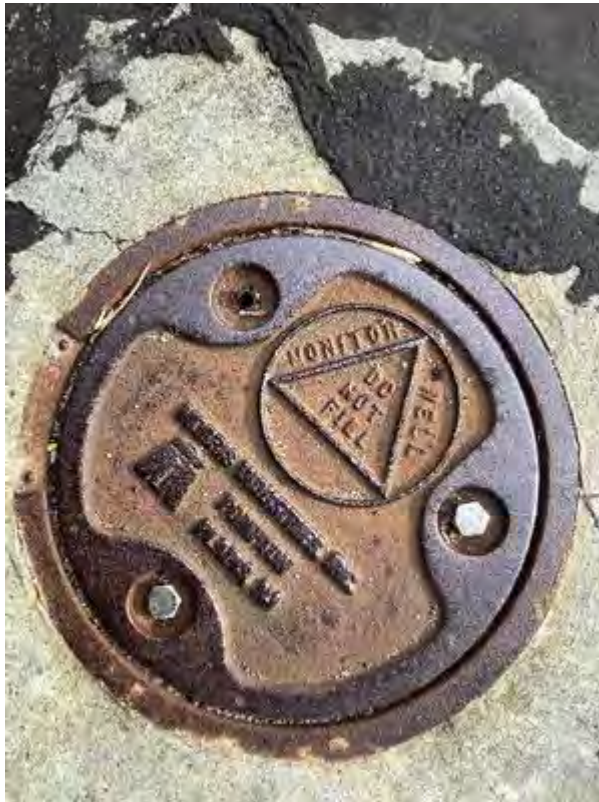
| <b>OVERALL CONDITION:</b> | FAIR |
| <b>Notes (Explain if answered No to any of the above)</b><br>Missing one bolt | |

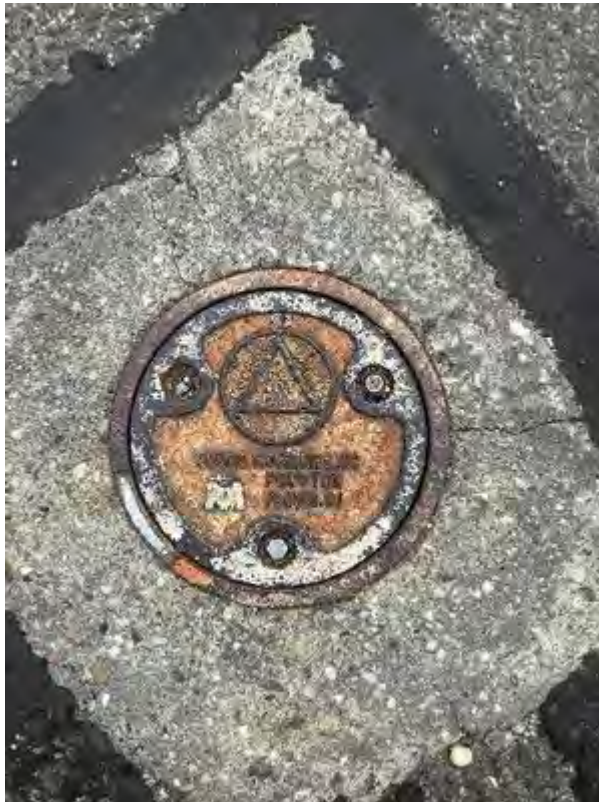
| <b>OVERALL CONDITION:</b> | FAIR |
| <b>Notes (Explain if answered No to any of the above)</b><br>Missing one bolt | |

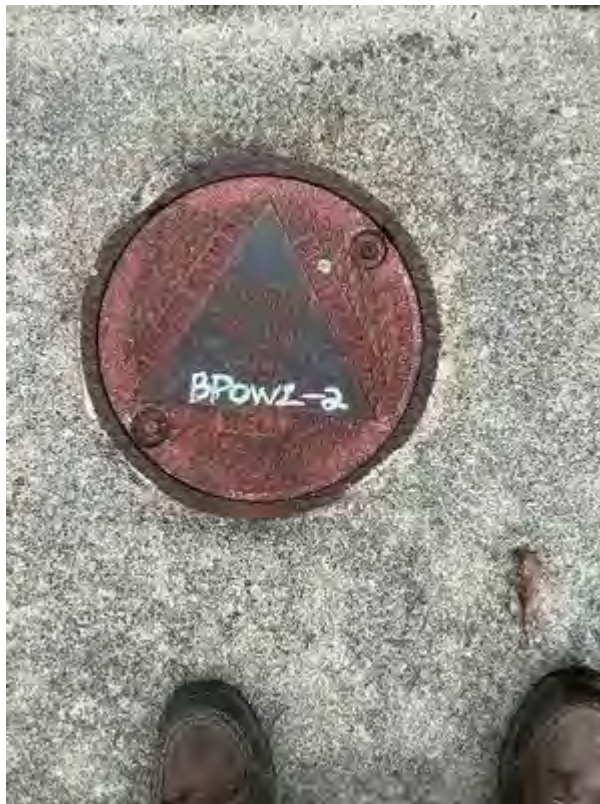
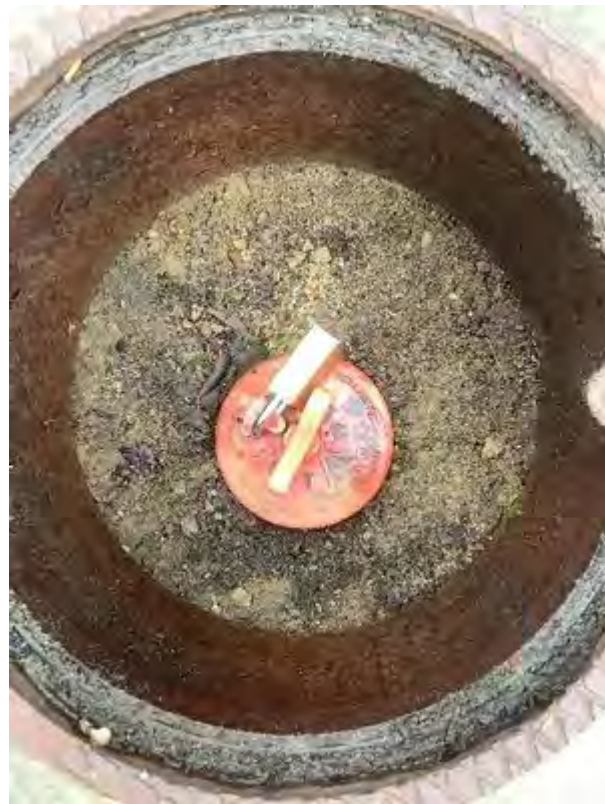
| <b>Notes (Explain if answered No to any of the above)</b><br>Two bolts stripped | |

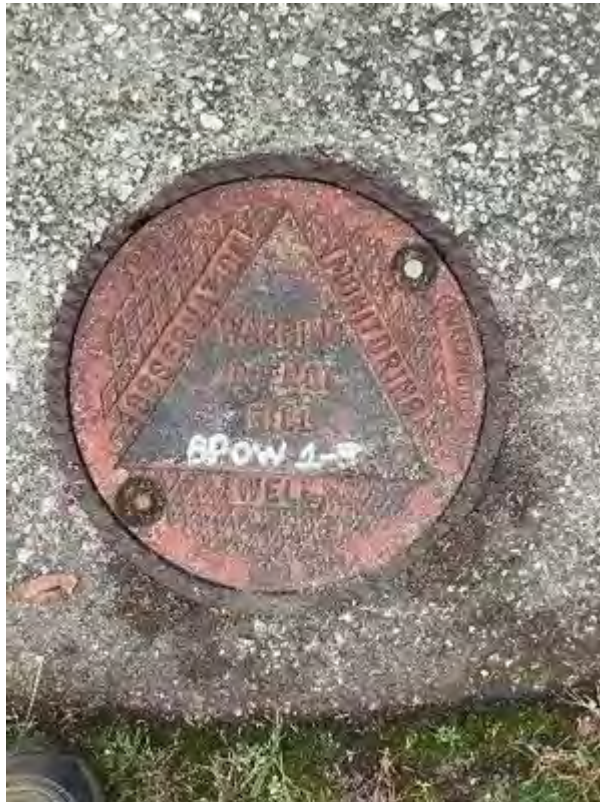
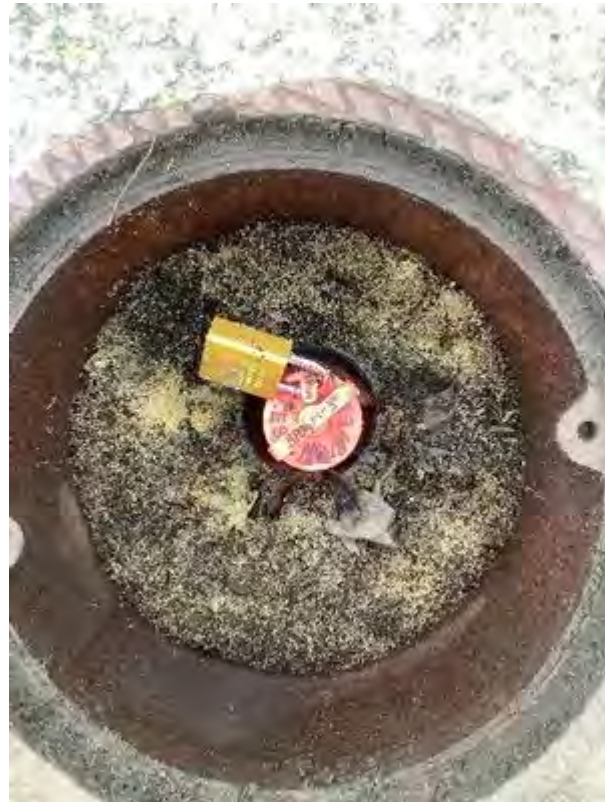
| <b>Notes (Explain if answered No to any of the above)</b><br>Two bolts stripped | |

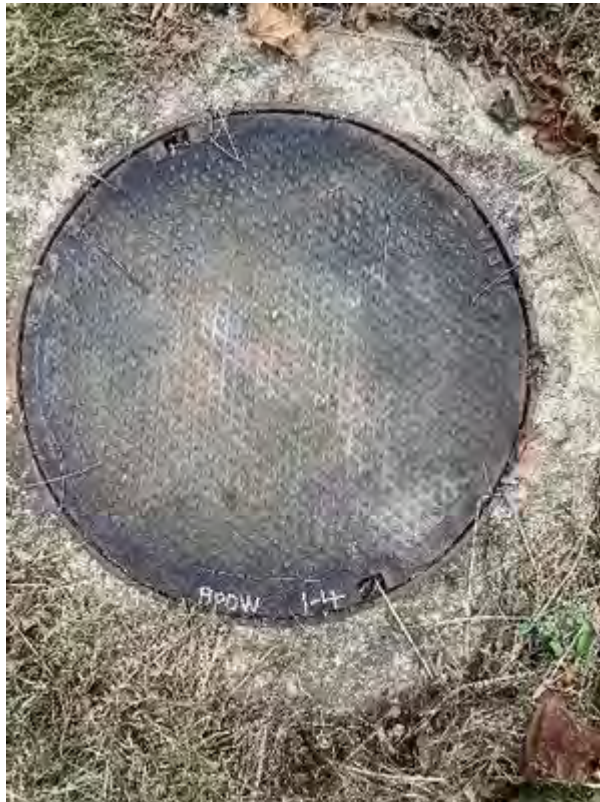
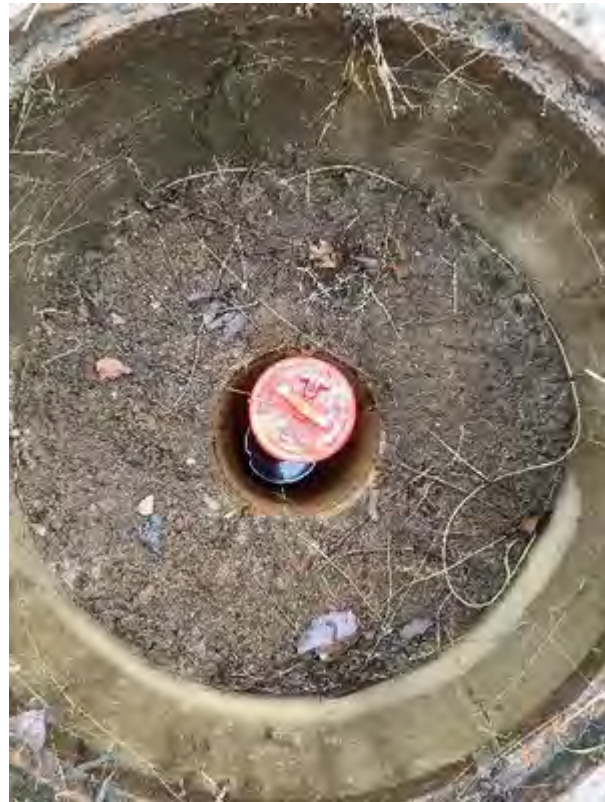
| <b>Notes (Explain if answered No to any of the above)</b><br>Manhole covered well. Needs backfill | |

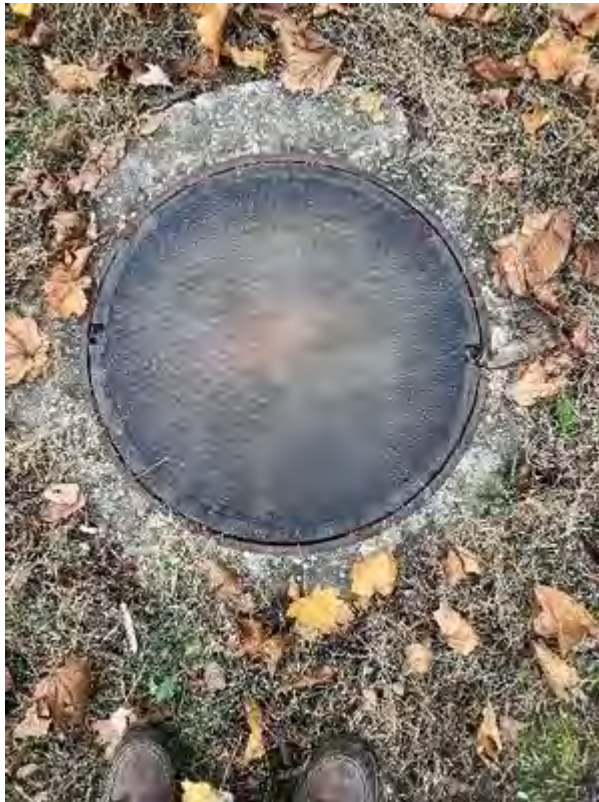
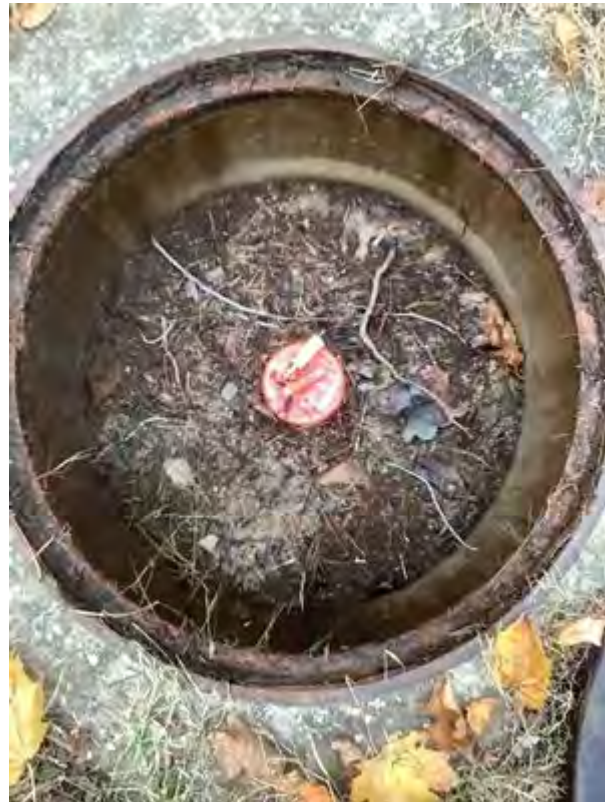
| <b>Notes (Explain if answered No to any of the above)</b><br>Manhole covered well | |

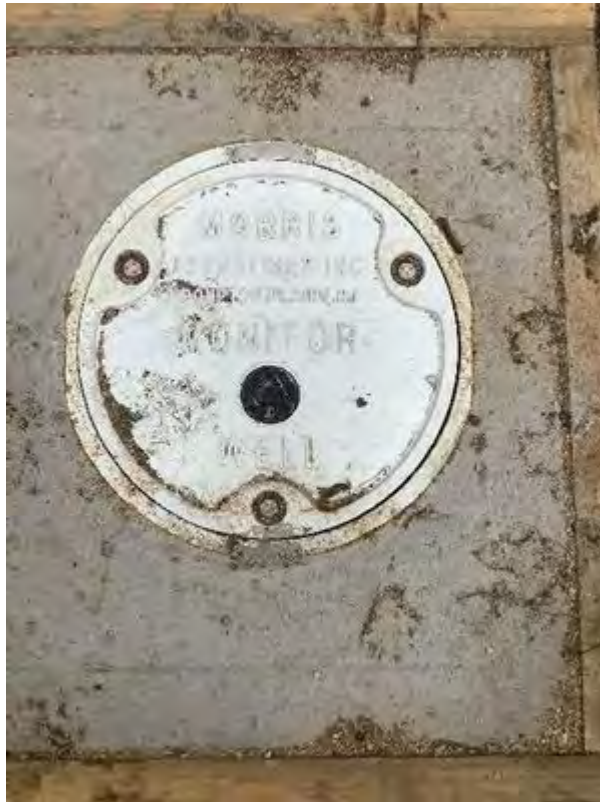
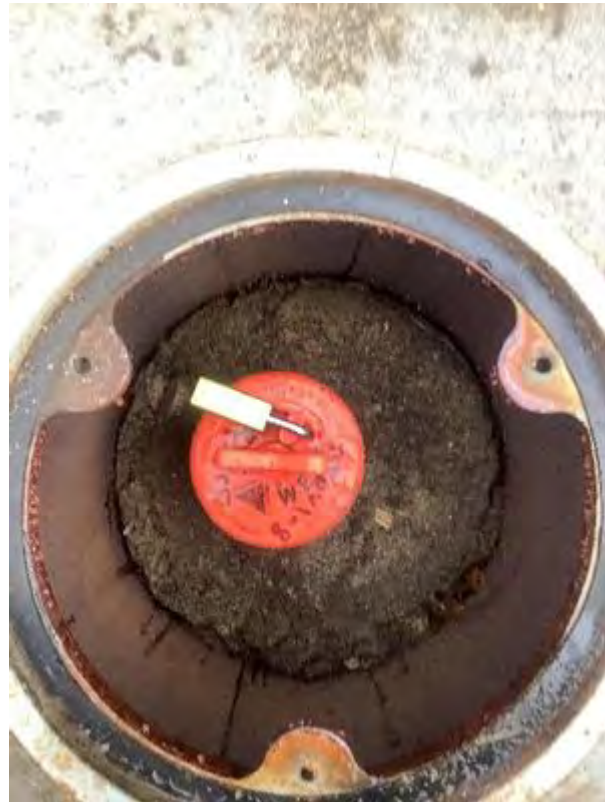
| <b>OVERALL CONDITION:</b> | FAIR |
| <b>Notes (Explain if answered No to any of the above)</b><br>Missing one bolt | |

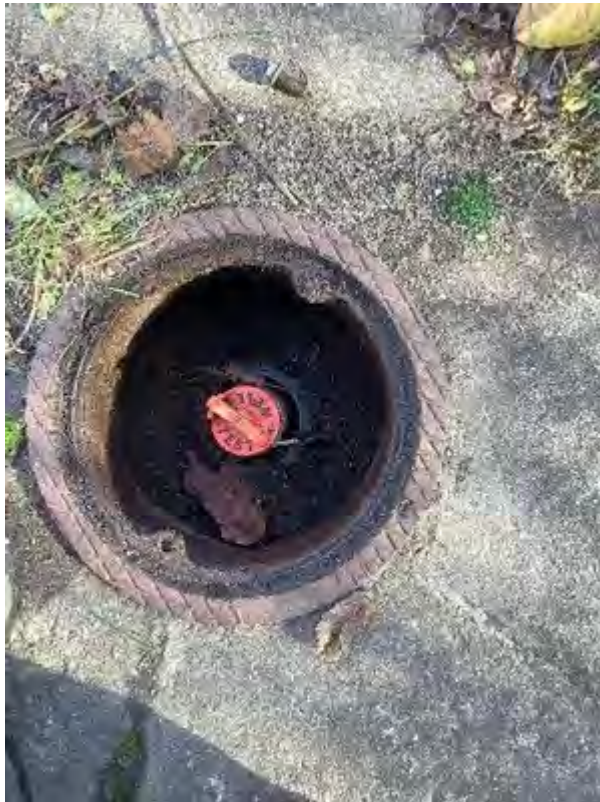
| <b>OVERALL CONDITION:</b> | FAIR |
| <b>Notes (Explain if answered No to any of the above)</b><br>Missing one bolt | |

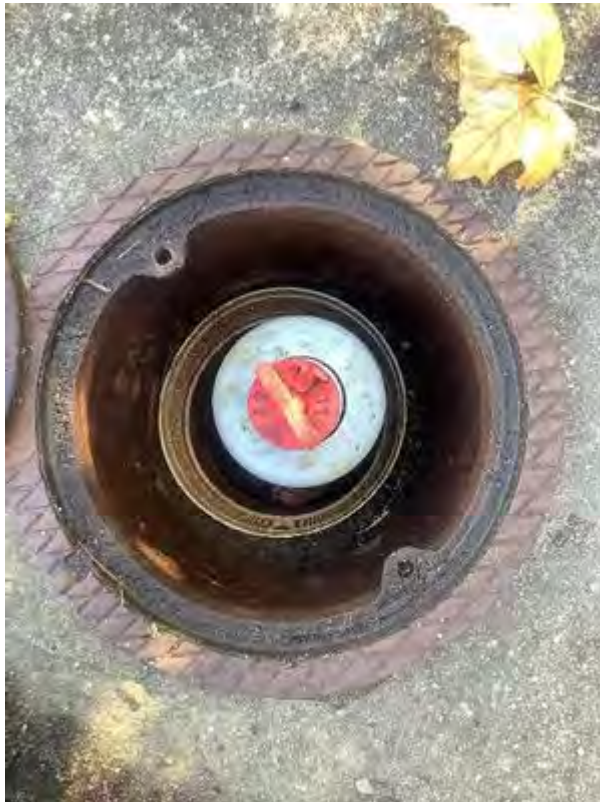
| <b>OVERALL CONDITION:</b> | FAIR |
| <b>Notes (Explain if answered No to any of the above)</b><br>Missing one bolt | |

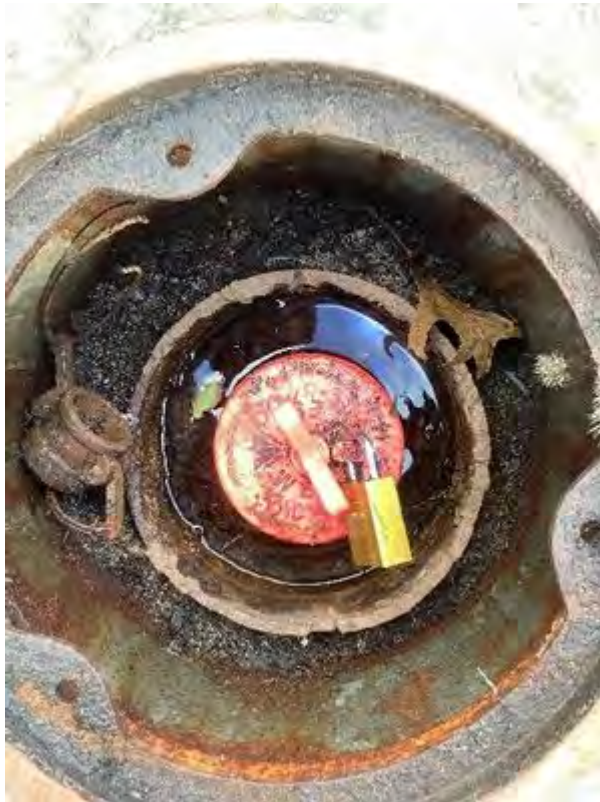
| <b>OVERALL CONDITION:</b> | GOOD |

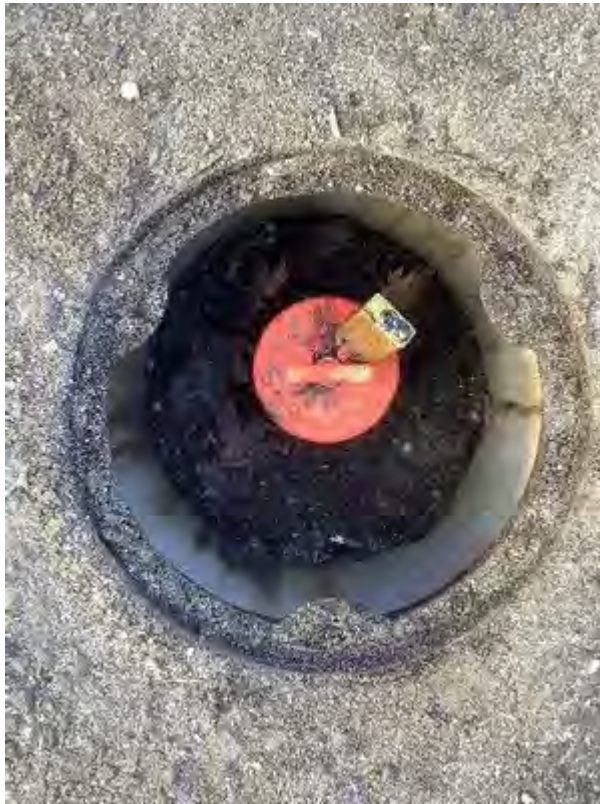
| <b>OVERALL CONDITION:</b> | FAIR |
| <b>Notes (Explain if answered No to any of the above)</b><br>Missing one bolt | |

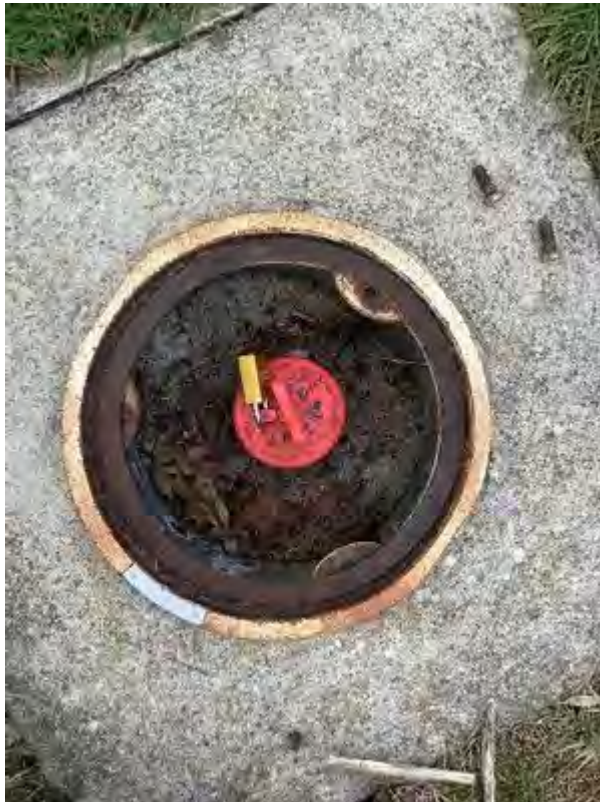
| <b>OVERALL CONDITION:</b> | FAIR |
| <b>Notes (Explain if answered No to any of the above)</b><br>Missing two bolts | |

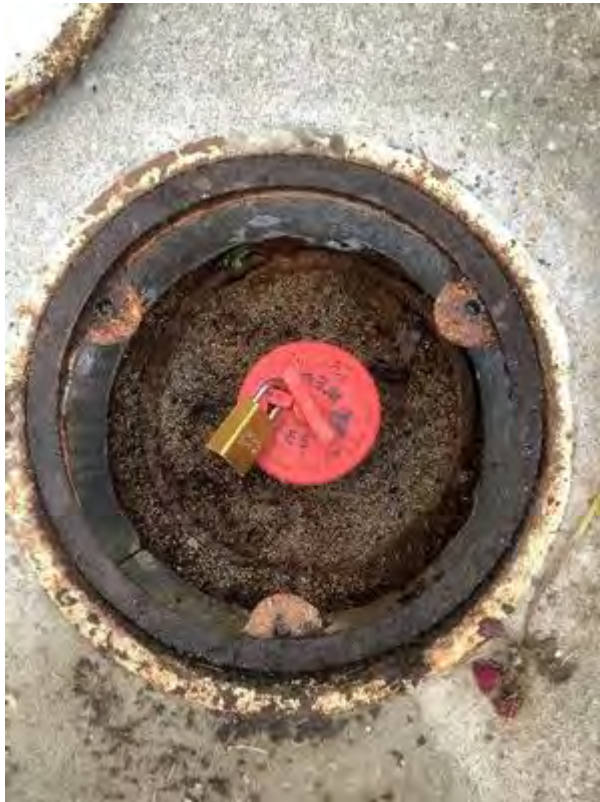
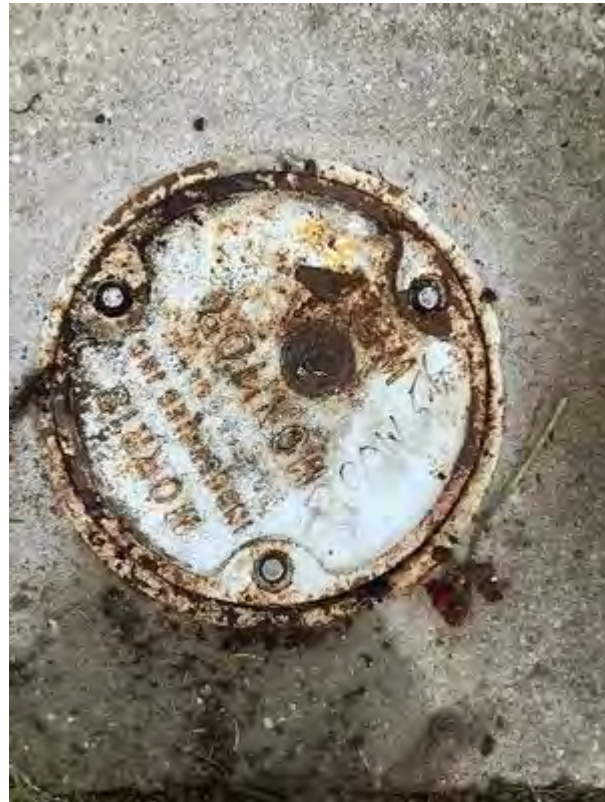
| <b>Notes (Explain if answered No to any of the above)</b><br>Needs backfill | |

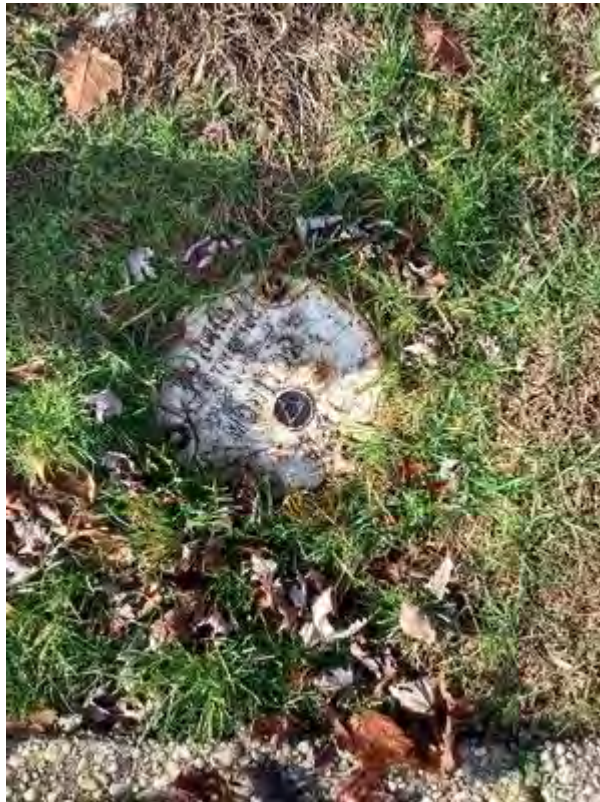
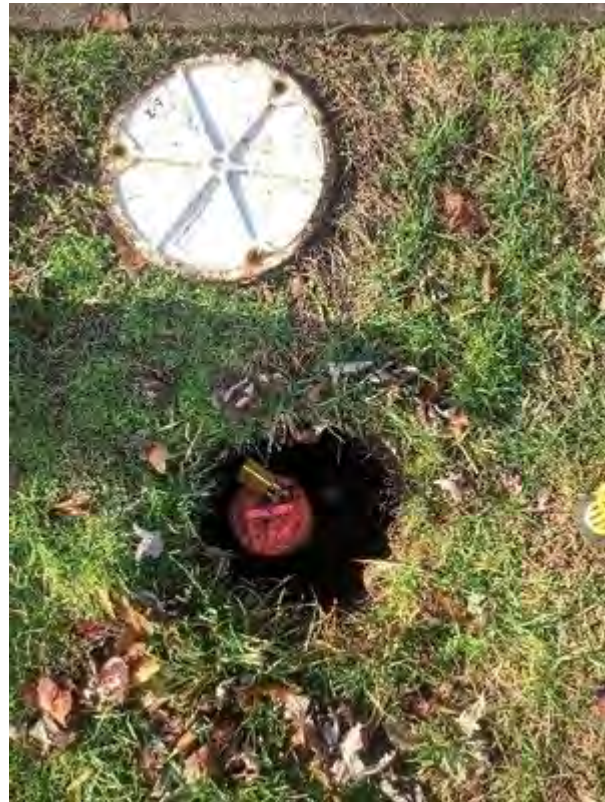
| <b>Notes (Explain if answered No to any of the above)</b><br>One bolt missing | |

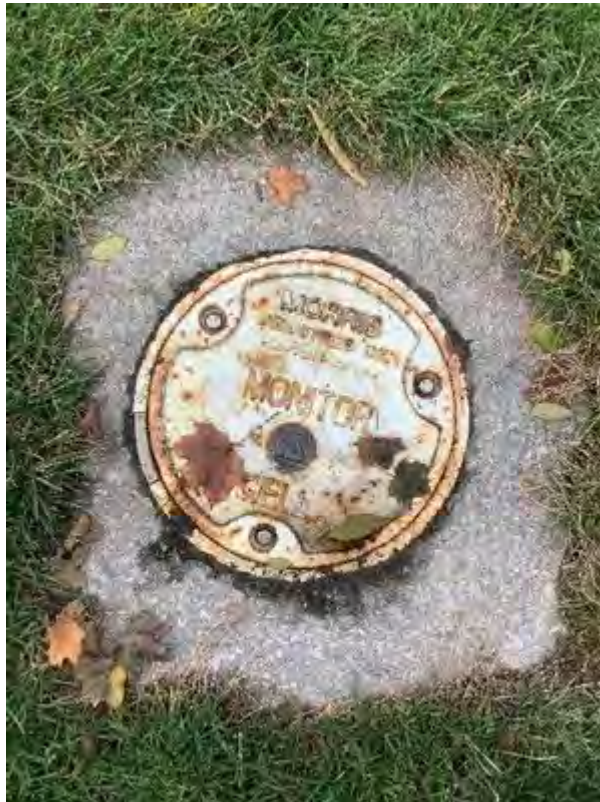
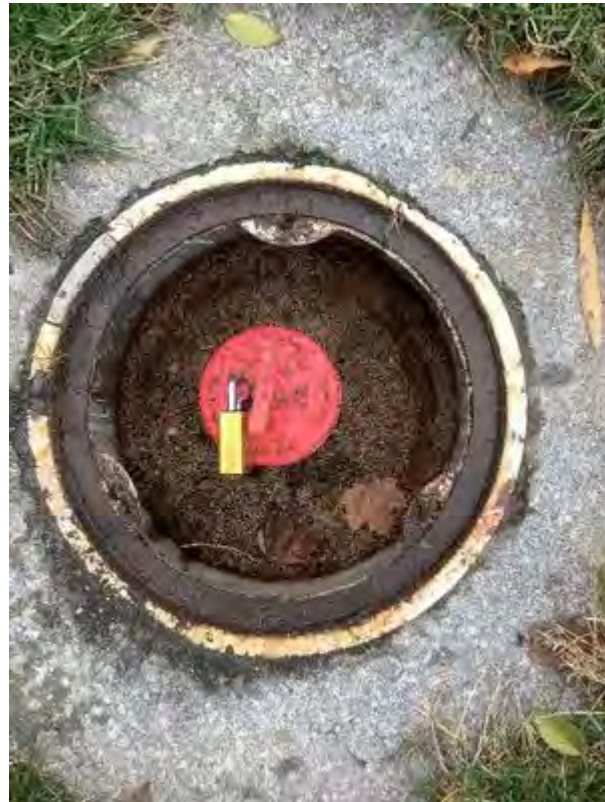
| <b>Notes (Explain if answered No to any of the above)</b><br>Missing one bolt and needs backfill | |

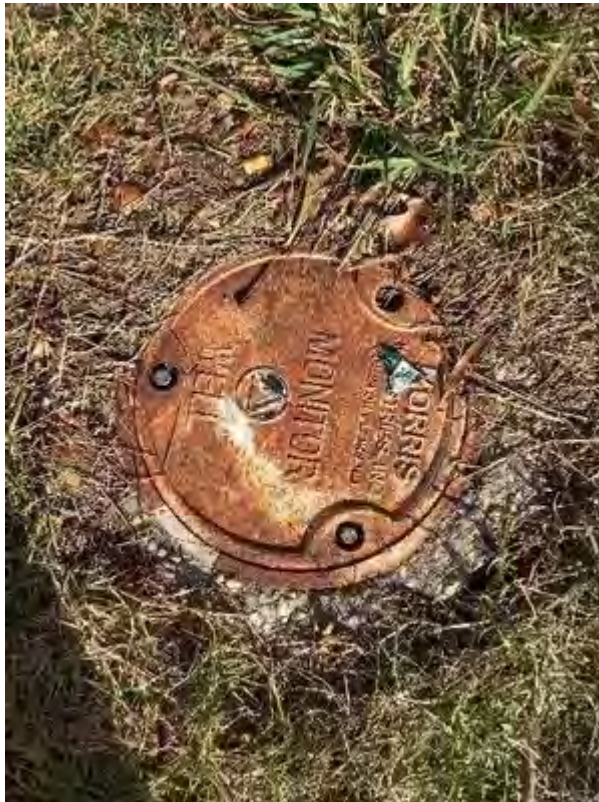
| <b>Notes (Explain if answered No to any of the above)</b><br>Missing one bolt | |

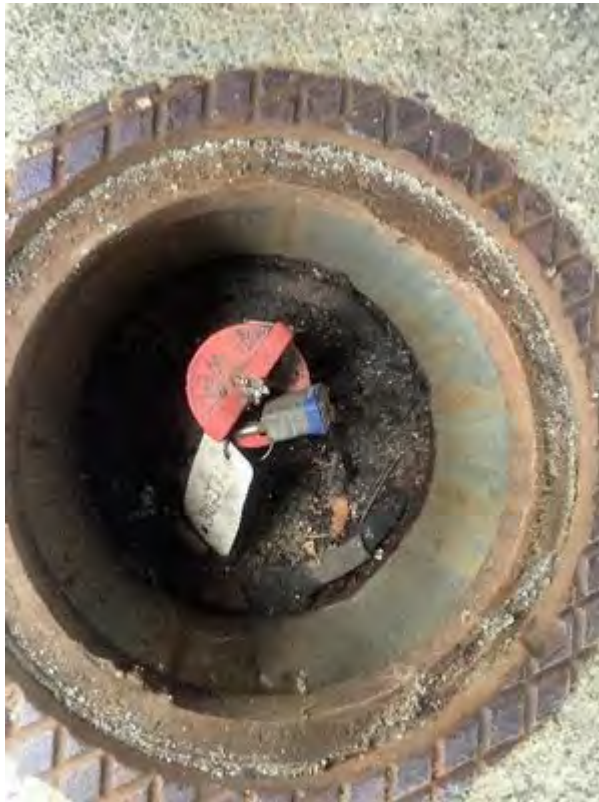
| <b>Manhole cover present and in working condition?</b> | NO |
| <b>OVERALL CONDITION:</b> | FAIR |
| <b>Notes (Explain if answered No to any of the above)</b><br>Missing two bolts. Manhole cover cracked. | |

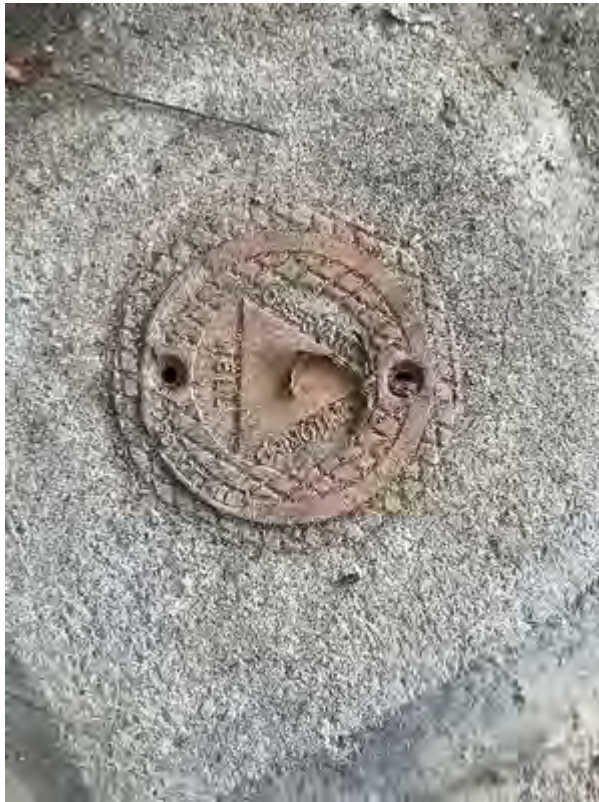
| <b>OVERALL CONDITION:</b> | FAIR |
| <b>Notes (Explain if answered No to any of the above)</b><br>Missing two bolts | |

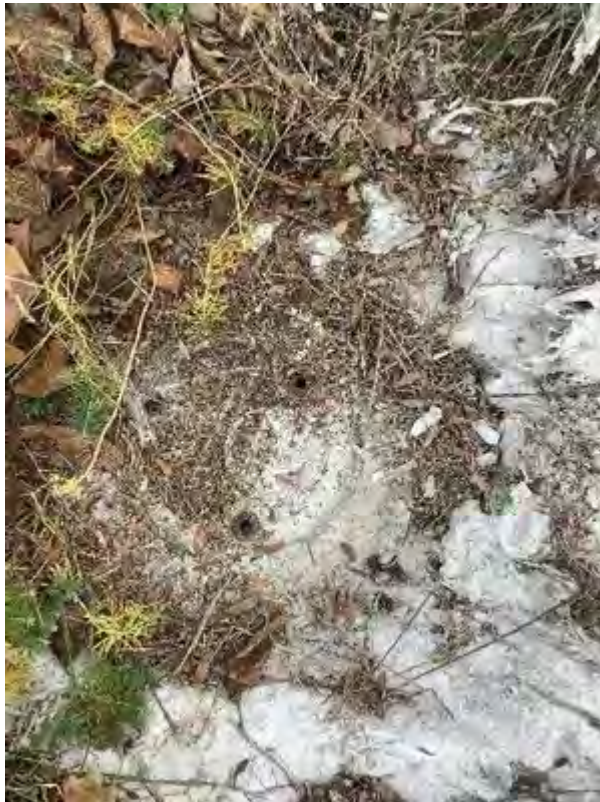
| <b>Notes (Explain if answered No to any of the above)</b><br>Manhole cover cemented in place | |

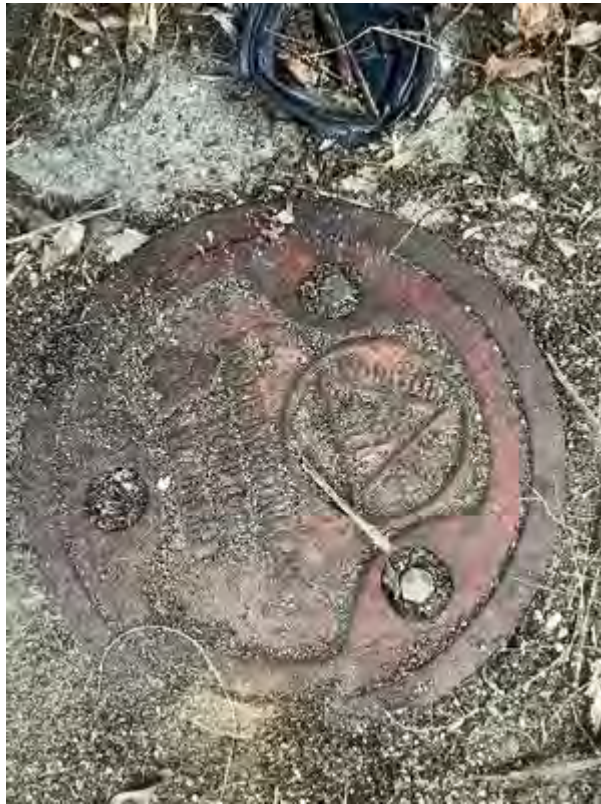
| <b>Notes (Explain if answered No to any of the above)</b><br>Missing one bolt, two bolts stripped | |

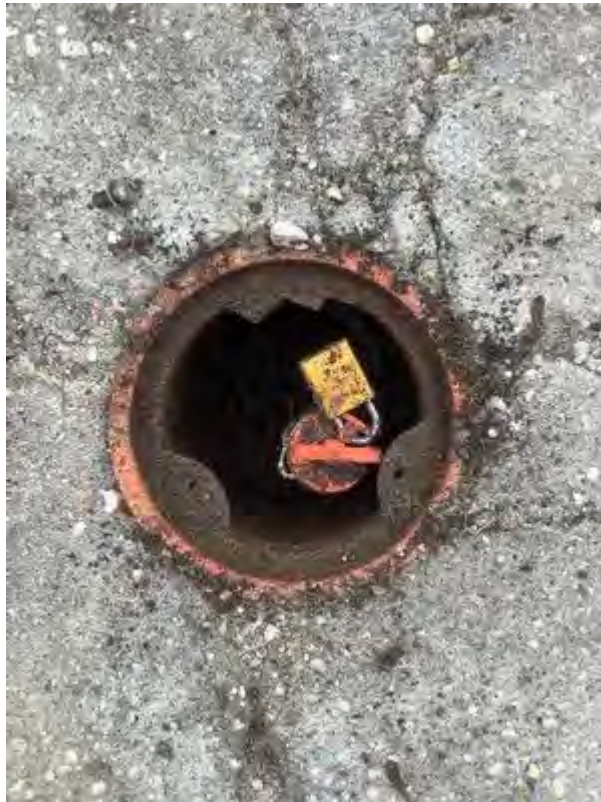
| <b>OVERALL CONDITION:</b> | FAIR |
| <b>Notes (Explain if answered No to any of the above)</b><br>Missing one bolt | |

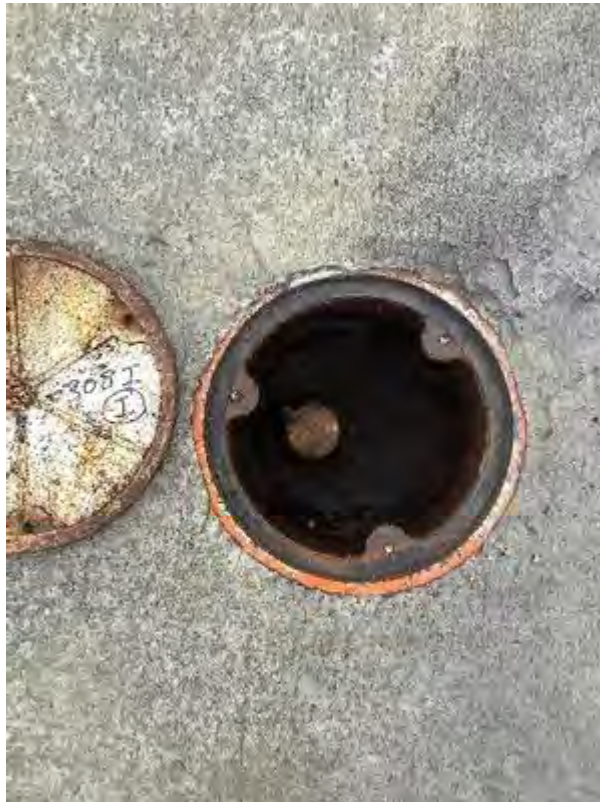
| <b>OVERALL CONDITION:</b> | FAIR |
| <b>Notes (Explain if answered No to any of the above)</b><br>Missing three bolts | |

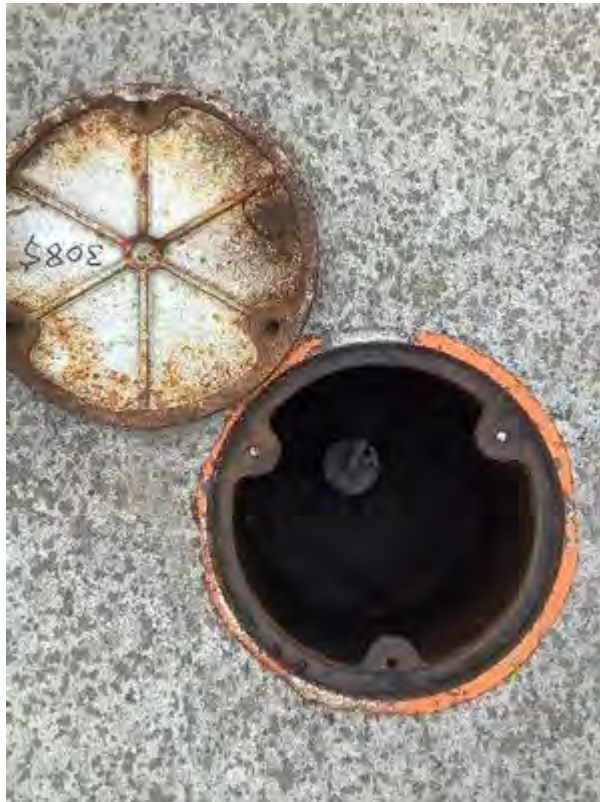
| <b>OVERALL CONDITION:</b> | FAIR |
| <b>Notes (Explain if answered No to any of the above)</b><br>Missing two bolts | |

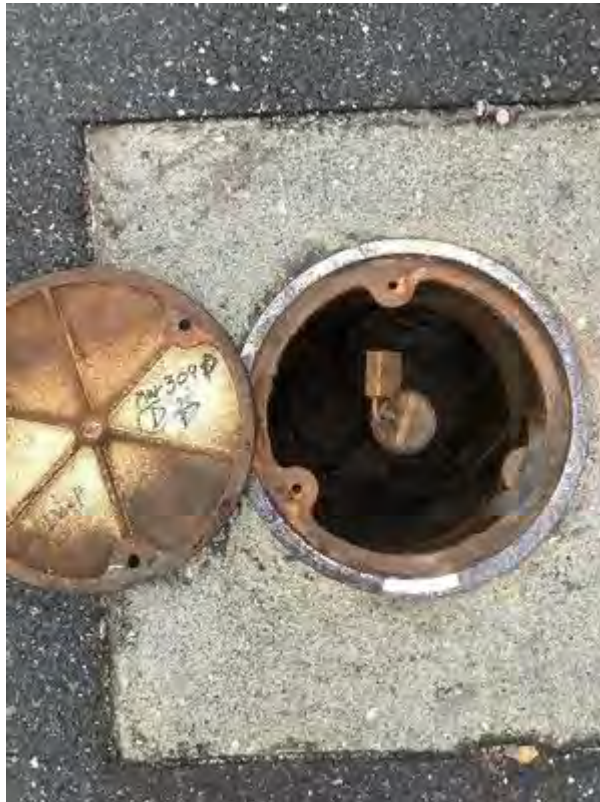
| <b>Notes (Explain if answered No to any of the above)</b><br>Missing one bolt | |

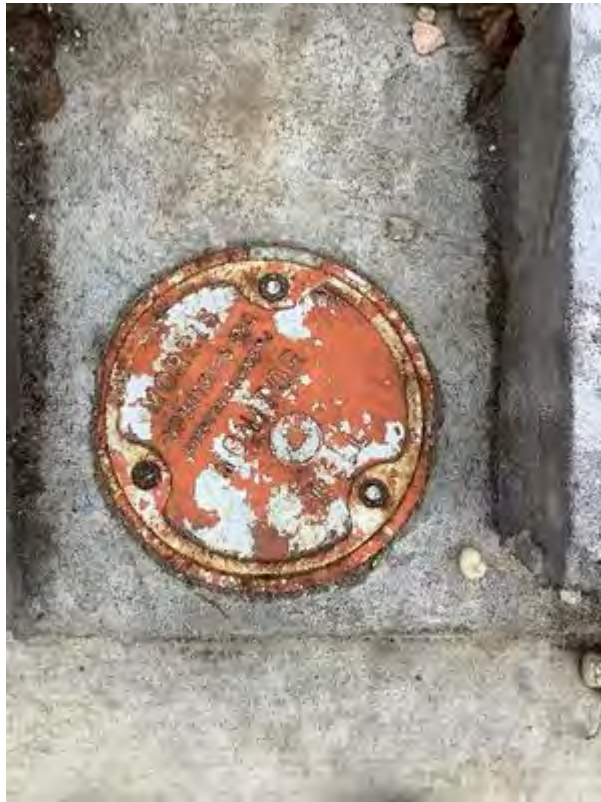
| <b>OVERALL CONDITION:</b> | FAIR |
| <b>Notes (Explain if answered No to any of the above)</b><br>Missing one bolt | |
