# Memorandum

To: Brian Murray, NAVFAC MIDLANT  
From: David Brayack, Tetra Tech  
Date: January 28, 2021  
Re: Annual LUC Inspection and Operation Summary Report: Sites 1, 2, 3, and 4 – NWIRP Bethpage  
Revision 1  
Contract/CTO Number: N6247016D9008/WE13

## 1.0 Introduction

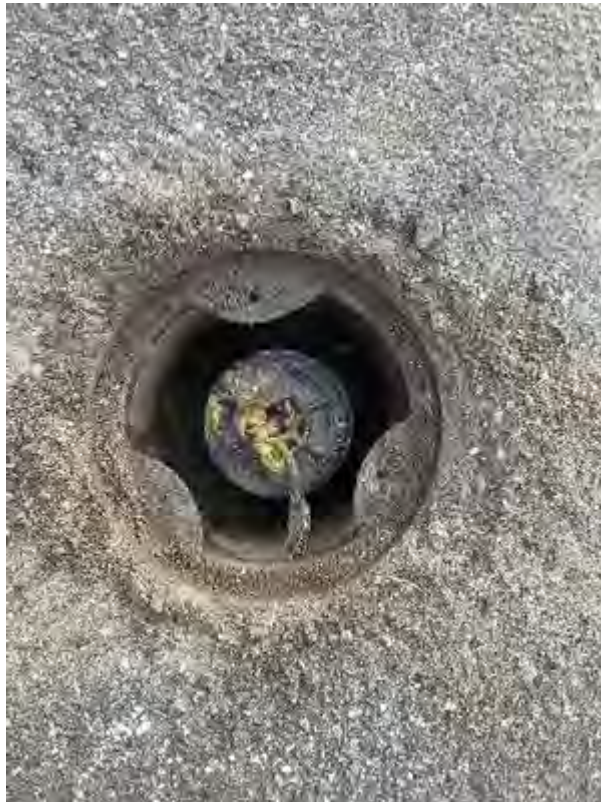
| <b>OVERALL CONDITION:</b> | FAIR |
| <b>Notes (Explain if answered No to any of the above)</b><br>Missing one bolt | |

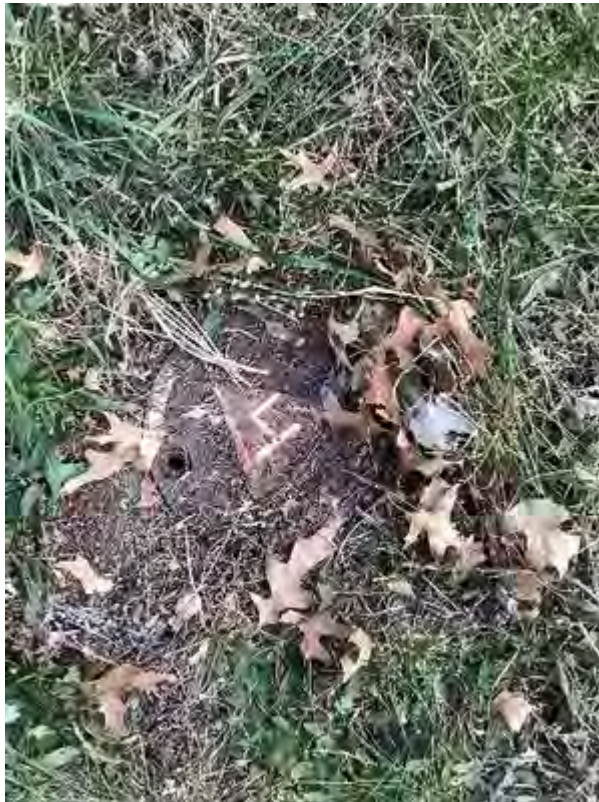
| <b>OVERALL CONDITION:</b> | FAIR |
| <b>Notes (Explain if answered No to any of the above)</b><br>Missing two bolts | |

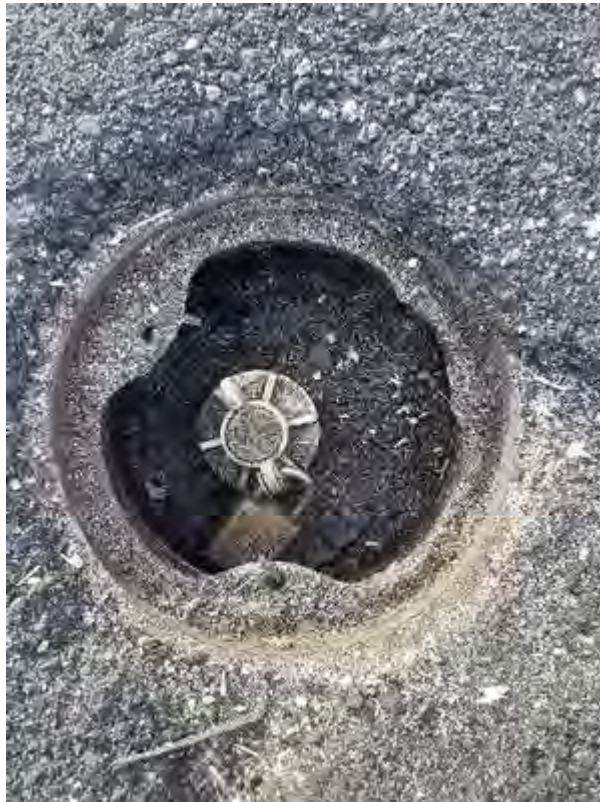
| <b>Notes (Explain if answered No to any of the above)</b><br>Missing one bolt | |

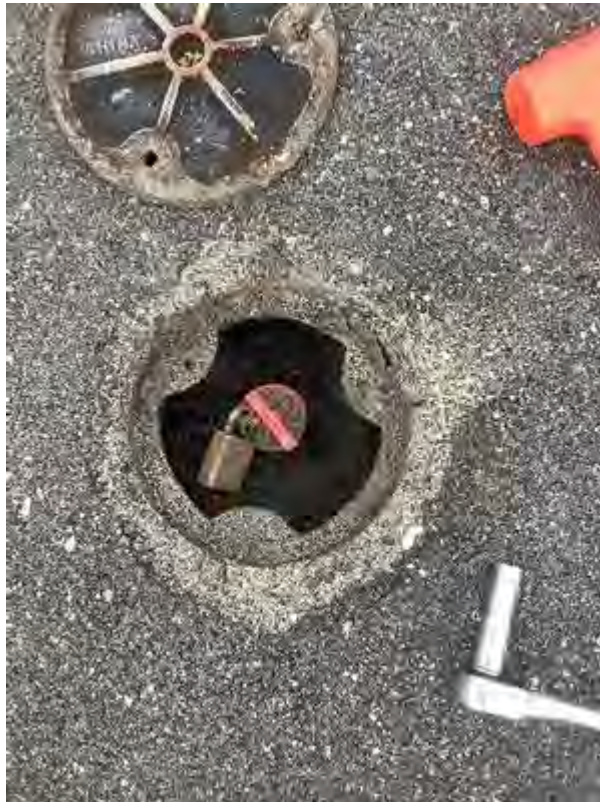
| <b>OVERALL CONDITION:</b> | FAIR |
| <b>Notes (Explain if answered No to any of the above)</b><br>Missing two bolts | |

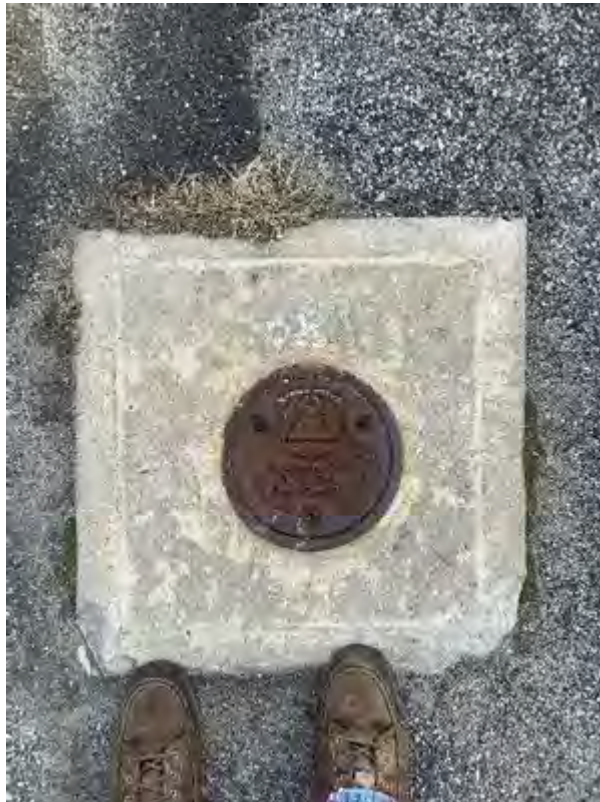
| <b>Notes (Explain if answered No to any of the above)</b><br>Missing three bolts | |

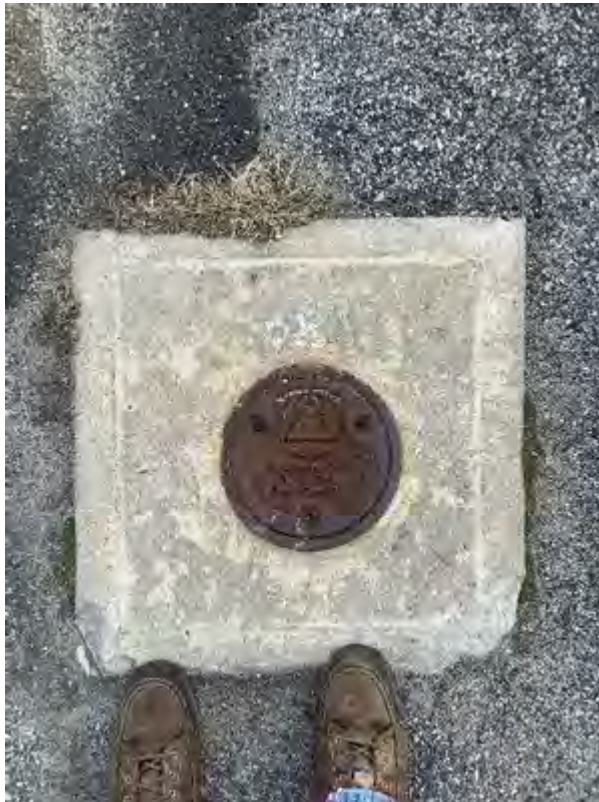
| <b>Notes (Explain if answered No to any of the above)</b><br>Missing three bolts | |

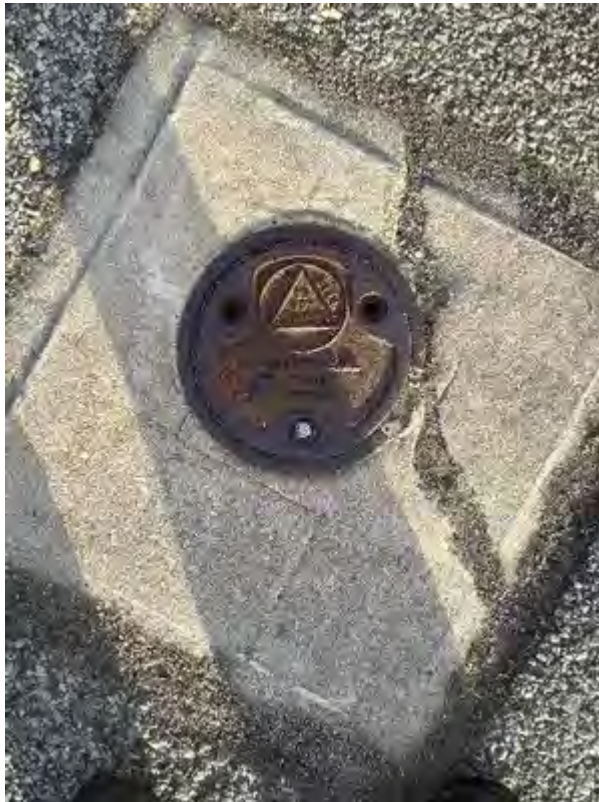
| <b>Notes (Explain if answered No to any of the above)</b><br>Missing two bolts | |

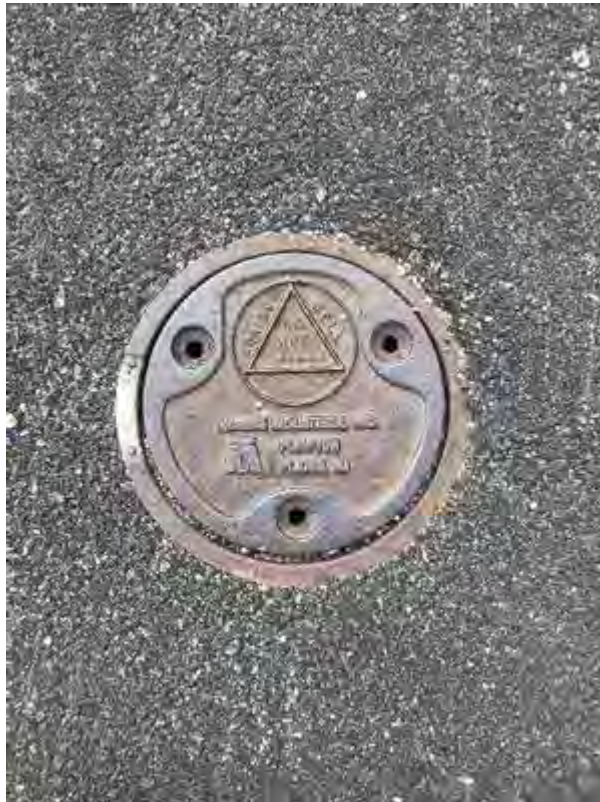
| <b>Notes (Explain if answered No to any of the above)</b><br>Missing two bolts | |

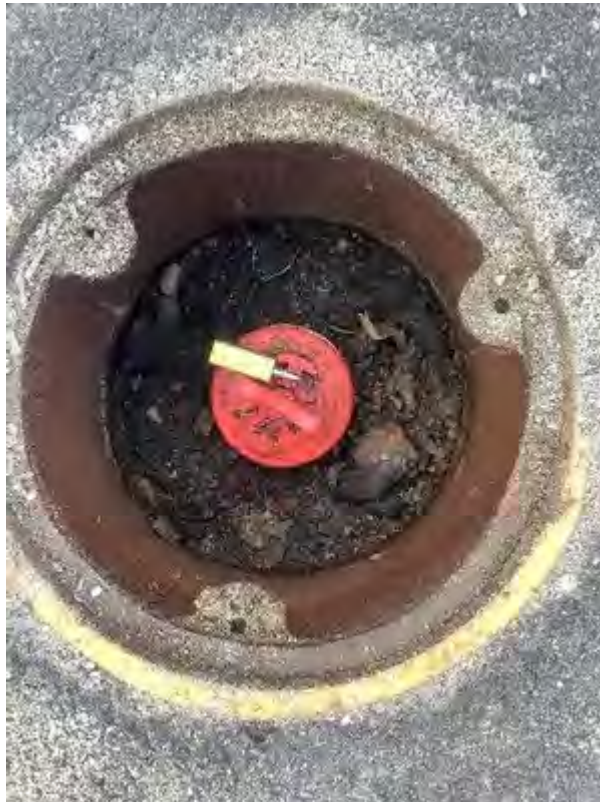
| <b>Notes (Explain if answered No to any of the above)</b><br>Missing one bolt | |

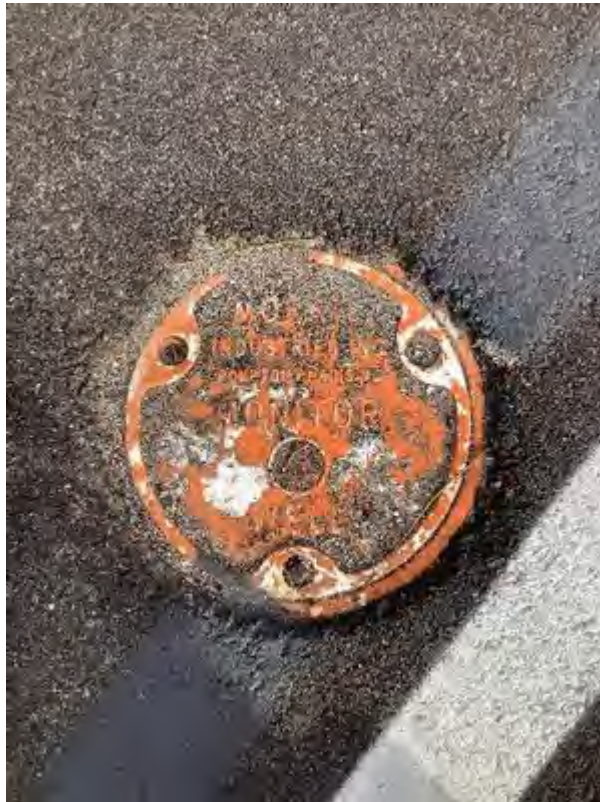
| <b>Notes (Explain if answered No to any of the above)</b><br>Missing two bolts | |

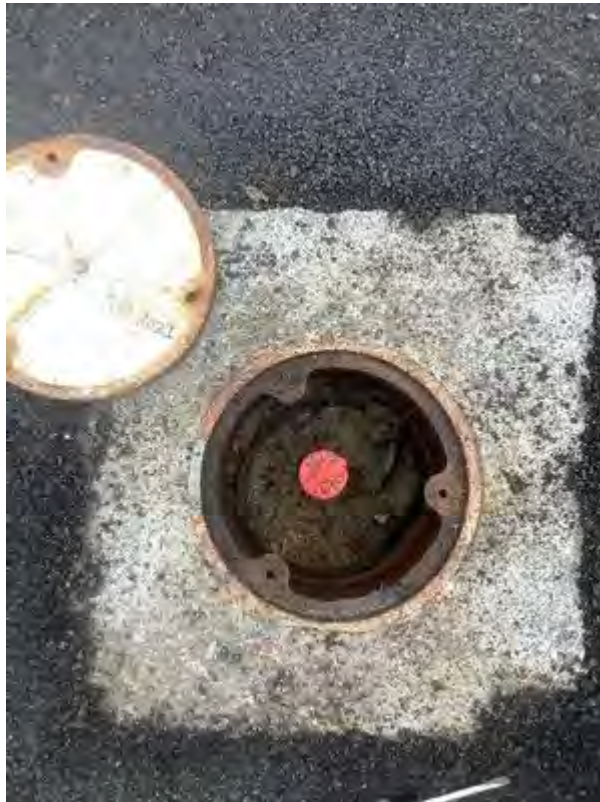
| <b>Notes (Explain if answered No to any of the above)</b><br>Missing two bolts | |

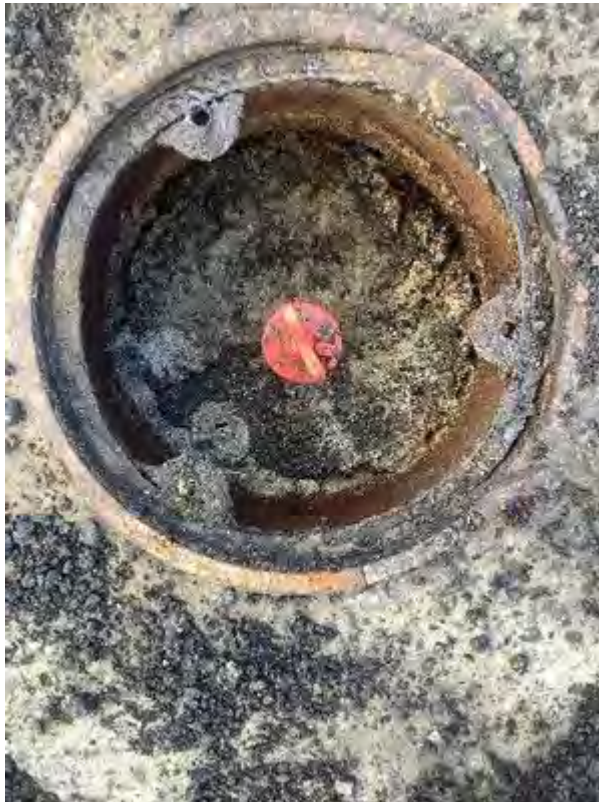
| <b>Notes (Explain if answered No to any of the above)</b><br>Missing one bolt | |

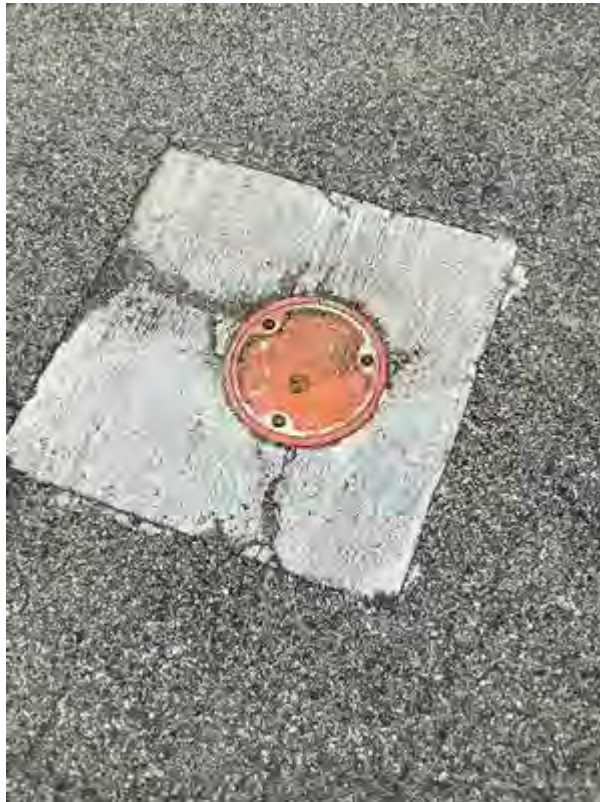
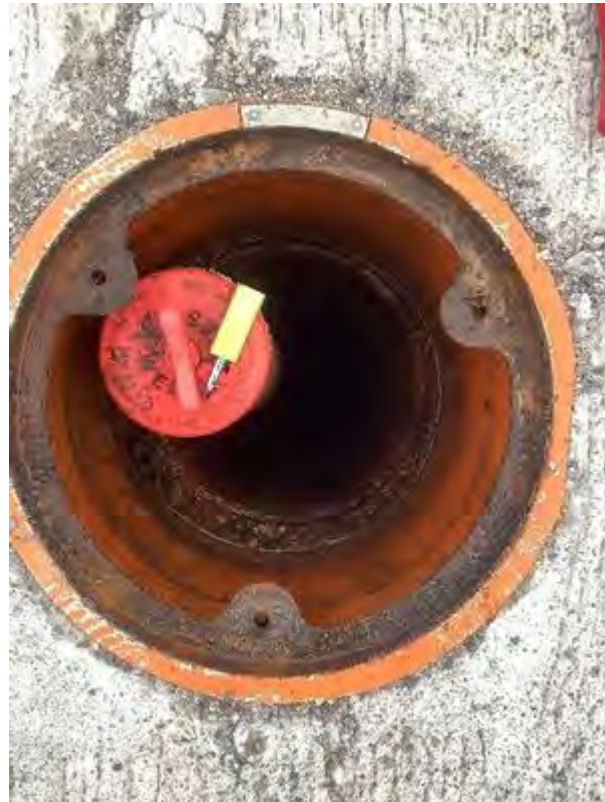
| <b>Notes (Explain if answered No to any of the above)</b><br>Needs backfill | |

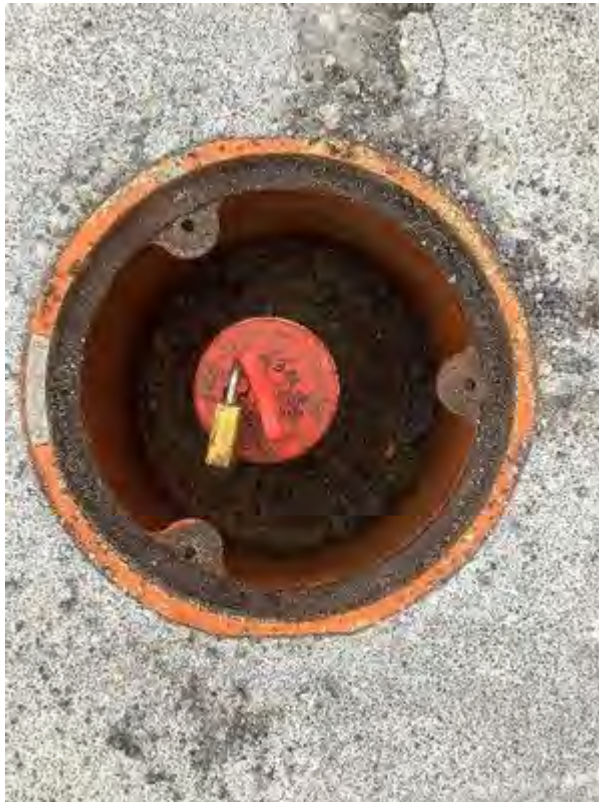
| <b>OVERALL CONDITION:</b> | FAIR |
| <b>Notes (Explain if answered No to any of the above)</b><br>Missing one bolt | |

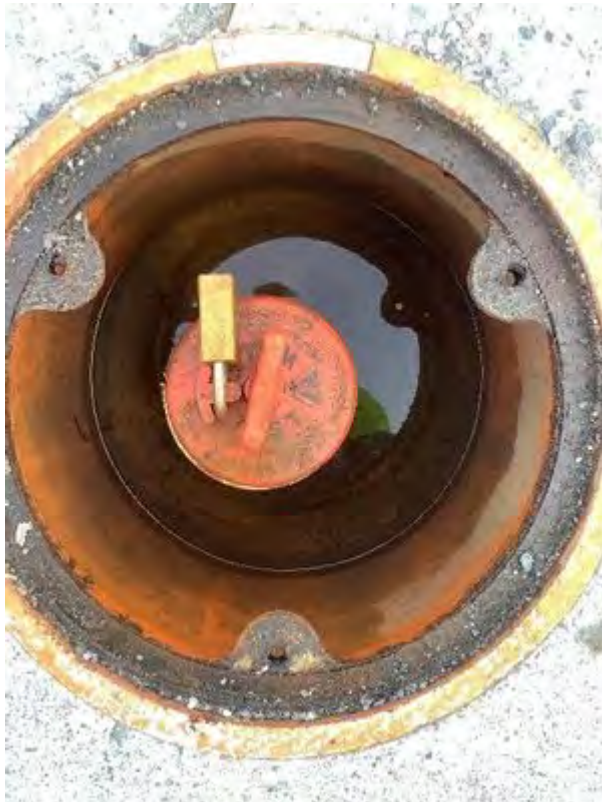
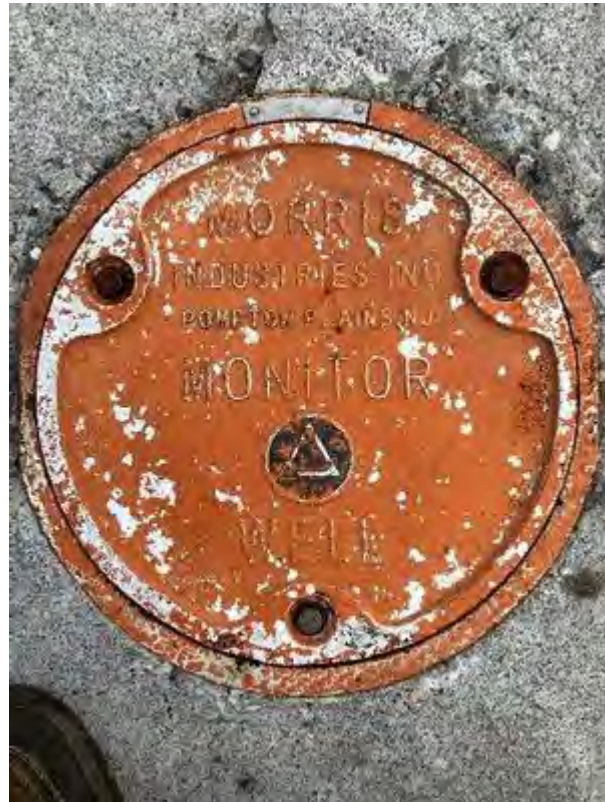
| <b>Notes (Explain if answered No to any of the above)</b><br>Standing water inside protective casing | |

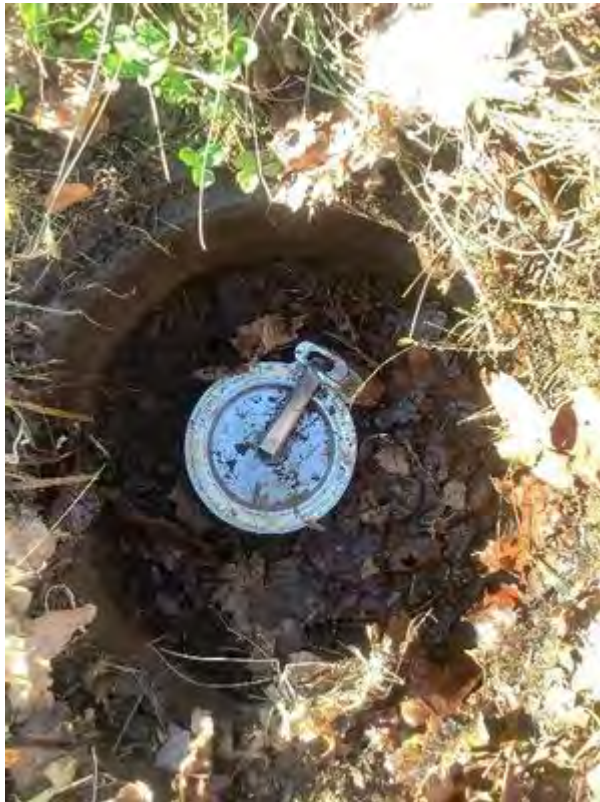
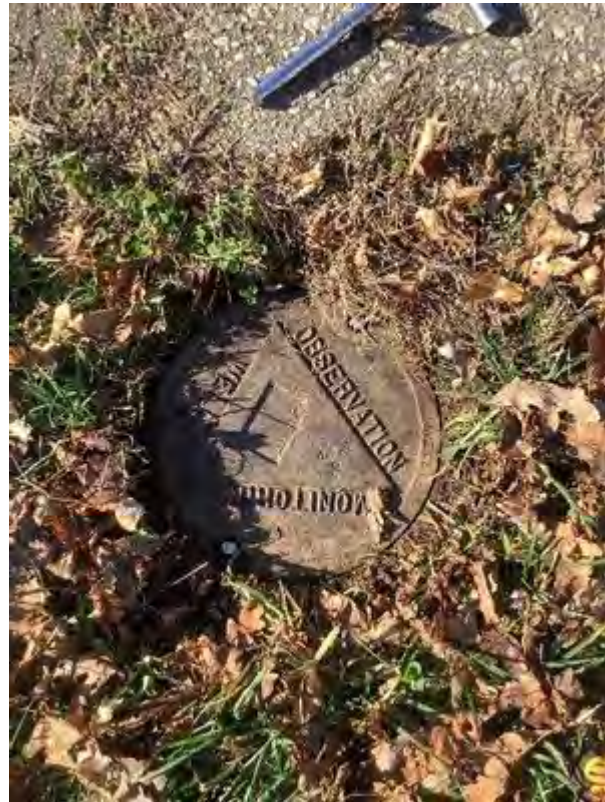
| <b>OVERALL CONDITION:</b> | FAIR |
| <b>Notes (Explain if answered No to any of the above)</b><br>Two bolts stripped | |

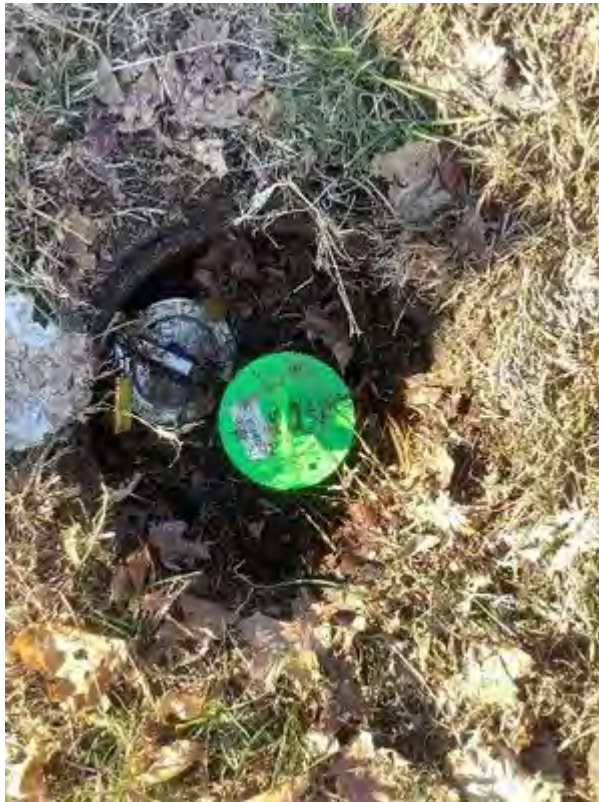
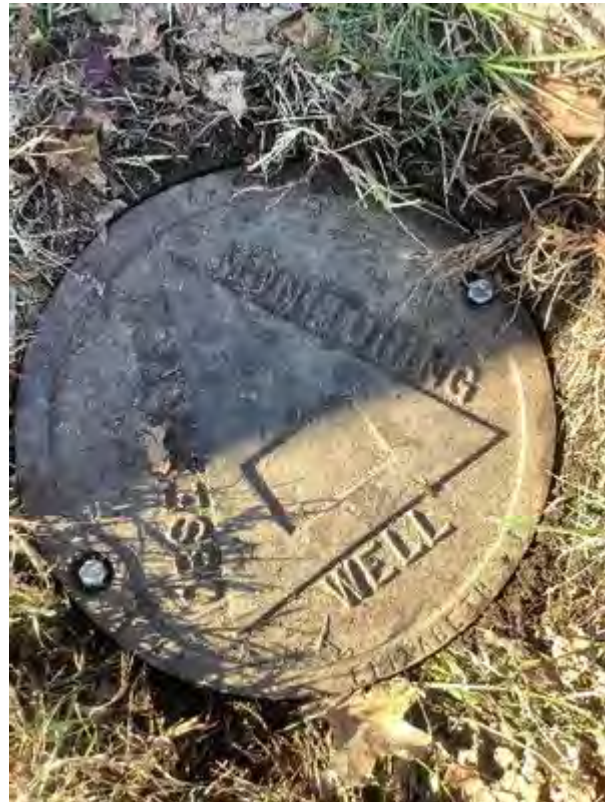
| <b>OVERALL CONDITION:</b> | FAIR |
| <b>Notes (Explain if answered No to any of the above)</b><br>One bolt stripped | |

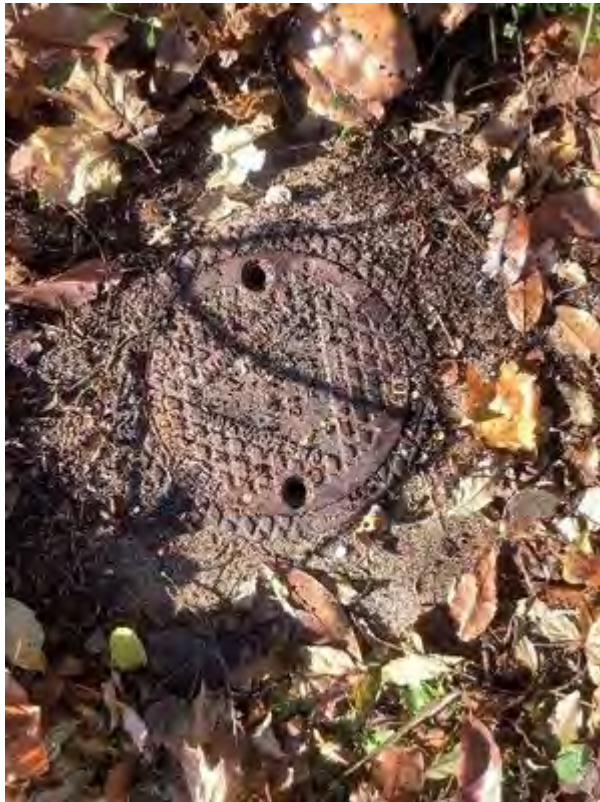
| <b>OVERALL CONDITION:</b> | FAIR |
| <b>Notes (Explain if answered No to any of the above)</b><br>Two bolts missing | |

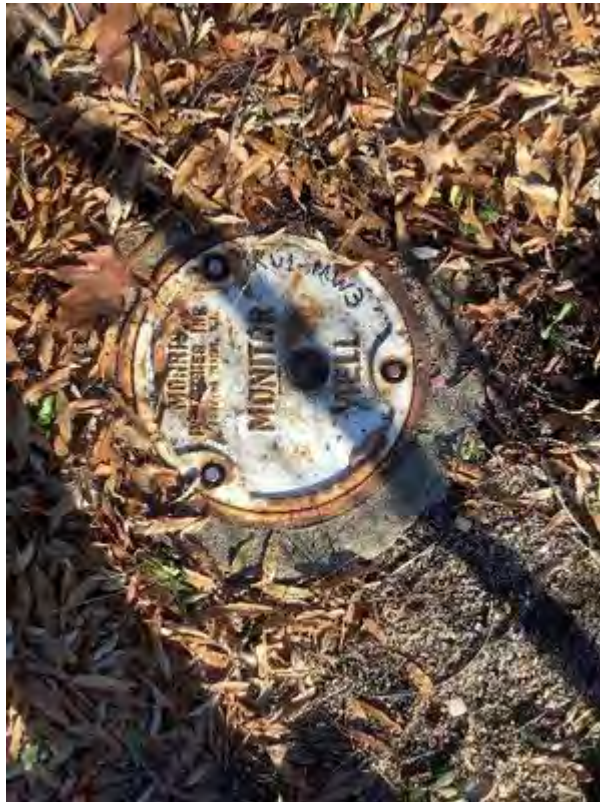
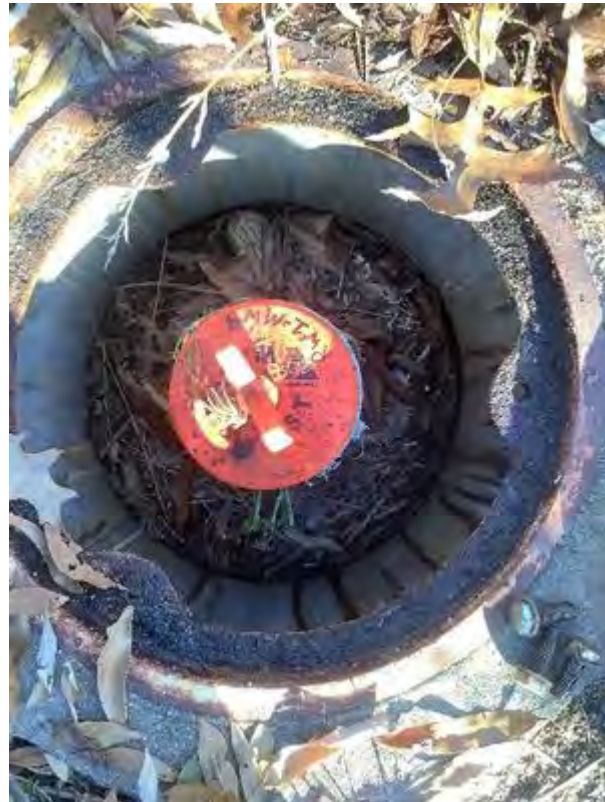
| <b>Notes (Explain if answered No to any of the above)</b><br>One bolt stripped | |

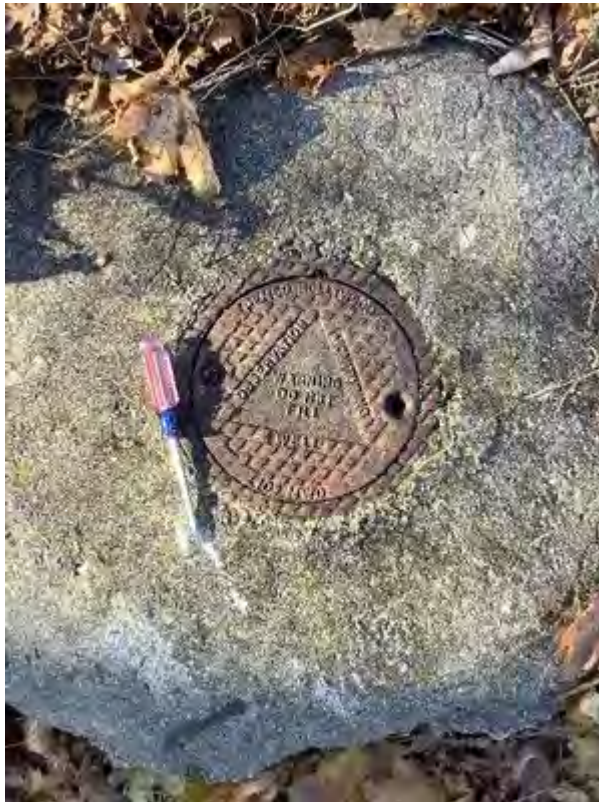
| <b>OVERALL CONDITION:</b> | FAIR |
| <b>Notes (Explain if answered No to any of the above)</b><br>Missing two bolts. Standing water inside protective casing | |

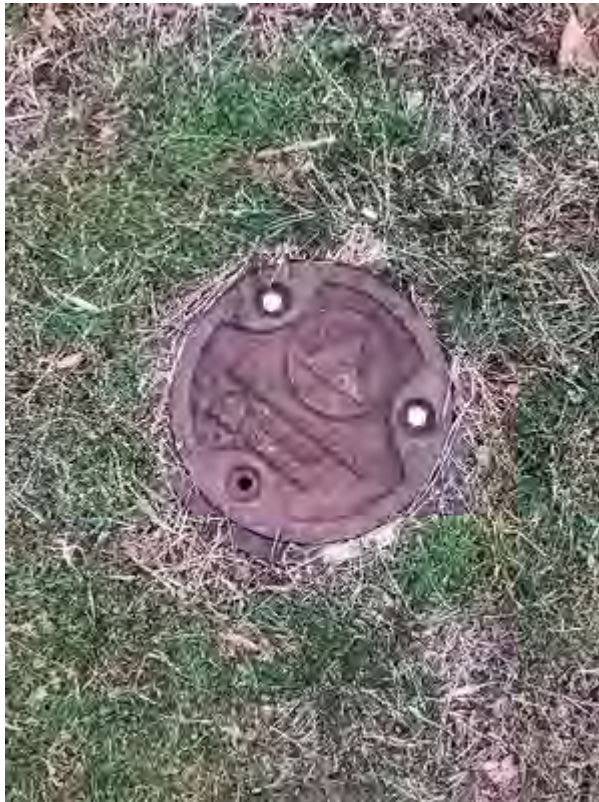
| <b>Notes (Explain if answered No to any of the above)</b><br>Missing one bolt | |

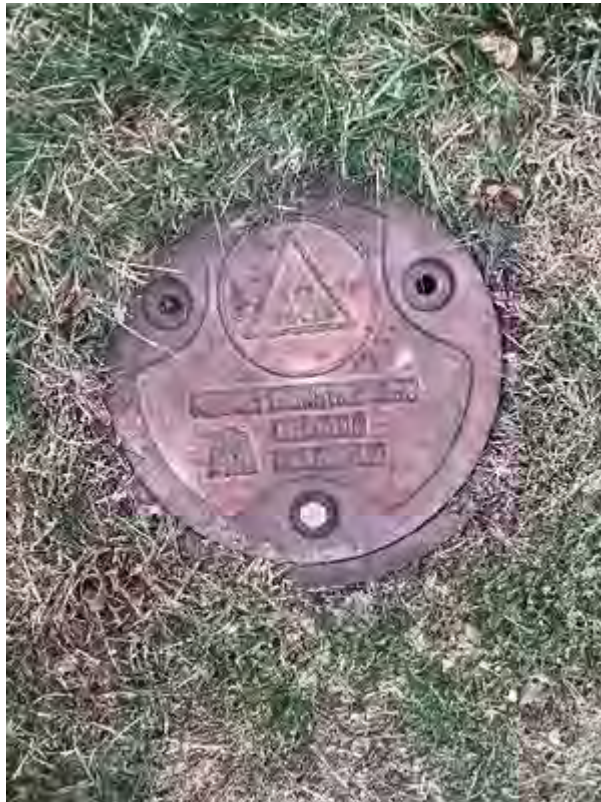
| <b>OVERALL CONDITION:</b> | FAIR |
| <b>Notes (Explain if answered No to any of the above)</b><br>Missing two bolts | |

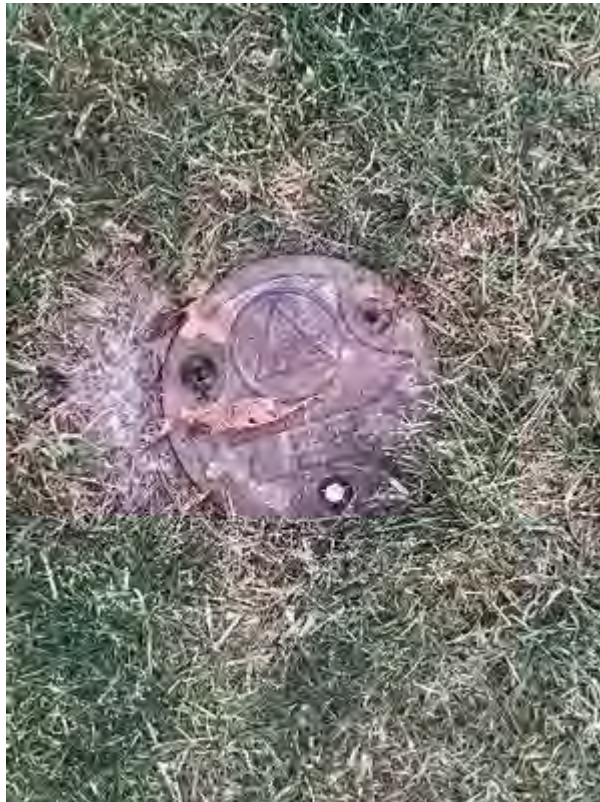
| <b>OVERALL CONDITION:</b> | FAIR |
| <b>Notes (Explain if answered No to any of the above)</b><br>Missing two bolts | |

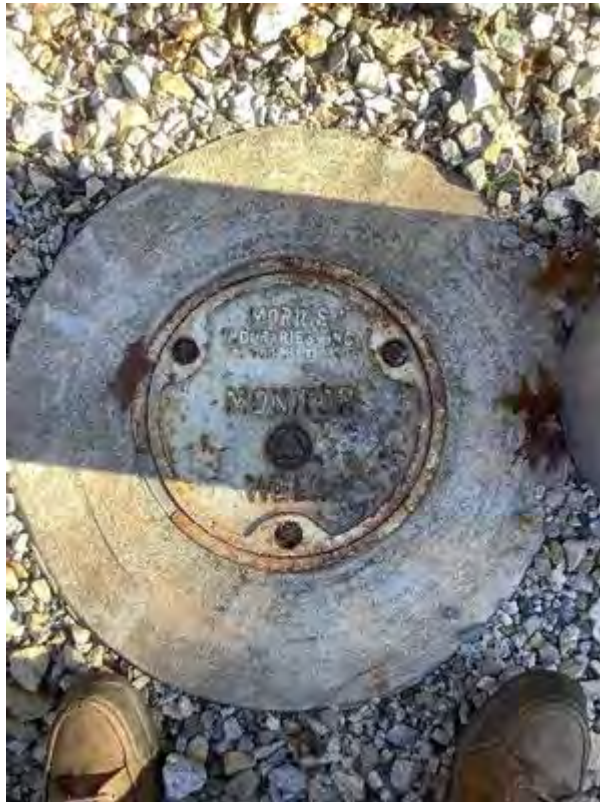
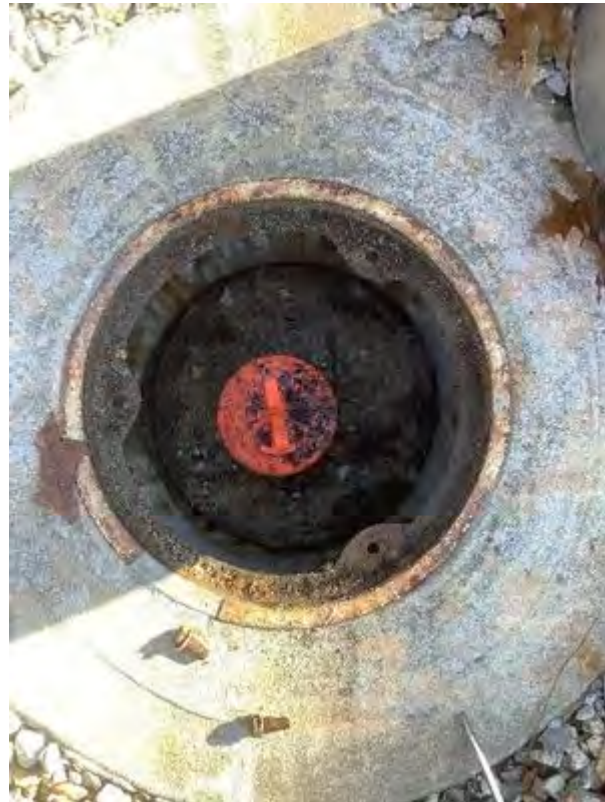
| <b>OVERALL CONDITION:</b> | FAIR |
| <b>Notes (Explain if answered No to any of the above)</b><br>Two bolts stripped | |

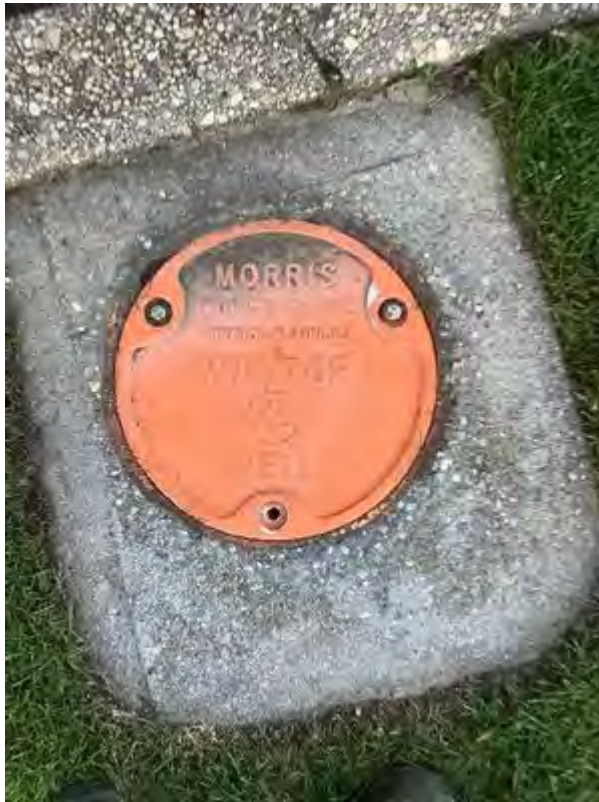
| <b>Notes (Explain if answered No to any of the above)</b><br>Missing one bolt | |

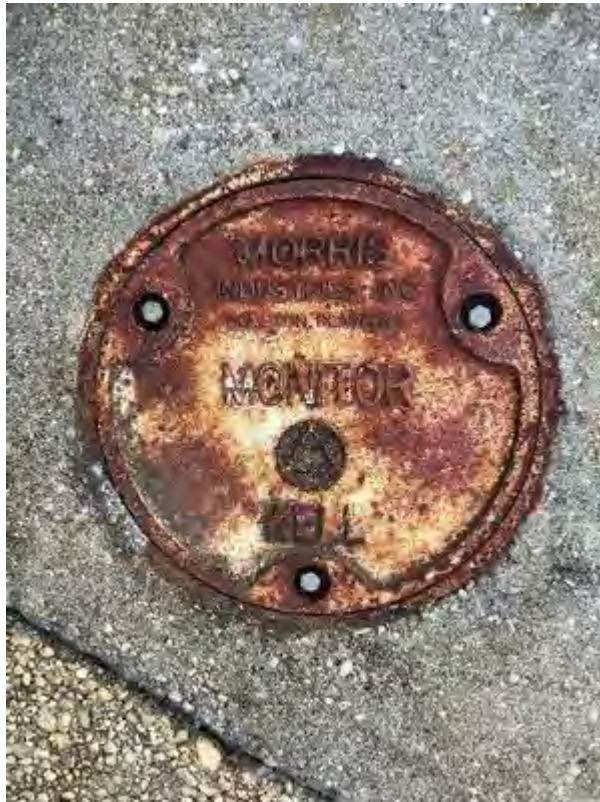
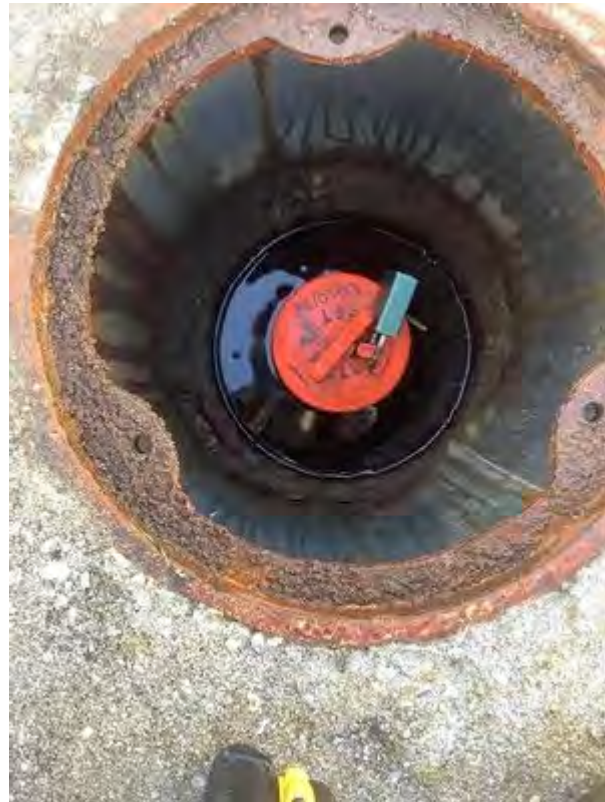
| <b>Notes (Explain if answered No to any of the above)</b><br>Standing water inside protective casing | |

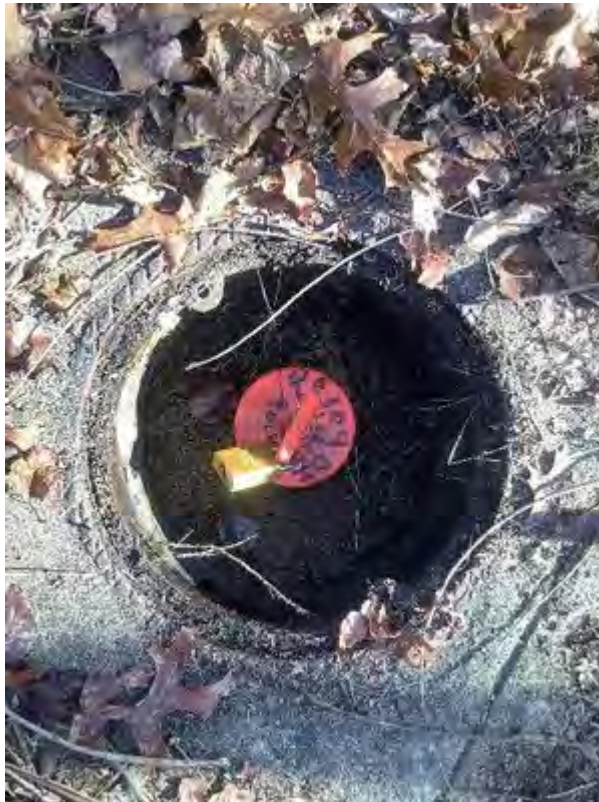
| <b>Notes (Explain if answered No to any of the above)</b><br>Missing one bolt | |

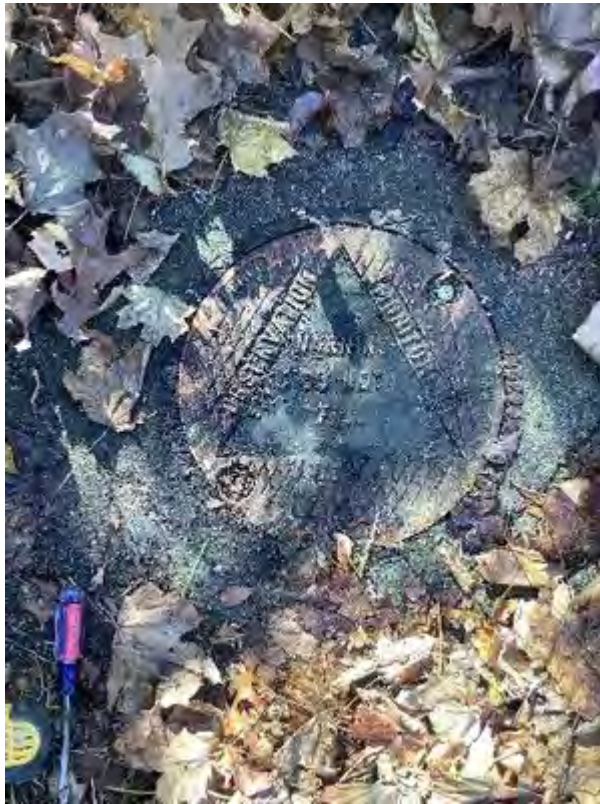
| <b>Notes (Explain if answered No to any of the above)</b><br>Missing one bolt | |

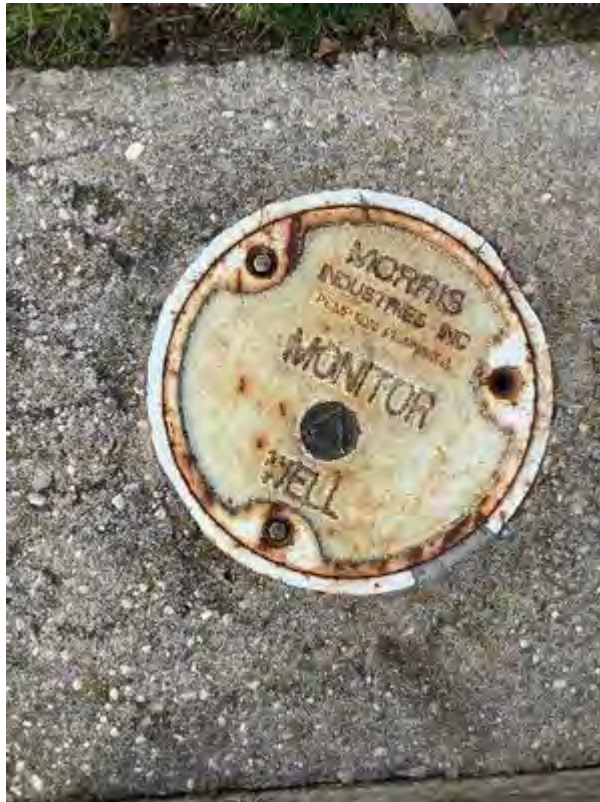
| <b>Notes (Explain if answered No to any of the above)</b><br>Missing one bolt | |

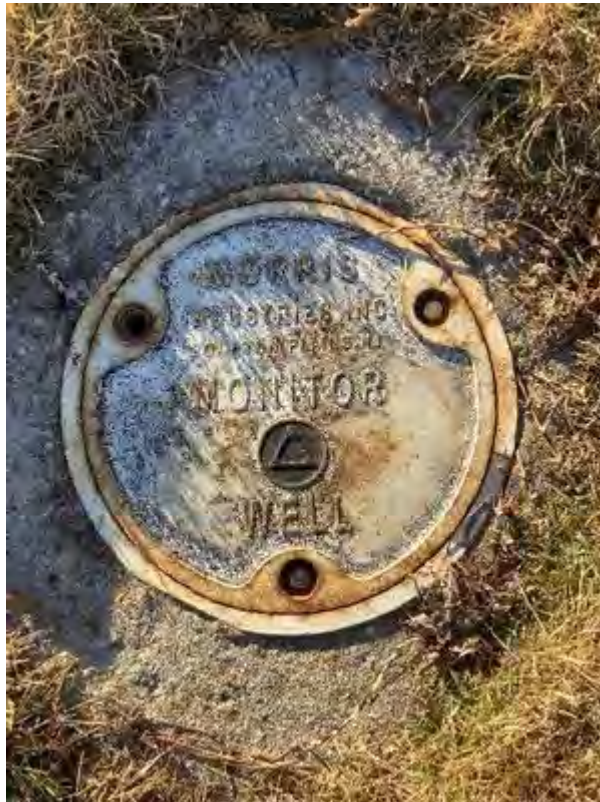
| <b>OVERALL CONDITION:</b> | FAIR |
| <b>Notes (Explain if answered No to any of the above)</b><br>Missing one bolt | |

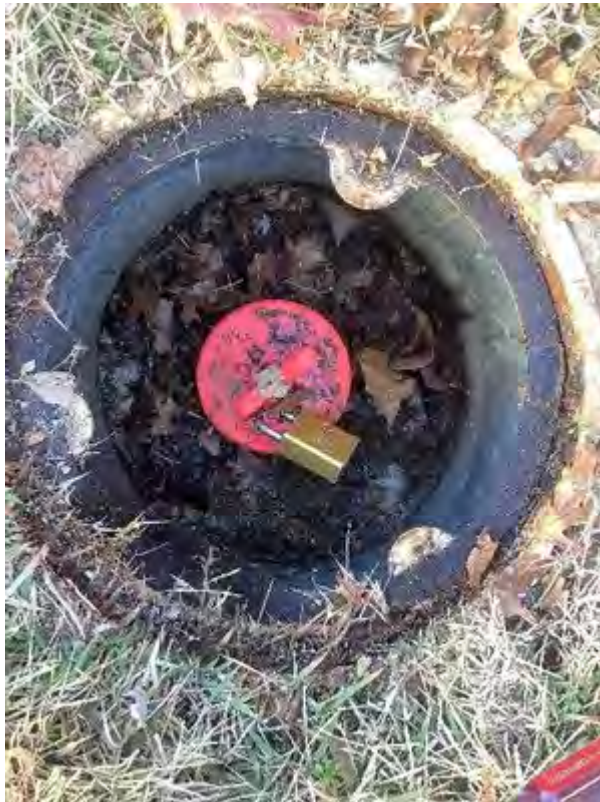
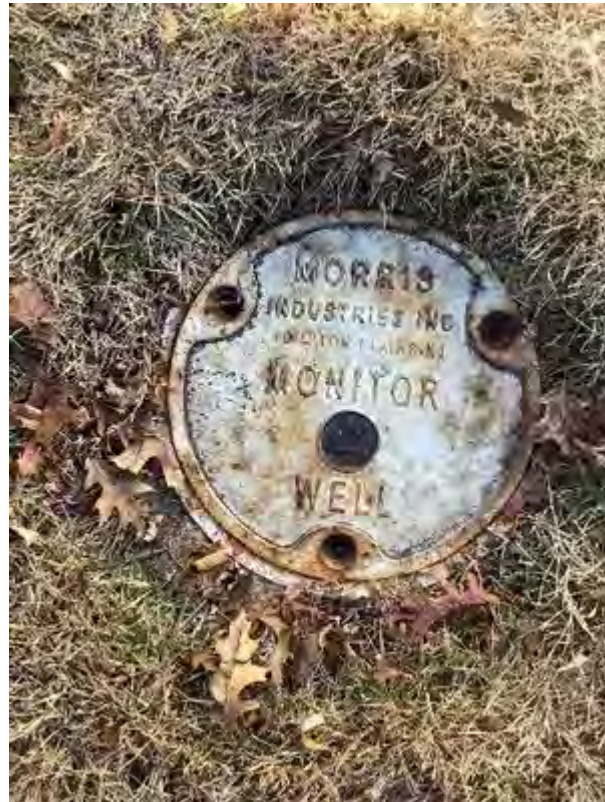
| <b>OVERALL CONDITION:</b> | FAIR |
| <b>Notes (Explain if answered No to any of the above)</b><br>Missing three bolts | |

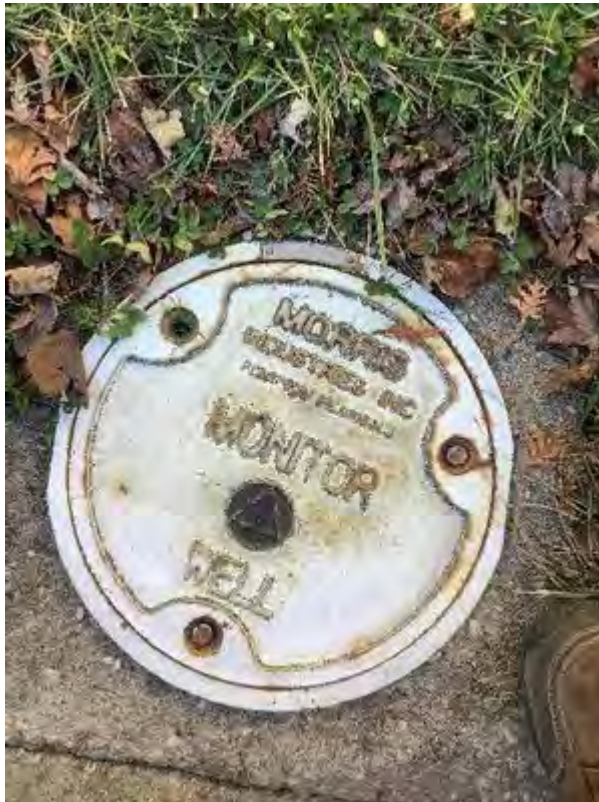
| <b>OVERALL CONDITION:</b> | POOR |
| <b>Notes (Explain if answered No to any of the above)</b><br>One bolt missing | |

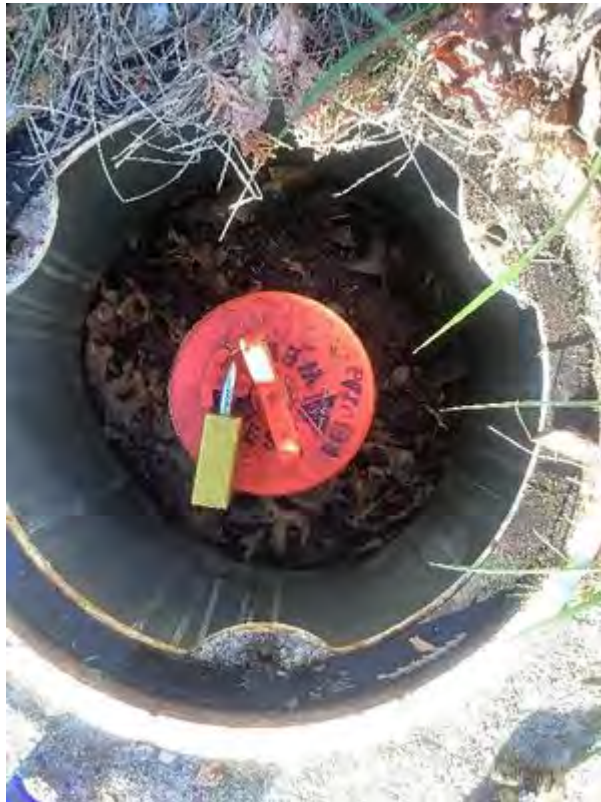
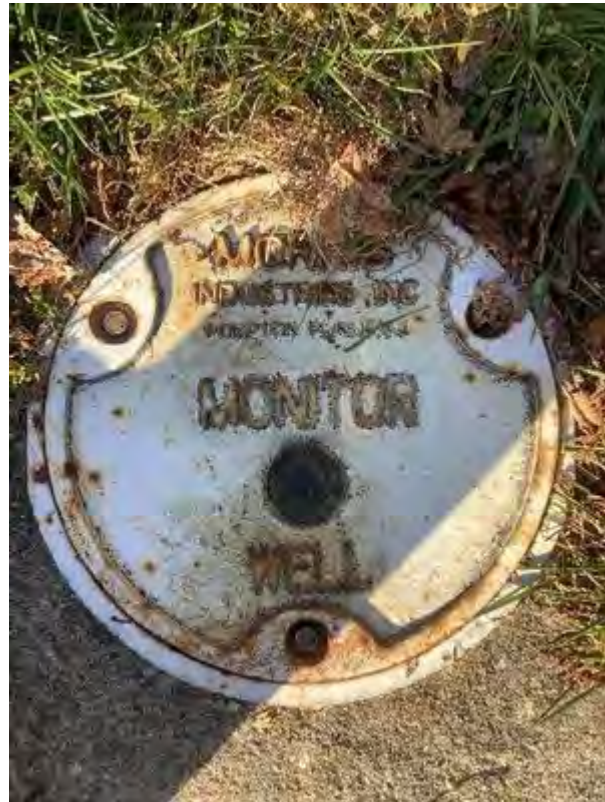
| <b>OVERALL CONDITION:</b> | FAIR |
| <b>Notes (Explain if answered No to any of the above)</b><br>Missing one bolt | |

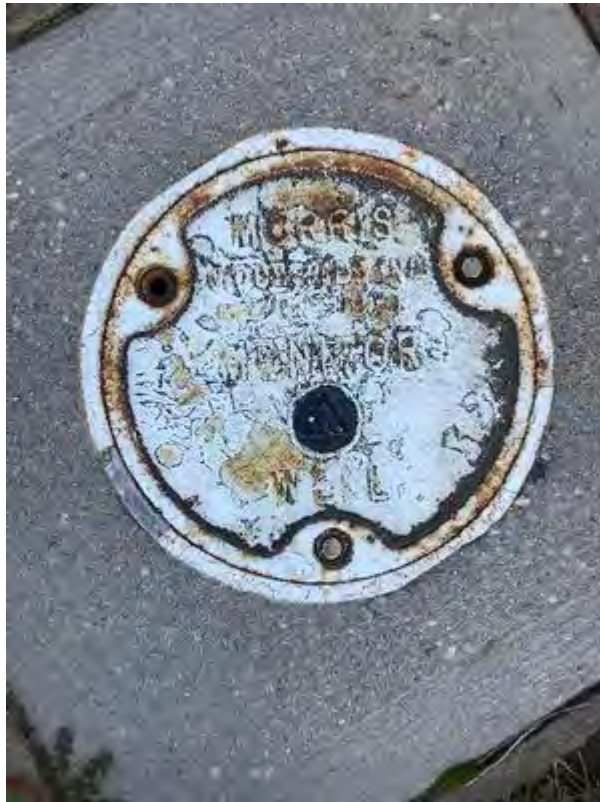
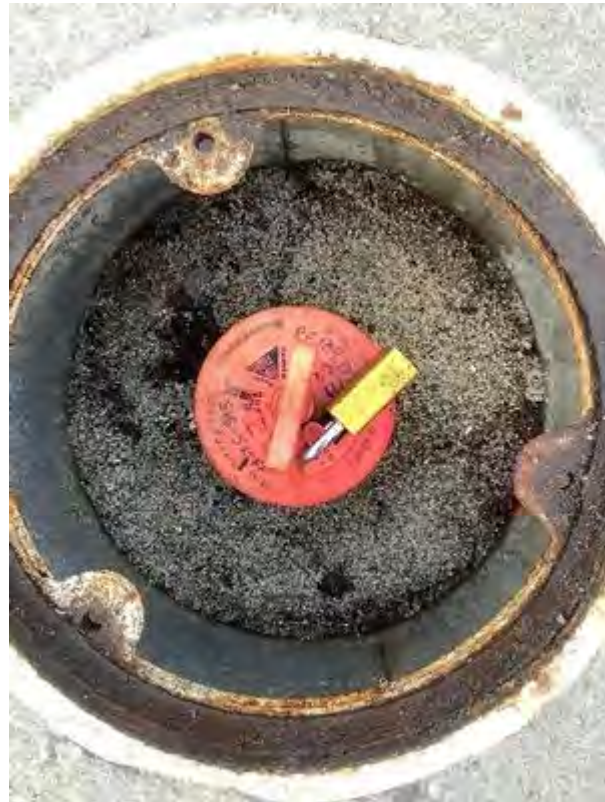
| <b>OVERALL CONDITION:</b> | FAIR |
| <b>Notes (Explain if answered No to any of the above)</b><br>Missing two bolts | |

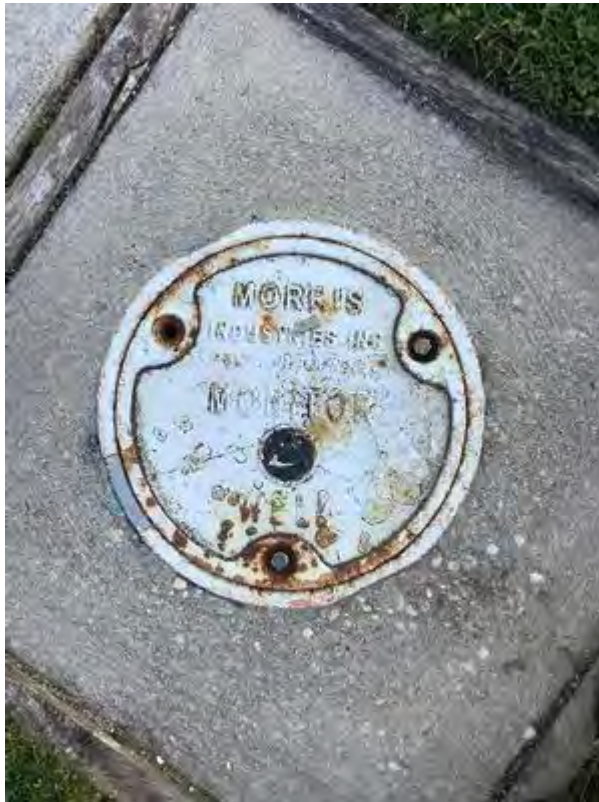
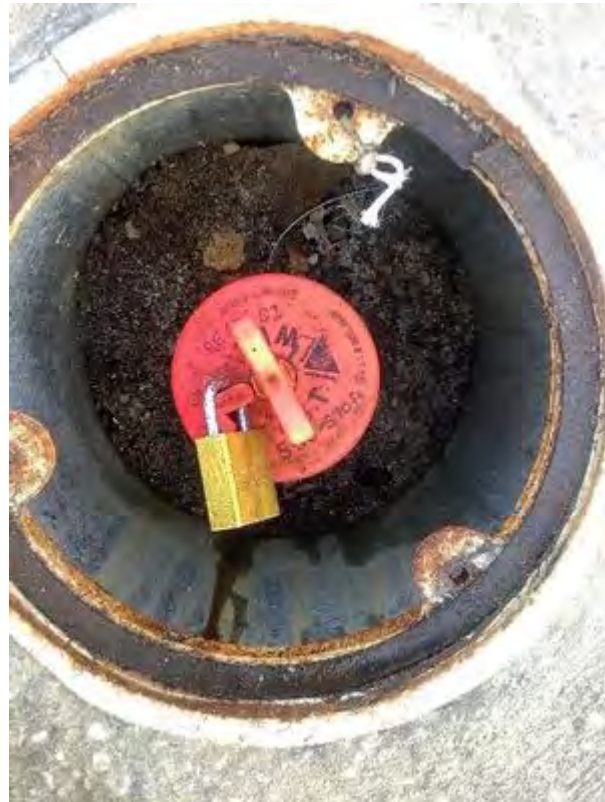
| <b>Notes (Explain if answered No to any of the above)</b><br>Missing one bolt | |
