# Memorandum

To: Brian Murray, NAVFAC MIDLANT  
From: David Brayack, Tetra Tech  
Date: January 28, 2021  
Re: Annual LUC Inspection and Operation Summary Report: Sites 1, 2, 3, and 4 – NWIRP Bethpage  
Revision 1  
Contract/CTO Number: N6247016D9008/WE13

## 1.0 Introduction

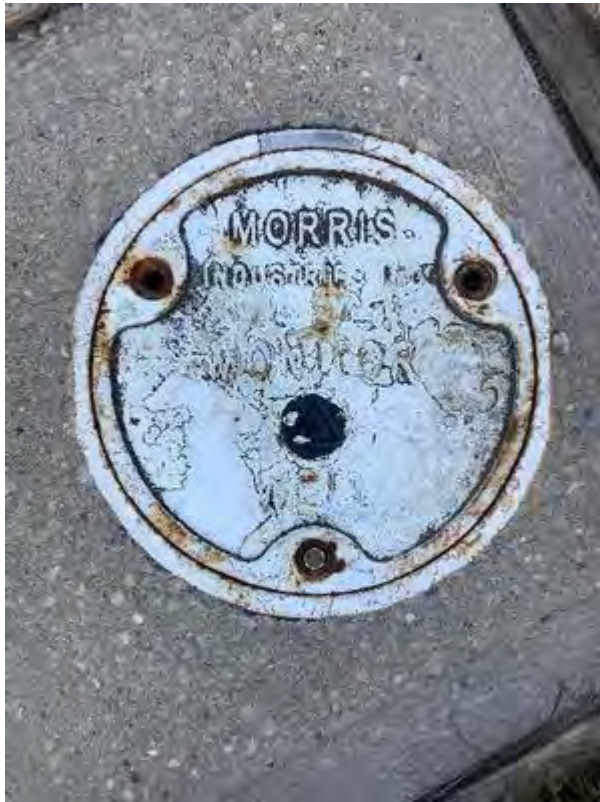
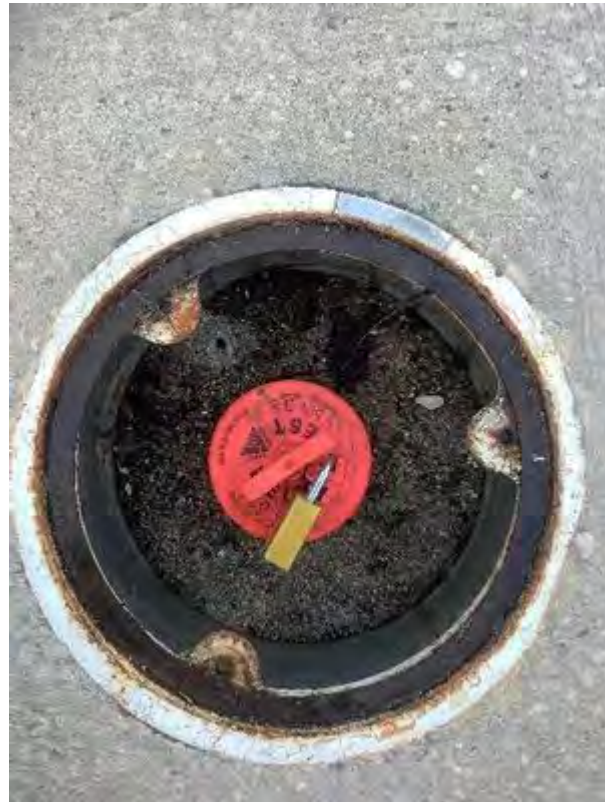
| <b>OVERALL CONDITION:</b> | FAIR |
| <b>Notes (Explain if answered No to any of the above)</b><br>Missing two bolts | |

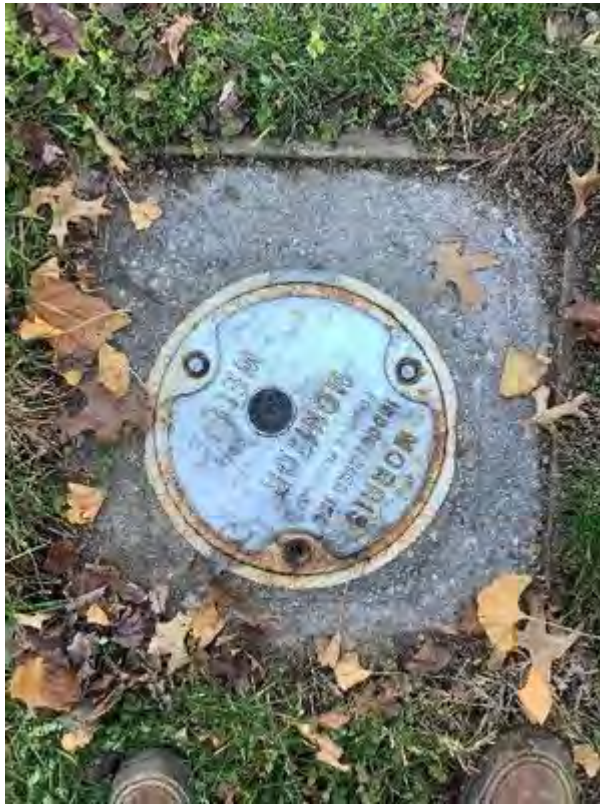
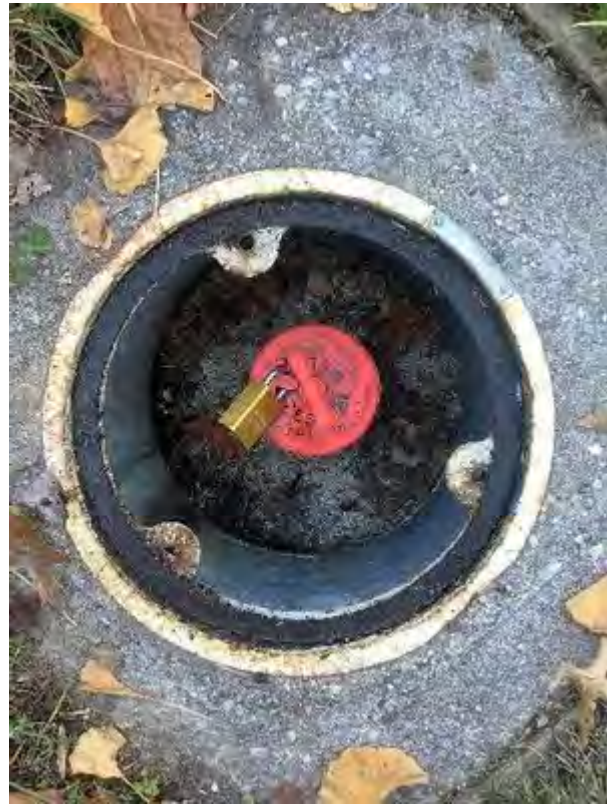
| <b>OVERALL CONDITION:</b> | FAIR |
| <b>Notes (Explain if answered No to any of the above)</b><br>Missing one bolt | |

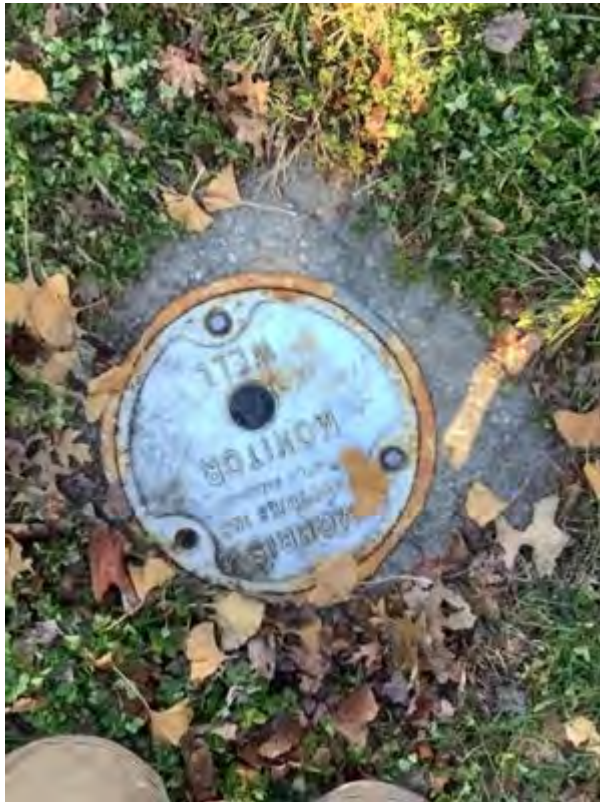
| <b>OVERALL CONDITION:</b> | FAIR |
| <b>Notes (Explain if answered No to any of the above)</b><br>Missing one bolt | |

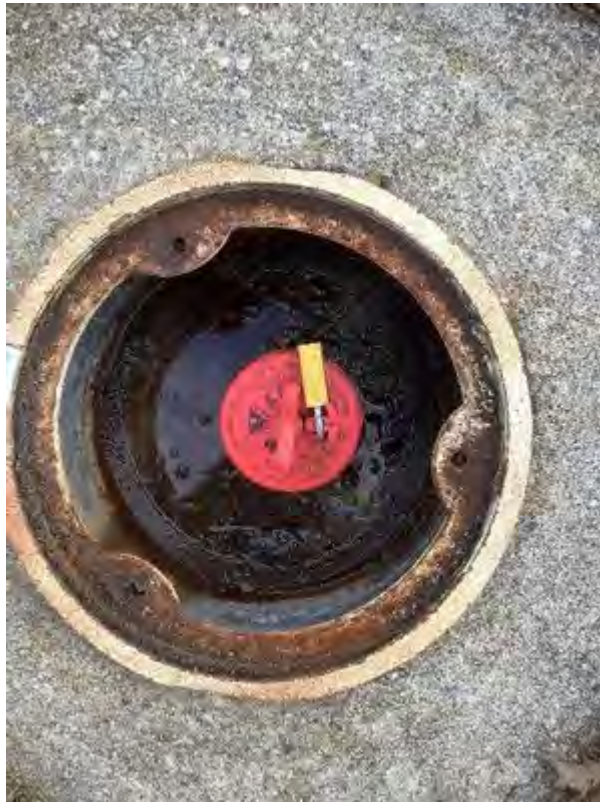
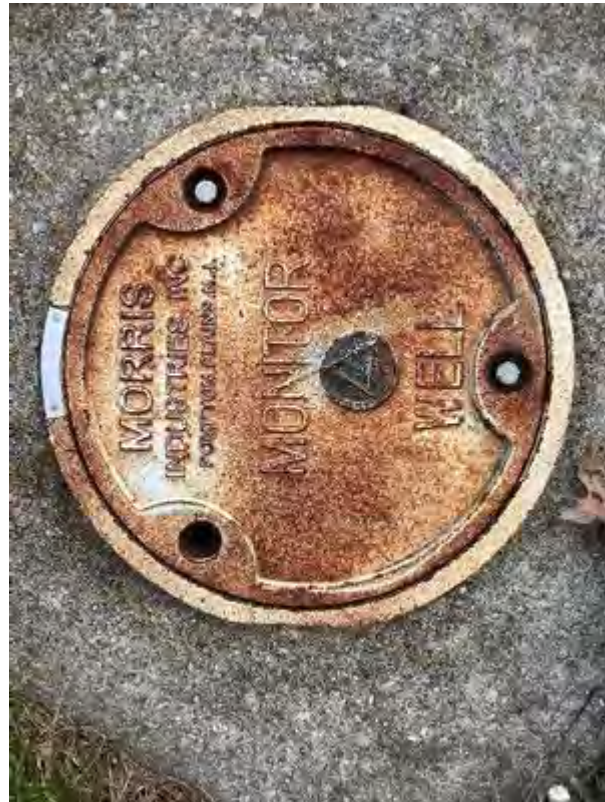
| <b>Notes (Explain if answered No to any of the above)</b><br>Missing one bolt | |

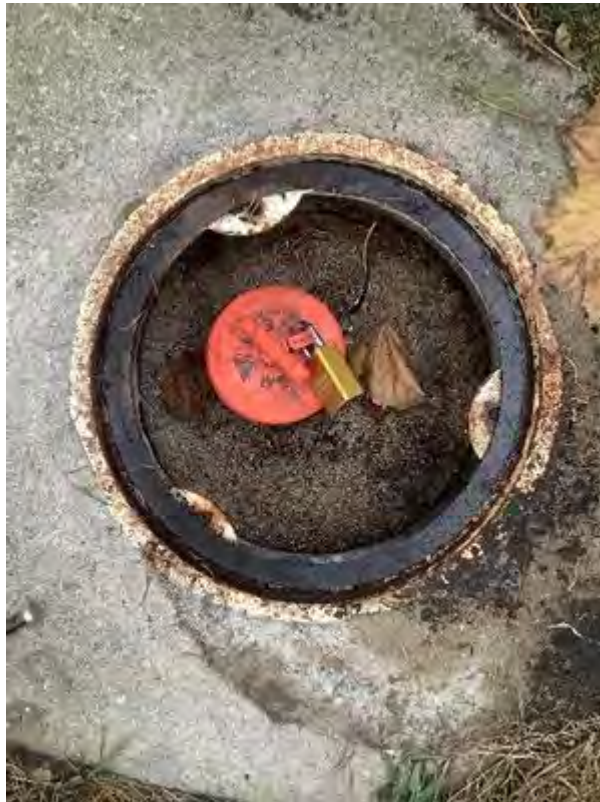
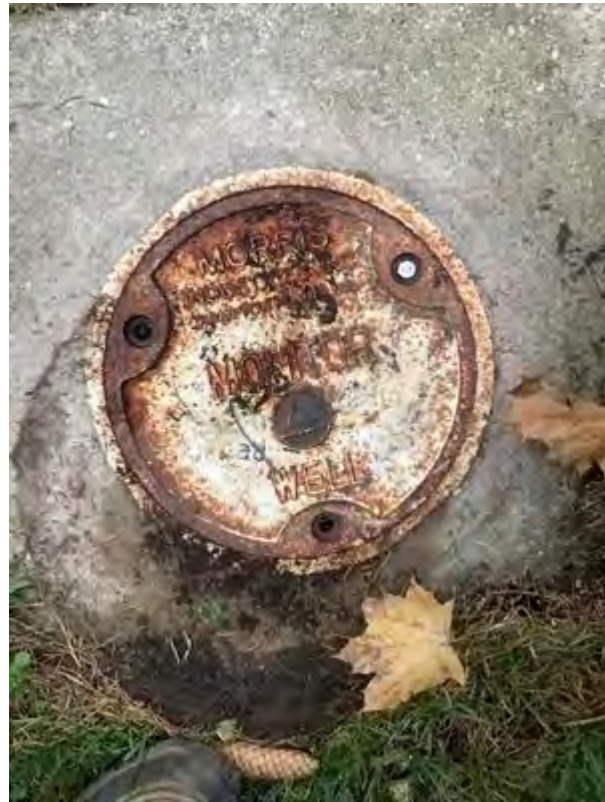
| <b>Notes (Explain if answered No to any of the above)</b><br>Missing two bolts | |

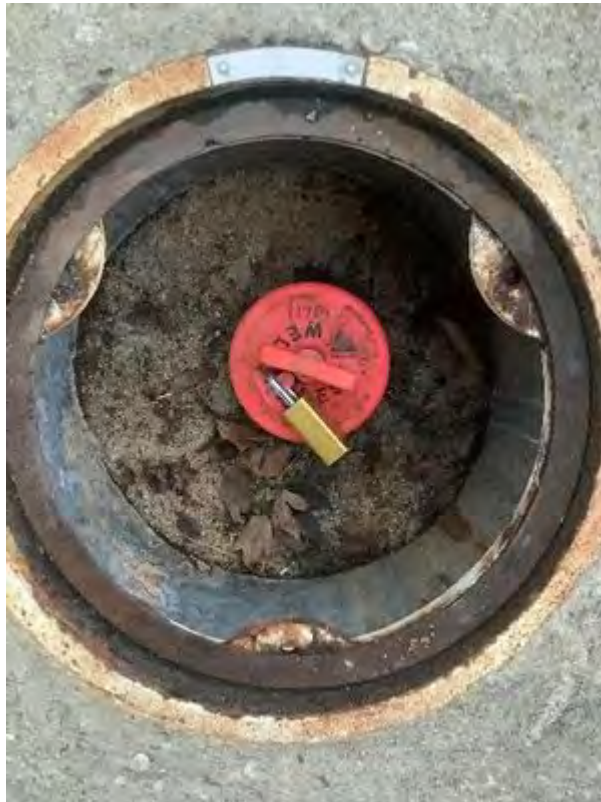
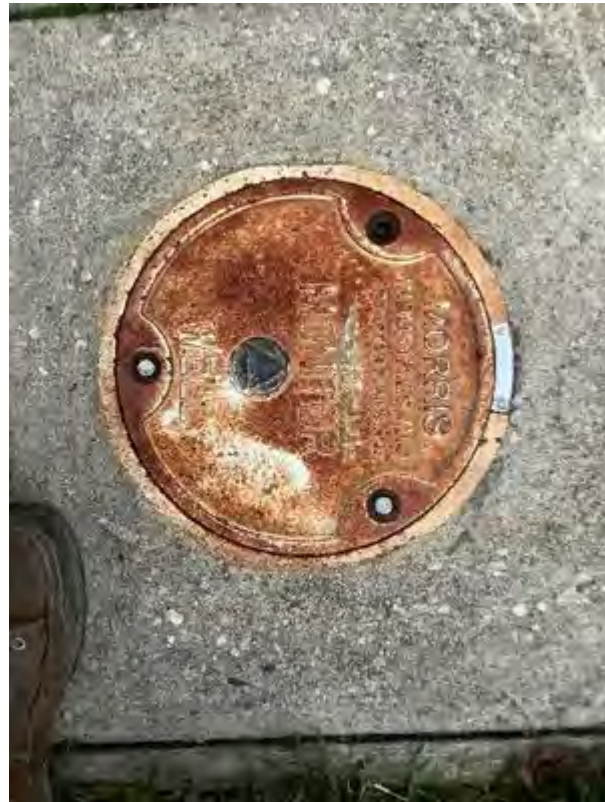
| <b>Notes (Explain if answered No to any of the above)</b><br>Missing one bolt | |

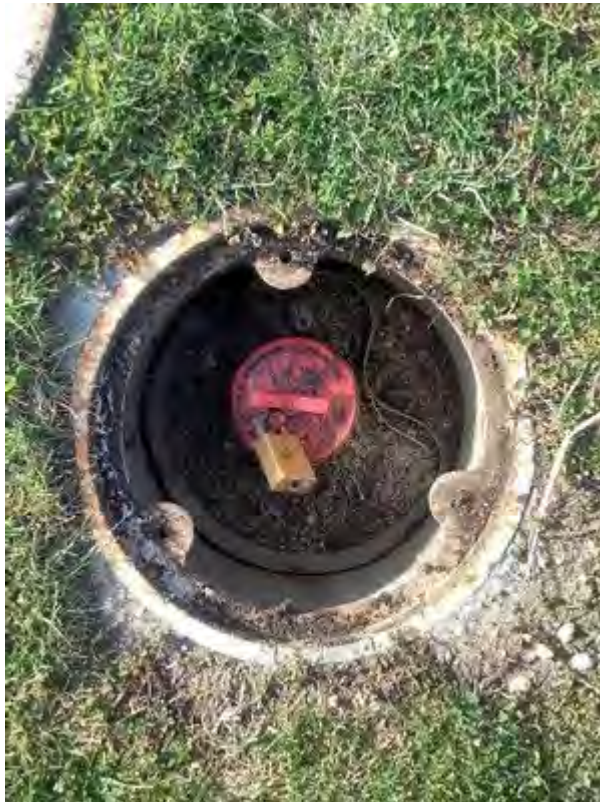
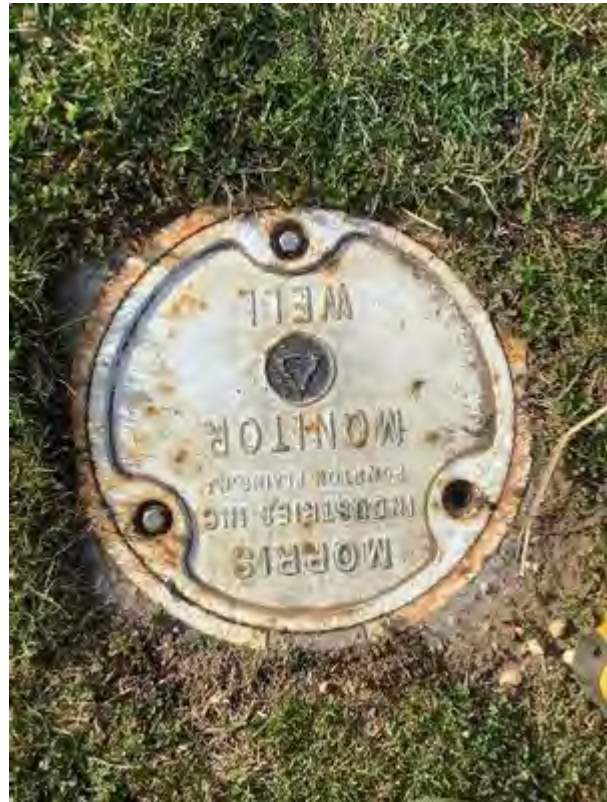
| <b>Notes (Explain if answered No to any of the above)</b><br>Missing one bolt | |

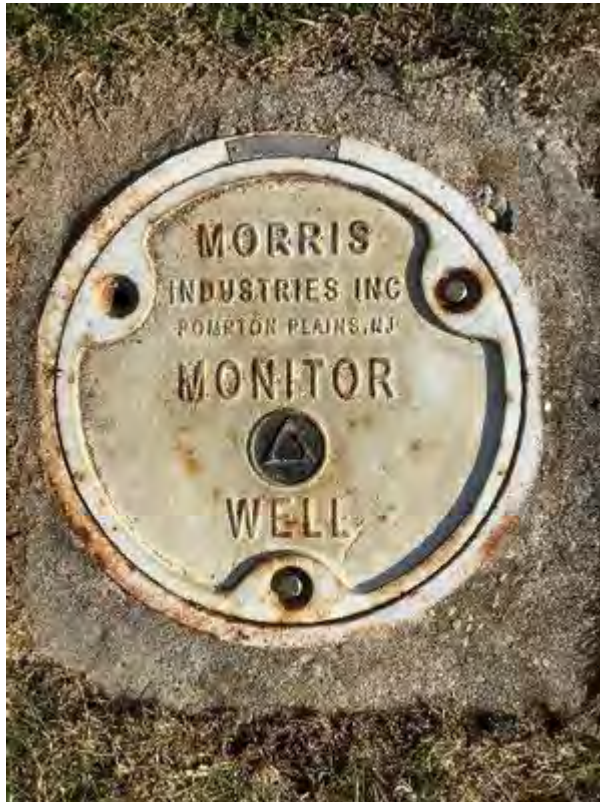
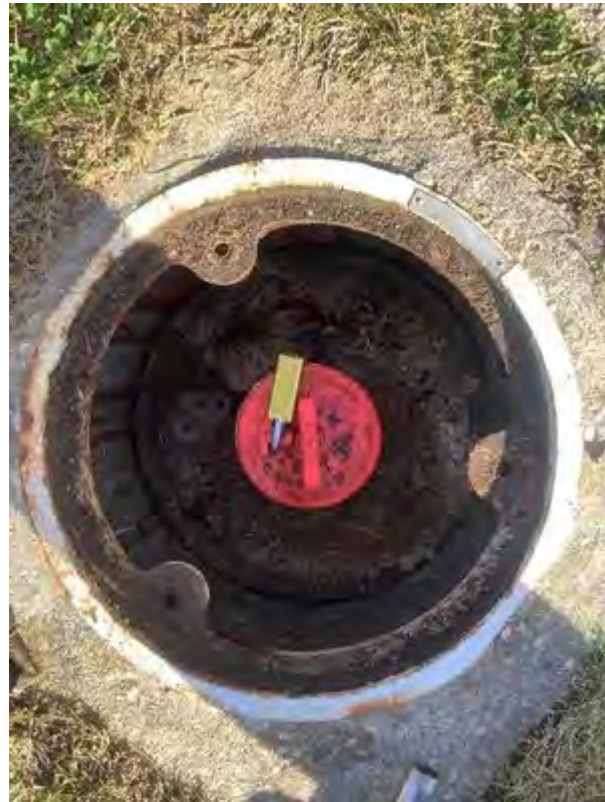
| <b>OVERALL CONDITION:</b> | FAIR |
| <b>Notes (Explain if answered No to any of the above)</b><br>Missing one bolt | |

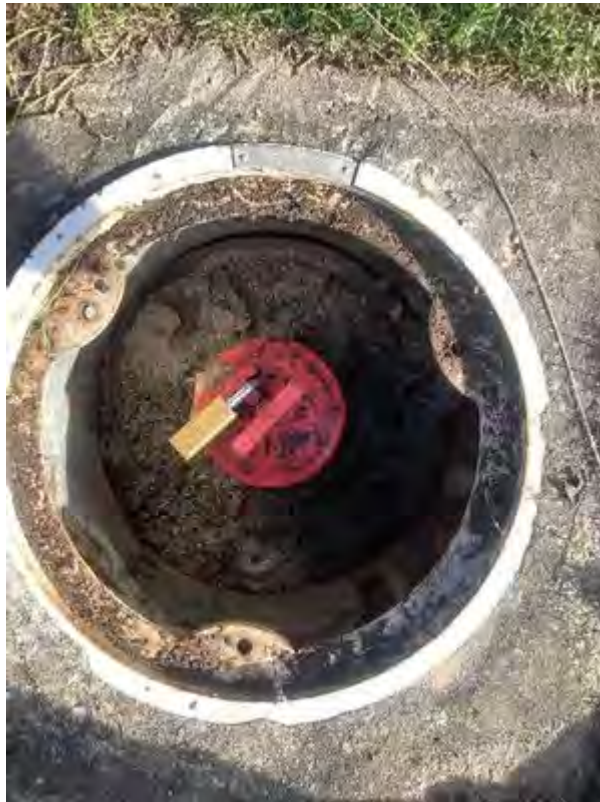
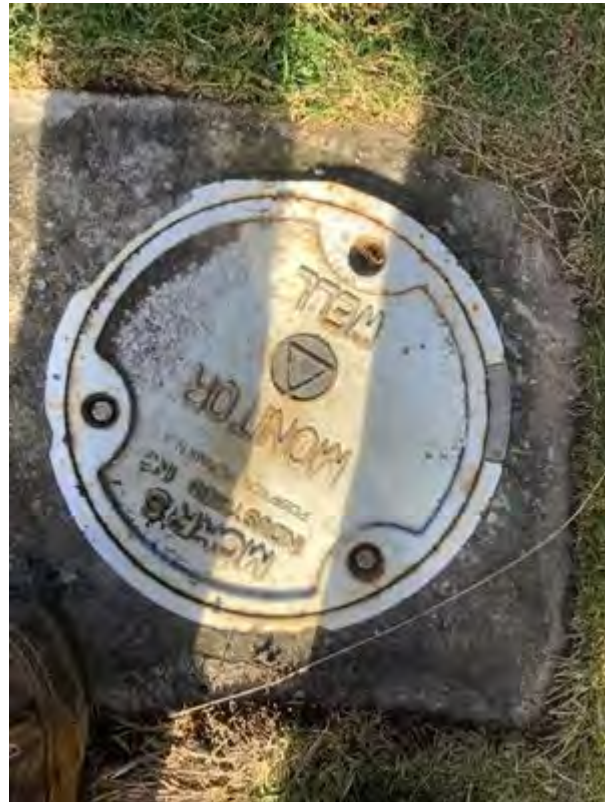
| <b>OVERALL CONDITION:</b> | FAIR |
| <b>Notes (Explain if answered No to any of the above)</b><br>Missing one bolt | |

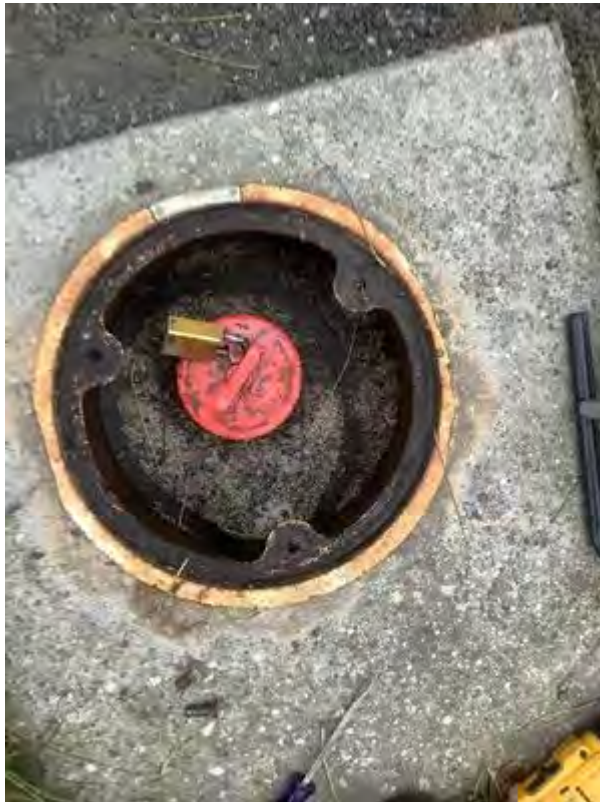
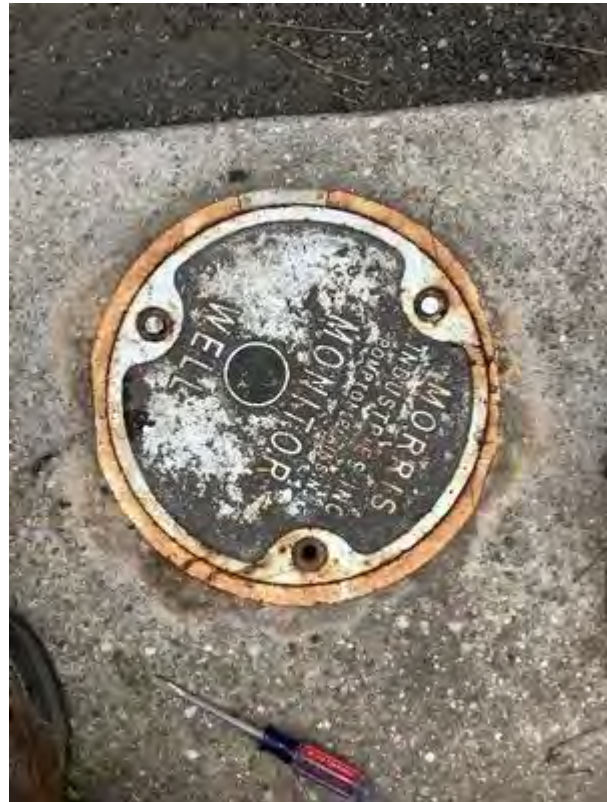
| <b>OVERALL CONDITION:</b> | GOOD |
| <b>Notes (Explain if answered No to any of the above)</b><br>Missing one bolt | |

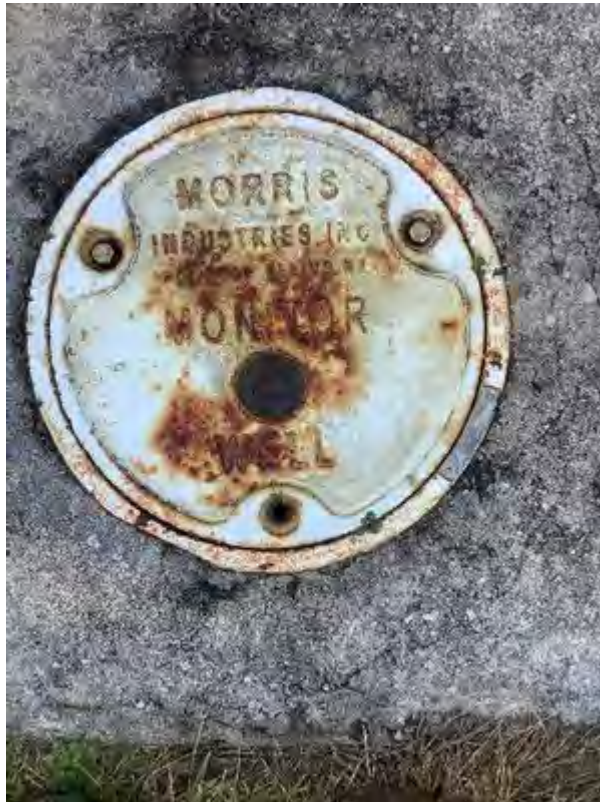
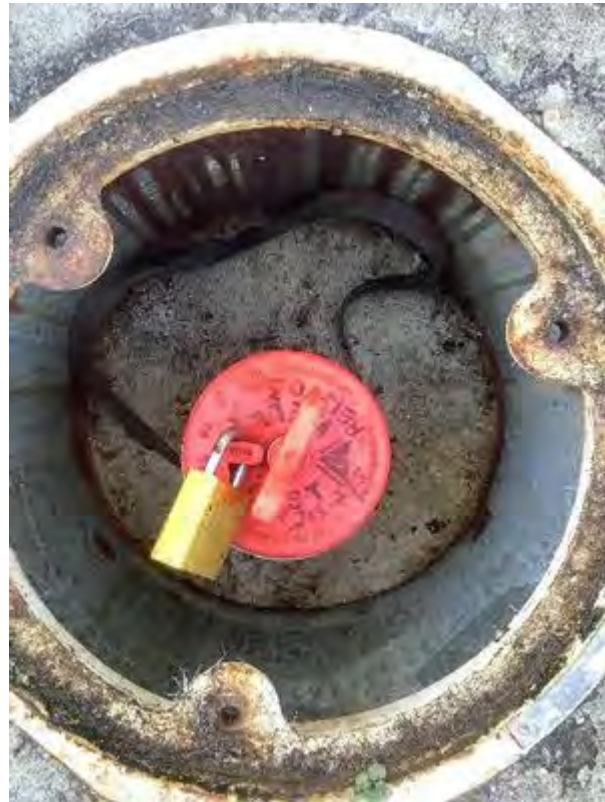
| <b>OVERALL CONDITION:</b> | FAIR |
| <b>Notes (Explain if answered No to any of the above)</b><br>Missing one bolt | |

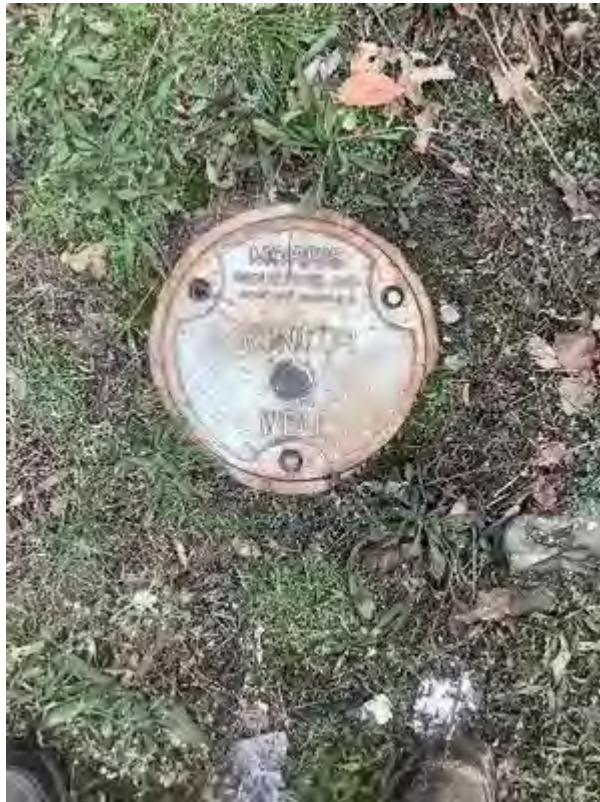
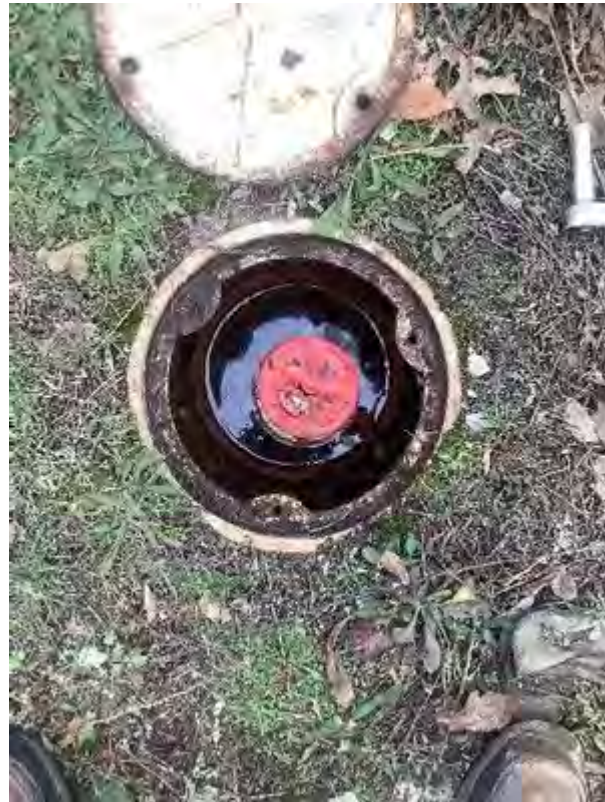
| <b>OVERALL CONDITION:</b> | FAIR |
| <b>Notes (Explain if answered No to any of the above)</b><br>Missing one bolt | |

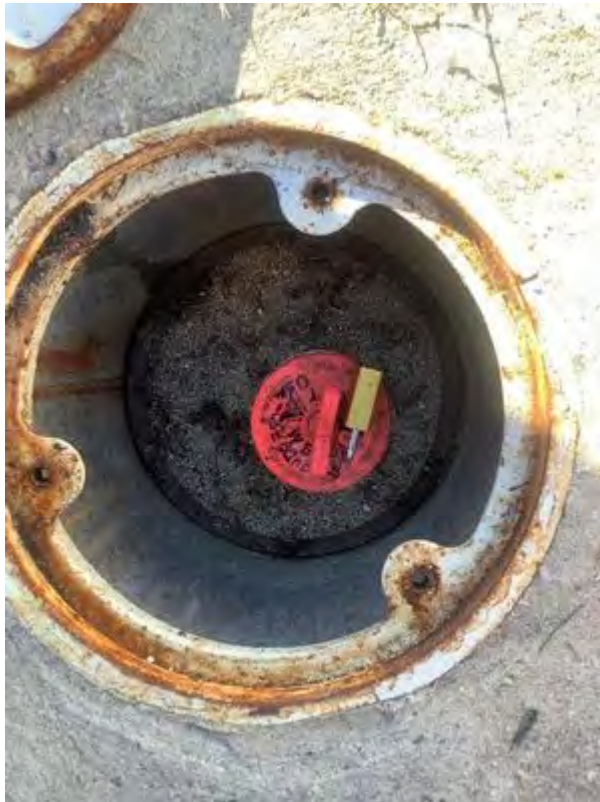
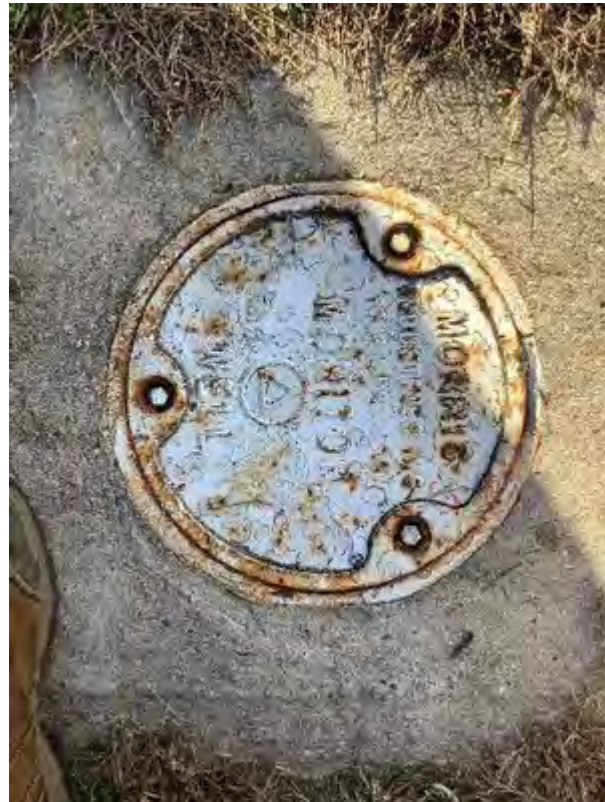
| <b>OVERALL CONDITION:</b> | FAIR |
| <b>Notes (Explain if answered No to any of the above)</b><br>Two bolts stripped | |

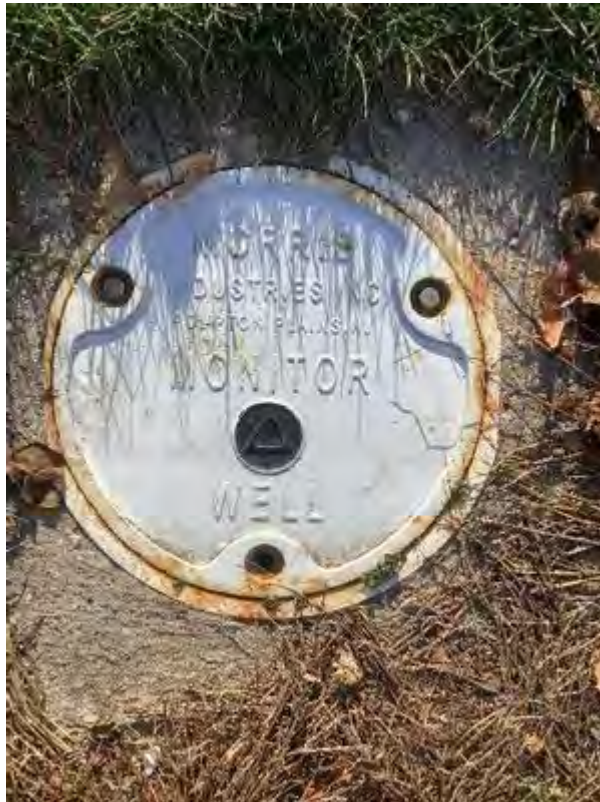
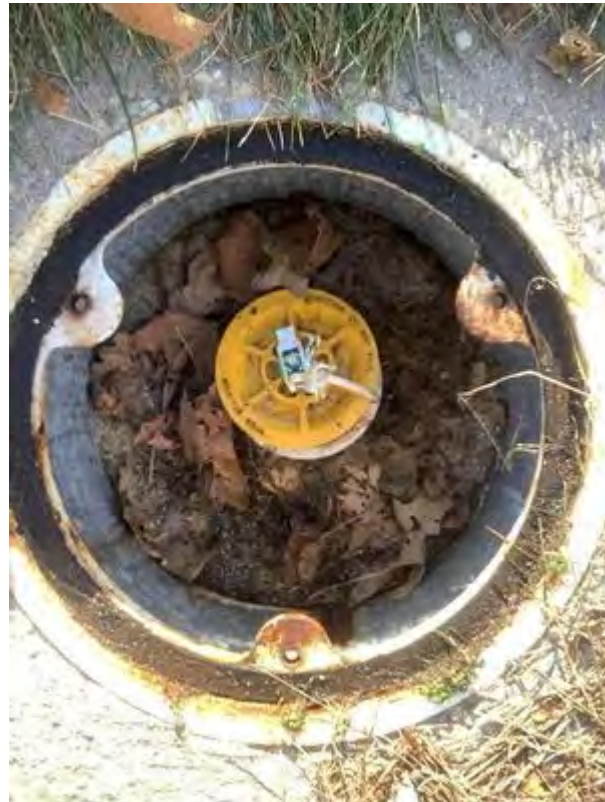
| <b>OVERALL CONDITION:</b> | FAIR |
| <b>Notes (Explain if answered No to any of the above)</b><br>Missing one bolt | |

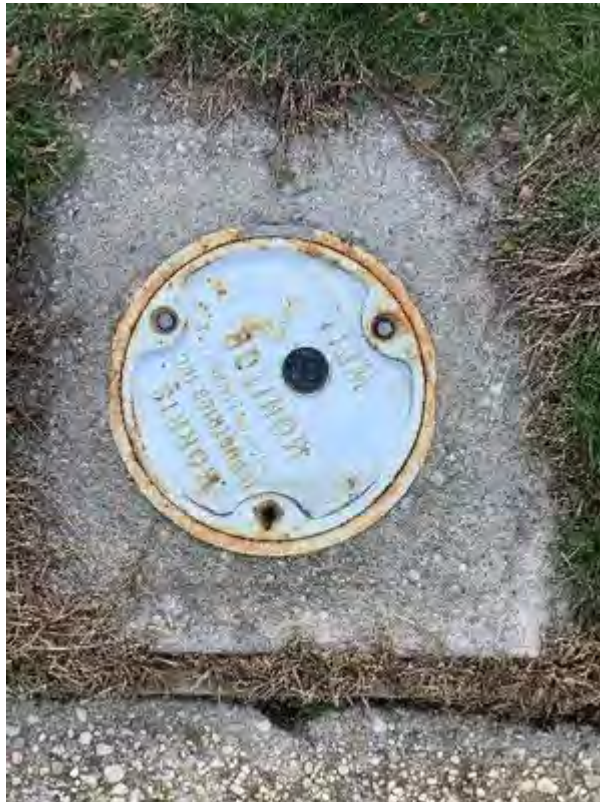
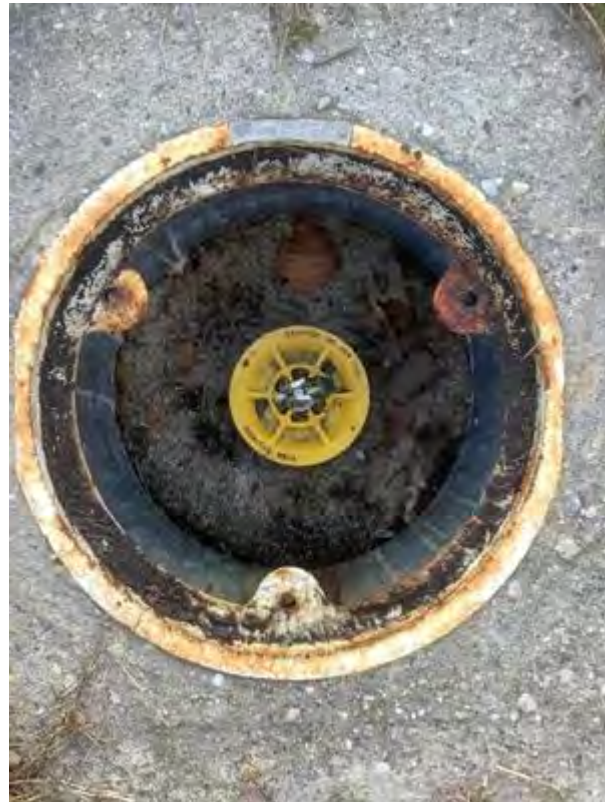
| <b>OVERALL CONDITION:</b> | FAIR |
| <b>Notes (Explain if answered No to any of the above)</b><br>Missing one bolt | |

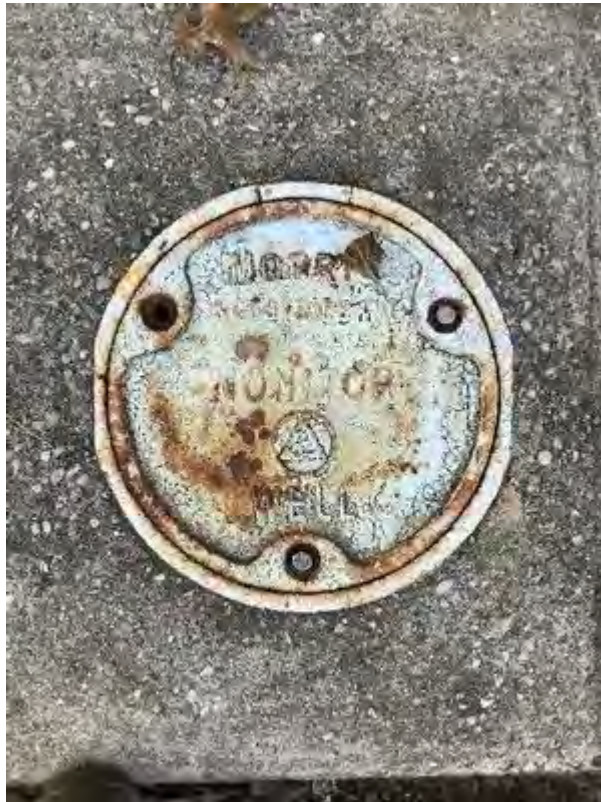
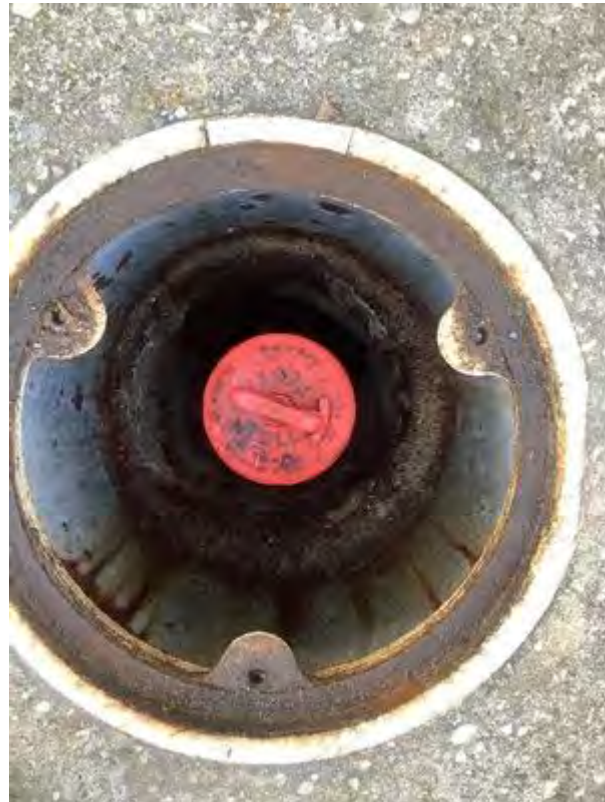
| <b>Notes (Explain if answered No to any of the above)</b><br>Missing one bolt. Needs backfill | |

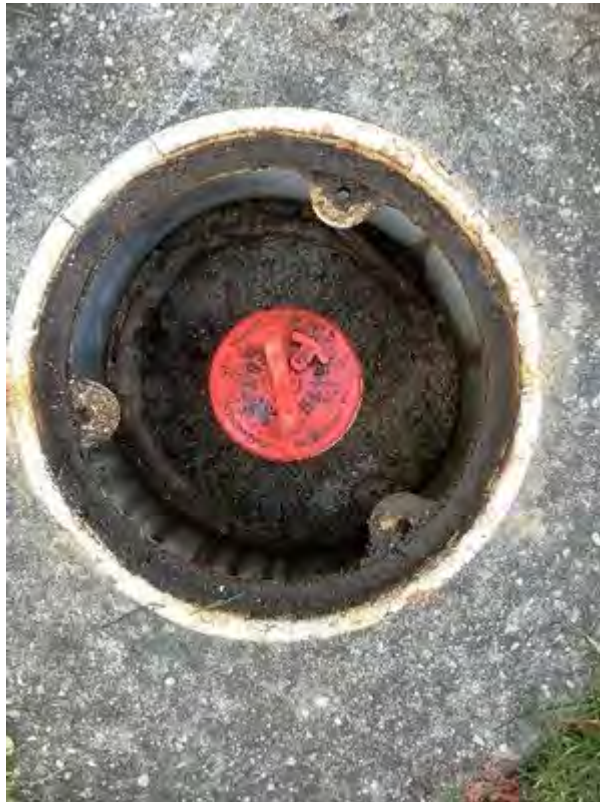
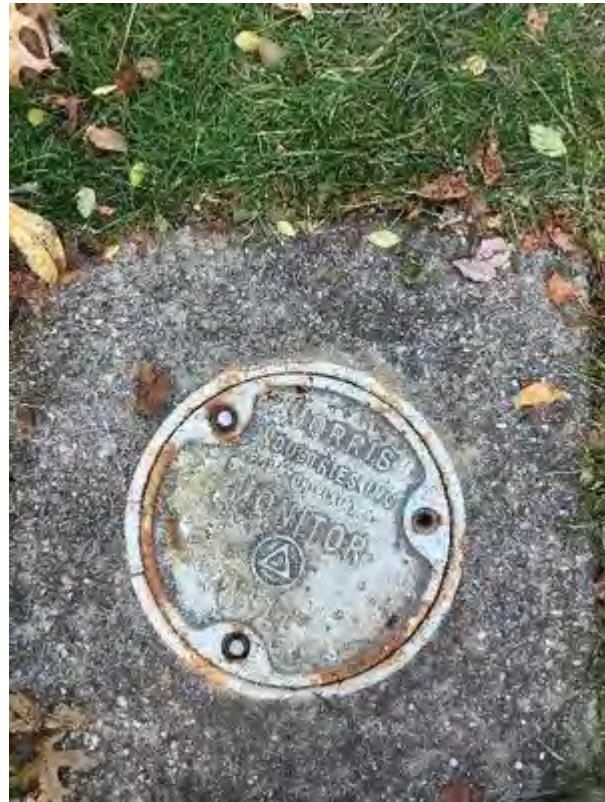
| <b>Notes (Explain if answered No to any of the above)</b><br>Missing one bolt | |

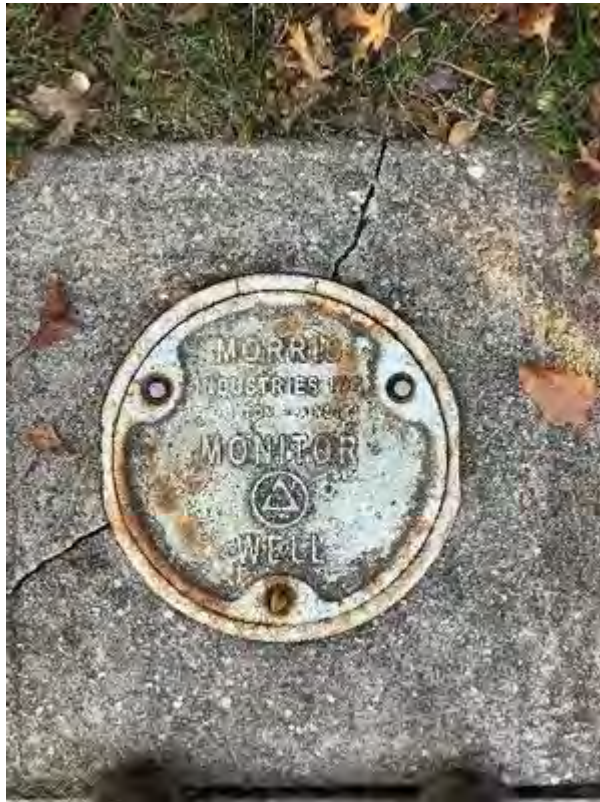
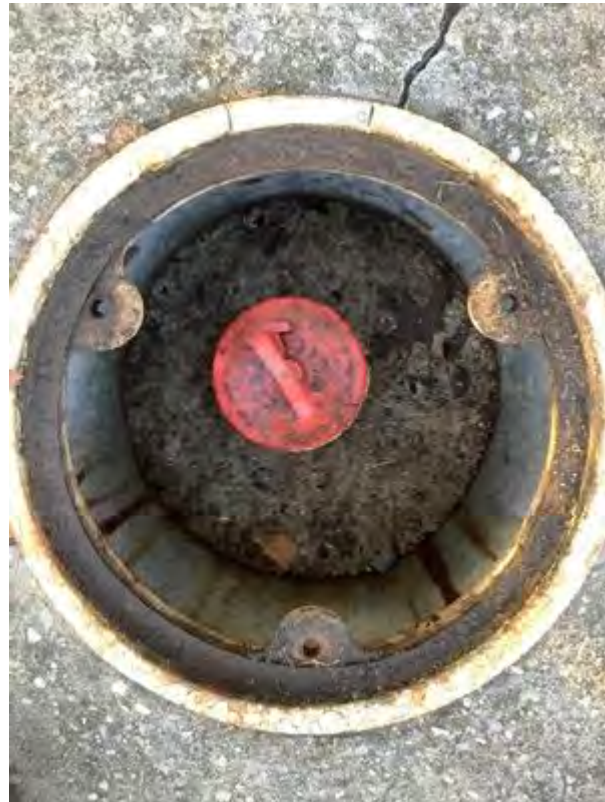
| <b>Notes (Explain if answered No to any of the above)</b><br>Missing one bolt | |

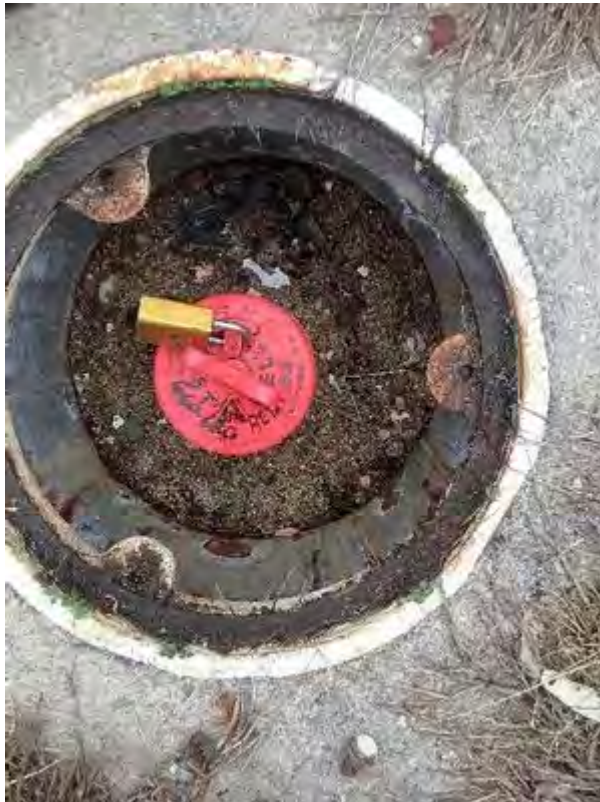
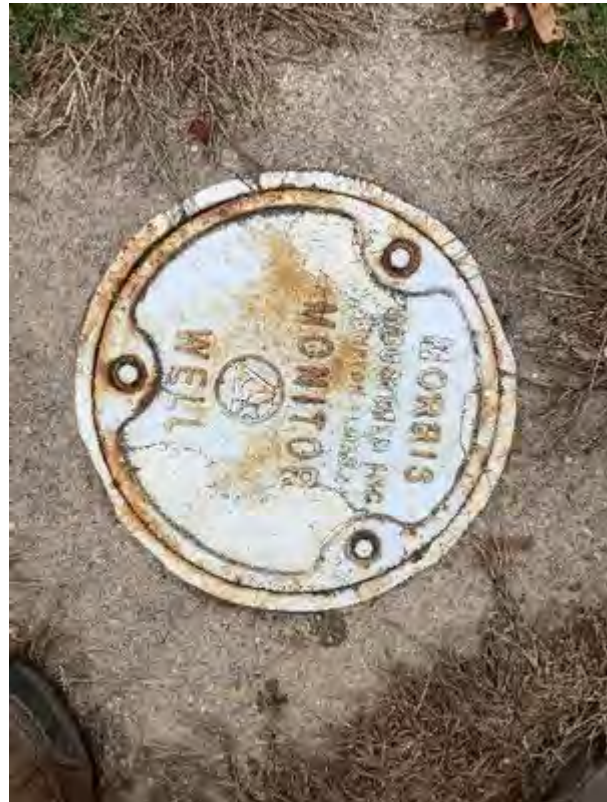
| <b>Notes (Explain if answered No to any of the above)</b><br>Two bolts stripped | |

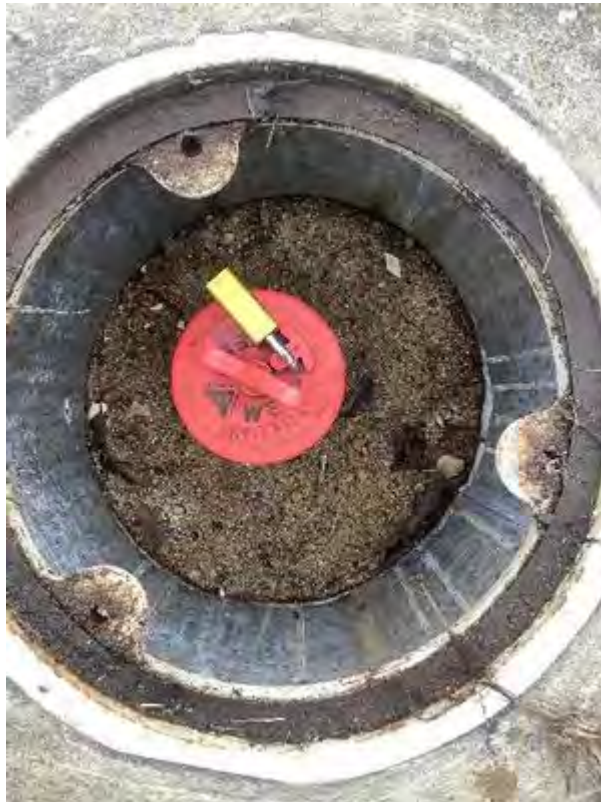
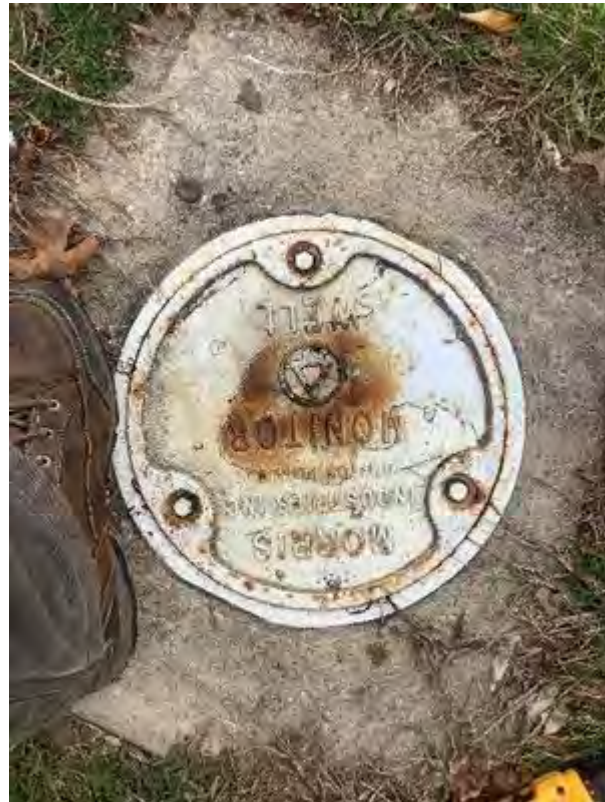
| <b>Notes (Explain if answered No to any of the above)</b><br>All bolts stripped | |

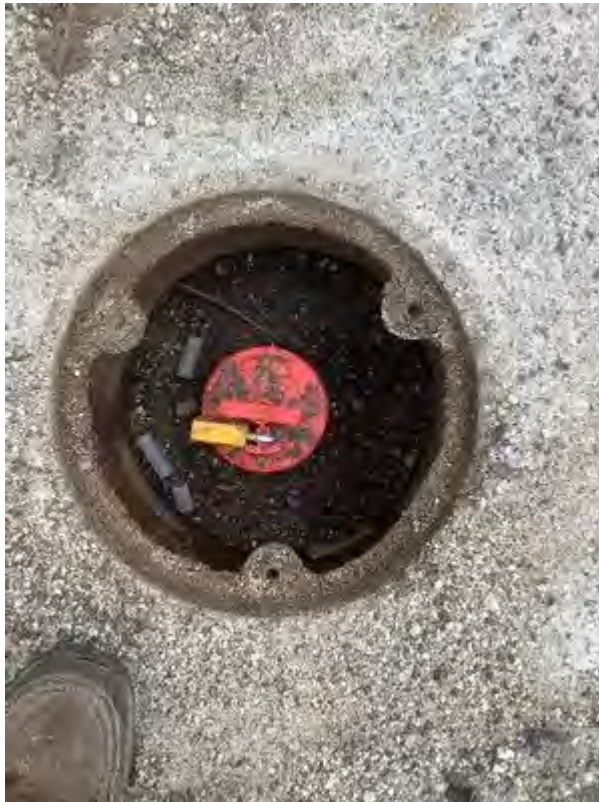
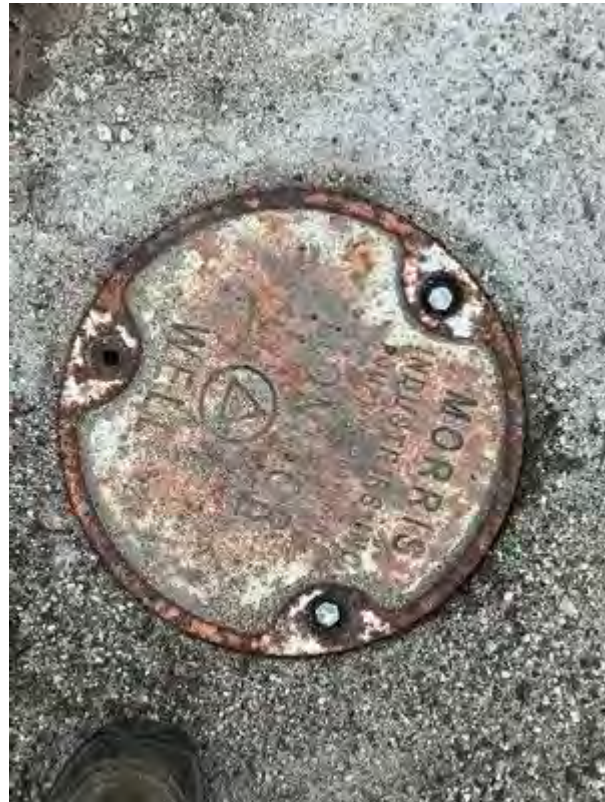
| <b>OVERALL CONDITION:</b> | FAIR |
| <b>Notes (Explain if answered No to any of the above)</b><br>Missing one bolt. Other two stripped. | |

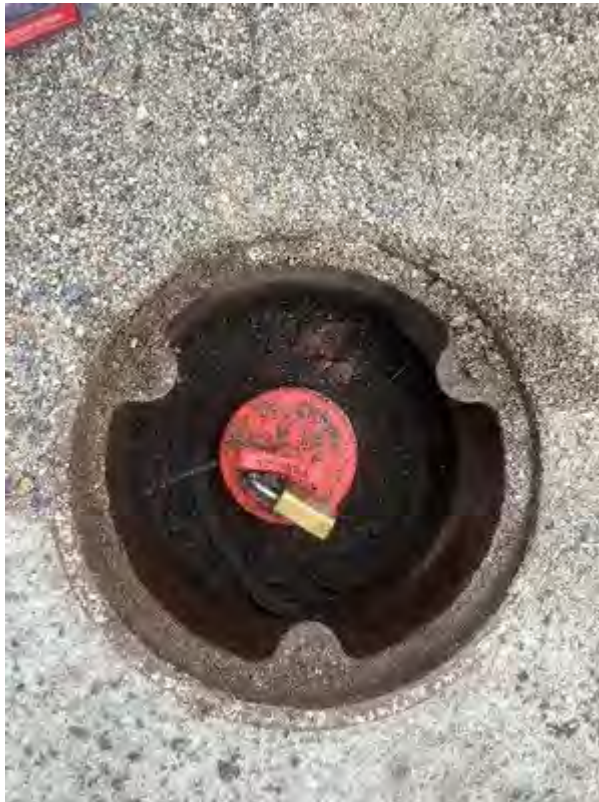
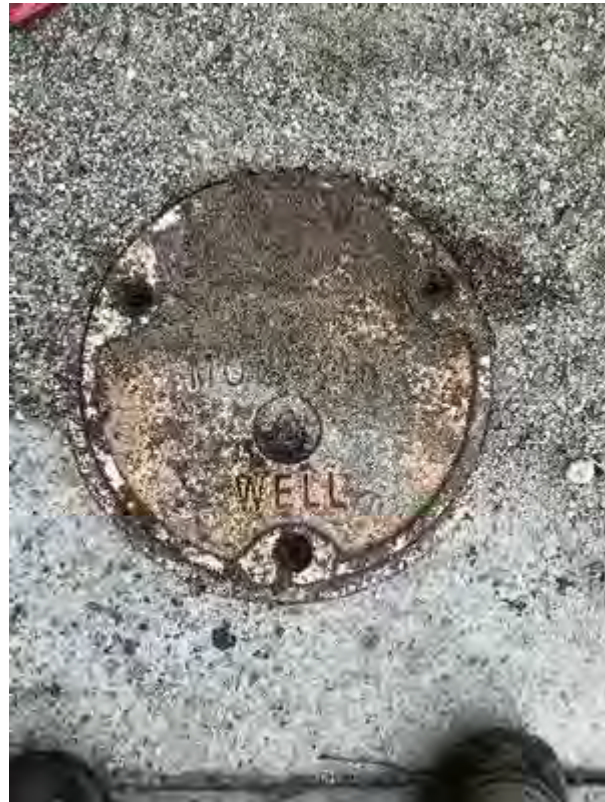
| <b>Concrete pad in acceptable condition i.e. no cracks?</b> | NO |
| <b>OVERALL CONDITION:</b> | FAIR |
| <b>Notes (Explain if answered No to any of the above)</b><br>Missing all bolts | |

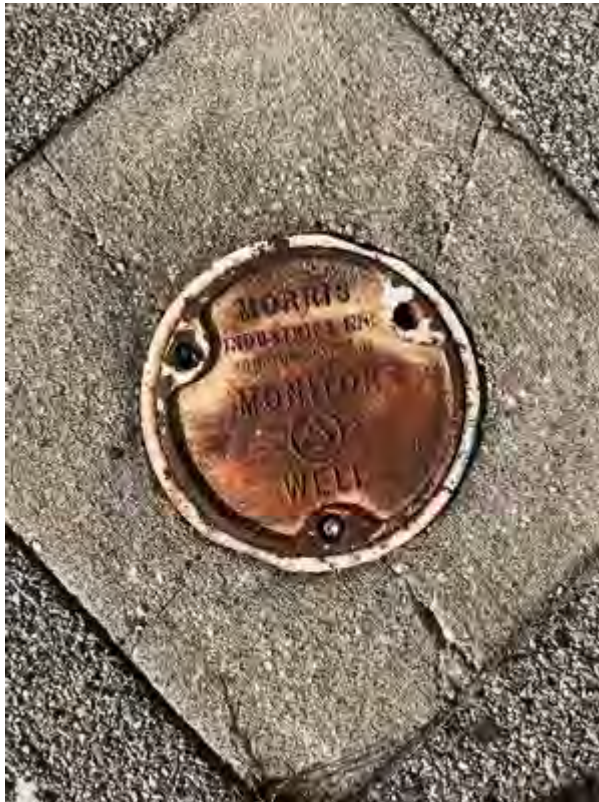
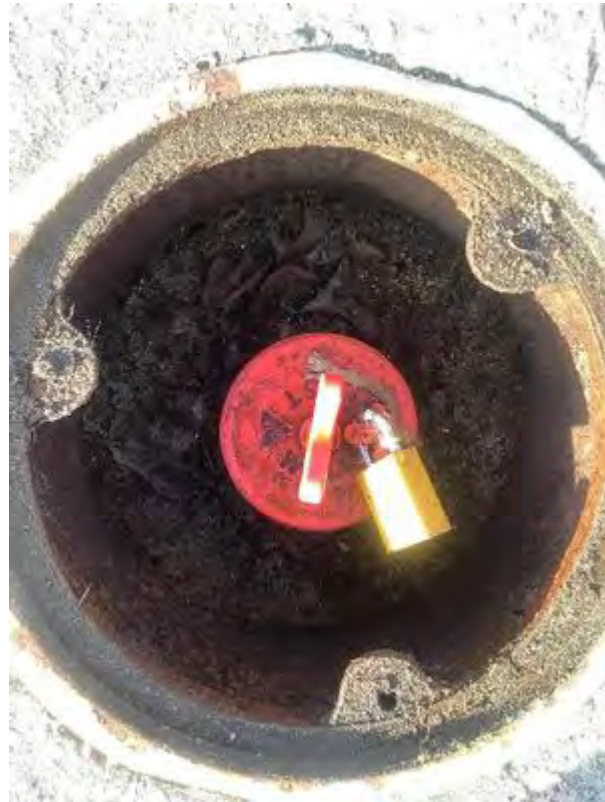
| <b>OVERALL CONDITION:</b> | FAIR |
| <b>Notes (Explain if answered No to any of the above)</b><br>Missing two bolts, one bolt stripped | |
