# Memorandum

To: Brian Murray, NAVFAC MIDLANT  
From: David Brayack, Tetra Tech  
Date: January 28, 2021  
Re: Annual LUC Inspection and Operation Summary Report: Sites 1, 2, 3, and 4 – NWIRP Bethpage  
Revision 1  
Contract/CTO Number: N6247016D9008/WE13

## 1.0 Introduction

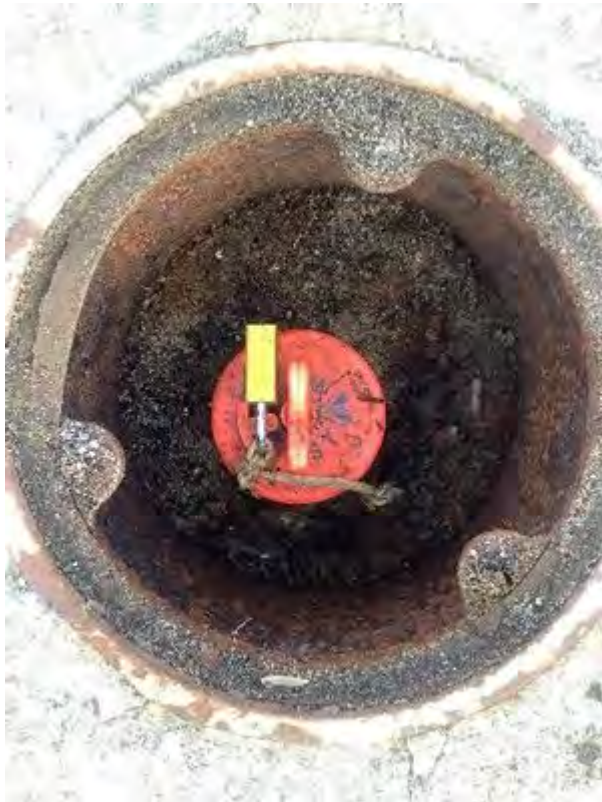
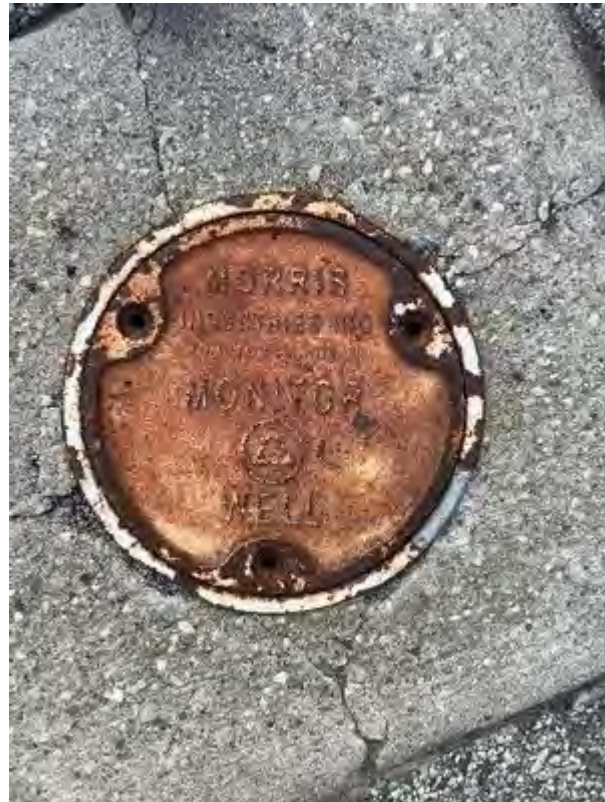
| <b>Notes (Explain if answered No to any of the above)</b><br>Missing three bolts | |

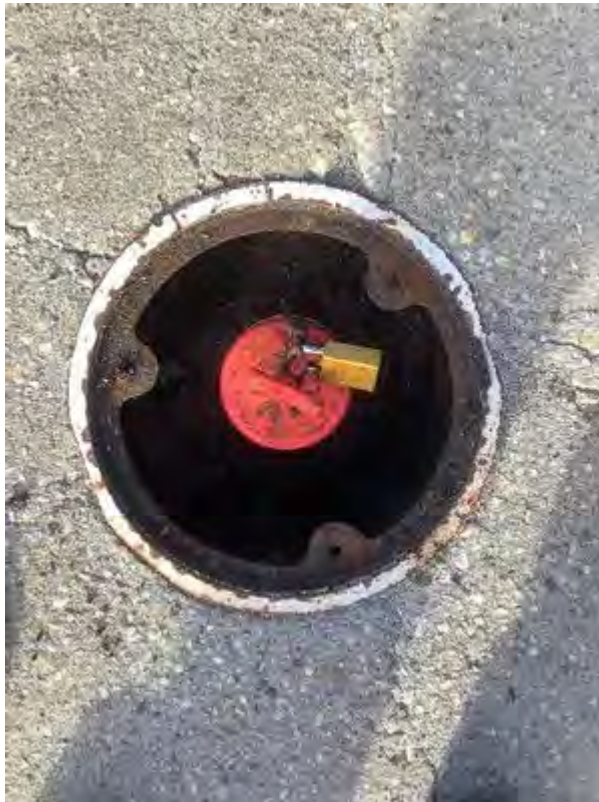
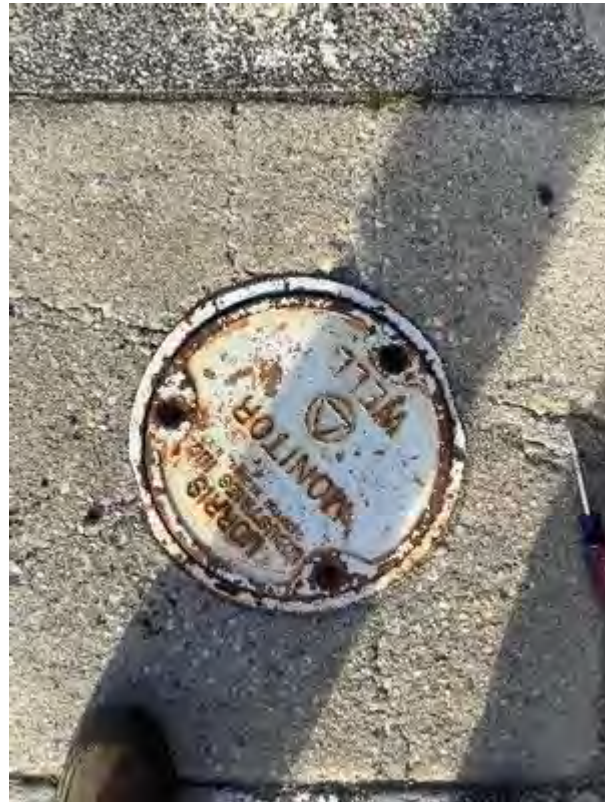
| <b>OVERALL CONDITION:</b> | FAIR |
| <b>Notes (Explain if answered No to any of the above)</b><br>Missing three bolts | |

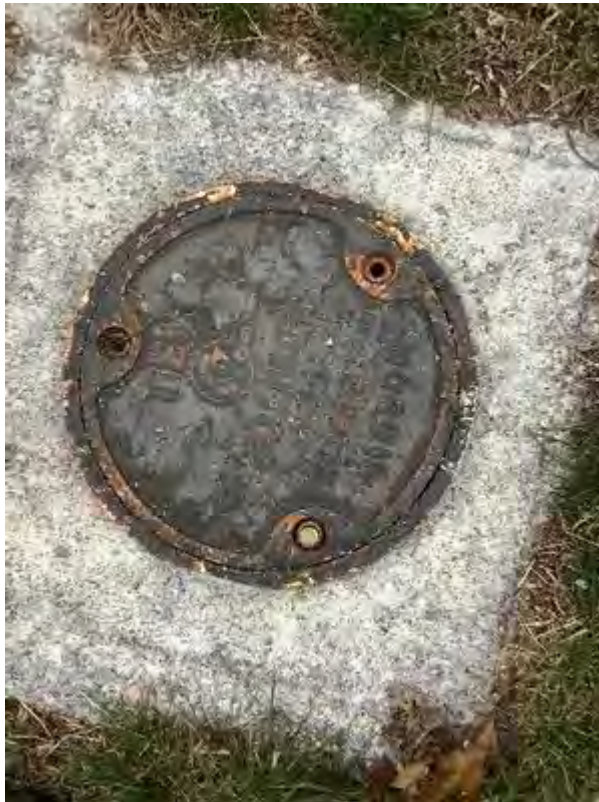
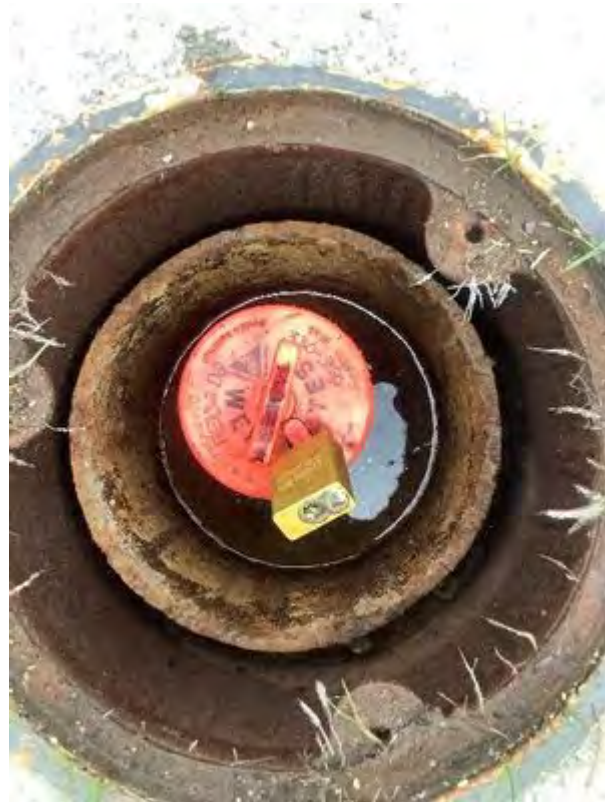
| <b>OVERALL CONDITION:</b> | FAIR |
| <b>Notes (Explain if answered No to any of the above)</b><br>Missing two bolts. Needs backfill | |

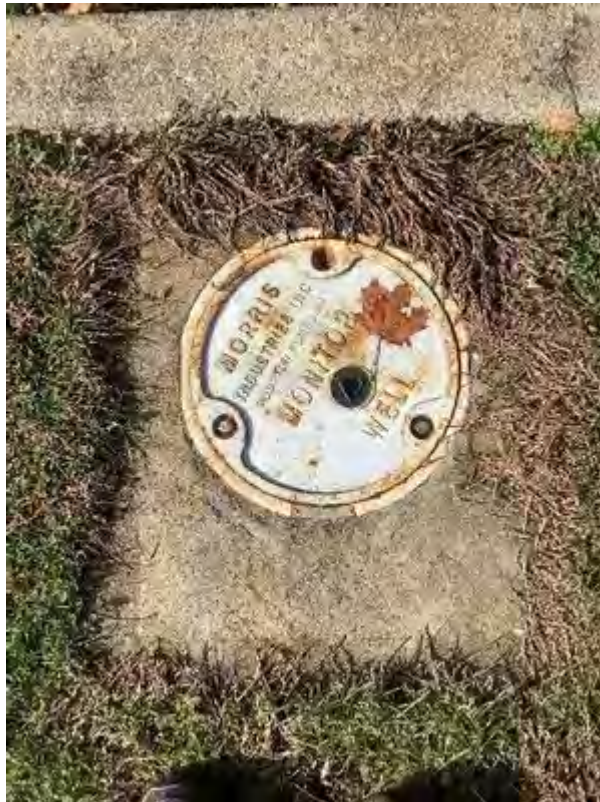
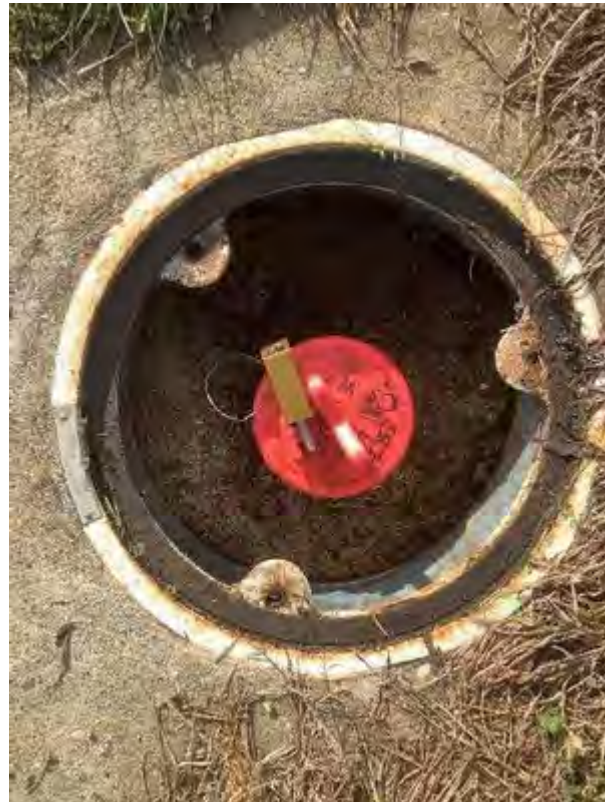
| <b>Notes (Explain if answered No to any of the above)</b><br>Missing one bolt | |

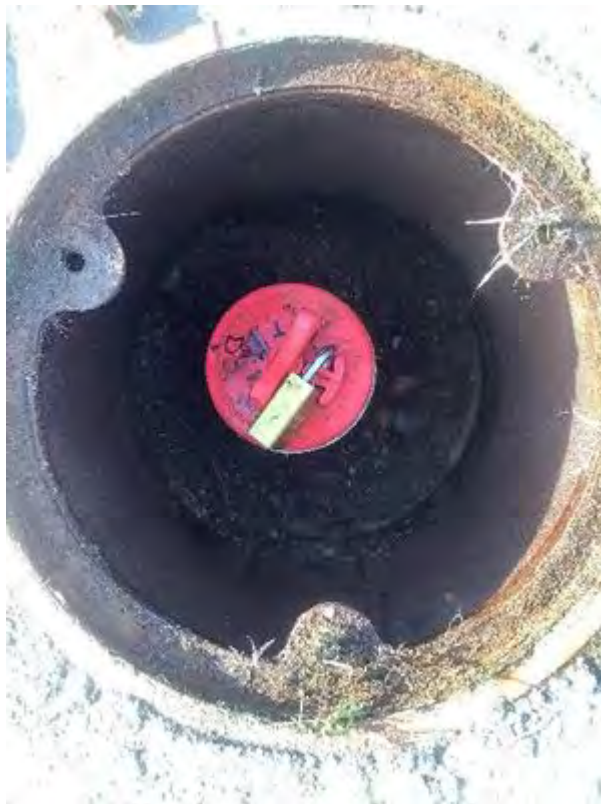
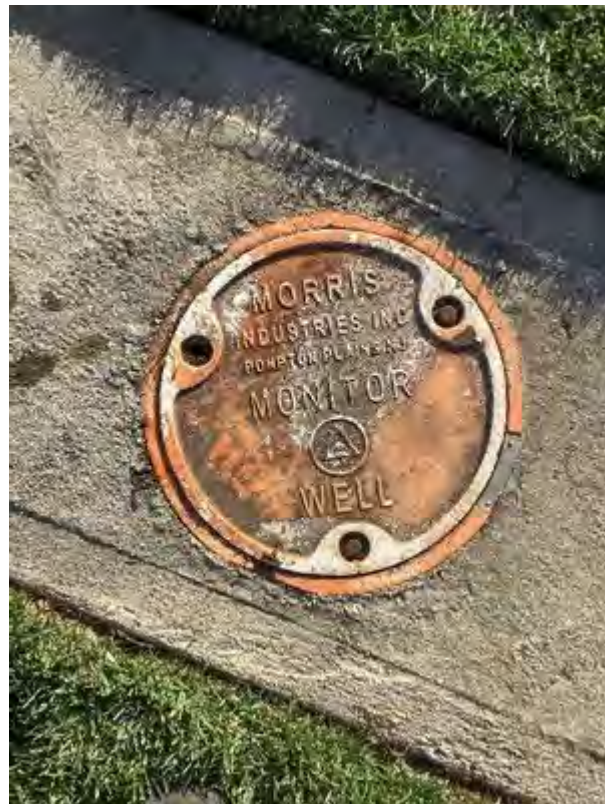
| <b>Notes (Explain if answered No to any of the above)</b><br>Missing two bolts | |

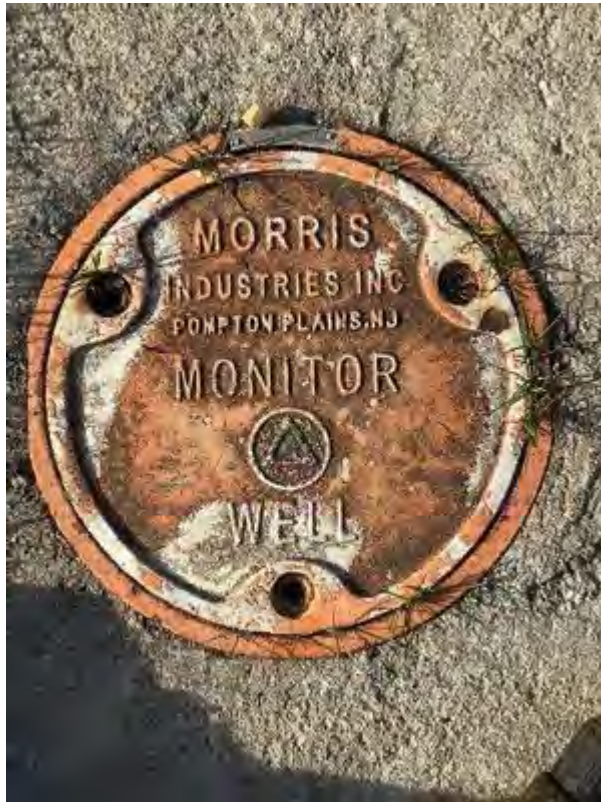
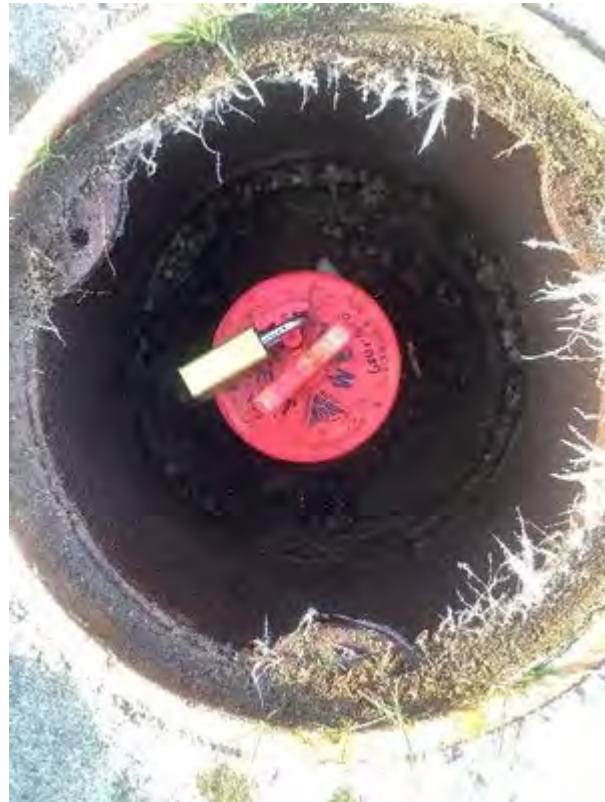
| <b>OVERALL CONDITION:</b> | FAIR |
| <b>Notes (Explain if answered No to any of the above)</b><br>Missing three bolts | |

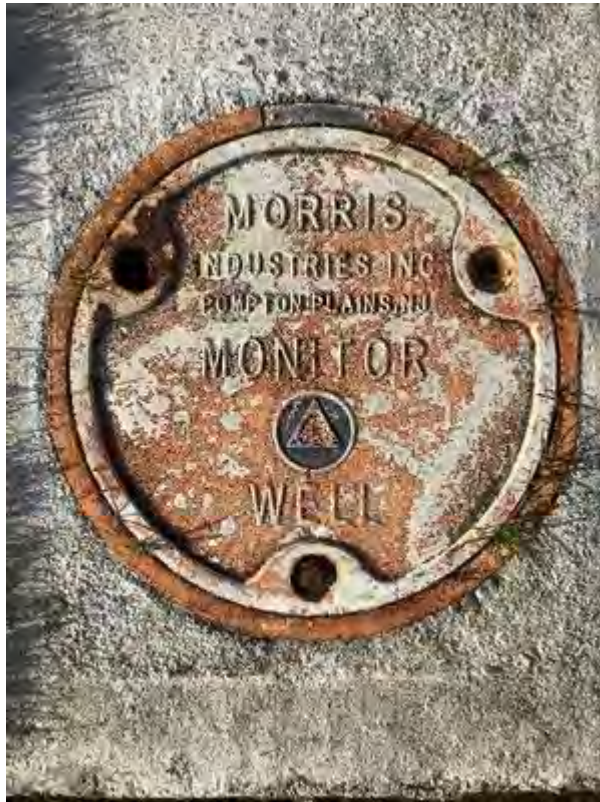
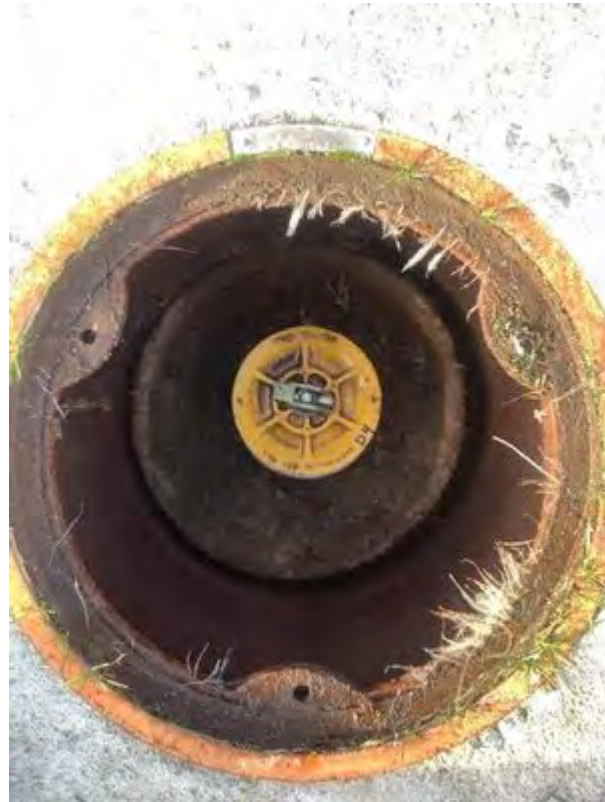
| <b>OVERALL CONDITION:</b> | FAIR |
| <b>Notes (Explain if answered No to any of the above)</b><br>Missing two bolts | |

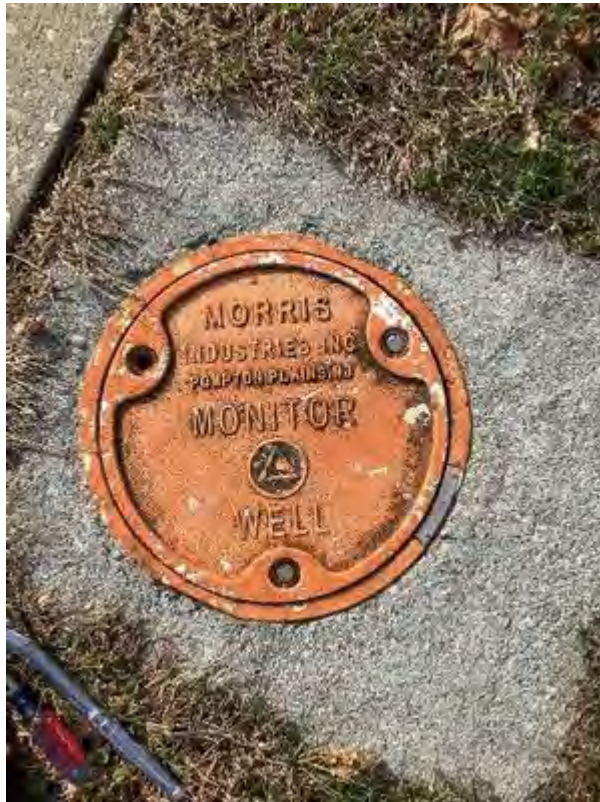
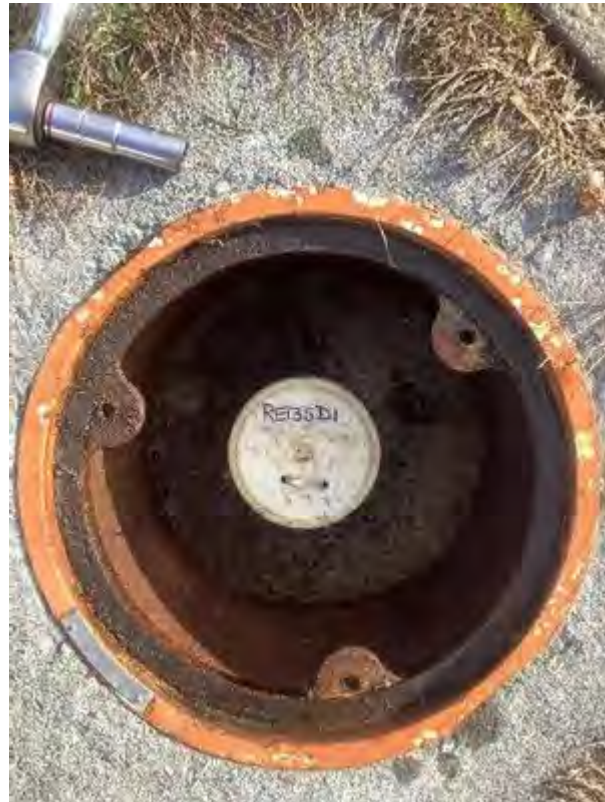
| <b>OVERALL CONDITION:</b> | FAIR |
| <b>Notes (Explain if answered No to any of the above)</b><br>Missing one bolt | |

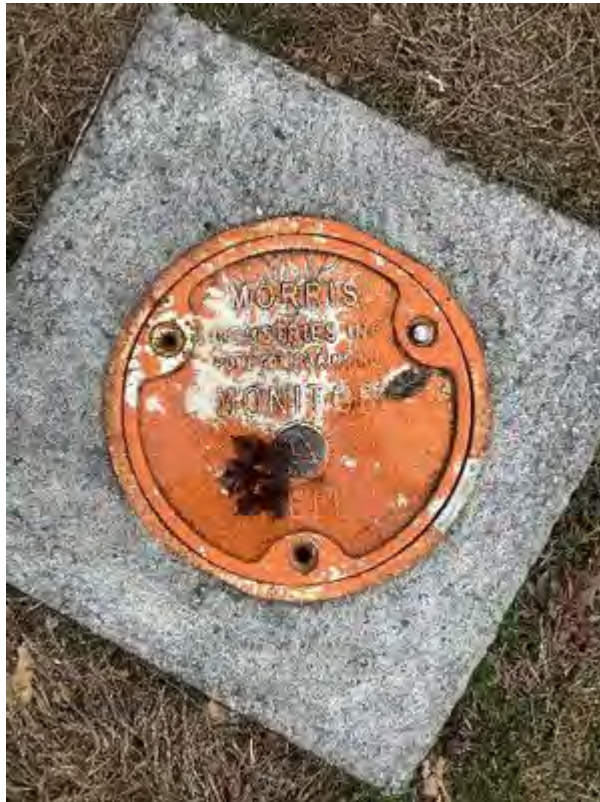
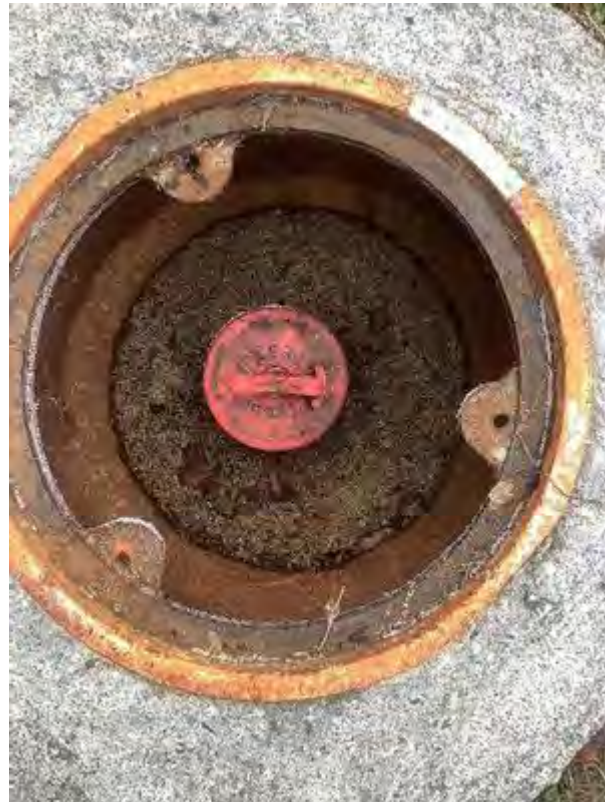
| <b>Notes (Explain if answered No to any of the above)</b><br>Missing two bolts | |

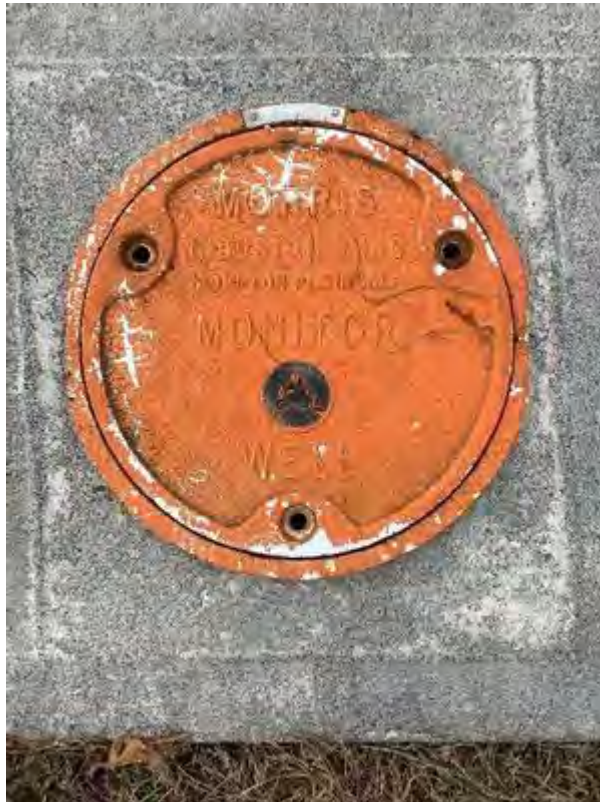
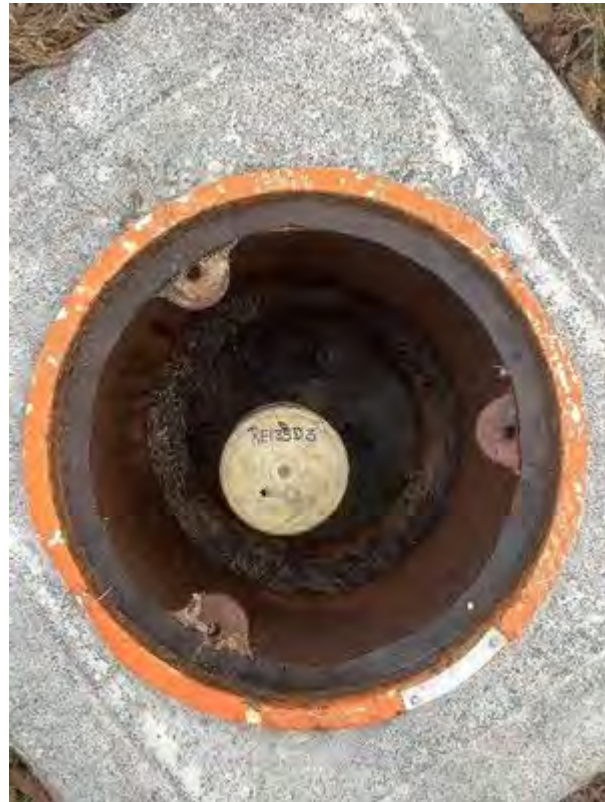
| <b>OVERALL CONDITION:</b> | FAIR |
| <b>Notes (Explain if answered No to any of the above)</b><br>Missing three bolts | |

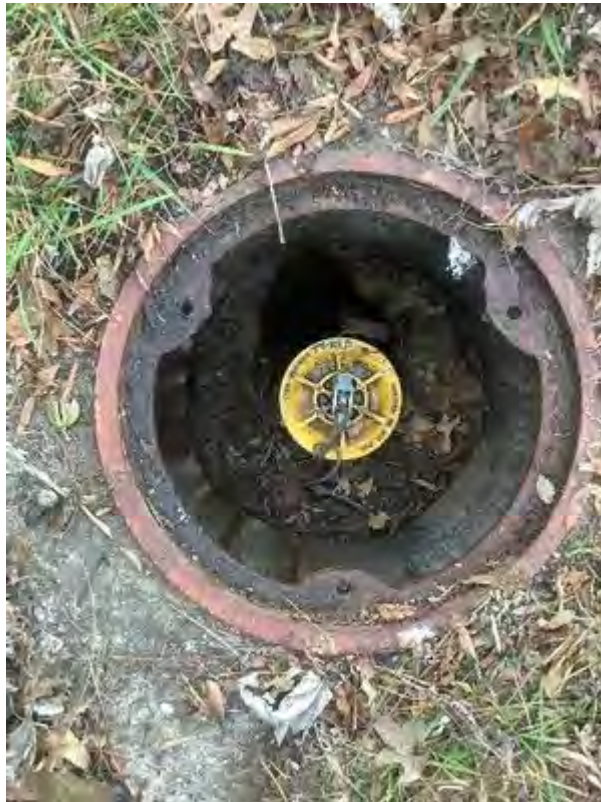
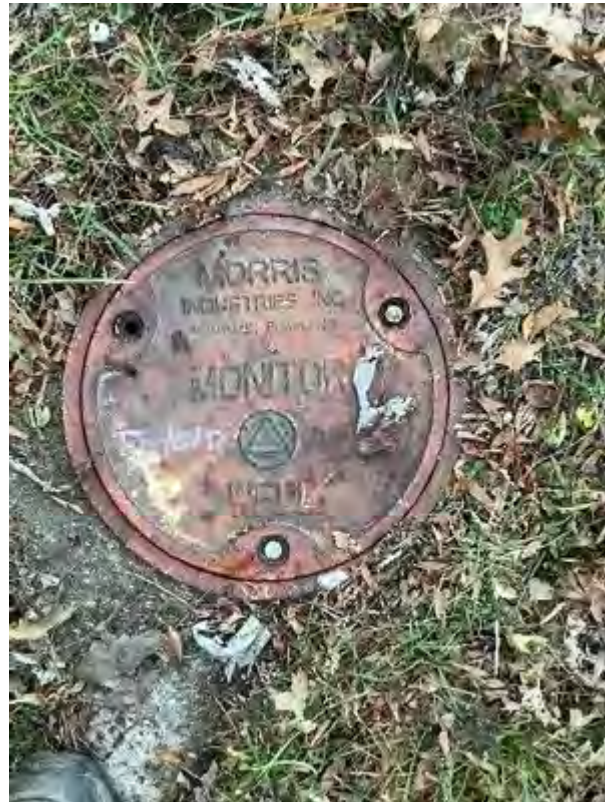
| <b>Notes (Explain if answered No to any of the above)</b><br>Missing one bolt. One bolt stripped | |

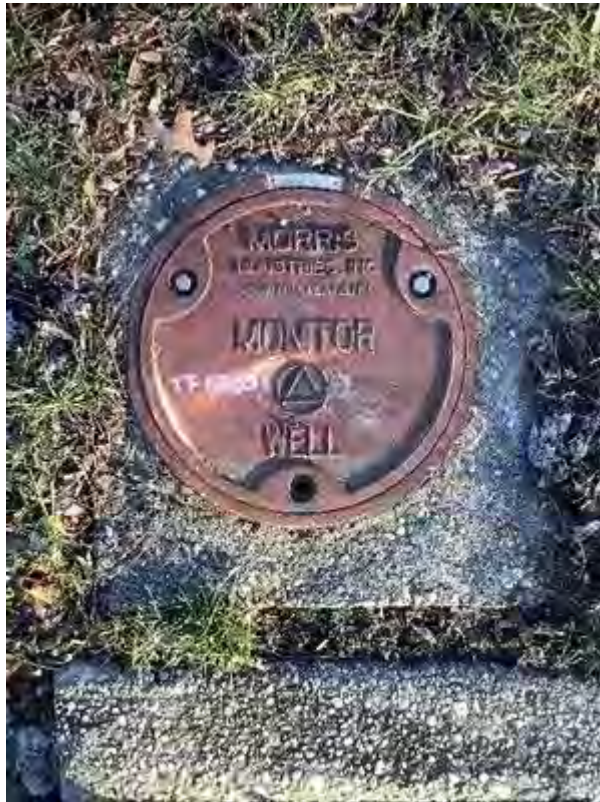
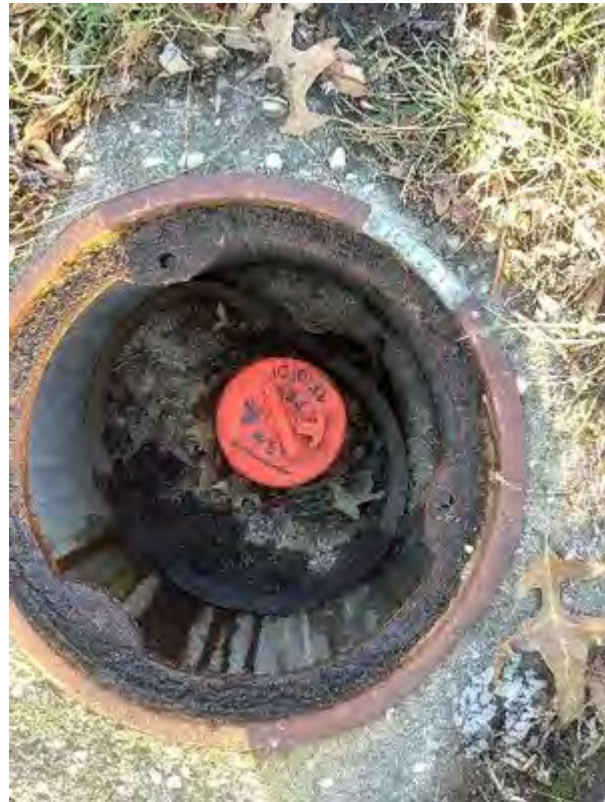
| <b>OVERALL CONDITION:</b> | FAIR |
| <b>Notes (Explain if answered No to any of the above)</b><br>One bolt missing, two bolts stripped | |

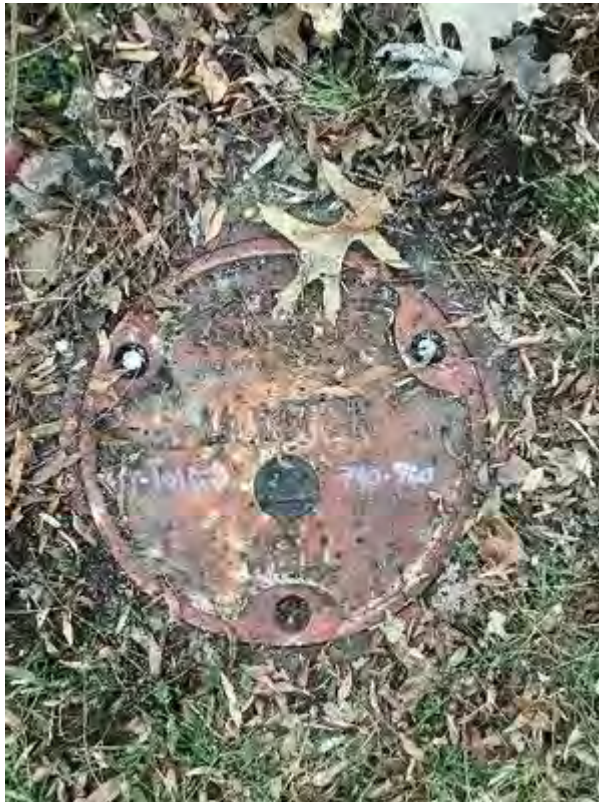
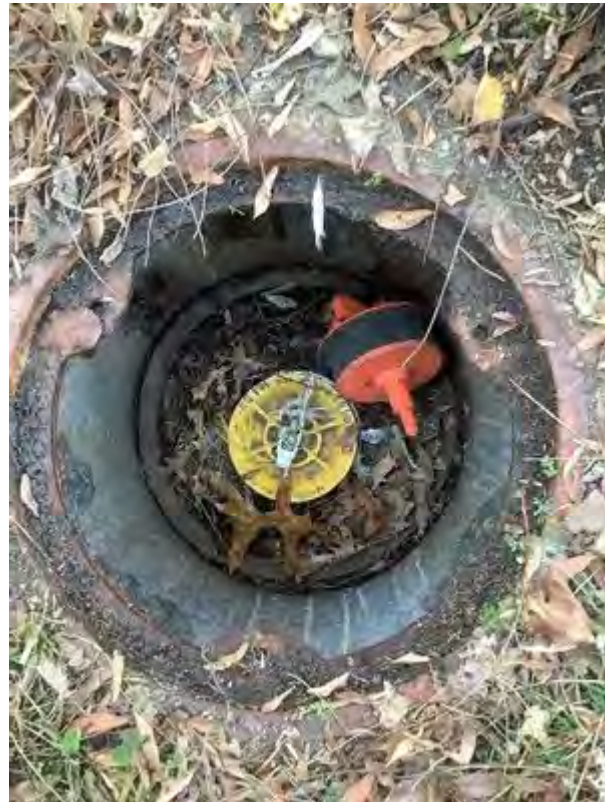
| <b>OVERALL CONDITION:</b> | FAIR |
| <b>Notes (Explain if answered No to any of the above)</b><br>Missing one bolt | |
