Memorandum

To: Scot Sokolowski, NAVFAC MIDLANT
From: David Brayack, Tetra Tech
Date: December 30, 2021
Re: Annual LUC Inspection and Operation Summary Report: Sites 1, 2, 3, and 4 – NWIRP Bethpage
Revision 1
Contract/CTO Number: N6247016D9008/WE13

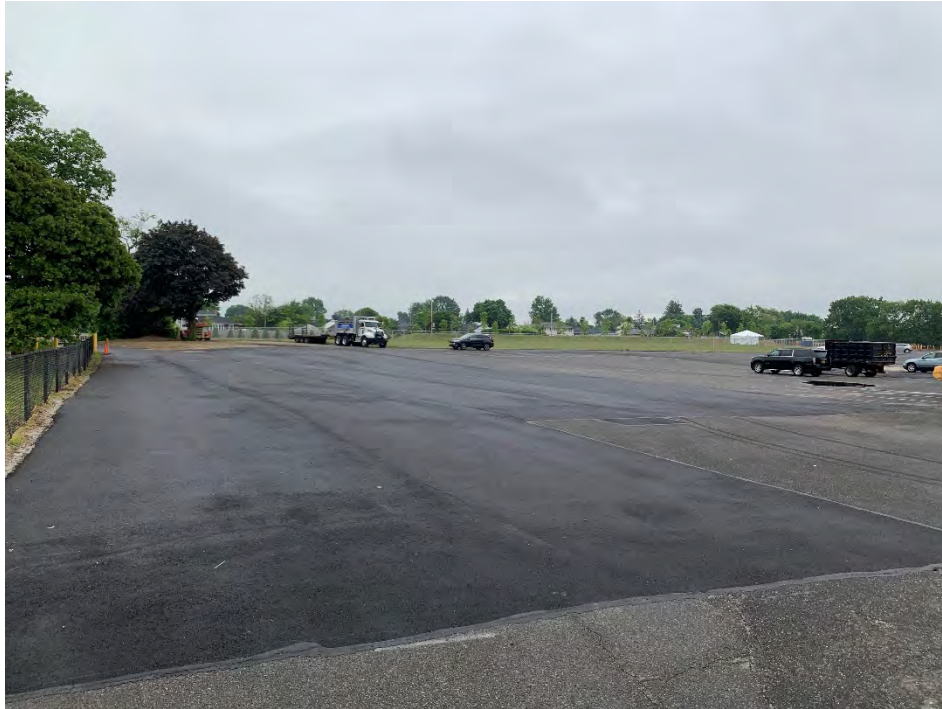
Photo 1A – Northwest corner of Site 1 looking east-southeast at new paving

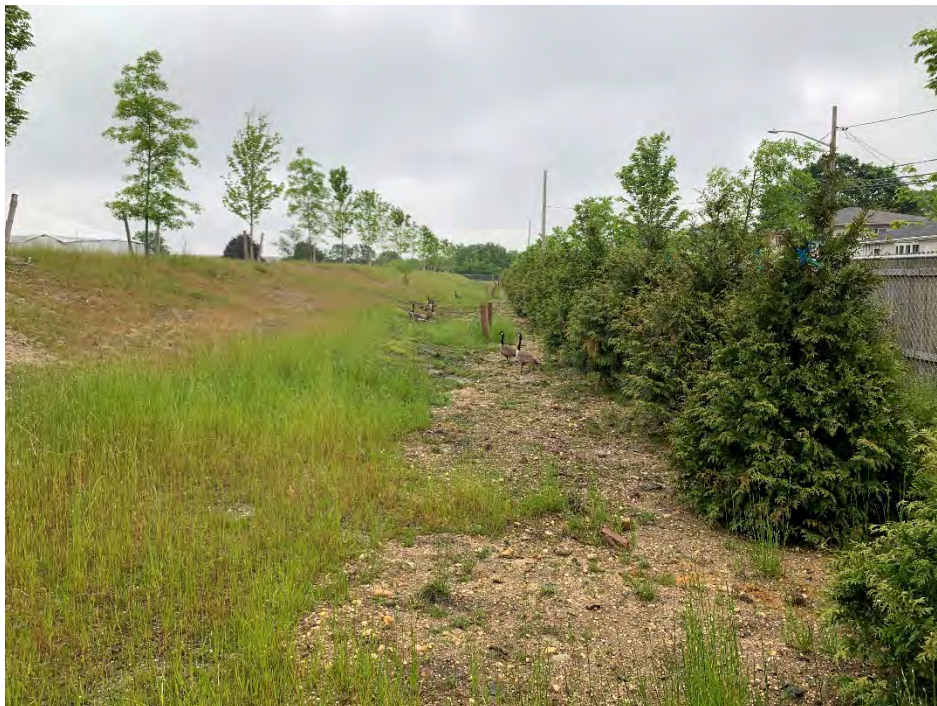
Photo 1B – Site 1 eastern boundary looking north towards SVE wells and new tree plantings

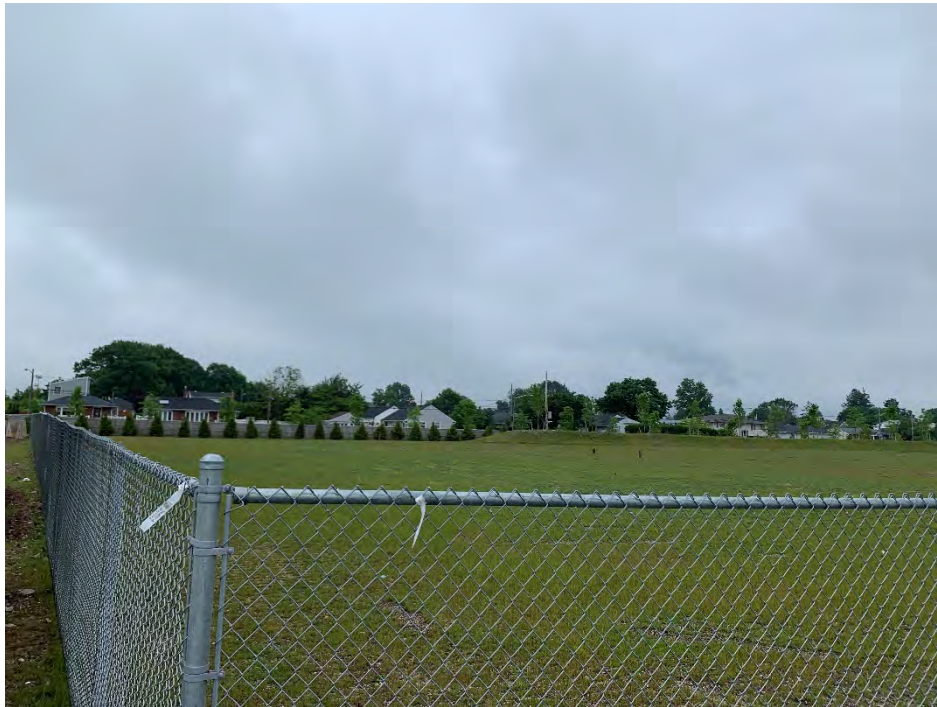
Photo 1C – Northwest corner of Site 1 looking east-southeast within fenced in area of Site 1 at berm, tree plantings and hydroseeding

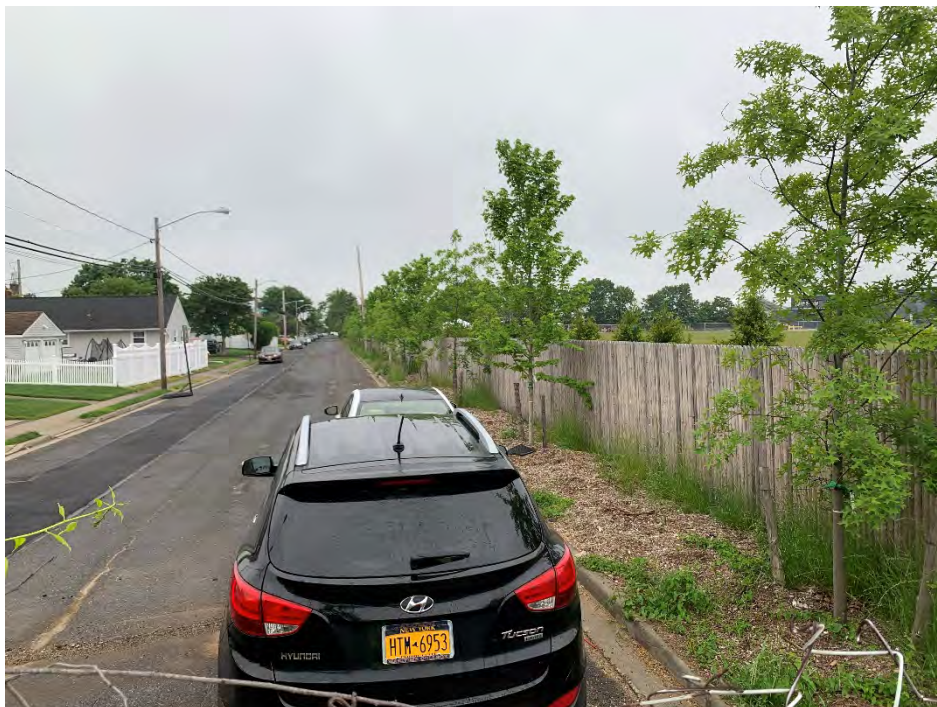
Photo 1D – Site 1 eastern boundary on 11th St looking south at stockade fence and tree plantings. US Government signs were added in June 2021 following inspection.

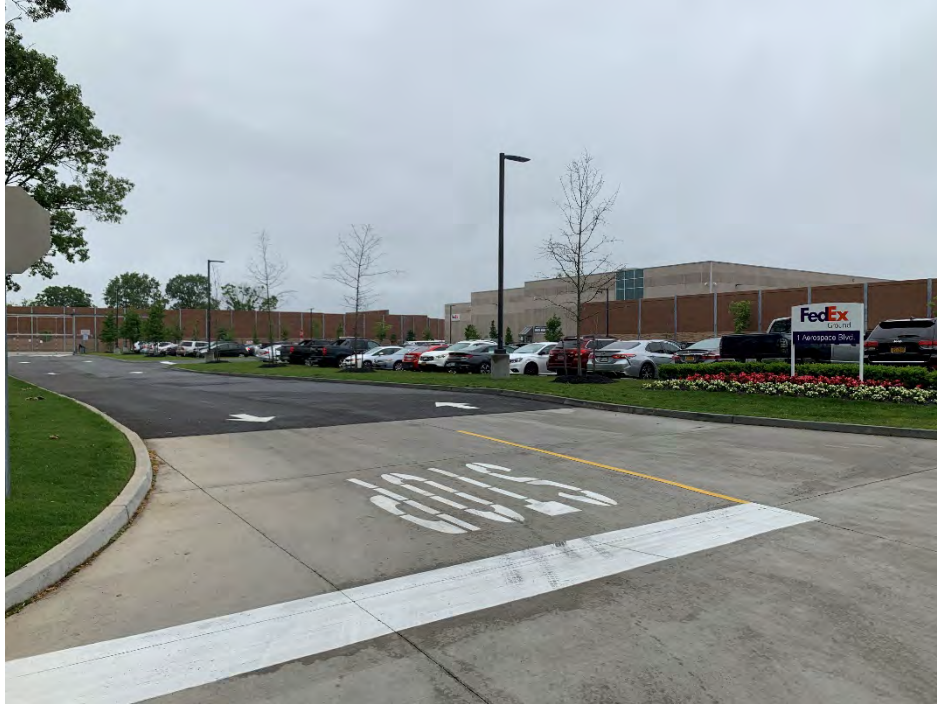
Photo 2A – Northwest portion of Site 2 looking southwest from Aerospace Blvd at FEDEX facility entrance

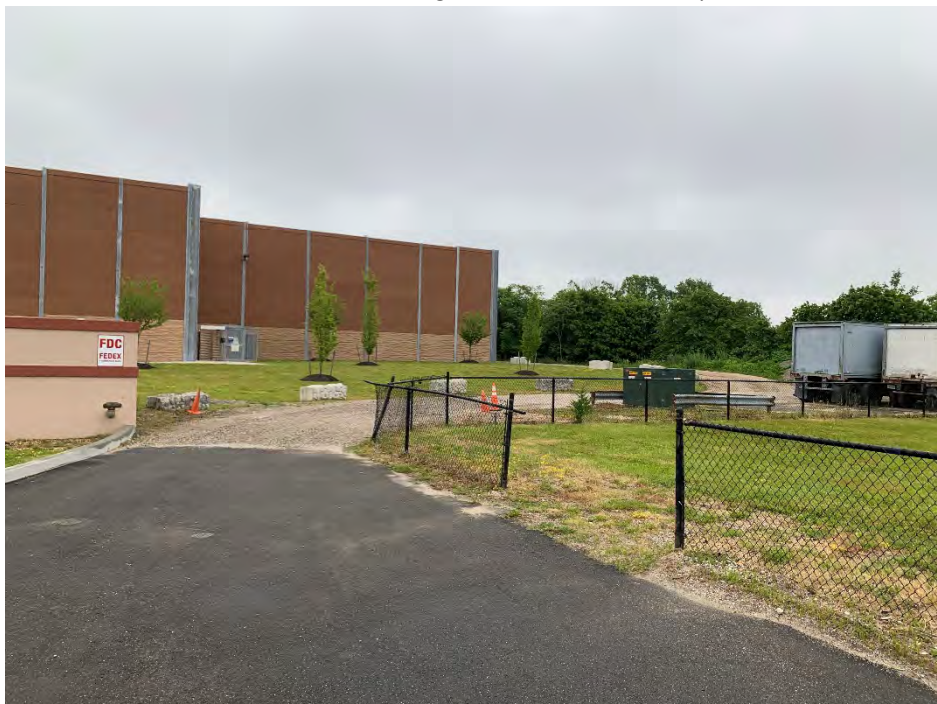
Photo 2B – Southwest corner of Site 2 looking northeast at FEDEX facility sound walls

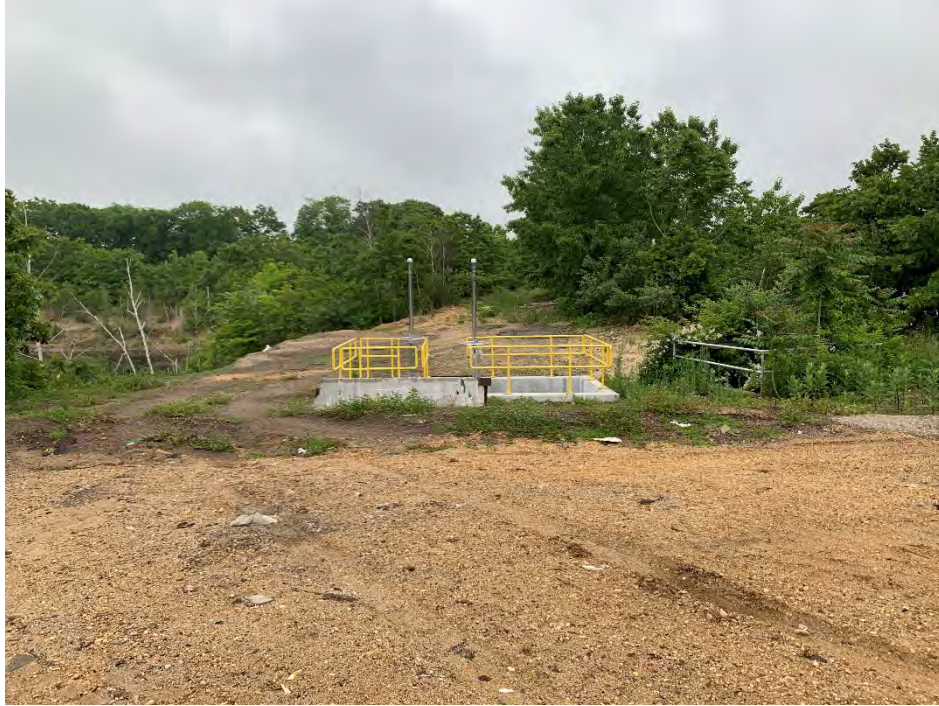
Photo 2C –Center of Site 2 looking east between the north and south basins at sluice gate

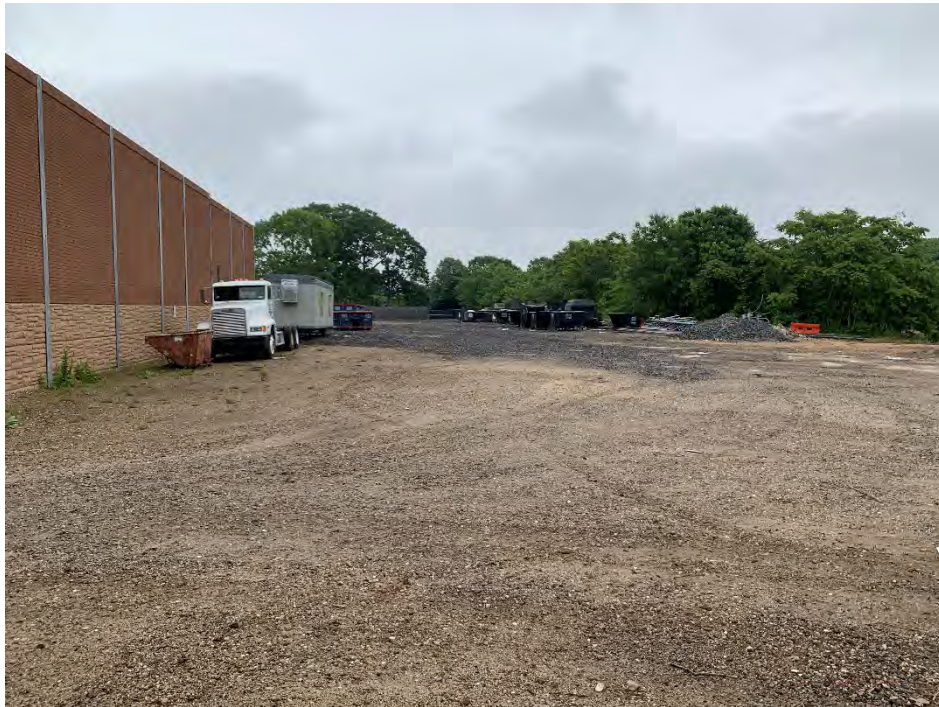
Photo 2D –Center of Site 2 looking north at Steel Equities laydown/storage area between the FEDEX hub terminal and north basin

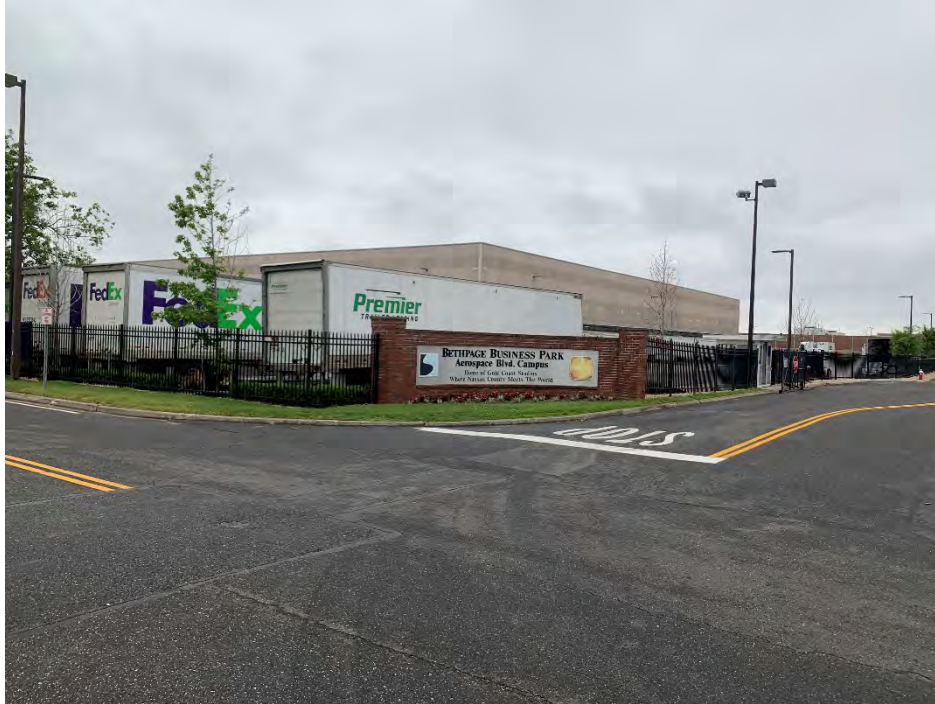
Photo 3A – Northwest corner of Site 3 looking southeast at FEDEX hub terminal

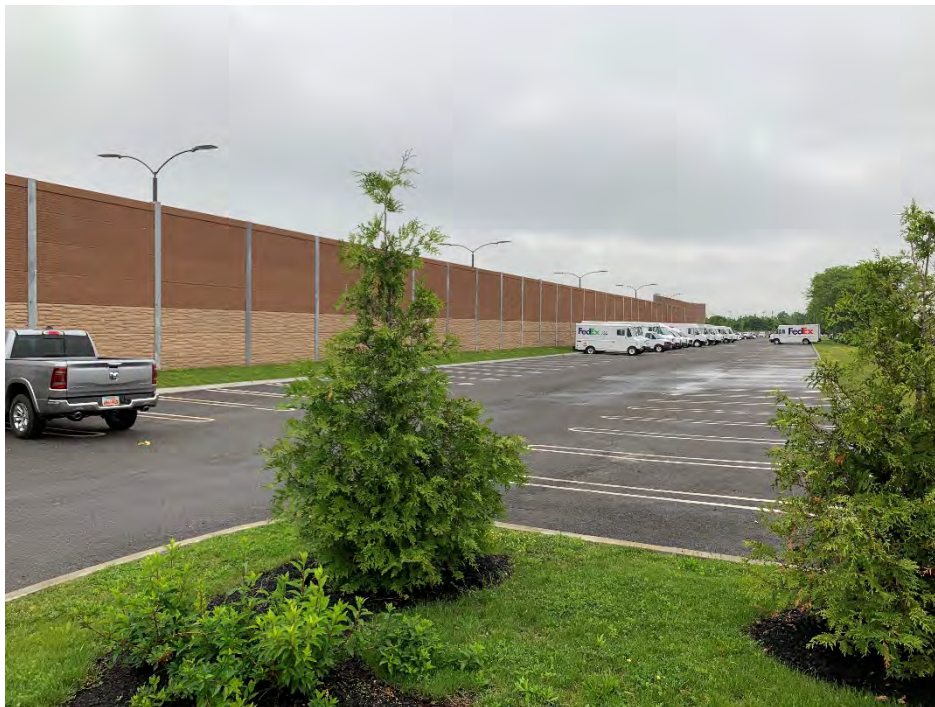
Photo 3B – Southwest corner of Site 3 looking east-northeast at FEDEX hub terminal sound walls and southern parking area

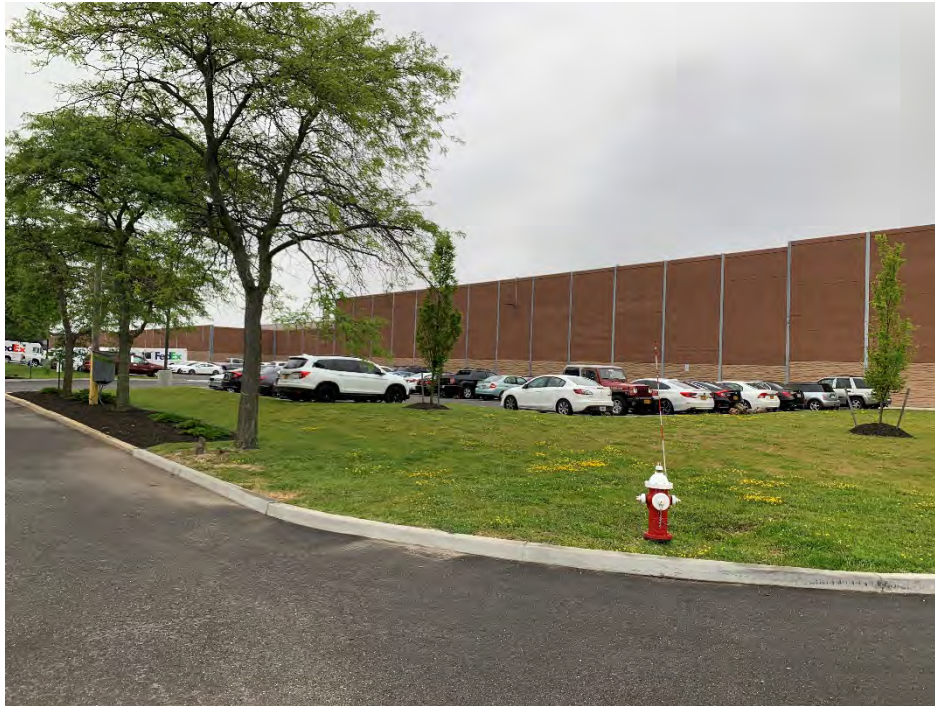
Photo 3C – Southeast corner of Site 3 facing northwest showing the FEDEX hub terminal sound walls and southern parking area

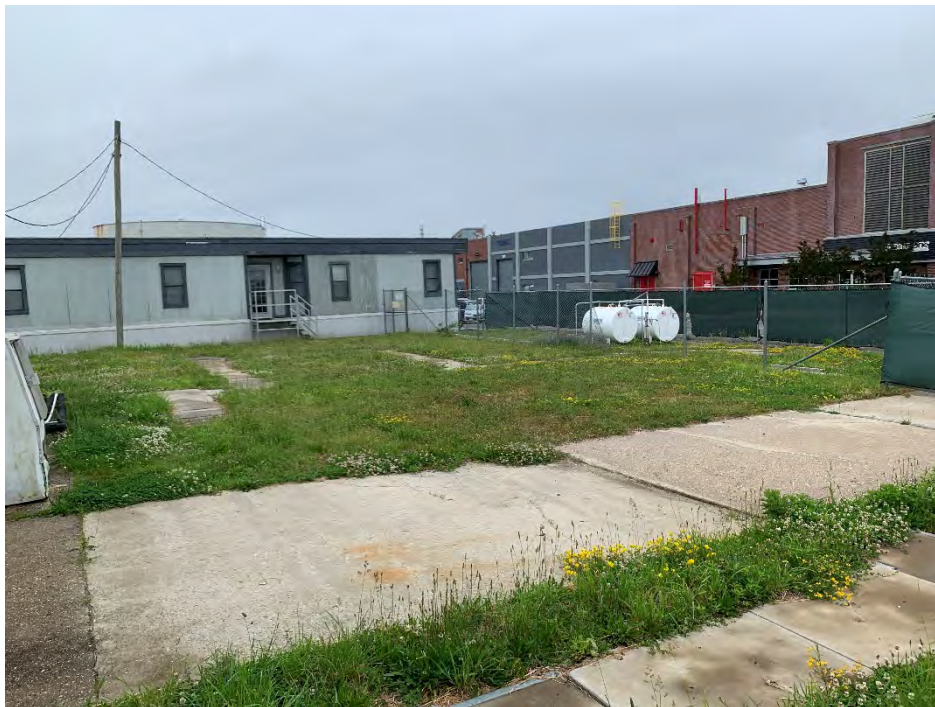
Photo 4A – Southeast corner of Site 4 facing northwest

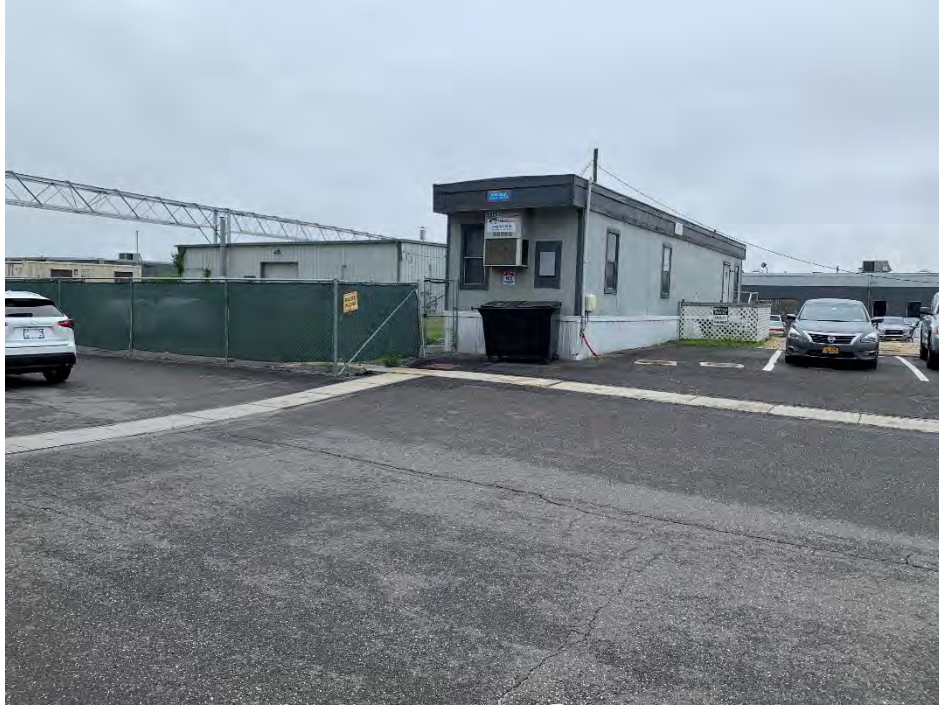
Photo 4B – Northwest corner of Site 4 facing southeast looking at Navy trailer, warehouse and fenced in area

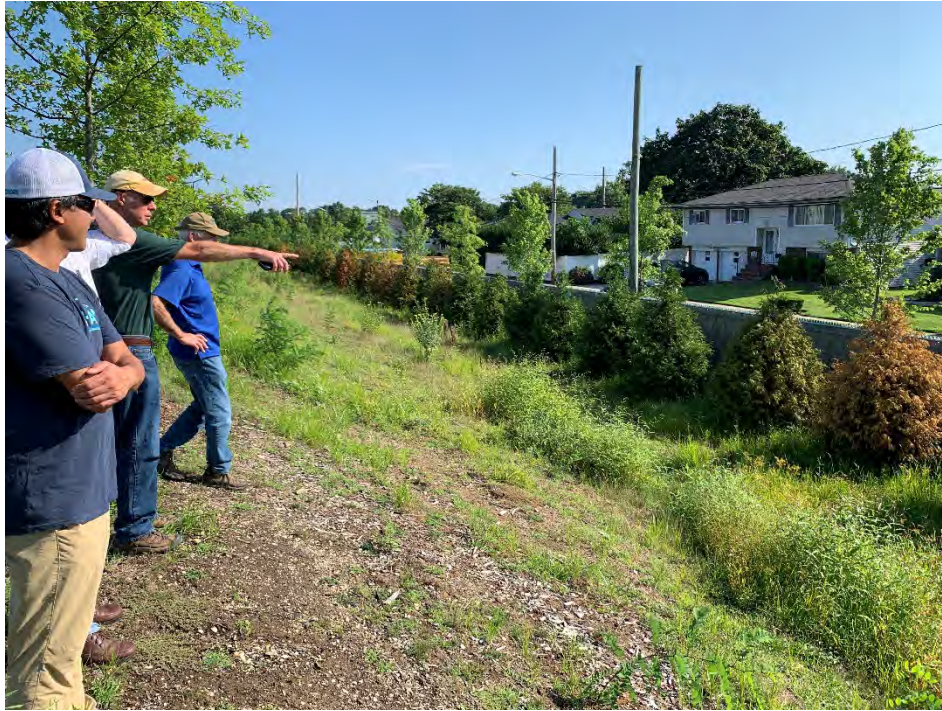
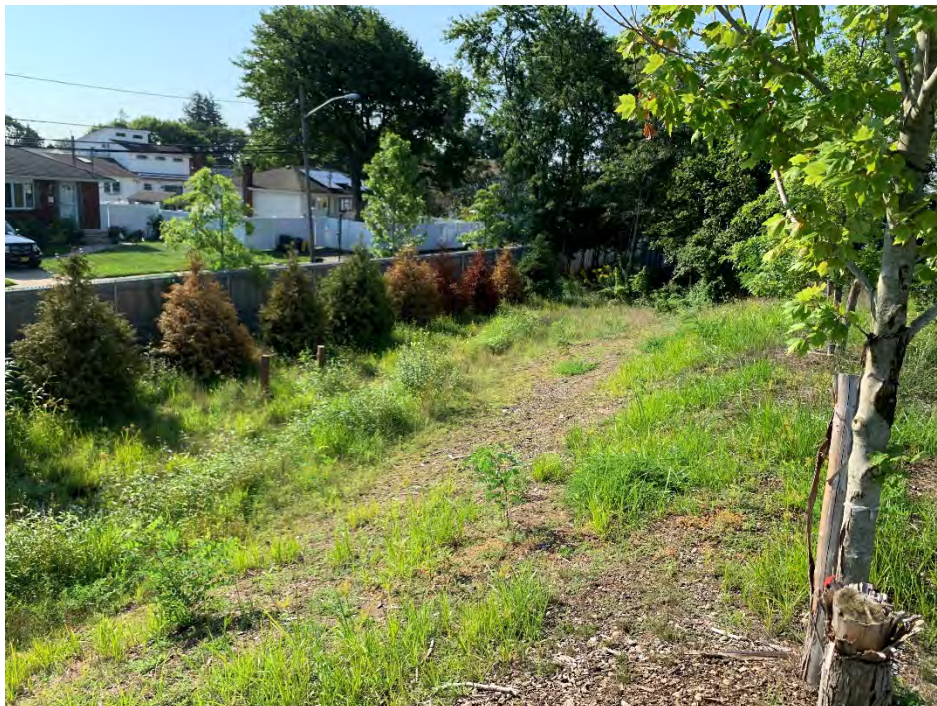
Note: during the site visit, approximately 15 trees were observed to be dying.

Eastern boundary of Site 1 looking southeast at distressed trees

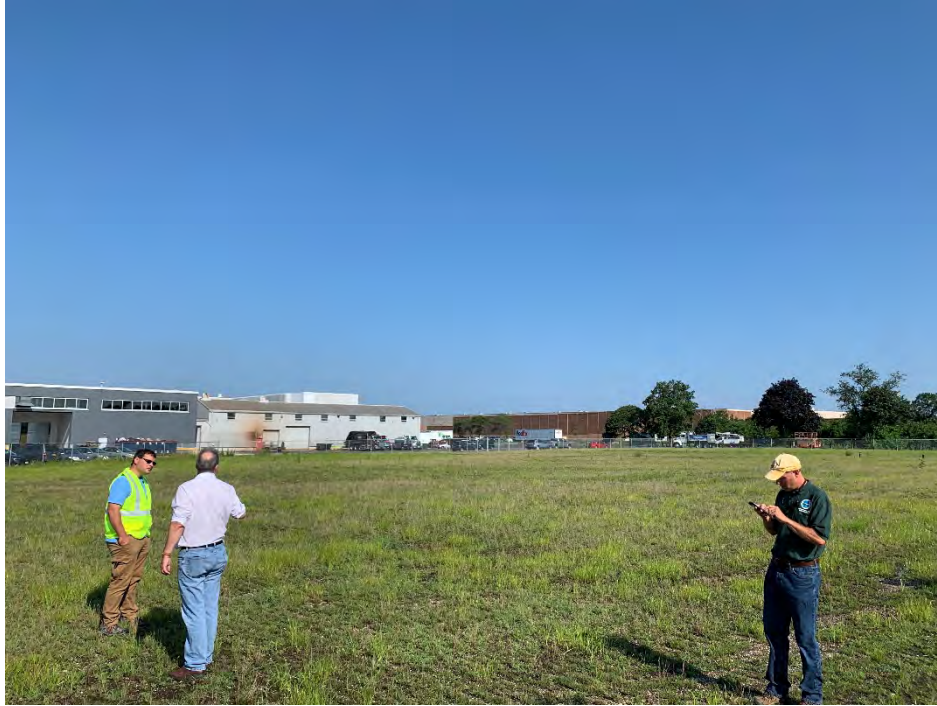
Southeast corner of Site 1 looking northwest within fenced in area of Site 1

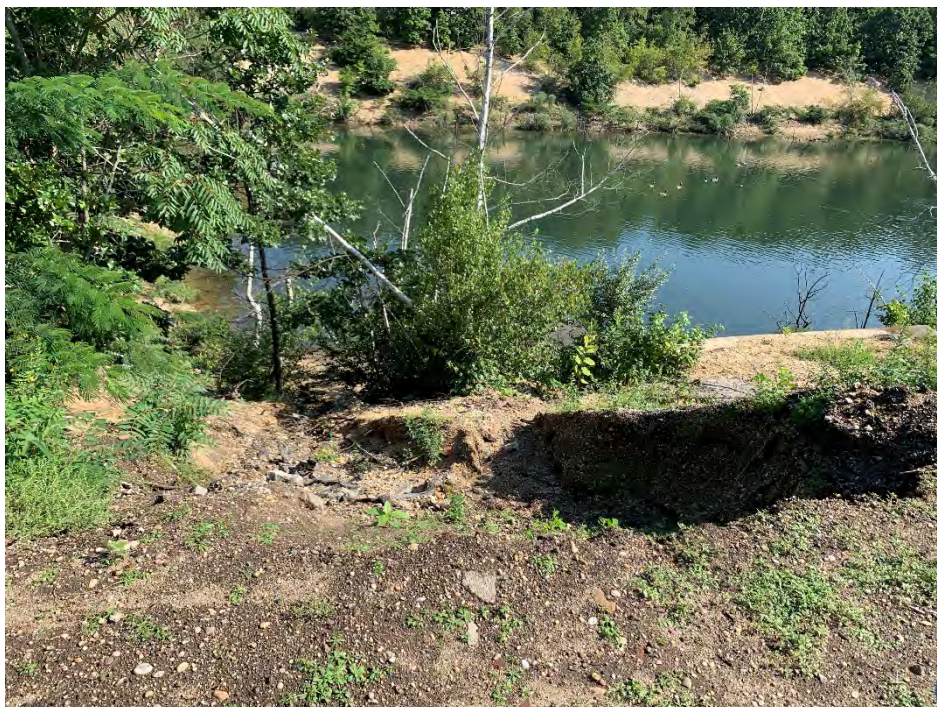
Note: during the site visit, excessive erosion was noted on the southwest corner of the northeastern basin.

View looking north at area of erosion on the northeast recharge basin

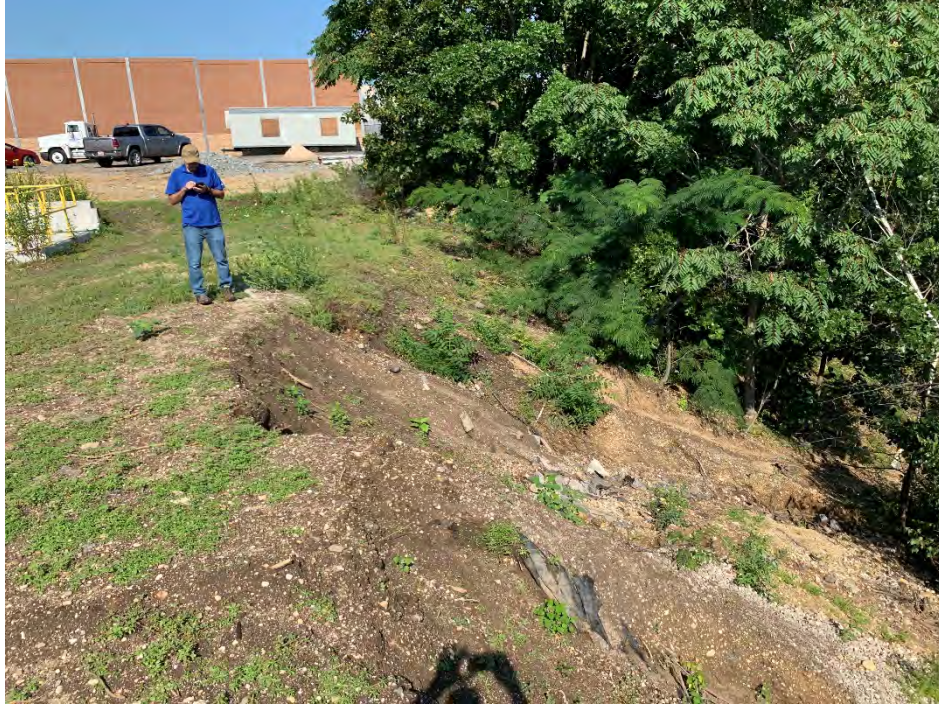
View looking west at area of erosion

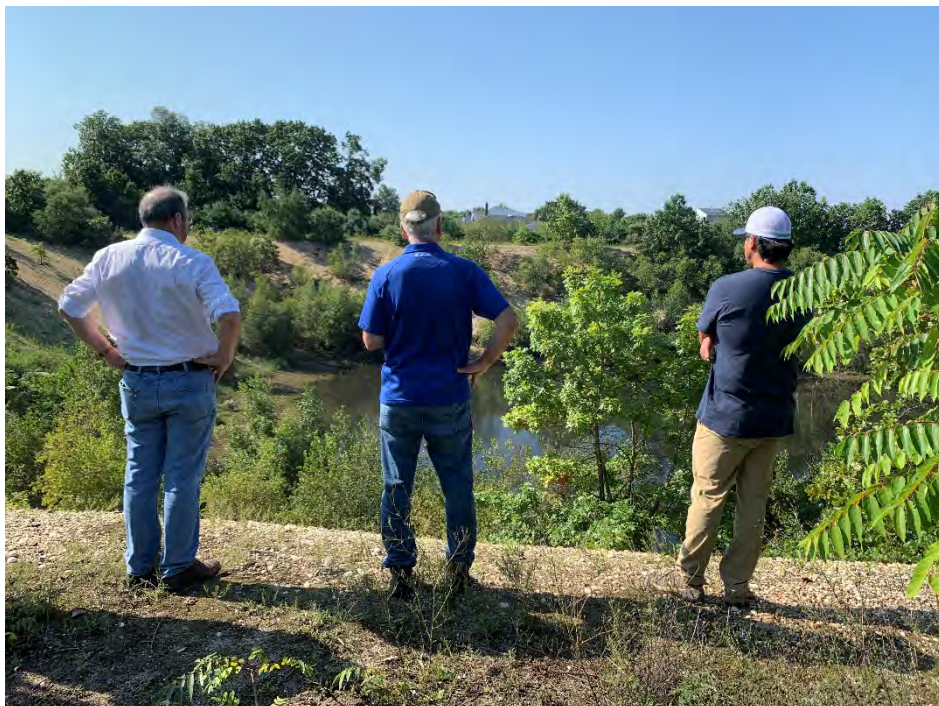
View looking south at southeastern recharge basin

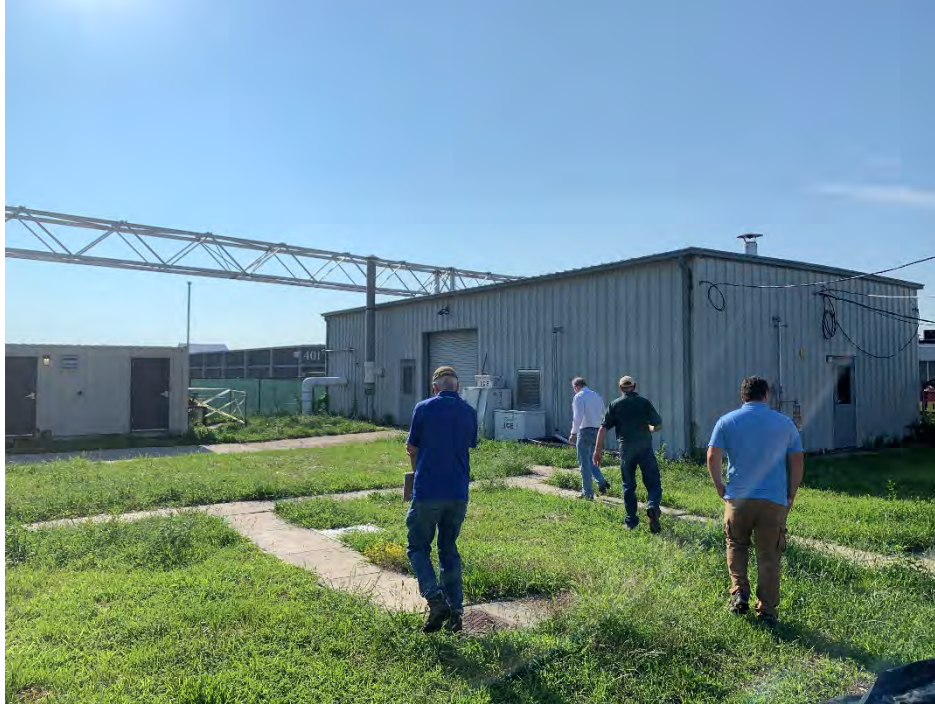
Northwest corner of Site 4 facing southeast looking at warehouse and fenced in area

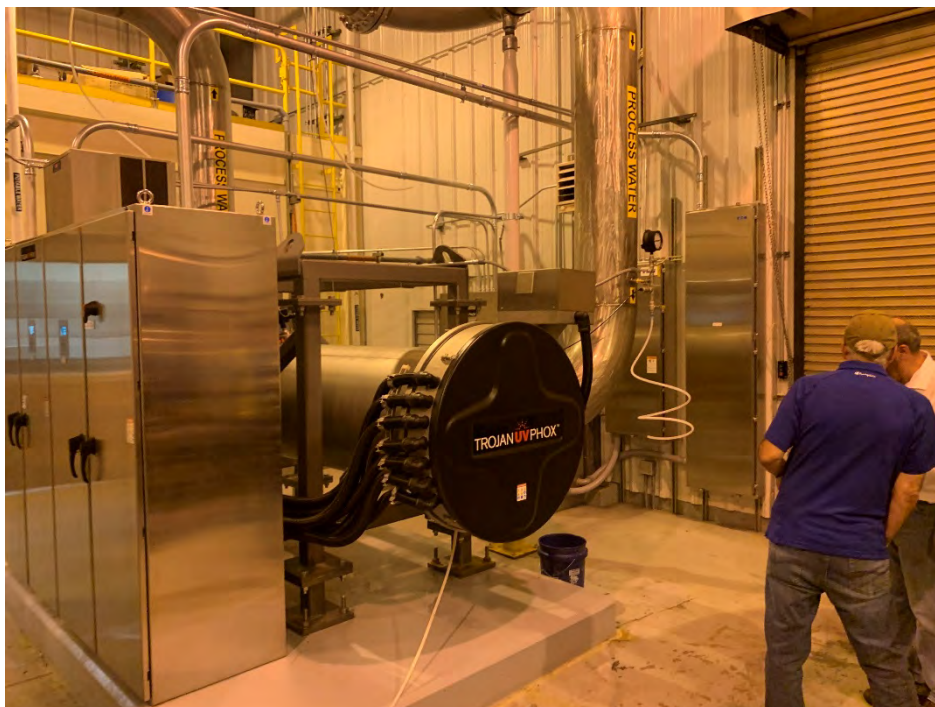
View of newly installed AOP system at GM-38 groundwater treatment facility

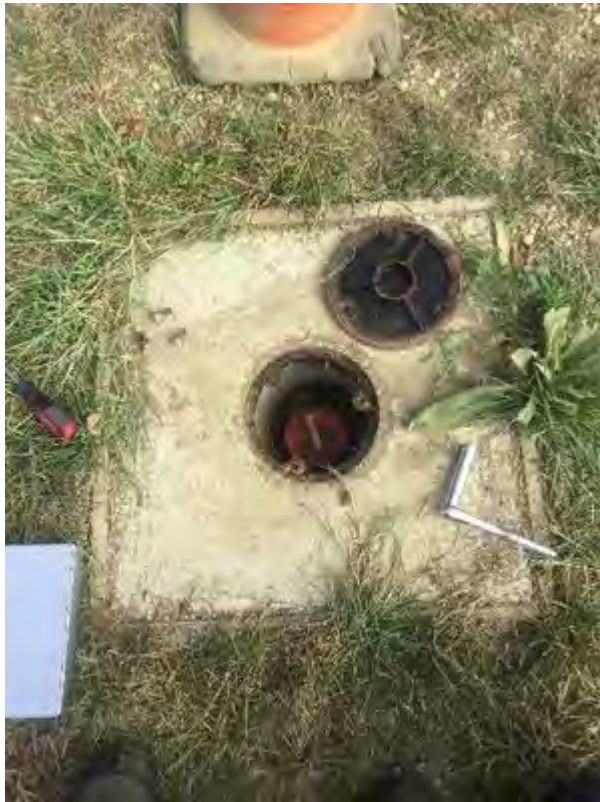
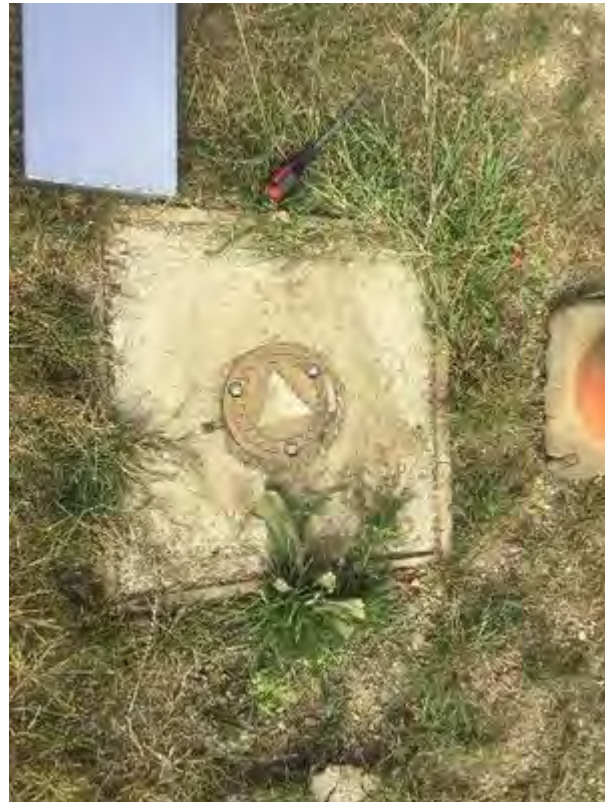
Client: Navy CLEAN	Facility: NWIRP Bethpage
Project Number: 112G08005-WE13	Location: Bethpage, New York
Date: September 23, 2021 10:06	Personnel: Wyatt Bostick
Well ID: BPGMMW74D2	Well Location: 209746.16 1126020.47
Well Status: Other	Screen Interval: 295-305
WELL INVENTORY CONDITION	
Concrete pad in acceptable condition i.e. no cracks?	YES
Manhole cover present and in working condition?	YES
All bolts on manhole present and not stripped?	YES
Well plug present, locked and in good working condition?	NO
OVERALL CONDITION:	FAIR
Notes (Explain if answered No to any of the above)

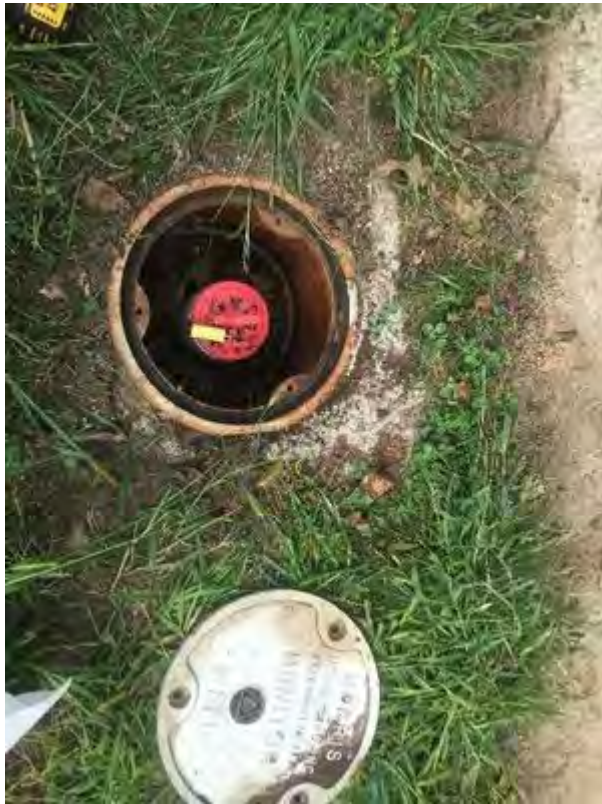
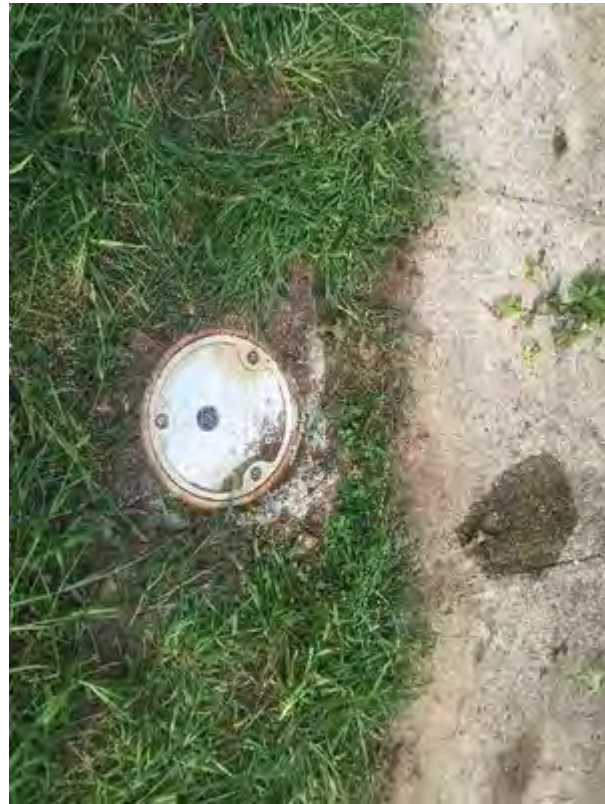
Client: Navy CLEAN	Facility: NWIRP Bethpage
Project Number: 112G08005-WE13	Location: Bethpage, New York
Date: September 14, 2021 16:22	Personnel: Wyatt Bostick
Well ID: BPOW 1-8	Well Location:
Well Status: Other	Screen Interval: 600-640
WELL INVENTORY CONDITION	
Concrete pad in acceptable condition i.e. no cracks?	YES
Manhole cover present and in working condition?	YES
All bolts on manhole present and not stripped?	YES
Well plug present, locked and in good working condition?	YES
OVERALL CONDITION:	GOOD
Notes (Explain if answered No to any of the above)

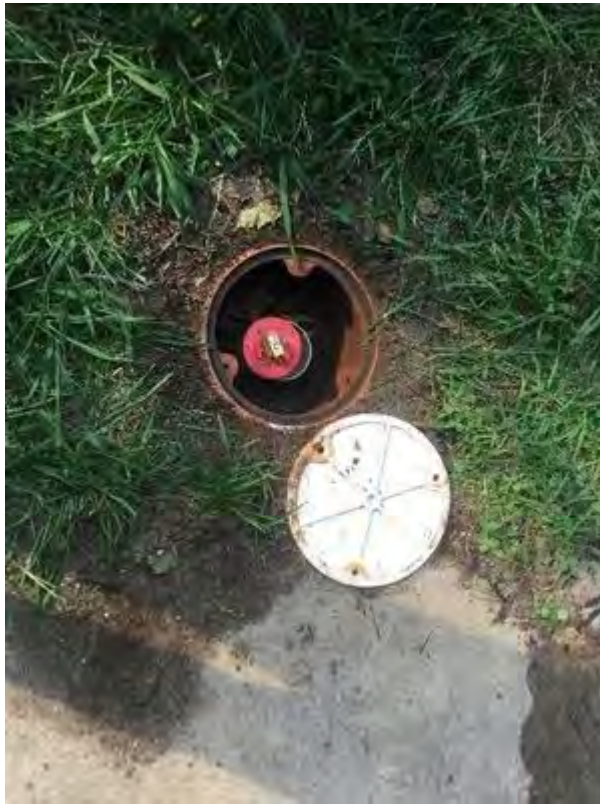
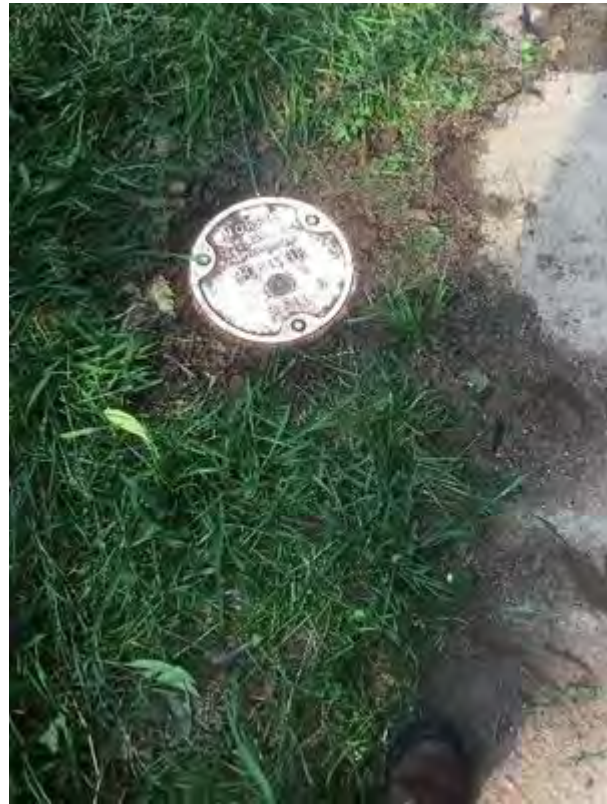
Client: Navy CLEAN	Facility: NWIRP Bethpage
Project Number: 112G08005-WE13	Location: Bethpage, New York
Date: September 14, 2021 15:56	Personnel: Wyatt Bostick
Well ID: BPOW1-7	Well Location: 201889.306192 1130750.23056
Well Status: Other	Screen Interval:
WELL INVENTORY CONDITION	
Concrete pad in acceptable condition i.e. no cracks?	YES
Manhole cover present and in working condition?	YES
All bolts on manhole present and not stripped?	YES
Well plug present, locked and in good working condition?	YES
OVERALL CONDITION:	GOOD
Notes (Explain if answered No to any of the above)

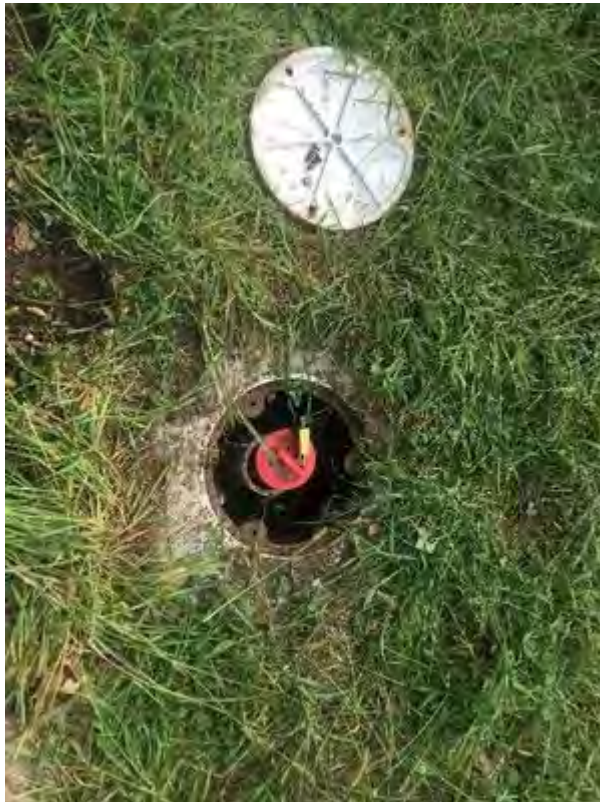
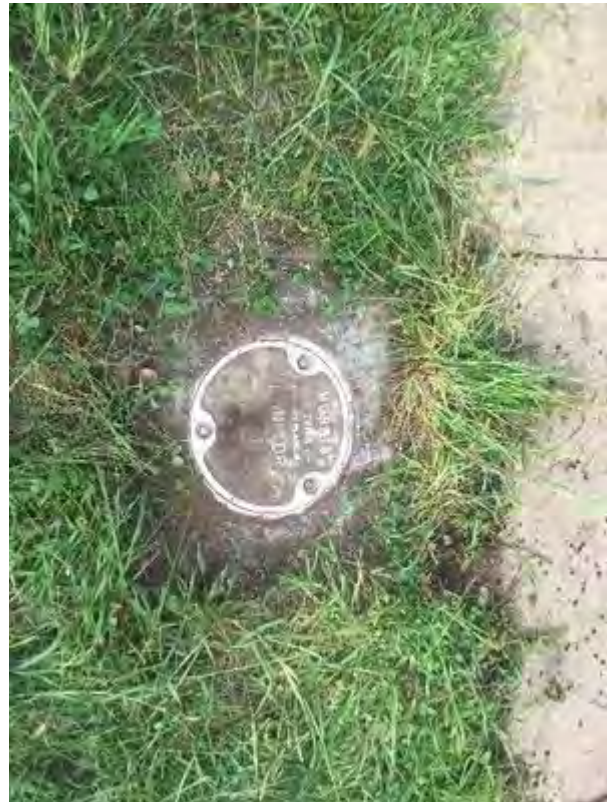
Client: Navy CLEAN	Facility: NWIRP Bethpage
Project Number: 112G08005-WE13	Location: Bethpage, New York
Date: September 14, 2021 16:05	Personnel: Wyatt Bostick
Well ID: BP-TT-MW181S	Well Location:
Well Status: Other	Screen Interval: 210-230
WELL INVENTORY CONDITION	
Concrete pad in acceptable condition i.e. no cracks?	YES
Manhole cover present and in working condition?	YES
All bolts on manhole present and not stripped?	YES
Well plug present, locked and in good working condition?	YES
OVERALL CONDITION:	GOOD
Notes (Explain if answered No to any of the above)

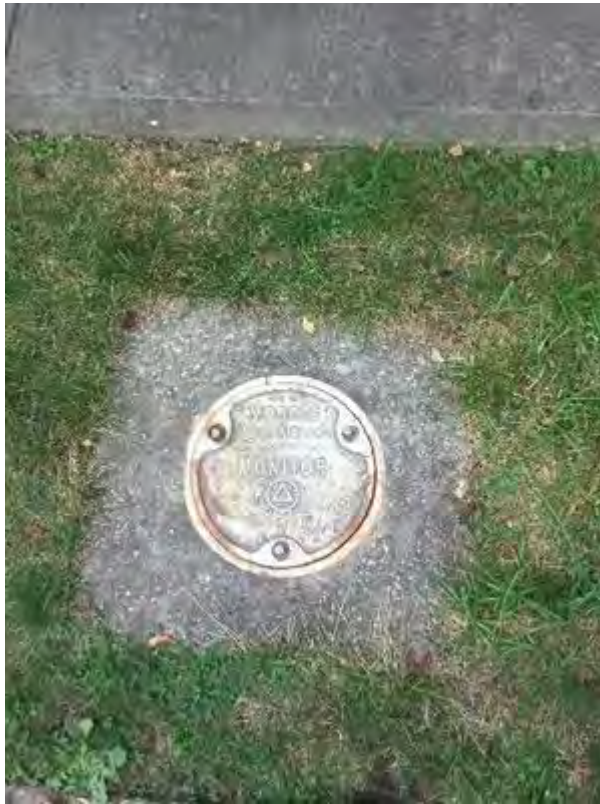
Client: Navy CLEAN	Facility: NWIRP Bethpage
Project Number: 112G08005-WE13	Location: Bethpage, New York
Date: September 20, 2021 14:27	Personnel: Noah Sprouse
Well ID: RE126D2	Well Location: 208584.28 1125643.78
Well Status: Other	Screen Interval: 555-575
WELL INVENTORY CONDITION	
Concrete pad in acceptable condition i.e. no cracks?	YES
Manhole cover present and in working condition?	YES
All bolts on manhole present and not stripped?	YES
Well plug present, locked and in good working condition?	YES
OVERALL CONDITION:	GOOD
Notes (Explain if answered No to any of the above)

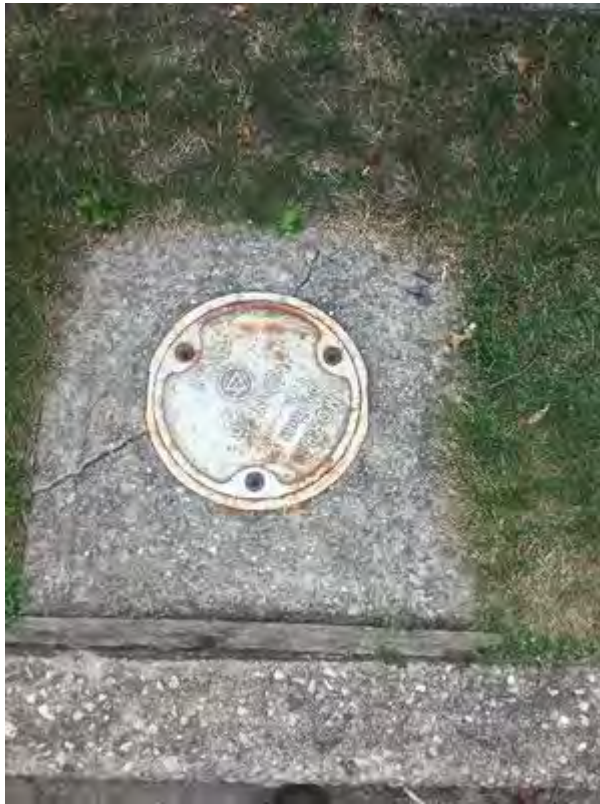
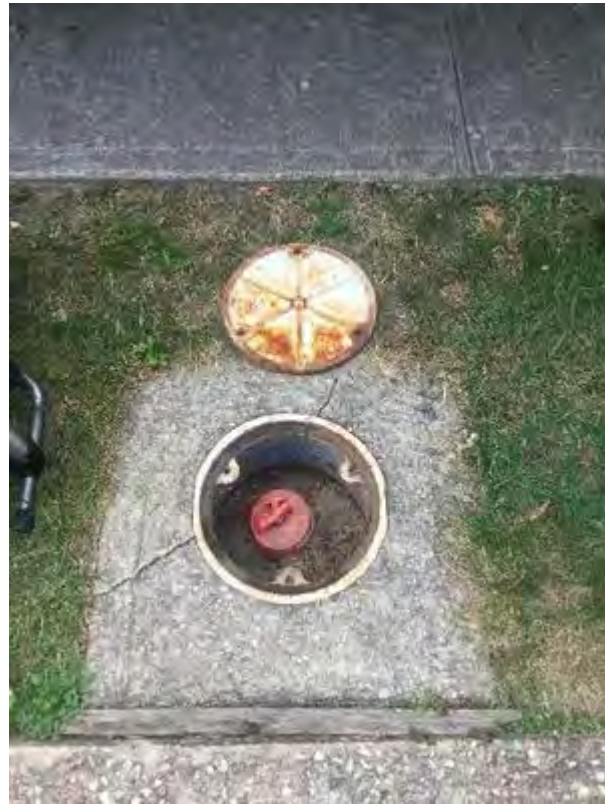
Client: Navy CLEAN	Facility: NWIRP Bethpage
Project Number: 112G08005-WE13	Location: Bethpage, New York
Date: September 20, 2021 14:21	Personnel: Noah Sprouse
Well ID: RE126D3	Well Location: 208568.11 1125643.6
Well Status: Other	Screen Interval: 640-660
WELL INVENTORY CONDITION	
Concrete pad in acceptable condition i.e. no cracks?	NO
Manhole cover present and in working condition?	YES
All bolts on manhole present and not stripped?	NO
Well plug present, locked and in good working condition?	YES
OVERALL CONDITION:	FAIR
Notes (Explain if answered No to any of the above) Concrete pad has cracks, all bolts stripped.

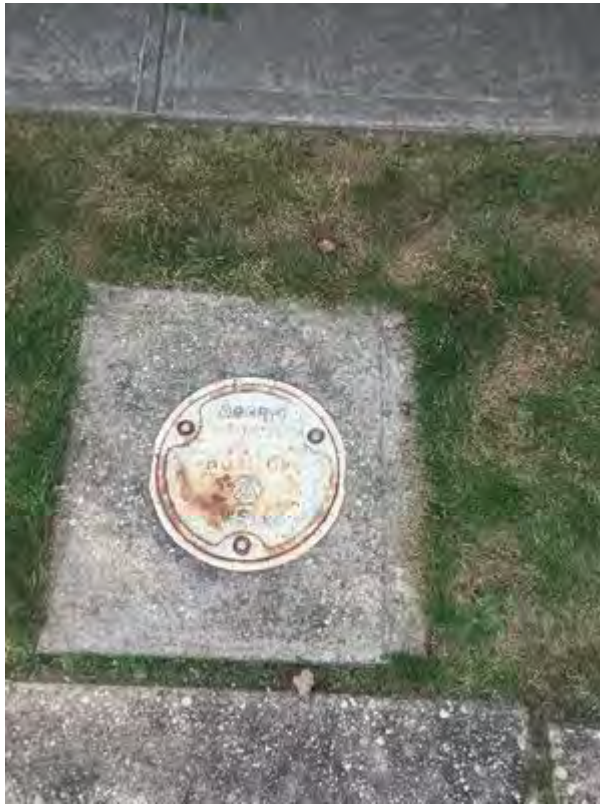
Client: Navy CLEAN	Facility: NWIRP Bethpage
Project Number: 112G08005-WE13	Location: Bethpage, New York
Date: September 20, 2021 14:12	Personnel: Noah Sprouse
Well ID: RE126D1	Well Location: 208553.86 1125643
Well Status: Other	Screen Interval: 500-520
WELL INVENTORY CONDITION	
Concrete pad in acceptable condition i.e. no cracks?	YES
Manhole cover present and in working condition?	YES
All bolts on manhole present and not stripped?	NO
Well plug present, locked and in good working condition?	YES
OVERALL CONDITION:	FAIR
Notes (Explain if answered No to any of the above) All bolts stripped.

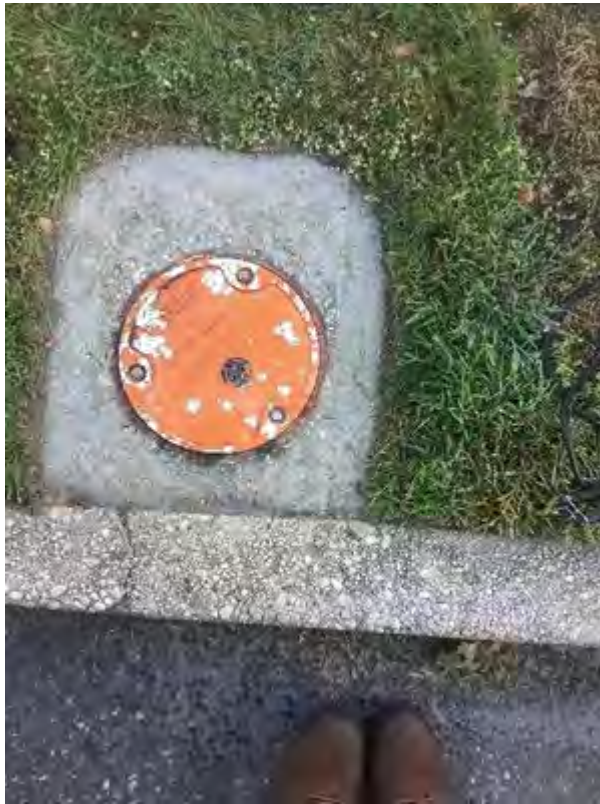
Client: Navy CLEAN	Facility: NWIRP Bethpage
Project Number: 112G08005-WE13	Location: Bethpage, New York
Date: September 20, 2021 08:24	Personnel: Noah Sprouse
Well ID: RE103D1	Well Location: 206694.59 1125111.764
Well Status: Other	Screen Interval: 625-640
WELL INVENTORY CONDITION	
Concrete pad in acceptable condition i.e. no cracks?	YES
Manhole cover present and in working condition?	YES
All bolts on manhole present and not stripped?	NO
Well plug present, locked and in good working condition?	YES
OVERALL CONDITION:	FAIR
Notes (Explain if answered No to any of the above) All bolts stripped, missing rubber gasket, needs fill
