Memorandum

To: Scot Sokolowski, NAVFAC MIDLANT
From: David Brayack, Tetra Tech
Date: December 30, 2021
Re: Annual LUC Inspection and Operation Summary Report: Sites 1, 2, 3, and 4 – NWIRP Bethpage
Revision 1
Contract/CTO Number: N6247016D9008/WE13

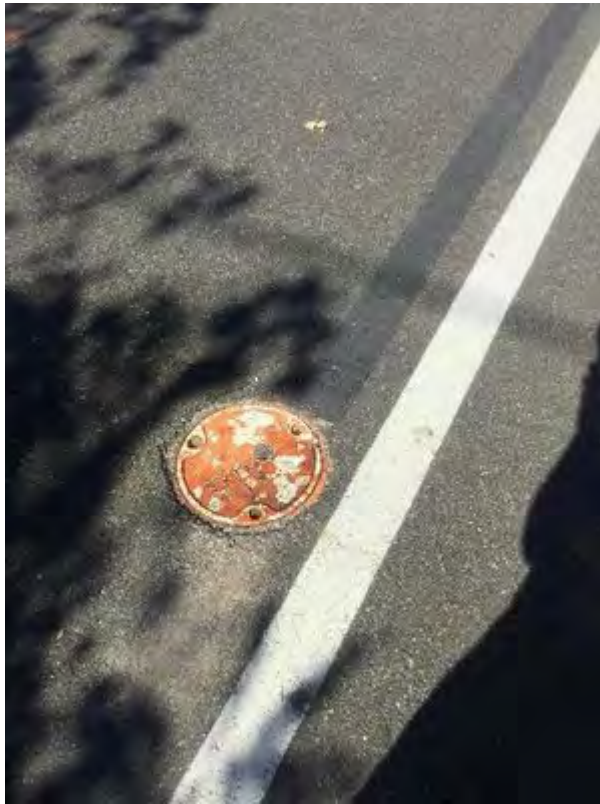
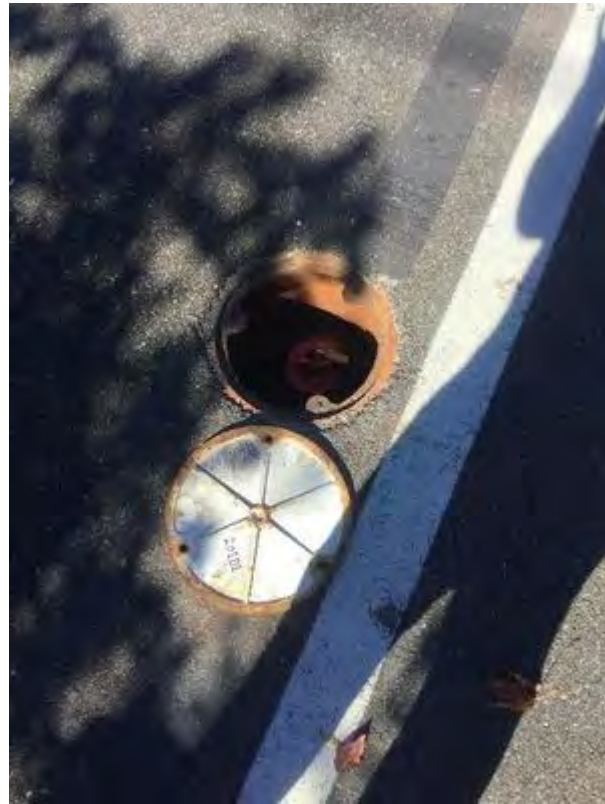
Client: Navy CLEAN	Facility: NWIRP Bethpage
Project Number: 112G08005-WE13	Location: Bethpage, New York
Date: September 19, 2021 15:07	Personnel: Noah Sprouse
Well ID: BP-TT-MW201D1	Well Location: 214055.8 1123155.3
Well Status: Other	Screen Interval: 480-500
WELL INVENTORY CONDITION	
Concrete pad in acceptable condition i.e. no cracks?	YES
Manhole cover present and in working condition?	YES
All bolts on manhole present and not stripped?	NO
Well plug present, locked and in good working condition?	YES
OVERALL CONDITION:	FAIR
Notes (Explain if answered No to any of the above) All three bolts snapped. Use this one (has both pictures).

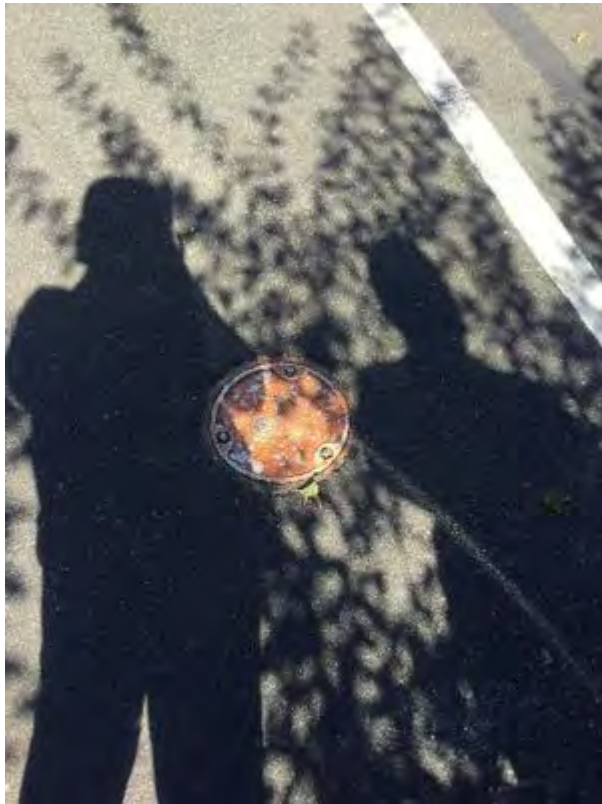
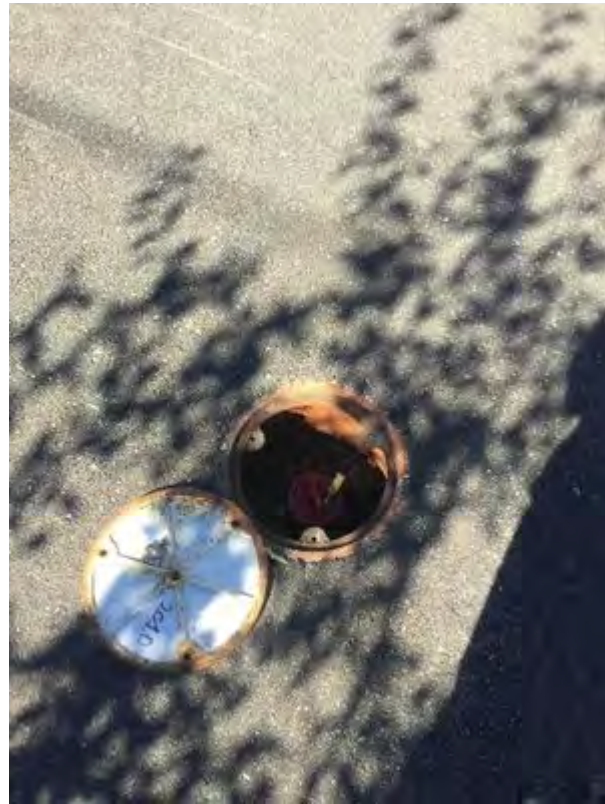
Client: Navy CLEAN	Facility: NWIRP Bethpage
Project Number: 112G08005-WE13	Location: Bethpage, New York
Date: September 19, 2021 15:03	Personnel: Noah Sprouse
Well ID: BP-TT-MW201D	Well Location: 214069.5 1123138.5
Well Status: Other	Screen Interval: 335-350
WELL INVENTORY CONDITION	
Concrete pad in acceptable condition i.e. no cracks?	YES
Manhole cover present and in working condition?	YES
All bolts on manhole present and not stripped?	YES
Well plug present, locked and in good working condition?	YES
OVERALL CONDITION:	GOOD
Notes (Explain if answered No to any of the above) Use this one (has both pictures).

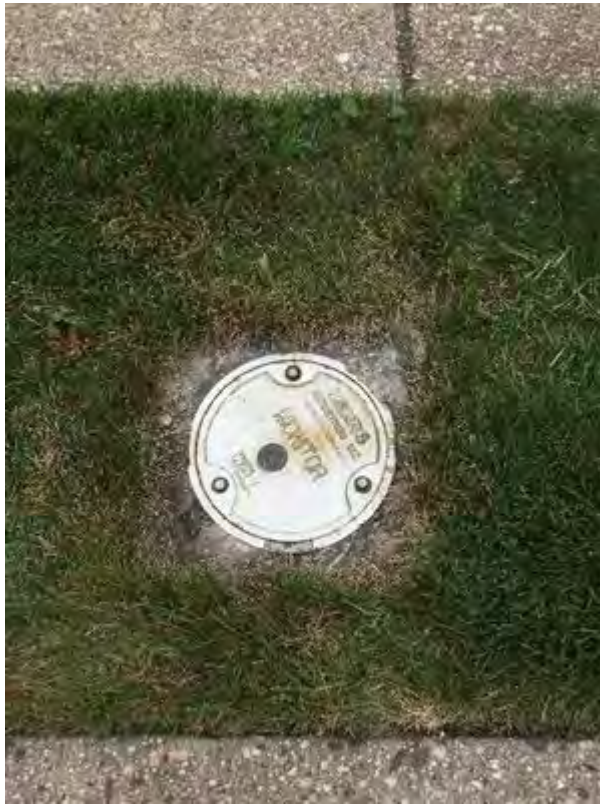
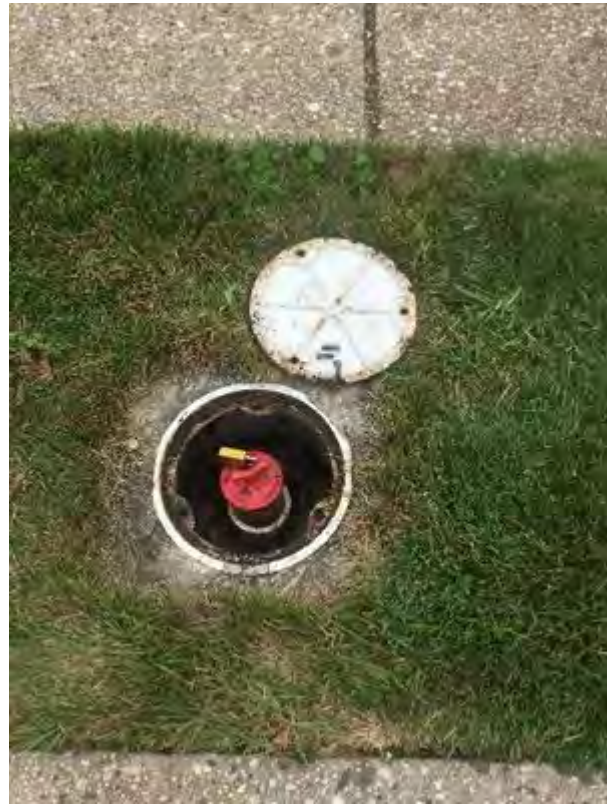
Client: Navy CLEAN	Facility: NWIRP Bethpage
Project Number: 112G08005-WE13	Location: Bethpage, New York
Date: September 17, 2021 12:05	Personnel: Noah Sprouse
Well ID: RE120D3	Well Location: 204590.37 1125060.7
Well Status: Other	Screen Interval: 740-760
WELL INVENTORY CONDITION	
Concrete pad in acceptable condition i.e. no cracks?	YES
Manhole cover present and in working condition?	YES
All bolts on manhole present and not stripped?	YES
Well plug present, locked and in good working condition?	YES
OVERALL CONDITION:	GOOD
Notes (Explain if answered No to any of the above)

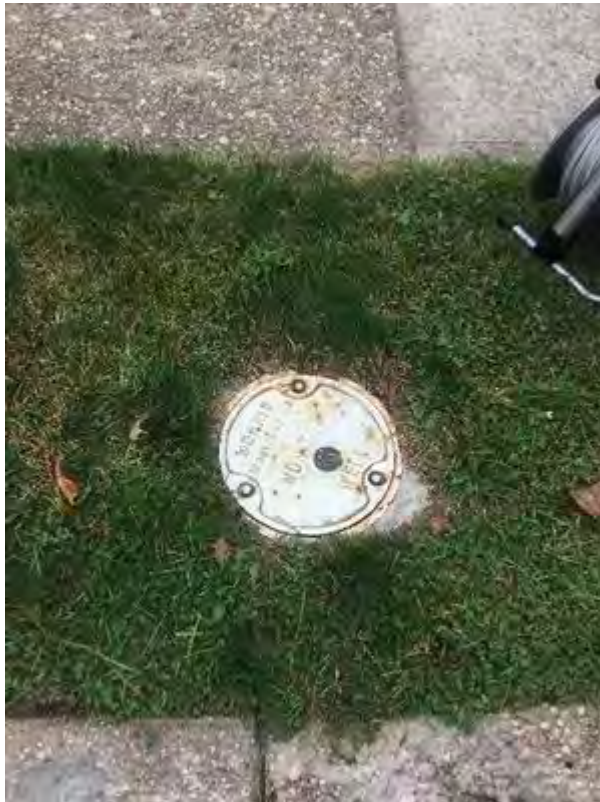
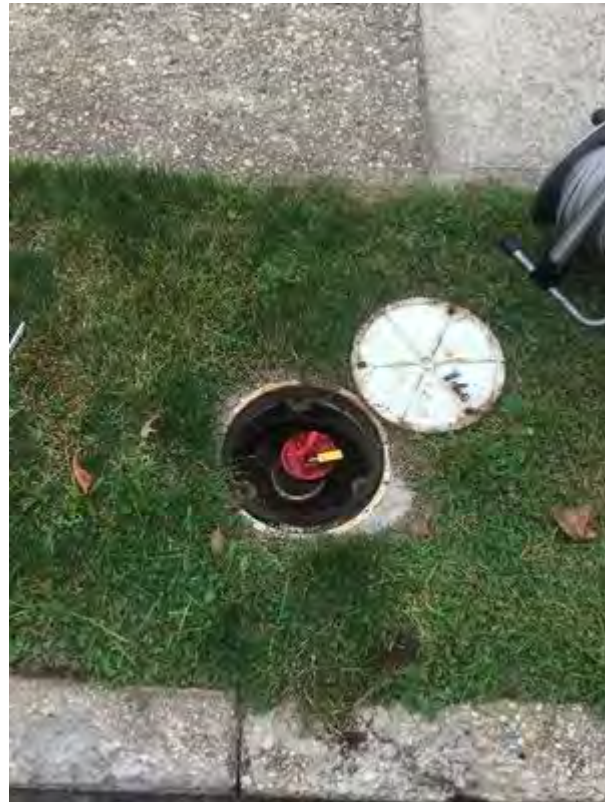
Client: Navy CLEAN	Facility: NWIRP Bethpage
Project Number: 112G08005-WE13	Location: Bethpage, New York
Date: September 17, 2021 11:59	Personnel: Noah Sprouse
Well ID: RE120D1	Well Location: 204618.12 1125061.88
Well Status: Other	Screen Interval: 630-650
WELL INVENTORY CONDITION	
Concrete pad in acceptable condition i.e. no cracks?	YES
Manhole cover present and in working condition?	YES
All bolts on manhole present and not stripped?	YES
Well plug present, locked and in good working condition?	YES
OVERALL CONDITION:	GOOD
Notes (Explain if answered No to any of the above)

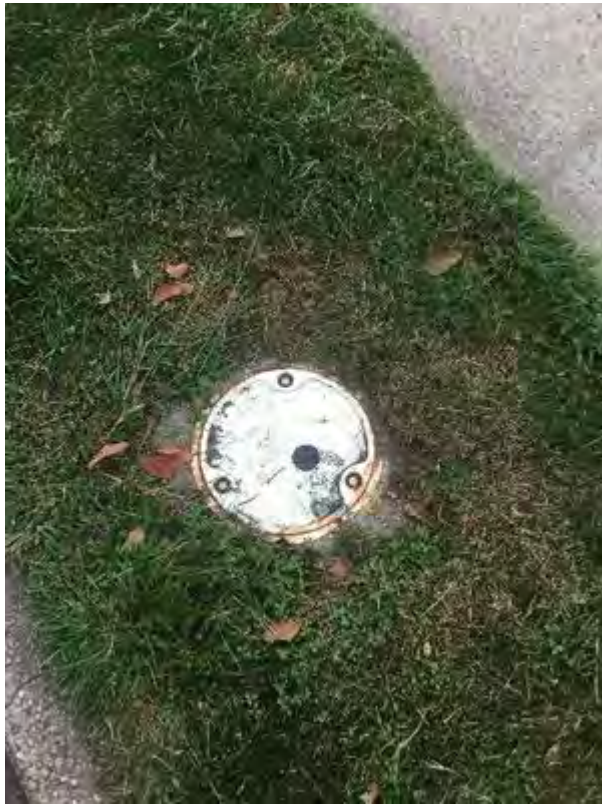
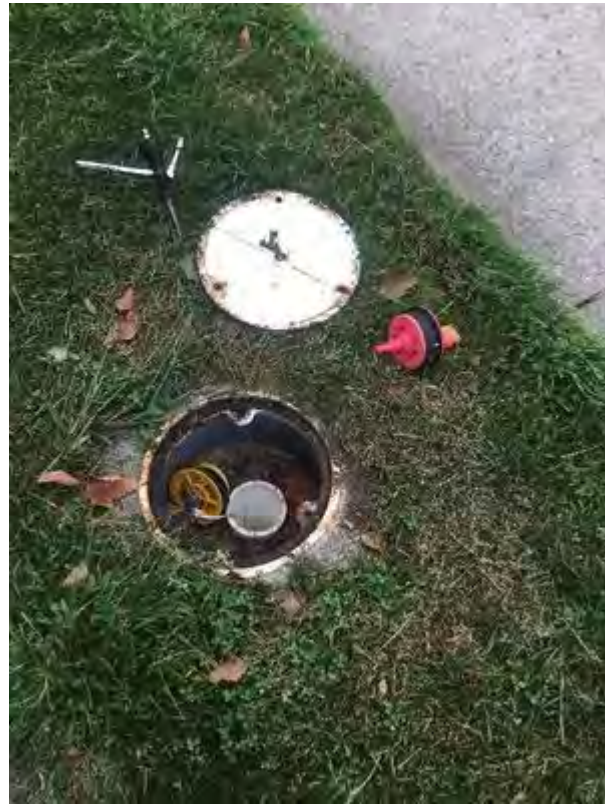
Client: Navy CLEAN	Facility: NWIRP Bethpage
Project Number: 112G08005-WE13	Location: Bethpage, New York
Date: September 17, 2021 08:13	Personnel: Noah Sprouse
Well ID: RE125D2	Well Location: 204725.38 1124490.61
Well Status: Unknown	Screen Interval: 580-600
WELL INVENTORY CONDITION	
Concrete pad in acceptable condition i.e. no cracks?	YES
Manhole cover present and in working condition?	YES
All bolts on manhole present and not stripped?	YES
Well plug present, locked and in good working condition?	YES
OVERALL CONDITION:	GOOD
Notes (Explain if answered No to any of the above)

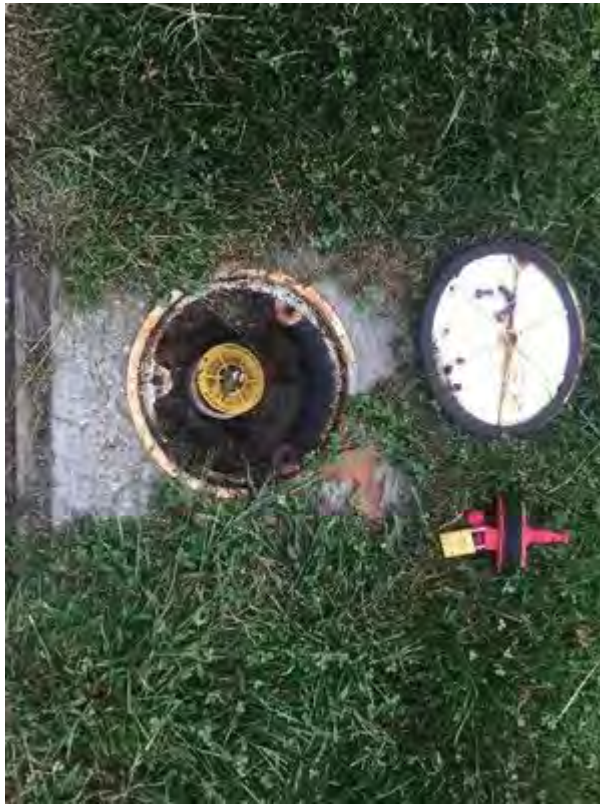
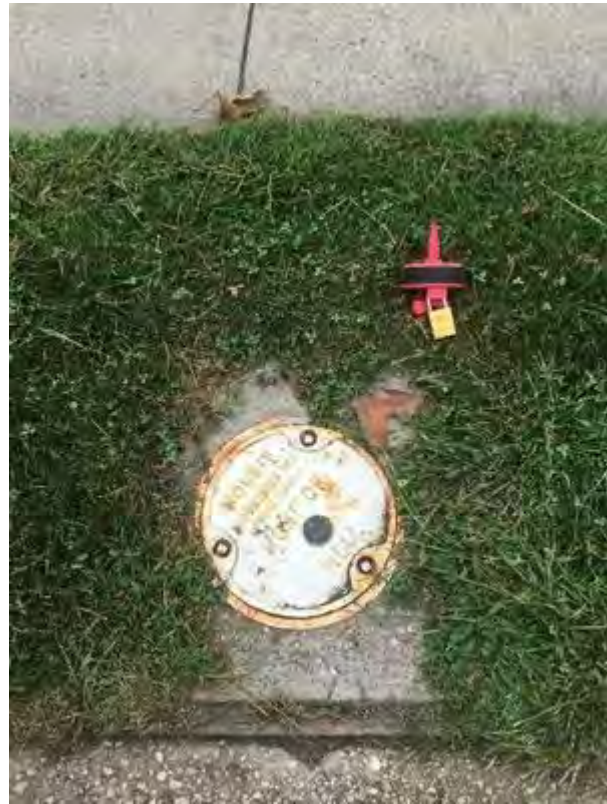
Client: Navy CLEAN	Facility: NWIRP Bethpage
Project Number: 112G08005-WE13	Location: Bethpage, New York
Date: September 17, 2021 08:11	Personnel: Wyatt Bostick
Well ID: RE125D3	Well Location: 204720.38 1124512.93
Well Status: Other	Screen Interval: 670-690
WELL INVENTORY CONDITION	
Concrete pad in acceptable condition i.e. no cracks?	YES
Manhole cover present and in working condition?	YES
All bolts on manhole present and not stripped?	YES
Well plug present, locked and in good working condition?	YES
OVERALL CONDITION:	GOOD
Notes (Explain if answered No to any of the above) Rope connector

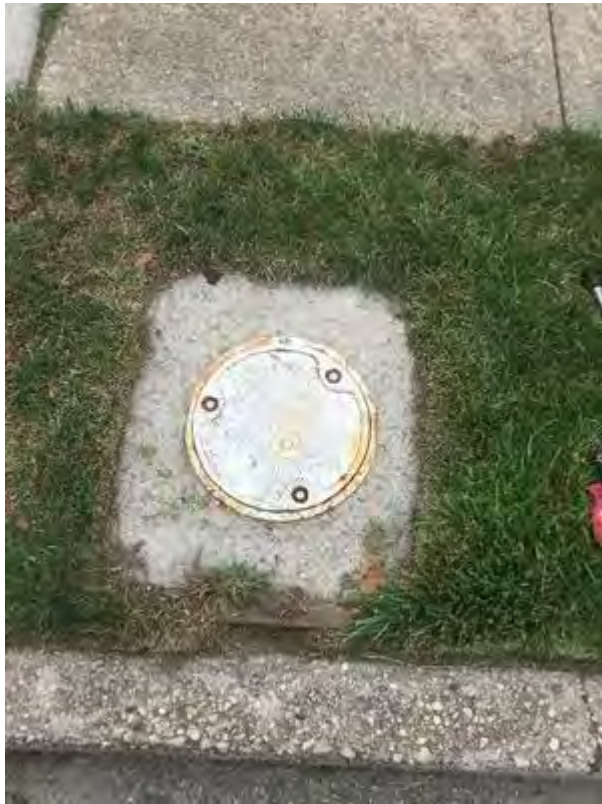
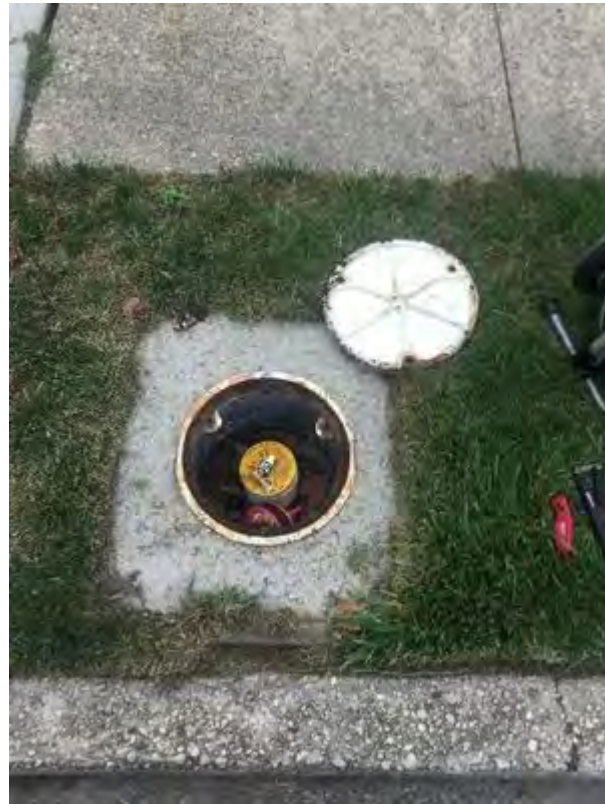
Client: Navy CLEAN	Facility: NWIRP Bethpage
Project Number: 112G08005-WE13	Location: Bethpage, New York
Date: September 17, 2021 08:07	Personnel: Noah Sprouse
Well ID: RE125D1	Well Location: 204730.49 1124477.58
Well Status: Other	Screen Interval: 320-340
WELL INVENTORY CONDITION	
Concrete pad in acceptable condition i.e. no cracks?	YES
Manhole cover present and in working condition?	YES
All bolts on manhole present and not stripped?	YES
Well plug present, locked and in good working condition?	YES
OVERALL CONDITION:	GOOD
Notes (Explain if answered No to any of the above)

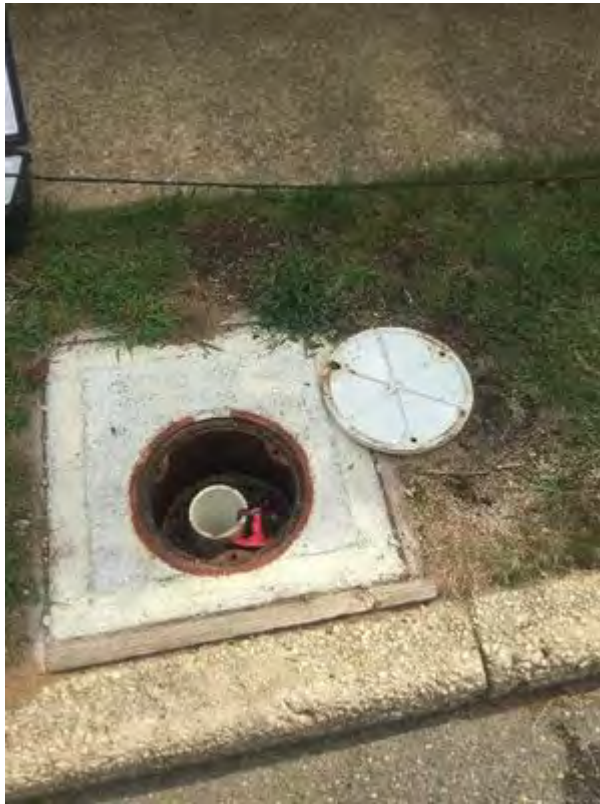
Client: Navy CLEAN	Facility: NWIRP Bethpage
Project Number: 112G08005-WE13	Location: Bethpage, New York
Date: September 16, 2021 13:56	Personnel: Noah Sprouse
Well ID: BP-TT-MW179D1	Well Location:
Well Status: Other	Screen Interval: 305-325
WELL INVENTORY CONDITION	
Concrete pad in acceptable condition i.e. no cracks?	YES
Manhole cover present and in working condition?	YES
All bolts on manhole present and not stripped?	YES
Well plug present, locked and in good working condition?	YES
OVERALL CONDITION:	GOOD
Notes (Explain if answered No to any of the above)

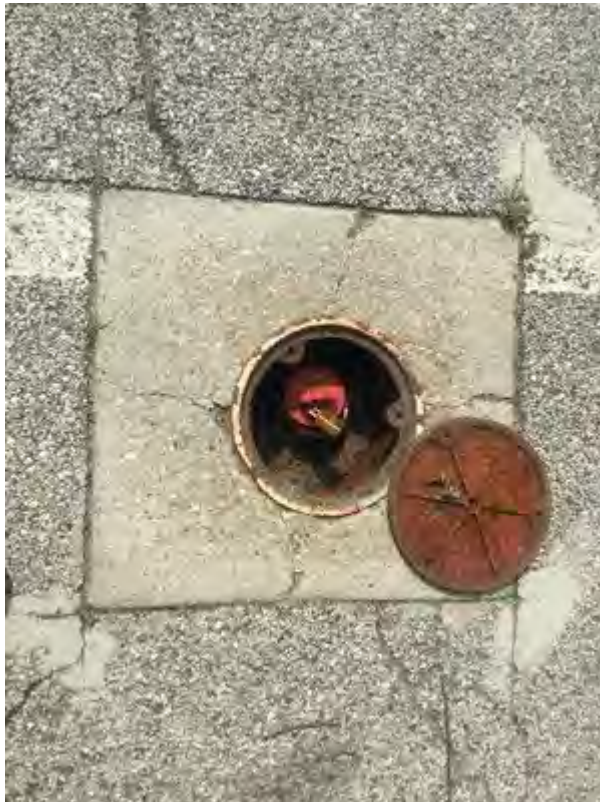
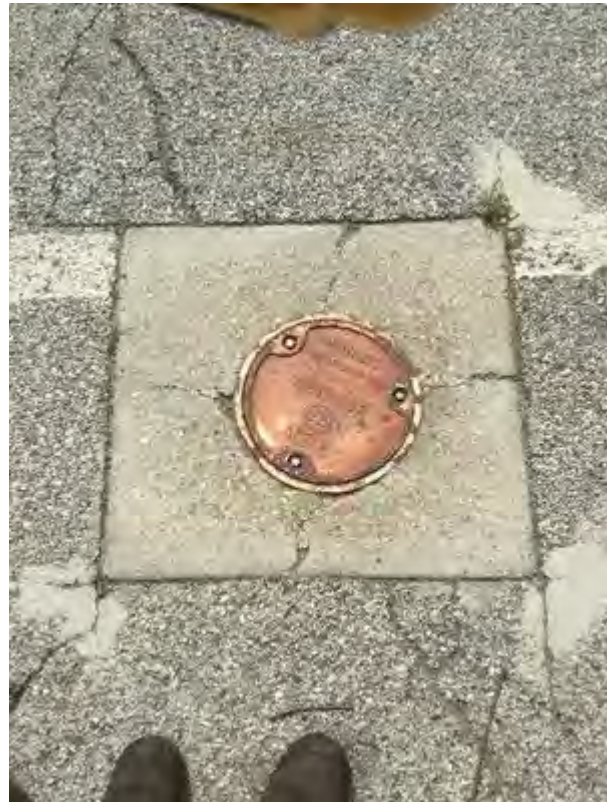
Client: Navy CLEAN	Facility: NWIRP Bethpage
Project Number: 112G08005-WE13	Location: Bethpage, New York
Date: September 15, 2021 11:57	Personnel: Wyatt Bostick
Well ID: RE131D2	Well Location: 204359.42 1123099.42
Well Status: Other	Screen Interval: 565-590
WELL INVENTORY CONDITION	
Concrete pad in acceptable condition i.e. no cracks?	NO
Manhole cover present and in working condition?	YES
All bolts on manhole present and not stripped?	YES
Well plug present, locked and in good working condition?	YES
OVERALL CONDITION:	GOOD
Notes (Explain if answered No to any of the above) Minor cracking

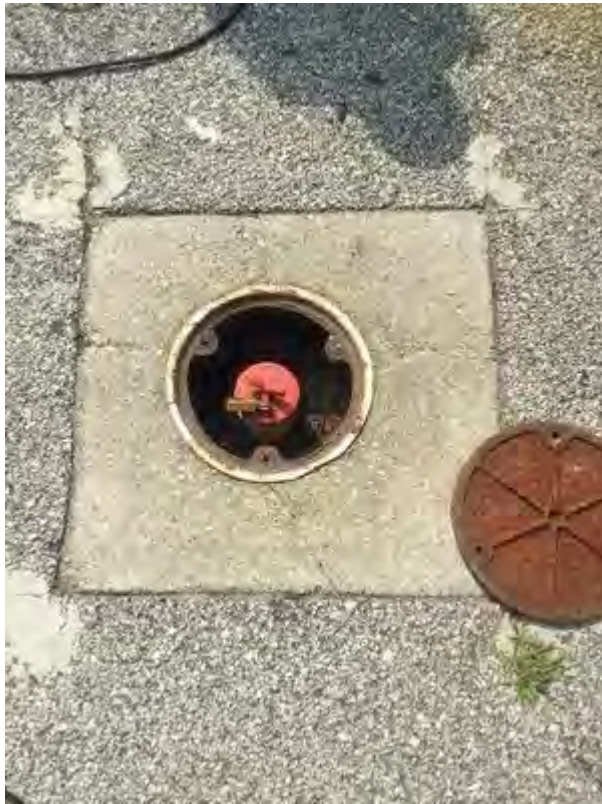
Client: Navy CLEA	Facility: NWIRP Bethpage
Project Number: 112G08005-WE13	Location: Bethpage, New York
Date: September 15, 2021 11:50	Personnel: Wyatt Bostick
Well ID: RE131D1	Well Location: 204367.45 1123114.27
Well Status: Other	Screen Interval: 430-450
WELL INVENTORY CONDITION	
Concrete pad in acceptable condition i.e. no cracks?	NO
Manhole cover present and in working condition?	YES
All bolts on manhole present and not stripped?	NO
Well plug present, locked and in good working condition?	YES
OVERALL CONDITION:	FAIR
Notes (Explain if answered No to any of the above) Snapped bolt, minor cracking

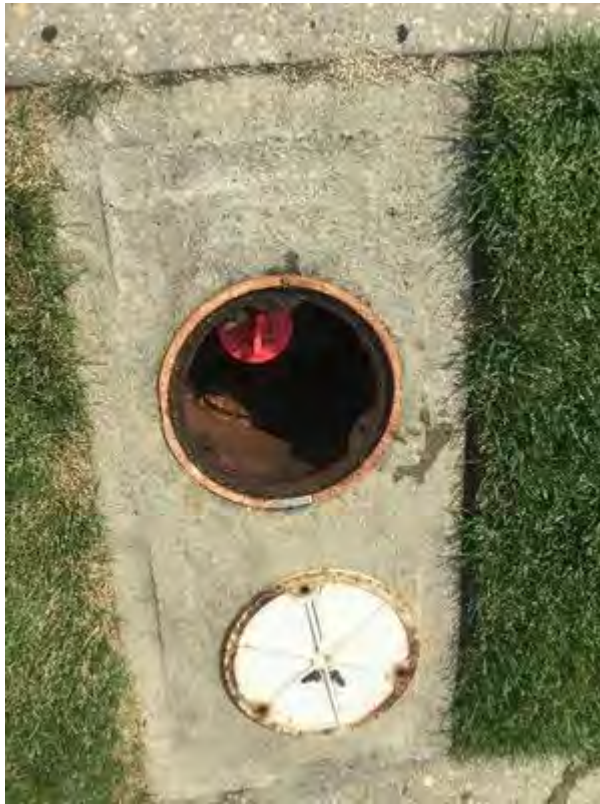
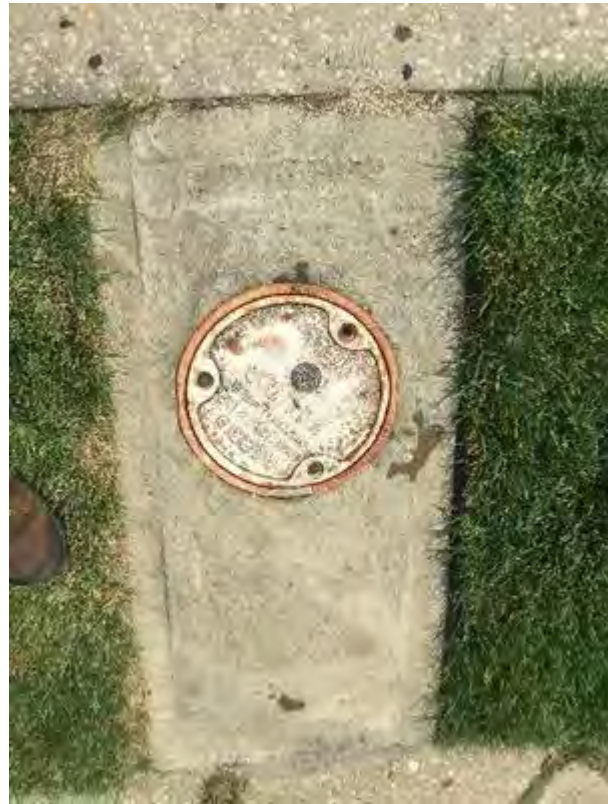
Client: Navy CLEAN	Facility: NWIRP Bethpage
Project Number: 112G08005-WE13	Location: Bethpage, New York
Date: September 15, 2021 11:17	Personnel: Wyatt Bostick
Well ID: RE134D1	Well Location: 206193.848977 1123302.32141
Well Status: Other	Screen Interval: 325-345
WELL INVENTORY CONDITION	
Concrete pad in acceptable condition i.e. no cracks?	YES
Manhole cover present and in working condition?	YES
All bolts on manhole present and not stripped?	NO
Well plug present, locked and in good working condition?	YES
OVERALL CONDITION:	FAIR
Notes (Explain if answered No to any of the above) Snapped bolt

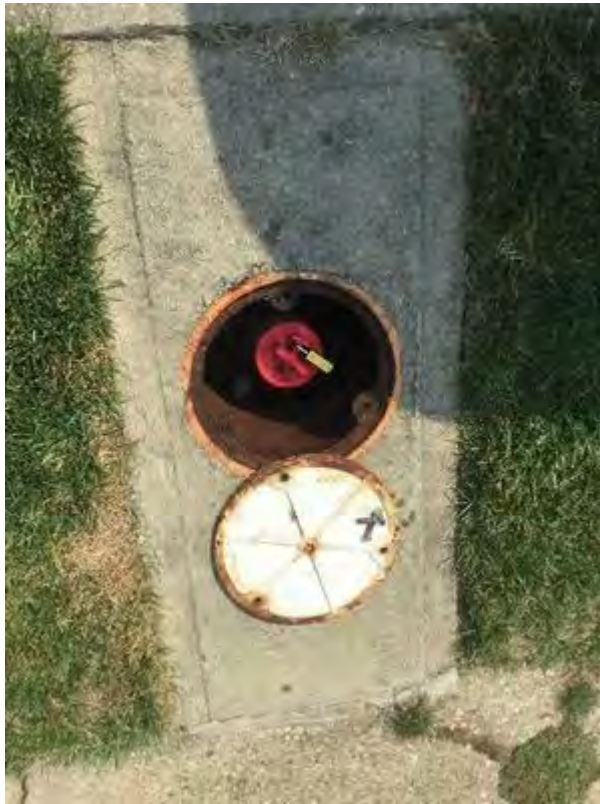
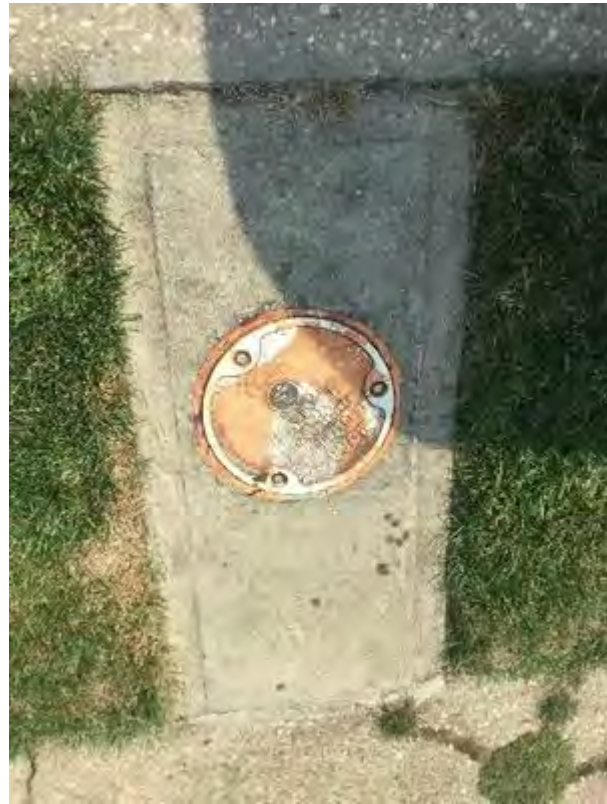
Client: Navy CLEAN	Facility: NWIRP Bethpage
Project Number: 112G08005-WE13	Location: Bethpage, New York
Date: September 15, 2021 11:14	Personnel: Wyatt Bostick
Well ID: RE134D2	Well Location: 206191.681194 1123304.48919
Well Status: Other	Screen Interval: 510-530
WELL INVENTORY CONDITION	
Concrete pad in acceptable condition i.e. no cracks?	YES
Manhole cover present and in working condition?	YES
All bolts on manhole present and not stripped?	YES
Well plug present, locked and in good working condition?	YES
OVERALL CONDITION:	GOOD
Notes (Explain if answered No to any of the above)

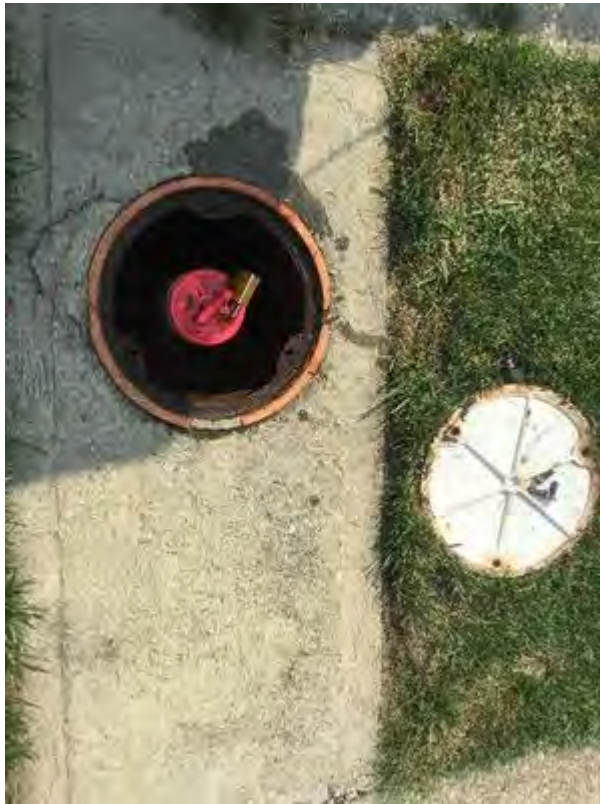
Client: Navy CLEAN	Facility: NWIRP Bethpage
Project Number: 112G08005-WE13	Location: Bethpage, New York
Date: September 15, 2021 11:11	Personnel: Wyatt Bostick
Well ID: RE134D3	Well Location: 206167.835578 1123295.81806
Well Status: Other	Screen Interval: 600-620
WELL INVENTORY CONDITION	
Concrete pad in acceptable condition i.e. no cracks?	YES
Manhole cover present and in working condition?	YES
All bolts on manhole present and not stripped?	YES
Well plug present, locked and in good working condition?	YES
OVERALL CONDITION:	GOOD
Notes (Explain if answered No to any of the above)

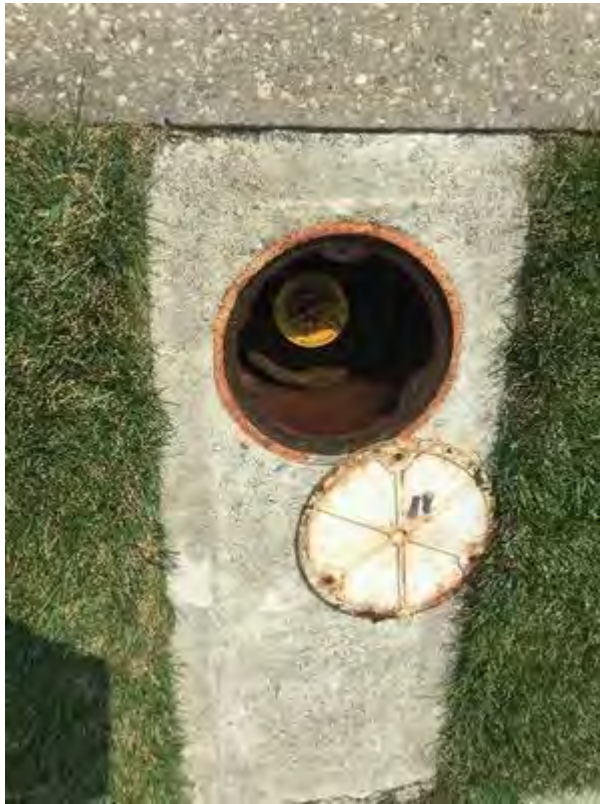
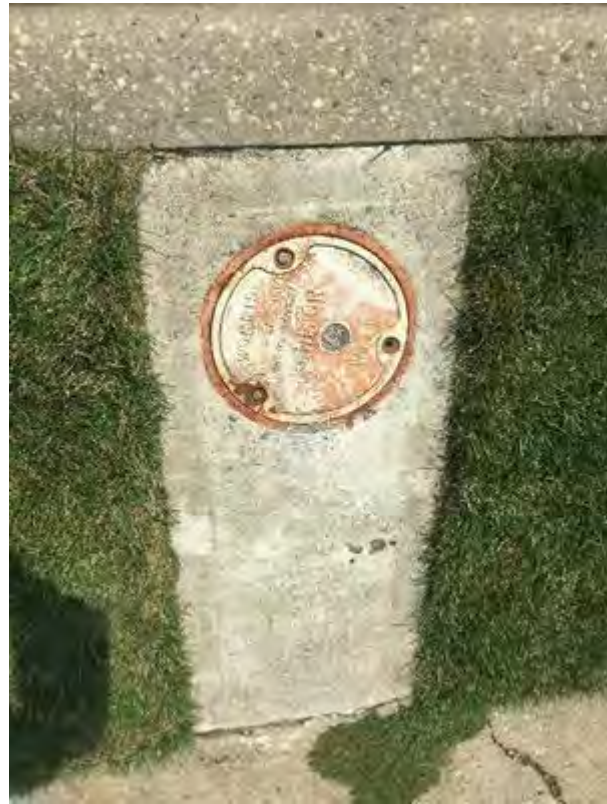
Client: Navy CLEAN	Facility: NWIRP Bethpage
Project Number: 112G08005-WE13	Location: Bethpage, New York
Date: September 15, 2021 11:07	Personnel: Wyatt Bostick
Well ID: RE134D4	Well Location: 206154.828879 1123280.64358
Well Status: Other	Screen Interval: 665-685
WELL INVENTORY CONDITION	
Concrete pad in acceptable condition i.e. no cracks?	YES
Manhole cover present and in working condition?	YES
All bolts on manhole present and not stripped?	NO
Well plug present, locked and in good working condition?	YES
OVERALL CONDITION:	GOOD
Notes (Explain if answered No to any of the above) Snapped bolt

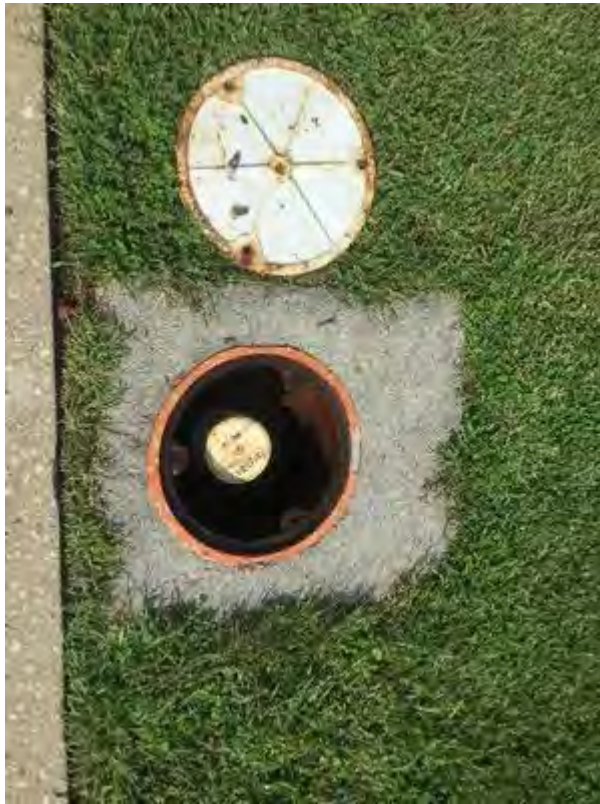
Client: Navy CLEAN	Facility: NWIRP Bethpage
Project Number: 112G08005-WE13	Location: Bethpage, New York
Date: September 15, 2021 10:47	Personnel: Wyatt Bostick
Well ID: RE135D1	Well Location: 204601.68 1120806.68
Well Status: Other	Screen Interval: 410-430
WELL INVENTORY CONDITION	
Concrete pad in acceptable condition i.e. no cracks?	YES
Manhole cover present and in working condition?	YES
All bolts on manhole present and not stripped?	YES
Well plug present, locked and in good working condition?	YES
OVERALL CONDITION:	GOOD
Notes (Explain if answered No to any of the above)

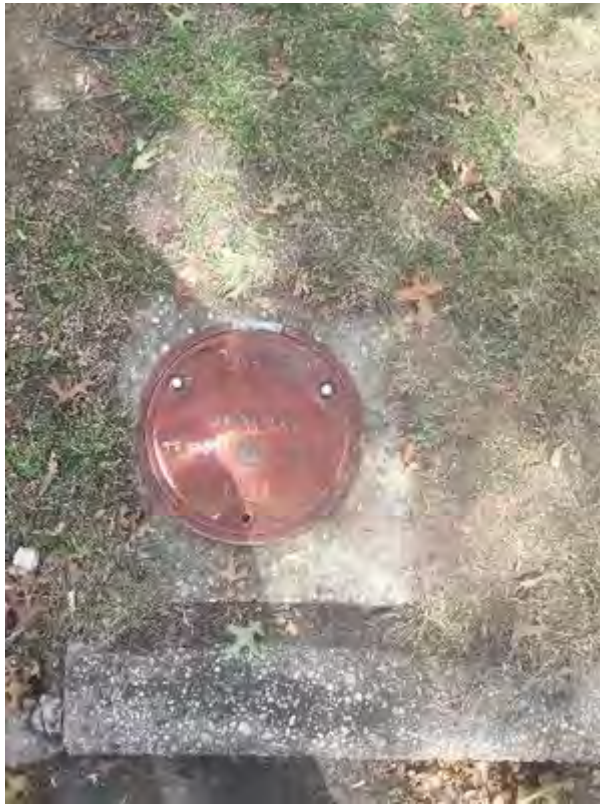
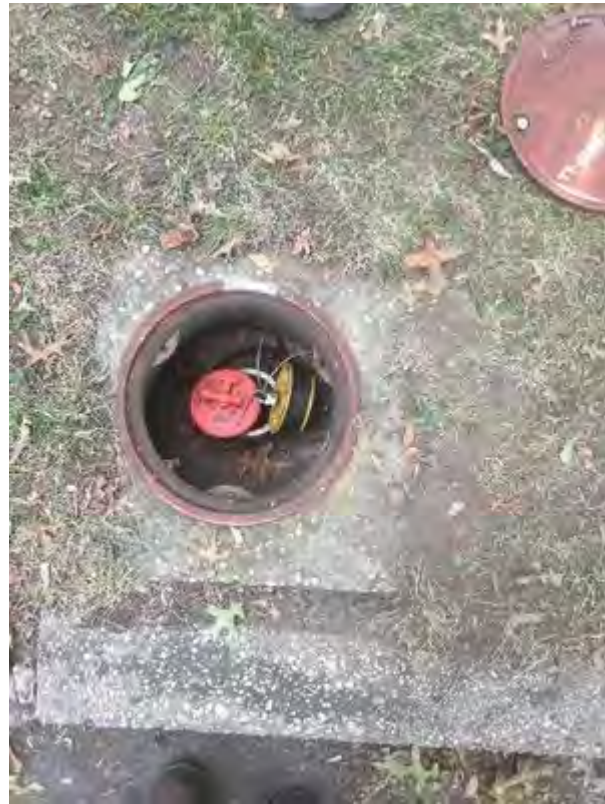
Client: Navy CLEAN	Facility: NWIRP Bethpage
Project Number: 112G08005-WE13	Location: Bethpage, New York
Date: September 21, 2021 11:55	Personnel: Noah Sprouse
Well ID: TT101D1	Well Location: 203545.086 1125484.11
Well Status: Other	Screen Interval: 570-590
WELL INVENTORY CONDITION	
Concrete pad in acceptable condition i.e. no cracks?	YES
Manhole cover present and in working condition?	YES
All bolts on manhole present and not stripped?	YES
Well plug present, locked and in good working condition?	YES
OVERALL CONDITION:	FAIR
Notes (Explain if answered No to any of the above) Missing one bolt

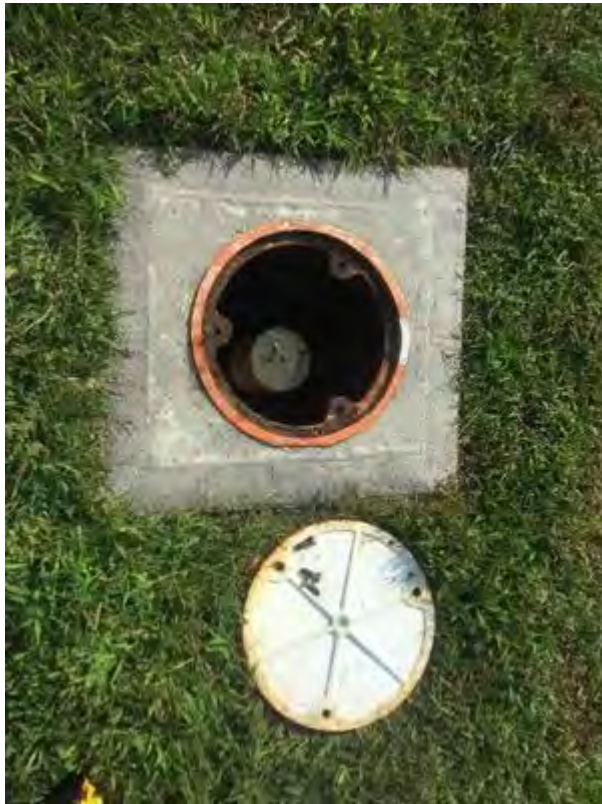
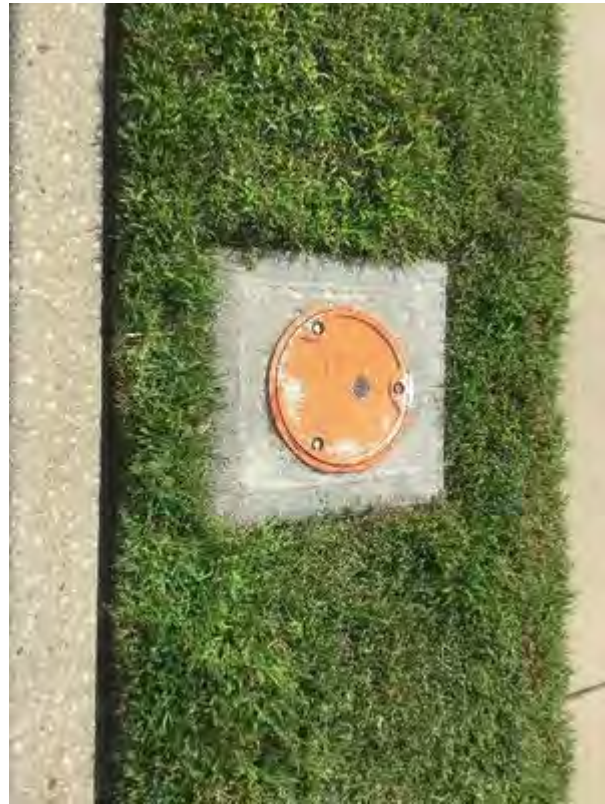
Client: Navy CLEAN	Facility: NWIRP Bethpage
Project Number: 112G08005-WE13	Location: Bethpage, New York
Date: September 15, 2021 10:42	Personnel: Wyatt Bostick
Well ID: RE135D3	Well Location: 204567.99 1120801.87
Well Status: Other	Screen Interval: 640-660
WELL INVENTORY CONDITION	
Concrete pad in acceptable condition i.e. no cracks?	YES
Manhole cover present and in working condition?	YES
All bolts on manhole present and not stripped?	YES
Well plug present, locked and in good working condition?	YES
OVERALL CONDITION:	GOOD
Notes (Explain if answered No to any of the above)

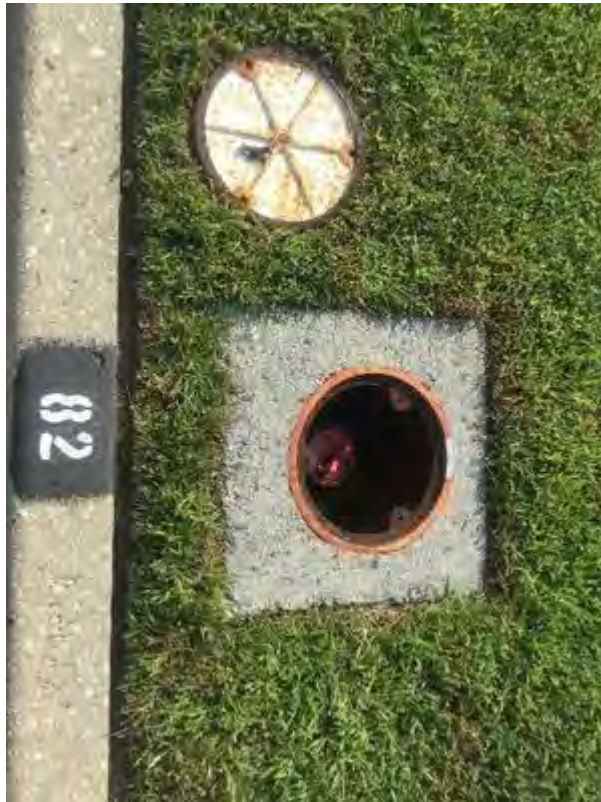
Client: Navy CLEAN	Facility: NWIRP Bethpage
Project Number: 112G08005-WE13	Location: Bethpage, New York
Date: September 15, 2021 10:38	Personnel: Wyatt Bostick
Well ID: RE135D2	Well Location: 204569.37 1120786.64
Well Status: Other	Screen Interval: 545-565
WELL INVENTORY CONDITION	
Concrete pad in acceptable condition i.e. no cracks?	YES
Manhole cover present and in working condition?	YES
All bolts on manhole present and not stripped?	YES
Well plug present, locked and in good working condition?	YES
OVERALL CONDITION:	GOOD
Notes (Explain if answered No to any of the above)

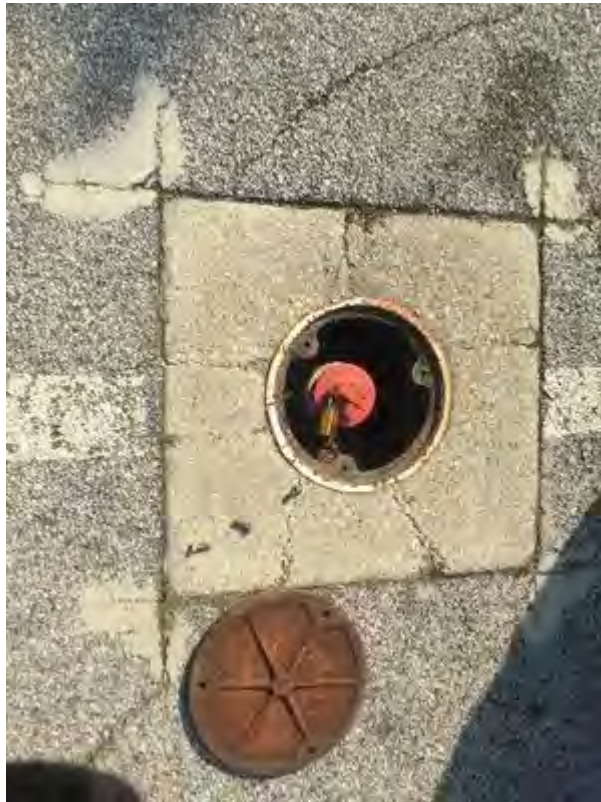
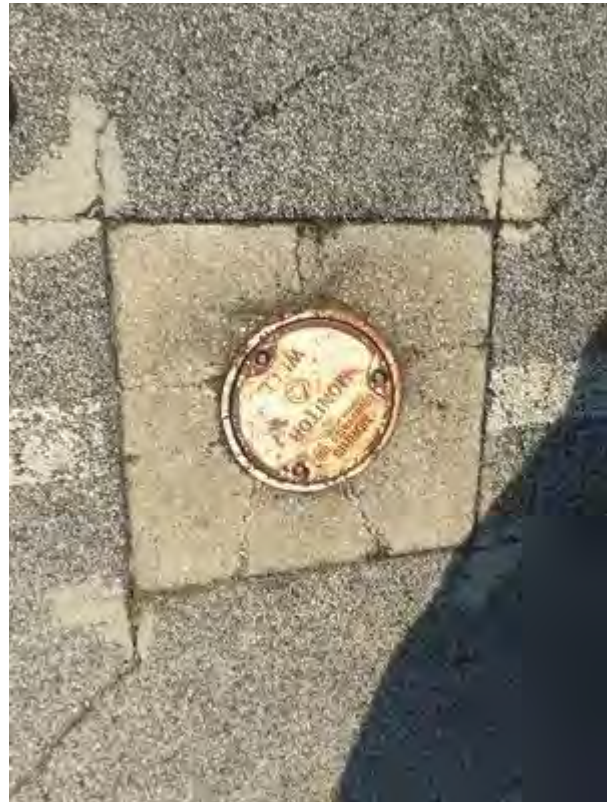
Client: Navy CLEAN	Facility: NWIRP Bethpage
Project Number: 112G08005-WE13	Location: Bethpage, New York
Date: September 15, 2021 10:16	Personnel: Wyatt Bostick
Well ID: RE131D3	Well Location: 204350.99 1123115.19
Well Status: Other	Screen Interval: 660-680
WELL INVENTORY CONDITION	
Concrete pad in acceptable condition i.e. no cracks?	NO
Manhole cover present and in working condition?	YES
All bolts on manhole present and not stripped?	YES
Well plug present, locked and in good working condition?	YES
OVERALL CONDITION:	FAIR
Notes (Explain if answered No to any of the above) Minor cracking of well pad

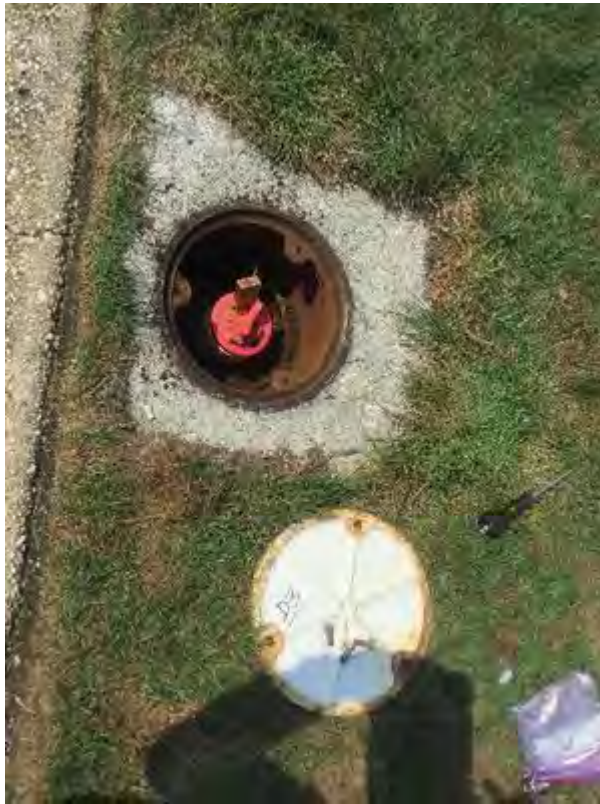
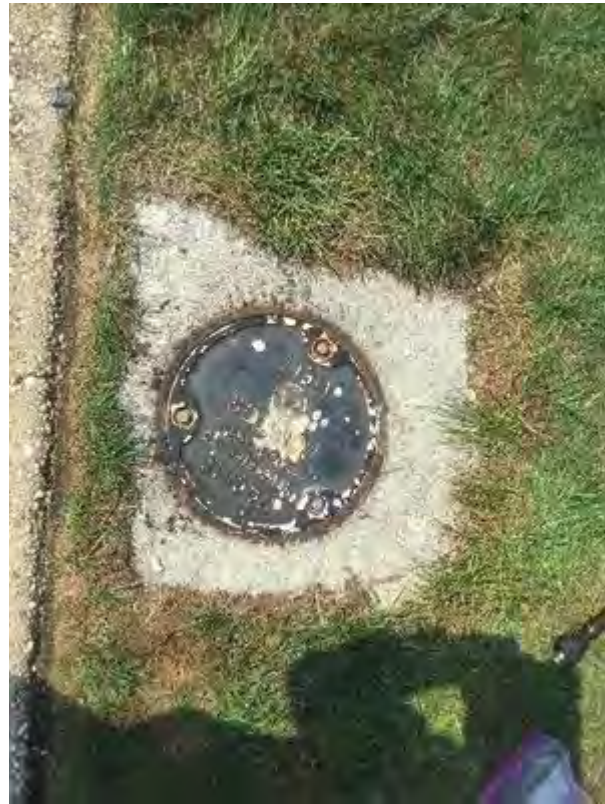
Client: Navy CLEAN	Facility: NWIRP Bethpage
Project Number: 112G08005-WE13	Location: Bethpage, New York
Date: September 14, 2021 13:35	Personnel: Wyatt Bostick
Well ID: RE132D3	Well Location: 203115.935552 1125709.72609
Well Status: Other	Screen Interval: 500-520
WELL INVENTORY CONDITION	
Concrete pad in acceptable condition i.e. no cracks?	YES
Manhole cover present and in working condition?	YES
All bolts on manhole present and not stripped?	YES
Well plug present, locked and in good working condition?	YES
OVERALL CONDITION:	GOOD
Notes (Explain if answered No to any of the above)

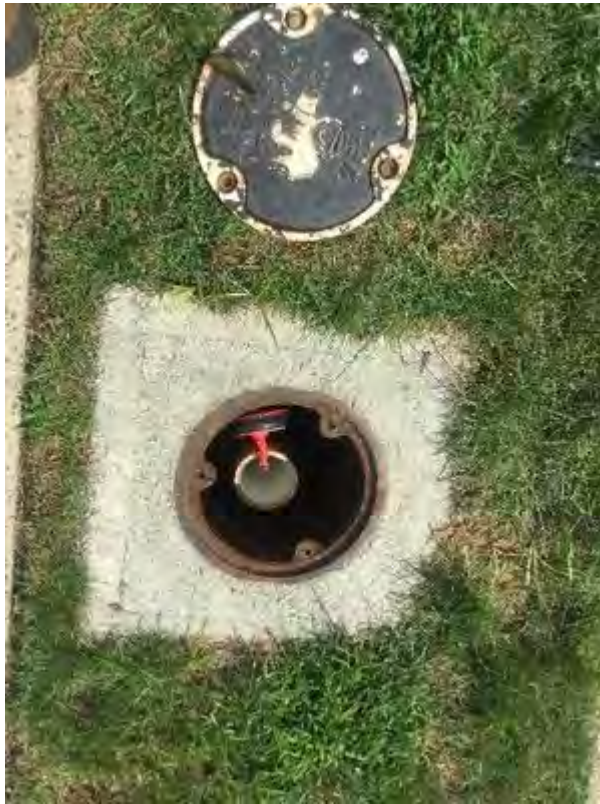
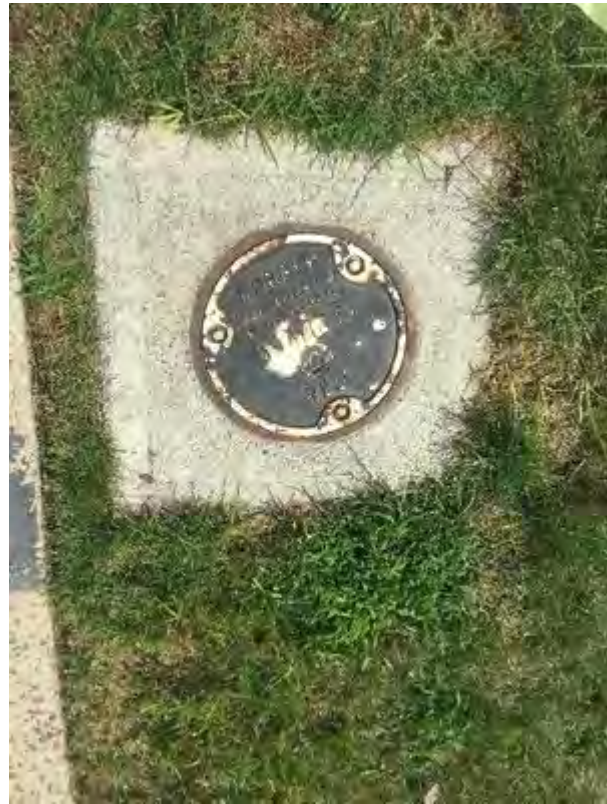
Client: Navy CLEAN	Facility: NWIRP Bethpage
Project Number: 112G08005-WE13	Location: Bethpage, New York
Date: September 14, 2021 13:28	Personnel: Wyatt Bostick
Well ID: RE132D5	Well Location: 203081.756345 1125716.59683
Well Status: Other	Screen Interval: 610-630
WELL INVENTORY CONDITION	
Concrete pad in acceptable condition i.e. no cracks?	YES
Manhole cover present and in working condition?	YES
All bolts on manhole present and not stripped?	YES
Well plug present, locked and in good working condition?	YES
OVERALL CONDITION:	GOOD
Notes (Explain if answered No to any of the above)

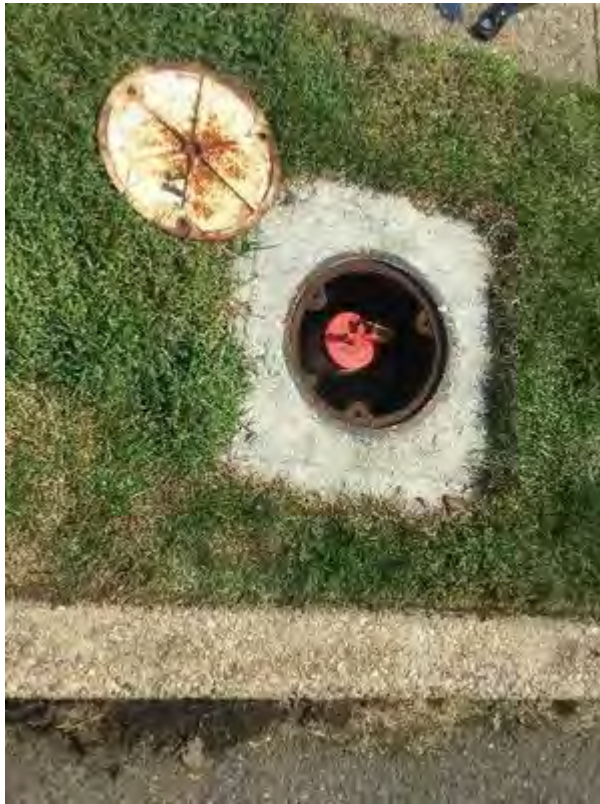
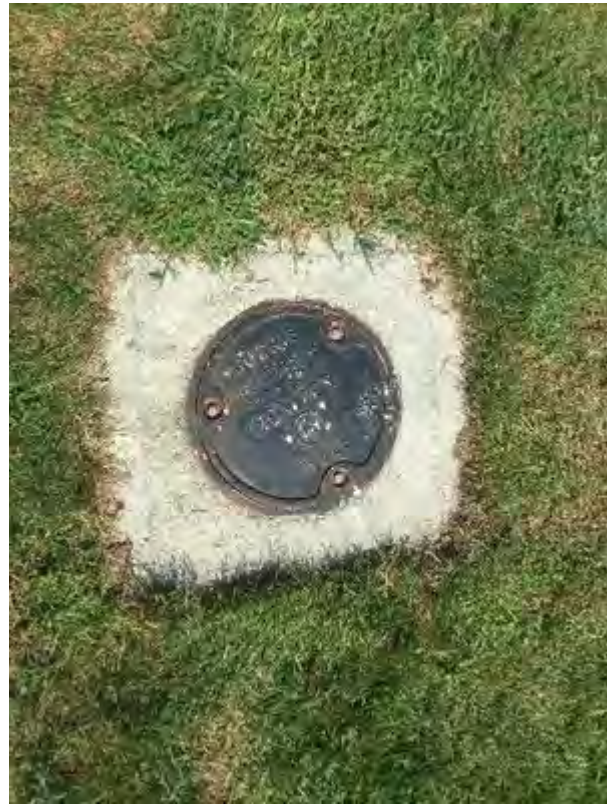
Client: Navy CLEAN	Facility: NWIRP Bethpage
Project Number: 112G08005-WE13	Location: Bethpage, New York
Date: September 14, 2021 13:11	Personnel: Wyatt Bostick
Well ID: RE132D6	Well Location: 203031.834656 1125662.73591
Well Status: Other	Screen Interval: 685-705
WELL INVENTORY CONDITION	
Concrete pad in acceptable condition i.e. no cracks?	YES
Manhole cover present and in working condition?	YES
All bolts on manhole present and not stripped?	YES
Well plug present, locked and in good working condition?	YES
OVERALL CONDITION:	GOOD
Notes (Explain if answered No to any of the above)
