Memorandum

To: Scot Sokolowski, NAVFAC MIDLANT
From: David Brayack, Tetra Tech
Date: December 30, 2021
Re: Annual LUC Inspection and Operation Summary Report: Sites 1, 2, 3, and 4 – NWIRP Bethpage
Revision 1
Contract/CTO Number: N6247016D9008/WE13

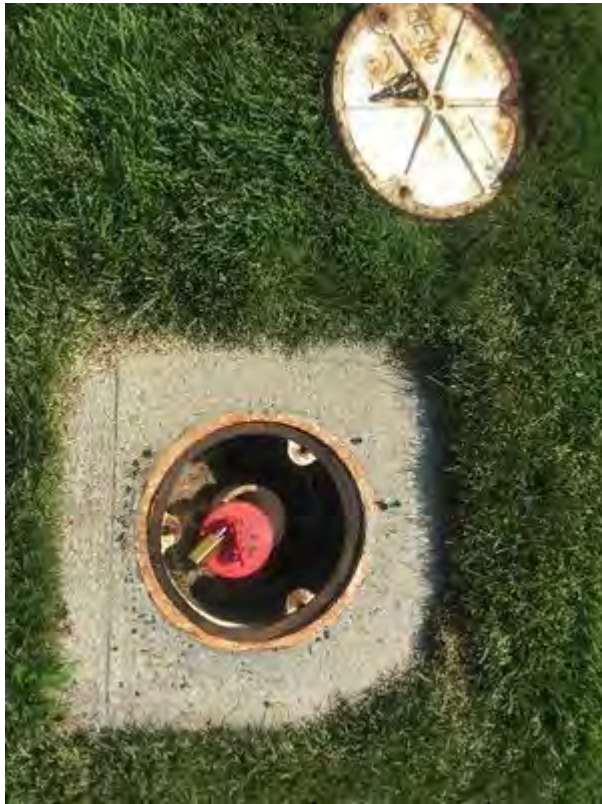
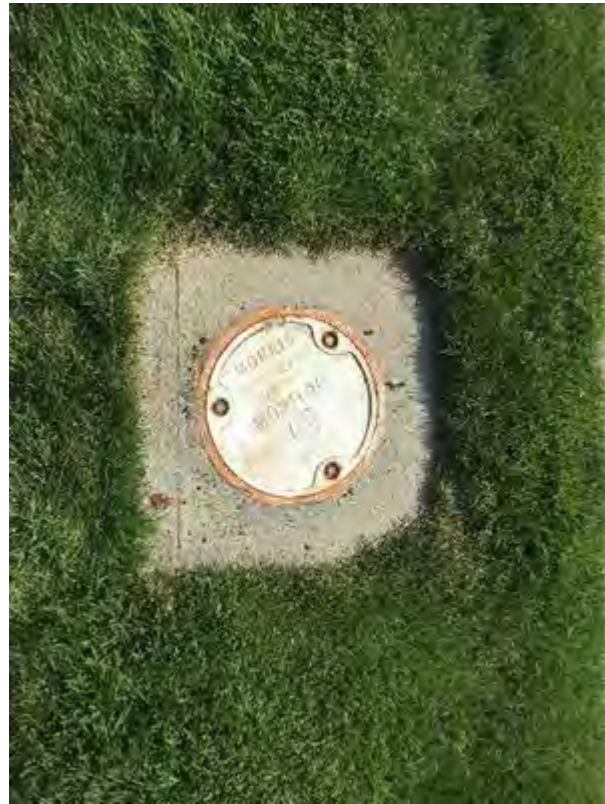
Client: Navy CLEAN	Facility: NWIRP Bethpage
Project Number: 112G08005-WE13	Location: Bethpage, New York
Date: September 14, 2021 12:40	Personnel: Wyatt Bostick
Well ID: RE116D1	Well Location: 202312.88 1128388.54
Well Status: Other	Screen Interval: 570-590
WELL INVENTORY CONDITION	
Concrete pad in acceptable condition i.e. no cracks?	YES
Manhole cover present and in working condition?	YES
All bolts on manhole present and not stripped?	YES
Well plug present, locked and in good working condition?	YES
OVERALL CONDITION:	GOOD
Notes (Explain if answered No to any of the above)

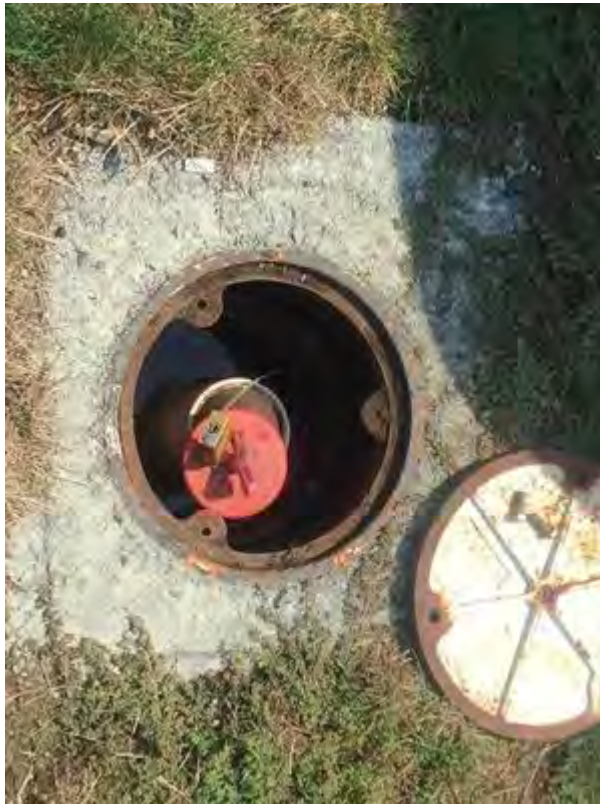
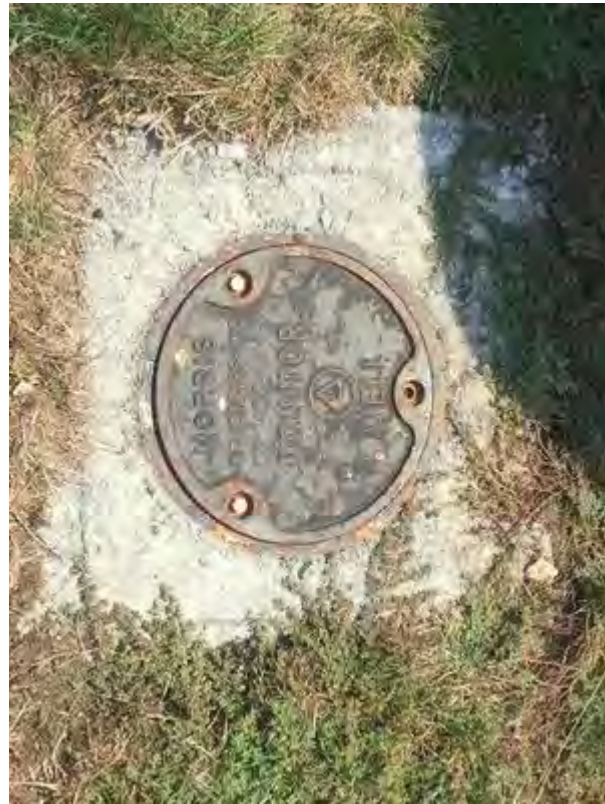
Client: Navy CLEAN	Facility: NWIRP Bethpage
Project Number: 112G08005-WE13	Location: Bethpage, New York
Date: September 14, 2021 12:21	Personnel: Wyatt Bostick
Well ID: RE132D2	Well Location: 203115.870081 1125692.65057
Well Status: Other	Screen Interval: 330-350
WELL INVENTORY CONDITION	
Concrete pad in acceptable condition i.e. no cracks?	YES
Manhole cover present and in working condition?	YES
All bolts on manhole present and not stripped?	NO
Well plug present, locked and in good working condition?	YES
OVERALL CONDITION:	FAIR
Notes (Explain if answered No to any of the above) One bolt snapped, needs fill

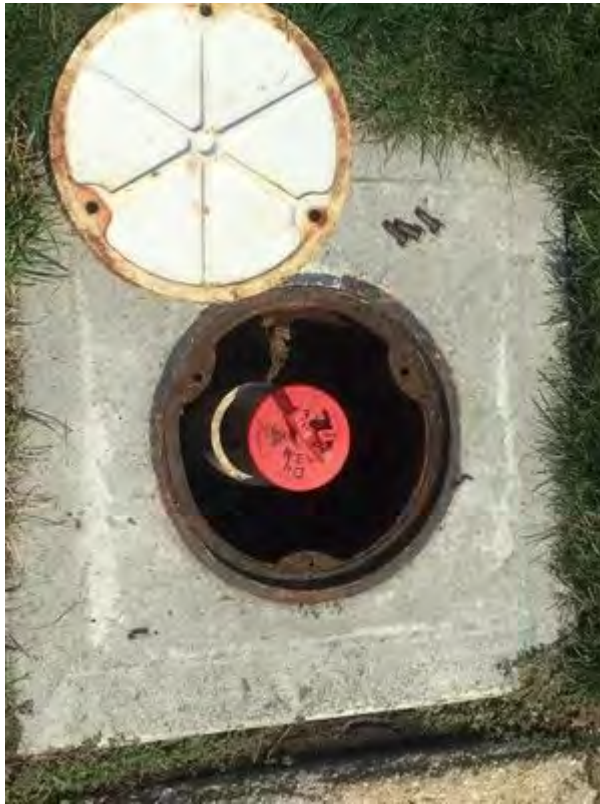
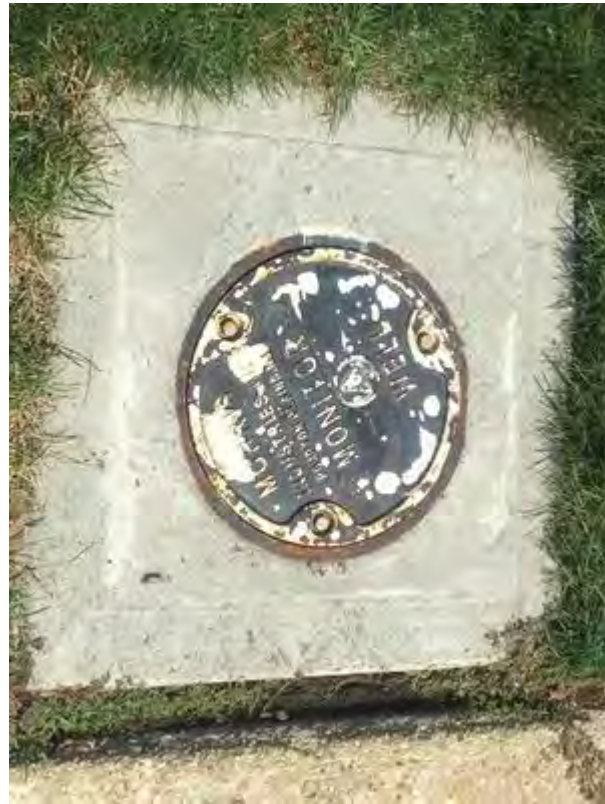
Client: Navy CLEAN	Facility: NWIRP Bethpage
Project Number: 112G08005-WE13	Location: Bethpage, New York
Date: September 14, 2021 12:16	Personnel: Wyatt Bostick
Well ID: RE132D4	Well Location: 203116.164447 1125724.39636
Well Status: Other	Screen Interval: 560-580
WELL INVENTORY CONDITION	
Concrete pad in acceptable condition i.e. no cracks?	YES
Manhole cover present and in working condition?	YES
All bolts on manhole present and not stripped?	YES
Well plug present, locked and in good working condition?	YES
OVERALL CONDITION:	GOOD
Notes (Explain if answered No to any of the above)

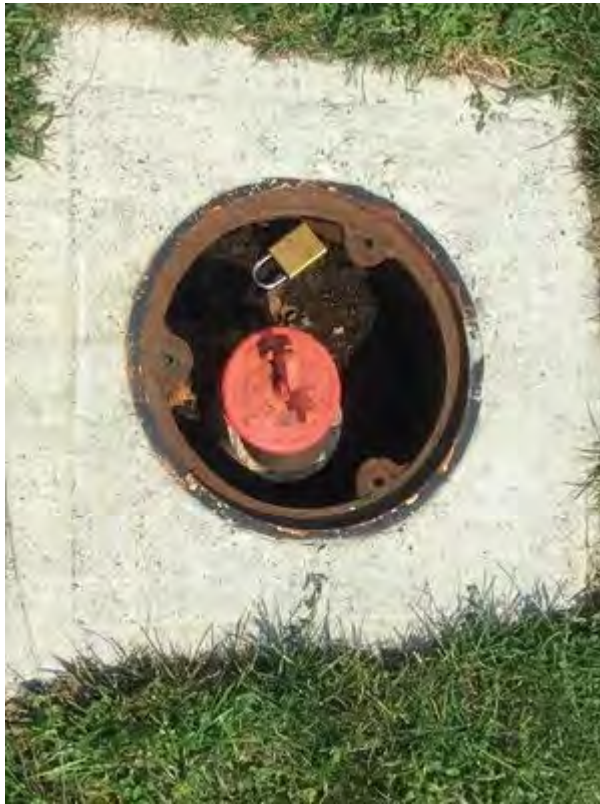
Client: Navy CLEAN	Facility: NWIRP Bethpage
Project Number: 112G08005-WE13	Location: Bethpage, New York
Date: September 14, 2021 12:11	Personnel: Wyatt Bostick
Well ID: RE132D7	Well Location: 203046.411837 1125661.82581
Well Status: Other	Screen Interval: 743-758
WELL INVENTORY CONDITION	
Concrete pad in acceptable condition i.e. no cracks?	YES
Manhole cover present and in working condition?	YES
All bolts on manhole present and not stripped?	YES
Well plug present, locked and in good working condition?	YES
OVERALL CONDITION:	GOOD
Notes (Explain if answered No to any of the above)

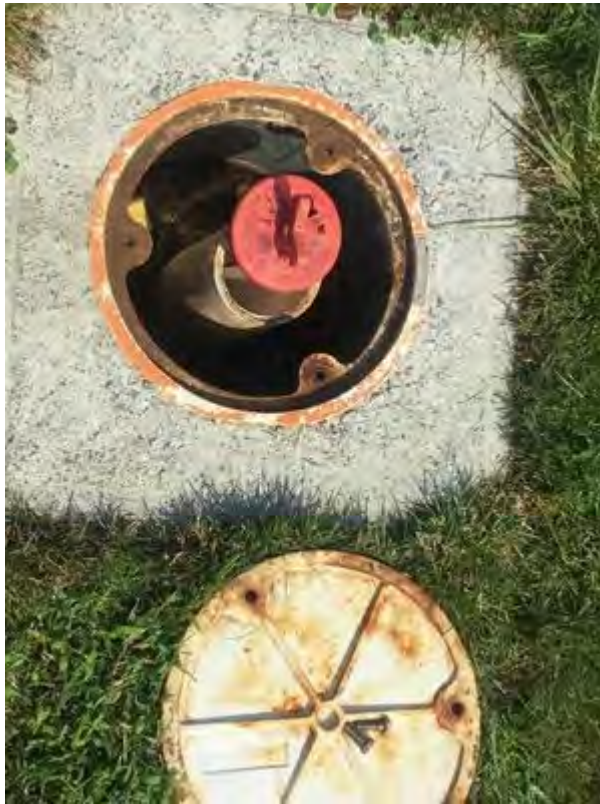
Client: Navy CLEAN	Facility: NWIRP Bethpage
Project Number: 112G08005-WE13	Location: Bethpage, New York
Date: September 14, 2021 12:02	Personnel: Wyatt Bostick
Well ID: RE132D1	Well Location: 203063.35272 1125662.70266
Well Status: Other	Screen Interval: 220-240
WELL INVENTORY CONDITION	
Concrete pad in acceptable condition i.e. no cracks?	YES
Manhole cover present and in working condition?	YES
All bolts on manhole present and not stripped?	YES
Well plug present, locked and in good working condition?	YES
OVERALL CONDITION:	GOOD
Notes (Explain if answered No to any of the above) No datalogger

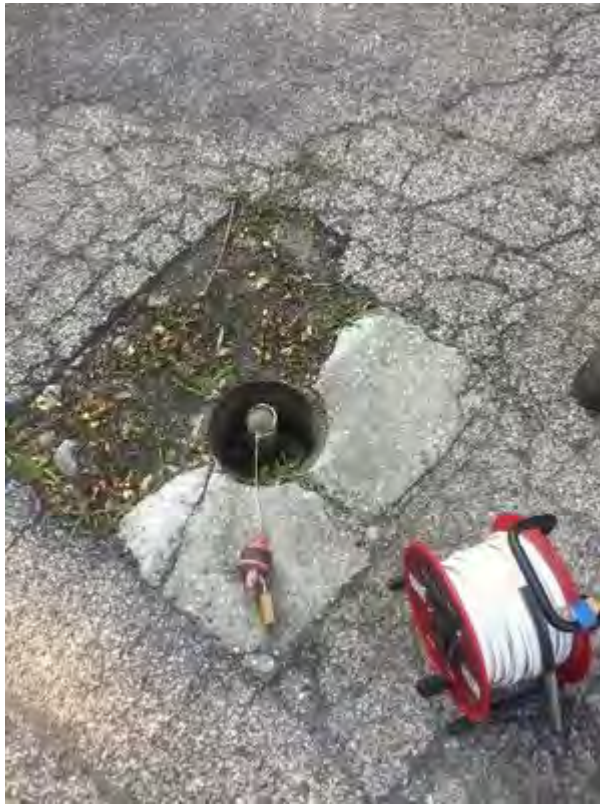
Client: Navy CLEAN	Facility: NWIRP Bethpage
Project Number: 112G08005-WE13	Location: Bethpage, New York
Date: September 13, 2021 16:51	Personnel: Noah Sprouse
Well ID: BPS1-TT-MW307S	Well Location: 213350.824 1124901.871
Well Status: Other	Screen Interval: 40.5-50.5
WELL INVENTORY CONDITION	
Concrete pad in acceptable condition i.e. no cracks?	NO
Manhole cover present and in working condition?	NO
All bolts on manhole present and not stripped?	NO
Well plug present, locked and in good working condition?	YES
OVERALL CONDITION:	FAIR
Notes (Explain if answered No to any of the above) No manhole cover, poor well pad, no bolts

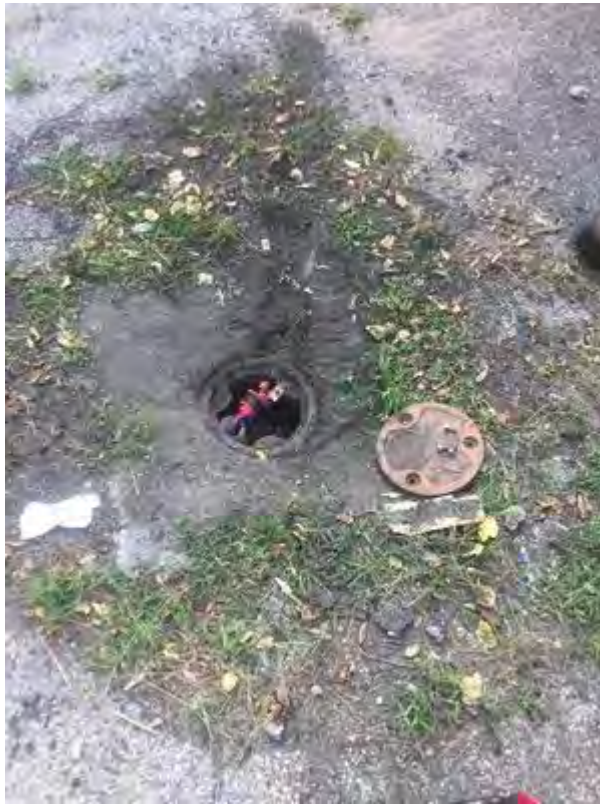
Client: Navy CLEAN	Facility: NWIRP Bethpage
Project Number: 112G08005-WE13	Location: Bethpage, New York
Date: September 13, 2021 16:47	Personnel: Noah Sprouse
Well ID: BPS1-TT-MW307I	Well Location: 213353.775 1124914.838
Well Status: Other	Screen Interval: 188-198
WELL INVENTORY CONDITION	
Concrete pad in acceptable condition i.e. no cracks?	NO
Manhole cover present and in working condition?	YES
All bolts on manhole present and not stripped?	YES
Well plug present, locked and in good working condition?	YES
OVERALL CONDITION:	FAIR
Notes (Explain if answered No to any of the above) Poor well pad (sunk and cracked)

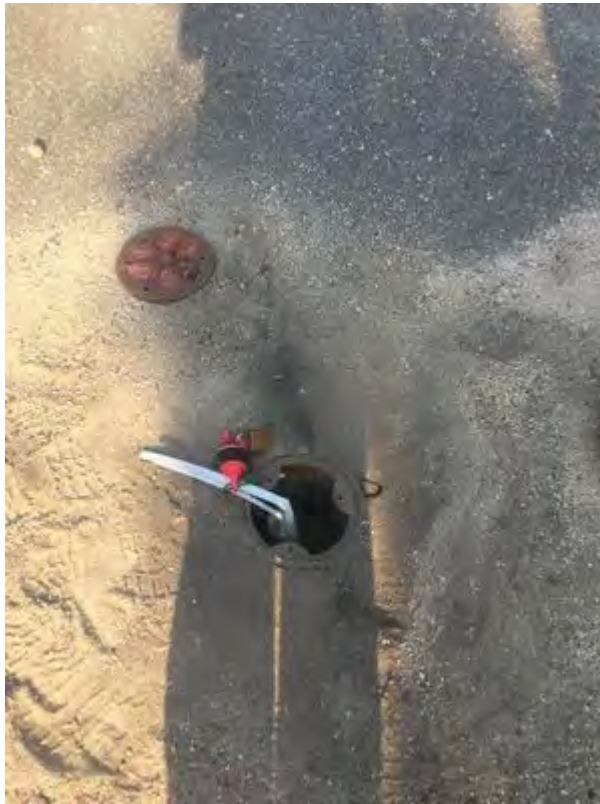
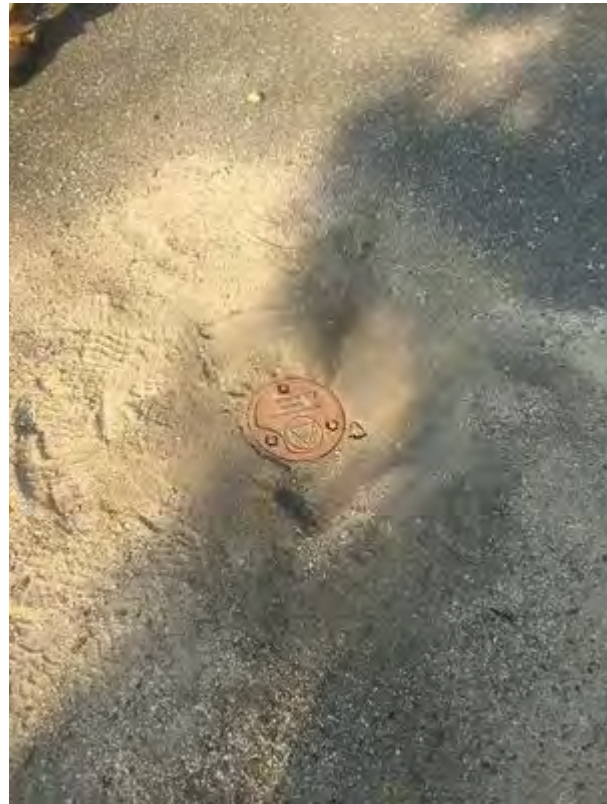
Client: Navy CLEAN	Facility: NWIRP Bethpage
Project Number: 112G08005-WE13	Location: Bethpage, New York
Date: September 13, 2021 16:44	Personnel: Noah Sprouse
Well ID: BPS1-TT-MW307D	Well Location: 213357.307 1124926.918
Well Status: Other	Screen Interval: 276-286
WELL INVENTORY CONDITION	
Concrete pad in acceptable condition i.e. no cracks?	NO
Manhole cover present and in working condition?	YES
All bolts on manhole present and not stripped?	YES
Well plug present, locked and in good working condition?	YES
OVERALL CONDITION:	FAIR
Notes (Explain if answered No to any of the above) Poor well pad (sunk and cracked)

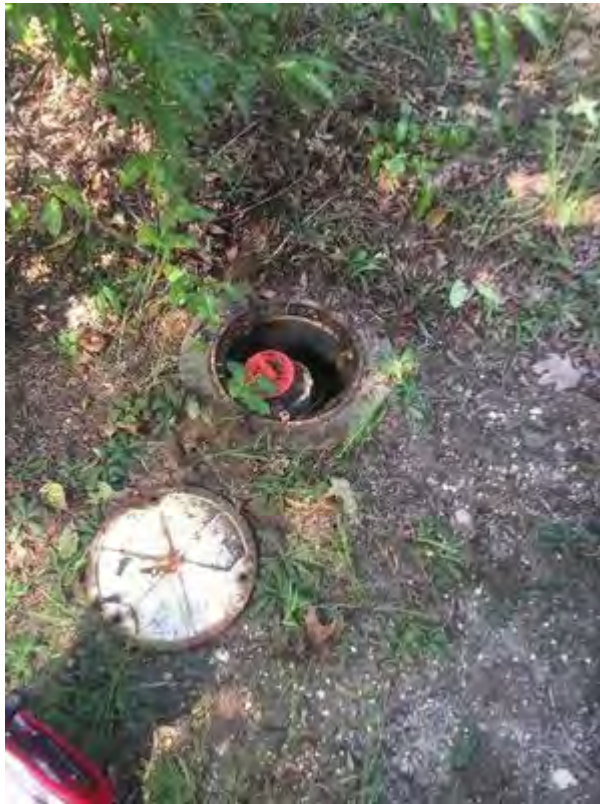
Client: Navy CLEAN	Facility: NWIRP Bethpage
Project Number: 112G08005-WE13	Location: Bethpage, New York
Date: September 13, 2021 15:09	Personnel: Noah Sprouse
Well ID: GM38-RW1-MW3	Well Location: 206502.7 1130071.3
Well Status: Other	Screen Interval: 395-435
WELL INVENTORY CONDITION	
Concrete pad in acceptable condition i.e. no cracks?	YES
Manhole cover present and in working condition?	YES
All bolts on manhole present and not stripped?	YES
Well plug present, locked and in good working condition?	YES
OVERALL CONDITION:	GOOD
Notes (Explain if answered No to any of the above)

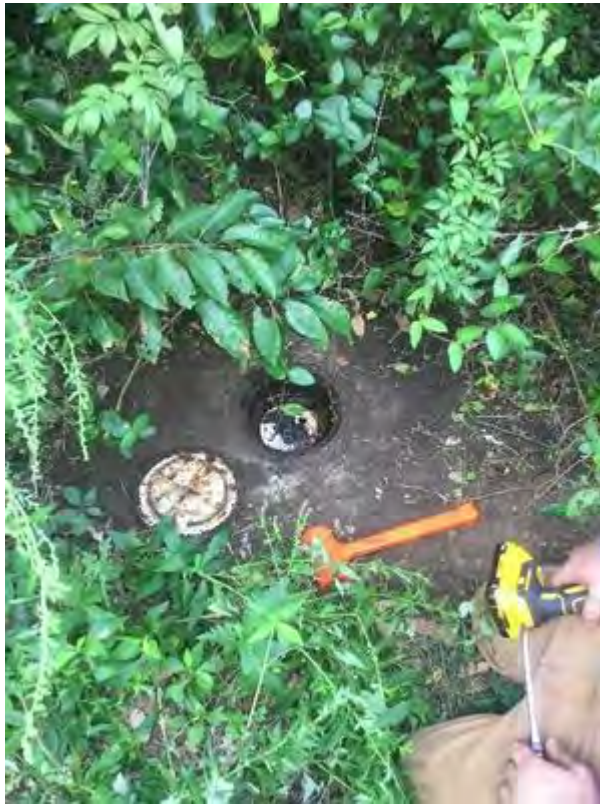
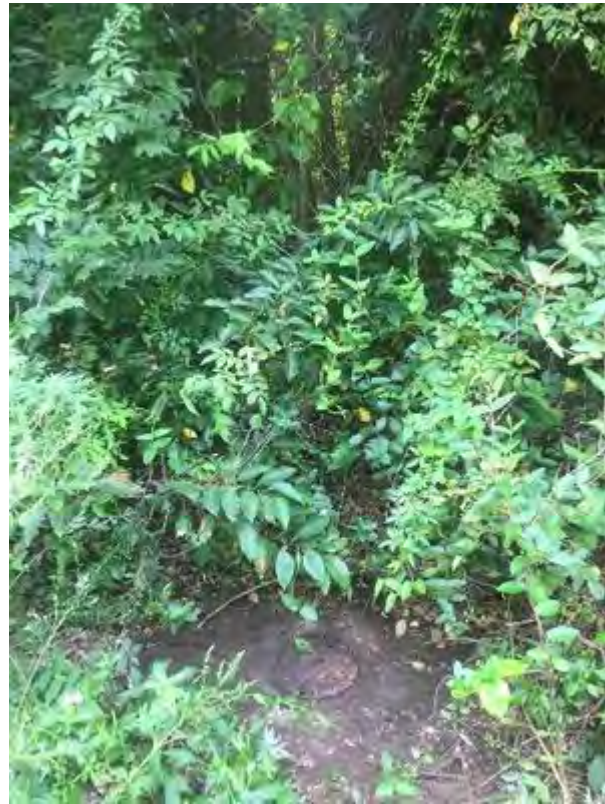
Client: Navy CLEAN	Facility: NWIRP Bethpage
Project Number: 112G08005-WE13	Location: Bethpage, New York
Date: September 13, 2021 14:42	Personnel: Noah Sprouse
Well ID: GM38-RW1-MW2	Well Location: 206077.6 1129746.4
Well Status: Other	Screen Interval: 395-435
WELL INVENTORY CONDITION	
Concrete pad in acceptable condition i.e. no cracks?	NO
Manhole cover present and in working condition?	YES
All bolts on manhole present and not stripped?	NO
Well plug present, locked and in good working condition?	YES
OVERALL CONDITION:	FAIR
Notes (Explain if answered No to any of the above) No bolts (missing two), inadequate well pad

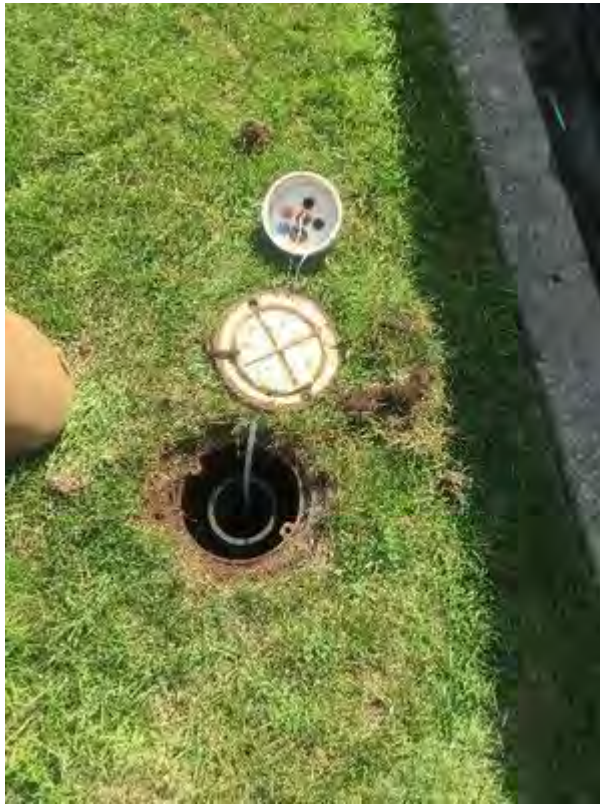
Client: Navy CLEAN	Facility: NWIRP Bethpage
Project Number: 112G08005-WE13	Location: Bethpage, New York
Date: September 13, 2021 14:20	Personnel: Noah Sprouse
Well ID: GM38-RW1-MW1	Well Location: 206068.116 1129607.668
Well Status: Other	Screen Interval: 395-435
WELL INVENTORY CONDITION	
Concrete pad in acceptable condition i.e. no cracks?	YES
Manhole cover present and in working condition?	YES
All bolts on manhole present and not stripped?	YES
Well plug present, locked and in good working condition?	YES
OVERALL CONDITION:	FAIR
Notes (Explain if answered No to any of the above) Missing seal

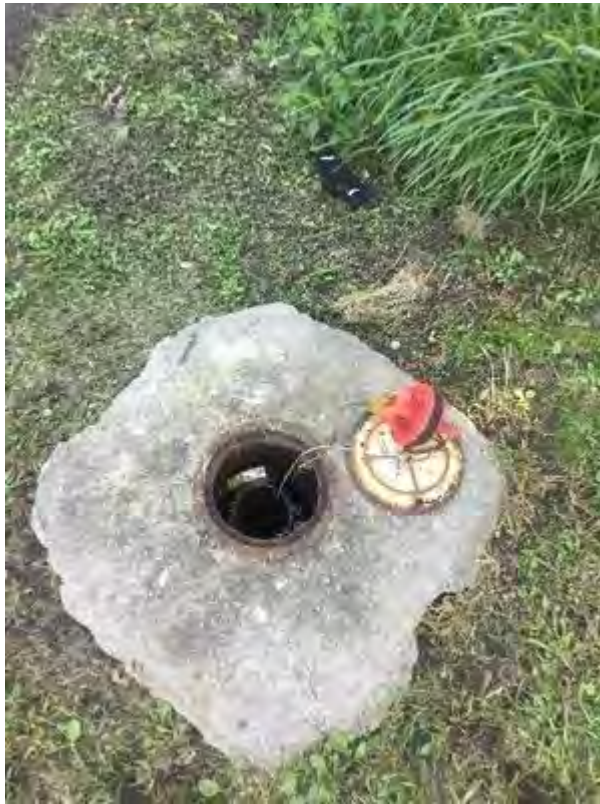
Client: Navy CLEAN	Facility: NWIRP Bethpage
Project Number: 112G08005-WE13	Location: Bethpage, New York
Date: September 13, 2021 13:38	Personnel: Noah Sprouse
Well ID: GM38-RW2-MW1	Well Location: 206433 1129248.1
Well Status: Other	Screen Interval: 470-510
WELL INVENTORY CONDITION	
Concrete pad in acceptable condition i.e. no cracks?	NO
Manhole cover present and in working condition?	NO
All bolts on manhole present and not stripped?	NO
Well plug present, locked and in good working condition?	NO
OVERALL CONDITION:	POOR
Notes (Explain if answered No to any of the above) Missing two bolts, missing tubing, undercut well pad, broken well cover

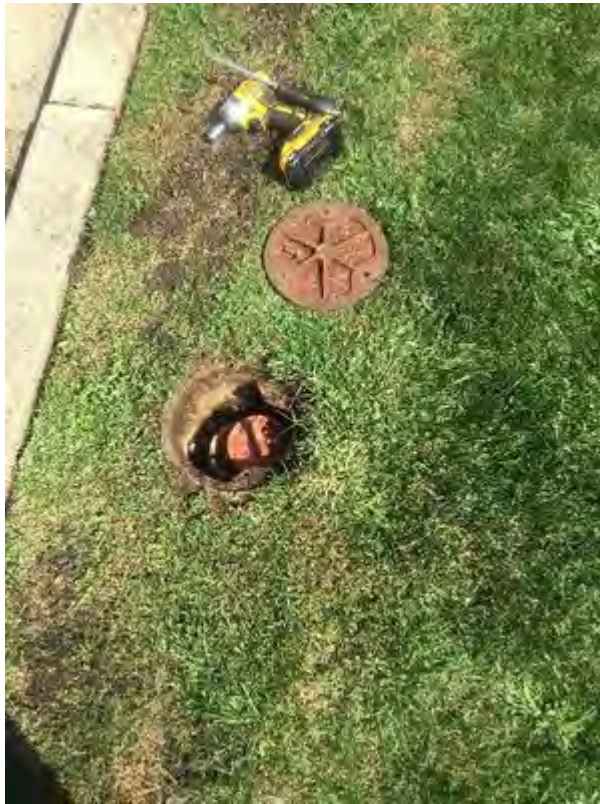
Client: Navy CLEAN	Facility: NWIRP Bethpage
Project Number: 112G08005-WE13	Location: Bethpage, New York
Date: September 13, 2021 13:28	Personnel: Noah Sprouse
Well ID: GM38-RW3-MW3	Well Location: 206763.9 1128986.6
Well Status: Other	Screen Interval: 320-340
WELL INVENTORY CONDITION	
Concrete pad in acceptable condition i.e. no cracks?	YES
Manhole cover present and in working condition?	YES
All bolts on manhole present and not stripped?	NO
Well plug present, locked and in good working condition?	YES
OVERALL CONDITION:	FAIR
Notes (Explain if answered No to any of the above) Missing two bolts

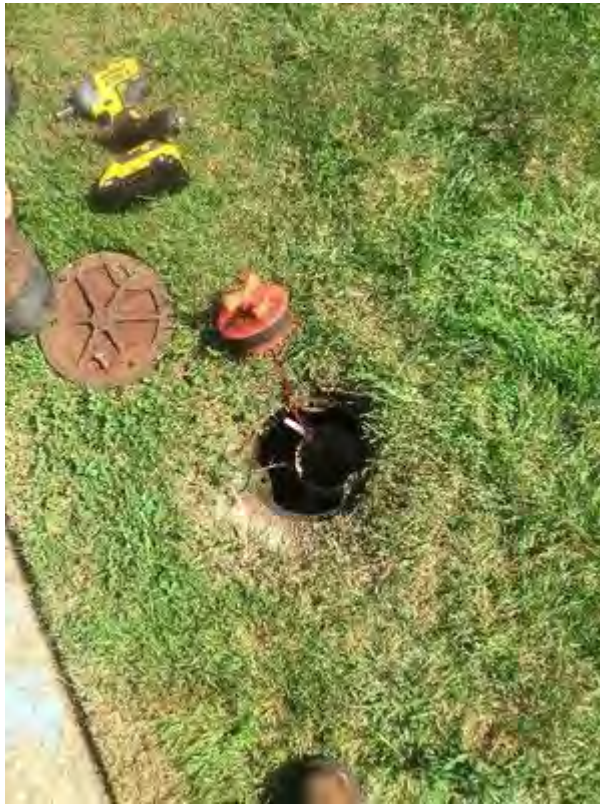
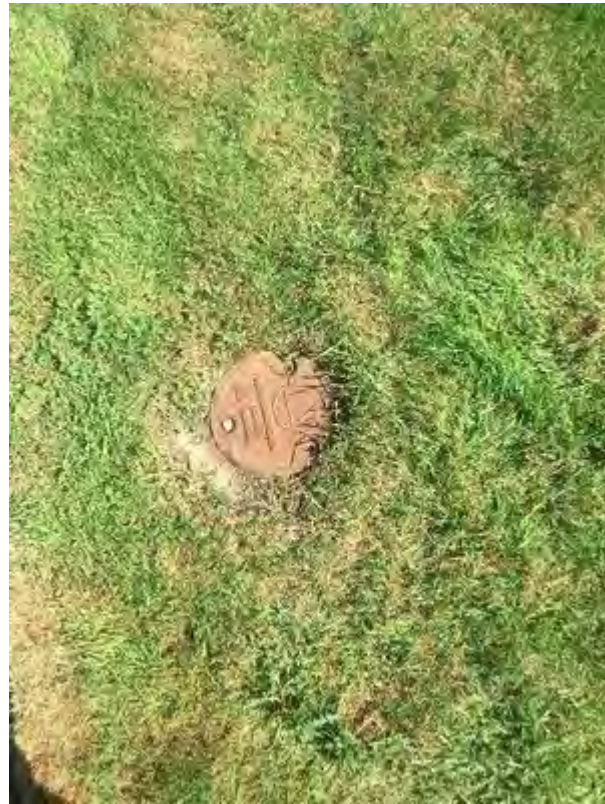
Client: Navy CLEAN	Facility: NWIRP Bethpage
Project Number: 112G08005-WE13	Location: Bethpage, New York
Date: September 13, 2021 13:25	Personnel: Noah Sprouse
Well ID: GM38-RW3-MW4	Well Location: 206759.7 1128970.5
Well Status: Other	Screen Interval: 475-495
WELL INVENTORY CONDITION	
Concrete pad in acceptable condition i.e. no cracks?	YES
Manhole cover present and in working condition?	YES
All bolts on manhole present and not stripped?	NO
Well plug present, locked and in good working condition?	YES
OVERALL CONDITION:	FAIR
Notes (Explain if answered No to any of the above) Missing two bolts, bad fill/stabilizer

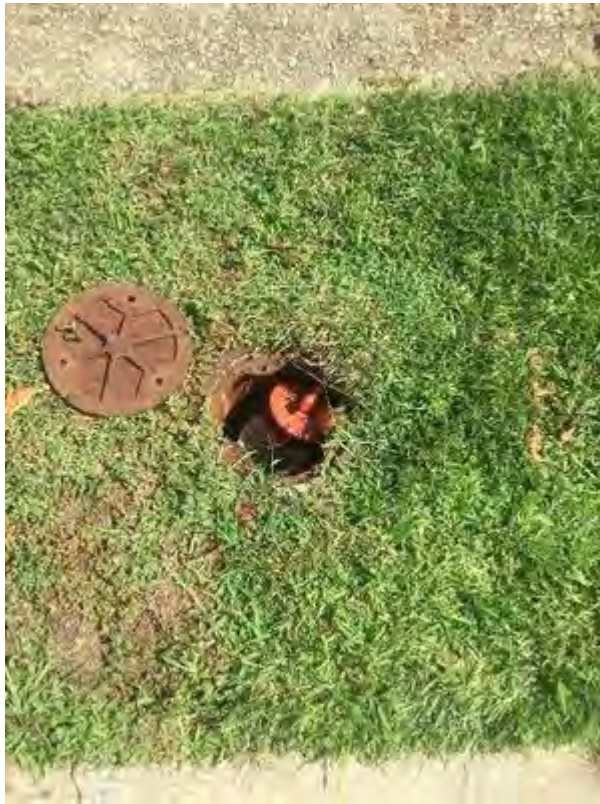
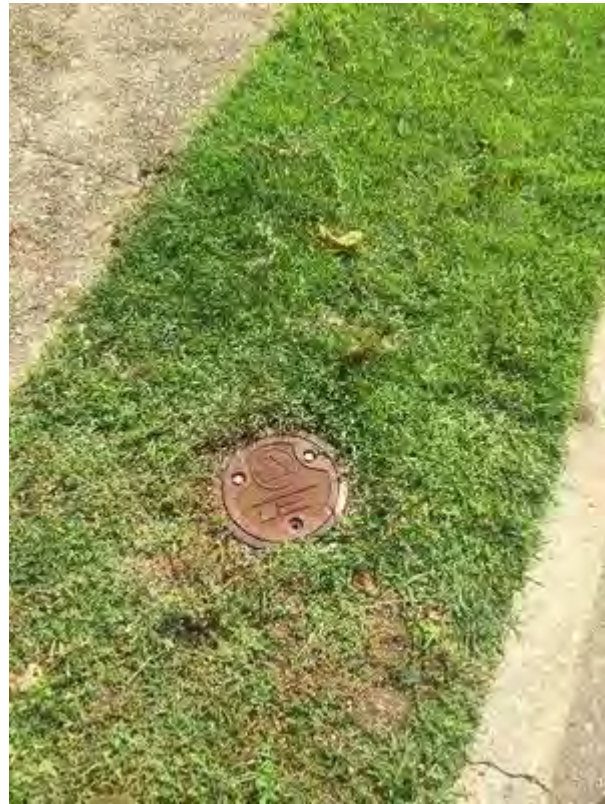
Client: Navy CLEAN	Facility: NWIRP Bethpage
Project Number: 112G08005-WE13	Location: Bethpage, New York
Date: September 13, 2021 13:10	Personnel: Noah Sprouse
Well ID: GM38-RW3-MW2	Well Location: 206545 1128454.5
Well Status: Other	Screen Interval: 330-350
WELL INVENTORY CONDITION	
Concrete pad in acceptable condition i.e. no cracks?	YES
Manhole cover present and in working condition?	NO
All bolts on manhole present and not stripped?	YES
Well plug present, locked and in good working condition?	NO
OVERALL CONDITION:	FAIR
Notes (Explain if answered No to any of the above) Missing one bolt, bad stabilizer, missing tubing

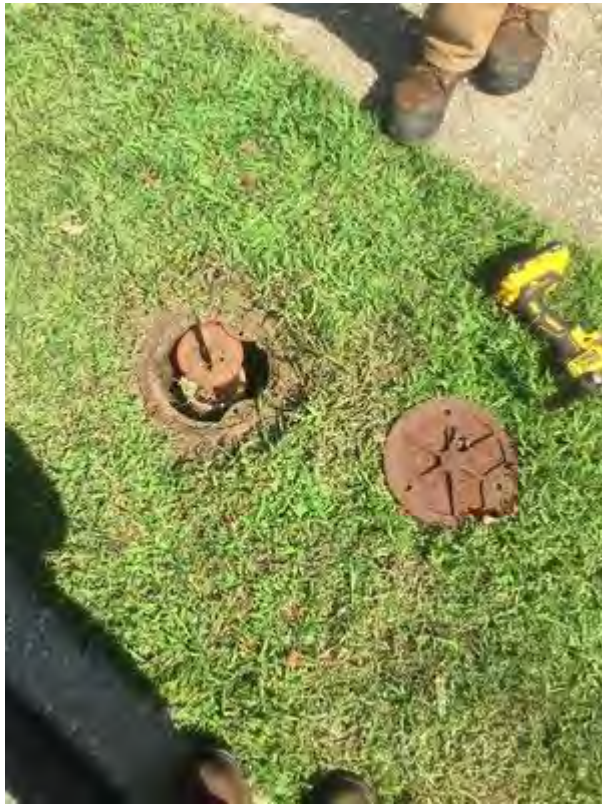
Client: Navy CLEAN	Facility: NWIRP Bethpage
Project Number: 112G08005-WE13	Location: Bethpage, New York
Date: September 13, 2021 13:05	Personnel: Noah Sprouse
Well ID: GM38-RW3-MW1	Well Location: 206560.3 1128455
Well Status: Other	Screen Interval: 475-495
WELL INVENTORY CONDITION	
Concrete pad in acceptable condition i.e. no cracks?	YES
Manhole cover present and in working condition?	YES
All bolts on manhole present and not stripped?	NO
Well plug present, locked and in good working condition?	YES
OVERALL CONDITION:	FAIR
Notes (Explain if answered No to any of the above) Missing one bolt, no seal

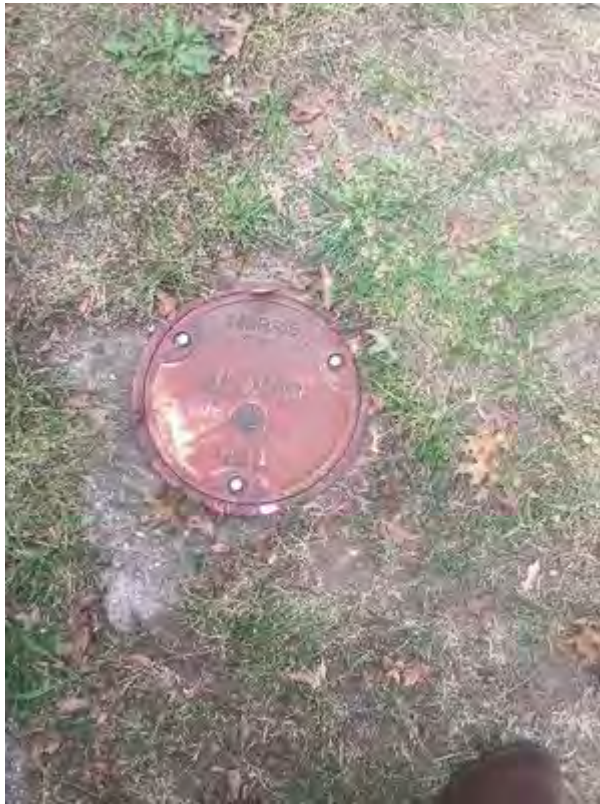
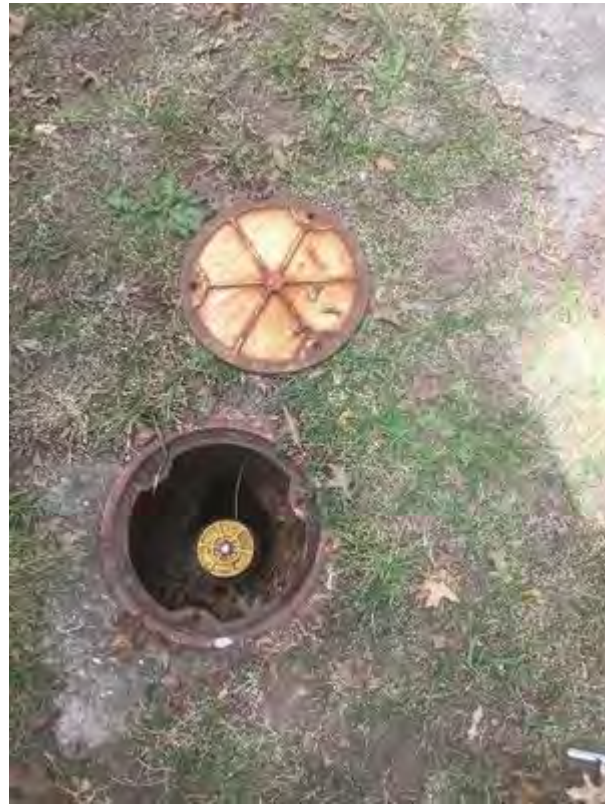
Client: Navy CLE	Facility: NWIRP Bethpage
Project Number: 112G08005-WE13	Location: Bethpage, New York
Date: September 21, 2021 12:05	Personnel: Noah Sprouse
Well ID: TT101D	Well Location: 203545.488 1125462.038
Well Status: Other	Screen Interval: 325-345
WELL INVENTORY CONDITION	
Concrete pad in acceptable condition i.e. no cracks?	YES
Manhole cover present and in working condition?	YES
All bolts on manhole present and not stripped?	YES
Well plug present, locked and in good working condition?	YES
OVERALL CONDITION:	FAIR
Notes (Explain if answered No to any of the above) Needs fill/ missing rubber gasket.

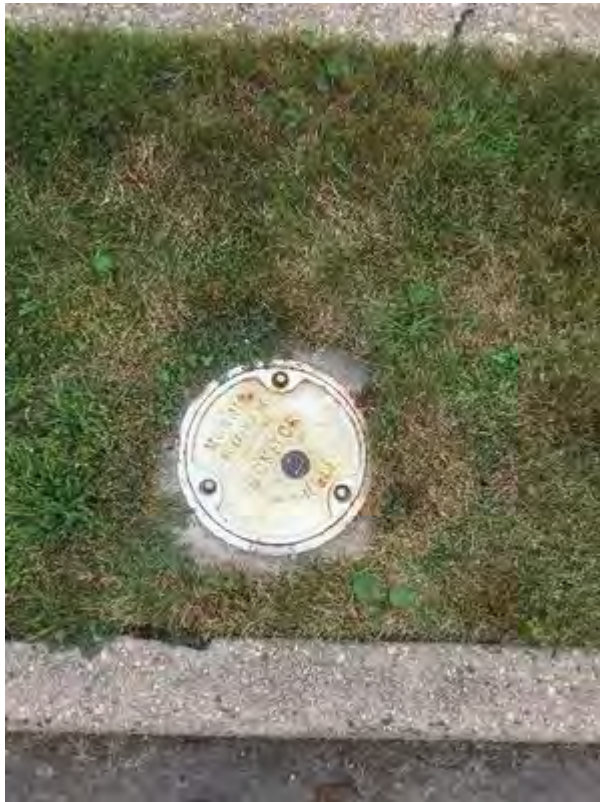
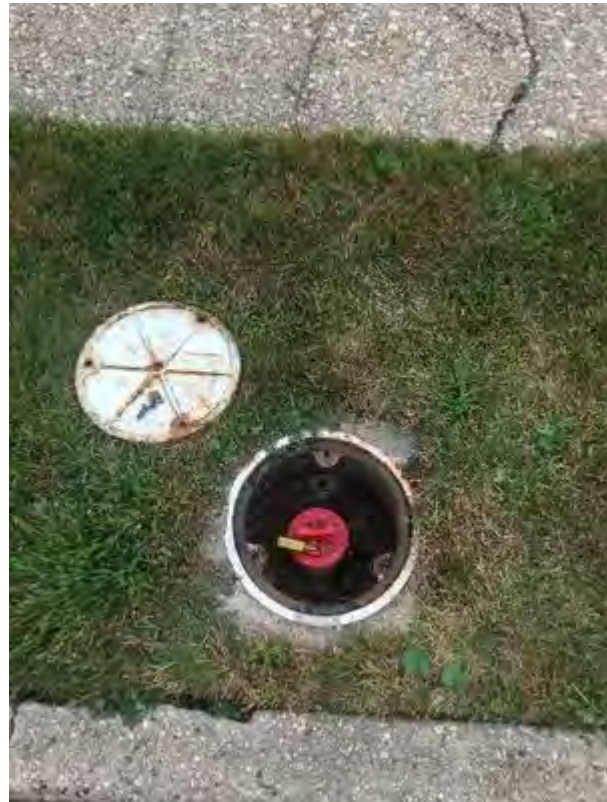
Client: Navy CLEAN	Facility: NWIRP Bethpage
Project Number: 112G08005-WE13	Location: Bethpage, New York
Date: September 17, 2021 12:08	Personnel: Noah Sprouse
Well ID: RE120D2	Well Location: 204576.78 1125060.08
Well Status: Other	Screen Interval: 690-710
WELL INVENTORY CONDITION	
Concrete pad in acceptable condition i.e. no cracks?	YES
Manhole cover present and in working condition?	YES
All bolts on manhole present and not stripped?	YES
Well plug present, locked and in good working condition?	YES
OVERALL CONDITION:	GOOD
Notes (Explain if answered No to any of the above)

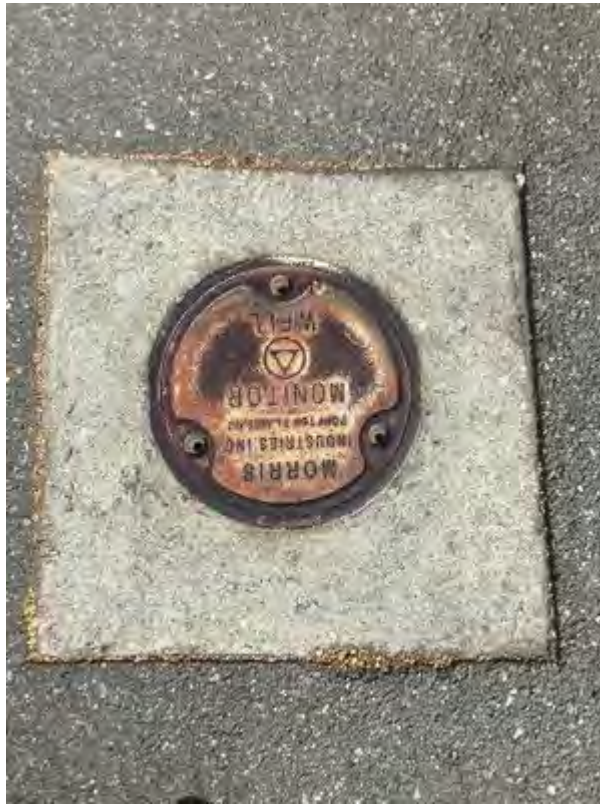
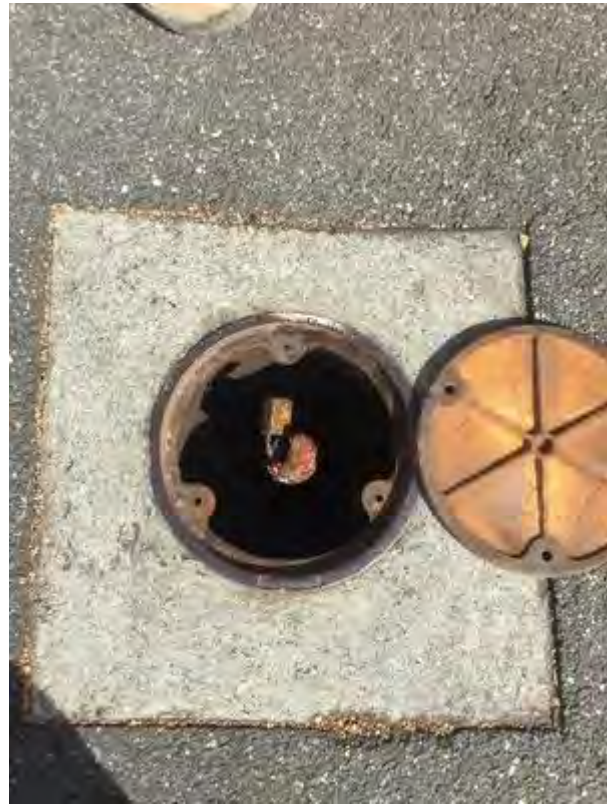
Client: Navy CLEAN	Facility: NWIRP Bethpage
Project Number: 112G08005-WE13	Location: Bethpage, New York
Date: September 23, 2021 10:58	Personnel: Noah Sprouse
Well ID: BPS1-TT-MW309D	Well Location: 215208.441 1125028.421
Well Status: Other	Screen Interval: 252-262
WELL INVENTORY CONDITION	
Concrete pad in acceptable condition i.e. no cracks?	YES
Manhole cover present and in working condition?	YES
All bolts on manhole present and not stripped?	NO
Well plug present, locked and in good working condition?	YES
OVERALL CONDITION:	GOOD
Notes (Explain if answered No to any of the above) All bolts missing, broken rubber gasket.

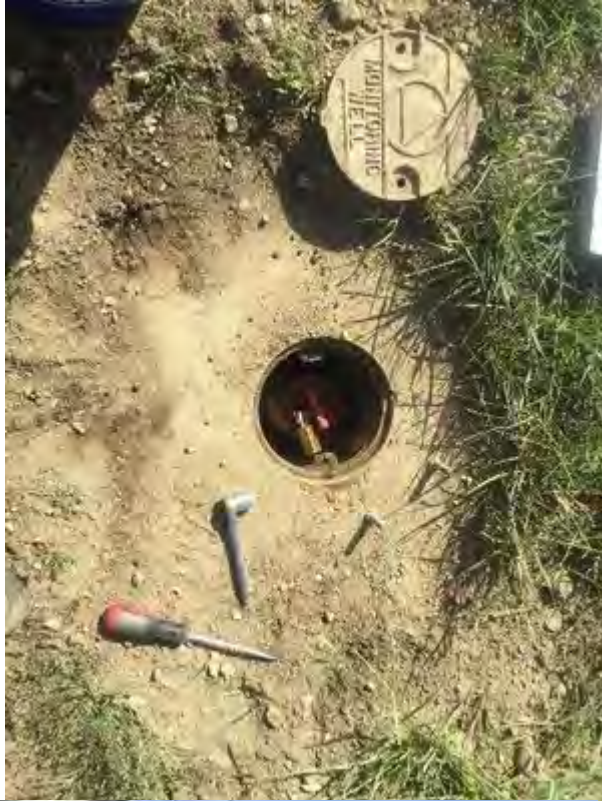
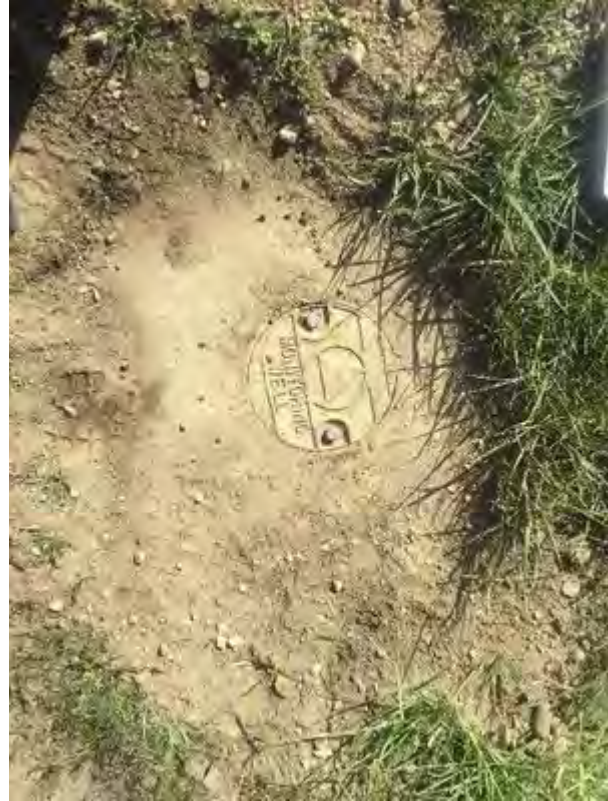
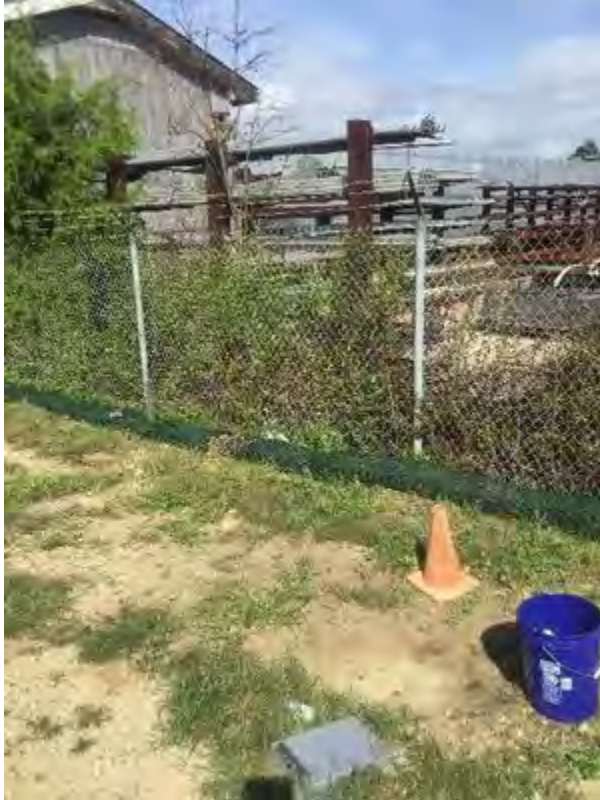
Client: Navy CLEAN	Facility: NWIRP Bethpage
Project Number: 112G08005-WE13	Location: Bethpage, New York
Date: September 23, 2021 10:48	Personnel: Wyatt Bostick
Well ID: BPGMMW73D2	Well Location: 209851.283 1124674.455
Well Status: Other	Screen Interval: 532-552
WELL INVENTORY CONDITION	
Concrete pad in acceptable condition i.e. no cracks?	YES
Manhole cover present and in working condition?	YES
All bolts on manhole present and not stripped?	YES
Well plug present, locked and in good working condition?	YES
OVERALL CONDITION:	GOOD
Notes (Explain if answered No to any of the above) Likely to get lost, below grade 2-3 in

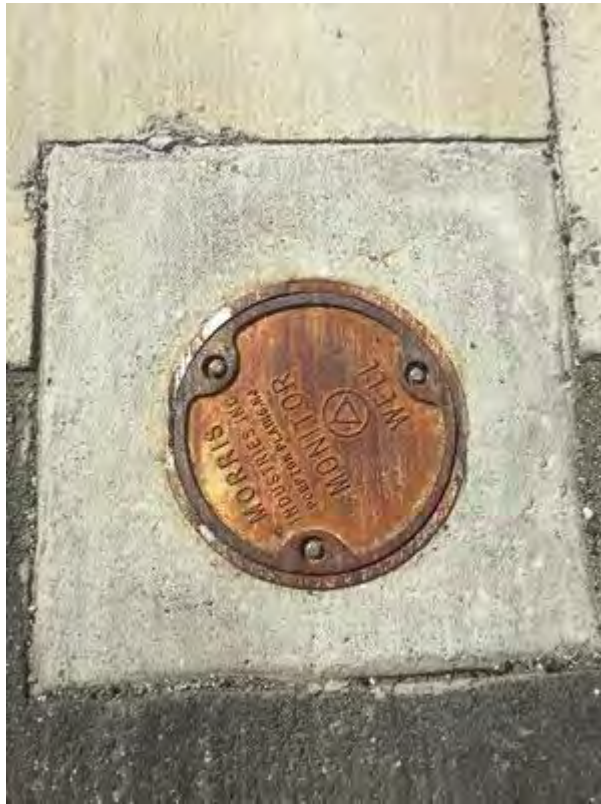
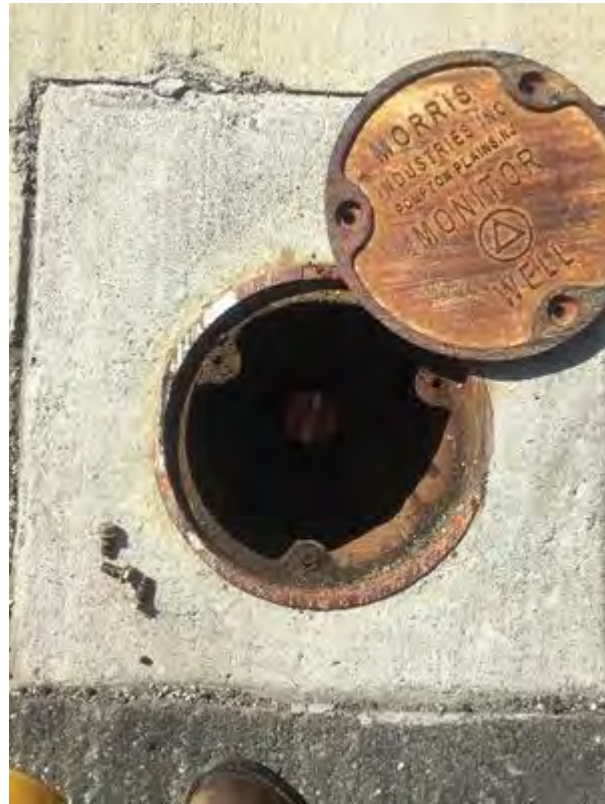
Client: Navy CLEAN	Facility: NWIRP Bethpage
Project Number: 112G08005-WE13	Location: Bethpage, New York
Date: September 23, 2021 10:43	Personnel: Noah Sprouse
Well ID: BPS1-TT-MW310S	Well Location: 215489.753 1124093.163
Well Status: Other	Screen Interval: 57.5-67.5
WELL INVENTORY CONDITION	
Concrete pad in acceptable condition i.e. no cracks?	YES
Manhole cover present and in working condition?	YES
All bolts on manhole present and not stripped?	NO
Well plug present, locked and in good working condition?	YES
OVERALL CONDITION:	FAIR
Notes (Explain if answered No to any of the above) All bolts stripped.

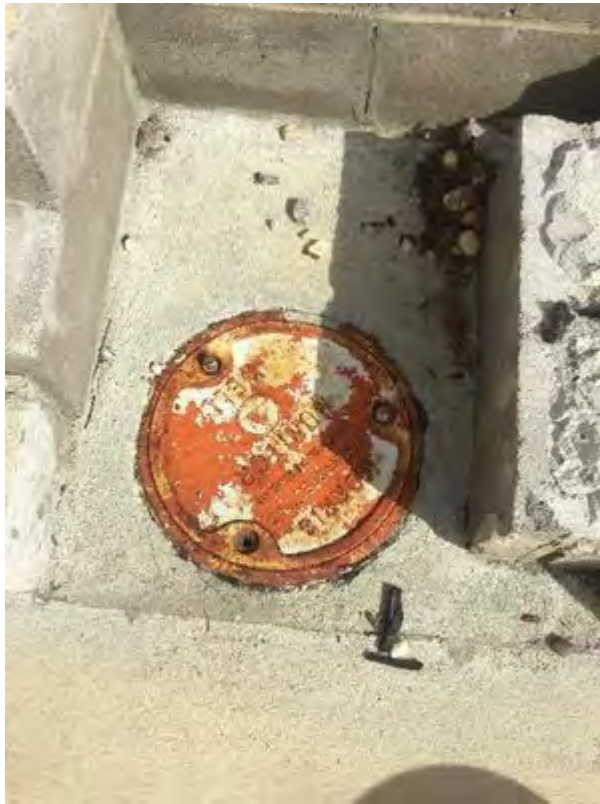
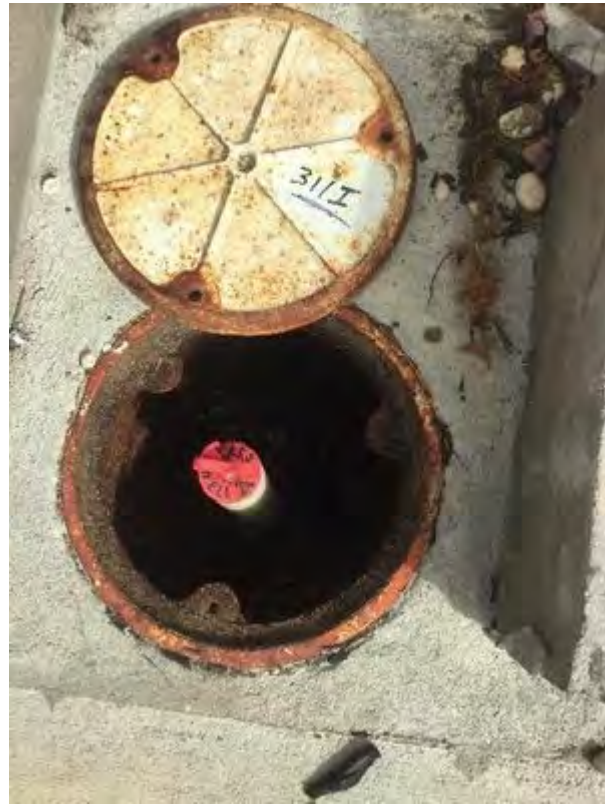
Client: Navy CLEAN	Facility: NWIRP Bethpage
Project Number: 112G08005-WE13	Location: Bethpage, New York
Date: September 23, 2021 10:36	Personnel: Noah Sprouse
Well ID: BPS1-TT-MW311I	Well Location: 215422.011 1124599.099
Well Status: Other	Screen Interval: 160-170
WELL INVENTORY CONDITION	
Concrete pad in acceptable condition i.e. no cracks?	YES
Manhole cover present and in working condition?	YES
All bolts on manhole present and not stripped?	NO
Well plug present, locked and in good working condition?	YES
OVERALL CONDITION:	FAIR
Notes (Explain if answered No to any of the above) Missing one bolt.

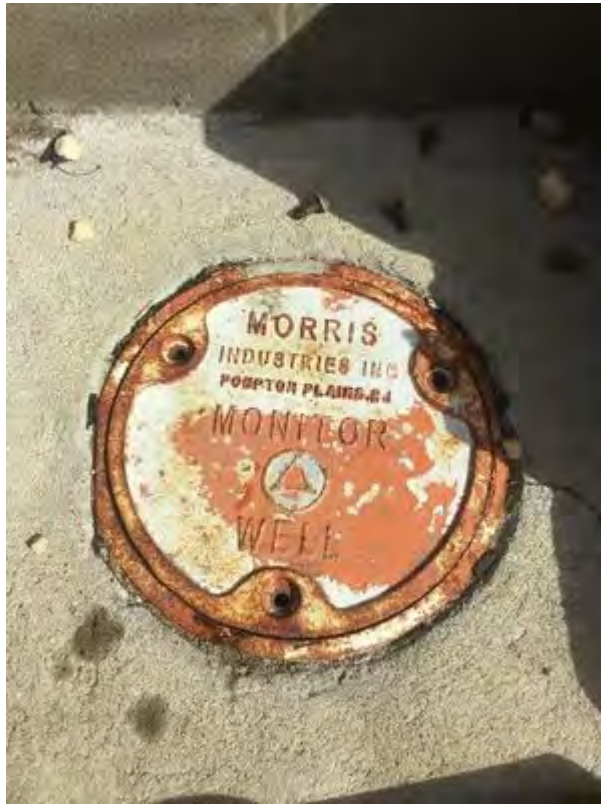
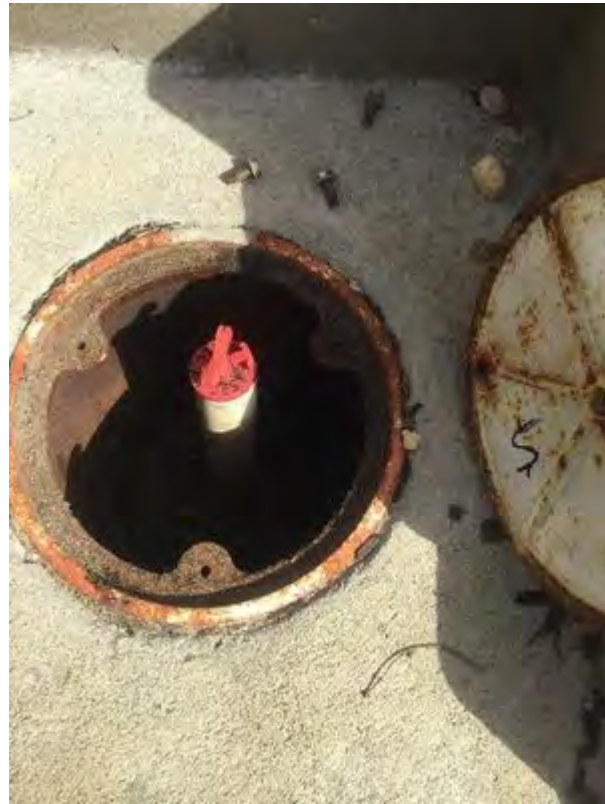
Client: Navy CLEAN	Facility: NWIRP Bethpage
Project Number: 112G08005-WE13	Location: Bethpage, New York
Date: September 23, 2021 10:33	Personnel: Noah Sprouse
Well ID: BPS1-TT-MW311S	Well Location: 215423.402 1124594.444
Well Status: Other	Screen Interval: 55-65
WELL INVENTORY CONDITION	
Concrete pad in acceptable condition i.e. no cracks?	YES
Manhole cover present and in working condition?	YES
All bolts on manhole present and not stripped?	YES
Well plug present, locked and in good working condition?	YES
OVERALL CONDITION:	FAIR
Notes (Explain if answered No to any of the above) Needs fill.
