Memorandum

To: Scot Sokolowski, NAVFAC MIDLANT
From: David Brayack, Tetra Tech
Date: December 30, 2021
Re: Annual LUC Inspection and Operation Summary Report: Sites 1, 2, 3, and 4 – NWIRP Bethpage
Revision 1
Contract/CTO Number: N6247016D9008/WE13

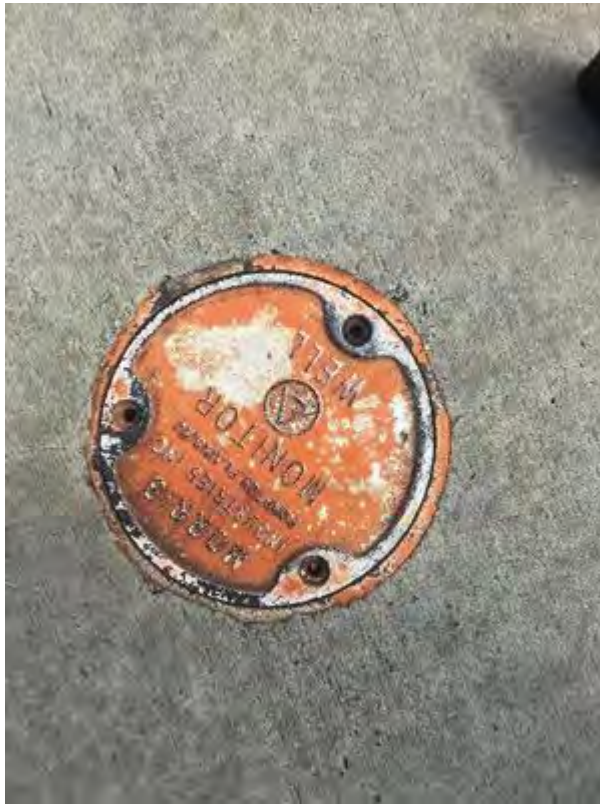
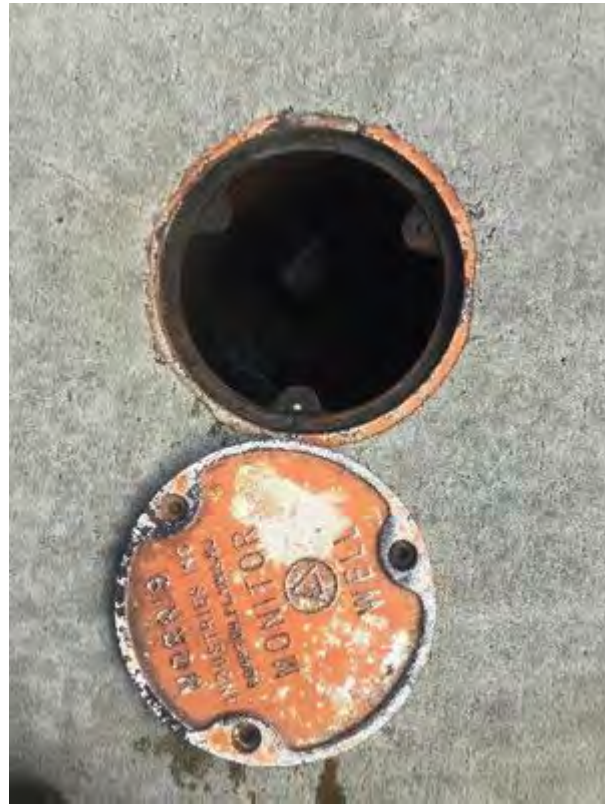
Client: Navy CLEAN	Facility: NWIRP Bethpage
Project Number: 112G08005-WE13	Location: Bethpage, New York
Date: September 23, 2021 10:25	Personnel: Noah Sprouse
Well ID: BPS1-TT-MW308S	Well Location: 214977.9 1124910.2
Well Status: Other	Screen Interval: 54-64
WELL INVENTORY CONDITION	
Concrete pad in acceptable condition i.e. no cracks?	YES
Manhole cover present and in working condition?	YES
All bolts on manhole present and not stripped?	NO
Well plug present, locked and in good working condition?	YES
OVERALL CONDITION:	FAIR
Notes (Explain if answered No to any of the above) Three bolts broken.

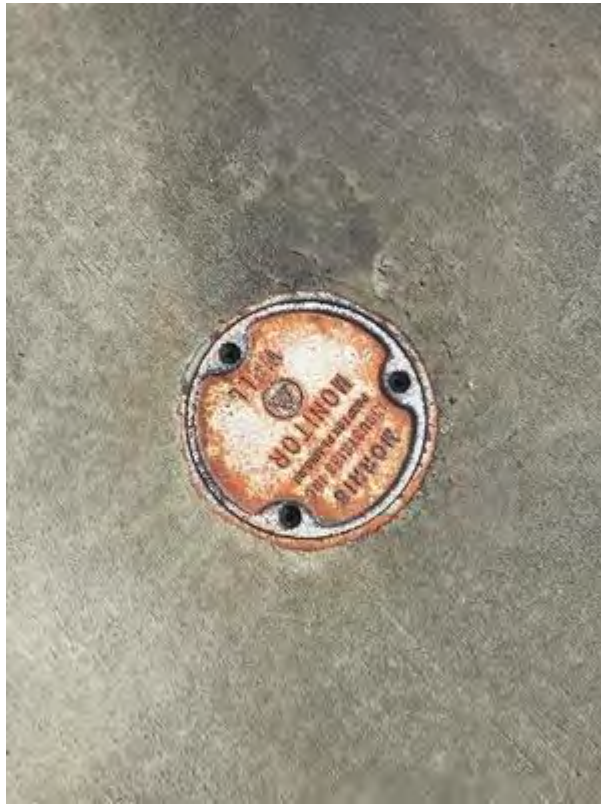
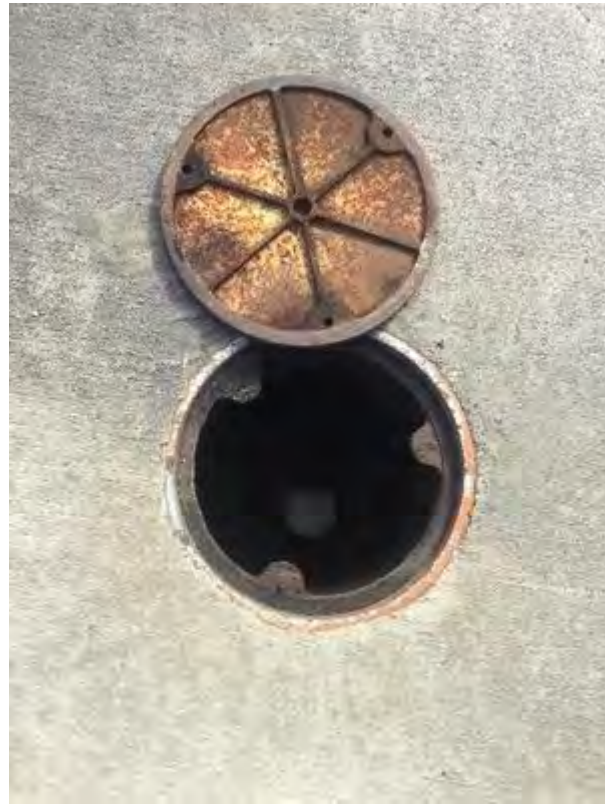
Client: Navy CLEAN	Facility: NWIRP Bethpage
Project Number: 112G08005-WE13	Location: Bethpage, New York
Date: September 23, 2021 10:04	Personnel: Noah Sprouse
Well ID: BPS1-TT-MW308I	Well Location: 214972.2 1124923.7
Well Status: Other	Screen Interval: 156-166
WELL INVENTORY CONDITION	
Concrete pad in acceptable condition i.e. no cracks?	YES
Manhole cover present and in working condition?	YES
All bolts on manhole present and not stripped?	NO
Well plug present, locked and in good working condition?	YES
OVERALL CONDITION:	FAIR
Notes (Explain if answered No to any of the above) All bolts broken/missing.

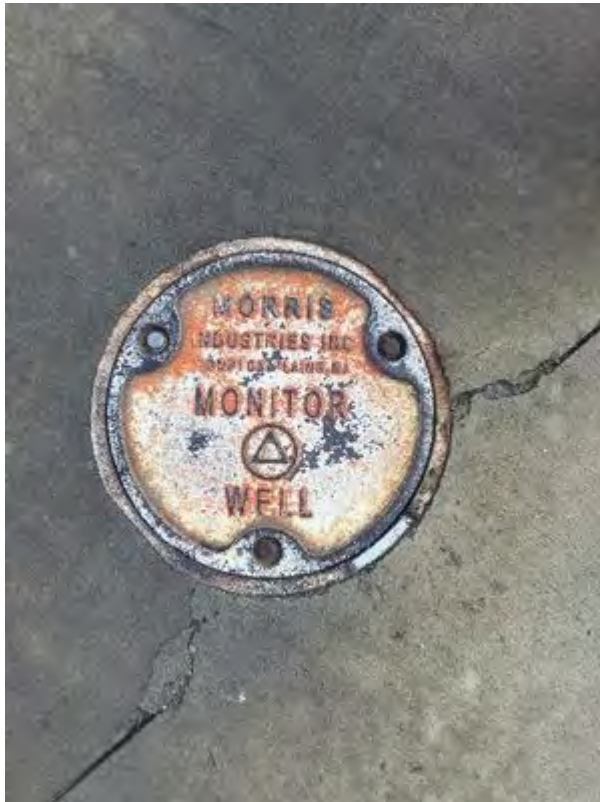
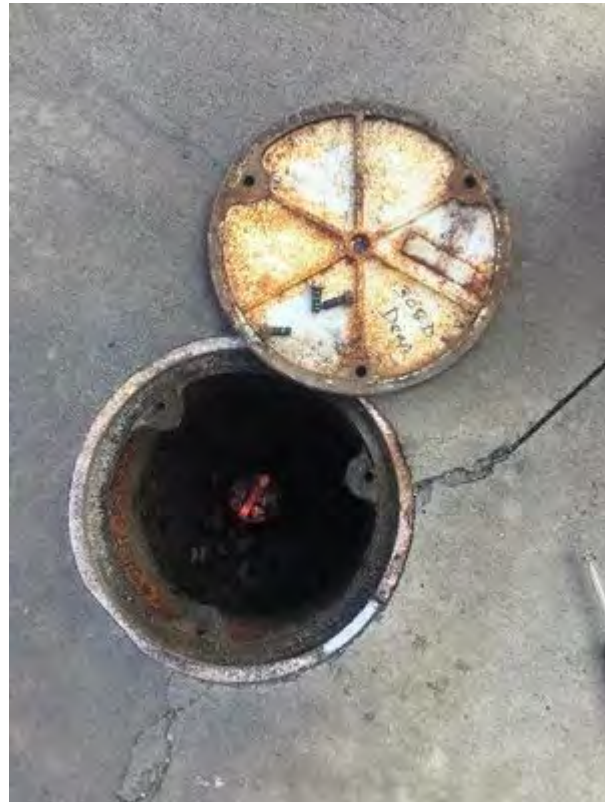
Client: Navy CLEAN	Facility: NWIRP Bethpage
Project Number: 112G08005-WE13	Location: Bethpage, New York
Date: September 23, 2021 10:02	Personnel: Noah Sprouse
Well ID: BPS1-TT-MW308D	Well Location: 214965.9 1124935.6
Well Status: Unknown	Screen Interval: 250-260
WELL INVENTORY CONDITION	
Concrete pad in acceptable condition i.e. no cracks?	YES
Manhole cover present and in working condition?	YES
All bolts on manhole present and not stripped?	NO
Well plug present, locked and in good working condition?	YES
OVERALL CONDITION:	FAIR
Notes (Explain if answered No to any of the above) Bolts stripped.

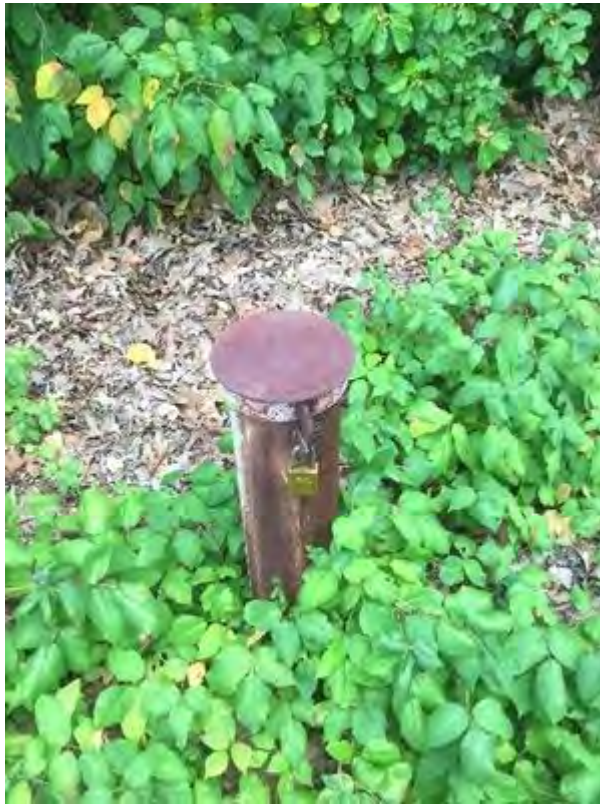
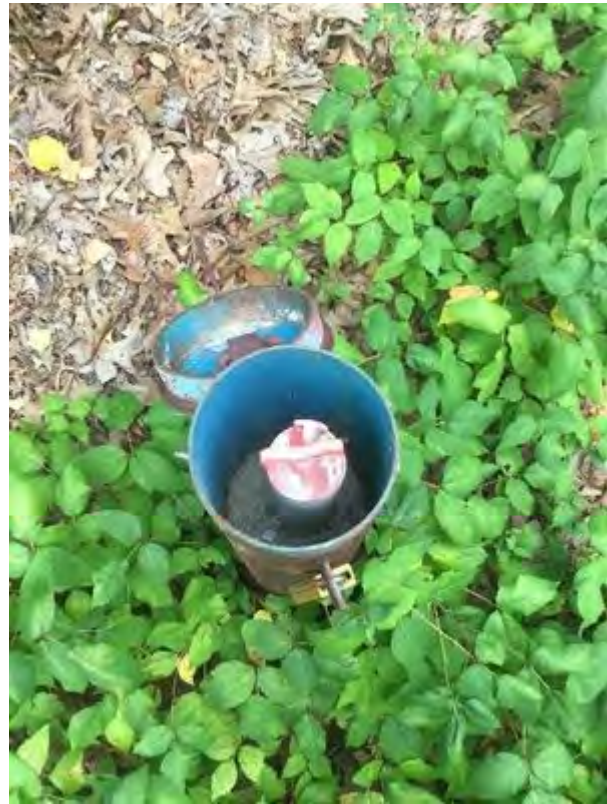
Client: Navy CLEAN	Facility: NWIRP Bethpage
Project Number: 112G08005-WE13	Location: Bethpage, New York
Date: September 23, 2021 09:01	Personnel: Noah Sprouse
Well ID: BPS1-TT-MW312I	Well Location: 215327.647 1125165.865
Well Status: Other	Screen Interval: 160-170
WELL INVENTORY CONDITION	
Concrete pad in acceptable condition i.e. no cracks?	YES
Manhole cover present and in working condition?	YES
All bolts on manhole present and not stripped?	YES
Well plug present, locked and in good working condition?	YES
OVERALL CONDITION:	GOOD
Notes (Explain if answered No to any of the above) Stick-up well.

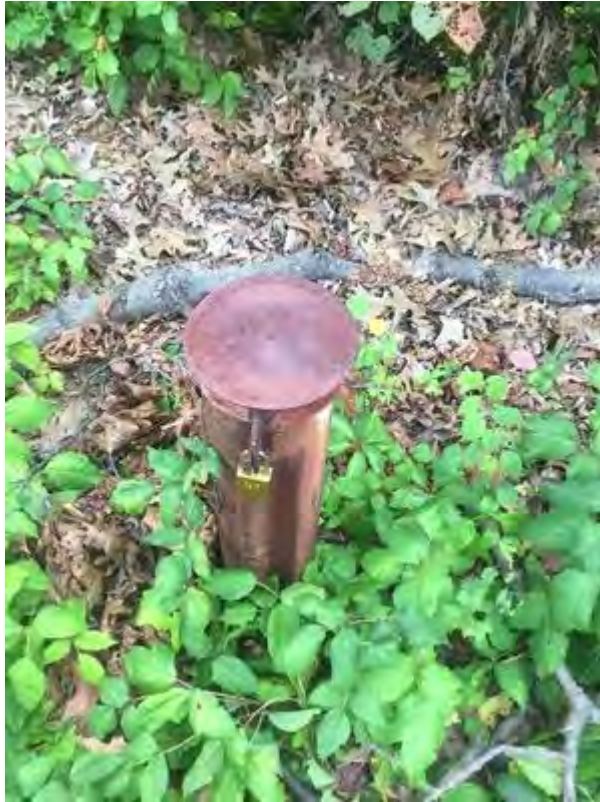
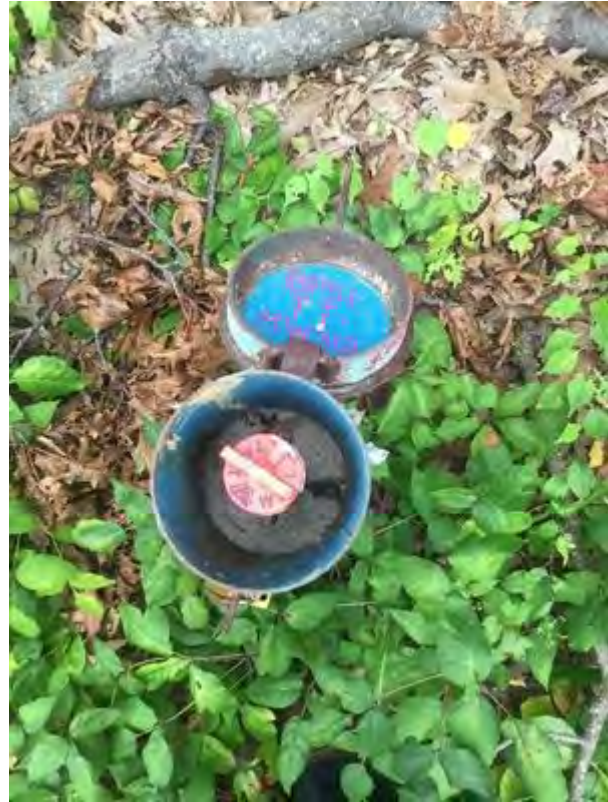
Client: Navy CLEAN	Facility: NWIRP Bethpage
Project Number: 112G08005-WE13	Location: Bethpage, New York
Date: September 23, 2021 08:59	Personnel: Noah Sprouse
Well ID: BPS1-TT-MW312S	Well Location: 215322.312 1125165.285
Well Status: Other	Screen Interval: 53-63
WELL INVENTORY CONDITION	
Concrete pad in acceptable condition i.e. no cracks?	YES
Manhole cover present and in working condition?	YES
All bolts on manhole present and not stripped?	YES
Well plug present, locked and in good working condition?	YES
OVERALL CONDITION:	GOOD
Notes (Explain if answered No to any of the above) Stick-up well.

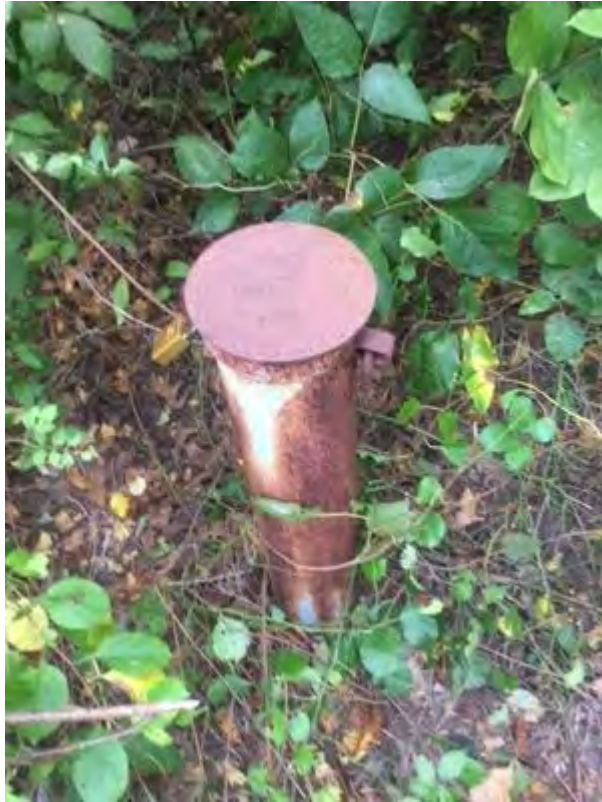
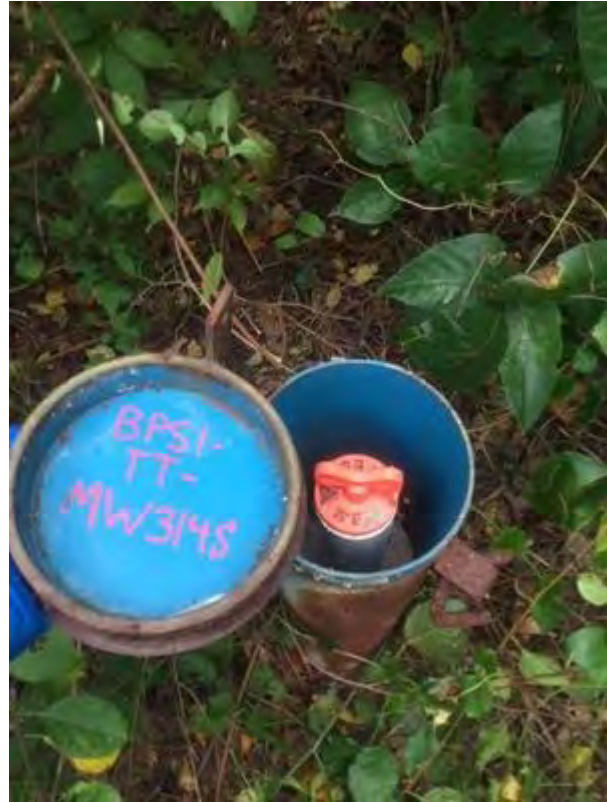
Client: Navy CLEAN	Facility: NWIRP Bethpage
Project Number: 112G08005-WE13	Location: Bethpage, New York
Date: September 23, 2021 08:50	Personnel: Vince Shickora
Well ID: BPS1-TT-MW314S	Well Location: 214,555.48 1,125,571.01
Well Status: Other	Screen Interval: 55-65
WELL INVENTORY CONDITION	
Concrete pad in acceptable condition i.e. no cracks?	YES
Manhole cover present and in working condition?	YES
All bolts on manhole present and not stripped?	YES
Well plug present, locked and in good working condition?	YES
OVERALL CONDITION:	GOOD
Notes (Explain if answered No to any of the above) Well installed as stickup.

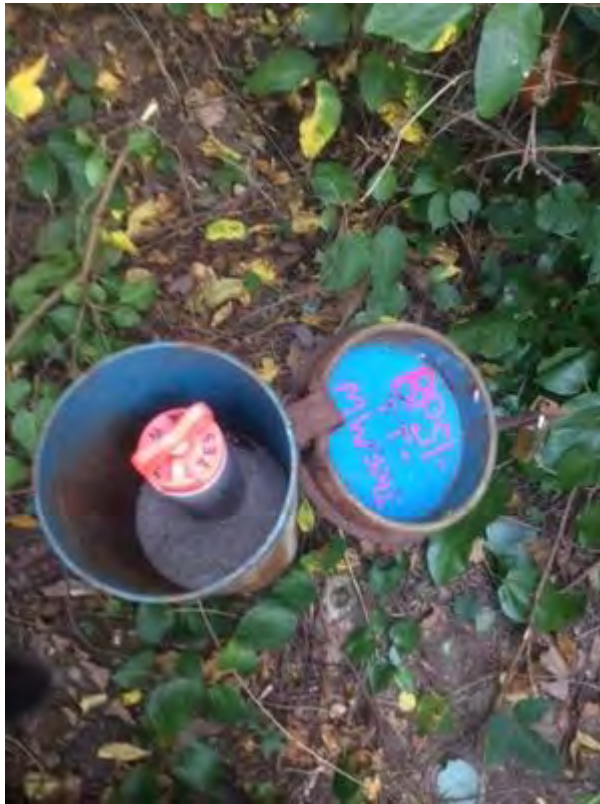
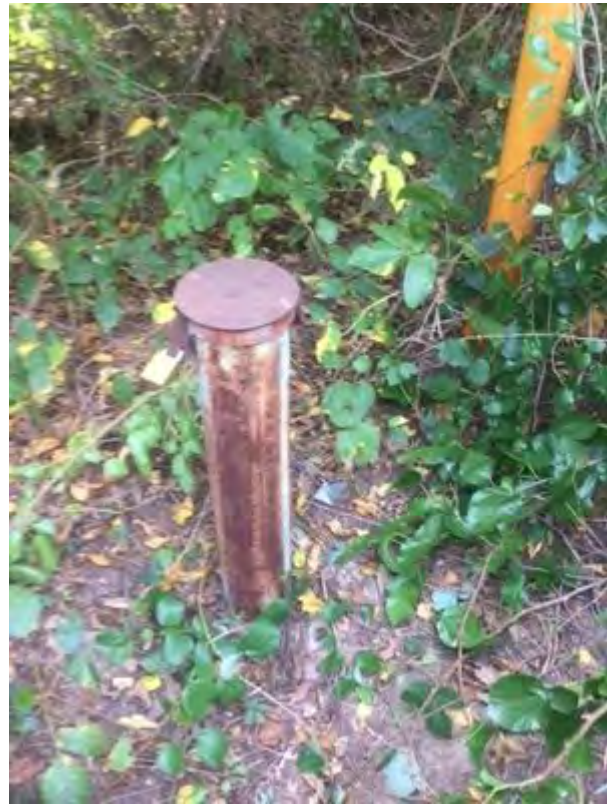
Client: Navy CLEAN	Facility: NWIRP Bethpage
Project Number: 112G08005-WE13	Location: Bethpage, New York
Date: September 23, 2021 08:47	Personnel: Vince Shickora
Well ID: BPS1-TT-MW314I	Well Location: 214,566.40 1,125,557.47
Well Status: Other	Screen Interval: 144-154
WELL INVENTORY CONDITION	
Concrete pad in acceptable condition i.e. no cracks?	YES
Manhole cover present and in working condition?	YES
All bolts on manhole present and not stripped?	YES
Well plug present, locked and in good working condition?	YES
OVERALL CONDITION:	GOOD
Notes (Explain if answered No to any of the above) Well installed as stickup.

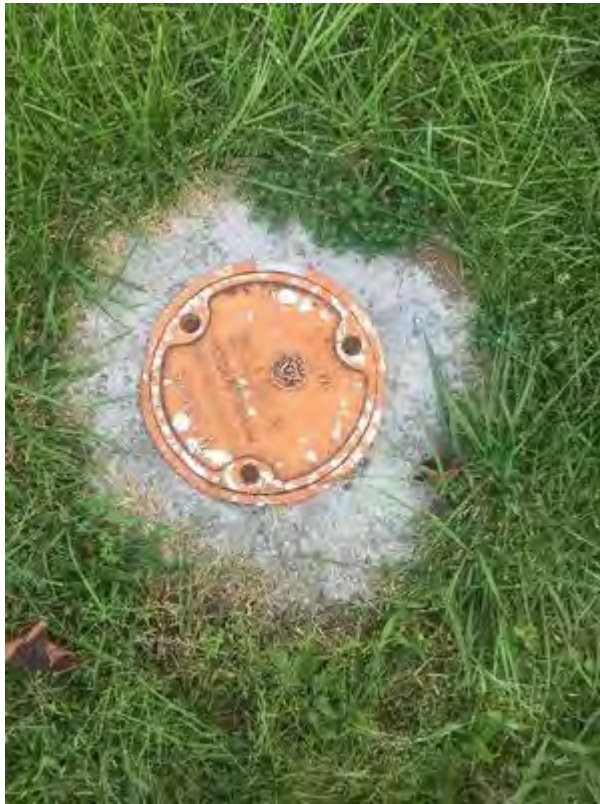
Client: Navy CLEAN	Facility: NWIRP Bethpage
Project Number: 112G08005-WE13	Location: Bethpage, New York
Date: September 23, 2021 08:18	Personnel: Noah Sprouse
Well ID: BP-TT-MW203I	Well Location: 215525.6 1123810
Well Status: Other	Screen Interval: 136-146
WELL INVENTORY CONDITION	
Concrete pad in acceptable condition i.e. no cracks?	YES
Manhole cover present and in working condition?	YES
All bolts on manhole present and not stripped?	YES
Well plug present, locked and in good working condition?	YES
OVERALL CONDITION:	GOOD
Notes (Explain if answered No to any of the above)

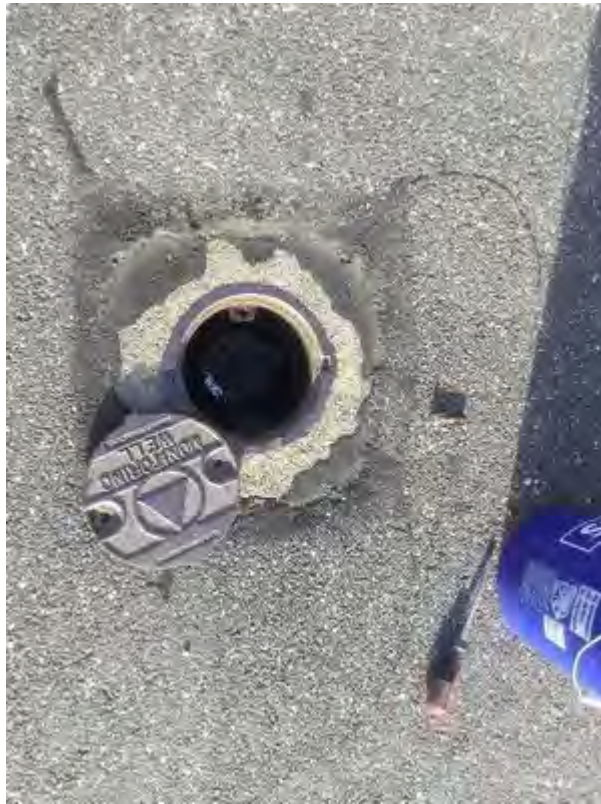
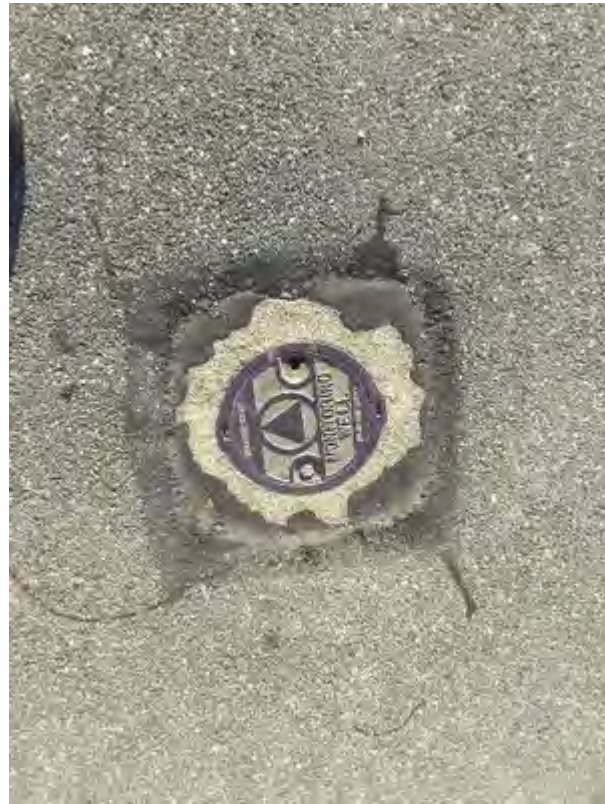
Client: Navy CLEAN	Facility: NWIRP Bethpage
Project Number: 112G08005-WE13	Location: Bethpage, New York
Date: September 23, 2021 08:27	Personnel: Wyatt Bostick
Well ID: BPGMMW39DA	Well Location: 209882 1124170
Well Status: Other	Screen Interval: 262-282
WELL INVENTORY CONDITION	
Concrete pad in acceptable condition i.e. no cracks?	NO
Manhole cover present and in working condition?	NO
All bolts on manhole present and not stripped?	NO
Well plug present, locked and in good working condition?	YES
OVERALL CONDITION:	FAIR
Notes (Explain if answered No to any of the above) Below grade, bolts stripped, and manhole chipped

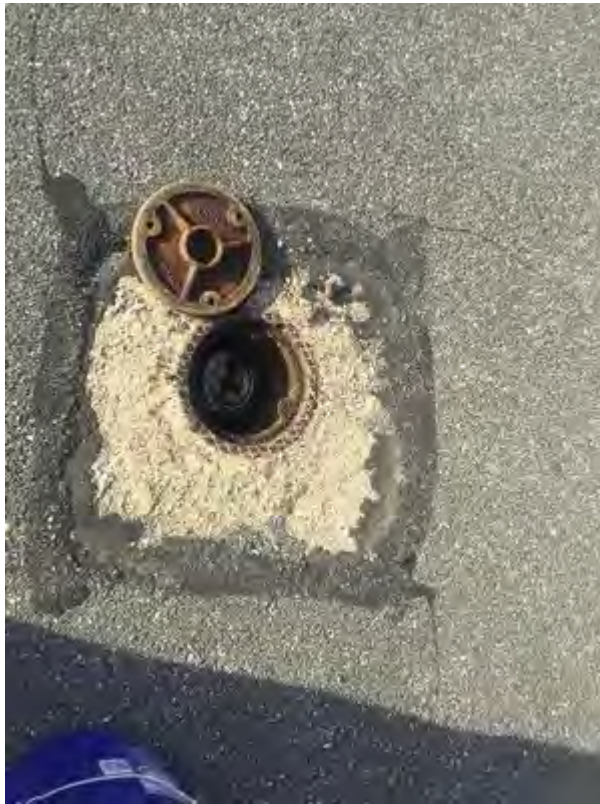
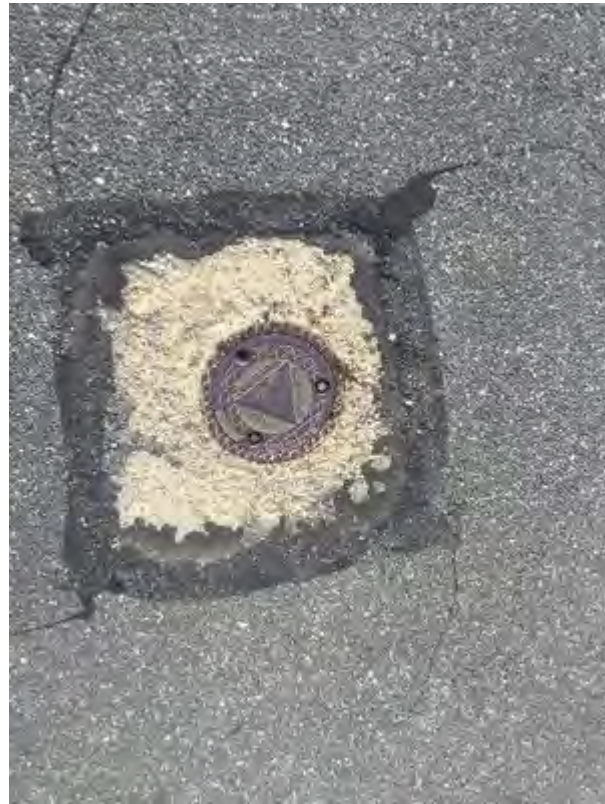
Client: Navy CLEAN	Facility: NWIRP Bethpage
Project Number: 112G08005-WE13	Location: Bethpage, New York
Date: September 23, 2021 08:21	Personnel: Wyatt Bostick
Well ID: BPGMMW39DB	Well Location: 209884 1124173
Well Status: Other	Screen Interval: 410-420
WELL INVENTORY CONDITION	
Concrete pad in acceptable condition i.e. no cracks?	NO
Manhole cover present and in working condition?	YES
All bolts on manhole present and not stripped?	NO
Well plug present, locked and in good working condition?	YES
OVERALL CONDITION:	FAIR
Notes (Explain if answered No to any of the above) Below grade, bolts stripped, and needs fill

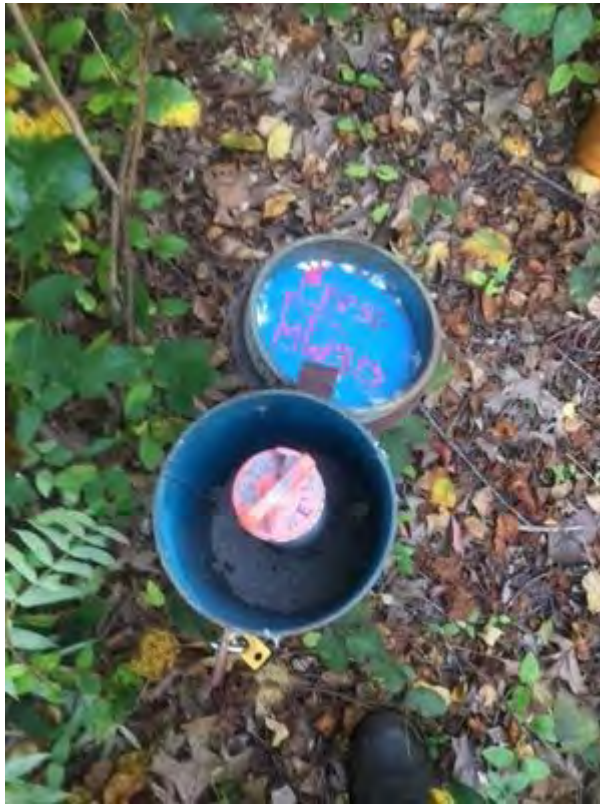
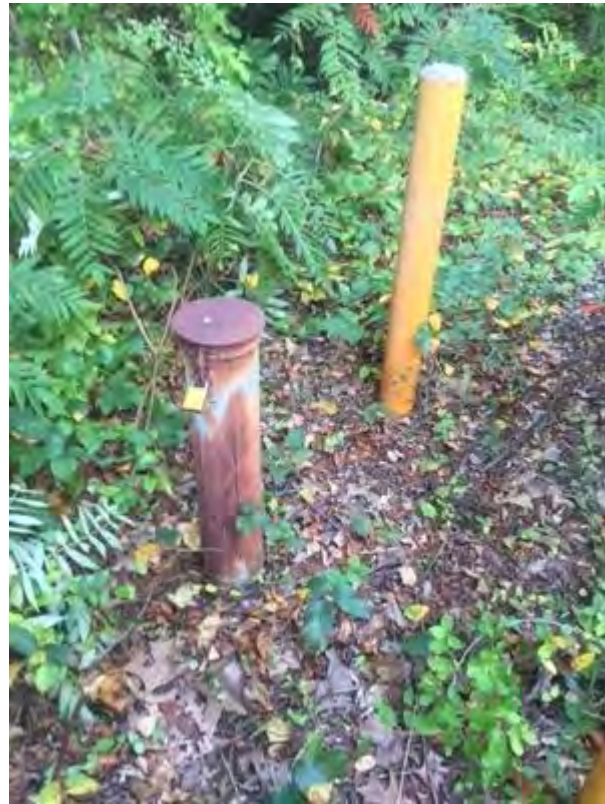
Client: Navy CLEAN	Facility: NWIRP Bethpage
Project Number: 112G08005-WE13	Location: Bethpage, New York
Date: September 23, 2021 08:23	Personnel: Vince Shickora
Well ID: BPS1-TT-MW313S	Well Location: 215,126.40 1,125,591.27
Well Status: Other	Screen Interval: 53-63
WELL INVENTORY CONDITION	
Concrete pad in acceptable condition i.e. no cracks?	YES
Manhole cover present and in working condition?	YES
All bolts on manhole present and not stripped?	YES
Well plug present, locked and in good working condition?	YES
OVERALL CONDITION:	GOOD
Notes (Explain if answered No to any of the above) Well installed as stickup.

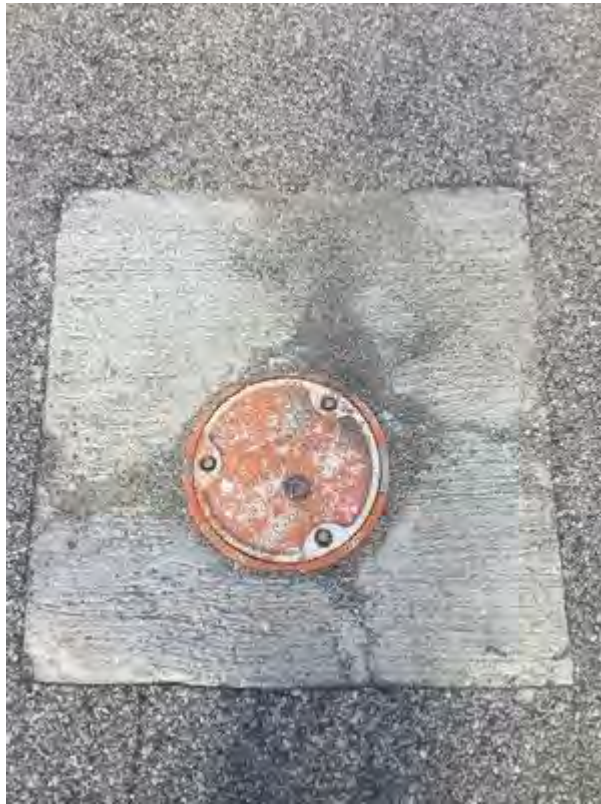
Client: Navy CLEAN	Facility: NWIRP Bethpage
Project Number: 112G08005-WE13	Location: Bethpage, New York
Date: September 23, 2021 08:12	Personnel: Noah Sprouse
Well ID: BP-TT-MW203D	Well Location: 215513 1123748
Well Status: Other	Screen Interval: 275-290
WELL INVENTORY CONDITION	
Concrete pad in acceptable condition i.e. no cracks?	NO
Manhole cover present and in working condition?	YES
All bolts on manhole present and not stripped?	YES
Well plug present, locked and in good working condition?	YES
OVERALL CONDITION:	FAIR
Notes (Explain if answered No to any of the above) Cracked well pad, missing rubber gasket.

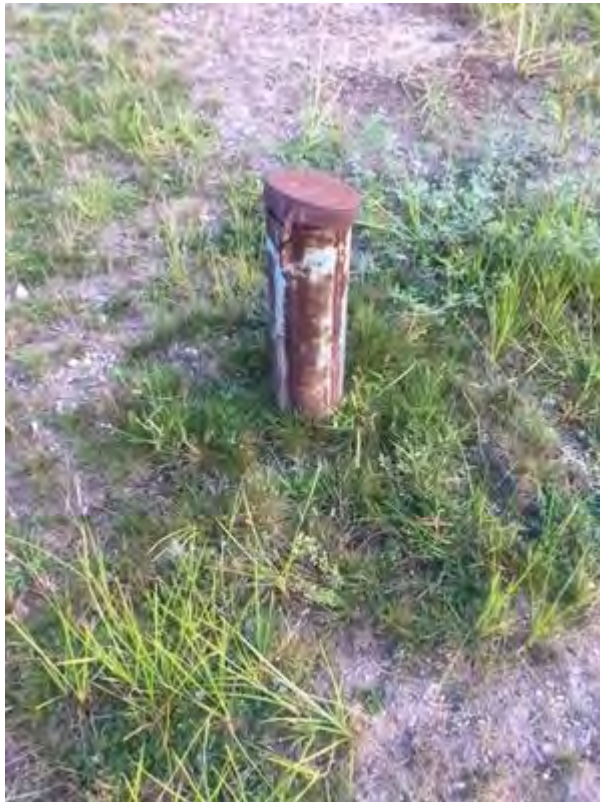
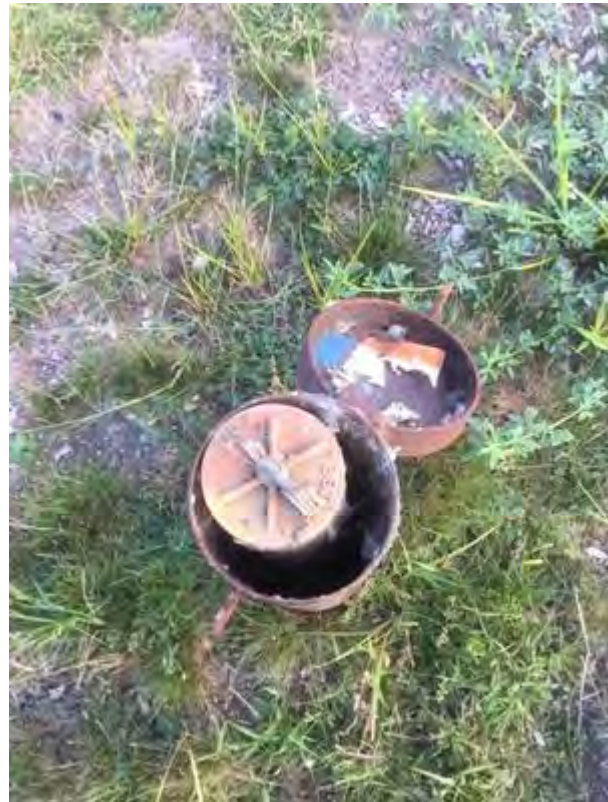
Client: Navy CLEAN	Facility: NWIRP Bethpage
Project Number: 112G08005-WE13	Location: Bethpage, New York
Date: September 23, 2021 08:06	Personnel: Vince Shickora
Well ID: BPHNMW27S	Well Location: 214,421.96 1,124,934.89
Well Status: Other	Screen Interval: 44-54
WELL INVENTORY CONDITION	
Concrete pad in acceptable condition i.e. no cracks?	NO
Manhole cover present and in working condition?	NO
All bolts on manhole present and not stripped?	NO
Well plug present, locked and in good working condition?	NO
OVERALL CONDITION:	POOR
Notes (Explain if answered No to any of the above) Cannot close security casing lid due to height of pvc well casing. No concrete pad observed. No locks on well. Well installed as stickup.

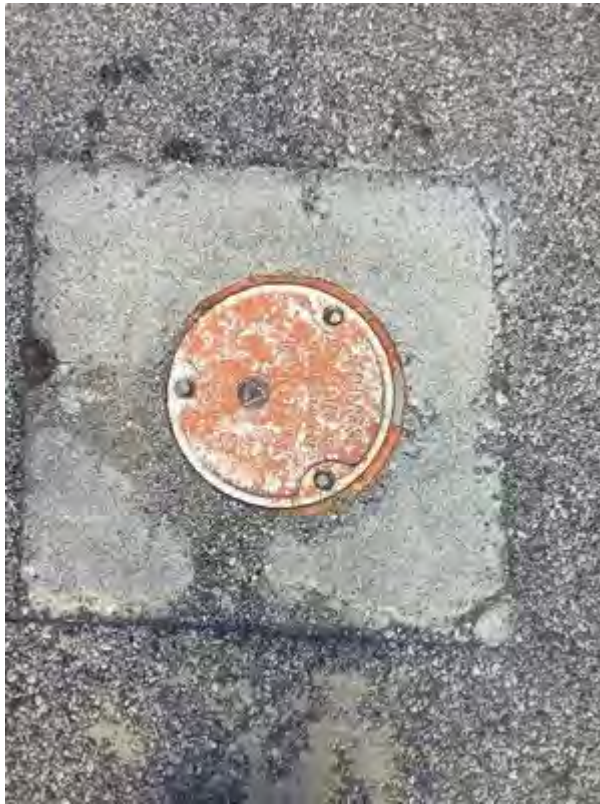
Client: Navy CLEAN	Facility: NWIRP Bethpage
Project Number: 112G08005-WE13	Location: Bethpage, New York
Date: September 23, 2021 08:07	Personnel: Noah Sprouse
Well ID: BP-TT-MW203D1	Well Location: 215510.7 1123763.1
Well Status: Other	Screen Interval: 335-350
WELL INVENTORY CONDITION	
Concrete pad in acceptable condition i.e. no cracks?	NO
Manhole cover present and in working condition?	YES
All bolts on manhole present and not stripped?	YES
Well plug present, locked and in good working condition?	YES
OVERALL CONDITION:	FAIR
Notes (Explain if answered No to any of the above) Cracked well pad.

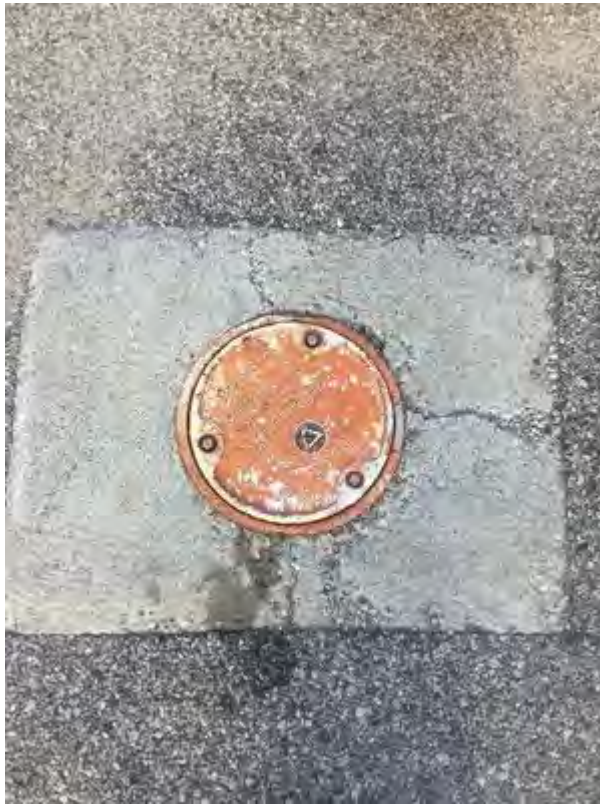
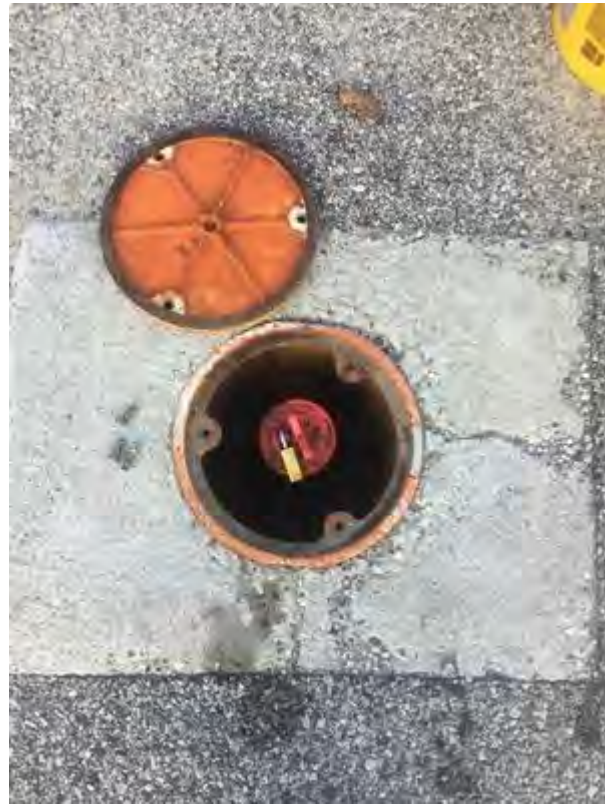
Client: Navy CLEAN	Facility: NWIRP Bethpage
Project Number: 112G08005-WE13	Location: Bethpage, New York
Date: September 23, 2021 08:02	Personnel: Noah Sprouse
Well ID: BP-TT-MW203D2	Well Location: 215507.2 1123778
Well Status: Other	Screen Interval: 435-450
WELL INVENTORY CONDITION	
Concrete pad in acceptable condition i.e. no cracks?	NO
Manhole cover present and in working condition?	YES
All bolts on manhole present and not stripped?	YES
Well plug present, locked and in good working condition?	YES
OVERALL CONDITION:	FAIR
Notes (Explain if answered No to any of the above) Cracked well pad.

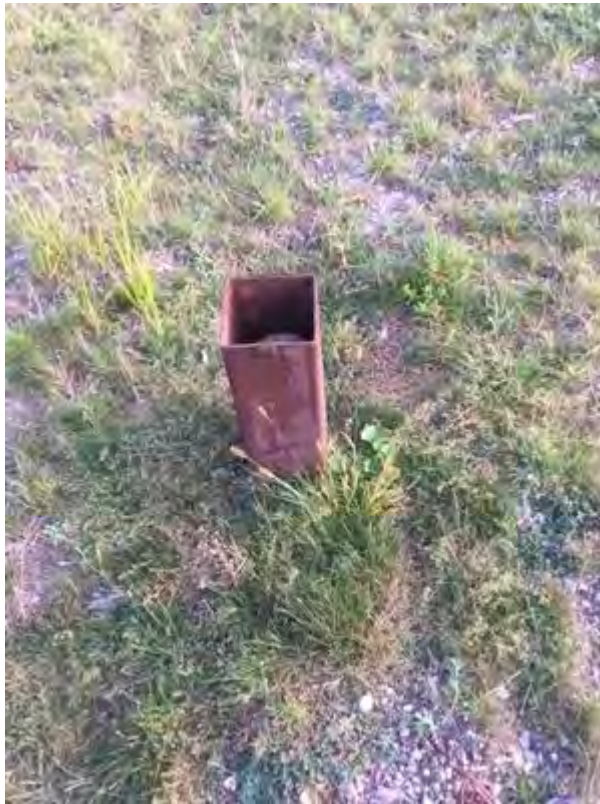
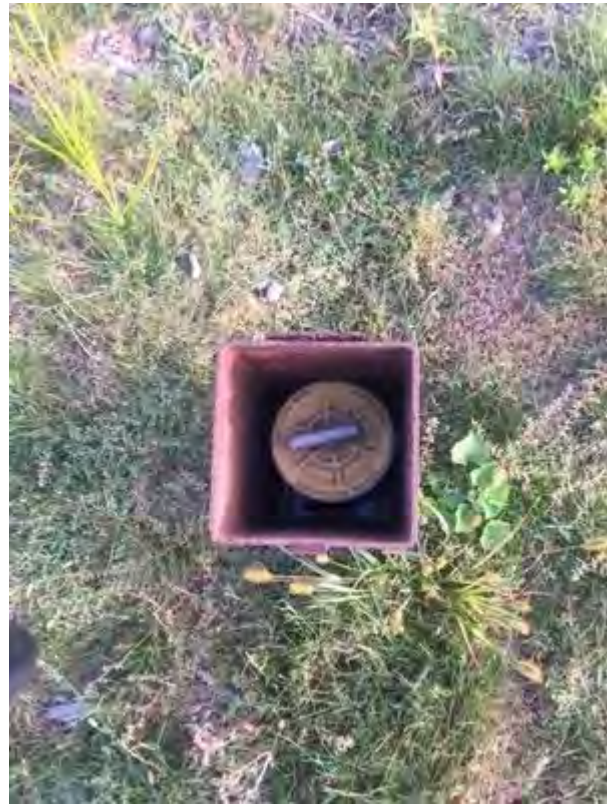
Client: Navy CLEAN	Facility: NWIRP Bethpage
Project Number: 112G08005-WE13	Location: Bethpage, New York
Date: September 23, 2021 08:02	Personnel: Vince Shickora
Well ID: BPHNMW271	Well Location: 214,405.60 1,124,952.18
Well Status: Other	Screen Interval: 100-110
WELL INVENTORY CONDITION	
Concrete pad in acceptable condition i.e. no cracks?	NO
Manhole cover present and in working condition?	NO
All bolts on manhole present and not stripped?	NO
Well plug present, locked and in good working condition?	NO
OVERALL CONDITION:	POOR
Notes (Explain if answered No to any of the above) Well is missing the security casing lid. Also no locks on well. No concrete pad. Well installed as stickup.

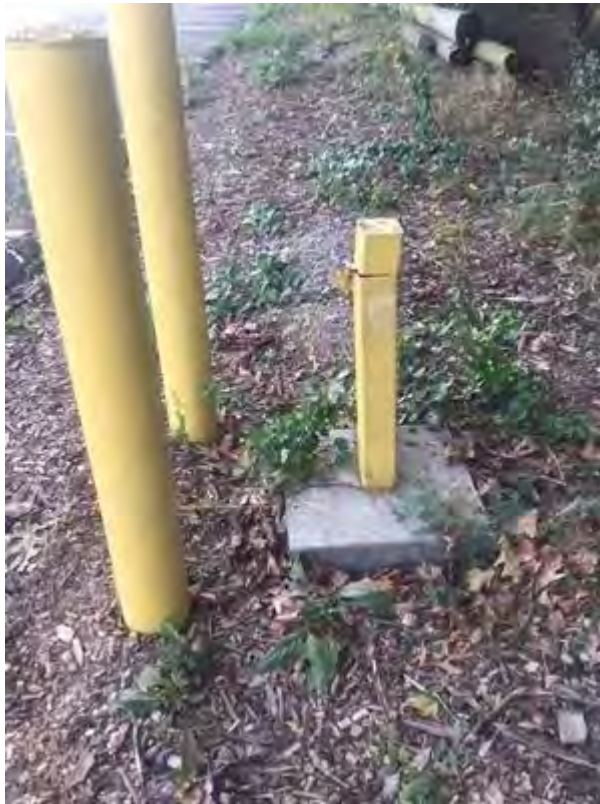
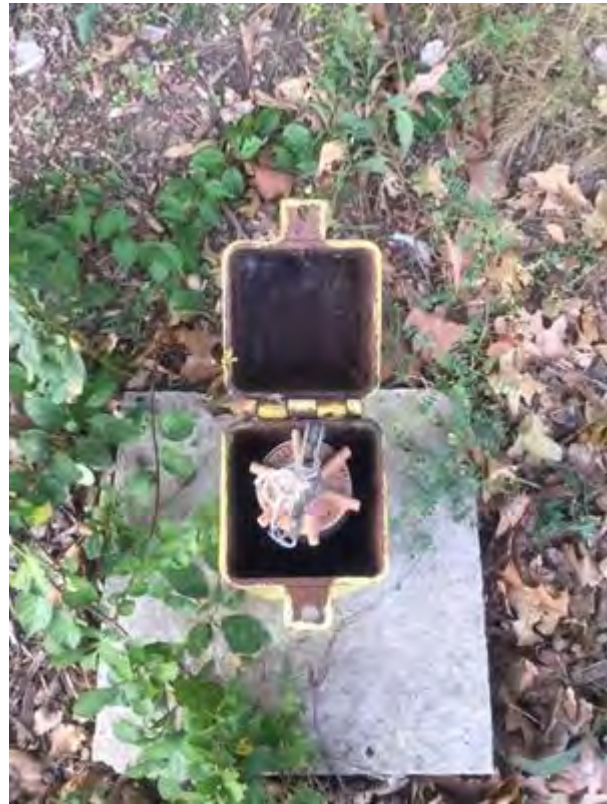
Client: Navy CLEAN	Facility: NWIRP Bethpage
Project Number: 112G08005-WE13	Location: Bethpage, New York
Date: September 23, 2021 07:52	Personnel: Vince Shickora
Well ID: BPS1FWMW02	Well Location: 213,967.37 1,124,866.32
Well Status: Other	Screen Interval: 52-67
WELL INVENTORY CONDITION	
Concrete pad in acceptable condition i.e. no cracks?	YES
Manhole cover present and in working condition?	YES
All bolts on manhole present and not stripped?	YES
Well plug present, locked and in good working condition?	YES
OVERALL CONDITION:	GOOD
Notes (Explain if answered No to any of the above) Well installed as stickup.

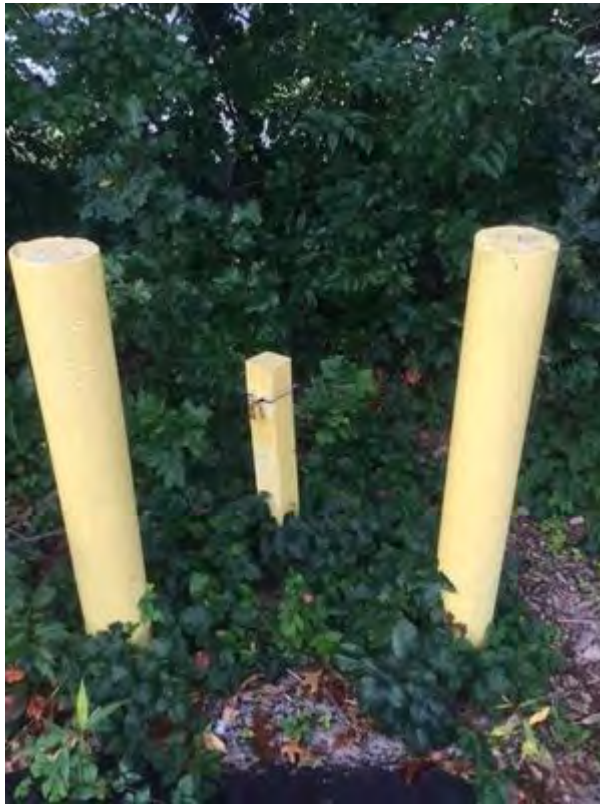
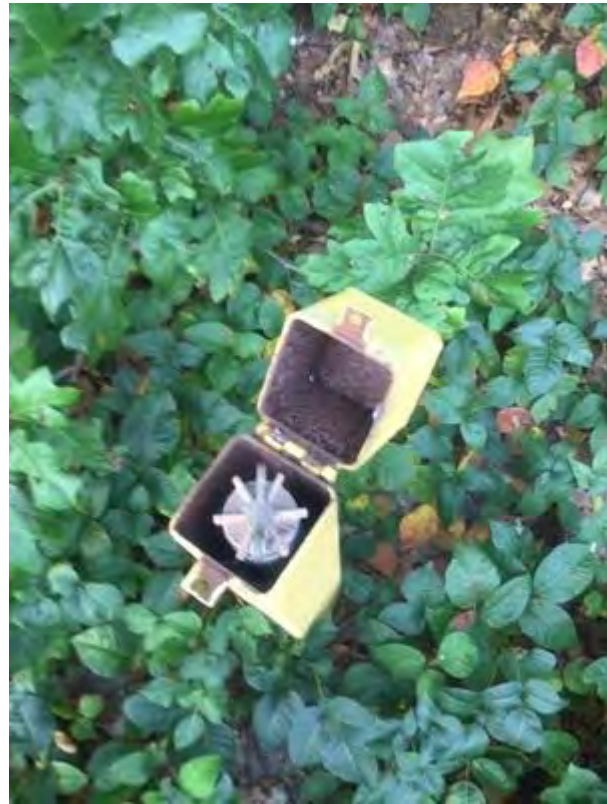
Client: Navy CLEAN	Facility: NWIRP Bethpage
Project Number: 112G08005-WE13	Location: Bethpage, New York
Date: September 23, 2021 07:47	Personnel: Vince Shickora
Well ID: BPS1FWMW01	Well Location: 213,962.95 1,124,963.13
Well Status: Other	Screen Interval: 48.5-63.5
WELL INVENTORY CONDITION	
Concrete pad in acceptable condition i.e. no cracks?	YES
Manhole cover present and in working condition?	YES
All bolts on manhole present and not stripped?	YES
Well plug present, locked and in good working condition?	YES
OVERALL CONDITION:	GOOD
Notes (Explain if answered No to any of the above) Well installed as stickup.

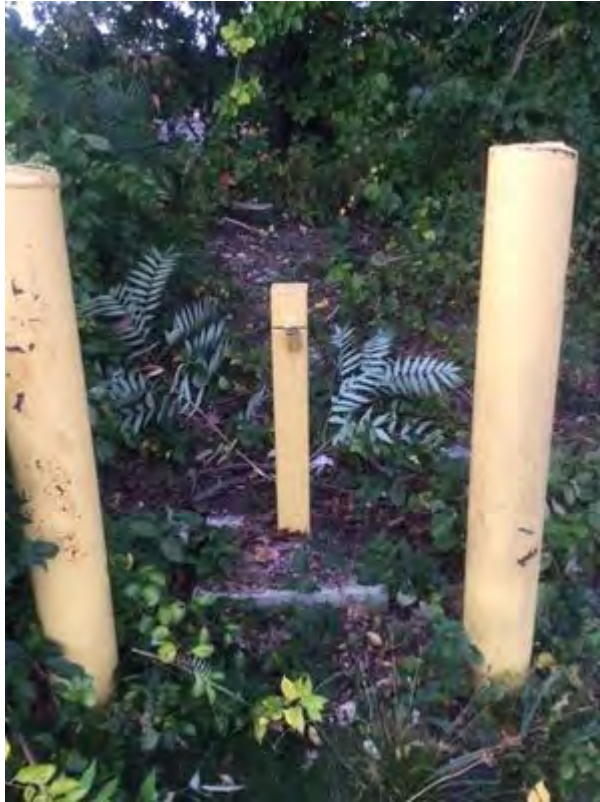
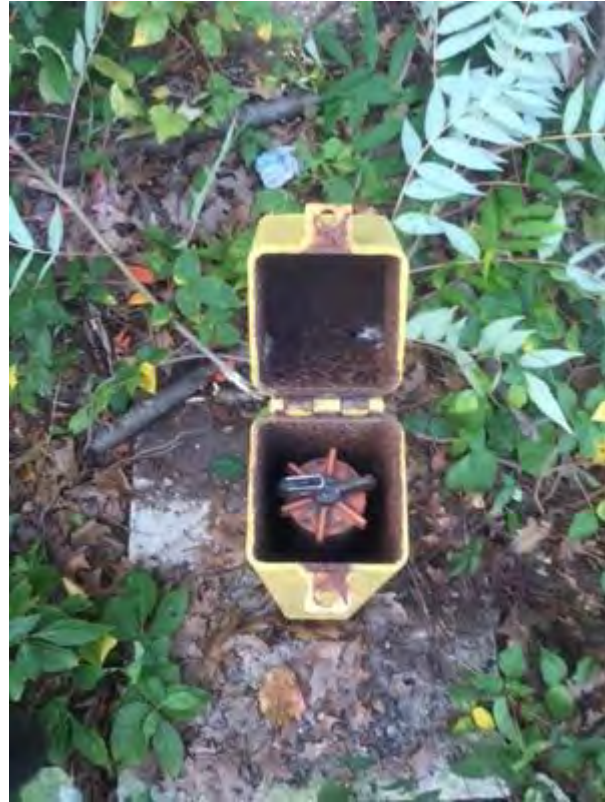
Client: Navy CLEAN	Facility: NWIRP Bethpage
Project Number: 112G08005-WE13	Location: Bethpage, New York
Date: September 23, 2021 07:43	Personnel: Vince Shickora
Well ID: BPS1FWMW03	Well Location: 213,978.52 1,124,733.42
Well Status: Other	Screen Interval: 52-67
WELL INVENTORY CONDITION	
Concrete pad in acceptable condition i.e. no cracks?	YES
Manhole cover present and in working condition?	YES
All bolts on manhole present and not stripped?	YES
Well plug present, locked and in good working condition?	YES
OVERALL CONDITION:	GOOD
Notes (Explain if answered No to any of the above) Well installed as stickup.

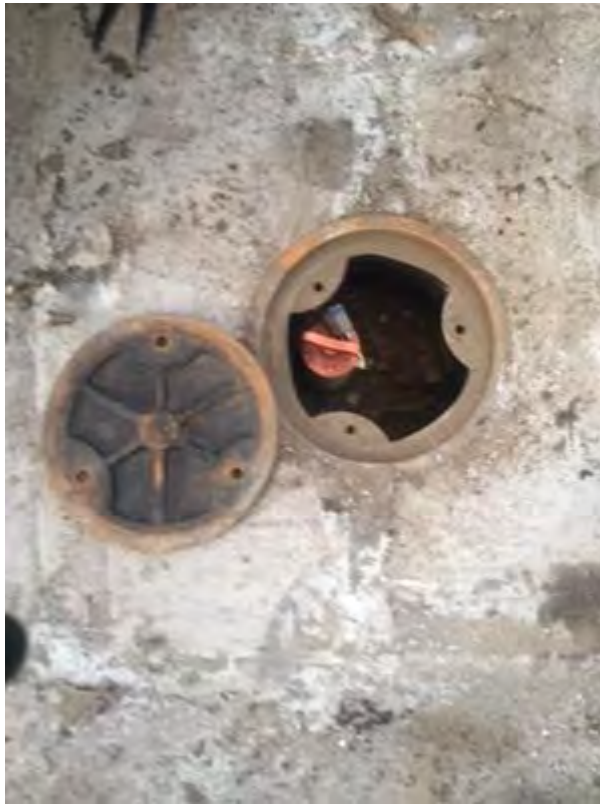
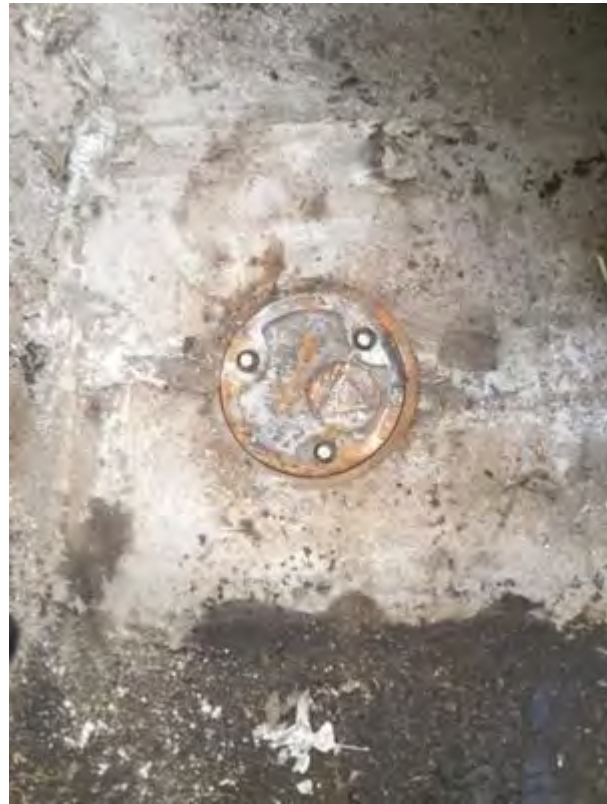
Client: Navy CLEAN	Facility: NWIRP Bethpage
Project Number: 112G08005-WE13	Location: Bethpage, New York
Date: September 23, 2021 07:07	Personnel: Vince Shickora
Well ID: BPS1-TT-MW303D	Well Location: 213,779.29 1,124,550.69
Well Status: Other	Screen Interval: 208-218
WELL INVENTORY CONDITION	
Concrete pad in acceptable condition i.e. no cracks?	YES
Manhole cover present and in working condition?	YES
All bolts on manhole present and not stripped?	YES
Well plug present, locked and in good working condition?	YES
OVERALL CONDITION:	GOOD
Notes (Explain if answered No to any of the above)

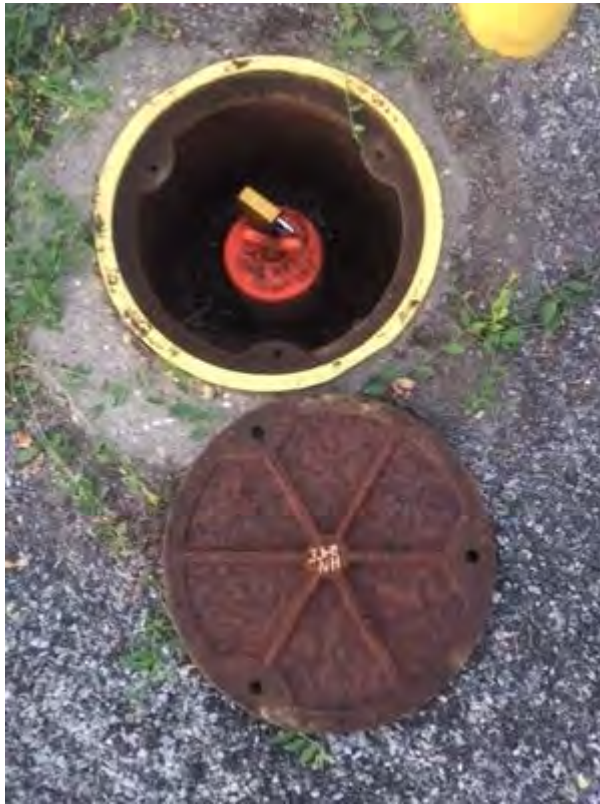
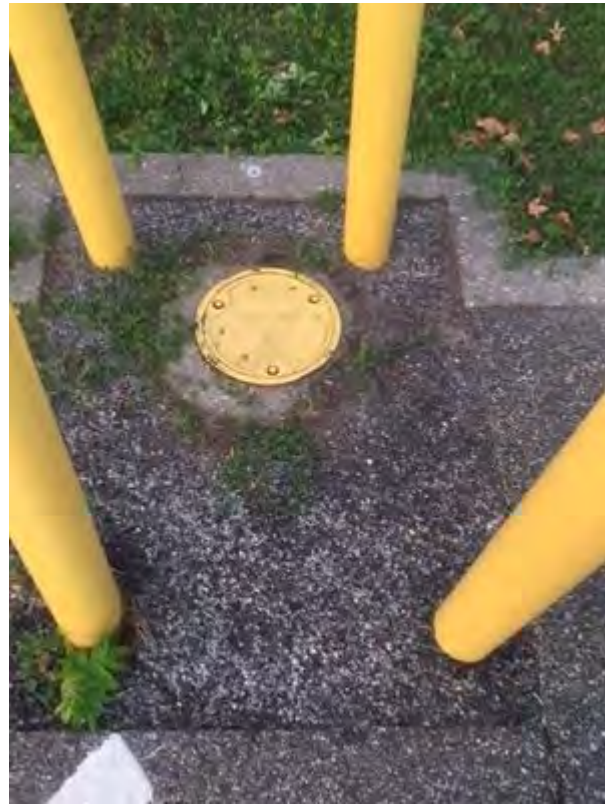
Client: Navy CLEAN	Facility: NWIRP Bethpage
Project Number: 112G08005-WE13	Location: Bethpage, New York
Date: September 23, 2021 06:50	Personnel: Vince Shickora
Well ID: BPHNMW24IR	Well Location: 214,063.74 1,123,251.03
Well Status: Other	Screen Interval: 148-158
WELL INVENTORY CONDITION	
Concrete pad in acceptable condition i.e. no cracks?	YES
Manhole cover present and in working condition?	YES
All bolts on manhole present and not stripped?	YES
Well plug present, locked and in good working condition?	YES
OVERALL CONDITION:	GOOD
Notes (Explain if answered No to any of the above)
