Memorandum

To: Scot Sokolowski, NAVFAC MIDLANT
From: David Brayack, Tetra Tech
Date: December 30, 2021
Re: Annual LUC Inspection and Operation Summary Report: Sites 1, 2, 3, and 4 – NWIRP Bethpage
Revision 1
Contract/CTO Number: N6247016D9008/WE13

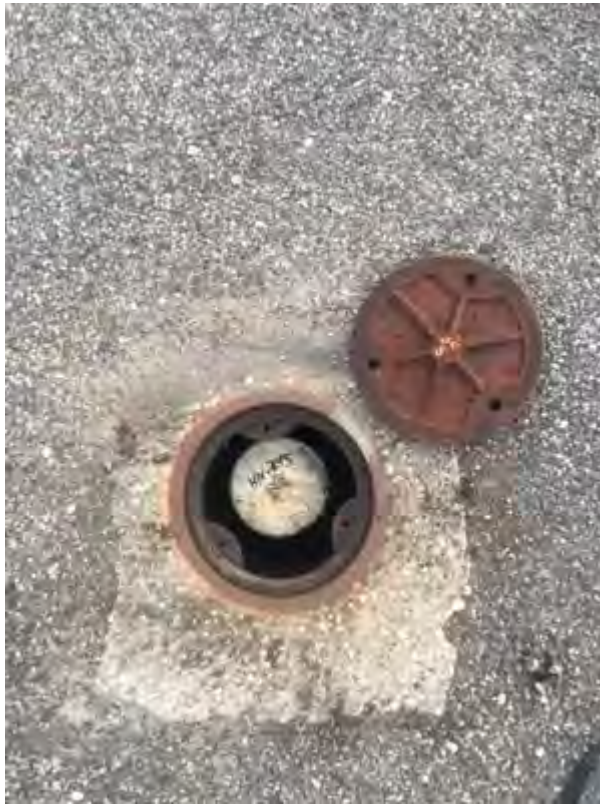
Client: Navy CLEAN	Facility: NWIRP Bethpage
Project Number: 112G08005-WE13	Location: Bethpage, New York
Date: September 23, 2021 06:44	Personnel: Vince Shickora
Well ID: BPHNMW24S	Well Location: 214,054.46 1,123,265.87
Well Status: Other	Screen Interval: 48.6-58.6
WELL INVENTORY CONDITION	
Concrete pad in acceptable condition i.e. no cracks?	YES
Manhole cover present and in working condition?	YES
All bolts on manhole present and not stripped?	YES
Well plug present, locked and in good working condition?	NO
OVERALL CONDITION:	GOOD
Notes (Explain if answered No to any of the above) No lock on well plug. Slip cap installed on well.

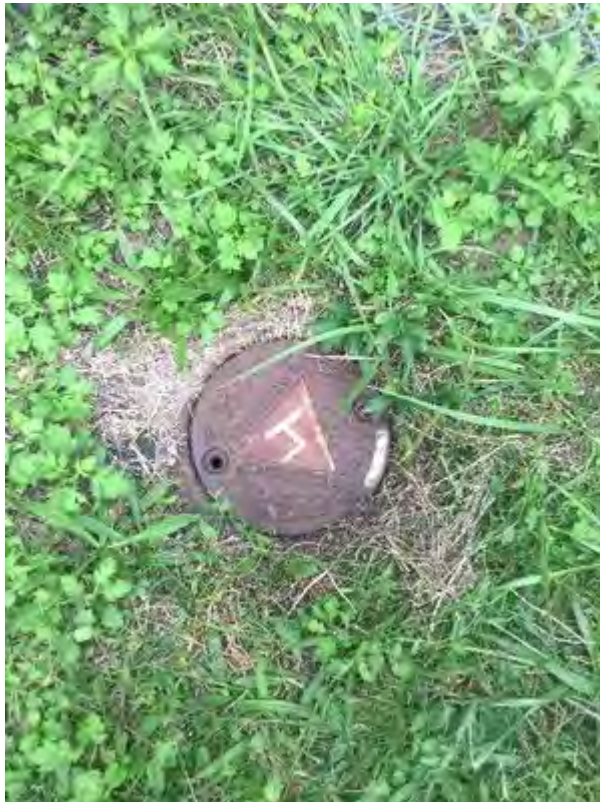
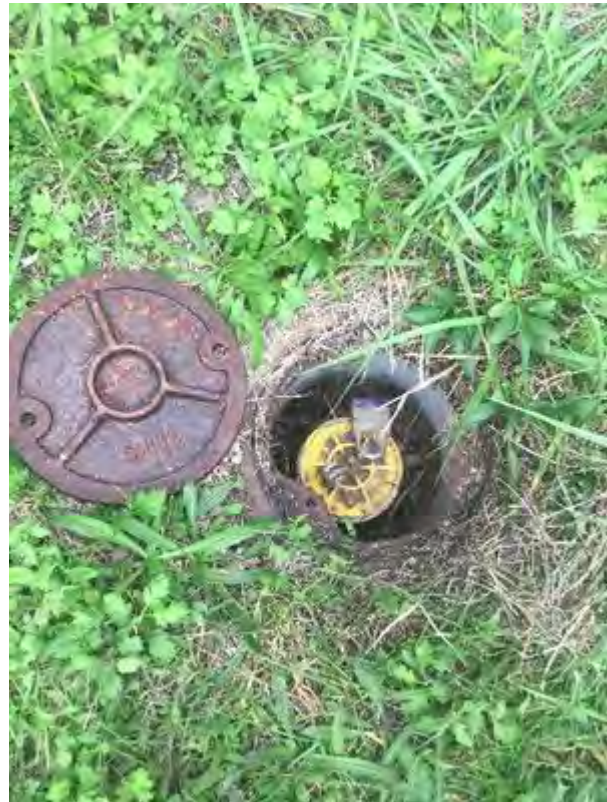
Client: Navy CLEAN	Facility: NWIRP Bethpage
Project Number: 112G08005-WE13	Location: Bethpage, New York
Date: September 22, 2021 17:36	Personnel: Noah Sprouse
Well ID: BPTTAOC22MW04	Well Location: 214026.062685 1123644.93391
Well Status: Other	Screen Interval: 46-66
WELL INVENTORY CONDITION	
Concrete pad in acceptable condition i.e. no cracks?	YES
Manhole cover present and in working condition?	YES
All bolts on manhole present and not stripped?	NO
Well plug present, locked and in good working condition?	YES
OVERALL CONDITION:	FAIR
Notes (Explain if answered No to any of the above) Missing two bolts, missing rubber gasket.

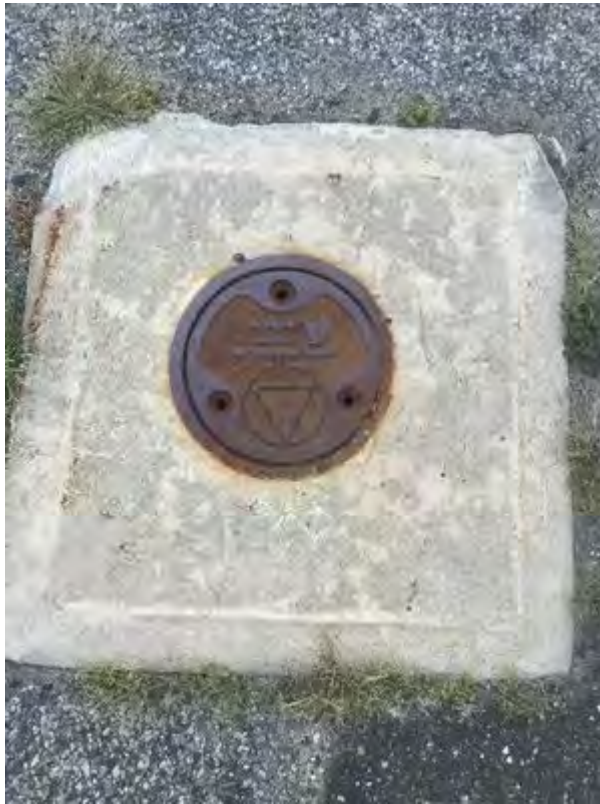
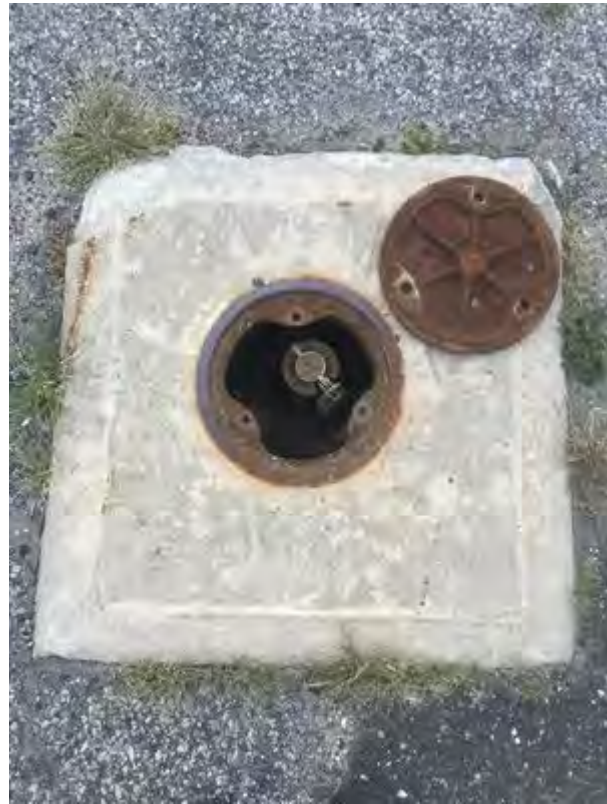
Client: Navy CLEAN	Facility: NWIRP Bethpage
Project Number: 112G08005-WE13	Location: Bethpage, New York
Date: September 22, 2021 17:33	Personnel: Noah Sprouse
Well ID: BPTTAOC22MW08	Well Location: 213932.291179 1123576.0651
Well Status: Other	Screen Interval: 52-62
WELL INVENTORY CONDITION	
Concrete pad in acceptable condition i.e. no cracks?	YES
Manhole cover present and in working condition?	YES
All bolts on manhole present and not stripped?	NO
Well plug present, locked and in good working condition?	YES
OVERALL CONDITION:	FAIR
Notes (Explain if answered No to any of the above) Missing three bolts, missing rubber gasket.

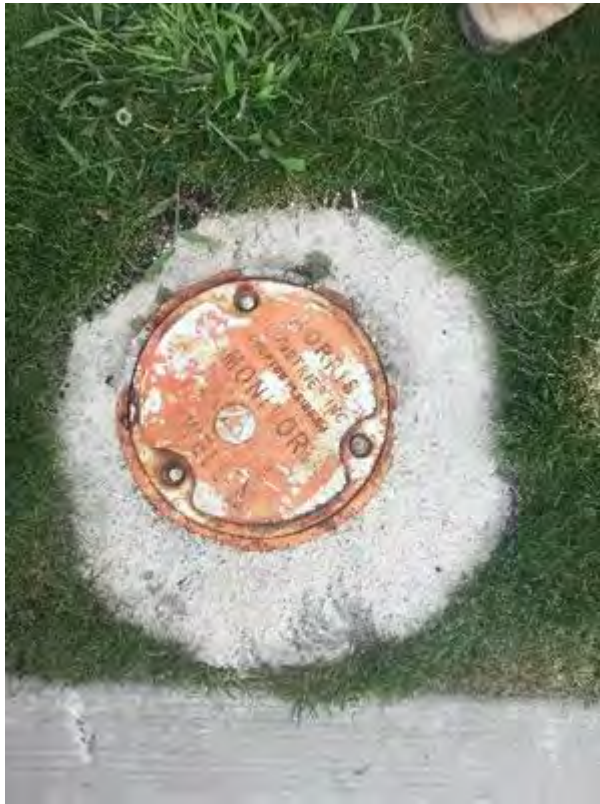
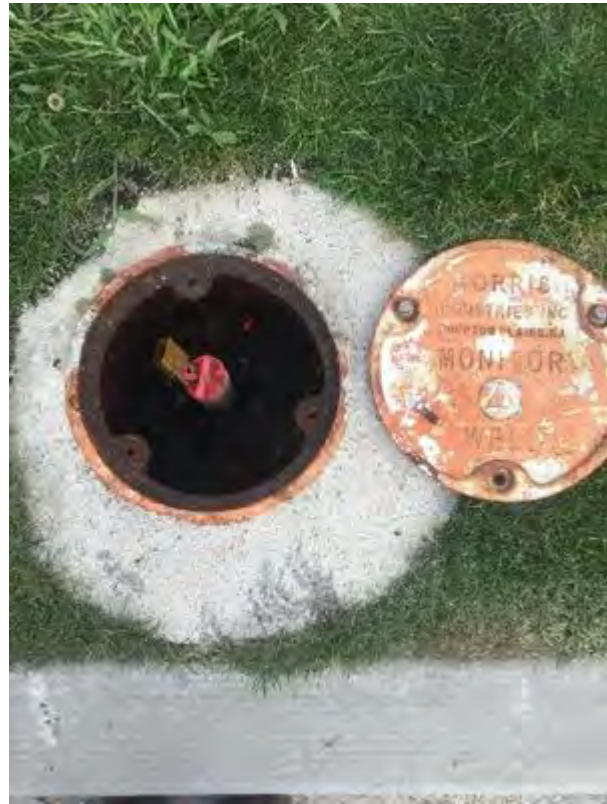
Client: Navy CLEAN	Facility: NWIRP Bethpage
Project Number: 112G08005-WE13	Location: Bethpage, New York
Date: September 22, 2021 17:13	Personnel: Noah Sprouse
Well ID: BPS1-TT-MW309S	Well Location: 215212.06 1124997.916
Well Status: Other	Screen Interval: 53-63
WELL INVENTORY CONDITION	
Concrete pad in acceptable condition i.e. no cracks?	YES
Manhole cover present and in working condition?	YES
All bolts on manhole present and not stripped?	YES
Well plug present, locked and in good working condition?	YES
OVERALL CONDITION:	GOOD
Notes (Explain if answered No to any of the above)

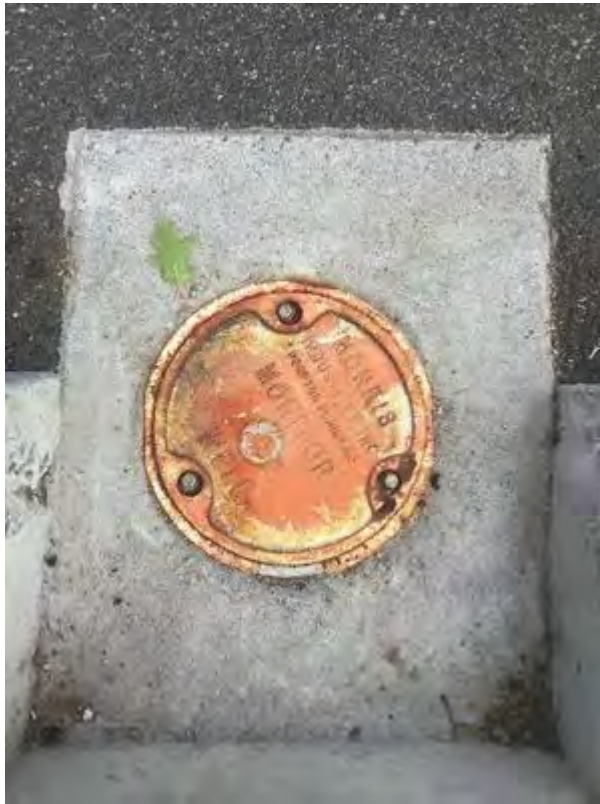
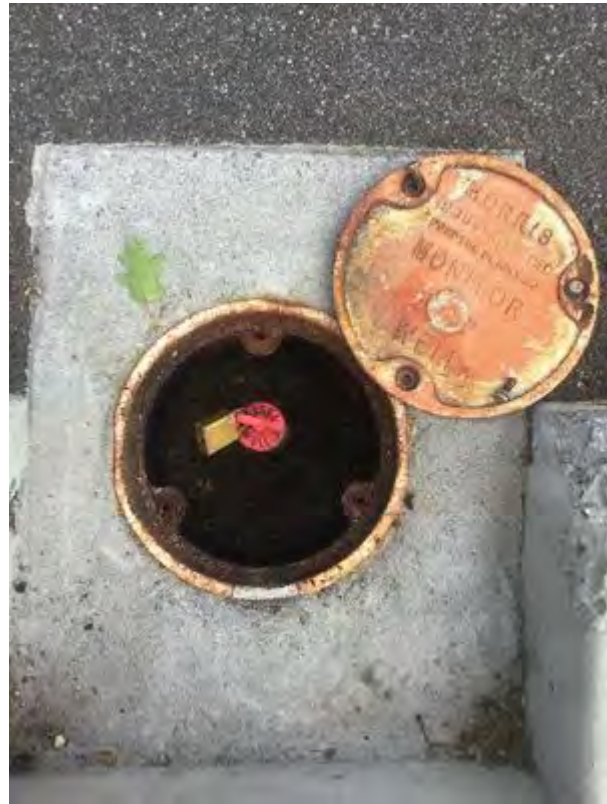
Client: Navy CLEAN	Facility: NWIRP Bethpage
Project Number: 112G08005-WE13	Location: Bethpage, New York
Date: September 22, 2021 17:10	Personnel: Noah Sprouse
Well ID: BPS1-TT-MW309I	Well Location: 215209.932 1125016.144
Well Status: Other	Screen Interval: 160-170
WELL INVENTORY CONDITION	
Concrete pad in acceptable condition i.e. no cracks?	YES
Manhole cover present and in working condition?	YES
All bolts on manhole present and not stripped?	YES
Well plug present, locked and in good working condition?	YES
OVERALL CONDITION:	GOOD
Notes (Explain if answered No to any of the above)

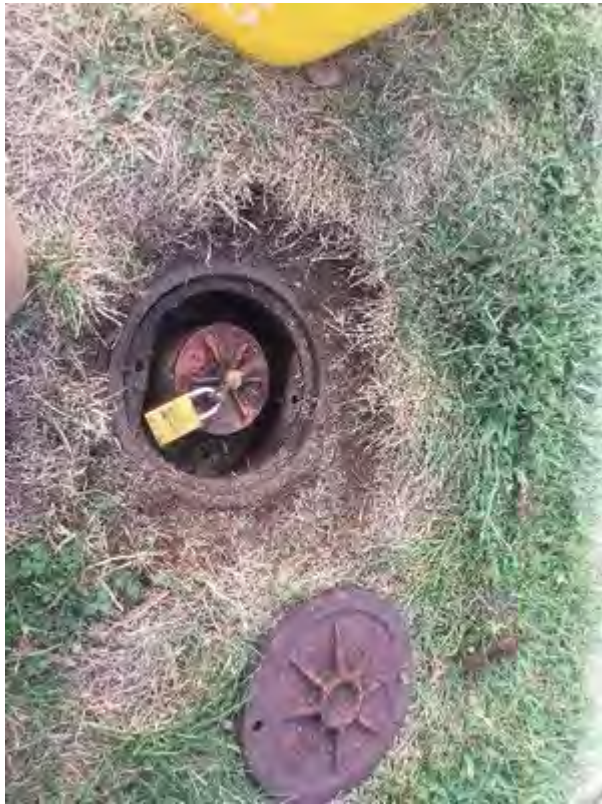
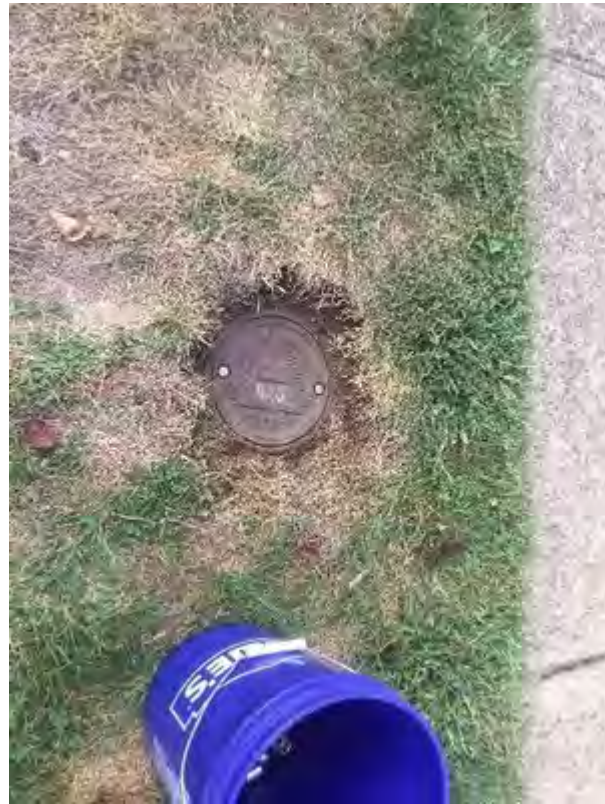
Client: Navy CLEAN	Facility: NWIRP Bethpage
Project Number: 112G08005-WE13	Location: Bethpage, New York
Date: September 22, 2021 16:54	Personnel: Wyatt Bostick
Well ID: BPHNMW42S	Well Location: 213792 1126065
Well Status: Other	Screen Interval: 50-60
WELL INVENTORY CONDITION	
Concrete pad in acceptable condition i.e. no cracks?	YES
Manhole cover present and in working condition?	YES
All bolts on manhole present and not stripped?	NO
Well plug present, locked and in good working condition?	YES
OVERALL CONDITION:	GOOD
Notes (Explain if answered No to any of the above) Bolts stripped

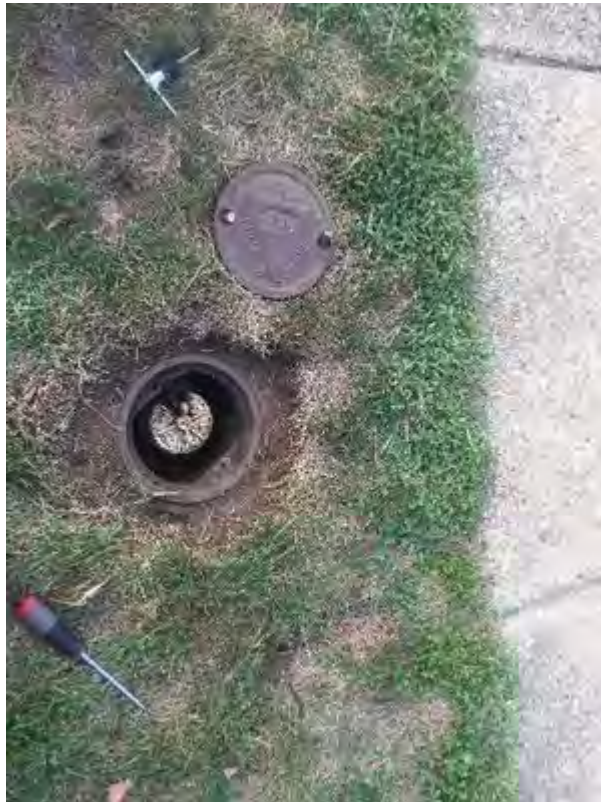
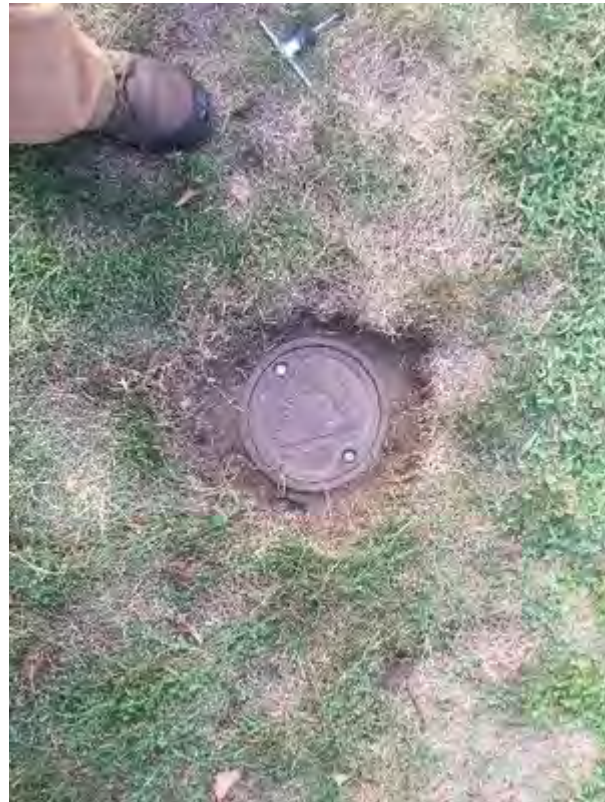
Client: Navy CLEAN	Facility: NWIRP Bethpage
Project Number: 112G08005-WE13	Location: Bethpage, New York
Date: September 22, 2021 16:48	Personnel: Wyatt Bostick
Well ID: BPHNMW42I	Well Location: 213879.1202 1126065.7364
Well Status: Other	Screen Interval: 100-110
WELL INVENTORY CONDITION	
Concrete pad in acceptable condition i.e. no cracks?	YES
Manhole cover present and in working condition?	YES
All bolts on manhole present and not stripped?	NO
Well plug present, locked and in good working condition?	YES
OVERALL CONDITION:	FAIR
Notes (Explain if answered No to any of the above)

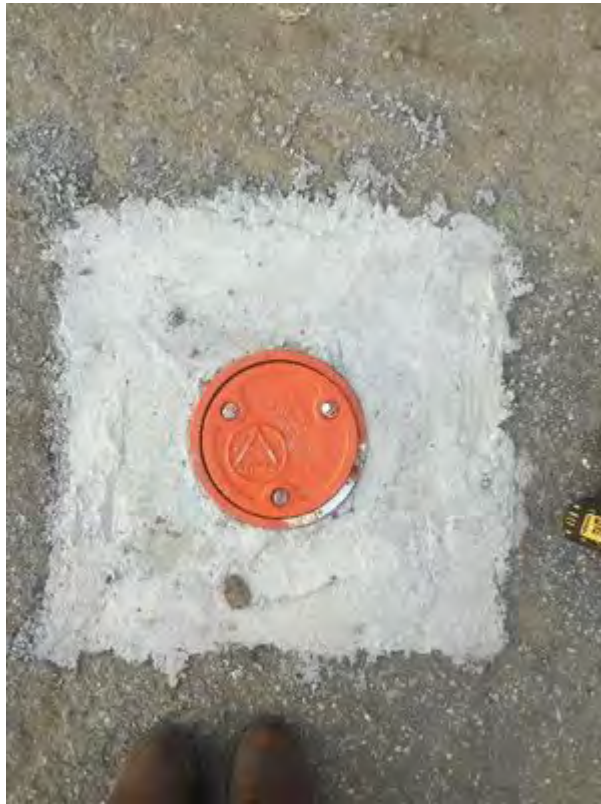
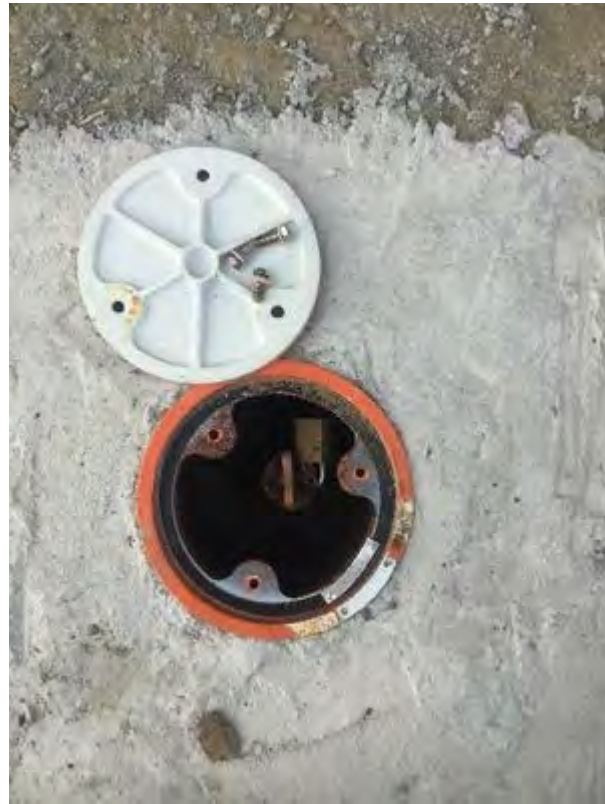
Client: Navy CLEAN	Facility: NWIRP Bethpage
Project Number: 112G08005-WE13	Location: Bethpage, New York
Date: September 22, 2021 16:32	Personnel: Noah Sprouse
Well ID: BPS1-TT-MW301D	Well Location: 214562.648 1124880.908
Well Status: Other	Screen Interval: 210-220
WELL INVENTORY CONDITION	
Concrete pad in acceptable condition i.e. no cracks?	YES
Manhole cover present and in working condition?	YES
All bolts on manhole present and not stripped?	YES
Well plug present, locked and in good working condition?	YES
OVERALL CONDITION:	GOOD
Notes (Explain if answered No to any of the above)

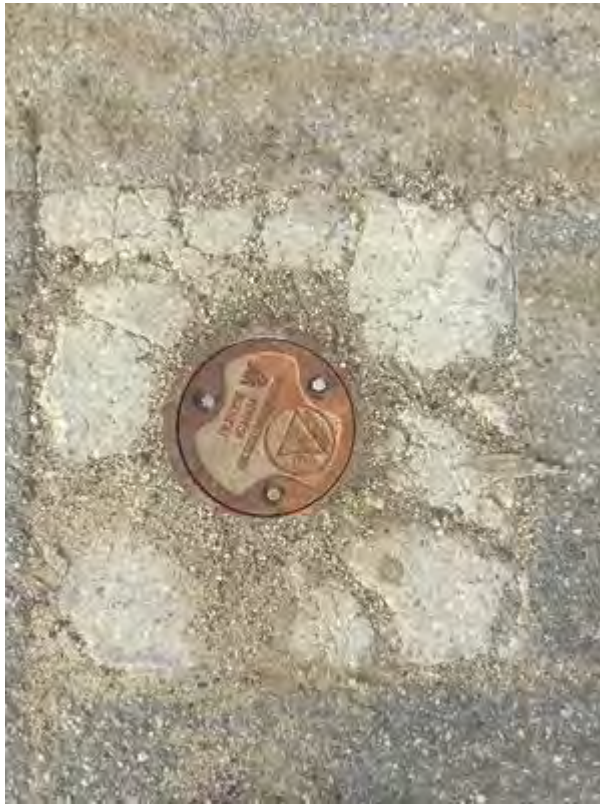
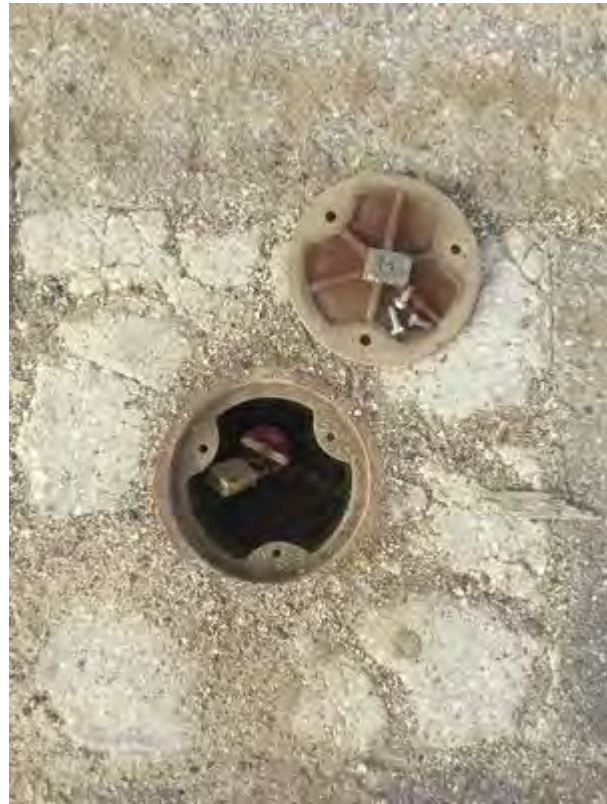
Client: Navy CLEAN	Facility: NWIRP Bethpage
Project Number: 112G08005-WE13	Location: Bethpage, New York
Date: September 22, 2021 16:27	Personnel: Noah Sprouse
Well ID: BPS1-TT-MW301I	Well Location: 214566.279 1124906.201
Well Status: Other	Screen Interval: 130-140
WELL INVENTORY CONDITION	
Concrete pad in acceptable condition i.e. no cracks?	NO
Manhole cover present and in working condition?	YES
All bolts on manhole present and not stripped?	YES
Well plug present, locked and in good working condition?	YES
OVERALL CONDITION:	FAIR
Notes (Explain if answered No to any of the above) Cracked well pad, broken rubber gasket, labelled "I" under manhole cover

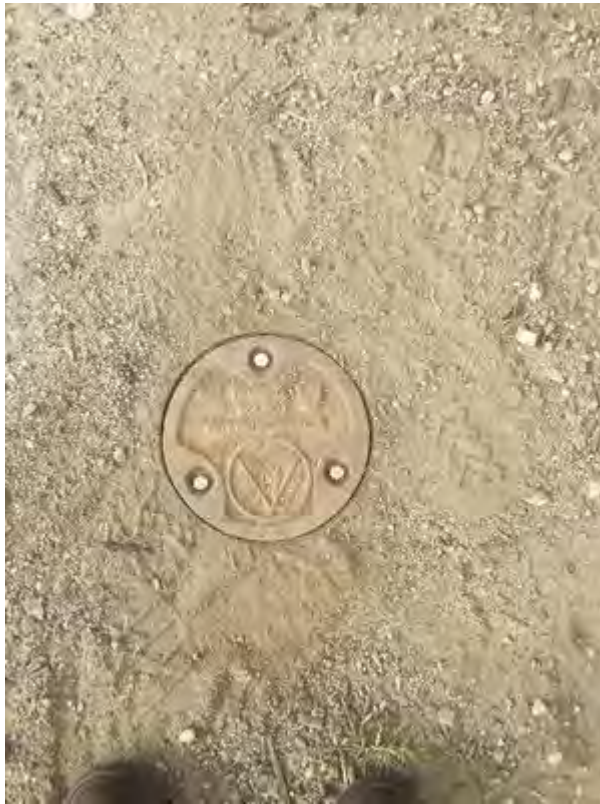
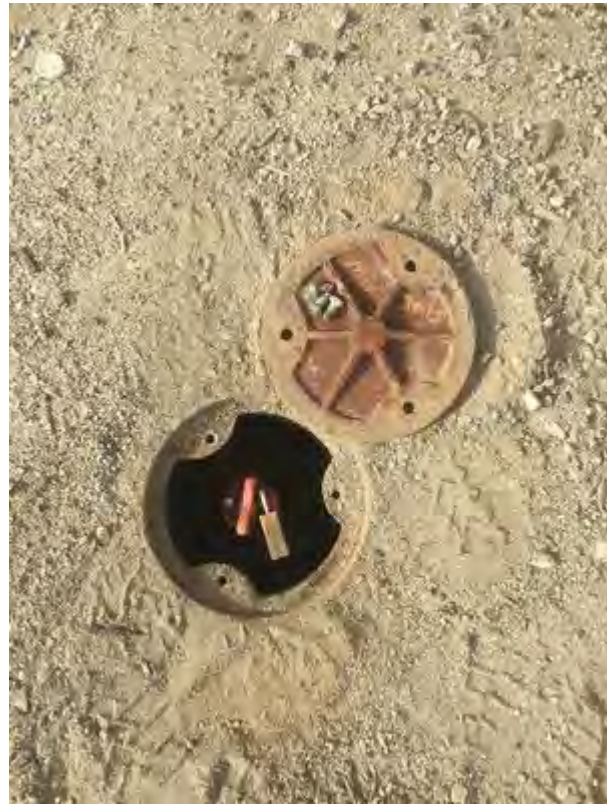
Client: Navy CLEAN	Facility: NWIRP Bethpage
Project Number: 112G08005-WE13	Location: Bethpage, New York
Date: September 22, 2021 16:23	Personnel: Noah Sprouse
Well ID: BPS1-TT-MW301S	Well Location: 214560.42 1124865.194
Well Status: Other	Screen Interval: 51-61
WELL INVENTORY CONDITION	
Concrete pad in acceptable condition i.e. no cracks?	YES
Manhole cover present and in working condition?	YES
All bolts on manhole present and not stripped?	YES
Well plug present, locked and in good working condition?	YES
OVERALL CONDITION:	FAIR
Notes (Explain if answered No to any of the above) Missing rubber gasket.

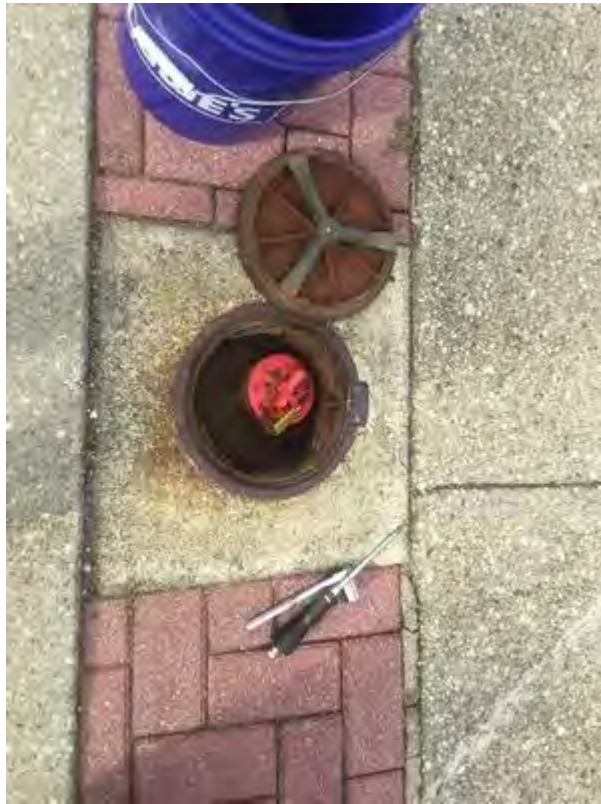
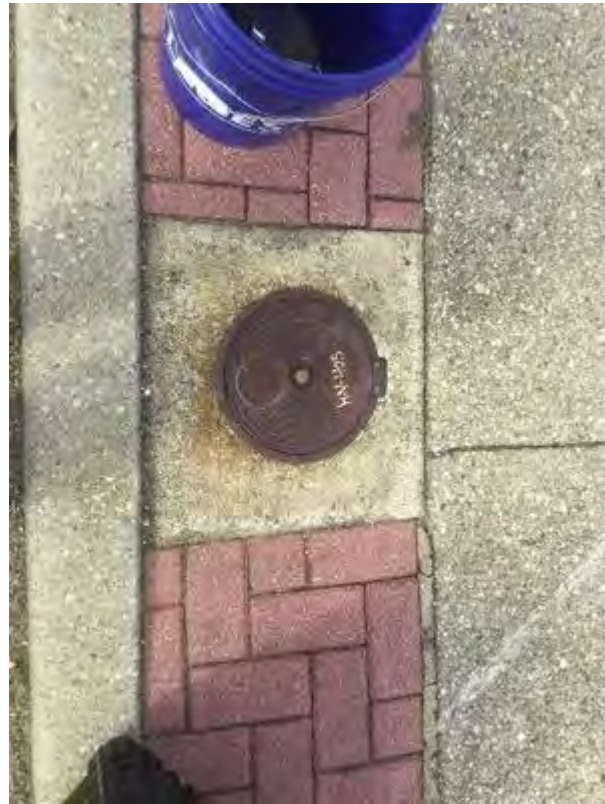
Client: Navy CLEAN	Facility: NWIRP Bethpage
Project Number: 112G08005-WE13	Location: Bethpage, New York
Date: September 22, 2021 16:22	Personnel: Wyatt Bostick
Well ID: BPHNMW40S	Well Location: 212474.1604 1126042.8203
Well Status: Other	Screen Interval: 49-59
WELL INVENTORY CONDITION	
Concrete pad in acceptable condition i.e. no cracks?	YES
Manhole cover present and in working condition?	YES
All bolts on manhole present and not stripped?	YES
Well plug present, locked and in good working condition?	YES
OVERALL CONDITION:	GOOD
Notes (Explain if answered No to any of the above)

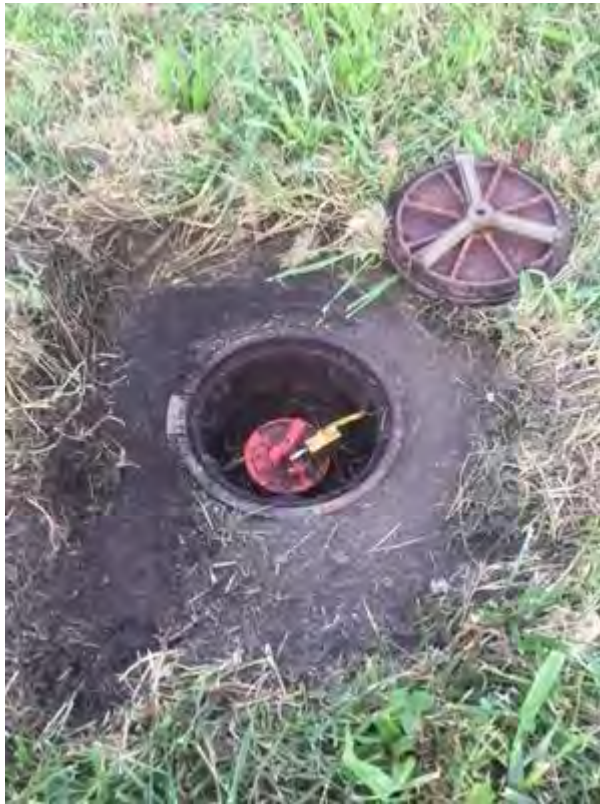
Client: Navy CLEAN	Facility: NWIRP Bethpage
Project Number: 112G08005-WE13	Location: Bethpage, New York
Date: September 22, 2021 16:20	Personnel: Vince Shickora
Well ID: BPGMMW75D2	Well Location: 208,507.00 1,124,246.00
Well Status: Other	Screen Interval: 505-525
WELL INVENTORY CONDITION	
Concrete pad in acceptable condition i.e. no cracks?	YES
Manhole cover present and in working condition?	YES
All bolts on manhole present and not stripped?	YES
Well plug present, locked and in good working condition?	YES
OVERALL CONDITION:	GOOD
Notes (Explain if answered No to any of the above)

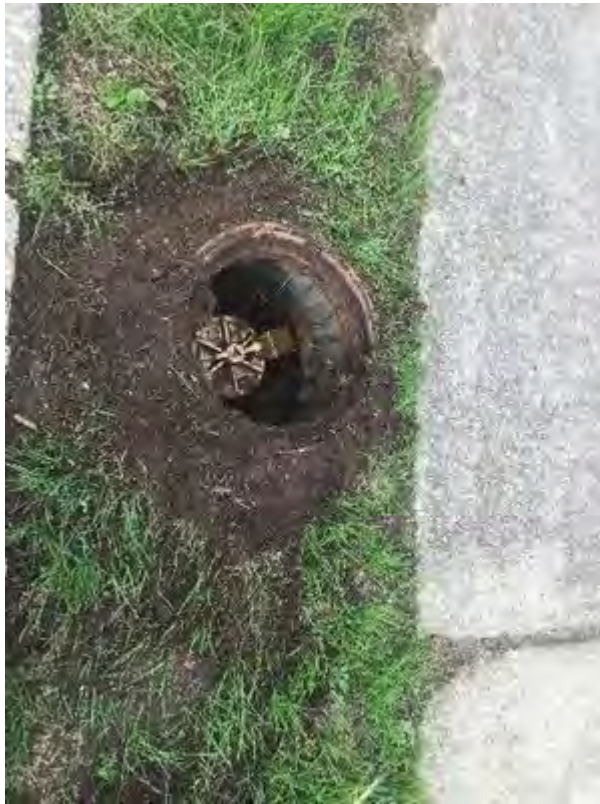
Client: Navy CLEAN	Facility: NWIRP Bethpage
Project Number: 112G08005-WE13	Location: Bethpage, New York
Date: September 22, 2021 16:17	Personnel: Wyatt Bostick
Well ID: BPHNMW40I	Well Location: 212473 1125986
Well Status: Other	Screen Interval: 108-118
WELL INVENTORY CONDITION	
Concrete pad in acceptable condition i.e. no cracks?	YES
Manhole cover present and in working condition?	YES
All bolts on manhole present and not stripped?	NO
Well plug present, locked and in good working condition?	YES
OVERALL CONDITION:	FAIR
Notes (Explain if answered No to any of the above) Bolts stripped

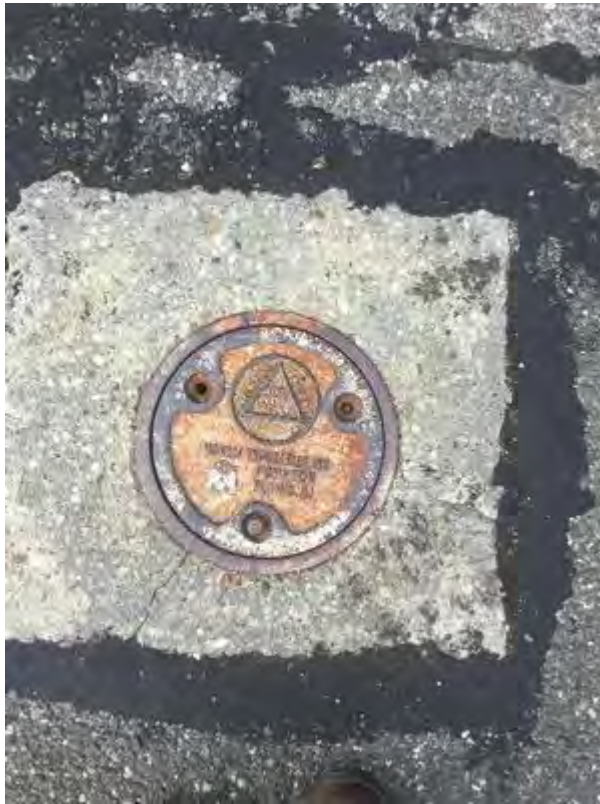
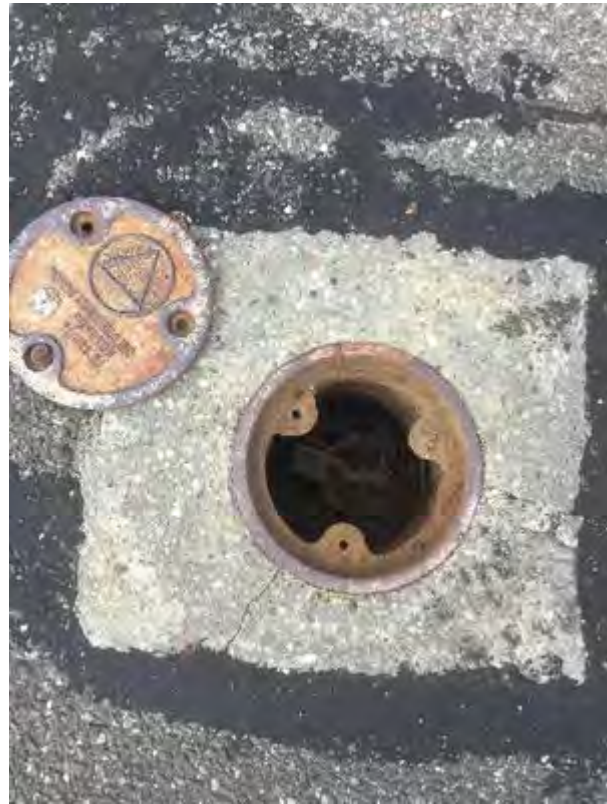
Client: Navy CLEAN	Facility: NWIRP Bethpage
Project Number: 112G08005-WE13	Location: Bethpage, New York
Date: September 22, 2021 15:48	Personnel: Noah Sprouse
Well ID: BPHNMW29I	Well Location: 213928.573 1124685.862
Well Status: Other	Screen Interval: 120-130
WELL INVENTORY CONDITION	
Concrete pad in acceptable condition i.e. no cracks?	NO
Manhole cover present and in working condition?	YES
All bolts on manhole present and not stripped?	NO
Well plug present, locked and in good working condition?	YES
OVERALL CONDITION:	FAIR
Notes (Explain if answered No to any of the above) One missing bolt, one broken bolt, one stripped bolt, broken rubber gasket.

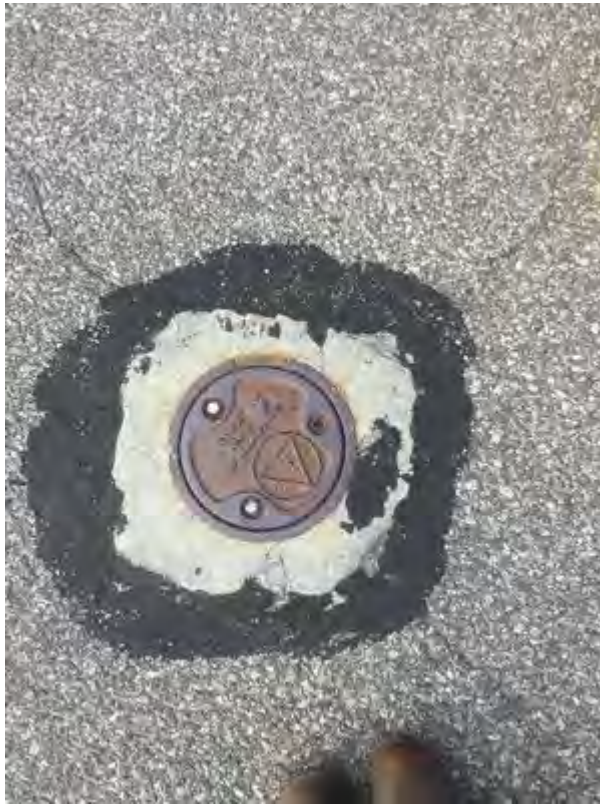
Client: Navy CLEAN	Facility: NWIRP Bethpage
Project Number: 112G08005-WE13	Location: Bethpage, New York
Date: September 22, 2021 15:46	Personnel: Noah Sprouse
Well ID: BPHNMW29D	Well Location: 213933.694 1124704.902
Well Status: Other	Screen Interval: 210-220
WELL INVENTORY CONDITION	
Concrete pad in acceptable condition i.e. no cracks?	NO
Manhole cover present and in working condition?	YES
All bolts on manhole present and not stripped?	NO
Well plug present, locked and in good working condition?	YES
OVERALL CONDITION:	FAIR
Notes (Explain if answered No to any of the above) Cracked well pad, missing one bolt, missing rubber gasket.

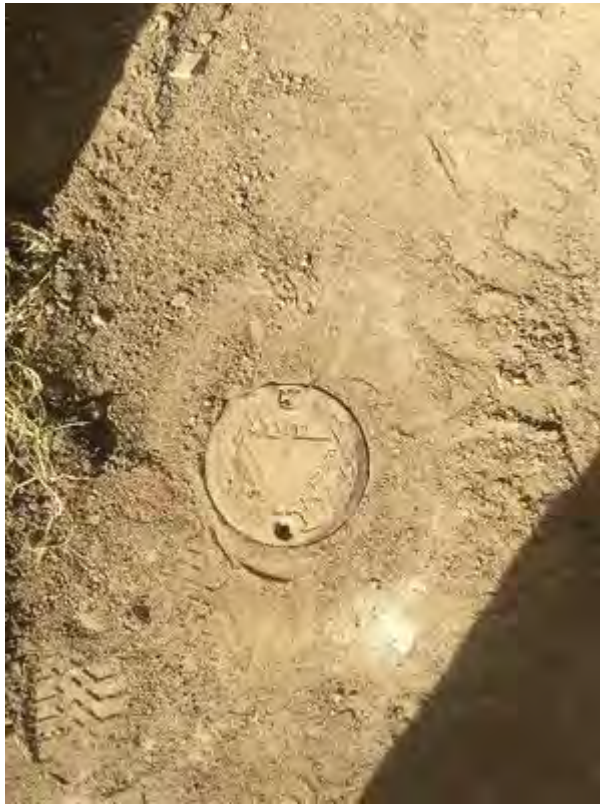
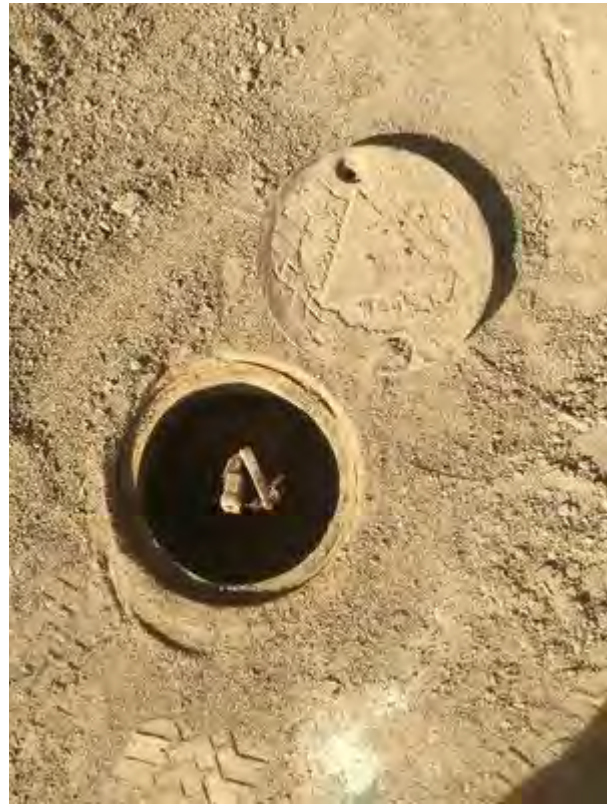
Client: Navy CLEAN	Facility: NWIRP Bethpage
Project Number: 112G08005-WE13	Location: Bethpage, New York
Date: September 22, 2021 15:33	Personnel: Noah Sprouse
Well ID: BPS1-TT-MW303I2	Well Location: 213779.054 1124562.054
Well Status: Other	Screen Interval: 146-156
WELL INVENTORY CONDITION	
Concrete pad in acceptable condition i.e. no cracks?	YES
Manhole cover present and in working condition?	YES
All bolts on manhole present and not stripped?	NO
Well plug present, locked and in good working condition?	YES
OVERALL CONDITION:	FAIR
Notes (Explain if answered No to any of the above) Missing two bolts.

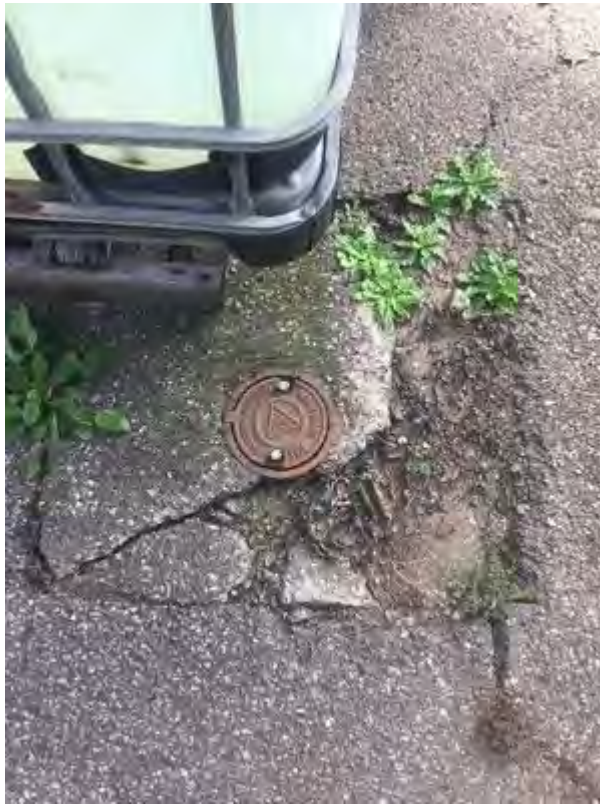
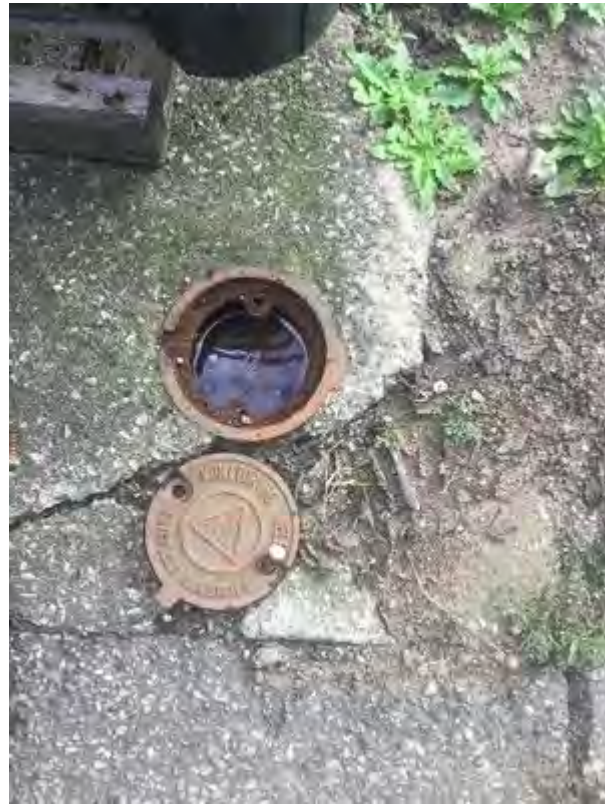
Client: Navy CLEAN	Facility: NWIRP Bethpage
Project Number: 112G08005-WE13	Location: Bethpage, New York
Date: September 22, 2021 15:30	Personnel: Noah Sprouse
Well ID: BPS1-TT-MW303S	Well Location: 213778.188 1124583.496
Well Status: Other	Screen Interval: 46-56
WELL INVENTORY CONDITION	
Concrete pad in acceptable condition i.e. no cracks?	NO
Manhole cover present and in working condition?	YES
All bolts on manhole present and not stripped?	YES
Well plug present, locked and in good working condition?	YES
OVERALL CONDITION:	FAIR
Notes (Explain if answered No to any of the above) Cracked well pad, water inside well casing

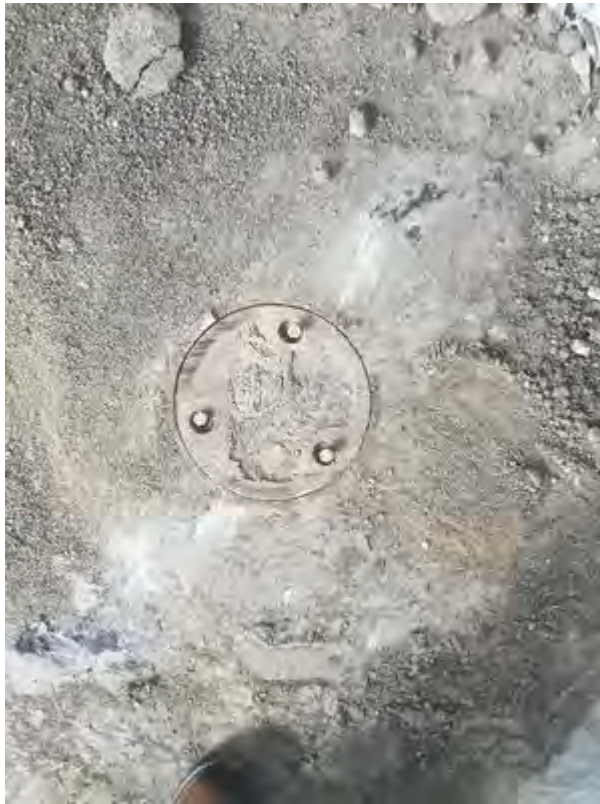
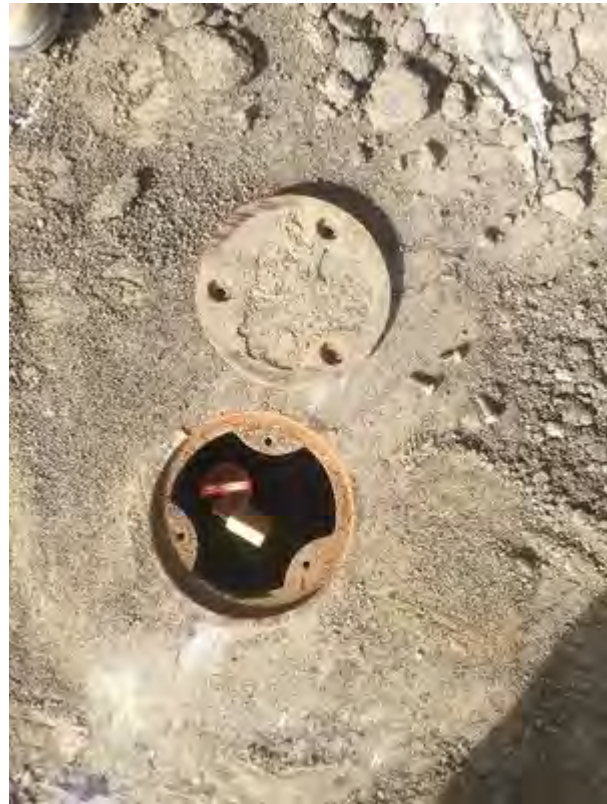
Client: Navy CLEAN	Facility: NWIRP Bethpage
Project Number: 112G08005-WE13	Location: Bethpage, New York
Date: September 22, 2021 15:26	Personnel: Noah Sprouse
Well ID: BPS1-TT-MW303I1	Well Location: 213778.636 1124572.255
Well Status: Other	Screen Interval: 95-105
WELL INVENTORY CONDITION	
Concrete pad in acceptable condition i.e. no cracks?	YES
Manhole cover present and in working condition?	YES
All bolts on manhole present and not stripped?	YES
Well plug present, locked and in good working condition?	YES
OVERALL CONDITION:	GOOD
Notes (Explain if answered No to any of the above) Missing rubber gasket.

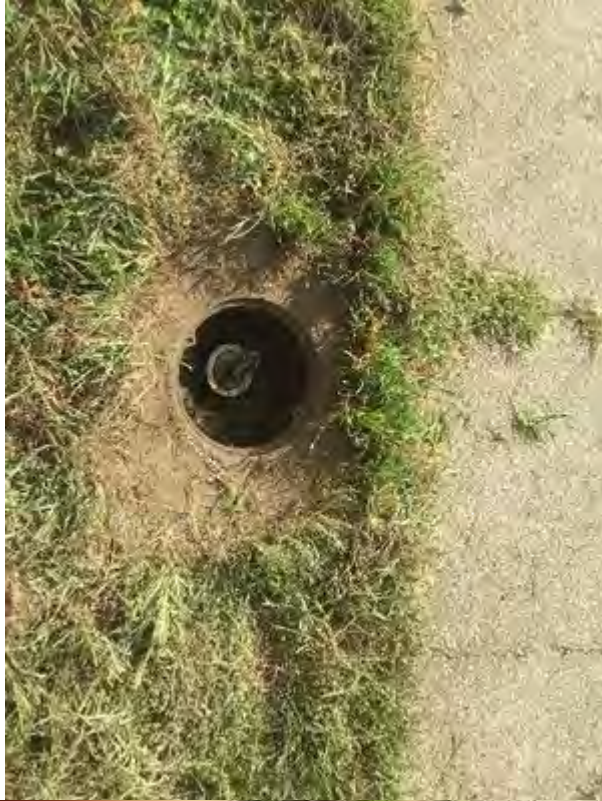
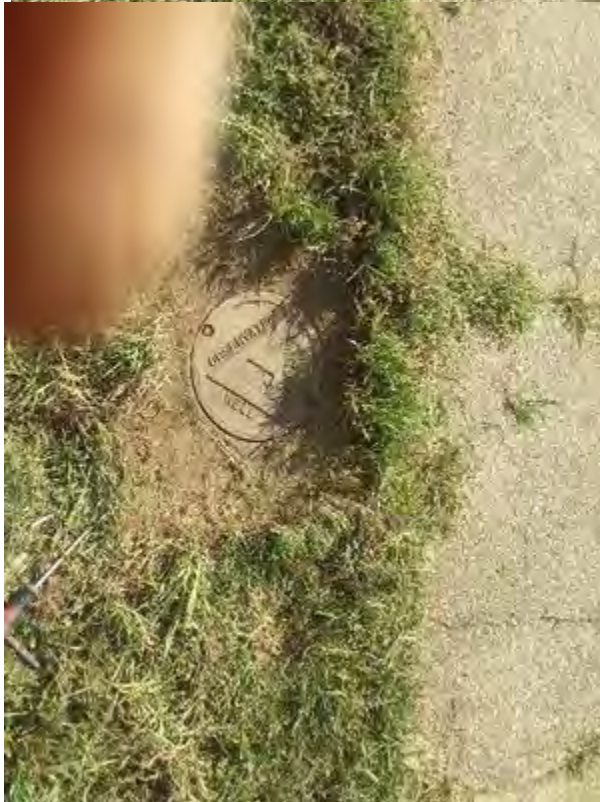
Client: Navy CLEAN	Facility: NWIRP Bethpage
Project Number: 112G08005-WE13	Location: Bethpage, New York
Date: September 22, 2021 15:04	Personnel: Wyatt Bostick
Well ID: GM38D	Well Location: 206354 1128945
Well Status: Other	Screen Interval: 320-340
WELL INVENTORY CONDITION	
Concrete pad in acceptable condition i.e. no cracks?	NO
Manhole cover present and in working condition?	YES
All bolts on manhole present and not stripped?	NO
Well plug present, locked and in good working condition?	YES
OVERALL CONDITION:	POOR
Notes (Explain if answered No to any of the above) Buried under sod and possible collapsing pad

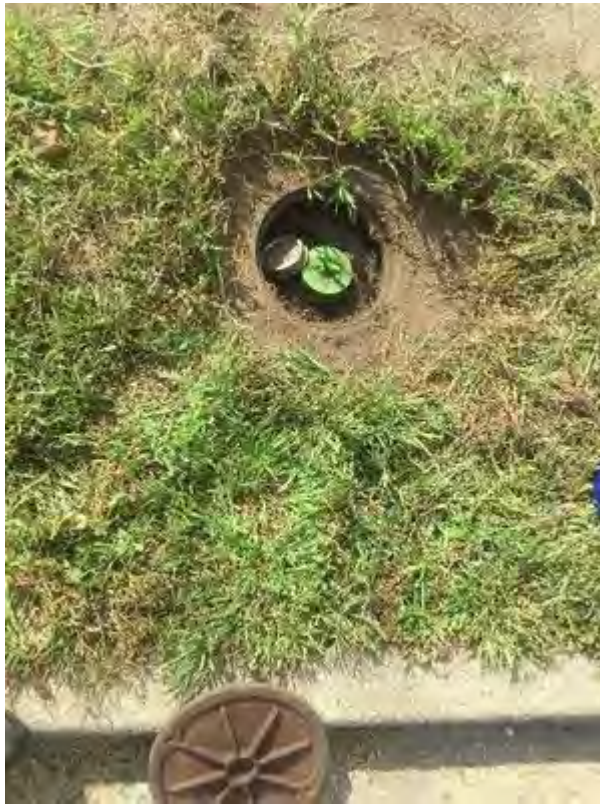
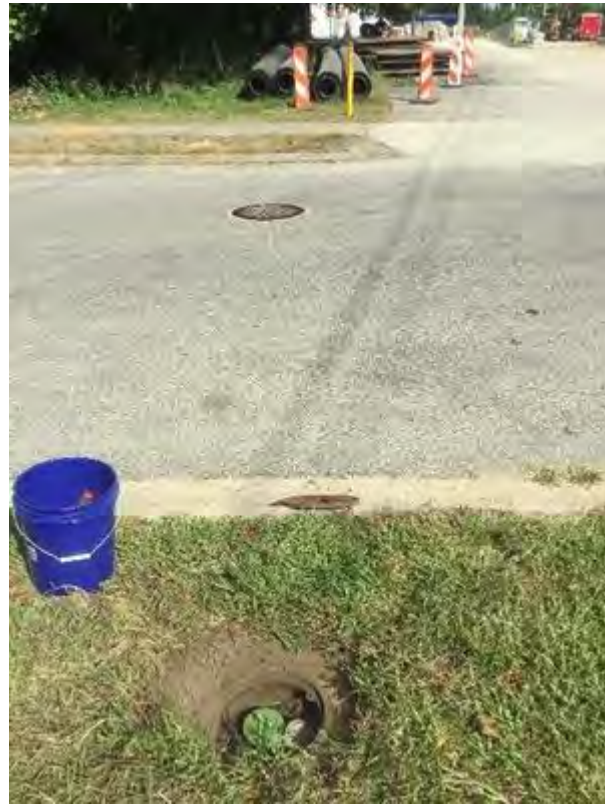
Client: Navy CLEAN	Facility: NWIRP Bethpage
Project Number: 112G08005-WE13	Location: Bethpage, New York
Date: September 22, 2021 14:57	Personnel: Wyatt Bostick
Well ID: GM38D2	Well Location: 206338 1128953
Well Status: Other	Screen Interval: 475-495
WELL INVENTORY CONDITION	
Concrete pad in acceptable condition i.e. no cracks?	NO
Manhole cover present and in working condition?	YES
All bolts on manhole present and not stripped?	NO
Well plug present, locked and in good working condition?	YES
OVERALL CONDITION:	POOR
Notes (Explain if answered No to any of the above) Burried under sod and possible collapsing pad

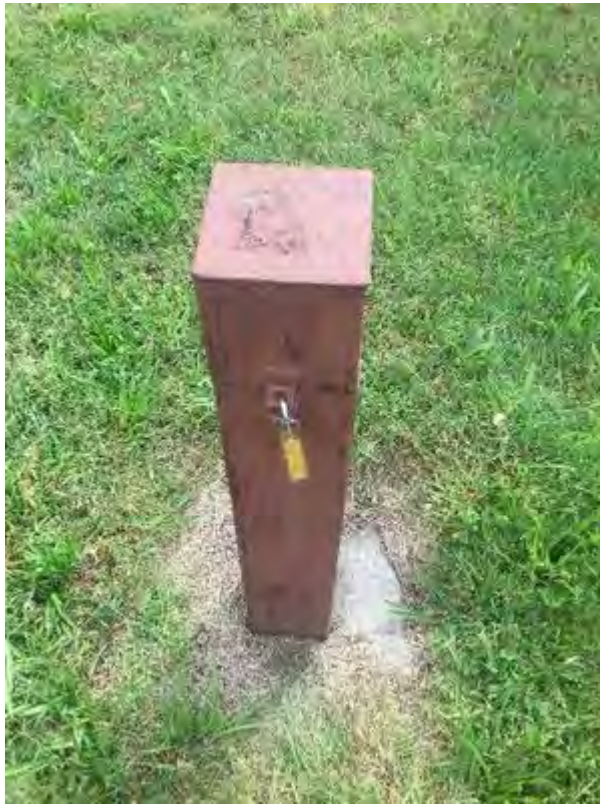
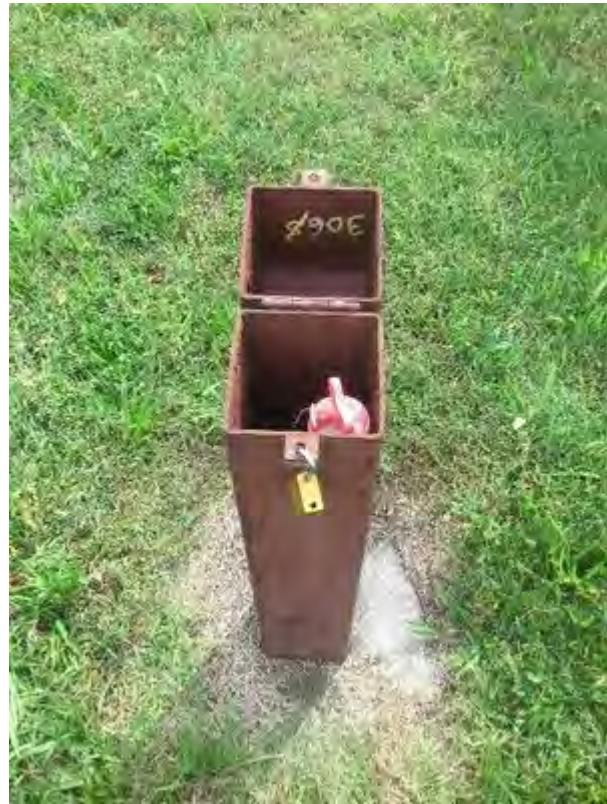
Client: Navy CLEAN	Facility: NWIRP Bethpage
Project Number: 112G08005-WE13	Location: Bethpage, New York
Date: September 22, 2021 14:39	Personnel: Noah Sprouse
Well ID: BPS1-TT-MW306S	Well Location: 213383.55 1124387.814
Well Status: Other	Screen Interval: 50-60
WELL INVENTORY CONDITION	
Concrete pad in acceptable condition i.e. no cracks?	YES
Manhole cover present and in working condition?	YES
All bolts on manhole present and not stripped?	YES
Well plug present, locked and in good working condition?	YES
OVERALL CONDITION:	GOOD
Notes (Explain if answered No to any of the above) Stick-up well.
