Memorandum

To: Scot Sokolowski, NAVFAC MIDLANT
From: David Brayack, Tetra Tech
Date: December 30, 2021
Re: Annual LUC Inspection and Operation Summary Report: Sites 1, 2, 3, and 4 – NWIRP Bethpage
Revision 1
Contract/CTO Number: N6247016D9008/WE13

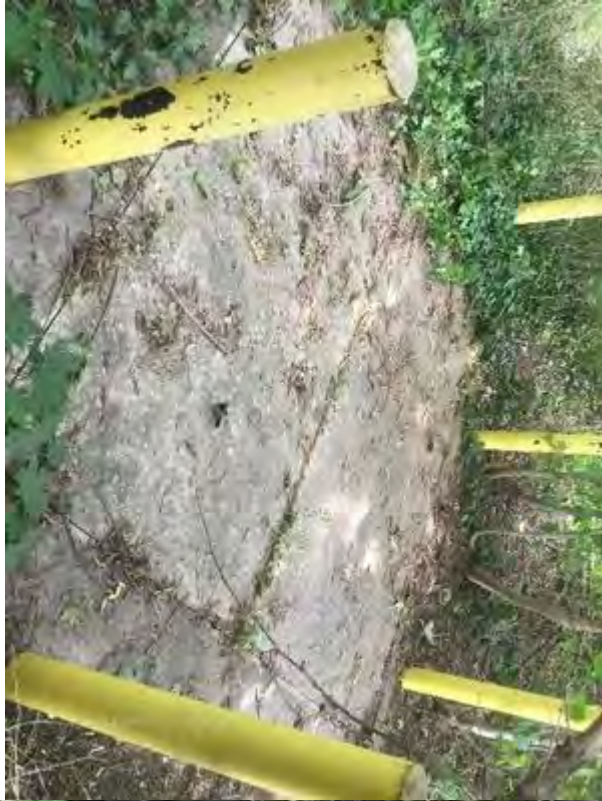
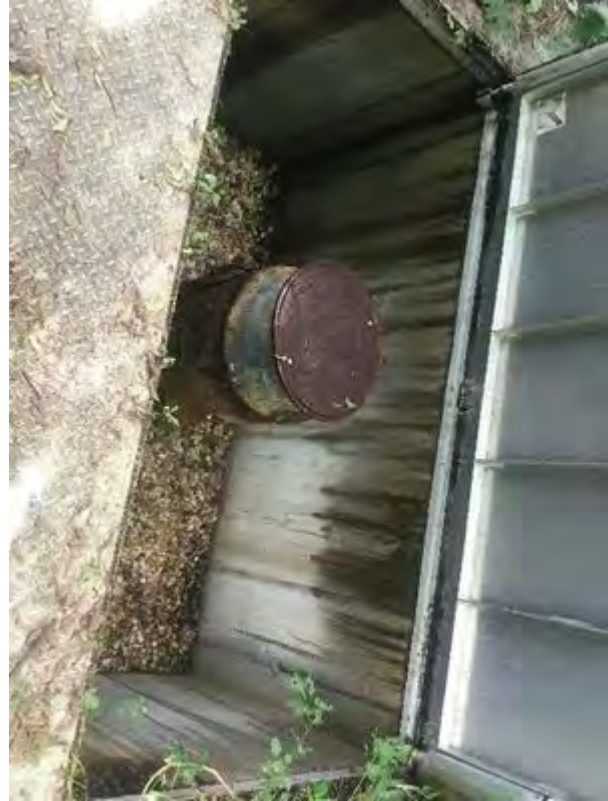
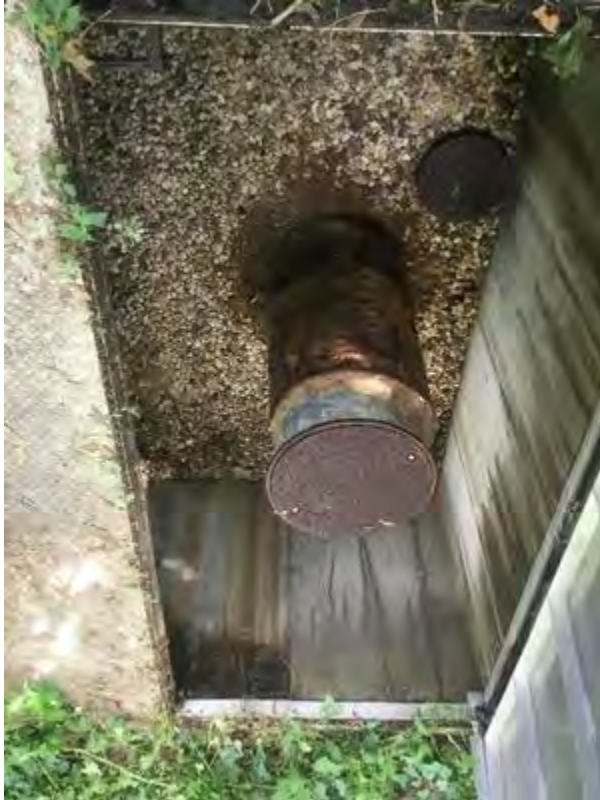
Client: Navy CLEAN	Facility: NWIRP Bethpage
Project Number: 112G08005-WE13	Location: Bethpage, New York
Date: September 22, 2021 14:41	Personnel: Wyatt Bostick
Well ID: GM38-RW2-MW3	Well Location: 206388.3 1129262.3
Well Status: Other	Screen Interval: 470-510
WELL INVENTORY CONDITION	
Concrete pad in acceptable condition i.e. no cracks?	YES
Manhole cover present and in working condition?	YES
All bolts on manhole present and not stripped?	YES
Well plug present, locked and in good working condition?	YES
OVERALL CONDITION:	GOOD
Notes (Explain if answered No to any of the above)

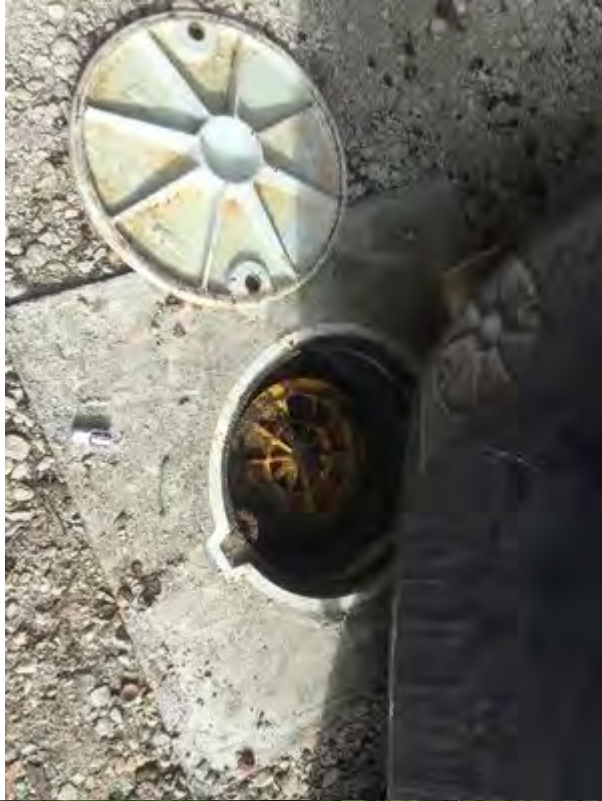
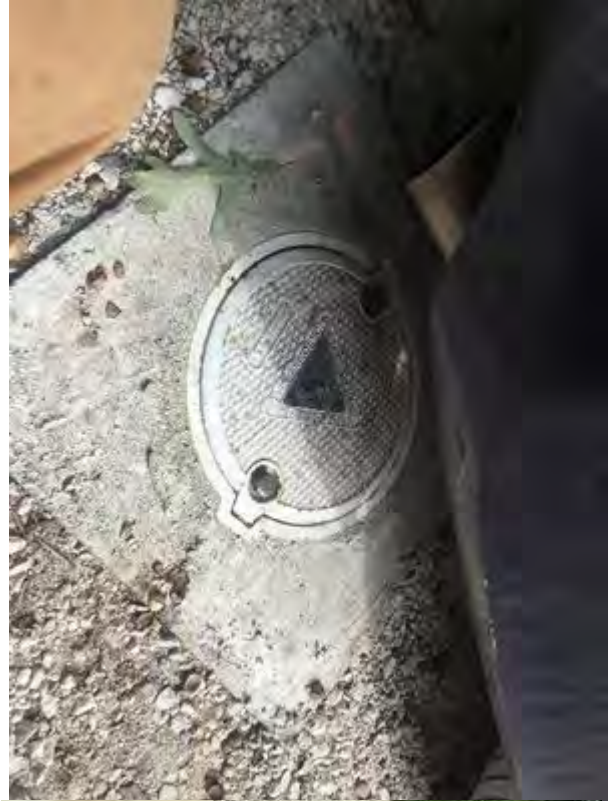
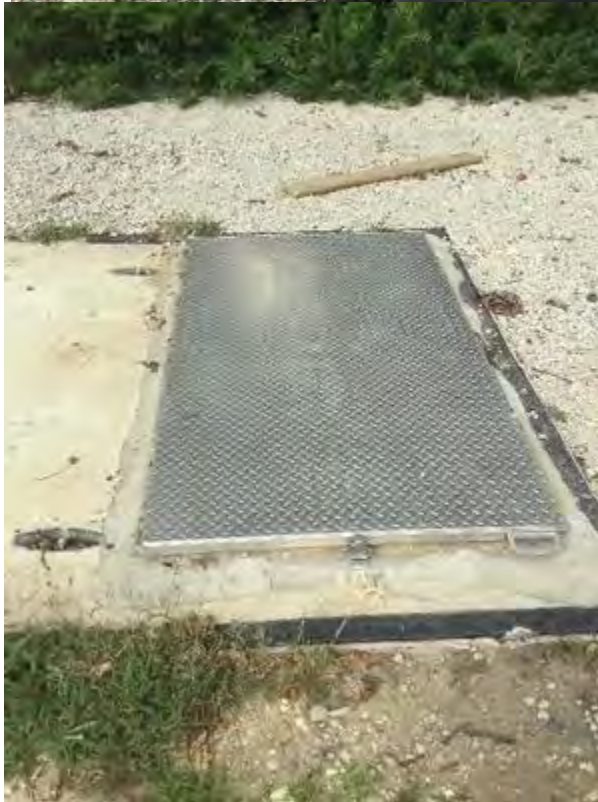
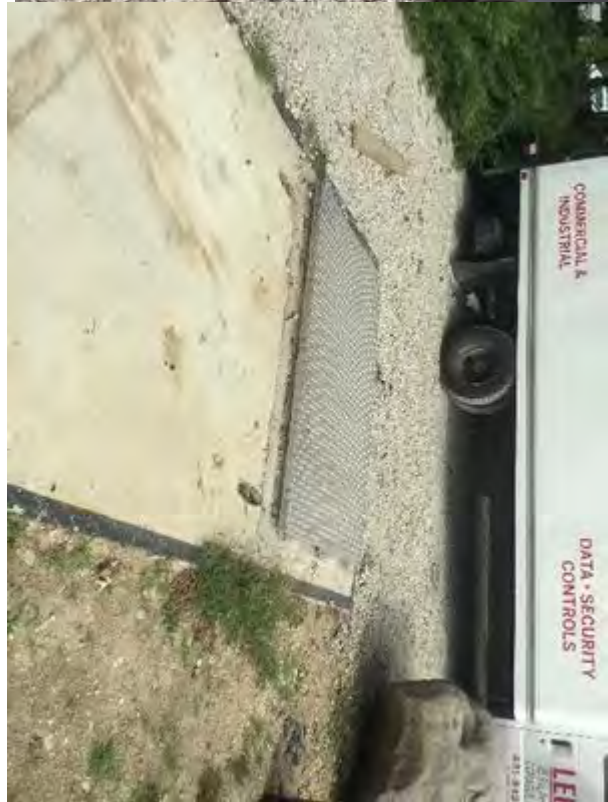
Client: Navy CLEAN	Facility: NWIRP Bethpage
Project Number: 112G08005-WE13	Location: Bethpage, New York
Date: September 22, 2021 14:37	Personnel: Wyatt Bostick
Well ID: GM38-RW2-MW2	Well Location: 206384.7 1129179.1
Well Status: Other	Screen Interval: 470-510
WELL INVENTORY CONDITION	
Concrete pad in acceptable condition i.e. no cracks?	YES
Manhole cover present and in working condition?	YES
All bolts on manhole present and not stripped?	YES
Well plug present, locked and in good working condition?	YES
OVERALL CONDITION:	GOOD
Notes (Explain if answered No to any of the above)

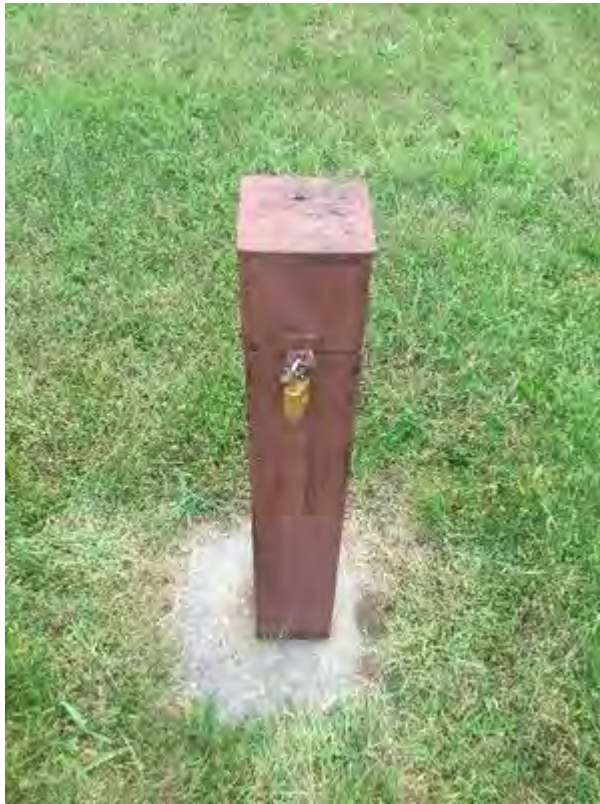
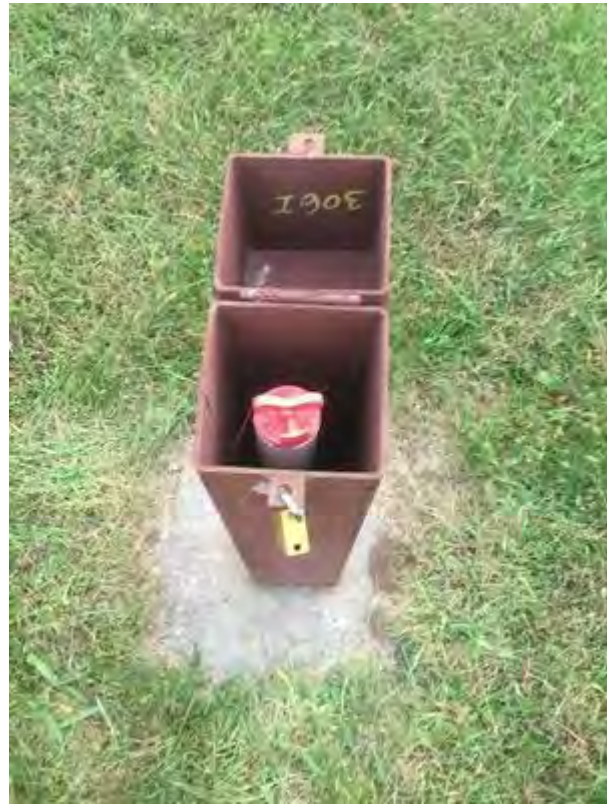
Client: Navy CLEAN	Facility: NWIRP Bethpage
Project Number: 112G08005-WE13	Location: Bethpage, New York
Date: September 22, 2021 14:37	Personnel: Noah Sprouse
Well ID: BPS1-TT-MW306I	Well Location: 213382.124 1124399.458
Well Status: Other	Screen Interval: 189-199
WELL INVENTORY CONDITION	
Concrete pad in acceptable condition i.e. no cracks?	YES
Manhole cover present and in working condition?	YES
All bolts on manhole present and not stripped?	YES
Well plug present, locked and in good working condition?	YES
OVERALL CONDITION:	GOOD
Notes (Explain if answered No to any of the above) Stick-up well.

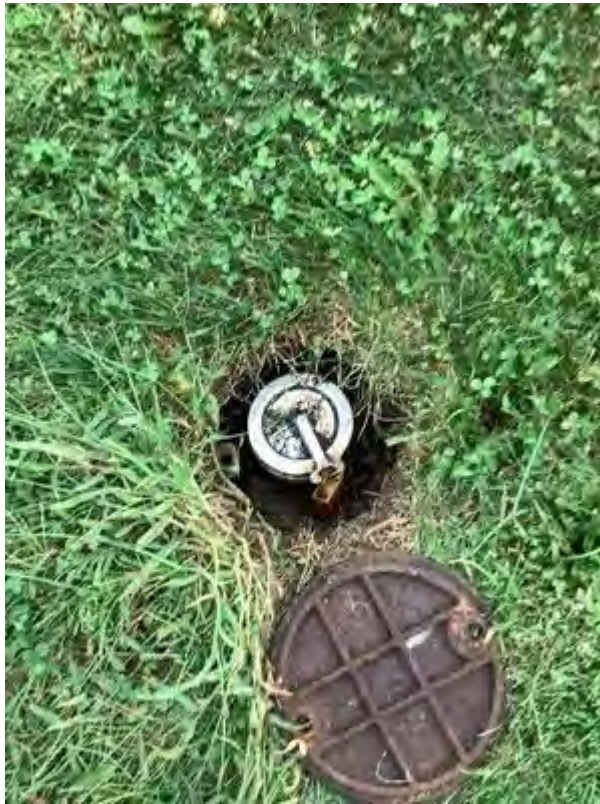
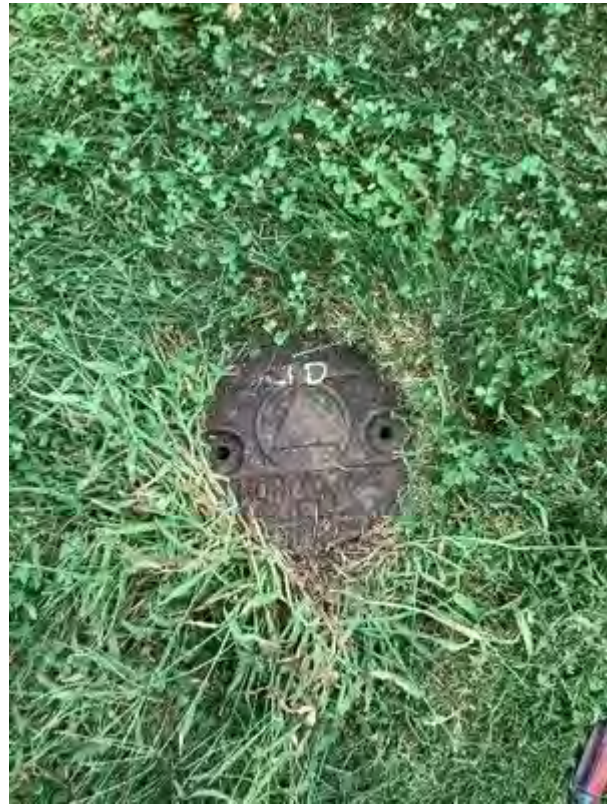
Client: Navy CLEAN	Facility: NWIRP Bethpage
Project Number: 112G08005-WE13	Location: Bethpage, New York
Date: September 22, 2021 14:36	Personnel: Beau Benfield
Well ID: BPGMMW21D	Well Location: 209428 1125462
Well Status: Other	Screen Interval: 278-288
WELL INVENTORY CONDITION	
Concrete pad in acceptable condition i.e. no cracks?	YES
Manhole cover present and in working condition?	YES
All bolts on manhole present and not stripped?	NO
Well plug present, locked and in good working condition?	YES
OVERALL CONDITION:	GOOD
Notes (Explain if answered No to any of the above) Could not thread bolts through manhole cover

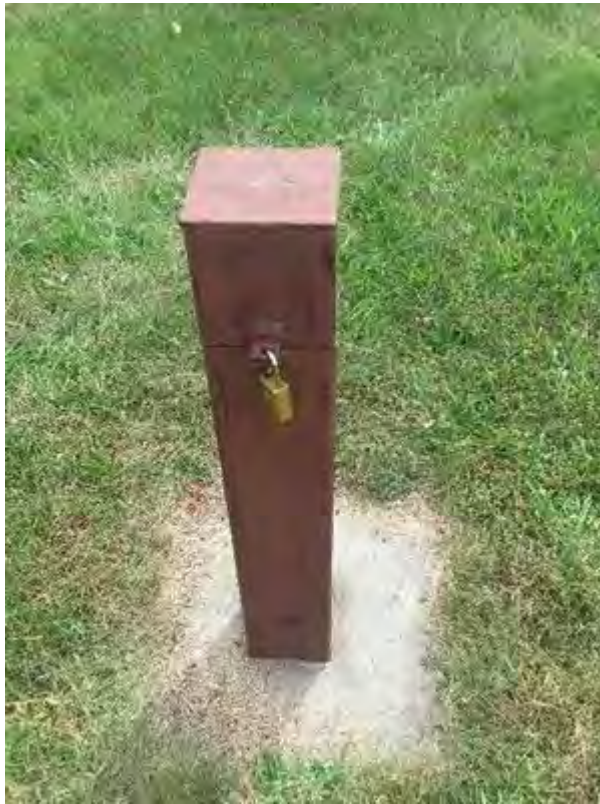
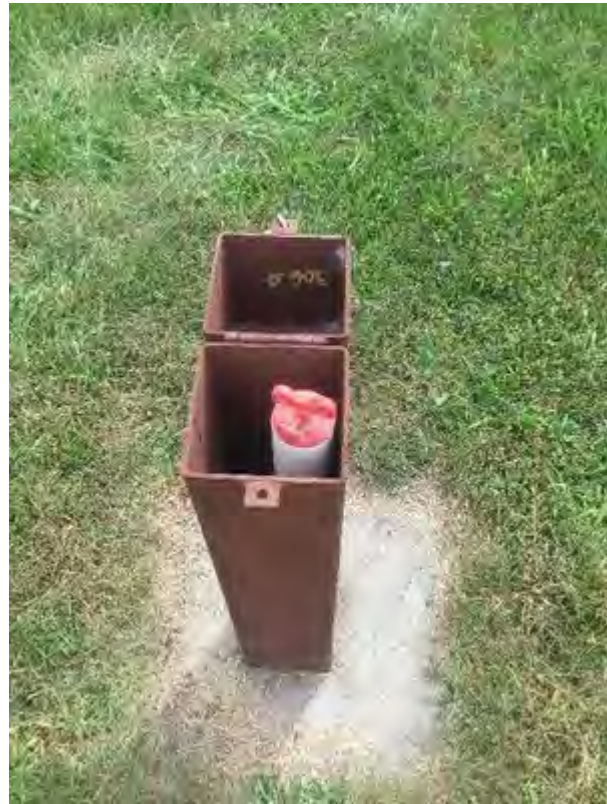
Client: Navy CLEAN	Facility: NWIRP Bethpage
Project Number: 112G08005-WE13	Location: Bethpage, New York
Date: September 22, 2021 14:34	Personnel: Noah Sprouse
Well ID: BPS1-TT-MW306D	Well Location: 213380.799 1124409.899
Well Status: Other	Screen Interval: 284-294
WELL INVENTORY CONDITION	
Concrete pad in acceptable condition i.e. no cracks?	YES
Manhole cover present and in working condition?	YES
All bolts on manhole present and not stripped?	YES
Well plug present, locked and in good working condition?	YES
OVERALL CONDITION:	GOOD
Notes (Explain if answered No to any of the above) Stick-up well

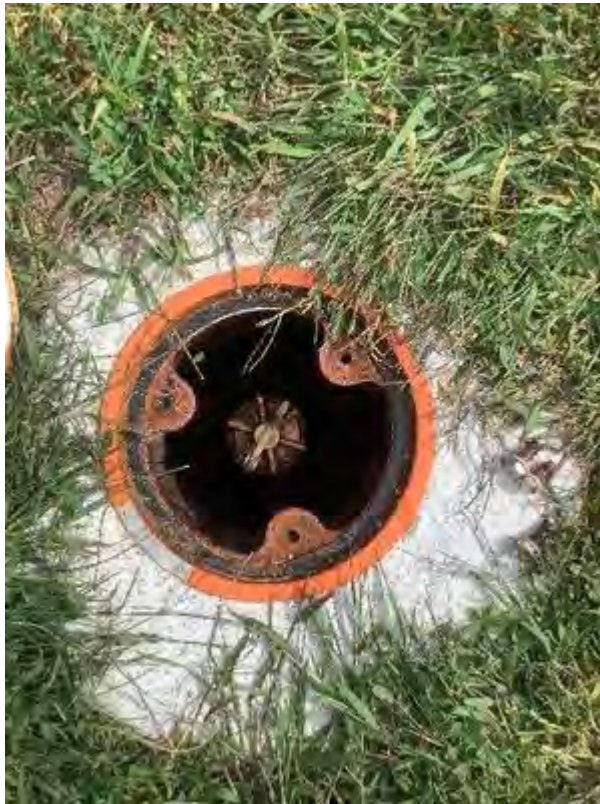
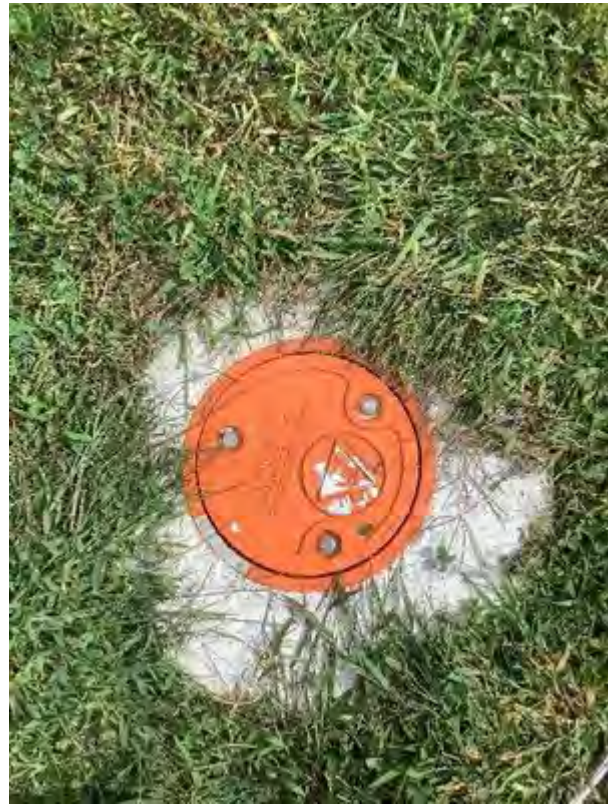
Client: Navy CLEAN	Facility: NWIRP Bethpage
Project Number: 112G08005-WE13	Location: Bethpage, New York
Date: September 22, 2021 14:33	Personnel: Beau Benfield
Well ID: BPGMMW21I	Well Location: 209438 1125464
Well Status: Other	Screen Interval: 130-140
WELL INVENTORY CONDITION	
Concrete pad in acceptable condition i.e. no cracks?	YES
Manhole cover present and in working condition?	YES
All bolts on manhole present and not stripped?	YES
Well plug present, locked and in good working condition?	YES
OVERALL CONDITION:	GOOD
Notes (Explain if answered No to any of the above)

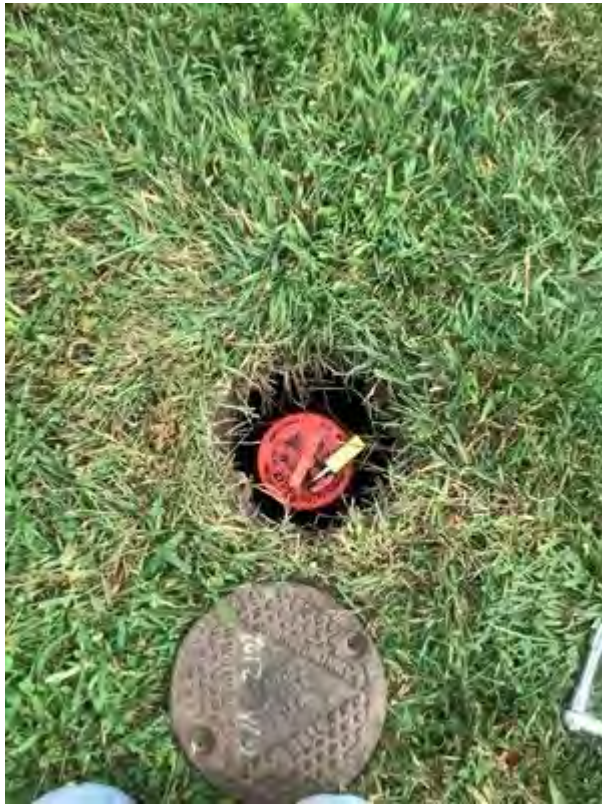
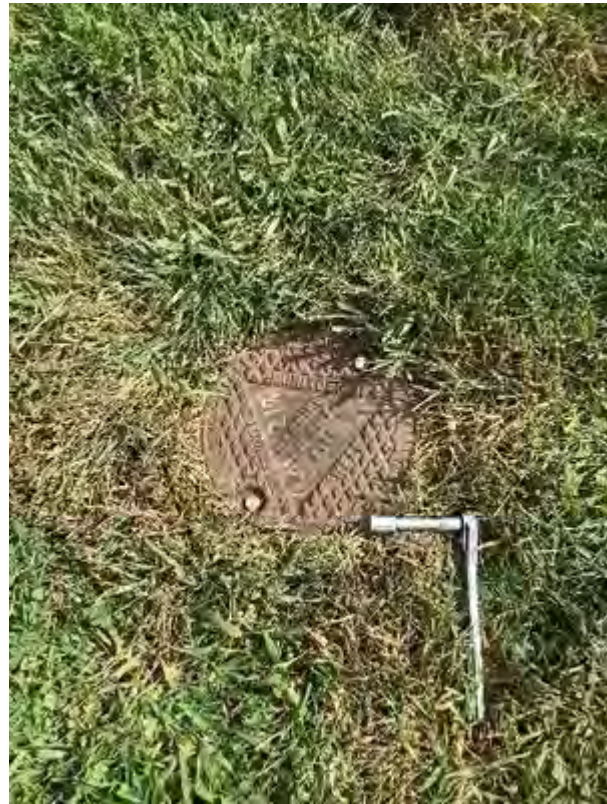
Client: Navy CLEAN	Facility: NWIRP Bethpage
Project Number: 112G08005-WE13	Location: Bethpage, New York
Date: September 22, 2021 14:28	Personnel: Beau Benfield
Well ID: BPGMMW21D2	Well Location: 209438 1125464
Well Status: Other	Screen Interval:
WELL INVENTORY CONDITION	
Concrete pad in acceptable condition i.e. no cracks?	YES
Manhole cover present and in working condition?	YES
All bolts on manhole present and not stripped?	YES
Well plug present, locked and in good working condition?	YES
OVERALL CONDITION:	GOOD
Notes (Explain if answered No to any of the above)

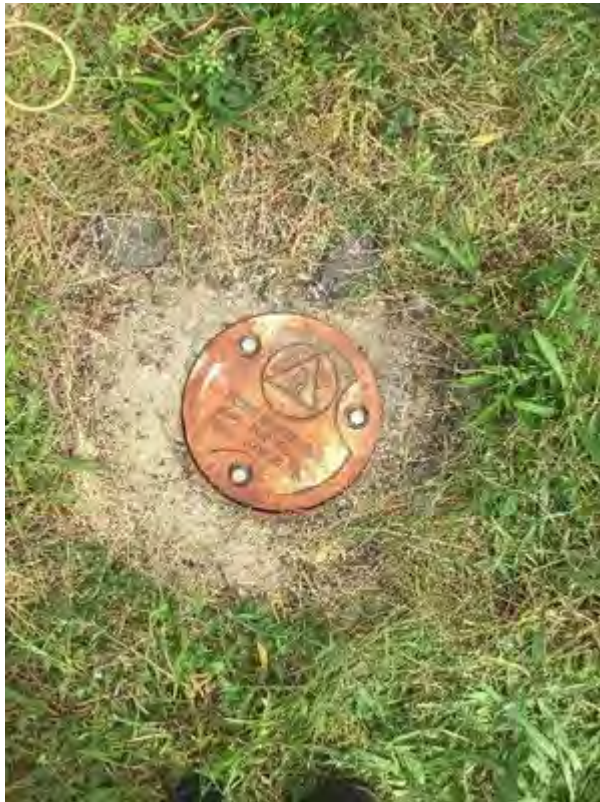
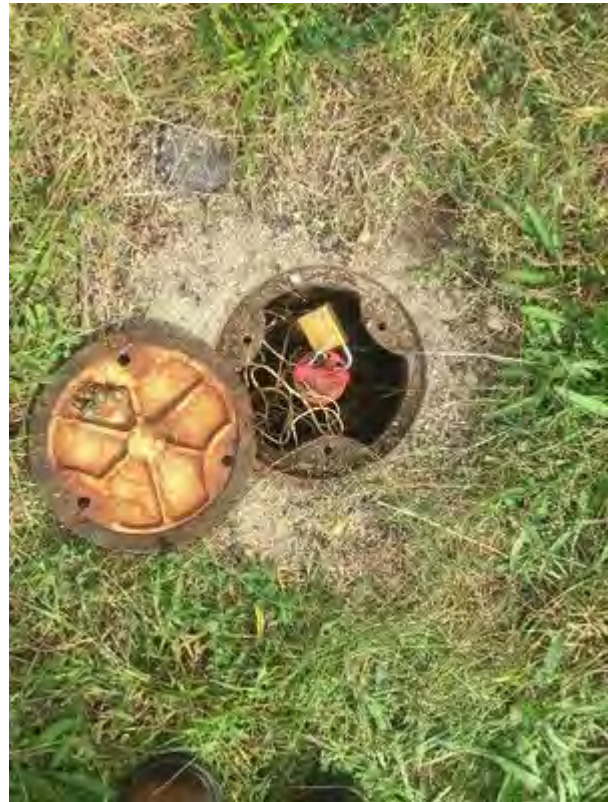
Client: Navy CLEAN	Facility: NWIRP Bethpage
Project Number: 112G08005-WE13	Location: Bethpage, New York
Date: September 22, 2021 14:26	Personnel: Noah Sprouse
Well ID: BPS1-TT-MW304I2	Well Location: 213705.436 1124989.868
Well Status: Other	Screen Interval: 140-150
WELL INVENTORY CONDITION	
Concrete pad in acceptable condition i.e. no cracks?	YES
Manhole cover present and in working condition?	YES
All bolts on manhole present and not stripped?	YES
Well plug present, locked and in good working condition?	YES
OVERALL CONDITION:	FAIR
Notes (Explain if answered No to any of the above)

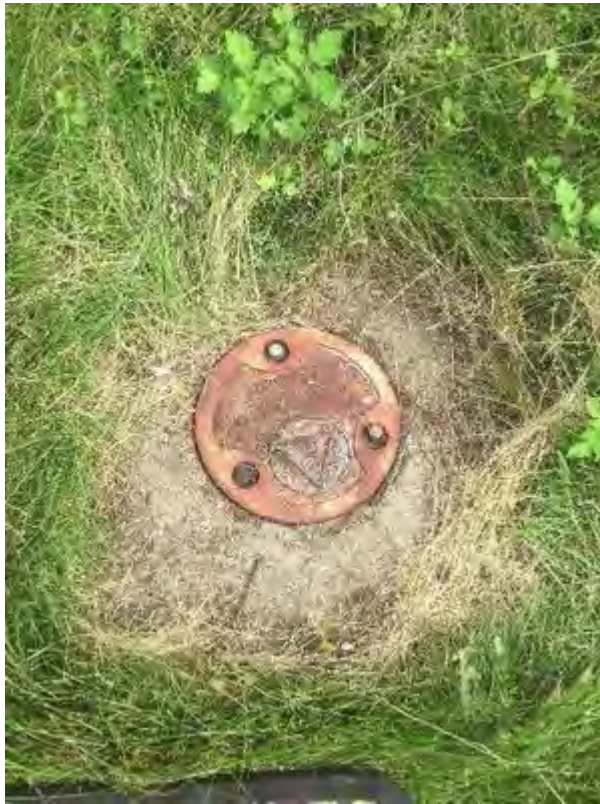
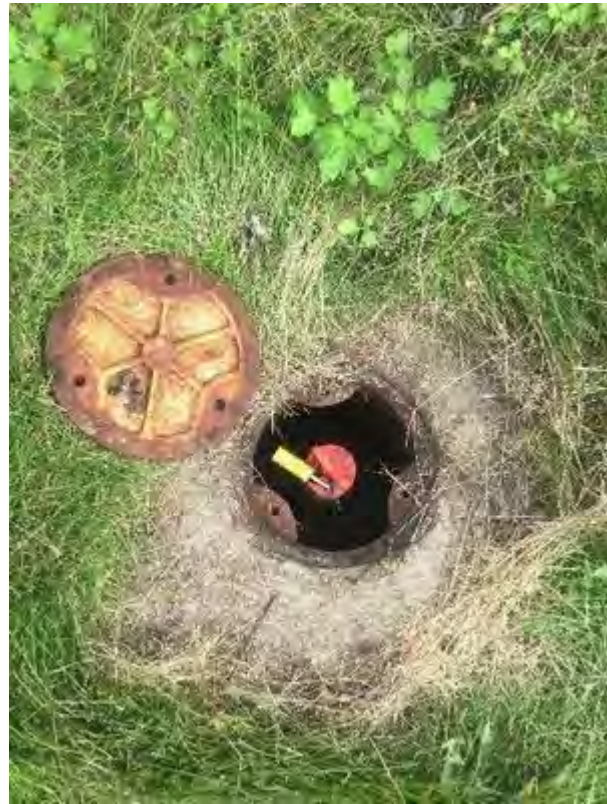
Client: Navy CLEAN	Facility: NWIRP Bethpage
Project Number: 112G08005-WE13	Location: Bethpage, New York
Date: September 22, 2021 14:23	Personnel: Noah Sprouse
Well ID: BPS1-TT-MW304D	Well Location: 213692.271 1124994.753
Well Status: Other	Screen Interval: 180-190
WELL INVENTORY CONDITION	
Concrete pad in acceptable condition i.e. no cracks?	YES
Manhole cover present and in working condition?	YES
All bolts on manhole present and not stripped?	YES
Well plug present, locked and in good working condition?	YES
OVERALL CONDITION:	GOOD
Notes (Explain if answered No to any of the above)

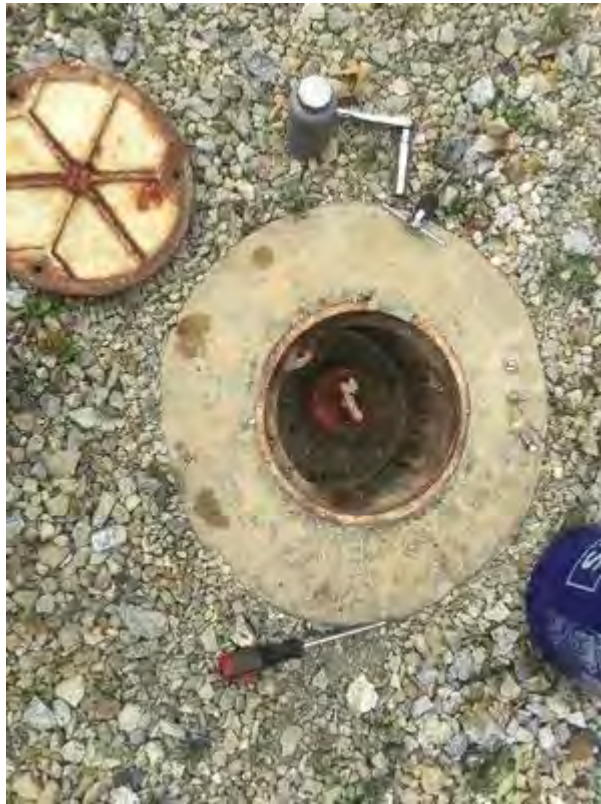
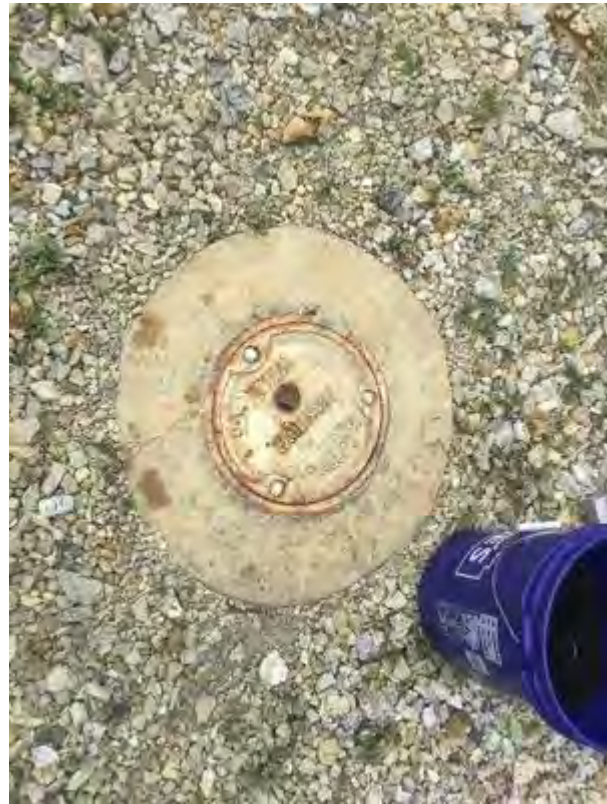
Client: Navy CLEAN	Facility: NWIRP Bethpage
Project Number: 112G08005-WE13	Location: Bethpage, New York
Date: September 22, 2021 14:19	Personnel: Wyatt Bostick
Well ID: GM38-TP-1	Well Location: 206472.6 1129712
Well Status: Other	Screen Interval: 450-470
WELL INVENTORY CONDITION	
Concrete pad in acceptable condition i.e. no cracks?	YES
Manhole cover present and in working condition?	YES
All bolts on manhole present and not stripped?	YES
Well plug present, locked and in good working condition?	YES
OVERALL CONDITION:	GOOD
Notes (Explain if answered No to any of the above)

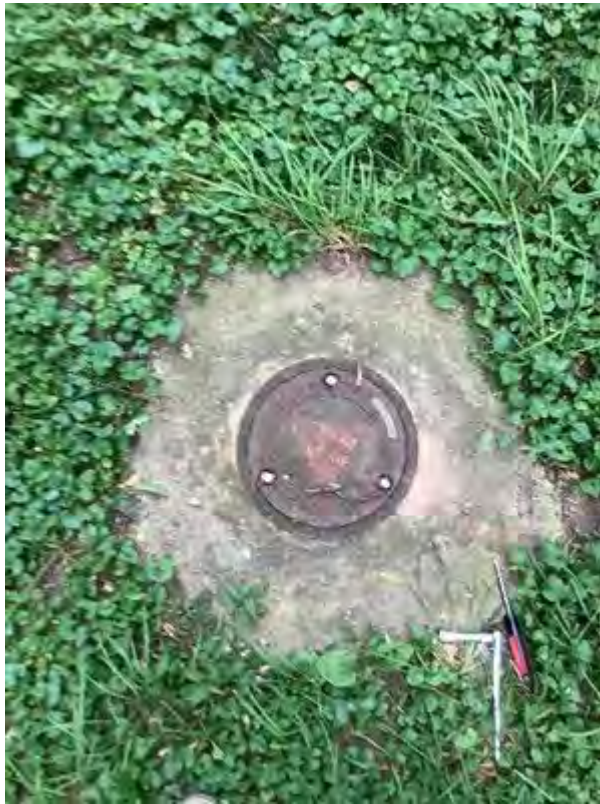
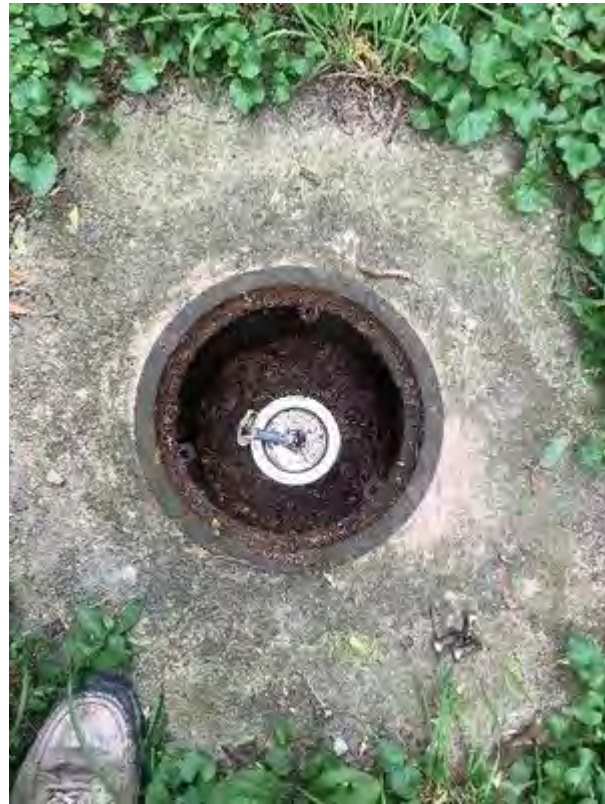
Client: Navy CLEAN	Facility: NWIRP Bethpage
Project Number: 112G08005-WE13	Location: Bethpage, New York
Date: September 22, 2021 14:18	Personnel: Beau Benfield
Well ID: BPGMMW79I	Well Location: 208857 1127550
Well Status: Other	Screen Interval: 170-180
WELL INVENTORY CONDITION	
Concrete pad in acceptable condition i.e. no cracks?	YES
Manhole cover present and in working condition?	YES
All bolts on manhole present and not stripped?	YES
Well plug present, locked and in good working condition?	YES
OVERALL CONDITION:	GOOD
Notes (Explain if answered No to any of the above)

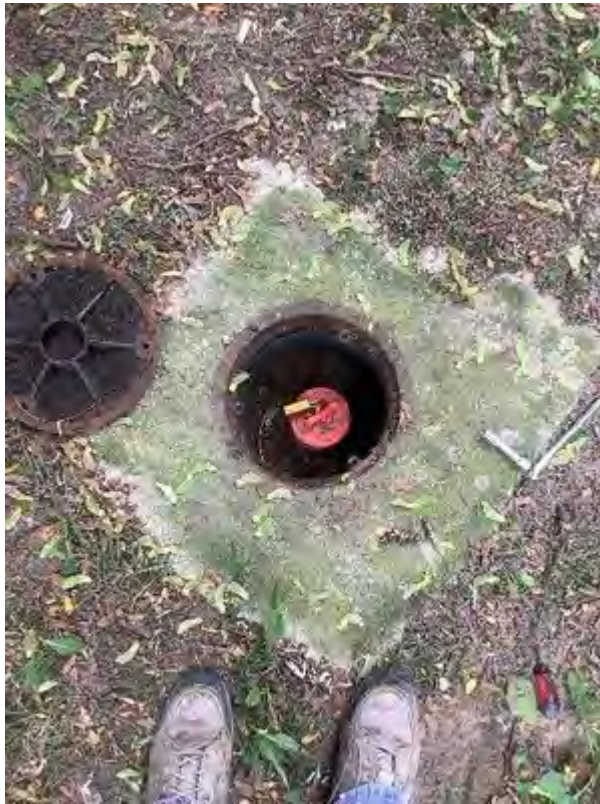
Client: Navy CLEAN	Facility: NWIRP Bethpage
Project Number: 112G08005-WE13	Location: Bethpage, New York
Date: September 22, 2021 14:16	Personnel: Beau Benfield
Well ID: BPGMMW79D	Well Location: 208856 1127534
Well Status: Other	Screen Interval: 280-290
WELL INVENTORY CONDITION	
Concrete pad in acceptable condition i.e. no cracks?	YES
Manhole cover present and in working condition?	YES
All bolts on manhole present and not stripped?	YES
Well plug present, locked and in good working condition?	YES
OVERALL CONDITION:	GOOD
Notes (Explain if answered No to any of the above)

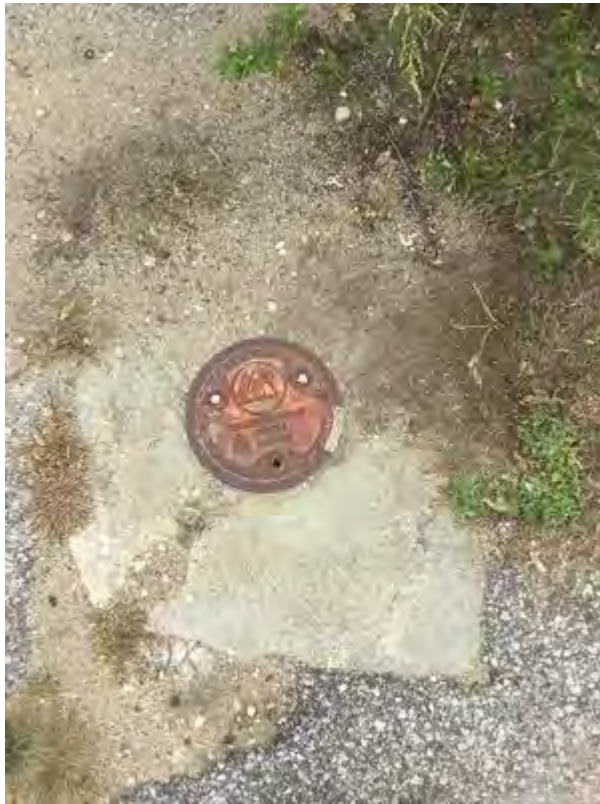
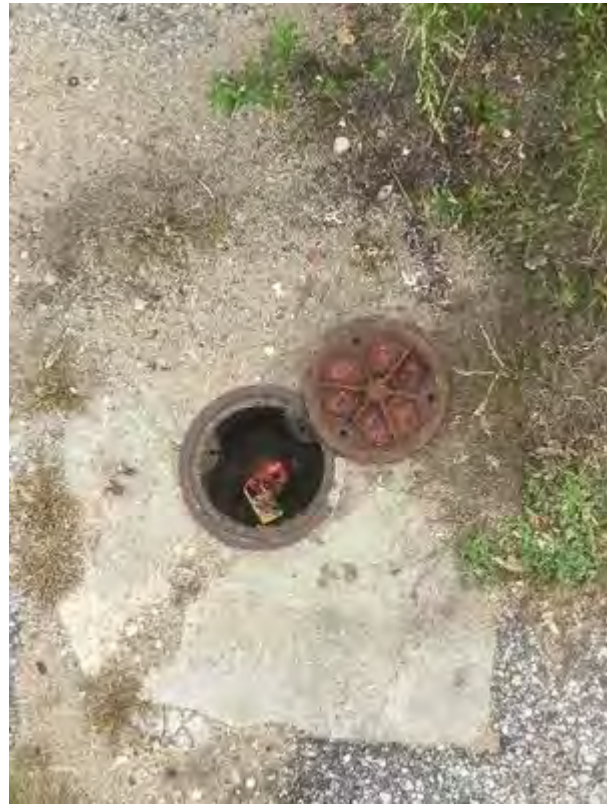
Client: Navy CLEAN	Facility: NWIRP Bethpage
Project Number: 112G08005-WE13	Location: Bethpage, New York
Date: September 22, 2021 14:11	Personnel: Noah Sprouse
Well ID: BPS1-TT-MW305D	Well Location: 213405.975 1123949.183
Well Status: Other	Screen Interval: 286-296
WELL INVENTORY CONDITION	
Concrete pad in acceptable condition i.e. no cracks?	NO
Manhole cover present and in working condition?	YES
All bolts on manhole present and not stripped?	NO
Well plug present, locked and in good working condition?	YES
OVERALL CONDITION:	POOR
Notes (Explain if answered No to any of the above) Cracked well pad, missing one bolt, two bolts stripped, missing rubber gasket.

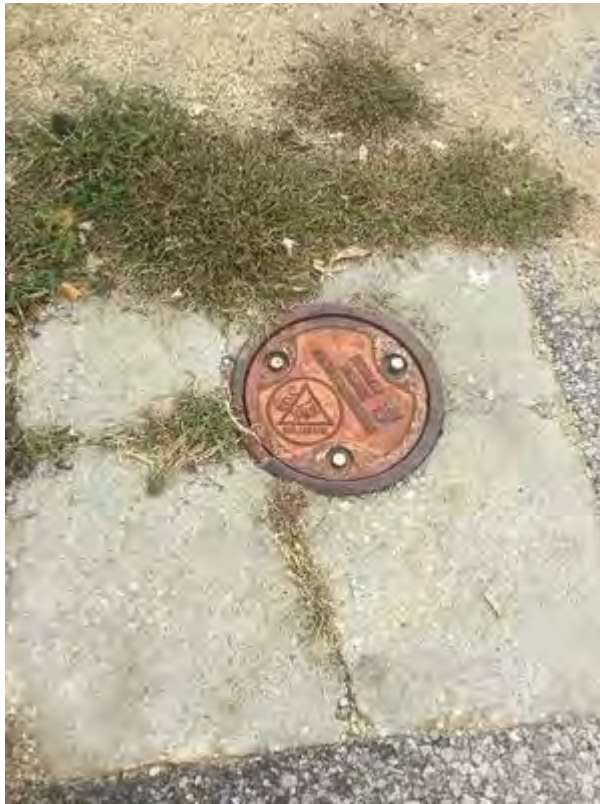
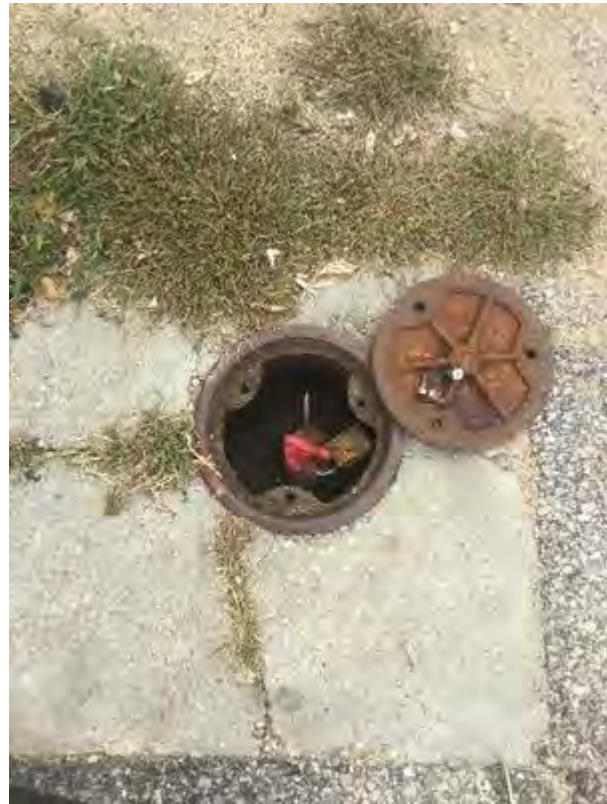
Client: Navy CLEAN	Facility: NWIRP Bethpage
Project Number: 112G08005-WE13	Location: Bethpage, New York
Date: September 22, 2021 14:08	Personnel: Noah Sprouse
Well ID: BPS1-TT-MW305I	Well Location: 213408.557 1123939.487
Well Status: Other	Screen Interval: 190-200
WELL INVENTORY CONDITION	
Concrete pad in acceptable condition i.e. no cracks?	NO
Manhole cover present and in working condition?	YES
All bolts on manhole present and not stripped?	YES
Well plug present, locked and in good working condition?	YES
OVERALL CONDITION:	FAIR
Notes (Explain if answered No to any of the above) Cracked well pad, missing rubber gasket.

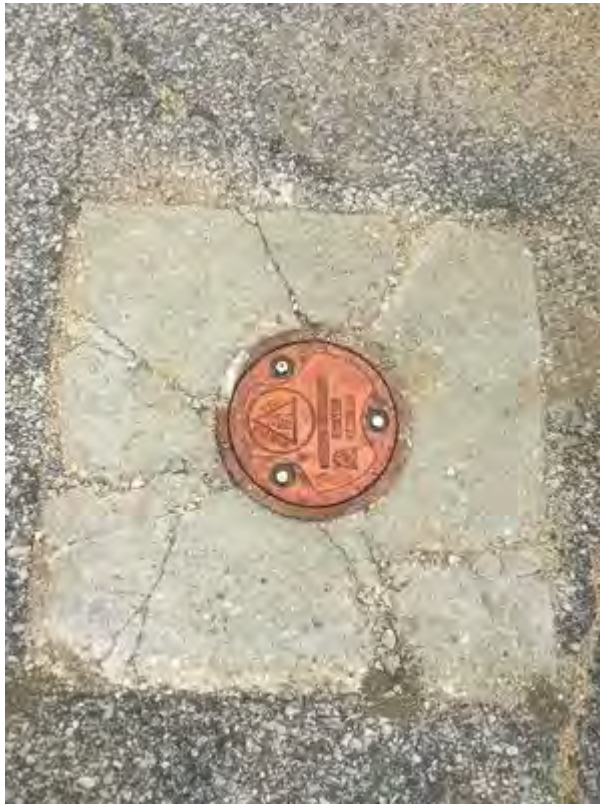
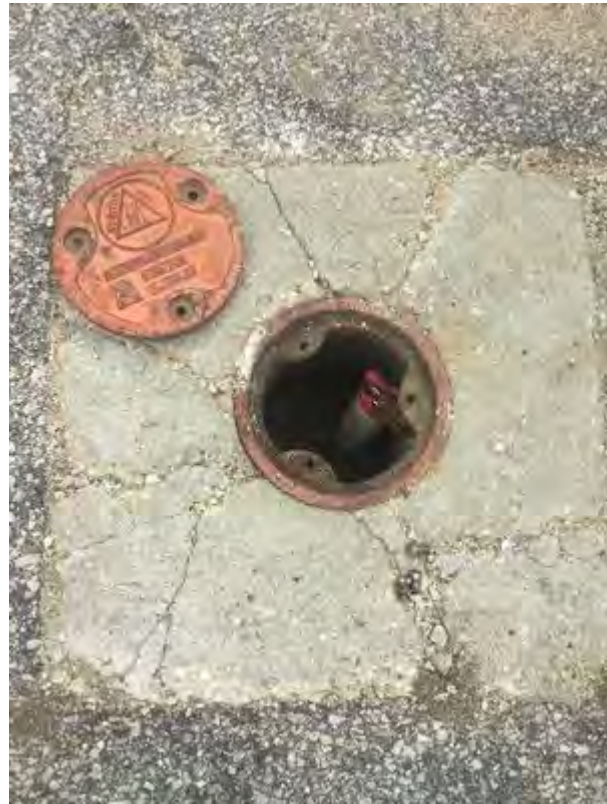
Client: Navy CLEAN	Facility: NWIRP Bethpage
Project Number: 112G08005-WE13	Location: Bethpage, New York
Date: September 22, 2021 14:05	Personnel: Noah Sprouse
Well ID: BPS1-TT-MW305S	Well Location: 213411.021 1123930.127
Well Status: Other	Screen Interval: 40-50
WELL INVENTORY CONDITION	
Concrete pad in acceptable condition i.e. no cracks?	NO
Manhole cover present and in working condition?	YES
All bolts on manhole present and not stripped?	YES
Well plug present, locked and in good working condition?	YES
OVERALL CONDITION:	FAIR
Notes (Explain if answered No to any of the above) Cracked well pad, missing rubber gasket.

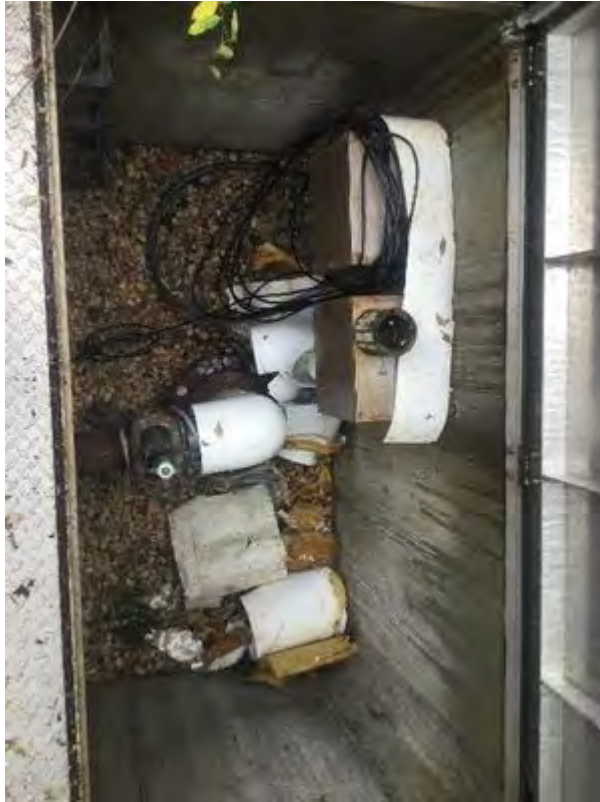
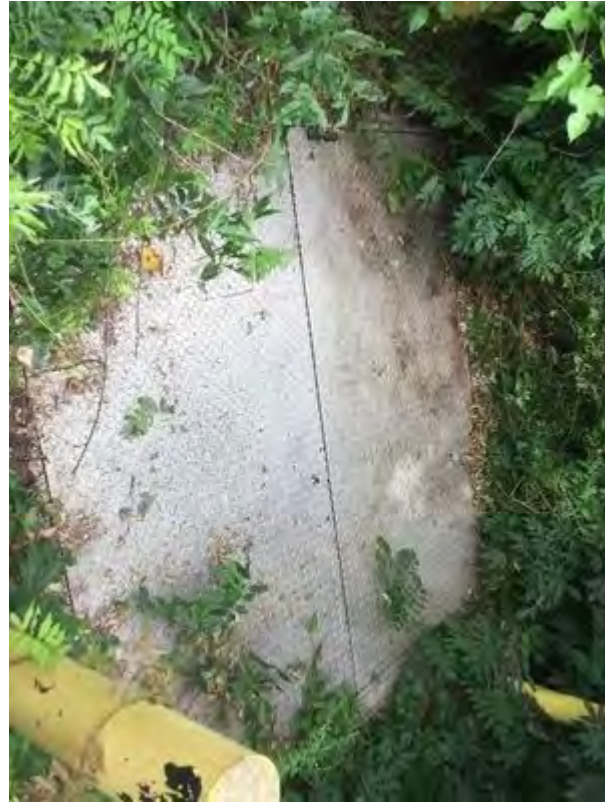
Client: Navy CLEAN	Facility: NWIRP Bethpage
Project Number: 112G08005-WE13	Location: Bethpage, New York
Date: September 22, 2021 13:59	Personnel: Wyatt Bostick
Well ID: GM38-IW1-MW1	Well Location: 205682.3 1129723
Well Status: Other	Screen Interval: 130-150
WELL INVENTORY CONDITION	
Concrete pad in acceptable condition i.e. no cracks?	YES
Manhole cover present and in working condition?	NO
All bolts on manhole present and not stripped?	YES
Well plug present, locked and in good working condition?	YES
OVERALL CONDITION:	GOOD
Notes (Explain if answered No to any of the above) Overgrown foilage

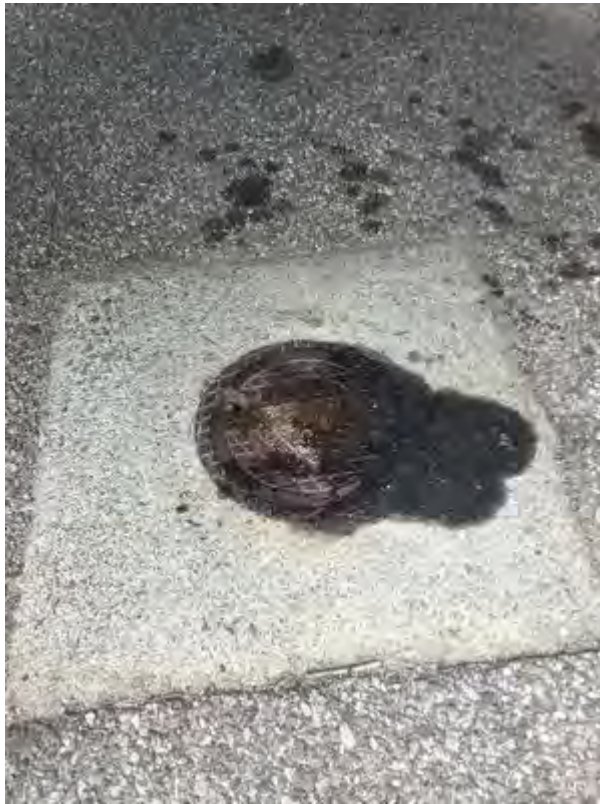
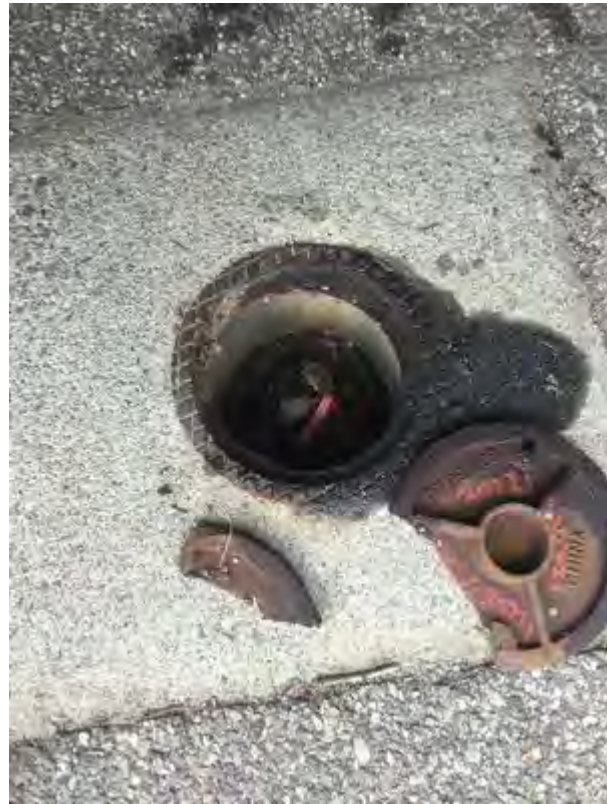
Client: Navy CLEAN	Facility: NWIRP Bethpag
Project Number: 112G08005-WE13	Location: Bethpage, New York
Date: September 22, 2021 13:58	Personnel: Noah Sprouse
Well ID: BPS1-TT-MW30211	Well Location: 213812.87 1124251.046
Well Status: Other	Screen Interval: 110-120
WELL INVENTORY CONDITION	
Concrete pad in acceptable condition i.e. no cracks?	YES
Manhole cover present and in working condition?	NO
All bolts on manhole present and not stripped?	NO
Well plug present, locked and in good working condition?	YES
OVERALL CONDITION:	POOR
Notes (Explain if answered No to any of the above) Cracked well cover, missing all bolts, missing rubber gasket.

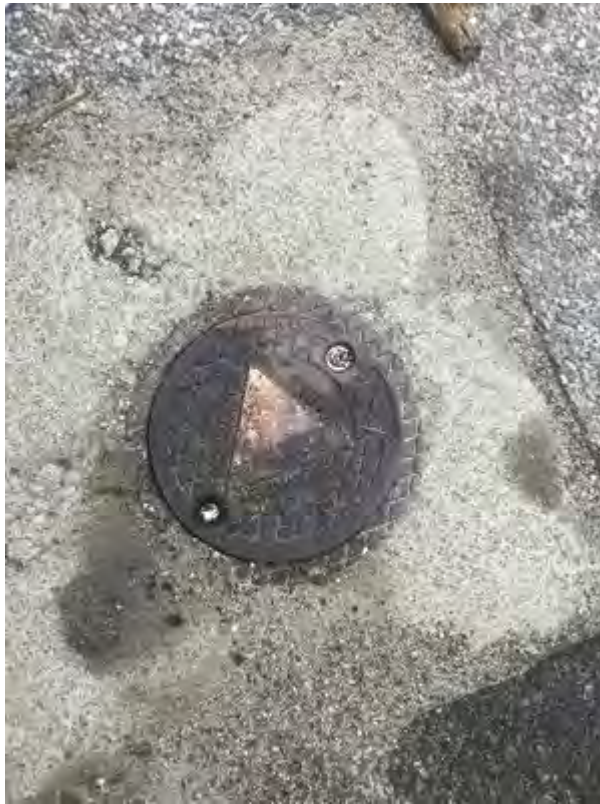
Client: Navy CLEAN	Facility: NWIRP Bethpage
Project Number: 112G08005-WE13	Location: Bethpage, New York
Date: September 22, 2021 13:56	Personnel: Noah Sprouse
Well ID: BPS1-TT-MW302S	Well Location: 213812.671 1124261.772
Well Status: Other	Screen Interval: 41-51
WELL INVENTORY CONDITION	
Concrete pad in acceptable condition i.e. no cracks?	YES
Manhole cover present and in working condition?	YES
All bolts on manhole present and not stripped?	YES
Well plug present, locked and in good working condition?	YES
OVERALL CONDITION:	GOOD
Notes (Explain if answered No to any of the above)

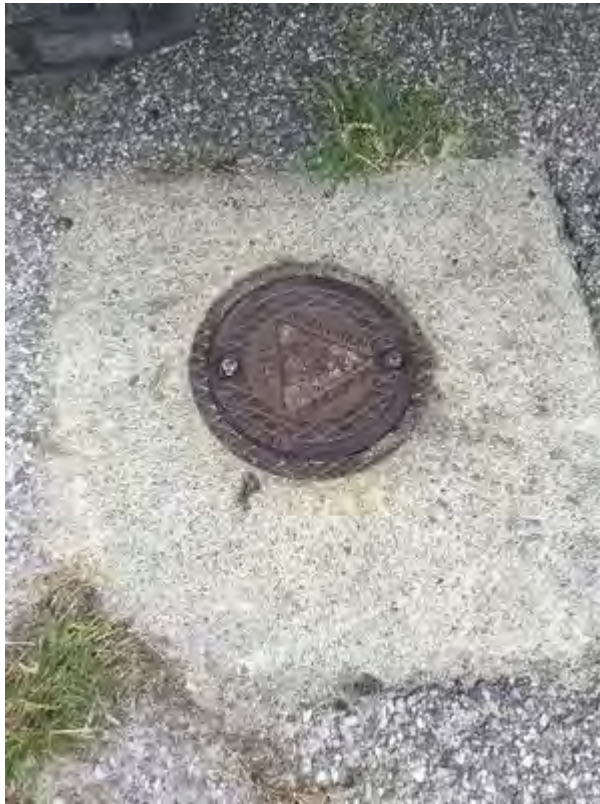
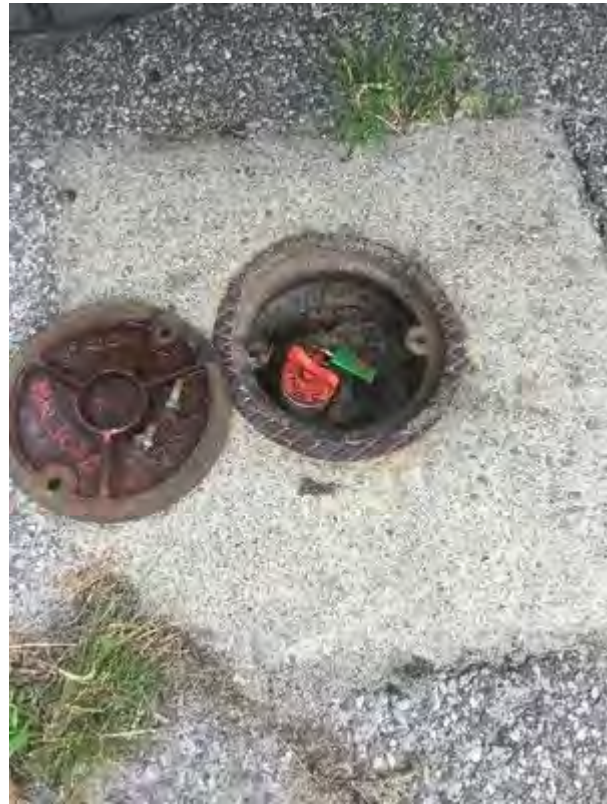
Client: Navy CLEAN	Facility: NWIRP Bethpage
Project Number: 112G08005-WE13	Location: Bethpage, New York
Date: September 22, 2021 13:53	Personnel: Noah Sprouse
Well ID: BPS1-TT-MW302D	Well Location: 213814.24 1124230.805
Well Status: Other	Screen Interval: 203-213
WELL INVENTORY CONDITION	
Concrete pad in acceptable condition i.e. no cracks?	YES
Manhole cover present and in working condition?	YES
All bolts on manhole present and not stripped?	NO
Well plug present, locked and in good working condition?	YES
OVERALL CONDITION:	GOOD
Notes (Explain if answered No to any of the above)
