Memorandum

To: Scot Sokolowski, NAVFAC MIDLANT
From: David Brayack, Tetra Tech
Date: December 30, 2021
Re: Annual LUC Inspection and Operation Summary Report: Sites 1, 2, 3, and 4 – NWIRP Bethpage
Revision 1
Contract/CTO Number: N6247016D9008/WE13

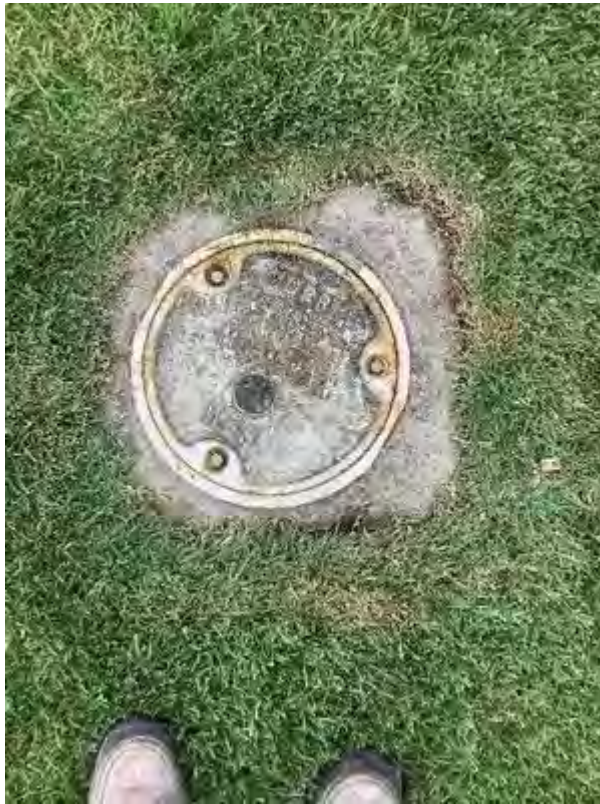
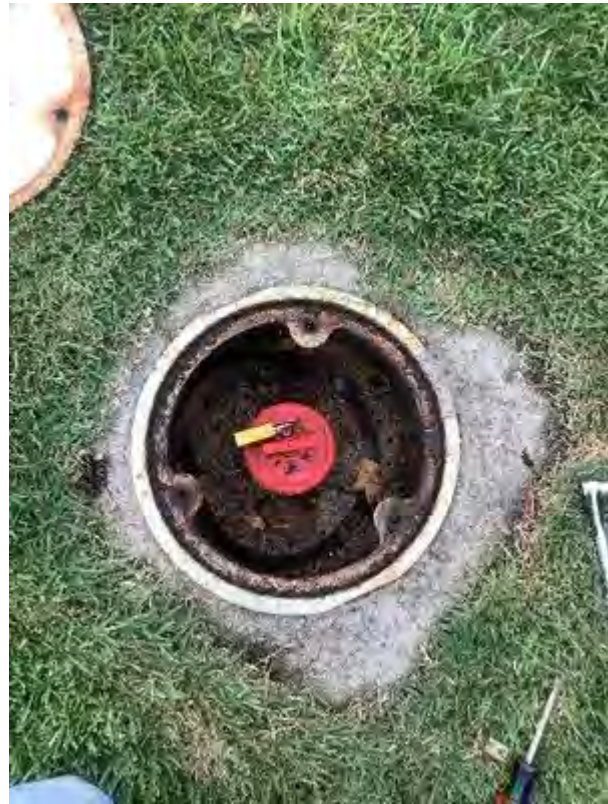
Client: Navy CLEAN	Facility: NWIRP Bethpage
Project Number: 112G08005-WE13	Location: Bethpage, New York
Date: September 22, 2021 13:49	Personnel: Beau Benfield
Well ID: RE107D2	Well Location: 208558.7 1123830.8
Well Status: Other	Screen Interval: 560-580
WELL INVENTORY CONDITION	
Concrete pad in acceptable condition i.e. no cracks?	YES
Manhole cover present and in working condition?	YES
All bolts on manhole present and not stripped?	YES
Well plug present, locked and in good working condition?	YES
OVERALL CONDITION:	GOOD
Notes (Explain if answered No to any of the above)

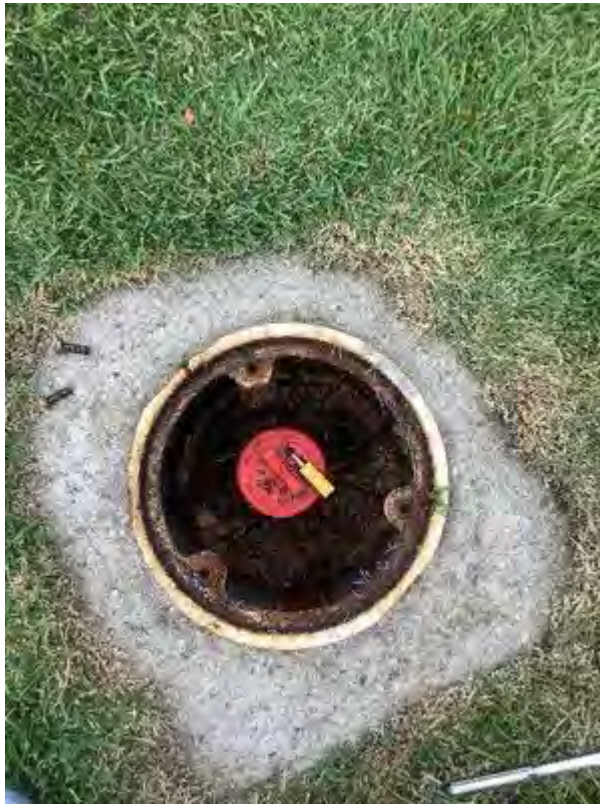
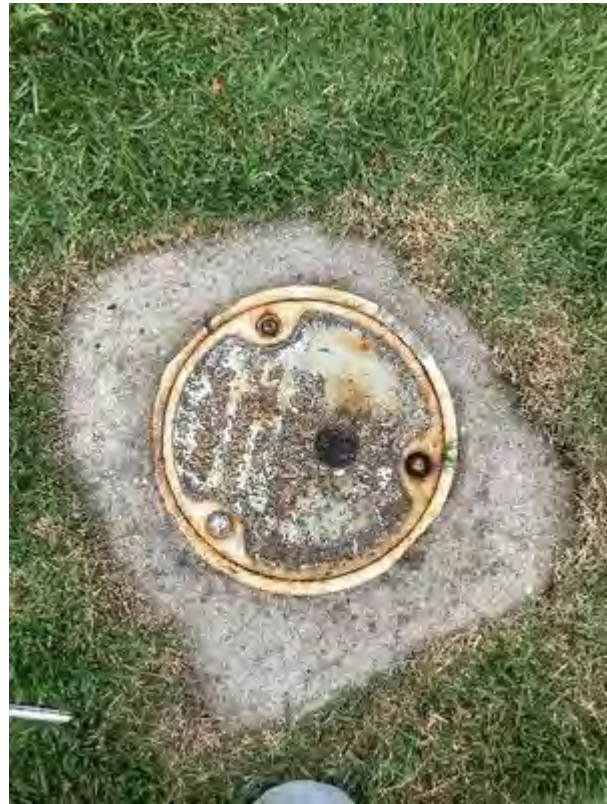
Client: Navy CLEAN	Facility: NWIRP Bethpage
Project Number: 112G08005-WE13	Location: Bethpage, New York
Date: September 22, 2021 13:45	Personnel: Beau Benfield
Well ID: RE107D1	Well Location: 208546.42 1123823.36
Well Status: Other	Screen Interval: 505-525
WELL INVENTORY CONDITION	
Concrete pad in acceptable condition i.e. no cracks?	YES
Manhole cover present and in working condition?	YES
All bolts on manhole present and not stripped?	YES
Well plug present, locked and in good working condition?	YES
OVERALL CONDITION:	GOOD
Notes (Explain if answered No to any of the above)

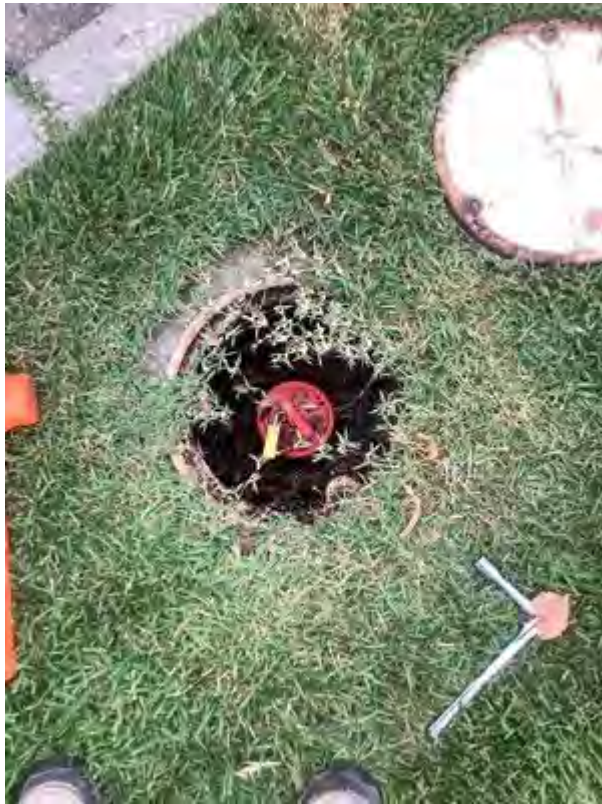
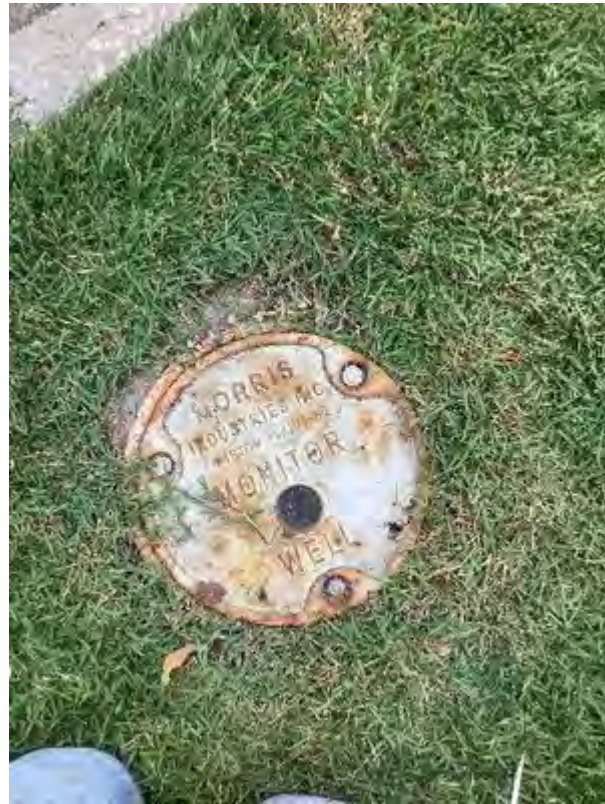
Client: Navy CLEAN	Facility: NWIRP Bethpage
Project Number: 112G08005-WE13	Location: Bethpage, New York
Date: September 22, 2021 13:41	Personnel: Beau Benfield
Well ID: RE107D3	Well Location: 208495.32 1123759.78
Well Status: Other	Screen Interval: 645-665
WELL INVENTORY CONDITION	
Concrete pad in acceptable condition i.e. no cracks?	YES
Manhole cover present and in working condition?	YES
All bolts on manhole present and not stripped?	YES
Well plug present, locked and in good working condition?	YES
OVERALL CONDITION:	GOOD
Notes (Explain if answered No to any of the above)

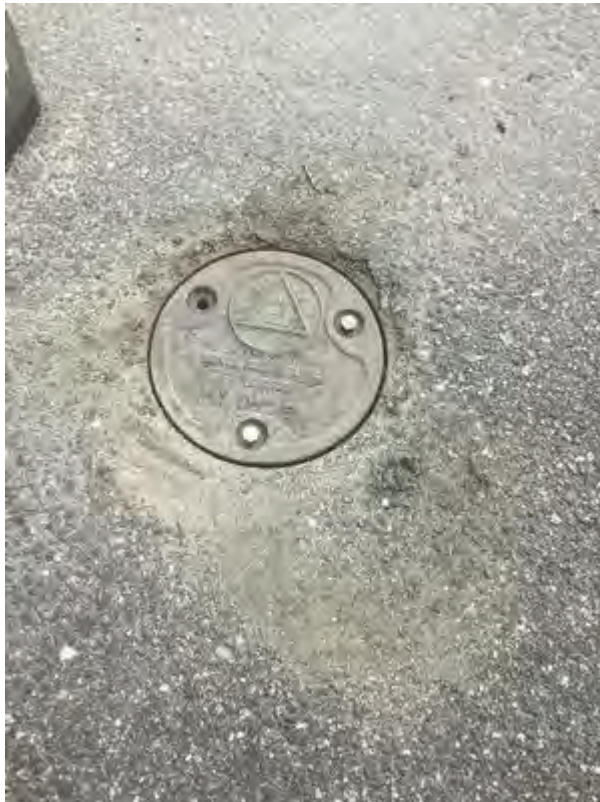
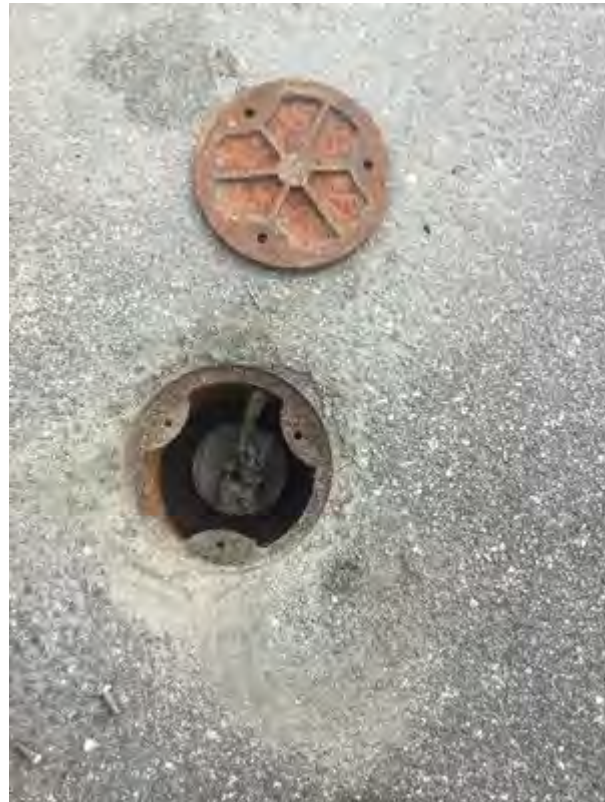
Client: Navy CLEAN	Facility: NWIRP Bethpage
Project Number: 112G08005-WE13	Location: Bethpage, New York
Date: September 22, 2021 13:42	Personnel: Noah Sprouse
Well ID: BPTTAOC22MW03	Well Location: 214146.208333 1123683.95833
Well Status: Other	Screen Interval: 45.5-65.5
WELL INVENTORY CONDITION	
Concrete pad in acceptable condition i.e. no cracks?	YES
Manhole cover present and in working condition?	YES
All bolts on manhole present and not stripped?	NO
Well plug present, locked and in good working condition?	YES
OVERALL CONDITION:	FAIR
Notes (Explain if answered No to any of the above) Missing one bolt, missing rubber gasket.

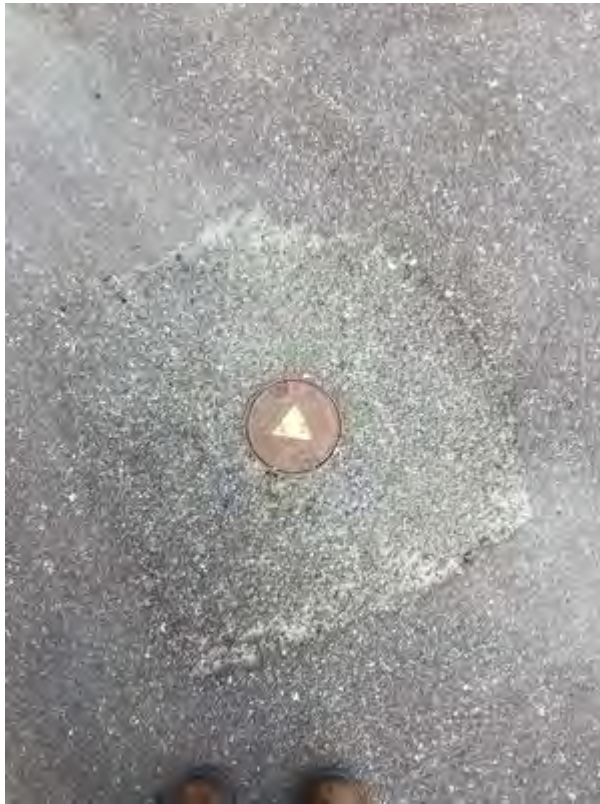
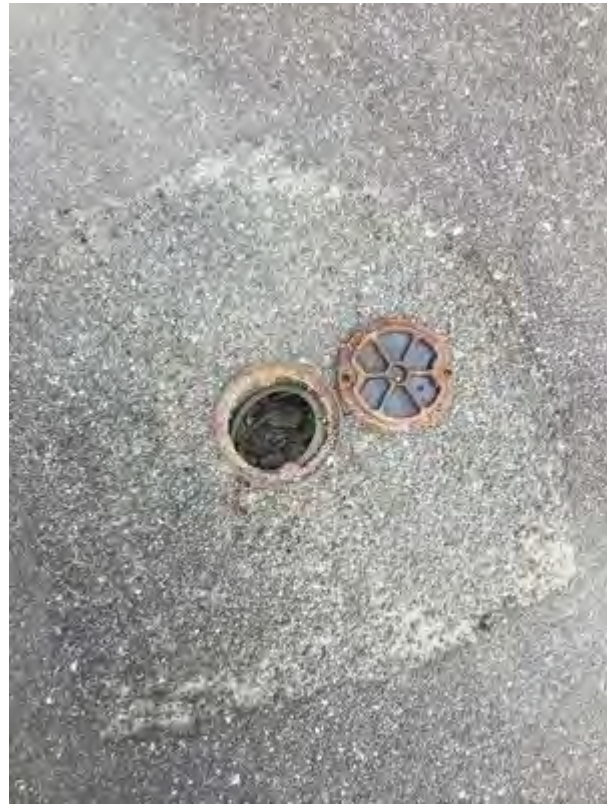
Client: Navy CLEAN	Facility: NWIRP Bethpage
Project Number: 112G08005-WE13	Location: Bethpage, New York
Date: September 22, 2021 13:39	Personnel: Noah Sprouse
Well ID: BPTTAOC22MW05	Well Location: 214173 1123702
Well Status: Abandoned	Screen Interval: 47-67
WELL INVENTORY CONDITION	
Concrete pad in acceptable condition i.e. no cracks?	YES
Manhole cover present and in working condition?	YES
All bolts on manhole present and not stripped?	NO
Well plug present, locked and in good working condition?	NO
OVERALL CONDITION:	POOR
Notes (Explain if answered No to any of the above) Abandoned well, missing rubber gasket, missing all two bolts.

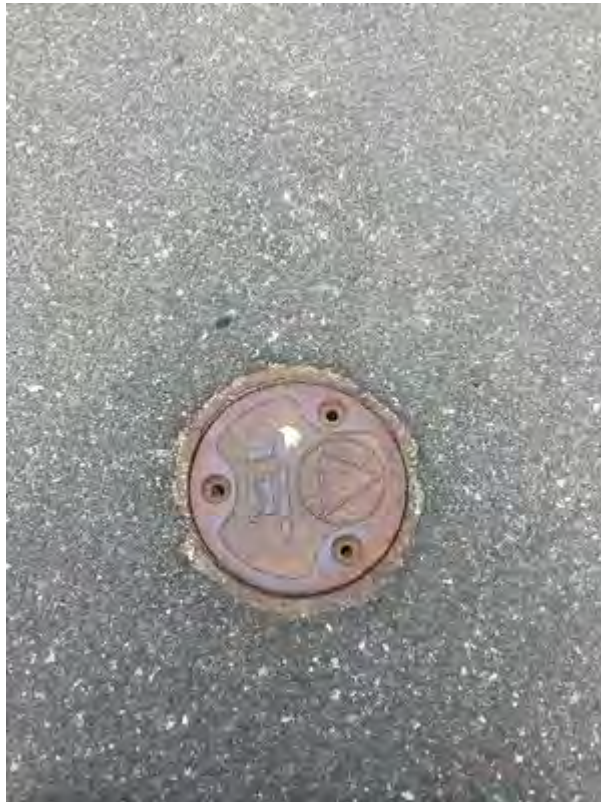
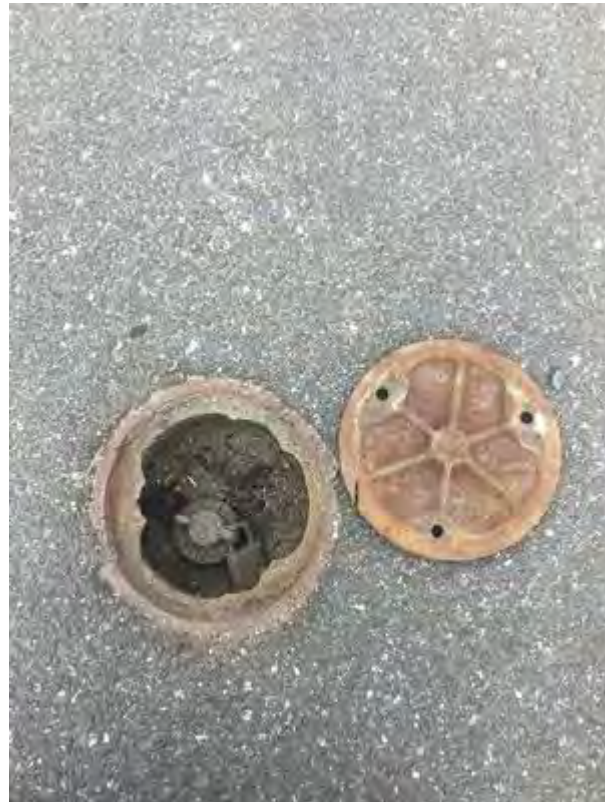
Client: Navy CLEAN	Facility: NWIRP Bethpage
Project Number: 112G08005-WE13	Location: Bethpage, New York
Date: September 22, 2021 13:35	Personnel: Noah Sprouse
Well ID: BPTTAOC22MW11	Well Location: 214145.28085 1123547.94787
Well Status: Other	Screen Interval: 53-63
WELL INVENTORY CONDITION	
Concrete pad in acceptable condition i.e. no cracks?	YES
Manhole cover present and in working condition?	YES
All bolts on manhole present and not stripped?	NO
Well plug present, locked and in good working condition?	YES
OVERALL CONDITION:	FAIR
Notes (Explain if answered No to any of the above) Missing three bolts, missing rubber gasket.

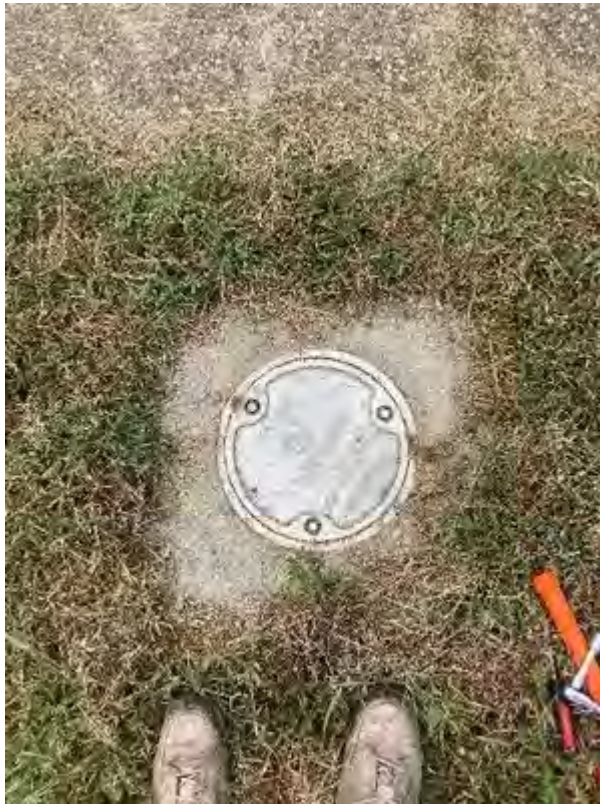
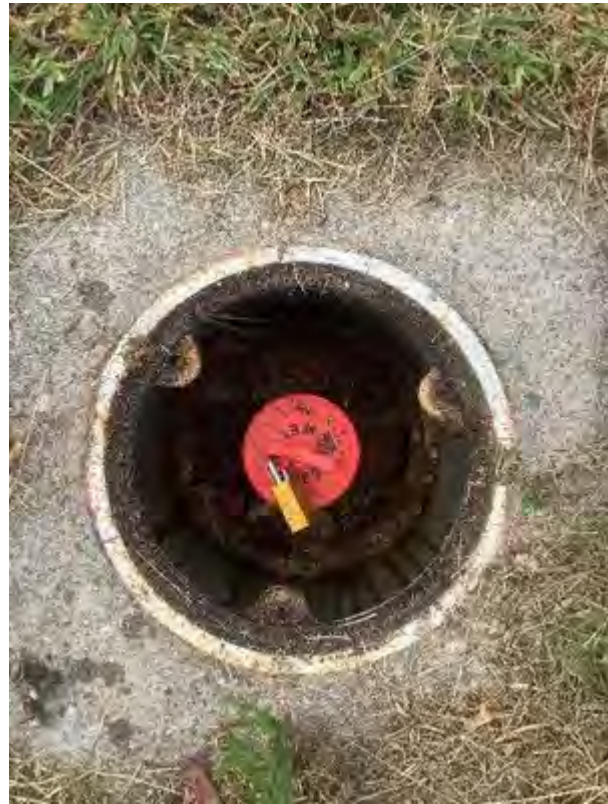
Client: Navy CLEAN	Facility: NWIRP Bethpage
Project Number: 112G08005-WE13	Location: Bethpage, New York
Date: September 22, 2021 13:32	Personnel: Beau Benfield
Well ID: RE106D2	Well Location: 209390.528269 1122872.74612
Well Status: Other	Screen Interval: 480-490
WELL INVENTORY CONDITION	
Concrete pad in acceptable condition i.e. no cracks?	YES
Manhole cover present and in working condition?	YES
All bolts on manhole present and not stripped?	YES
Well plug present, locked and in good working condition?	YES
OVERALL CONDITION:	GOOD
Notes (Explain if answered No to any of the above)

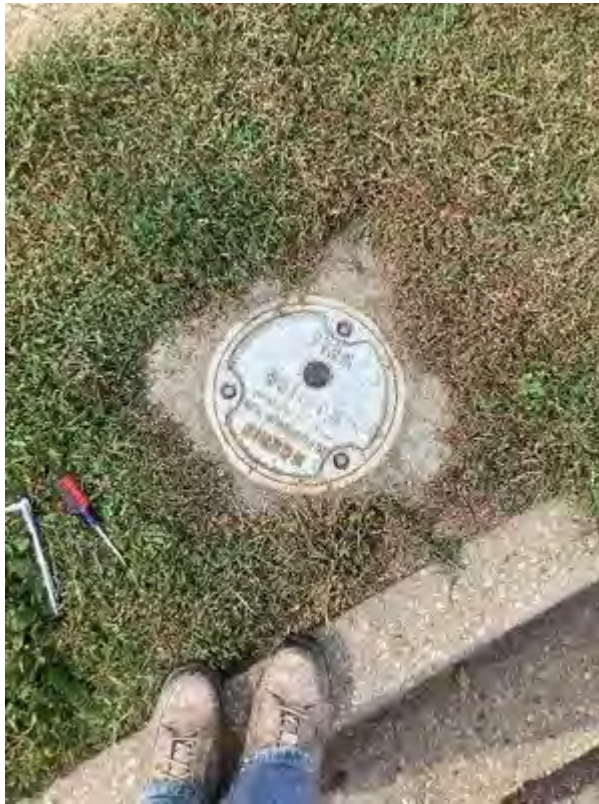
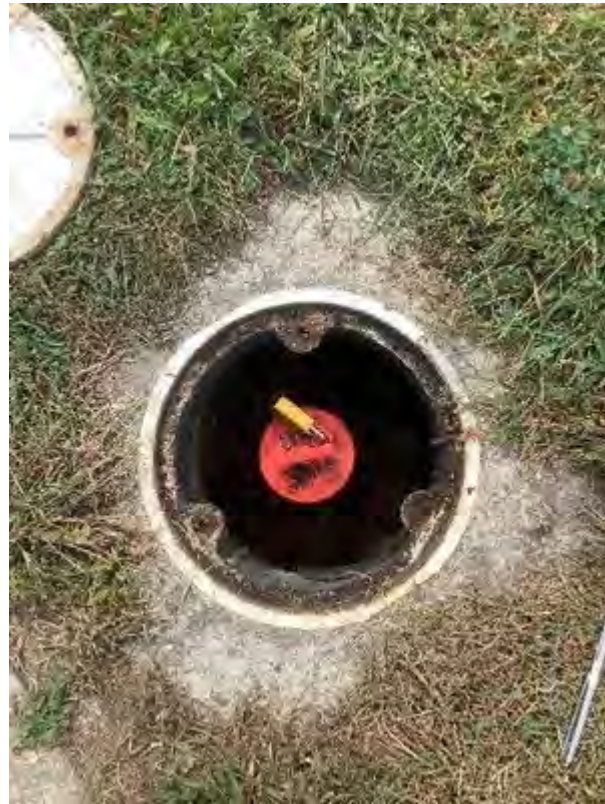
Client: Navy CLEAN	Facility: NWIRP Bethpage
Project Number: 112G08005-WE13	Location: Bethpage, New York
Date: September 22, 2021 13:29	Personnel: Beau Benfield
Well ID: RE106D1	Well Location: 209375.211689 1122871.78883
Well Status: Other	Screen Interval: 440-460
WELL INVENTORY CONDITION	
Concrete pad in acceptable condition i.e. no cracks?	YES
Manhole cover present and in working condition?	YES
All bolts on manhole present and not stripped?	YES
Well plug present, locked and in good working condition?	YES
OVERALL CONDITION:	GOOD
Notes (Explain if answered No to any of the above)

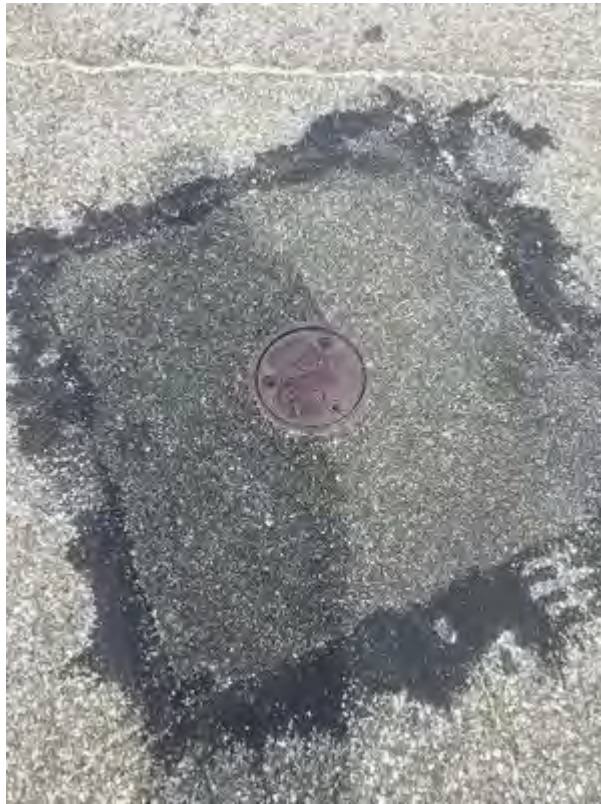
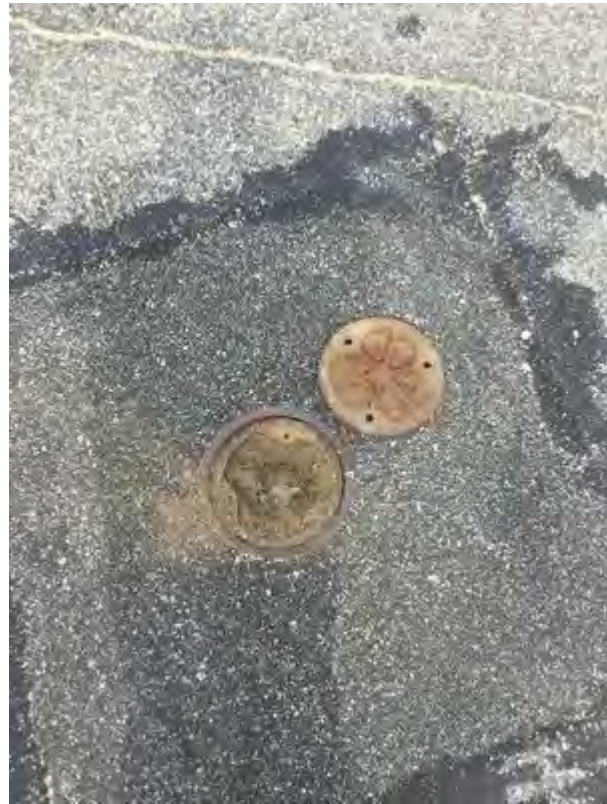
Client: Navy CLEAN	Facility: NWIRP Bethpage
Project Number: 112G08005-WE13	Location: Bethpage, New York
Date: September 22, 2021 13:27	Personnel: Will Yeung
Well ID: BPTTAOC22MW10	Well Location: 213950.533507 1123833.5788
Well Status: Other	Screen Interval: 49-59
WELL INVENTORY CONDITION	
Concrete pad in acceptable condition i.e. no cracks?	YES
Manhole cover present and in working condition?	YES
All bolts on manhole present and not stripped?	NO
Well plug present, locked and in good working condition?	YES
OVERALL CONDITION:	FAIR
Notes (Explain if answered No to any of the above) Missing all three bolts.

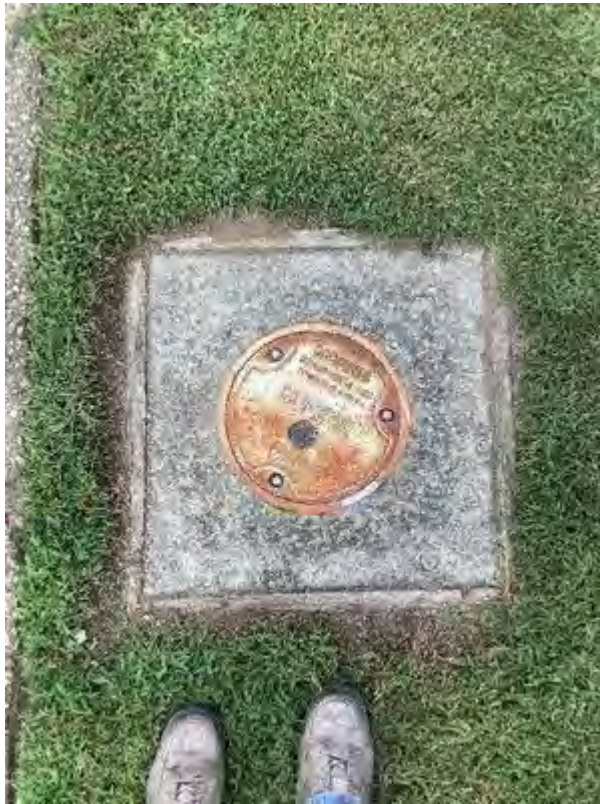
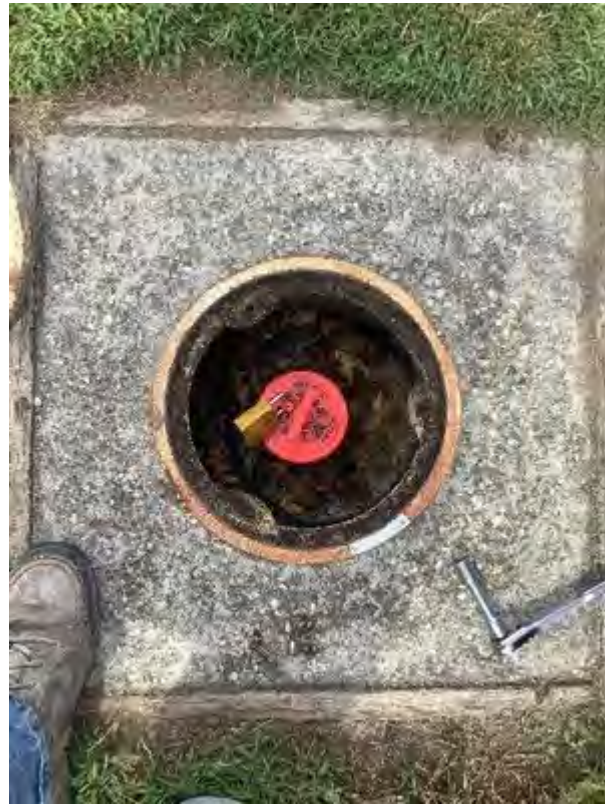
Client: Navy CLEAN	Facility: NWIRP Bethpage
Project Number: 112G08005-WE13	Location: Bethpage, New York
Date: September 22, 2021 13:25	Personnel: Beau Benfield
Well ID: RE106D3	Well Location: 209335.962952 1122868.91698
Well Status: Other	Screen Interval: 510-530
WELL INVENTORY CONDITION	
Concrete pad in acceptable condition i.e. no cracks?	YES
Manhole cover present and in working condition?	YES
All bolts on manhole present and not stripped?	YES
Well plug present, locked and in good working condition?	YES
OVERALL CONDITION:	GOOD
Notes (Explain if answered No to any of the above)

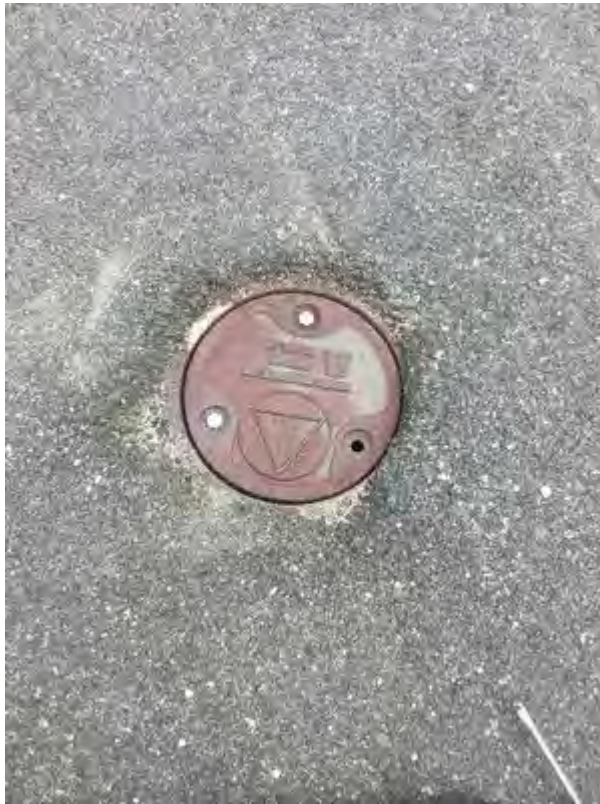
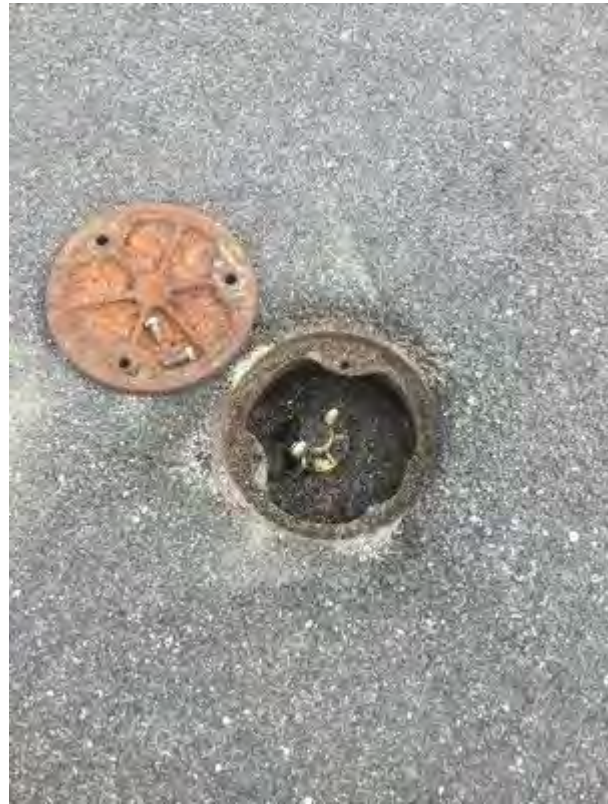
Client: Navy CLEAN	Facility: NWIRP Bethpage
Project Number: 112G08005-WE13	Location: Bethpage, New York
Date: September 22, 2021 13:23	Personnel: Noah Sprouse
Well ID: BPTTAOC22MW06	Well Location: 213898.349824 1123746.01449
Well Status: Other	Screen Interval: 52-62
WELL INVENTORY CONDITION	
Concrete pad in acceptable condition i.e. no cracks?	YES
Manhole cover present and in working condition?	YES
All bolts on manhole present and not stripped?	NO
Well plug present, locked and in good working condition?	YES
OVERALL CONDITION:	FAIR
Notes (Explain if answered No to any of the above) Both bolts stripped, missing one bolt, missing rubber gasket.

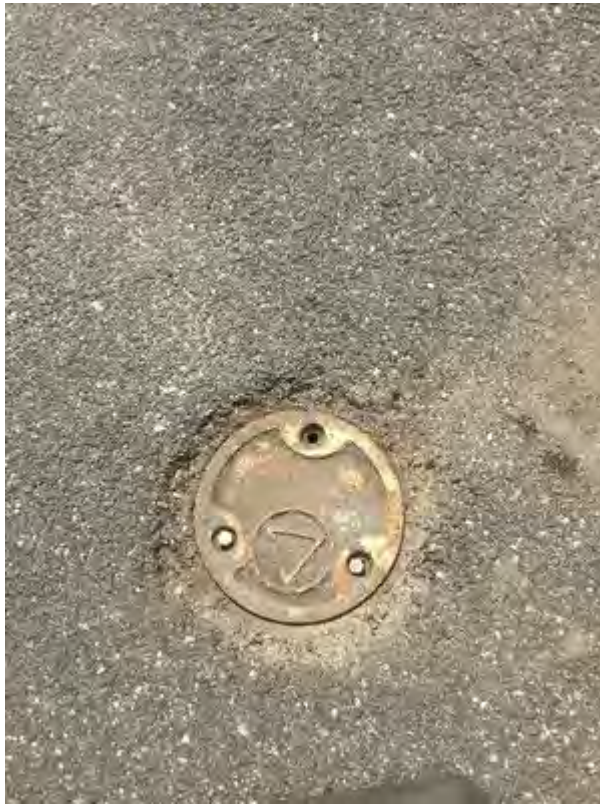
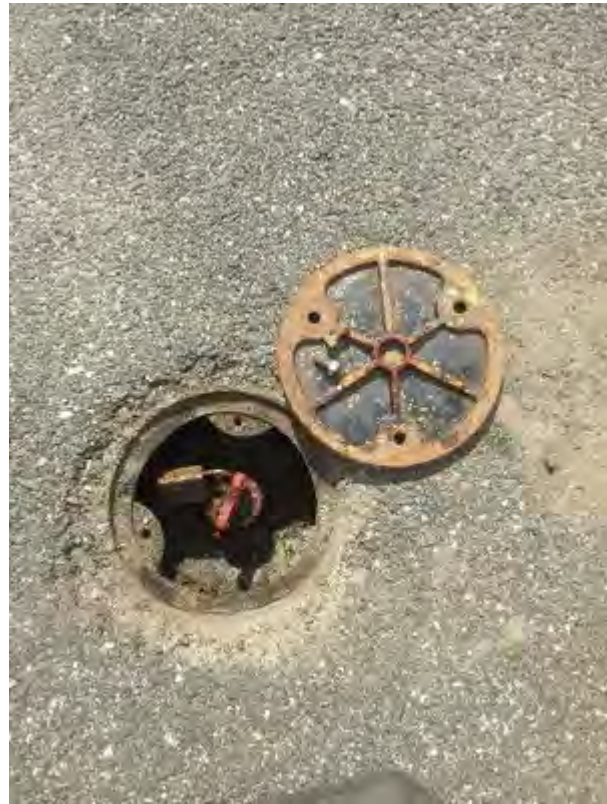
Client: Navy CLEAN	Facility: NWIRP Bethpage
Project Number: 112G08005-WE13	Location: Bethpage, New York
Date: September 22, 2021 13:18	Personnel: Noah Sprouse
Well ID: BPTTAOC22MW07	Well Location: 213883.666163 1123660.8565
Well Status: Other	Screen Interval: 52-62
WELL INVENTORY CONDITION	
Concrete pad in acceptable condition i.e. no cracks?	YES
Manhole cover present and in working condition?	YES
All bolts on manhole present and not stripped?	NO
Well plug present, locked and in good working condition?	YES
OVERALL CONDITION:	FAIR
Notes (Explain if answered No to any of the above) Missing one bolt.

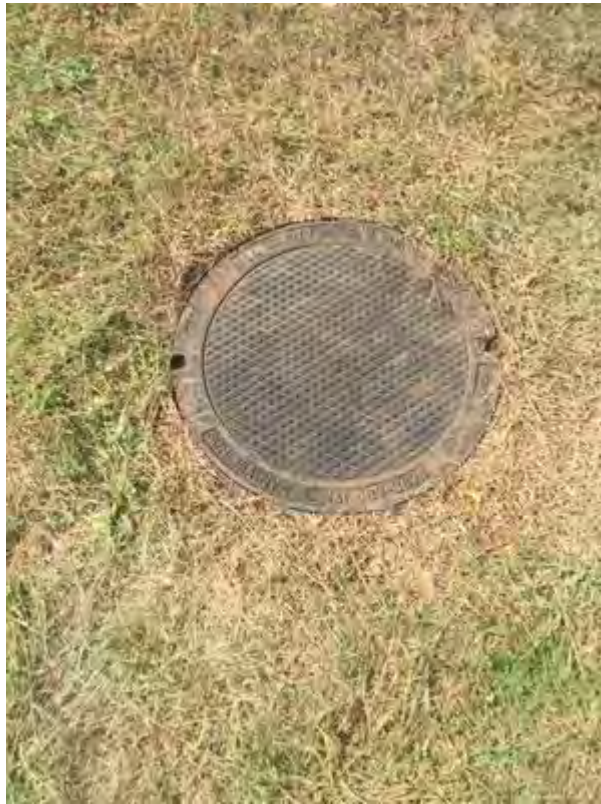
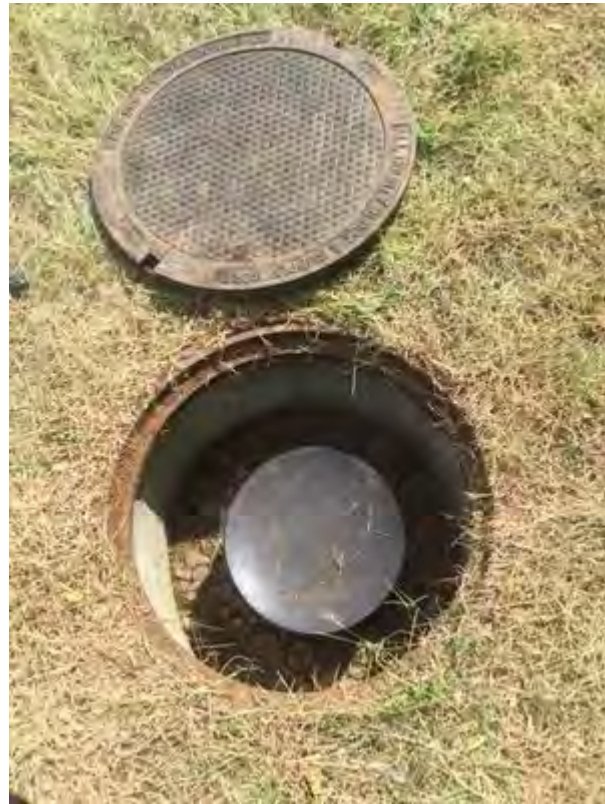
Client: Navy CLEAN	Facility: NWIRP Bethpage
Project Number: 112G08005-WE13	Location: Bethpage, New York
Date: September 22, 2021 13:07	Personnel: Vince Shickora
Well ID: RE137	Well Location: 204415.52776 1125691.57156
Well Status: Other	Screen Interval:
WELL INVENTORY CONDITION	
Concrete pad in acceptable condition i.e. no cracks?	YES
Manhole cover present and in working condition?	YES
All bolts on manhole present and not stripped?	NO
Well plug present, locked and in good working condition?	YES
OVERALL CONDITION:	GOOD
Notes (Explain if answered No to any of the above) No bolts. Well has manhole cover. No lock present on well cover. Slip fit well cover installed.

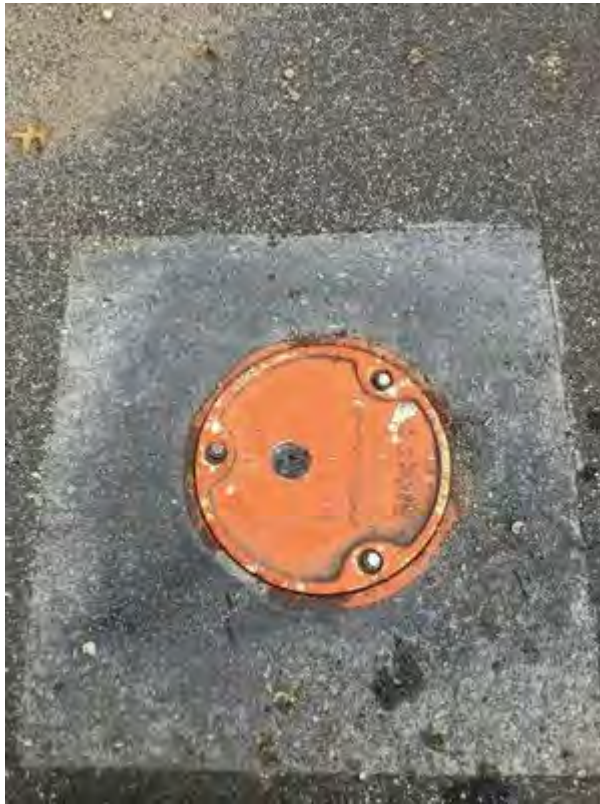
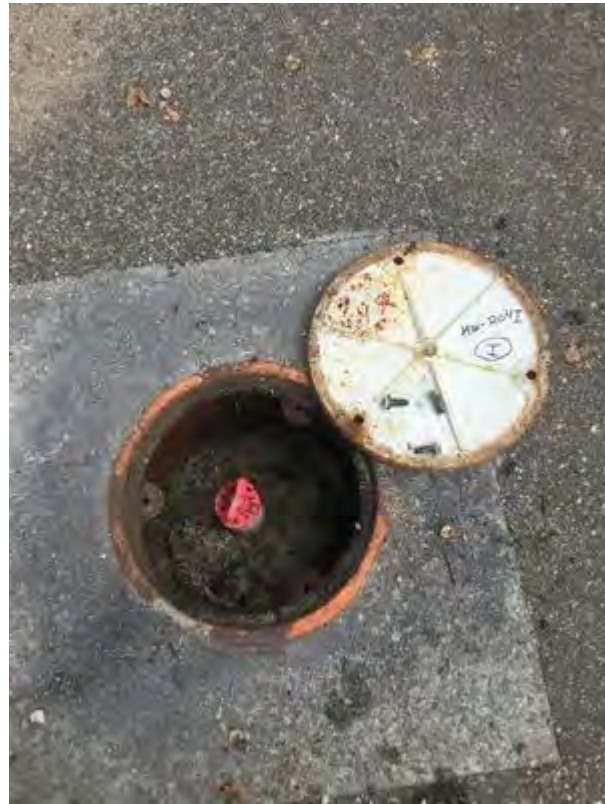
Client: Navy CLEAN	Facility: NWIRP Bethpage
Project Number: 112G08005-WE13	Location: Bethpage, New York
Date: September 22, 2021 13:05	Personnel: Noah Sprouse
Well ID: BP-TT-MW204I	Well Location: 214590.42848 1123023.60859
Well Status: Other	Screen Interval: 142-152
WELL INVENTORY CONDITION	
Concrete pad in acceptable condition i.e. no cracks?	YES
Manhole cover present and in working condition?	YES
All bolts on manhole present and not stripped?	YES
Well plug present, locked and in good working condition?	YES
OVERALL CONDITION:	GOOD
Notes (Explain if answered No to any of the above)

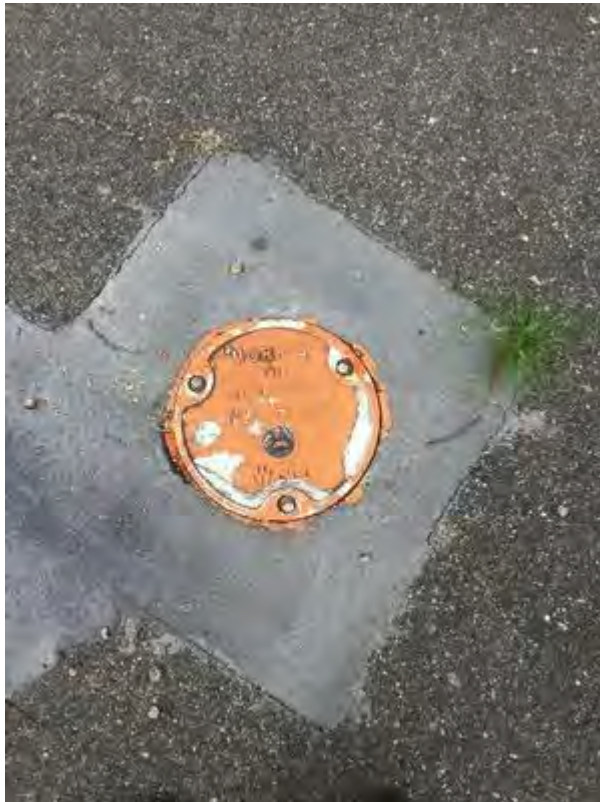
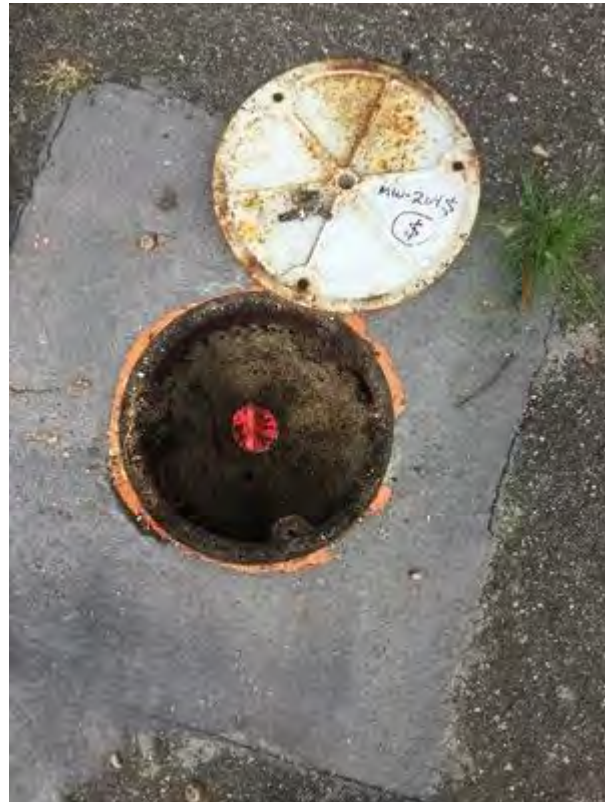
Client: Navy CLEAN	Facility: NWIRP Bethpage
Project Number: 112G08005-WE13	Location: Bethpage, New York
Date: September 22, 2021 12:52	Personnel: Noah Sprouse
Well ID: BP-TT-MW204S	Well Location: 214592.181952 1123034.79783
Well Status: Other	Screen Interval: 50-60
WELL INVENTORY CONDITION	
Concrete pad in acceptable condition i.e. no cracks?	YES
Manhole cover present and in working condition?	YES
All bolts on manhole present and not stripped?	YES
Well plug present, locked and in good working condition?	YES
OVERALL CONDITION:	GOOD
Notes (Explain if answered No to any of the above)

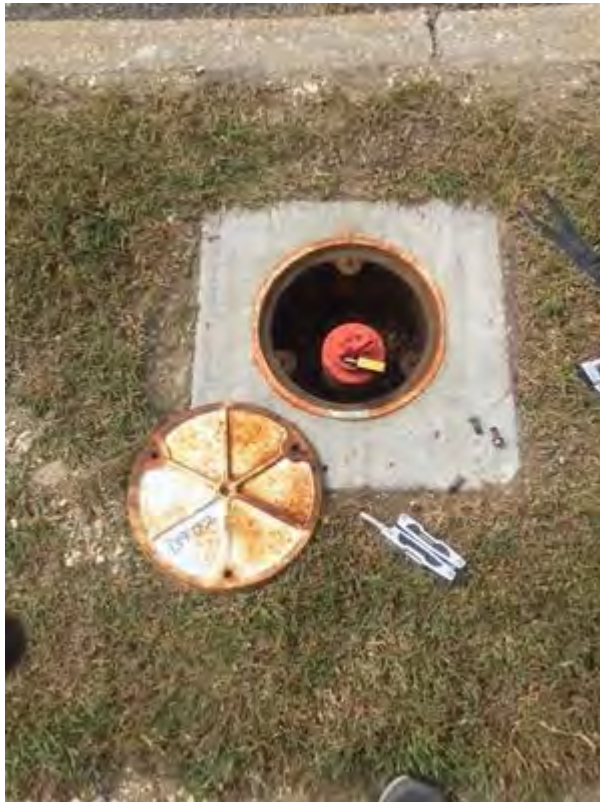
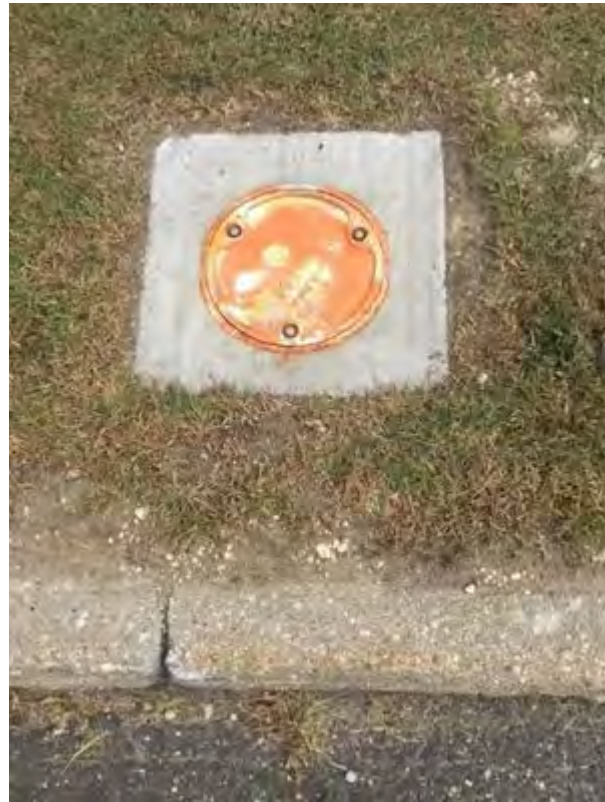
Client: Navy CLEAN	Facility: NWIRP Bethpage
Project Number: 112G08005-WE13	Location: Bethpage, New York
Date: September 22, 2021 12:46	Personnel: Vince Shickora
Well ID: BPOW 3-5 (also known as RE139D2).	Well Location:
Well Status: In Use (Confirmed)	Screen Interval: 740-760
WELL INVENTORY CONDITION	
Concrete pad in acceptable condition i.e. no cracks?	YES
Manhole cover present and in working condition?	YES
All bolts on manhole present and not stripped?	YES
Well plug present, locked and in good working condition?	YES
OVERALL CONDITION:	GOOD
Notes (Explain if answered No to any of the above)

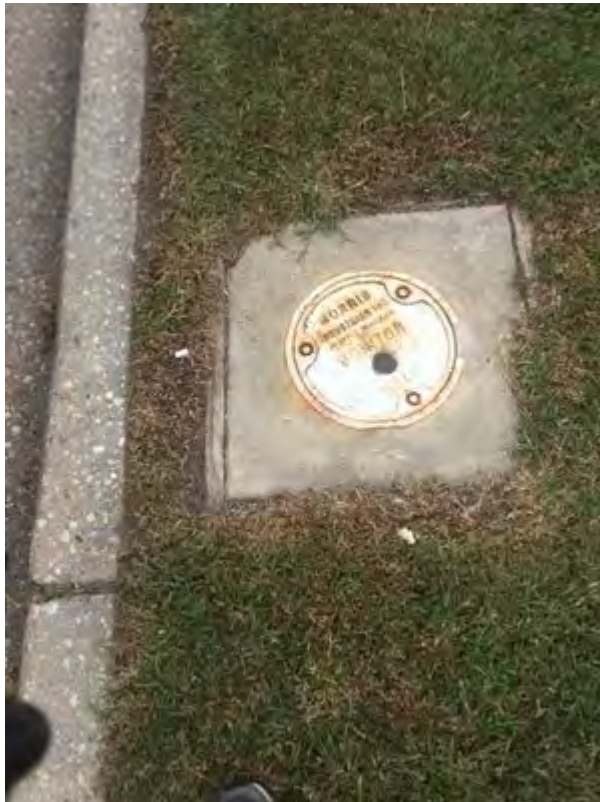
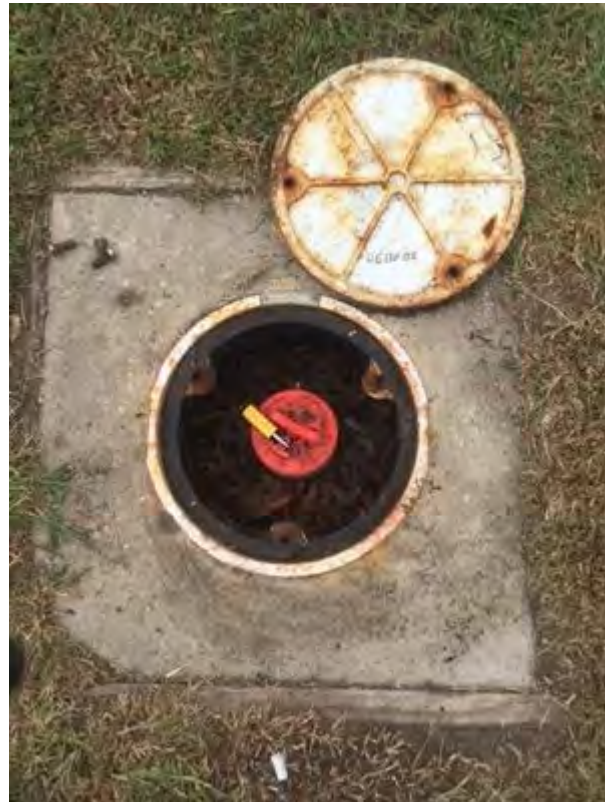
Client: Navy CLEAN	Facility: NWIRP Bethpage
Project Number: 112G08005-WE13	Location: Bethpage, New York
Date: September 22, 2021 12:27	Personnel: Vince Shickora
Well ID: RE130D2	Well Location: 197605.107397 1122370.72401
Well Status: Other	Screen Interval: 640-660
WELL INVENTORY CONDITION	
Concrete pad in acceptable condition i.e. no cracks?	YES
Manhole cover present and in working condition?	YES
All bolts on manhole present and not stripped?	YES
Well plug present, locked and in good working condition?	YES
OVERALL CONDITION:	GOOD
Notes (Explain if answered No to any of the above)

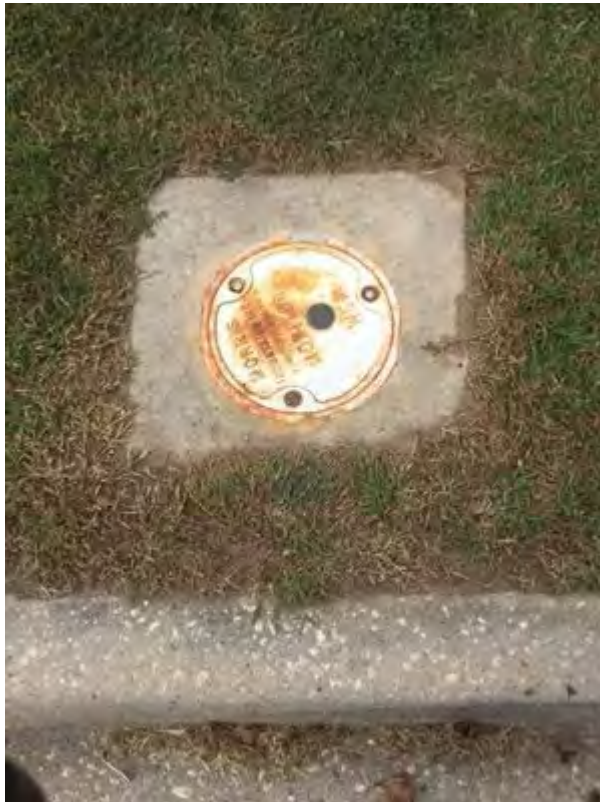
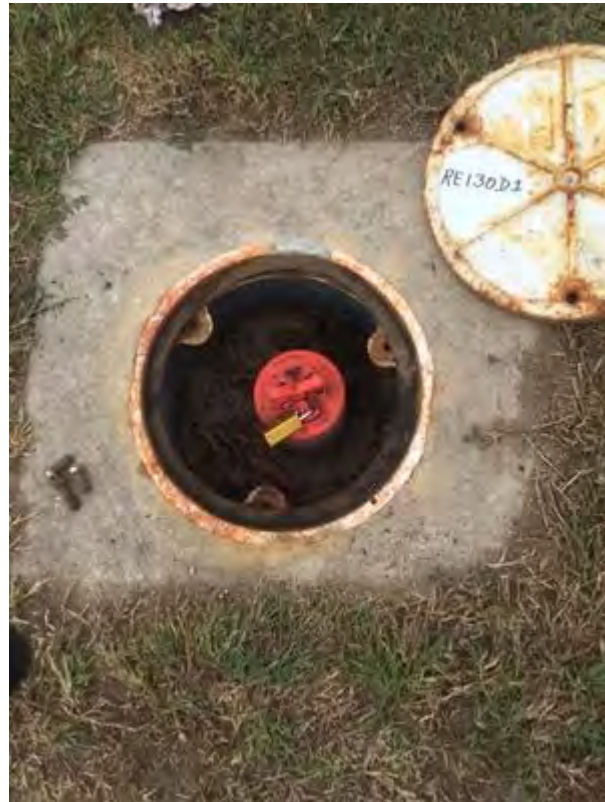
Client: Navy CLEAN	Facility: NWIRP Bethpage
Project Number: 112G08005-WE13	Location: Bethpage, New York
Date: September 22, 2021 12:18	Personnel: Vince Shickora
Well ID: RE130D1	Well Location: 197584.95509 1122360.2922
Well Status: Other	Screen Interval: 555-575
WELL INVENTORY CONDITION	
Concrete pad in acceptable condition i.e. no cracks?	YES
Manhole cover present and in working condition?	YES
All bolts on manhole present and not stripped?	YES
Well plug present, locked and in good working condition?	YES
OVERALL CONDITION:	GOOD
Notes (Explain if answered No to any of the above)

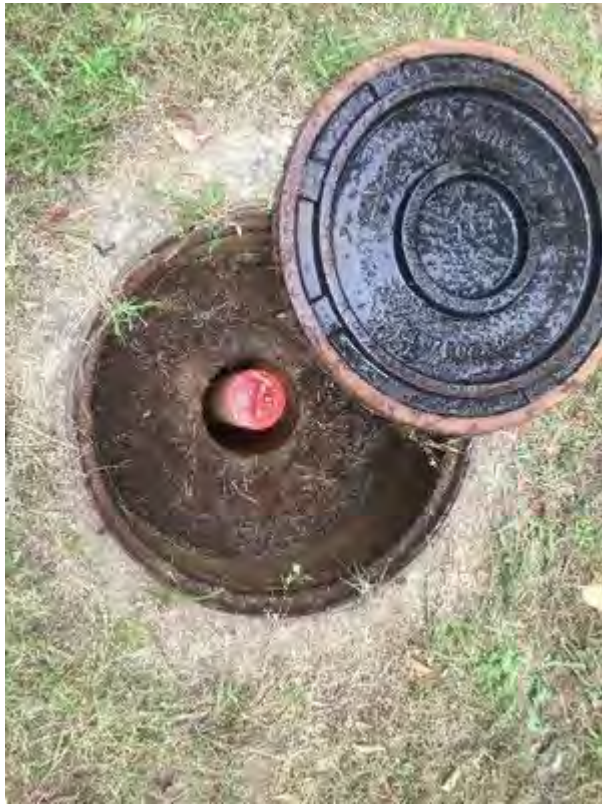
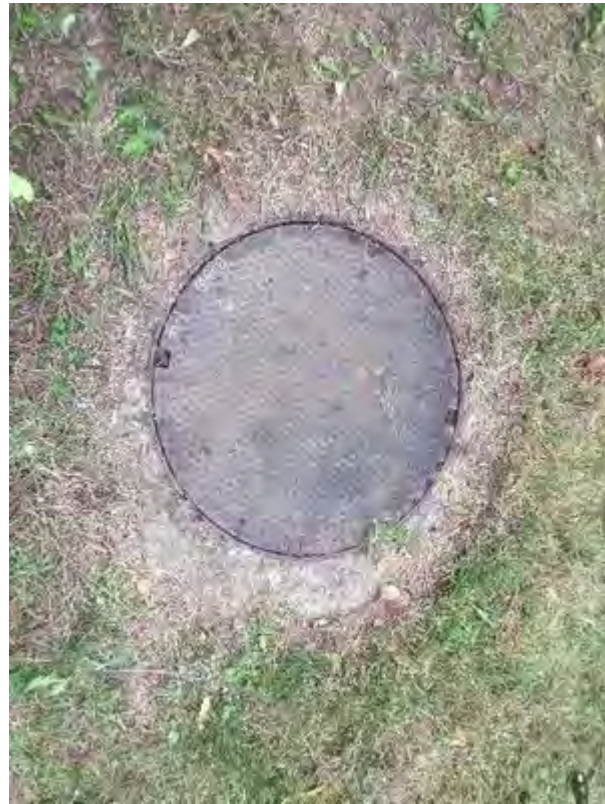
Client: Navy CLEAN	Facility: NWIRP Bethpage
Project Number: 112G08005-WE13	Location: Bethpage, New York
Date: September 22, 2021 12:18	Personnel: Wyatt Bostick
Well ID: BPOW 1-4	Well Location: 203327.989 1132135.673
Well Status: Other	Screen Interval: 340-400
WELL INVENTORY CONDITION	
Concrete pad in acceptable condition i.e. no cracks?	YES
Manhole cover present and in working condition?	YES
All bolts on manhole present and not stripped?	YES
Well plug present, locked and in good working condition?	NO
OVERALL CONDITION:	FAIR
Notes (Explain if answered No to any of the above) Needs 4-5 ft of fill

*All wells in Fair/Poor condition will be repaired and/or addressed prior to the next Annual Well Inventory to the extent practicable

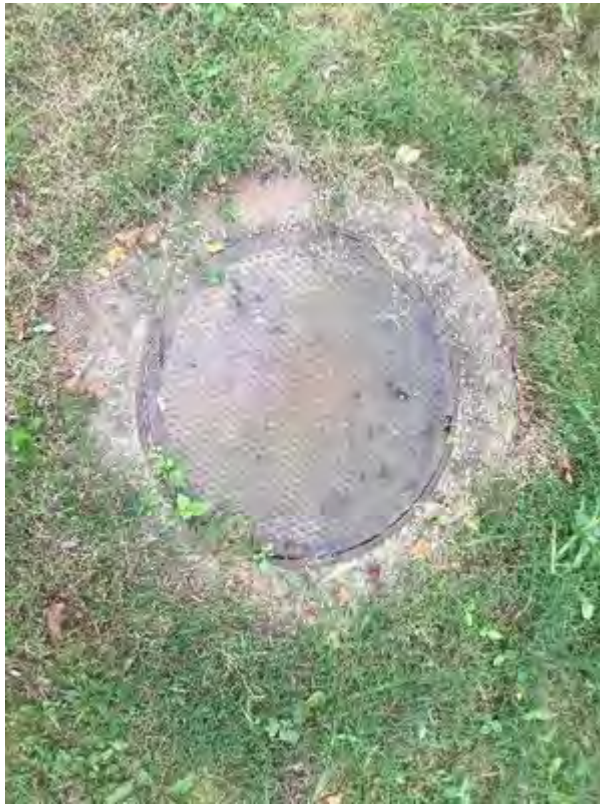
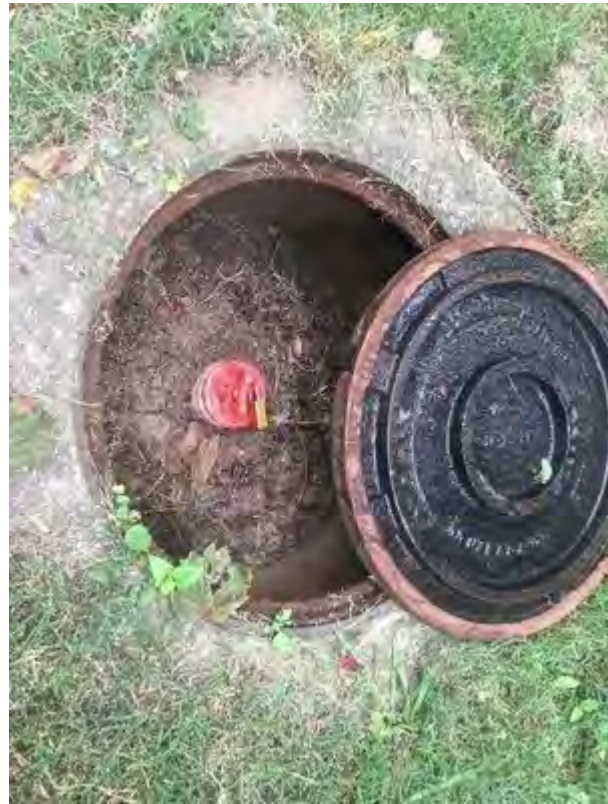
Client: Navy CLEAN	Facility: NWIRP Bethpage
Project Number: 112G08005-WE13	Location: Bethpage, New York
Date: September 22, 2021 12:15	Personnel: Wyatt Bostick
Well ID: BPOW 1-5	Well Location: 203315.538 1132141.261
Well Status: Other	Screen Interval: 600-650
WELL INVENTORY CONDITION	
Concrete pad in acceptable condition i.e. no cracks?	YES
Manhole cover present and in working condition?	YES
All bolts on manhole present and not stripped?	YES
Well plug present, locked and in good working condition?	YES
OVERALL CONDITION:	GOOD
Notes (Explain if answered No to any of the above)
