Memorandum

To: Scot Sokolowski, NAVFAC MIDLANT
From: David Brayack, Tetra Tech
Date: December 30, 2021
Re: Annual LUC Inspection and Operation Summary Report: Sites 1, 2, 3, and 4 – NWIRP Bethpage
Revision 1
Contract/CTO Number: N6247016D9008/WE13

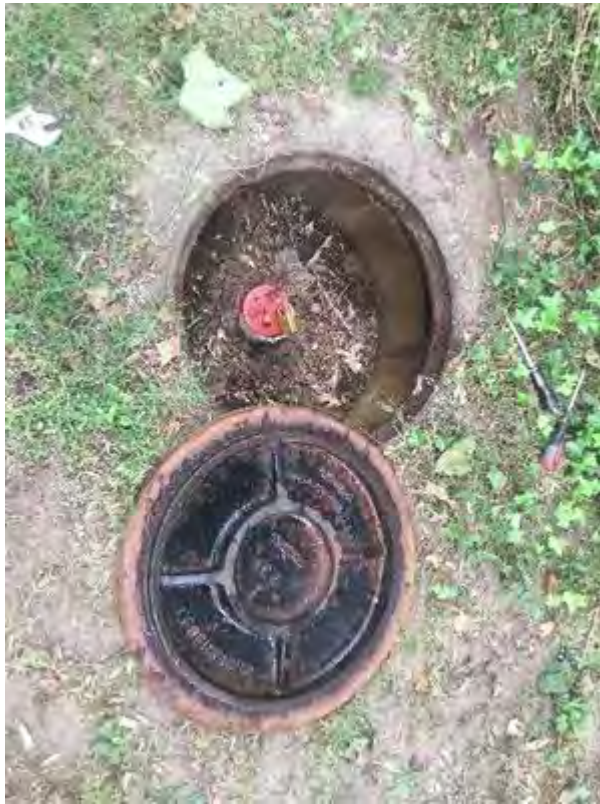
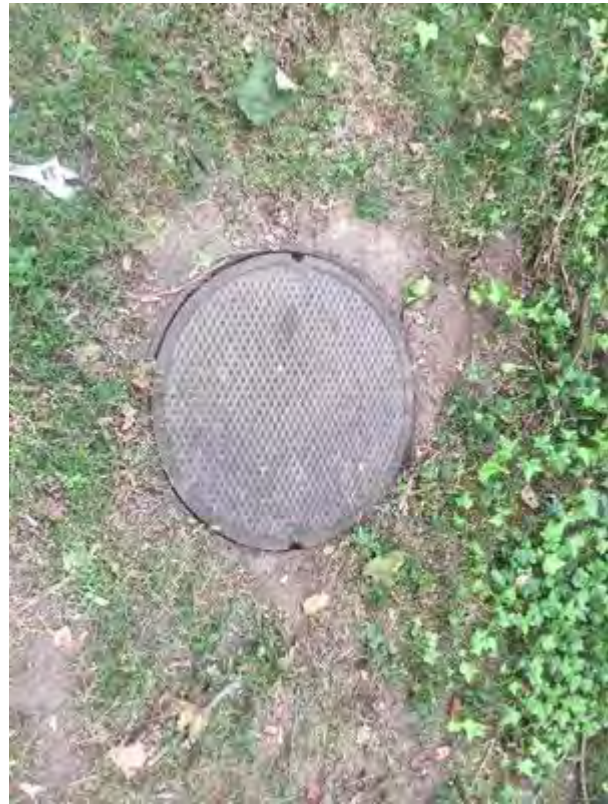
Client: Navy CLEAN	Facility: NWIRP Bethpage
Project Number: 112G08005-WE13	Location: Bethpage, New York
Date: September 22, 2021 12:12	Personnel: Wyatt Bostick
Well ID: BPOW 1-6	Well Location: 203299.025 1132142.003
Well Status: Other	Screen Interval: 700-750
WELL INVENTORY CONDITION	
Concrete pad in acceptable condition i.e. no cracks?	YES
Manhole cover present and in working condition?	YES
All bolts on manhole present and not stripped?	YES
Well plug present, locked and in good working condition?	YES
OVERALL CONDITION:	GOOD
Notes (Explain if answered No to any of the above)

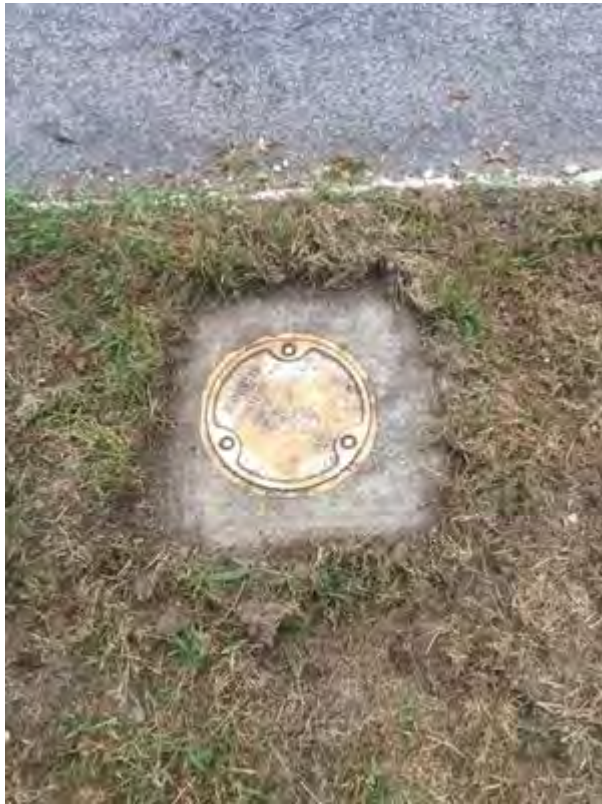
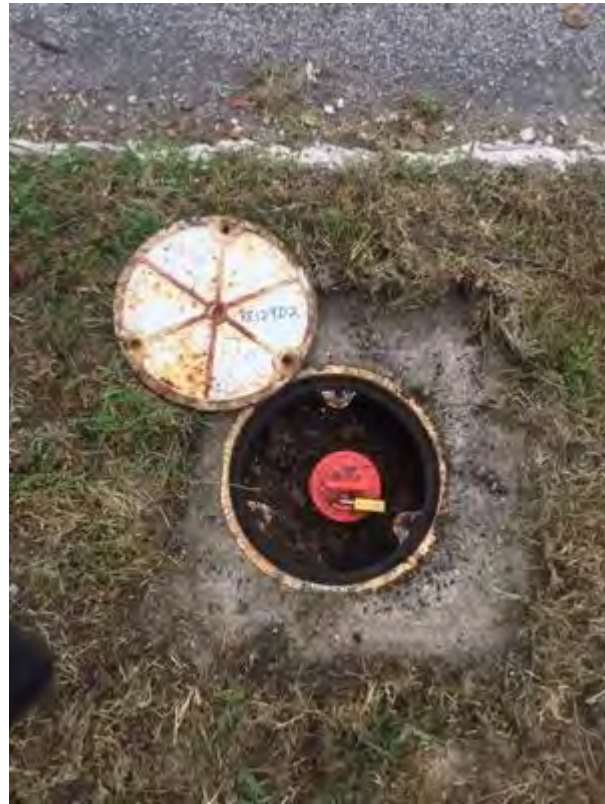
Client: Navy CLEAN	Facility: NWIRP Bethpage
Project Number: 112G08005-WE13	Location: Bethpage, New York
Date: September 22, 2021 11:58	Personnel: Vince Shickora
Well ID: RE129D2	Well Location: 196073.15 1124074.2
Well Status: Other	Screen Interval: 805-825
WELL INVENTORY CONDITION	
Concrete pad in acceptable condition i.e. no cracks?	YES
Manhole cover present and in working condition?	YES
All bolts on manhole present and not stripped?	YES
Well plug present, locked and in good working condition?	YES
OVERALL CONDITION:	GOOD
Notes (Explain if answered No to any of the above)

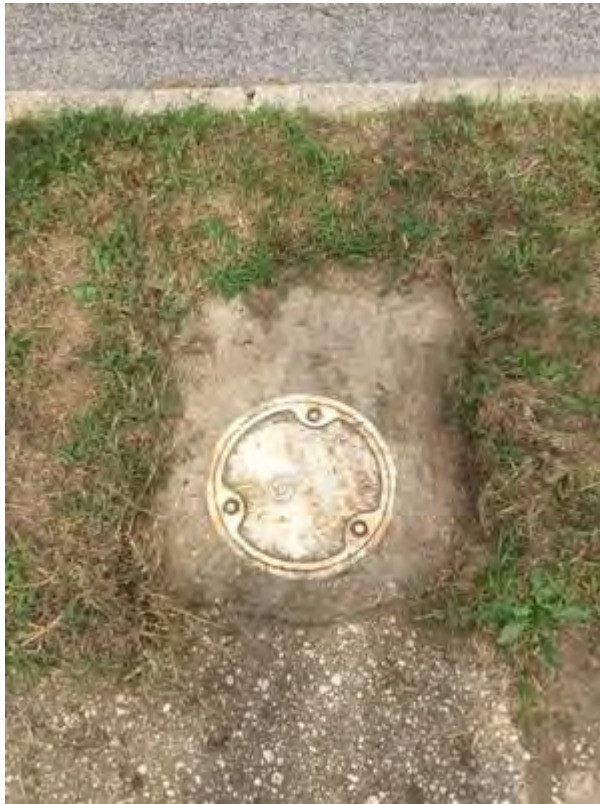
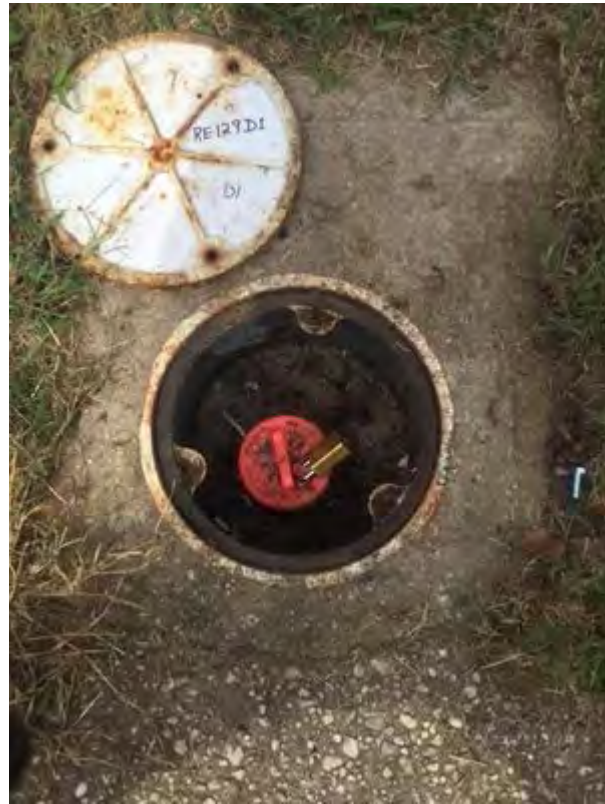
Client: Navy CLEAN	Facility: NWIRP Bethpage
Project Number: 112G08005-WE13	Location: Bethpage, New York
Date: September 22, 2021 11:47	Personnel: Vince Shickora
Well ID: RE129D1	Well Location: 196086.63 1124099.54
Well Status: Other	Screen Interval: 690-710
WELL INVENTORY CONDITION	
Concrete pad in acceptable condition i.e. no cracks?	YES
Manhole cover present and in working condition?	YES
All bolts on manhole present and not stripped?	YES
Well plug present, locked and in good working condition?	YES
OVERALL CONDITION:	GOOD
Notes (Explain if answered No to any of the above)

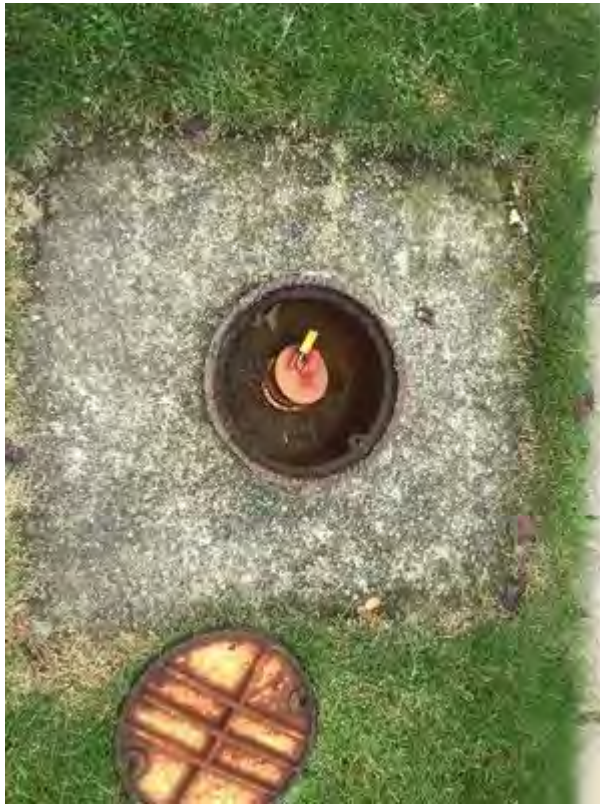
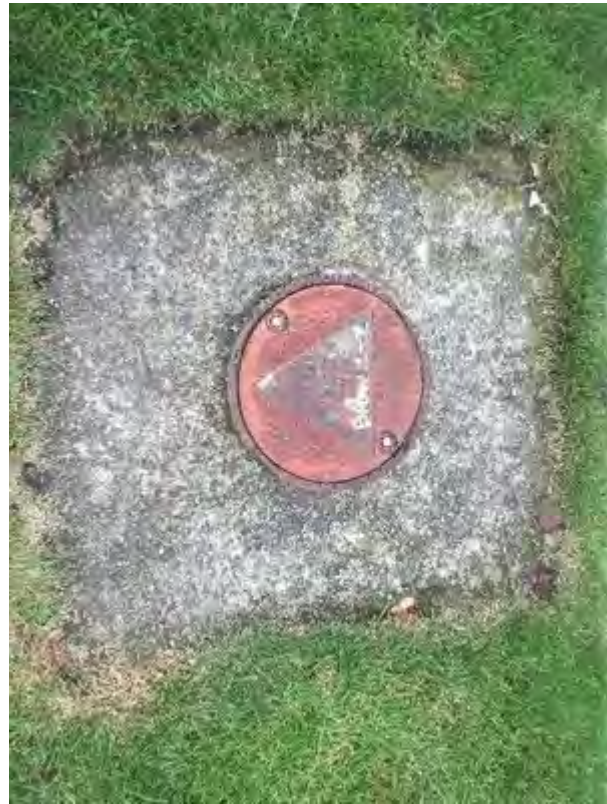
Client: Navy CLEAN	Facility: NWIRP Bethpage
Project Number: 112G08005-WE13	Location: Bethpage, New York
Date: September 22, 2021 11:43	Personnel: Wyatt Bostick
Well ID: BPOW 1-1	Well Location: 202008.734 1132151.643
Well Status: Other	Screen Interval: 196-241
WELL INVENTORY CONDITION	
Concrete pad in acceptable condition i.e. no cracks?	YES
Manhole cover present and in working condition?	YES
All bolts on manhole present and not stripped?	YES
Well plug present, locked and in good working condition?	YES
OVERALL CONDITION:	GOOD
Notes (Explain if answered No to any of the above) Could use new bolts

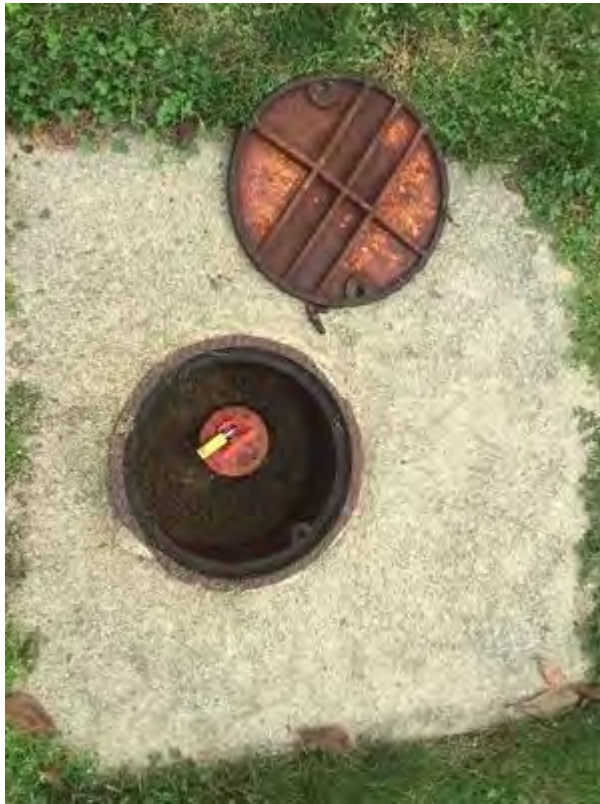
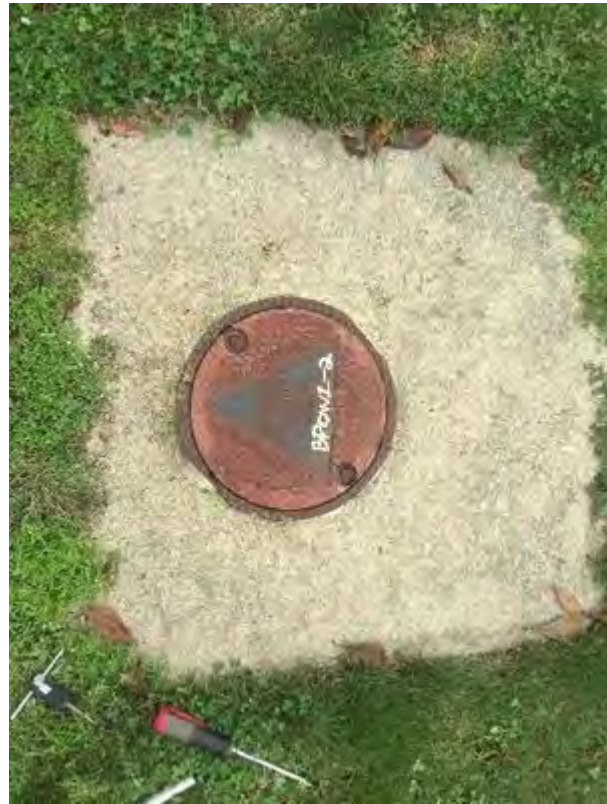
Client: Navy CLEAN	Facility: NWIRP Bethpage
Project Number: 112G08005-WE13	Location: Bethpage, New York
Date: September 22, 2021 11:39	Personnel: Wyatt Bostick
Well ID: BPOW 1-2	Well Location: 202009.697 1132173.169
Well Status: Other	Screen Interval: 310-335
WELL INVENTORY CONDITION	
Concrete pad in acceptable condition i.e. no cracks?	YES
Manhole cover present and in working condition?	YES
All bolts on manhole present and not stripped?	YES
Well plug present, locked and in good working condition?	YES
OVERALL CONDITION:	GOOD
Notes (Explain if answered No to any of the above) Could use new bolts

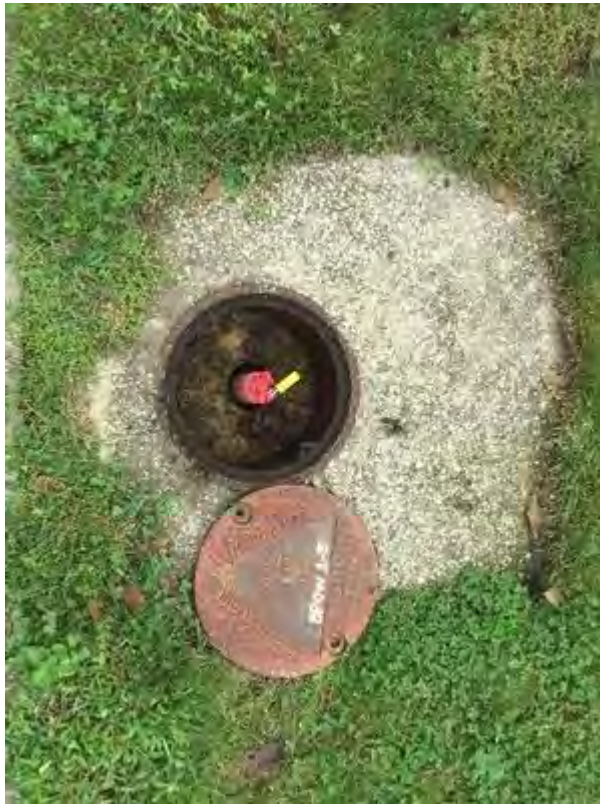
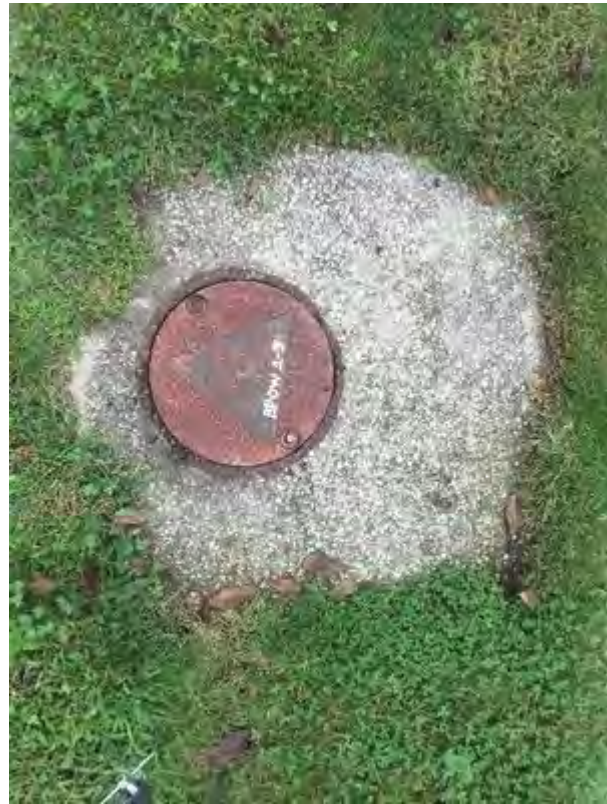
Client: Navy CLEAN	Facility: NWIRP Bethpage
Project Number: 112G08005-WE13	Location: Bethpage, New York
Date: September 22, 2021 11:34	Personnel: Wyatt Bostick
Well ID: BPOW 1-3	Well Location: 202010.024 1132189.152
Well Status: Other	Screen Interval: 374-419
WELL INVENTORY CONDITION	
Concrete pad in acceptable condition i.e. no cracks?	YES
Manhole cover present and in working condition?	YES
All bolts on manhole present and not stripped?	YES
Well plug present, locked and in good working condition?	YES
OVERALL CONDITION:	GOOD
Notes (Explain if answered No to any of the above) Could use new bolts

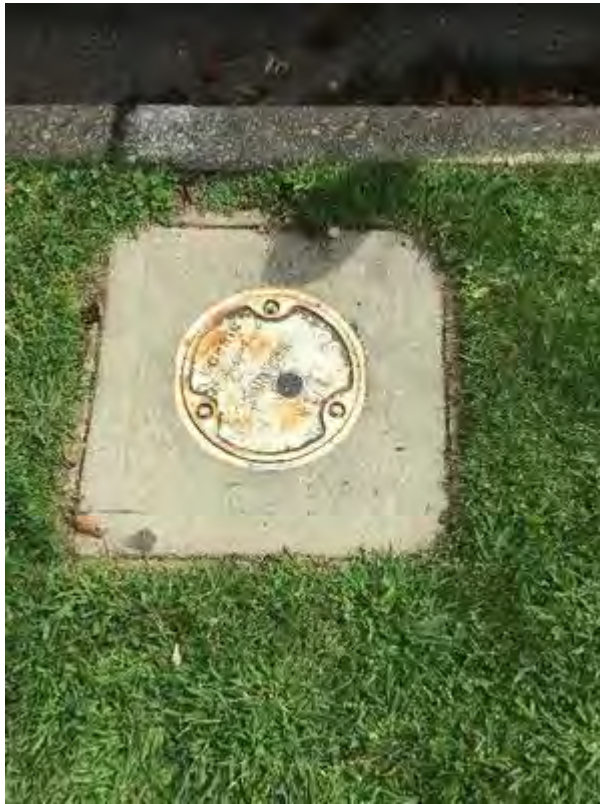
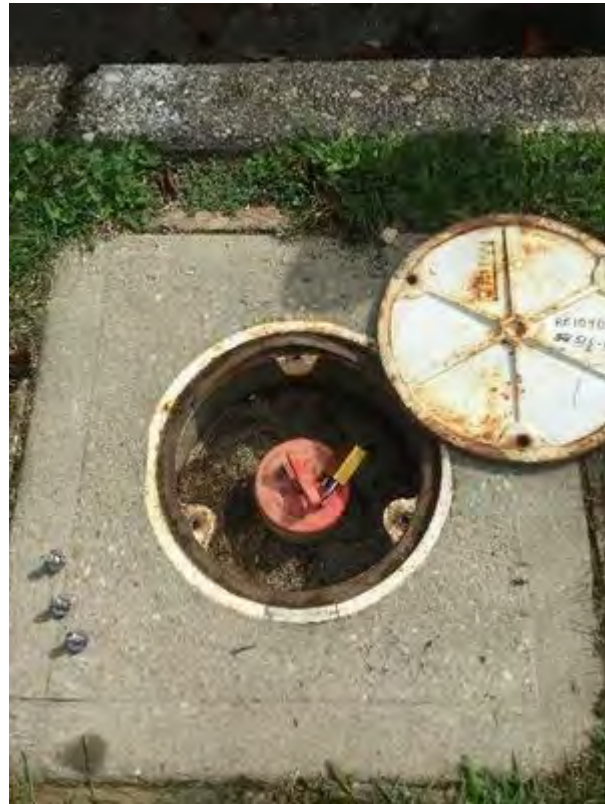
Client: Navy CLEAN	Facility: NWIRP Bethpage
Project Number: 112G08005-WE13	Location: Bethpage, New York
Date: September 22, 2021 11:33	Personnel: Noah Sprouse
Well ID: RE109D1	Well Location: 208538.659716 1126654.17272
Well Status: Other	Screen Interval: 515-535
WELL INVENTORY CONDITION	
Concrete pad in acceptable condition i.e. no cracks?	YES
Manhole cover present and in working condition?	YES
All bolts on manhole present and not stripped?	YES
Well plug present, locked and in good working condition?	YES
OVERALL CONDITION:	GOOD
Notes (Explain if answered No to any of the above)

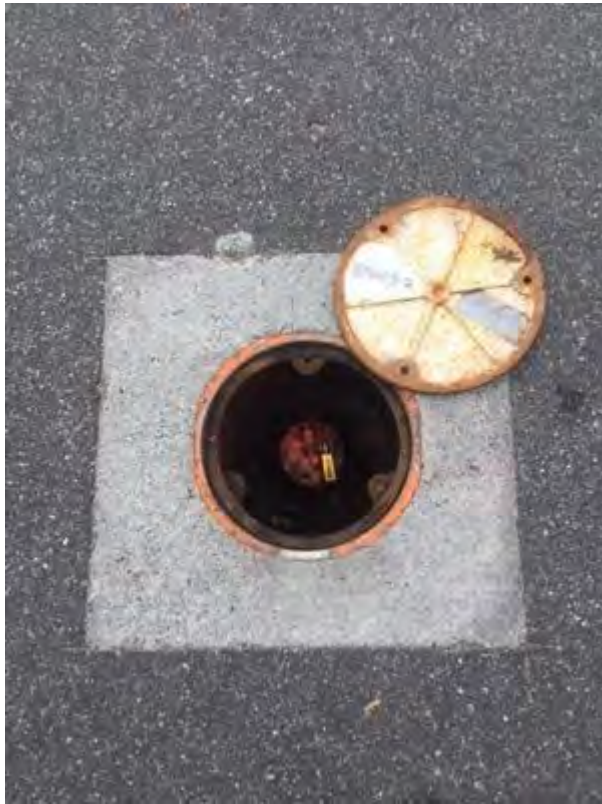
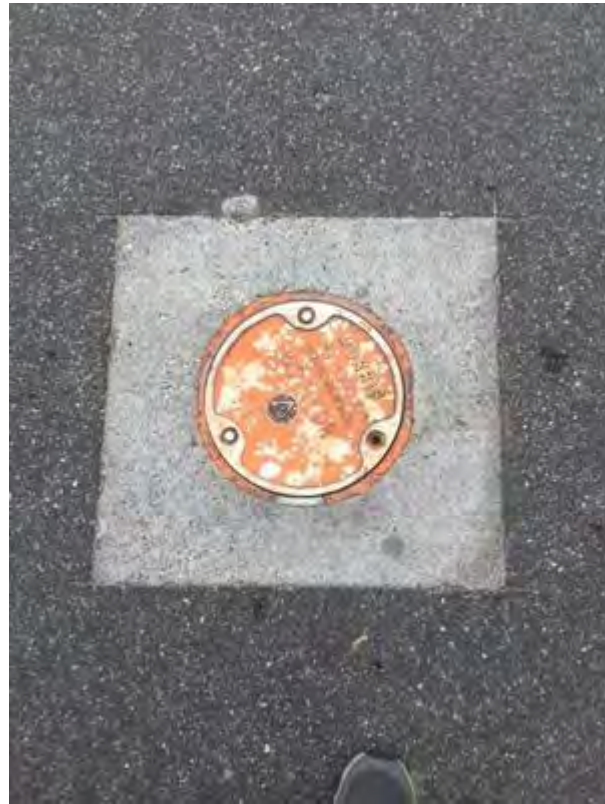
Client: Navy CLEAN	Facility: NWIRP Bethpage
Project Number: 112G08005-WE13	Location: Bethpage, New York
Date: September 22, 2021 11:29	Personnel: Vince Shickora
Well ID: BPOW 5-2	Well Location: 198410.857 1127152.768
Well Status: Other	Screen Interval: 540-580
WELL INVENTORY CONDITION	
Concrete pad in acceptable condition i.e. no cracks?	YES
Manhole cover present and in working condition?	YES
All bolts on manhole present and not stripped?	NO
Well plug present, locked and in good working condition?	YES
OVERALL CONDITION:	FAIR
Notes (Explain if answered No to any of the above) One bolt broken off in threaded ear of flush-mount.

*All wells in Fair/Poor condition will be repaired and/or addressed prior to the next Annual Well Inventory to the extent practicable

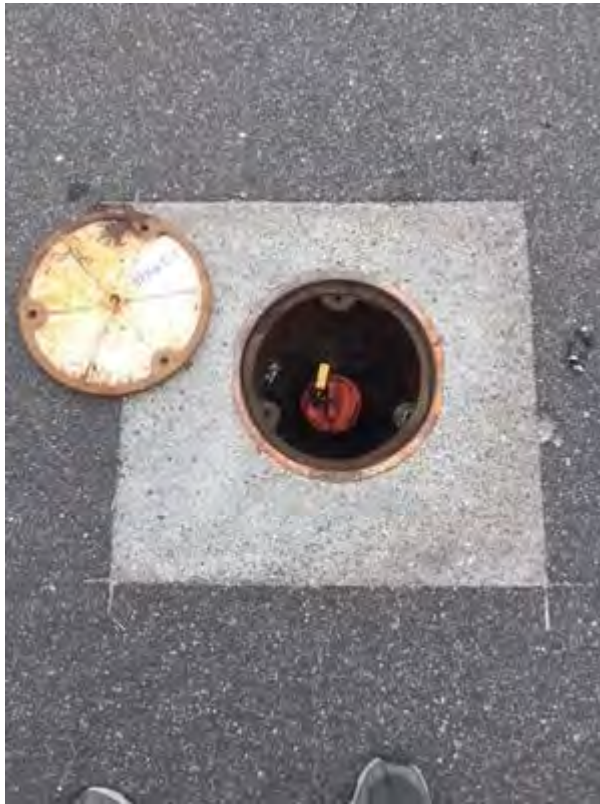
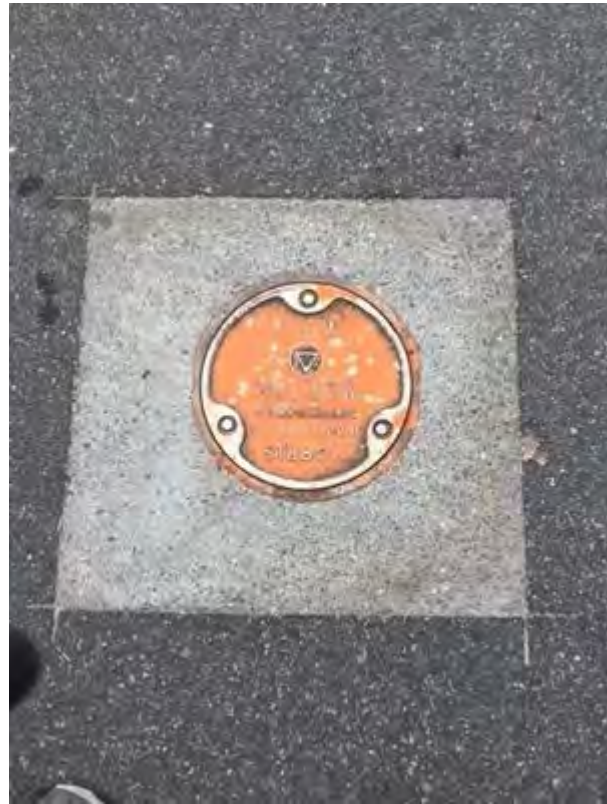
Client: Navy CLEAN	Facility: NWIRP Bethpage
Project Number: 112G08005-WE13	Location: Bethpage, New York
Date: September 22, 2021 11:26	Personnel: Vince Shickora
Well ID: BPOW 5-1	Well Location: 198399.79 1127145.842
Well Status: Other	Screen Interval: 480-510
WELL INVENTORY CONDITION	
Concrete pad in acceptable condition i.e. no cracks?	YES
Manhole cover present and in working condition?	YES
All bolts on manhole present and not stripped?	YES
Well plug present, locked and in good working condition?	YES
OVERALL CONDITION:	GOOD
Notes (Explain if answered No to any of the above)

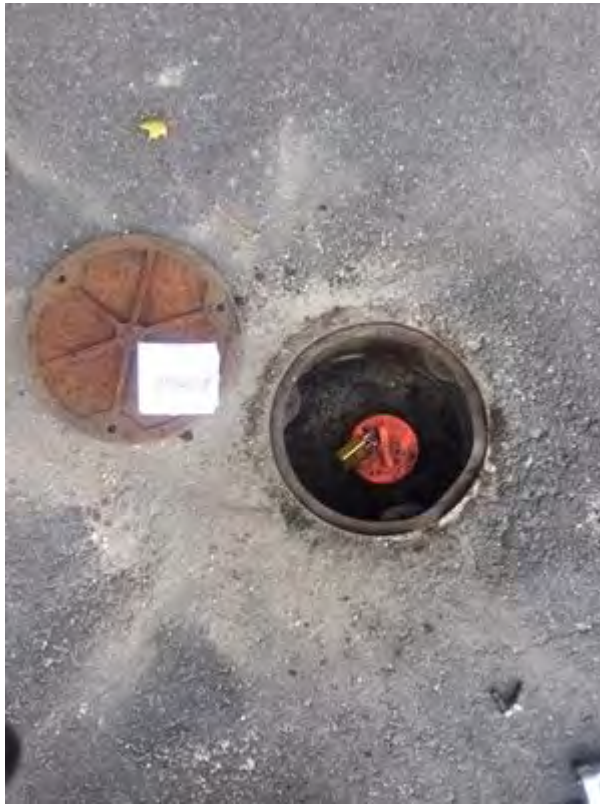
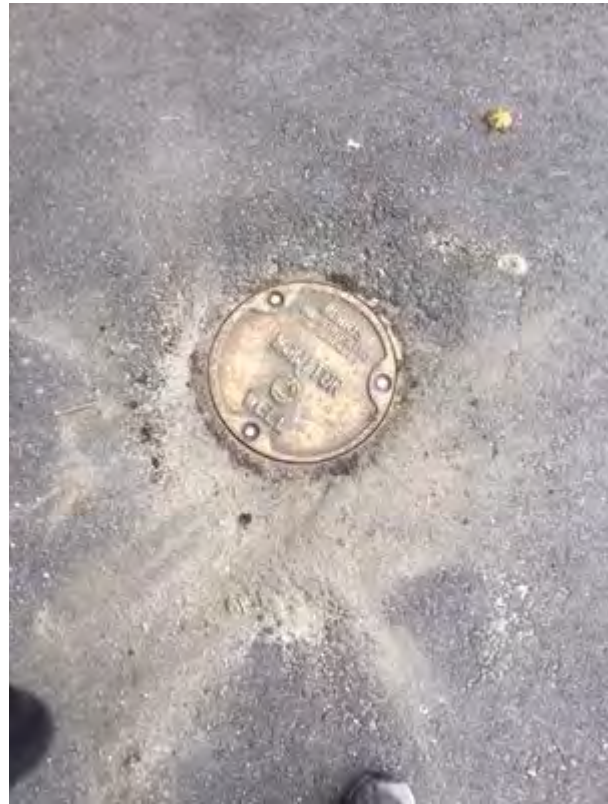
Client: Navy CLEAN	Facility: NWIRP Bethpage
Project Number: 112G08005-WE13	Location: Bethpage, New York
Date: September 22, 2021 11:16	Personnel: Vince Shickora
Well ID: BPOW 5-3	Well Location: 198389.891 1127156.801
Well Status: Other	Screen Interval: 620-660
WELL INVENTORY CONDITION	
Concrete pad in acceptable condition i.e. no cracks?	YES
Manhole cover present and in working condition?	YES
All bolts on manhole present and not stripped?	NO
Well plug present, locked and in good working condition?	YES
OVERALL CONDITION:	FAIR
Notes (Explain if answered No to any of the above)	
Bolts present. The threaded ears on flush-mount are stripped and bolts will not tighten.

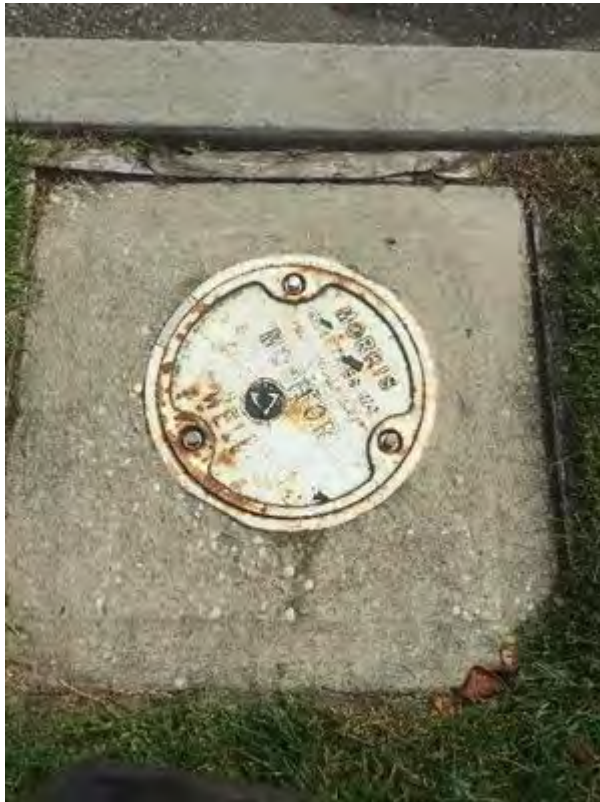
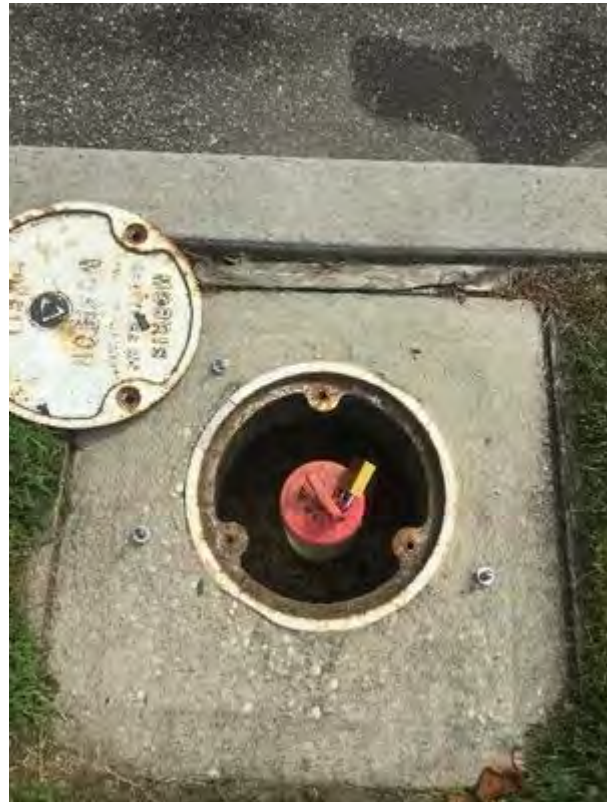
Client: Navy CLEAN	Facility: NWIRP Bethpage
Project Number: 112G08005-WE13	Location: Bethpage, New York
Date: September 22, 2021 10:56	Personnel: Noah Sprouse
Well ID: RE109D2	Well Location: 208580.6727 1126656.46753
Well Status: Other	Screen Interval: 550-570
WELL INVENTORY CONDITION	
Concrete pad in acceptable condition i.e. no cracks?	YES
Manhole cover present and in working condition?	YES
All bolts on manhole present and not stripped?	YES
Well plug present, locked and in good working condition?	YES
OVERALL CONDITION:	FAIR
Notes (Explain if answered No to any of the above) Missing rubber gasket.

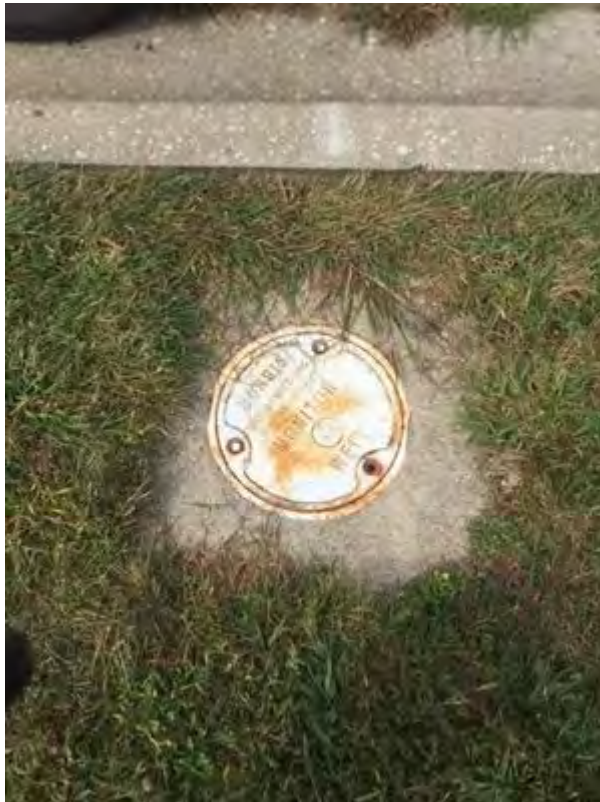
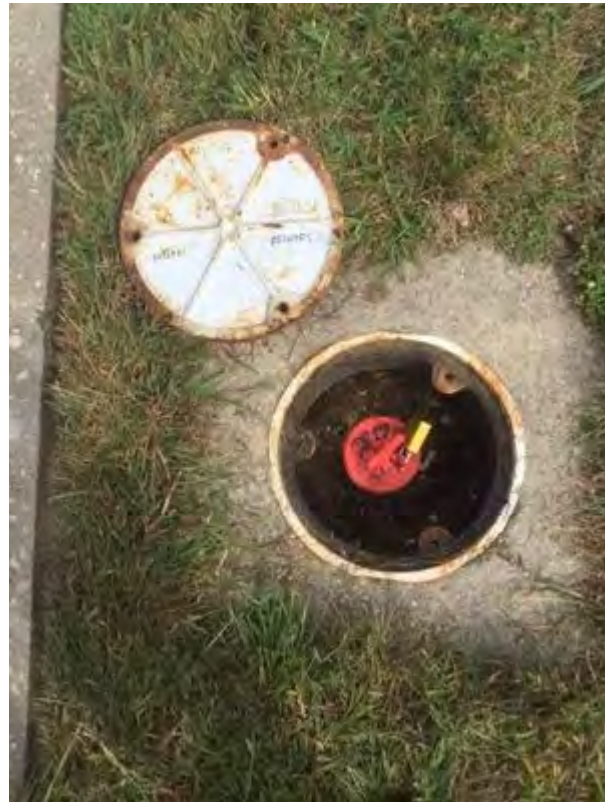
Client: Navy CLEAN	Facility: NWIRP Bethpage
Project Number: 112G08005-WE13	Location: Bethpage, New York
Date: September 22, 2021 10:55	Personnel: Vince Shickora
Well ID: RE127D1	Well Location: 199120.06 1131245.1
Well Status: Other	Screen Interval: 660-680
WELL INVENTORY CONDITION	
Concrete pad in acceptable condition i.e. no cracks?	YES
Manhole cover present and in working condition?	YES
All bolts on manhole present and not stripped?	YES
Well plug present, locked and in good working condition?	YES
OVERALL CONDITION:	GOOD
Notes (Explain if answered No to any of the above)

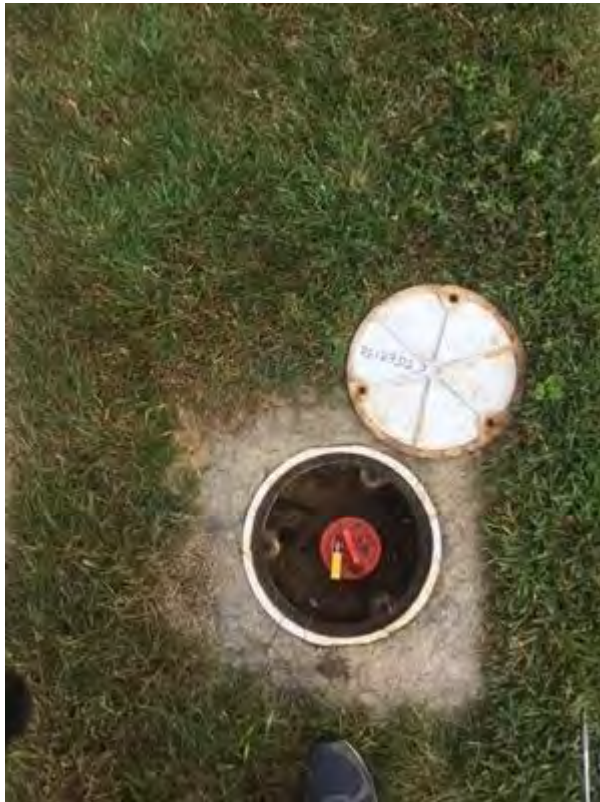
Client: Navy CLEAN	Facility: NWIRP Bethpage
Project Number: 112G08005-WE13	Location: Bethpage, New York
Date: September 22, 2021 10:50	Personnel: Vince Shickora
Well ID: RE127D2	Well Location: 199105.31 1131245.65
Well Status: Other	Screen Interval: 755-775
WELL INVENTORY CONDITION	
Concrete pad in acceptable condition i.e. no cracks?	YES
Manhole cover present and in working condition?	YES
All bolts on manhole present and not stripped?	YES
Well plug present, locked and in good working condition?	YES
OVERALL CONDITION:	GOOD
Notes (Explain if answered No to any of the above)

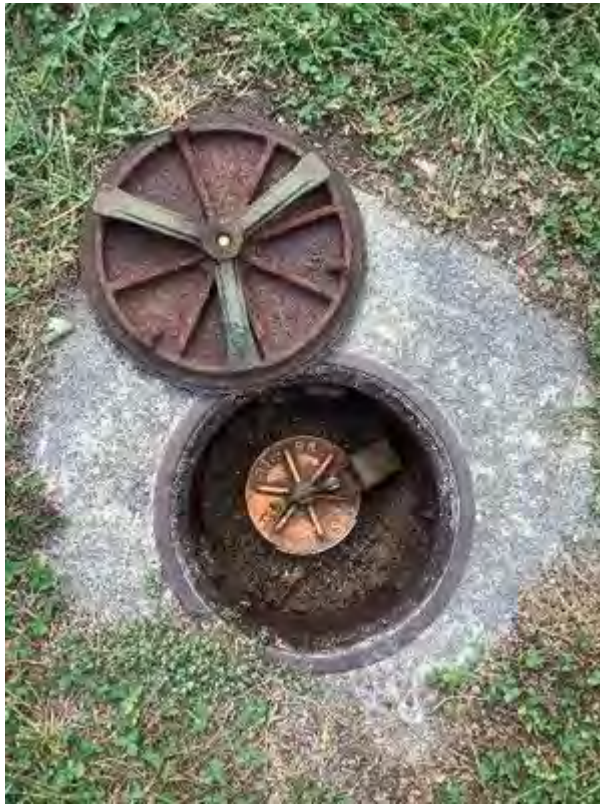
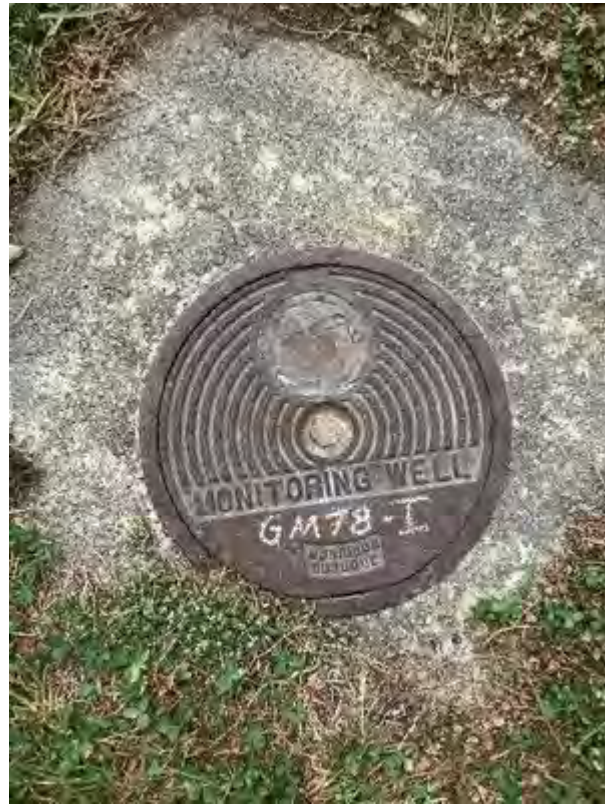
Client: Navy CLEAN	Facility: NWIRP Bethpage
Project Number: 112G08005-WE13	Location: Bethpage, New York
Date: September 22, 2021 10:52	Personnel: Beau Benfield
Well ID: BPGMMW78I	Well Location: 209362 1123624
Well Status: Other	Screen Interval: 90-100
WELL INVENTORY CONDITION	
Concrete pad in acceptable condition i.e. no cracks?	YES
Manhole cover present and in working condition?	YES
All bolts on manhole present and not stripped?	YES
Well plug present, locked and in good working condition?	YES
OVERALL CONDITION:	GOOD
Notes (Explain if answered No to any of the above)

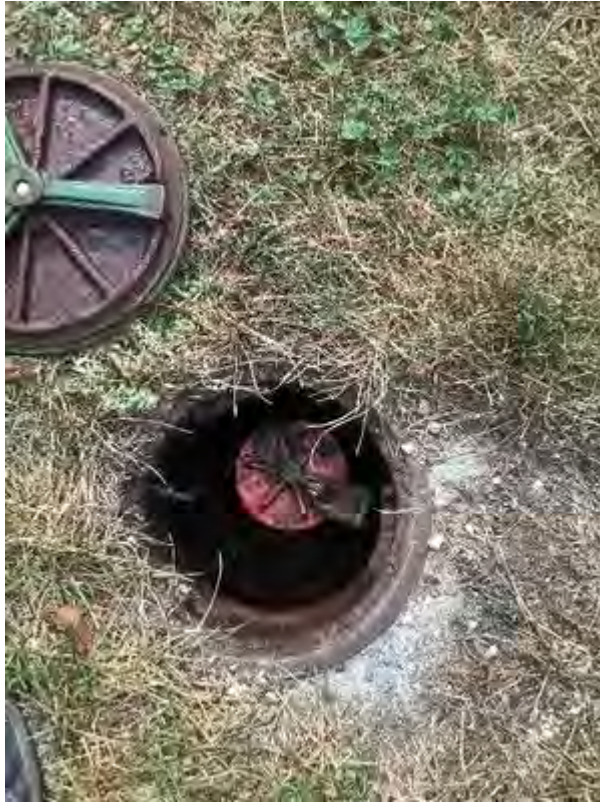
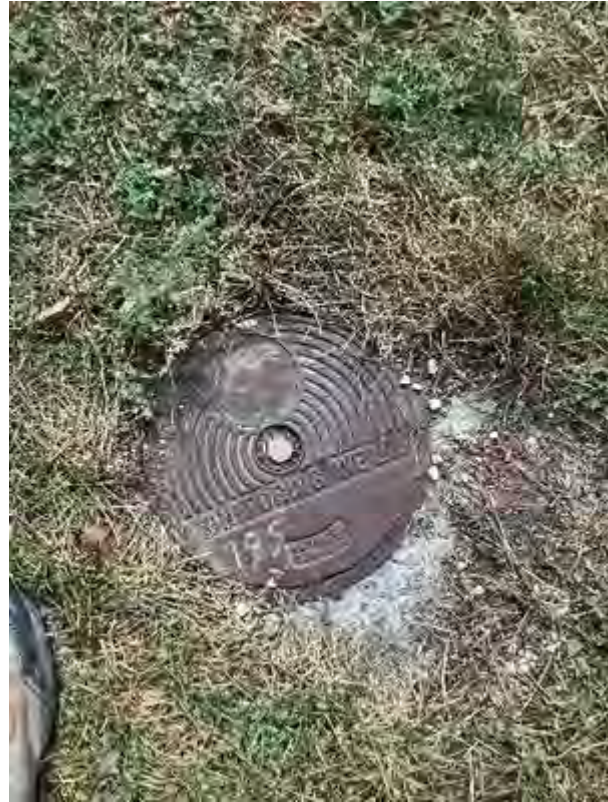
Client: Navy CLEAN	Facility: NWIRP Bethpage
Project Number: 112G08005-WE13	Location: Bethpage, New York
Date: September 22, 2021 10:51	Personnel: Beau Benfield
Well ID: BPGMMW78S	Well Location: 209359 1123618
Well Status: Other	Screen Interval: 60-70
WELL INVENTORY CONDITION	
Concrete pad in acceptable condition i.e. no cracks?	YES
Manhole cover present and in working condition?	YES
All bolts on manhole present and not stripped?	YES
Well plug present, locked and in good working condition?	YES
OVERALL CONDITION:	GOOD
Notes (Explain if answered No to any of the above)

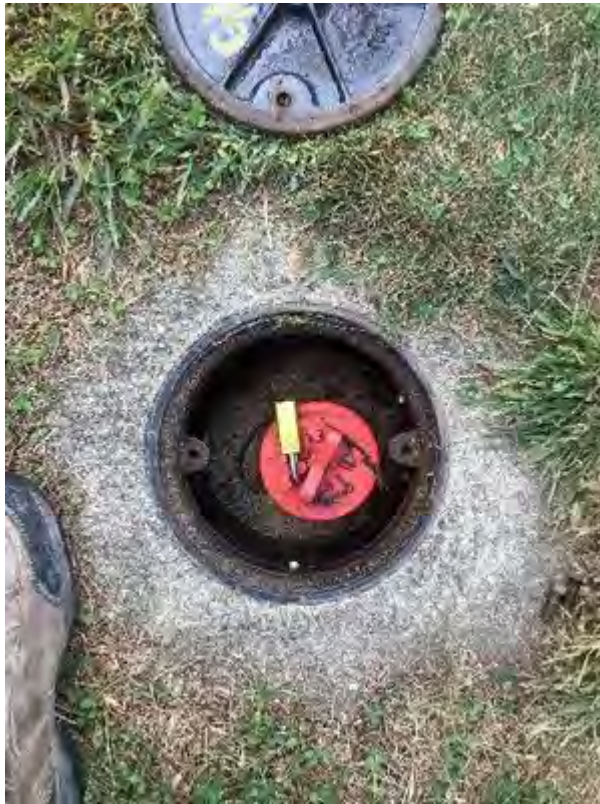
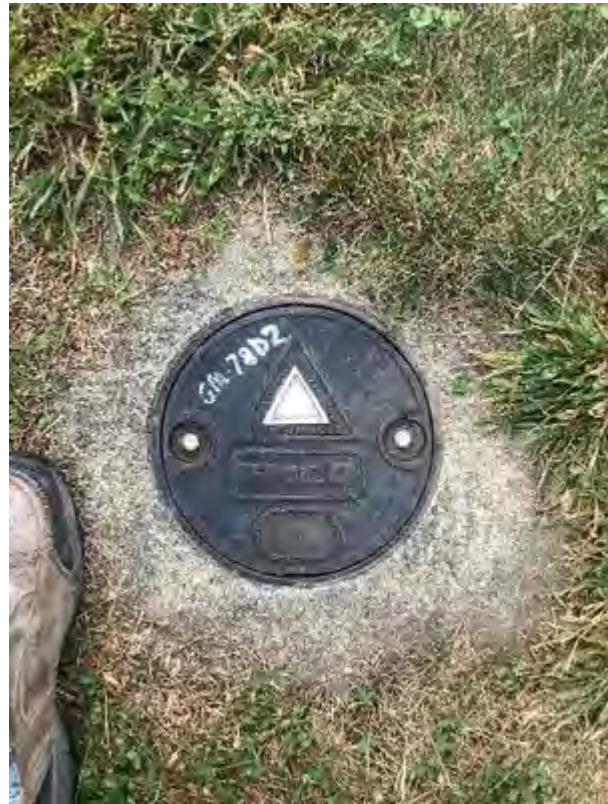
Client: Navy CLEAN	Facility: NWIRP Bethpage
Project Number: 112G08005-WE13	Location: Bethpage, New York
Date: September 22, 2021 10:49	Personnel: Beau Benfield
Well ID: BPGMMW78D2	Well Location:
Well Status: Other	Screen Interval:
WELL INVENTORY CONDITION	
Concrete pad in acceptable condition i.e. no cracks?	YES
Manhole cover present and in working condition?	YES
All bolts on manhole present and not stripped?	YES
Well plug present, locked and in good working condition?	YES
OVERALL CONDITION:	GOOD
Notes (Explain if answered No to any of the above)

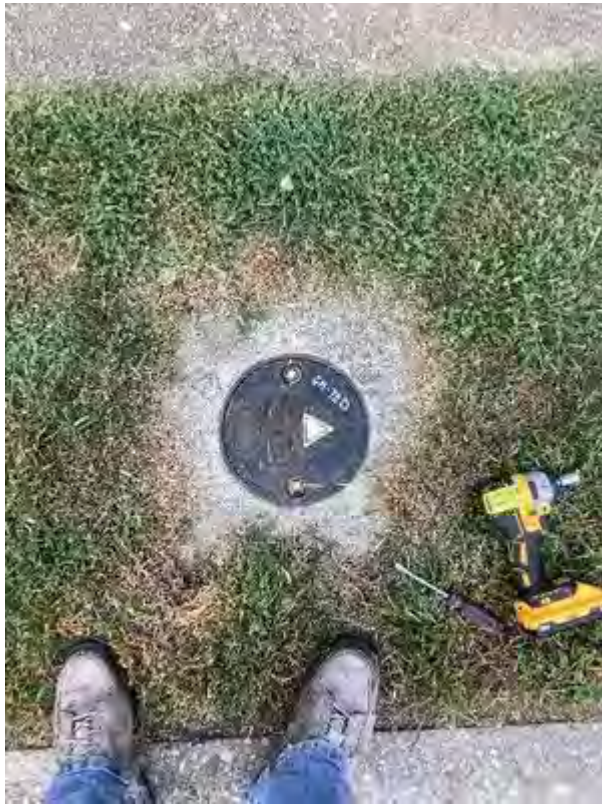
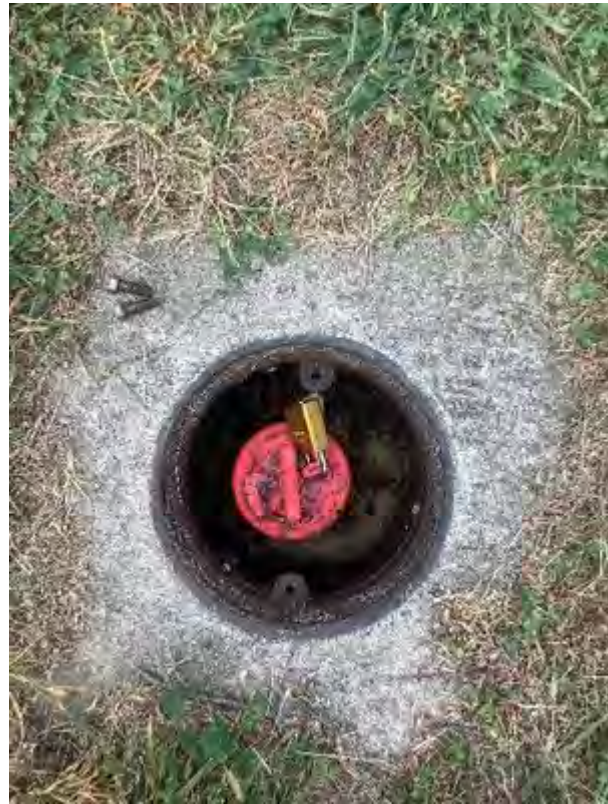
Client: Navy CLEAN	Facility: NWIRP Bethpage
Project Number: 112G08005-WE13	Location: Bethpage, New York
Date: September 22, 2021 10:48	Personnel: Beau Benfield
Well ID: BPGMMW78D	Well Location:
Well Status: Other	Screen Interval:
WELL INVENTORY CONDITION	
Concrete pad in acceptable condition i.e. no cracks?	YES
Manhole cover present and in working condition?	YES
All bolts on manhole present and not stripped?	YES
Well plug present, locked and in good working condition?	YES
OVERALL CONDITION:	GOOD
Notes (Explain if answered No to any of the above)

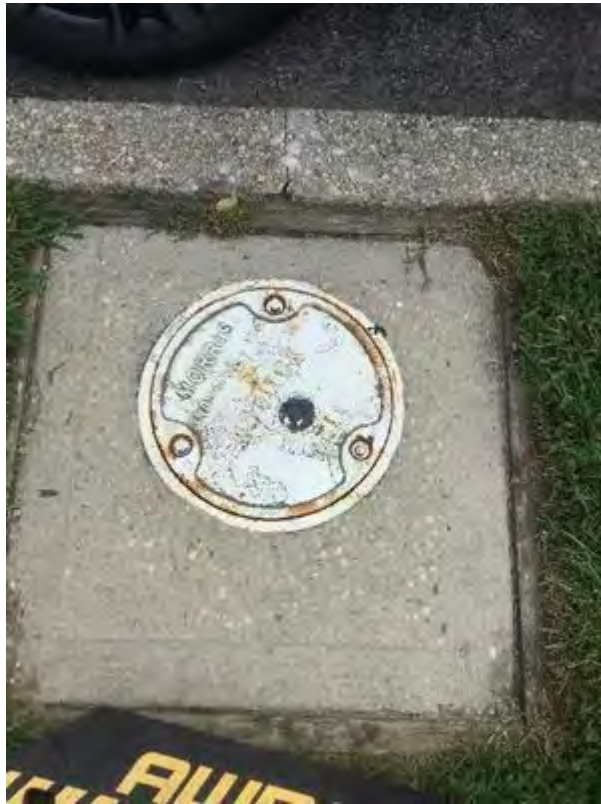
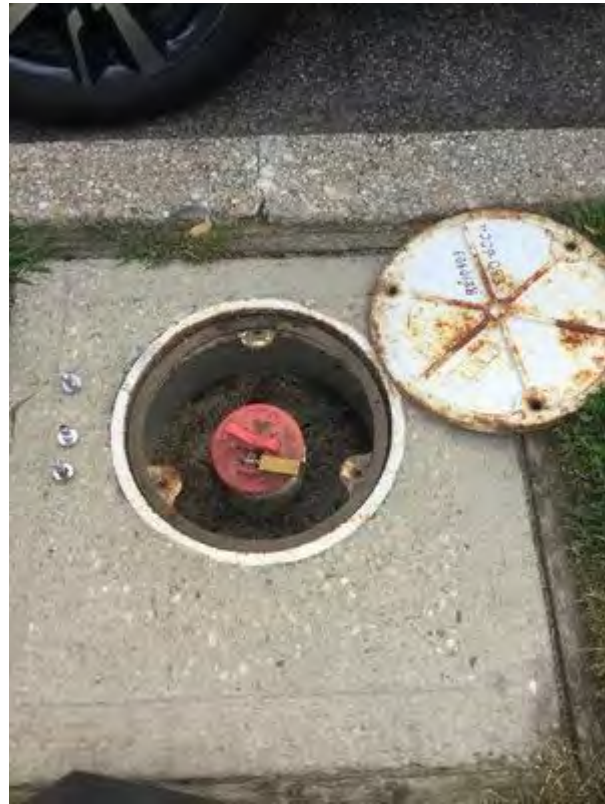
PHOTO LOG:

Client: Navy CLEAN	Facility: NWIRP Bethpage
Project Number: 112G08005-WE13	Location: Bethpage, New York
Date: September 22, 2021 10:44	Personnel: Noah Sprouse
Well ID: RE109D3	Well Location:
Well Status: Other	Screen Interval:
WELL INVENTORY CONDITION	
Concrete pad in acceptable condition i.e. no cracks?	YES
Manhole cover present and in working condition?	YES
All bolts on manhole present and not stripped?	YES
Well plug present, locked and in good working condition?	YES
OVERALL CONDITION:	GOOD
Notes (Explain if answered No to any of the above)

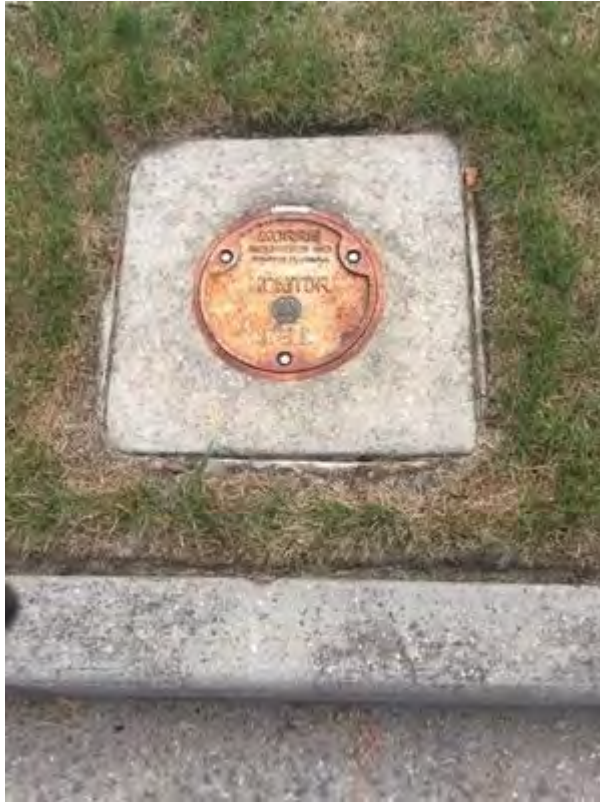
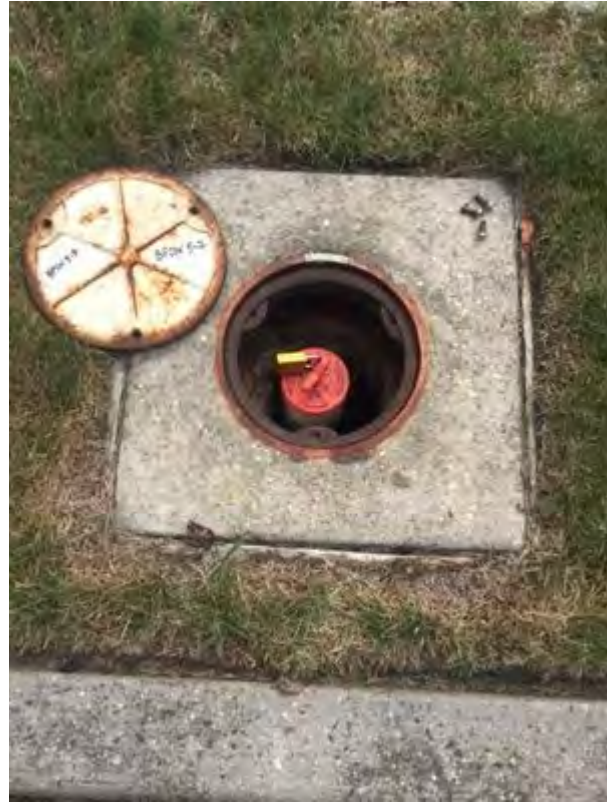
PHOTO LOG:

Client: Navy CLEAN	Facility: NWIRP Bethpage
Project Number: 112G08005-WE13	Location: Bethpage, New York
Date: September 22, 2021 10:33	Personnel: Vince Shickora
Well ID: BPOW 5-7	Well Location: 197274.15 1128702.39
Well Status: Other	Screen Interval: 525-550
WELL INVENTORY CONDITION	
Concrete pad in acceptable condition i.e. no cracks?	YES
Manhole cover present and in working condition?	YES
All bolts on manhole present and not stripped?	YES
Well plug present, locked and in good working condition?	YES
OVERALL CONDITION:	GOOD
Notes (Explain if answered No to any of the above)

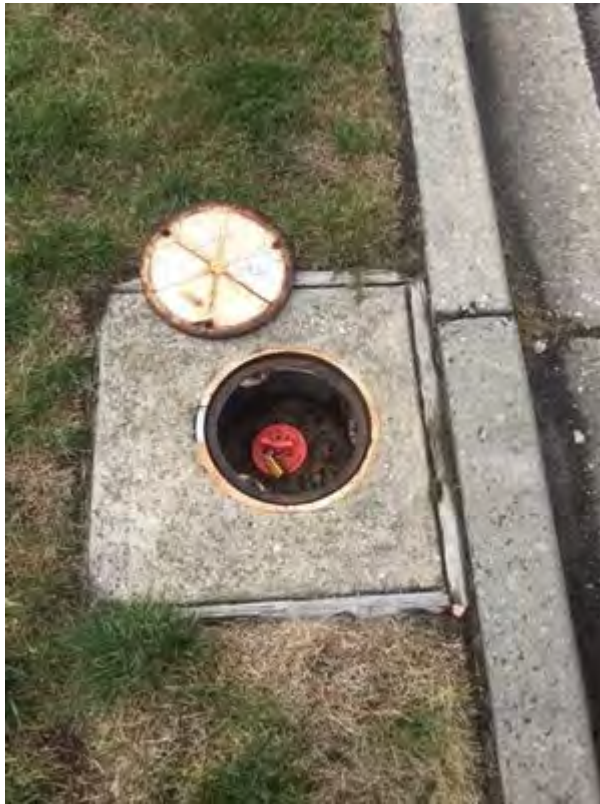
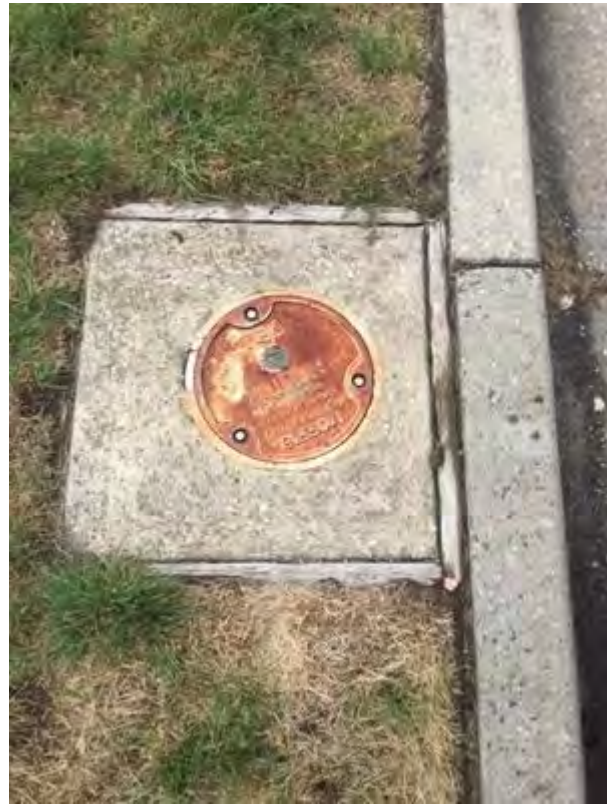
PHOTO LOG:

Client: Navy CLEAN	Facility: NWIRP Bethpage
Project Number: 112G08005-WE13	Location: Bethpage, New York
Date: September 22, 2021 10:28	Personnel: Vince Shickora
Well ID: RE119D1	Well Location: 197245.89 1128694.84
Well Status: Other	Screen Interval: 715-740
WELL INVENTORY CONDITION	
Concrete pad in acceptable condition i.e. no cracks?	YES
Manhole cover present and in working condition?	YES
All bolts on manhole present and not stripped?	YES
Well plug present, locked and in good working condition?	YES
OVERALL CONDITION:	GOOD
Notes (Explain if answered No to any of the above)
