Memorandum

To: Scot Sokolowski, NAVFAC MIDLANT
From: David Brayack, Tetra Tech
Date: December 30, 2021
Re: Annual LUC Inspection and Operation Summary Report: Sites 1, 2, 3, and 4 – NWIRP Bethpage
Revision 1
Contract/CTO Number: N6247016D9008/WE13

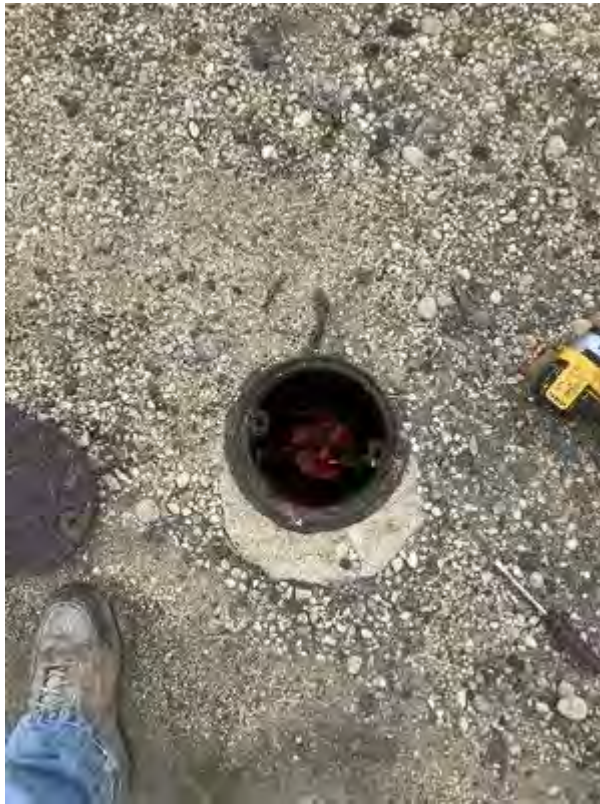
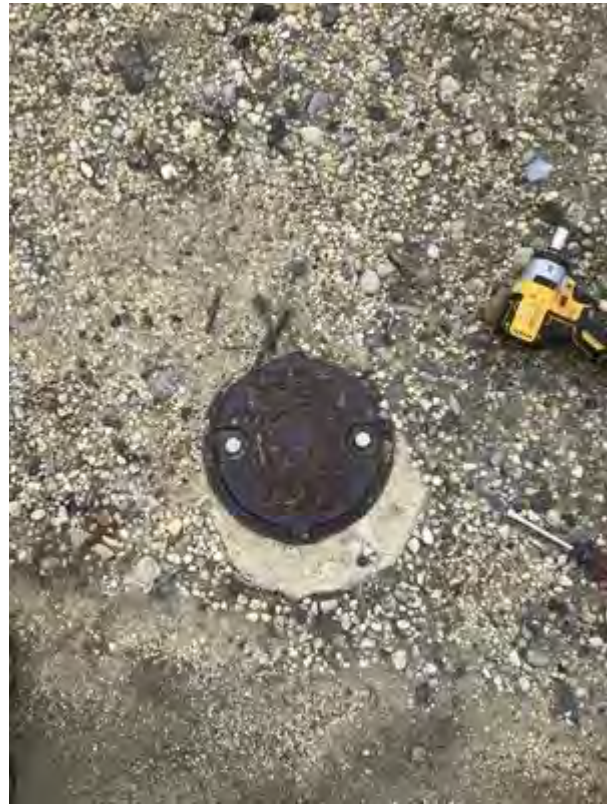
PHOTO LOG:

Client: Navy CLEAN	Facility: NWIRP Bethpage
Project Number: 112G08005-WE13	Location: Bethpage, New York
Date: September 22, 2021 10:17	Personnel: Beau Benfield
Well ID: GM-17SR	Well Location: 211377.743056 1122835.51042
Well Status: Other	Screen Interval:
WELL INVENTORY CONDITION	
Concrete pad in acceptable condition i.e. no cracks?	YES
Manhole cover present and in working condition?	YES
All bolts on manhole present and not stripped?	NO
Well plug present, locked and in good working condition?	YES
OVERALL CONDITION:	GOOD
Notes (Explain if answered No to any of the above) Bolts stripped

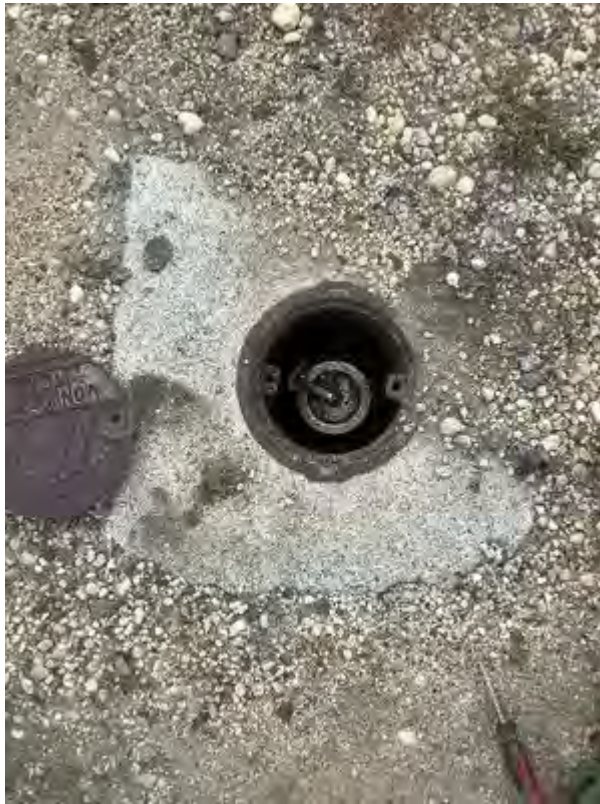
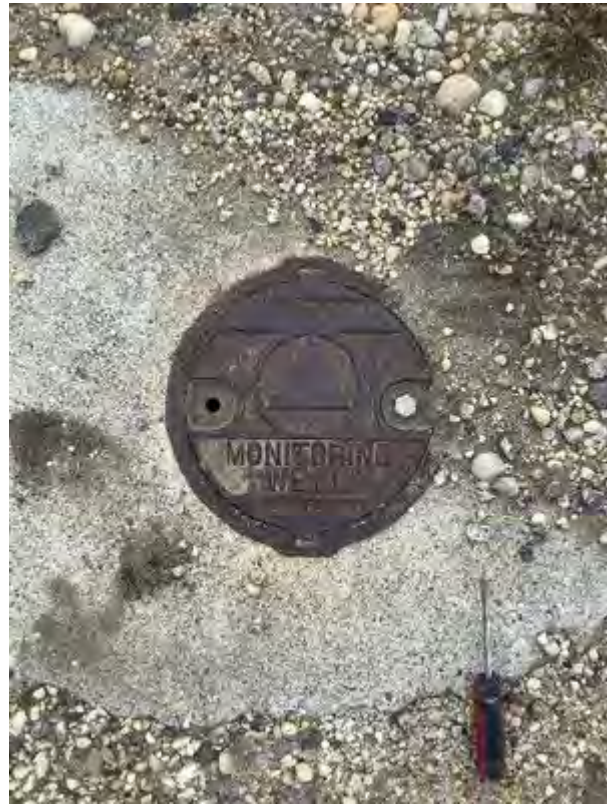
PHOTO LOG:

Client: Navy CLEAN	Facility: NWIRP Bethpage
Project Number: 112G08005-WE13	Location: Bethpage, New York
Date: September 22, 2021 10:14	Personnel: Beau Benfield
Well ID: BPGMMW171	Well Location: 211391.428 1122830.969
Well Status: Other	Screen Interval: 100-120
WELL INVENTORY CONDITION	
Concrete pad in acceptable condition i.e. no cracks?	YES
Manhole cover present and in working condition?	YES
All bolts on manhole present and not stripped?	NO
Well plug present, locked and in good working condition?	YES
OVERALL CONDITION:	GOOD
Notes (Explain if answered No to any of the above) Could not thread new bolt through manhole cover

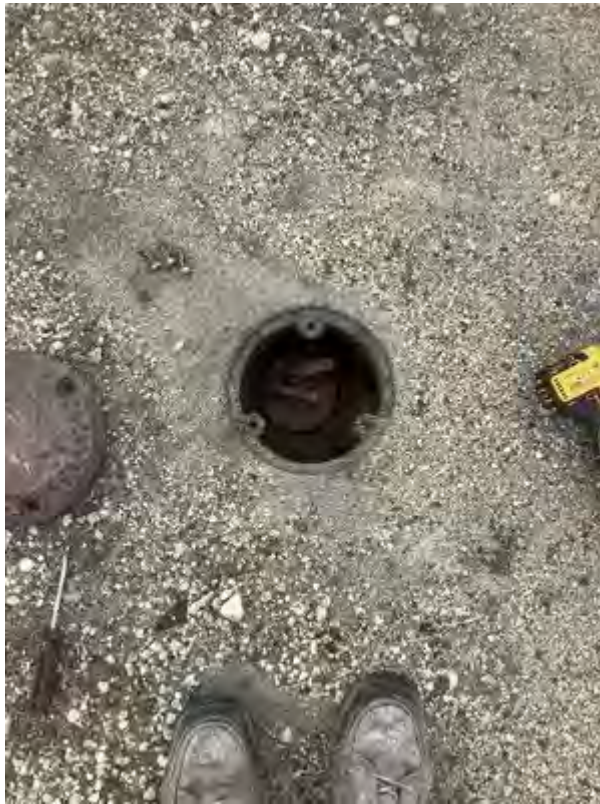
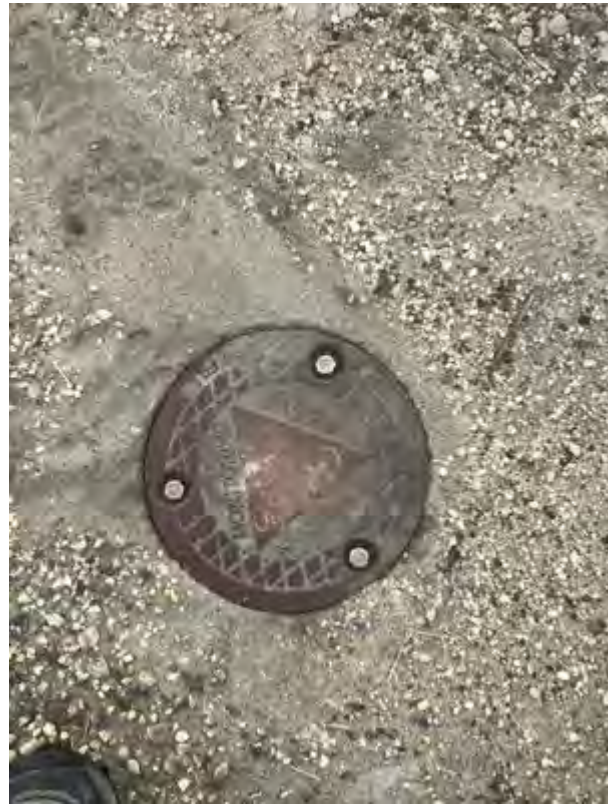
PHOTO LOG:

Client: Navy CLEAN	Facility: NWIRP Bethpage
Project Number: 112G08005-WE13	Location: Bethpage, New York
Date: September 22, 2021 10:12	Personnel: Beau Benfield
Well ID: BPGMMW17D	Well Location: 211382.161 1122827.429
Well Status: Other	Screen Interval: 278-298
WELL INVENTORY CONDITION	
Concrete pad in acceptable condition i.e. no cracks?	YES
Manhole cover present and in working condition?	YES
All bolts on manhole present and not stripped?	YES
Well plug present, locked and in good working condition?	YES
OVERALL CONDITION:	GOOD
Notes (Explain if answered No to any of the above)

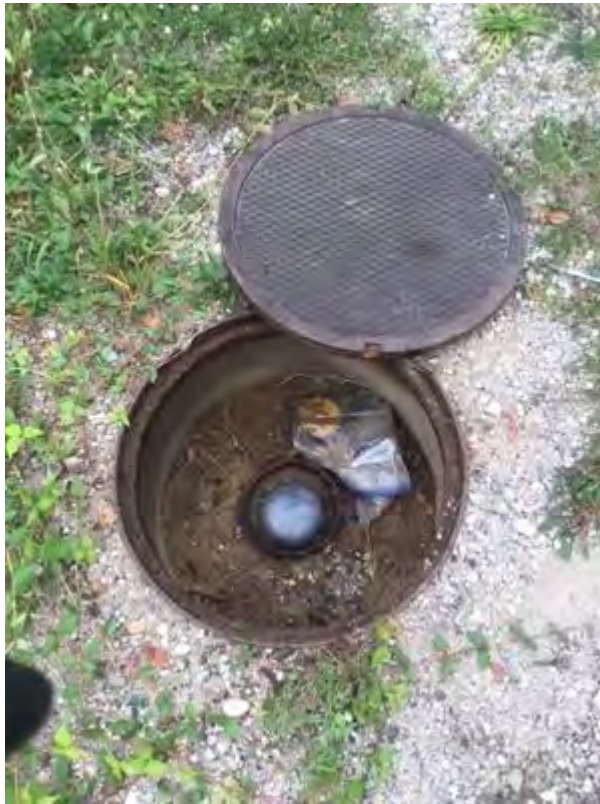
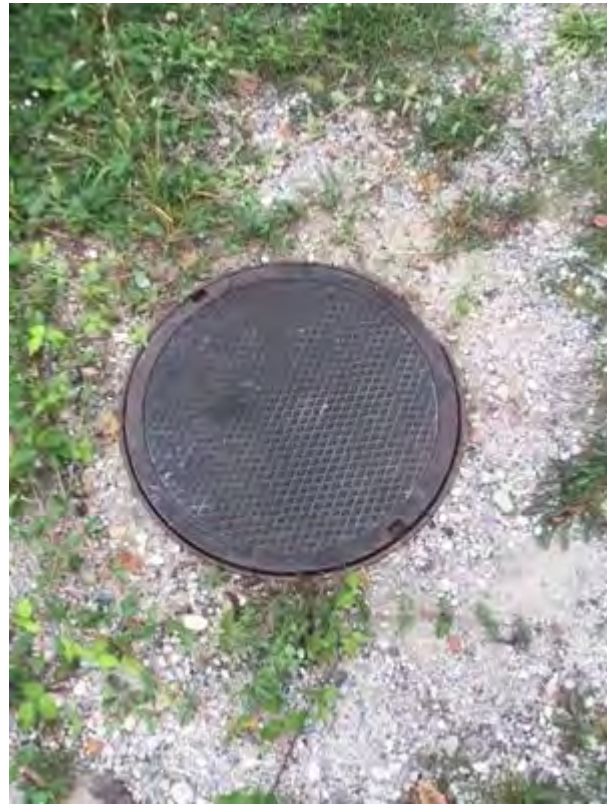
PHOTO LOG:

Client: Navy CLEAN	Facility: NWIRP Bethpage
Project Number: 112G08005-WE13	Location: Bethpage, New York
Date: September 22, 2021 10:09	Personnel: Vince Shickora
Well ID: TT102D2	Well Location: 195346.266 1127132.843
Well Status: Other	Screen Interval: 740-770
WELL INVENTORY CONDITION	
Concrete pad in acceptable condition i.e. no cracks?	YES
Manhole cover present and in working condition?	YES
All bolts on manhole present and not stripped?	YES
Well plug present, locked and in good working condition?	NO
OVERALL CONDITION:	GOOD
Notes (Explain if answered No to any of the above) No lock on well plug. Slip cap installed on well.

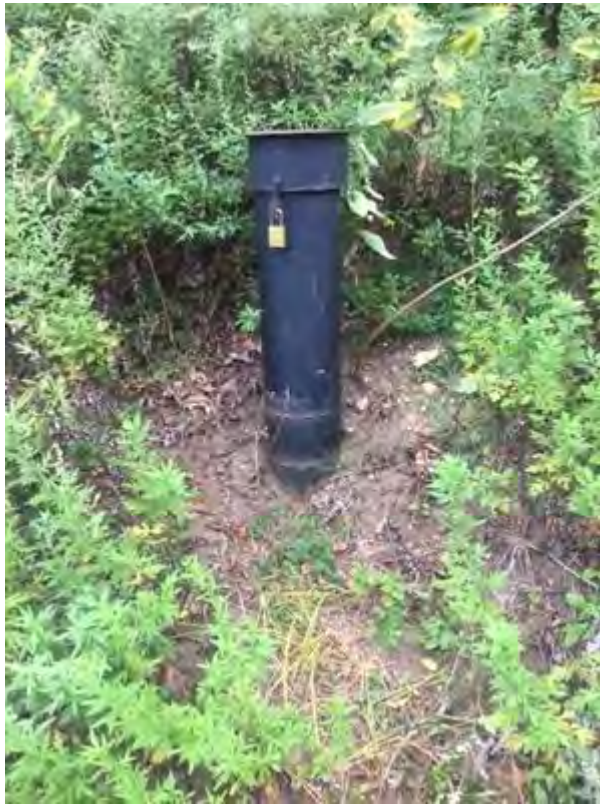
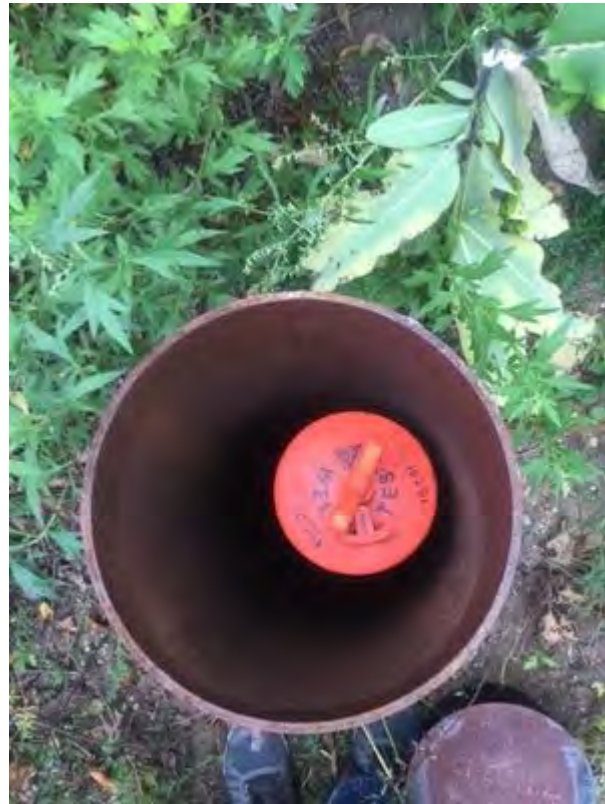
PHOTO LOG:

Client: Navy CLEAN	Facility: NWIRP Bethpage
Project Number: 112G08005-WE13	Location: Bethpage, New York
Date: September 22, 2021 10:01	Personnel: Vince Shickora
Well ID: TT102D	Well Location: 195341.937 1127148.911
Well Status: Other	Screen Interval: 560-600
WELL INVENTORY CONDITION	
Concrete pad in acceptable condition i.e. no cracks?	YES
Manhole cover present and in working condition?	NO
All bolts on manhole present and not stripped?	NO
Well plug present, locked and in good working condition?	YES
OVERALL CONDITION:	GOOD
Notes (Explain if answered No to any of the above) No flush-mount manhole or bolts at this well. Well installed as stickup.

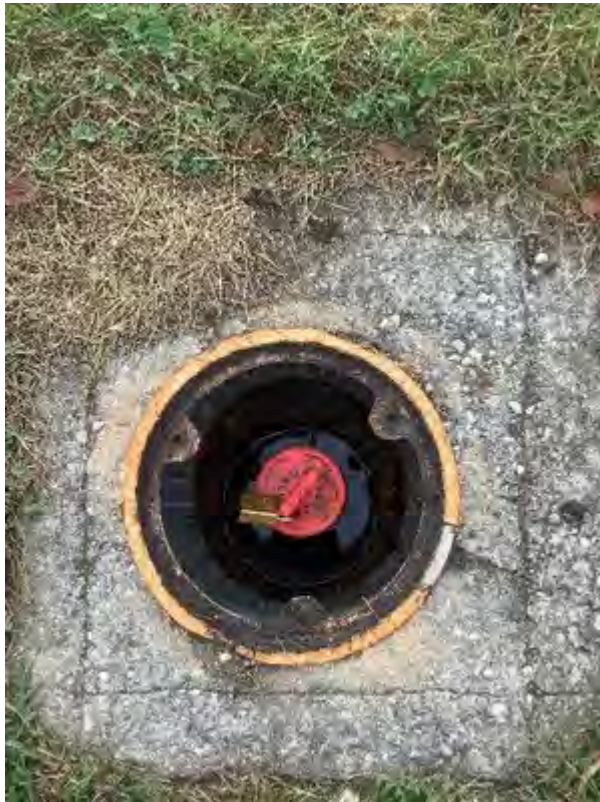
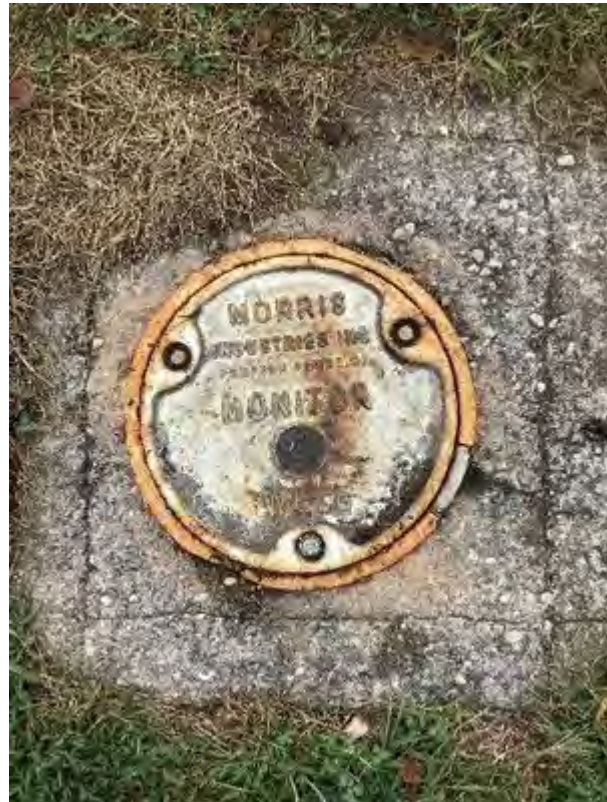
PHOTO LOG:

Client: Navy CLEAN	Facility: NWIRP Bethpage
Project Number: 112G08005-WE13	Location: Bethpage, New York
Date: September 22, 2021 09:44	Personnel: Beau Benfield
Well ID: RE121D1	Well Location: 203062.13 1126707.85
Well Status: Other	Screen Interval: 550-570
WELL INVENTORY CONDITION	
Concrete pad in acceptable condition i.e. no cracks?	YES
Manhole cover present and in working condition?	YES
All bolts on manhole present and not stripped?	YES
Well plug present, locked and in good working condition?	YES
OVERALL CONDITION:	GOOD
Notes (Explain if answered No to any of the above)

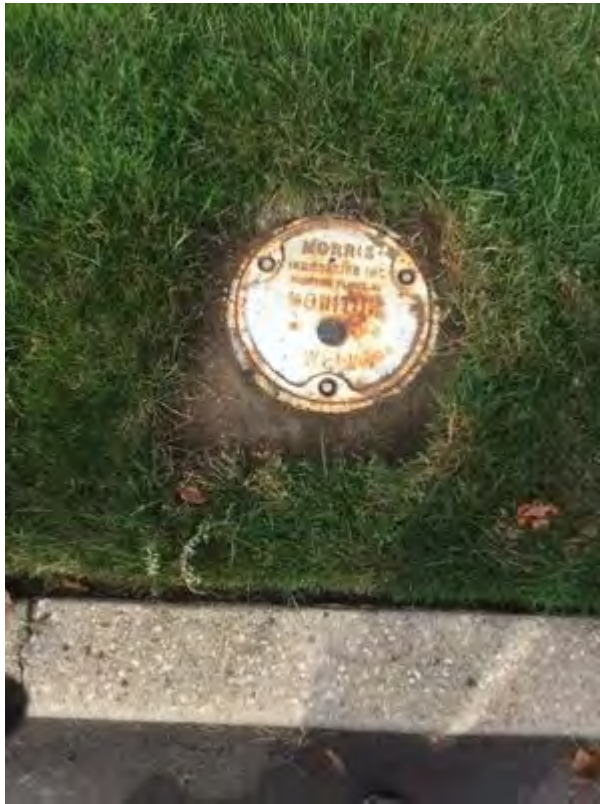
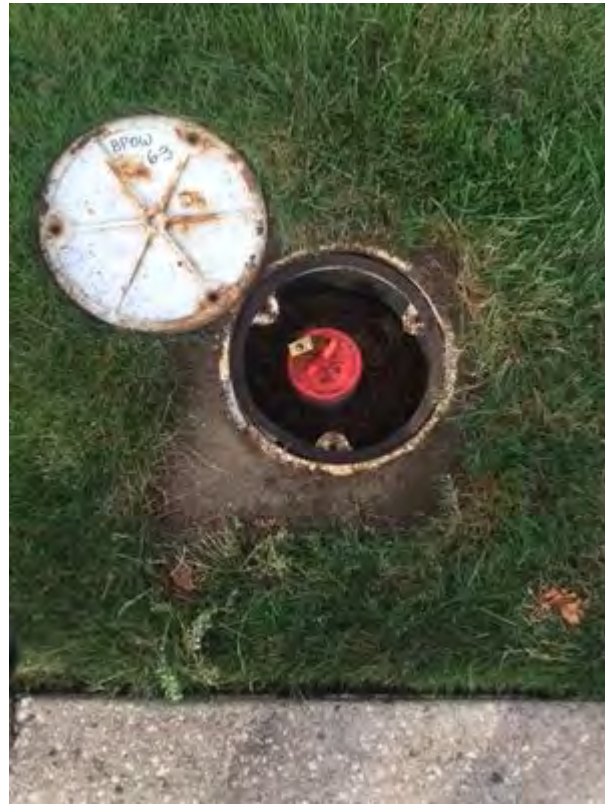
PHOTO LOG:

Client: Navy CLEAN	Facility: NWIRP Bethpage
Project Number: 112G08005-WE13	Location: Bethpage, New York
Date: September 22, 2021 09:36	Personnel: Vince Shickora
Well ID: BPOW 6-3	Well Location: 194106.07 1127582.36
Well Status: Other	Screen Interval: 750-775
WELL INVENTORY CONDITION	
Concrete pad in acceptable condition i.e. no cracks?	YES
Manhole cover present and in working condition?	YES
All bolts on manhole present and not stripped?	YES
Well plug present, locked and in good working condition?	YES
OVERALL CONDITION:	GOOD
Notes (Explain if answered No to any of the above)

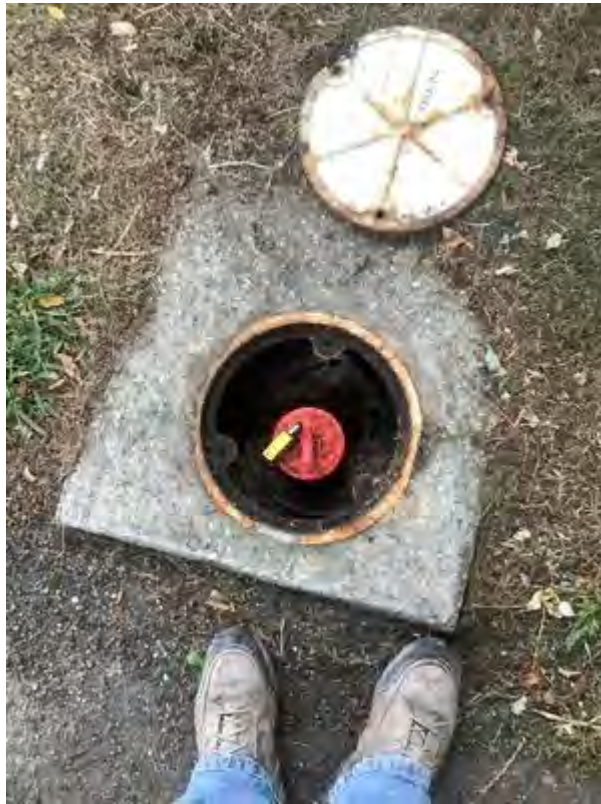
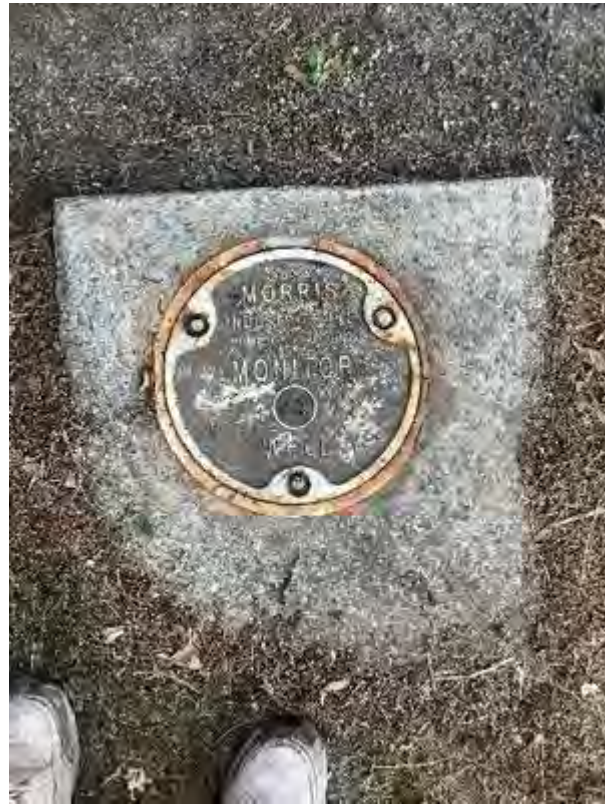
PHOTO LOG:

Client: Navy CLEAN	Facility: NWIRP Bethpage
Project Number: 112G08005-WE13	Location: Bethpage, New York
Date: September 22, 2021 09:38	Personnel: Beau Benfield
Well ID: RE121D2	Well Location: 203003.36 1126663.5
Well Status: Other	Screen Interval: 730-750
WELL INVENTORY CONDITION	
Concrete pad in acceptable condition i.e. no cracks?	YES
Manhole cover present and in working condition?	YES
All bolts on manhole present and not stripped?	YES
Well plug present, locked and in good working condition?	YES
OVERALL CONDITION:	GOOD
Notes (Explain if answered No to any of the above)

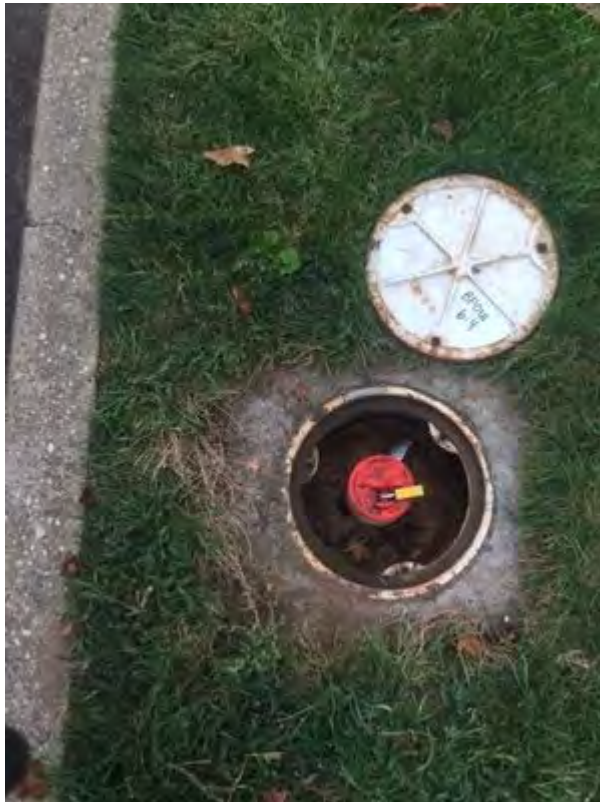
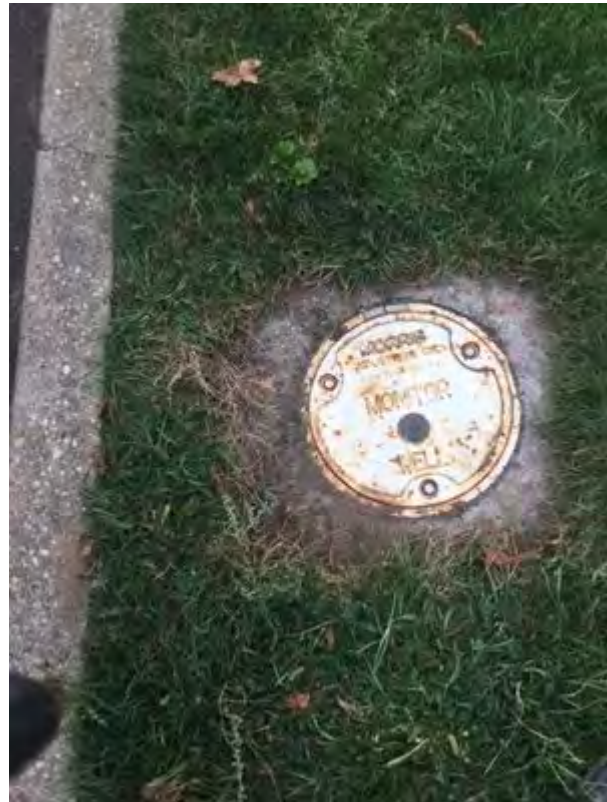
PHOTO LOG:

Client: Navy CLEAN	Facility: NWIRP Bethpage
Project Number: 112G08005-WE13	Location: Bethpage, New York
Date: September 22, 2021 09:30	Personnel: Vince Shickora
Well ID: BPOW 6-4	Well Location: 194127 1127580.66
Well Status: Other	Screen Interval: 545-570
WELL INVENTORY CONDITION	
Concrete pad in acceptable condition i.e. no cracks?	YES
Manhole cover present and in working condition?	YES
All bolts on manhole present and not stripped?	NO
Well plug present, locked and in good working condition?	YES
OVERALL CONDITION:	FAIR
Notes (Explain if answered No to any of the above)	
Bolts are present but the threaded ears on flush-mount base are stripped. Bolts won't tighten.

*All wells in Fair/Poor condition will be repaired and/or addressed prior to the next Annual Well Inventory to the extent practicable

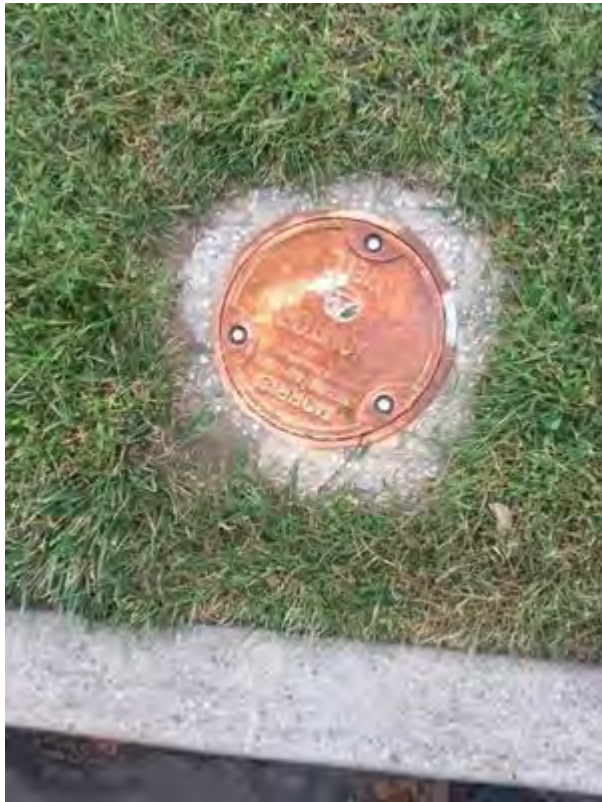
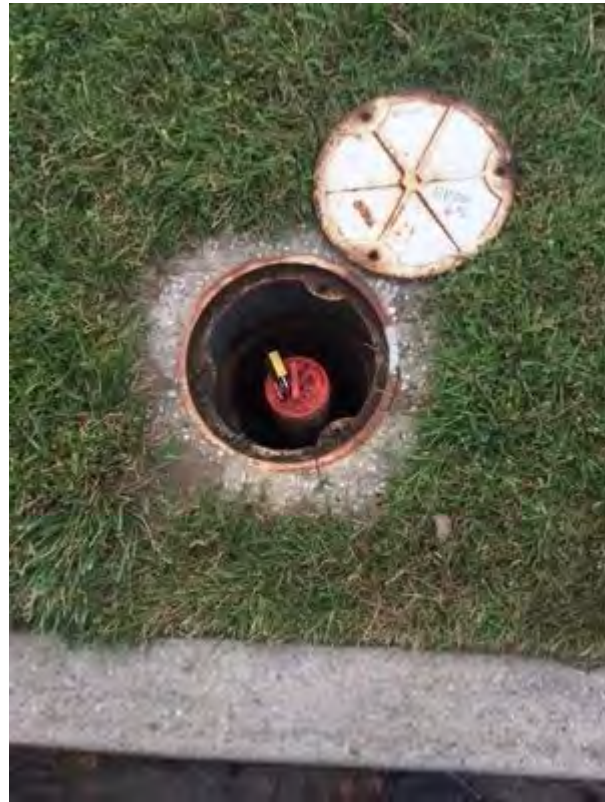
PHOTO LOG:

Client: Navy CLEAN	Facility: NWIRP Bethpage
Project Number: 112G08005-WE13	Location: Bethpage, New York
Date: September 22, 2021 09:12	Personnel: Vince Shickora
Well ID: BPOW 6-5	Well Location: 194045.49 1128178.28
Well Status: Other	Screen Interval: 525-550
WELL INVENTORY CONDITION	
Concrete pad in acceptable condition i.e. no cracks?	YES
Manhole cover present and in working condition?	YES
All bolts on manhole present and not stripped?	YES
Well plug present, locked and in good working condition?	YES
OVERALL CONDITION:	GOOD
Notes (Explain if answered No to any of the above)

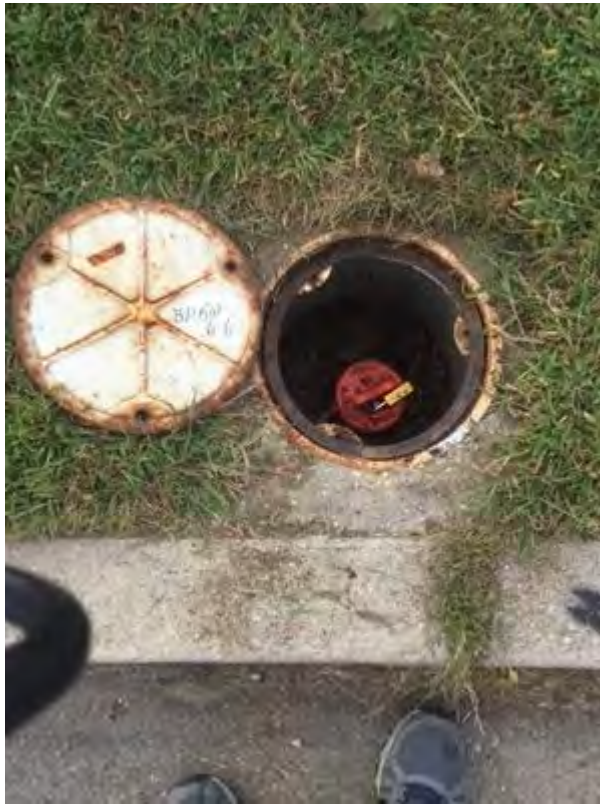
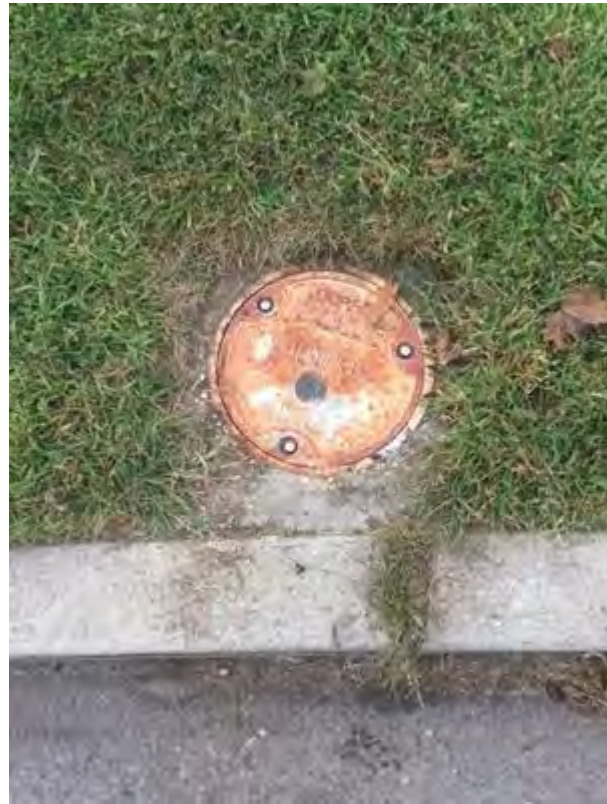
PHOTO LOG:

Client: Navy CLEAN	Facility: NWIRP Bethpage
Project Number: 112G08005-WE13	Location: Bethpage, New York
Date: September 22, 2021 09:08	Personnel: Vince Shickora
Well ID: BPOW 6-6	Well Location: 194044.59 1128163.72
Well Status: Other	Screen Interval: 770-795
WELL INVENTORY CONDITION	
Concrete pad in acceptable condition i.e. no cracks?	YES
Manhole cover present and in working condition?	YES
All bolts on manhole present and not stripped?	YES
Well plug present, locked and in good working condition?	NO
OVERALL CONDITION:	GOOD
Notes (Explain if answered No to any of the above)

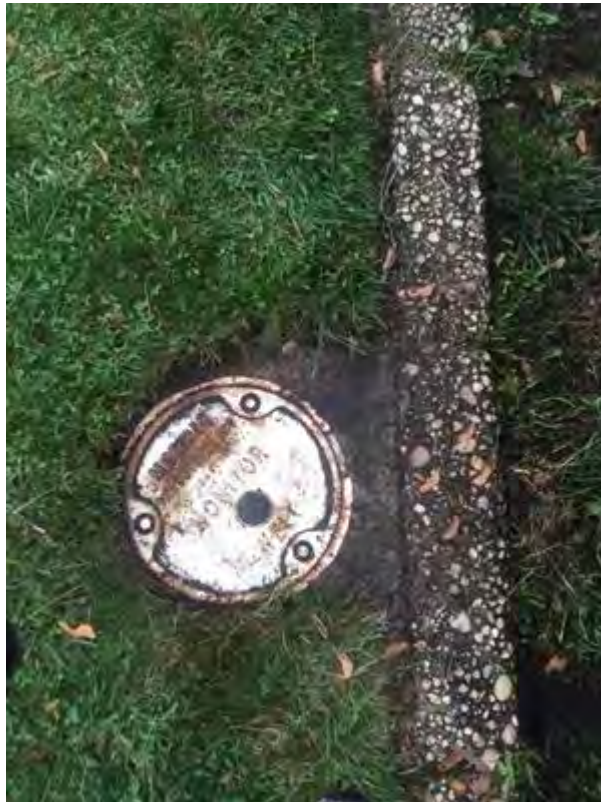
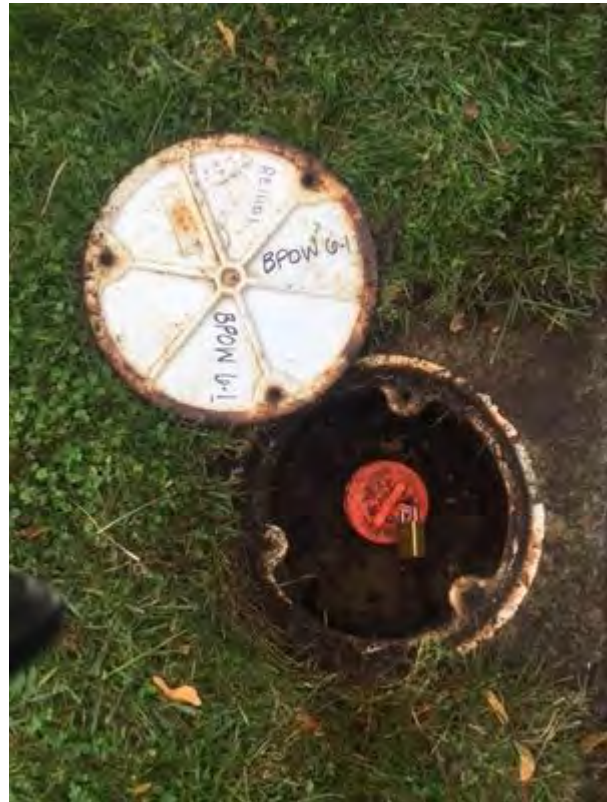
PHOTO LOG:

Client: Navy CLEAN	Facility: NWIRP Bethpage
Project Number: 112G08005-WE13	Location: Bethpage, New York
Date: September 22, 2021 08:45	Personnel: Vince Shickora
Well ID: BPOW 6-1	Well Location: 193228.16 1126796.92
Well Status: Other	Screen Interval: 550-575
WELL INVENTORY CONDITION	
Concrete pad in acceptable condition i.e. no cracks?	YES
Manhole cover present and in working condition?	YES
All bolts on manhole present and not stripped?	NO
Well plug present, locked and in good working condition?	YES
OVERALL CONDITION:	FAIR
Notes (Explain if answered No to any of the above) Bolts present. Threaded ears on flush-mount are stripped. Bolts will not tighten.

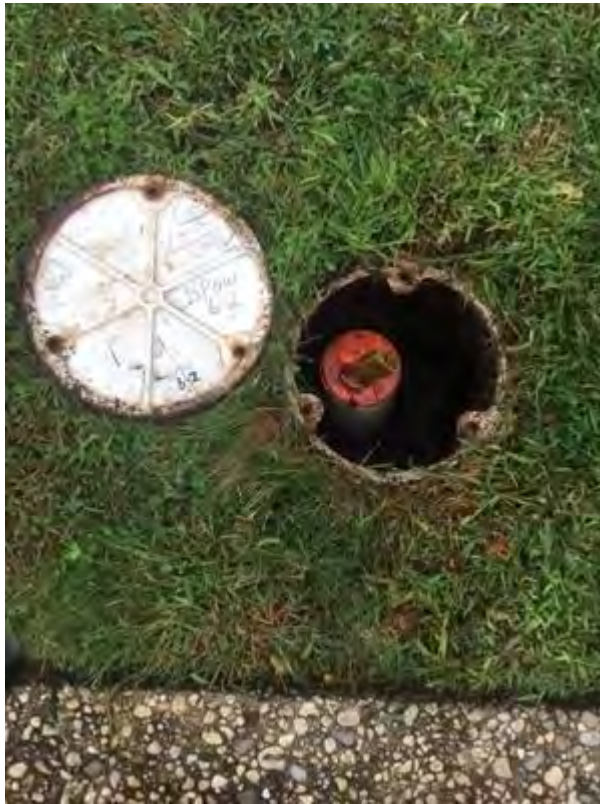
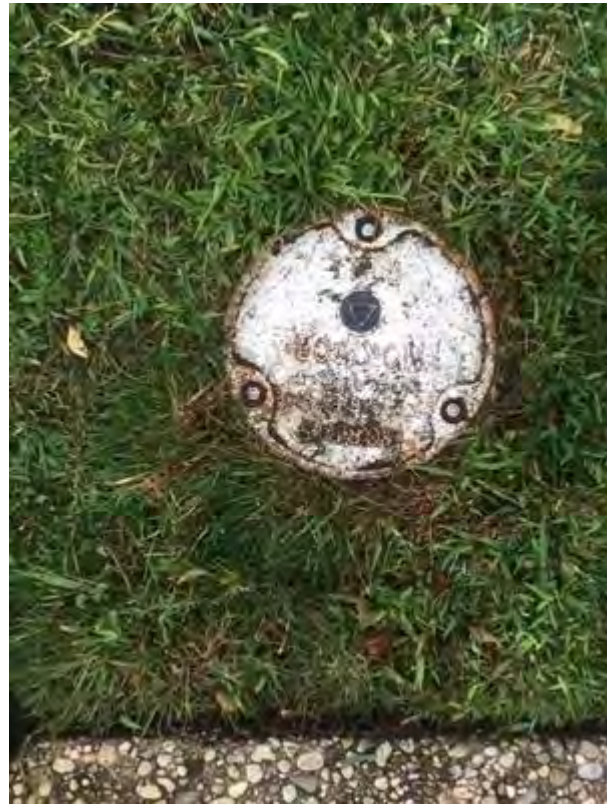
PHOTO LOG:

Client: Navy CLEAN	Facility: NWIRP Bethpage
Project Number: 112G08005-WE13	Location: Bethpage, New York
Date: September 22, 2021 08:38	Personnel: Vince Shickora
Well ID: BPOW 6-2	Well Location: 193253.75 1126785.34
Well Status: Other	Screen Interval: 755-780
WELL INVENTORY CONDITION	
Concrete pad in acceptable condition i.e. no cracks?	YES
Manhole cover present and in working condition?	YES
All bolts on manhole present and not stripped?	YES
Well plug present, locked and in good working condition?	YES
OVERALL CONDITION:	GOOD
Notes (Explain if answered No to any of the above)

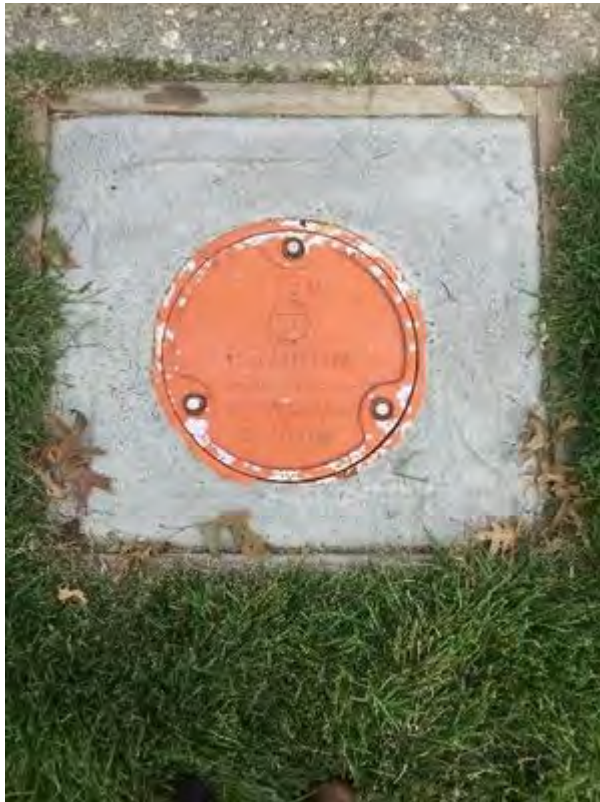
PHOTO LOG:

Client: Navy CLEAN	Facility: NWIRP Bethpage
Project Number: 112G08005-WE13	Location: Bethpage, New York
Date: September 21, 2021 17:25	Personnel: Noah Sprouse
Well ID: BP-TT-MW178I	Well Location:
Well Status: Other	Screen Interval: 290-310
WELL INVENTORY CONDITION	
Concrete pad in acceptable condition i.e. no cracks?	YES
Manhole cover present and in working condition?	YES
All bolts on manhole present and not stripped?	YES
Well plug present, locked and in good working condition?	YES
OVERALL CONDITION:	FAIR
Notes (Explain if answered No to any of the above) Needs fill.

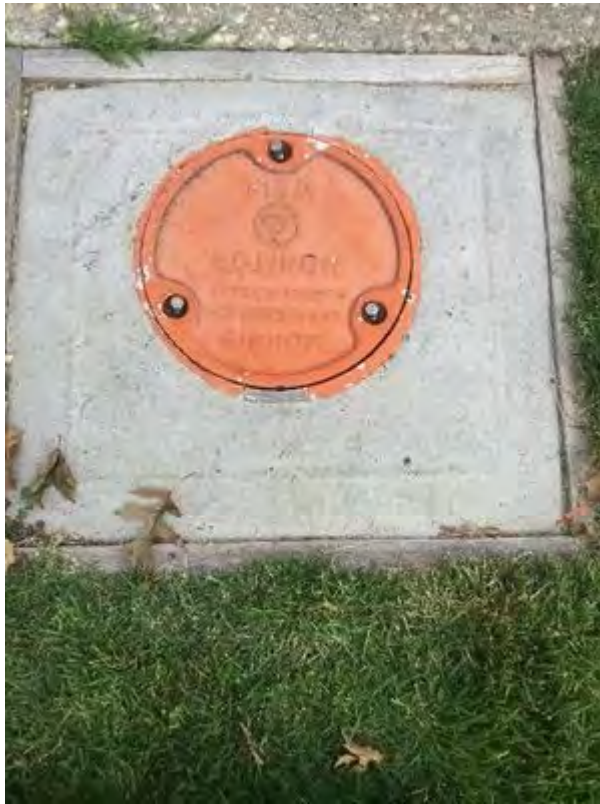
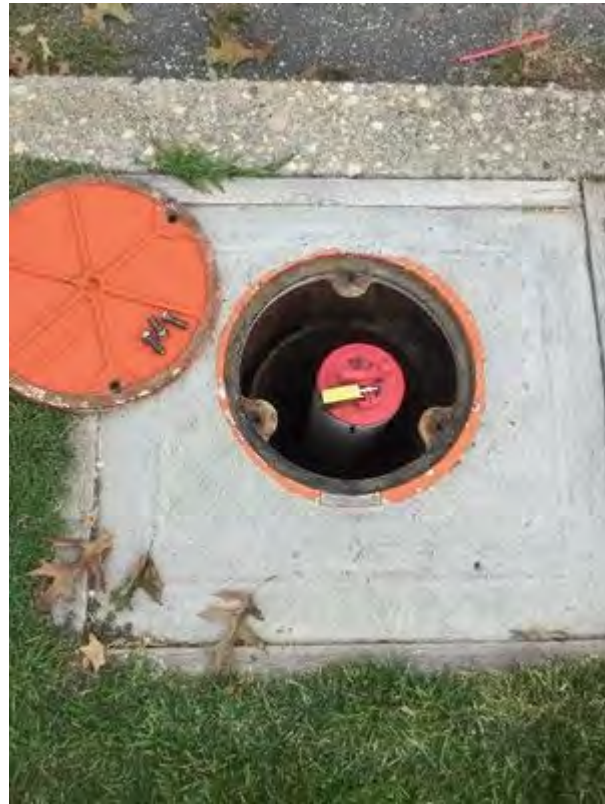
PHOTO LOG:

Client: Navy CLEAN	Facility: NWIRP Bethpage
Project Number: 112G08005-WE13	Location: Bethpage, New York
Date: September 21, 2021 17:23	Personnel: Noah Sprouse
Well ID: BP-TT-MW178S	Well Location:
Well Status: Other	Screen Interval: 190-210
WELL INVENTORY CONDITION	
Concrete pad in acceptable condition i.e. no cracks?	YES
Manhole cover present and in working condition?	YES
All bolts on manhole present and not stripped?	YES
Well plug present, locked and in good working condition?	YES
OVERALL CONDITION:	FAIR
Notes (Explain if answered No to any of the above) Needs fill.

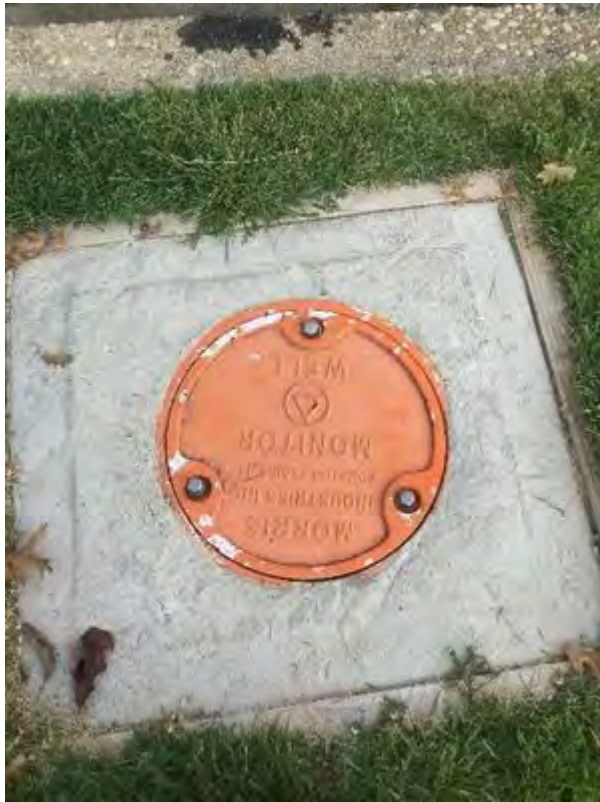
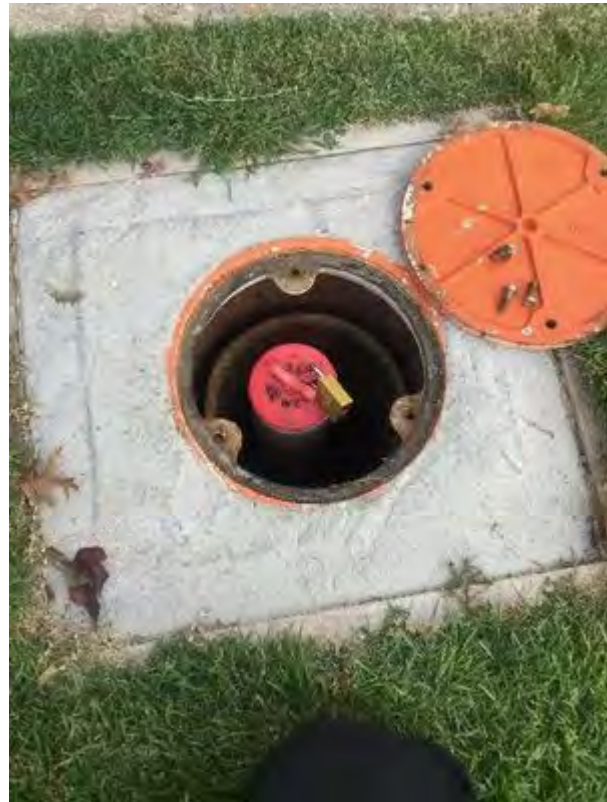
PHOTO LOG:

Client: Navy CLEAN	Facility: NWIRP Bethpage
Project Number: 112G08005-WE13	Location: Bethpage, New York
Date: September 21, 2021 17:19	Personnel: Noah Sprouse
Well ID: BP-TT-MW17811	Well Location:
Well Status: Other	Screen Interval: 420-440
WELL INVENTORY CONDITION	
Concrete pad in acceptable condition i.e. no cracks?	YES
Manhole cover present and in working condition?	YES
All bolts on manhole present and not stripped?	YES
Well plug present, locked and in good working condition?	YES
OVERALL CONDITION:	FAIR
Notes (Explain if answered No to any of the above) Needs fill

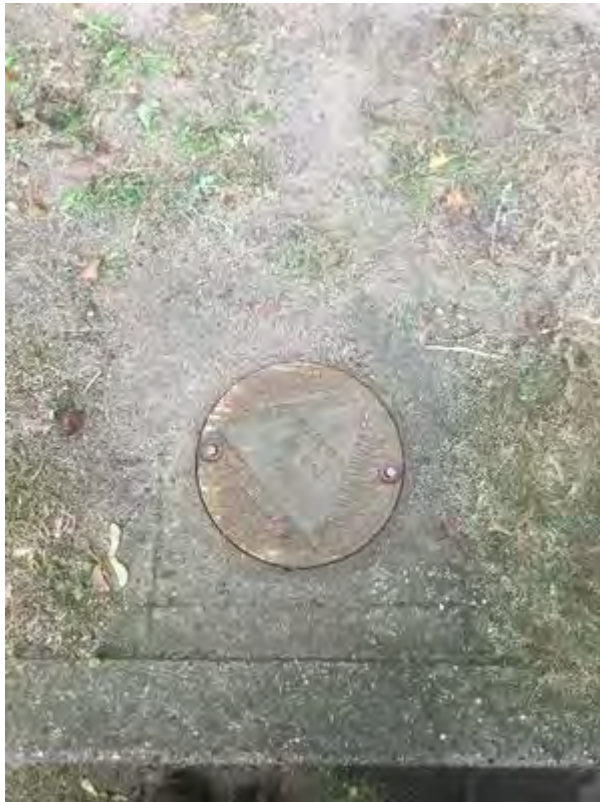
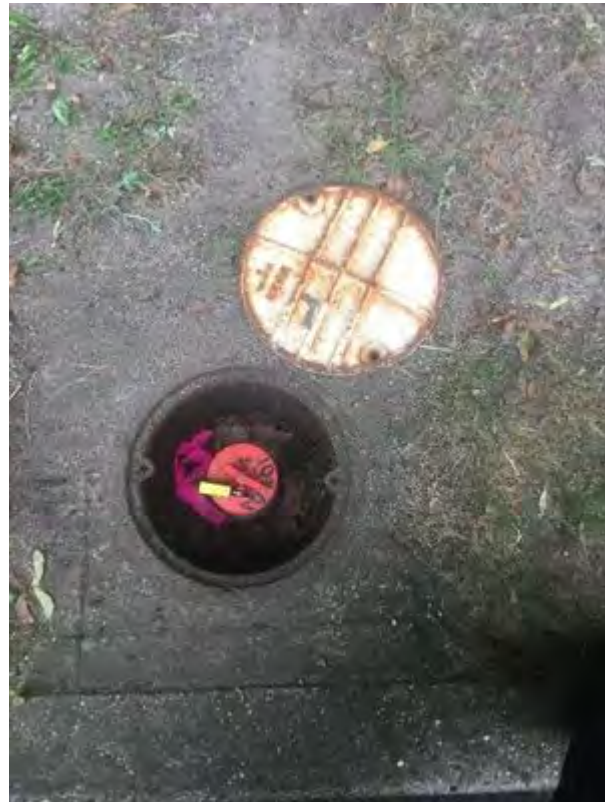
PHOTO LOG:

Client: Navy CLEAN	Facility: NWIRP Bethpage
Project Number: 112G08005-WE13	Location: Bethpage, New York
Date: September 21, 2021 14:59	Personnel: Noah Sprouse
Well ID: RE104D3	Well Location: 206993.50182 1127695.55436
Well Status: Other	Screen Interval: 760-780
WELL INVENTORY CONDITION	
Concrete pad in acceptable condition i.e. no cracks?	YES
Manhole cover present and in working condition?	YES
All bolts on manhole present and not stripped?	NO
Well plug present, locked and in good working condition?	YES
OVERALL CONDITION:	FAIR
Notes (Explain if answered No to any of the above) Both bolts stripped, missing rubber gasket

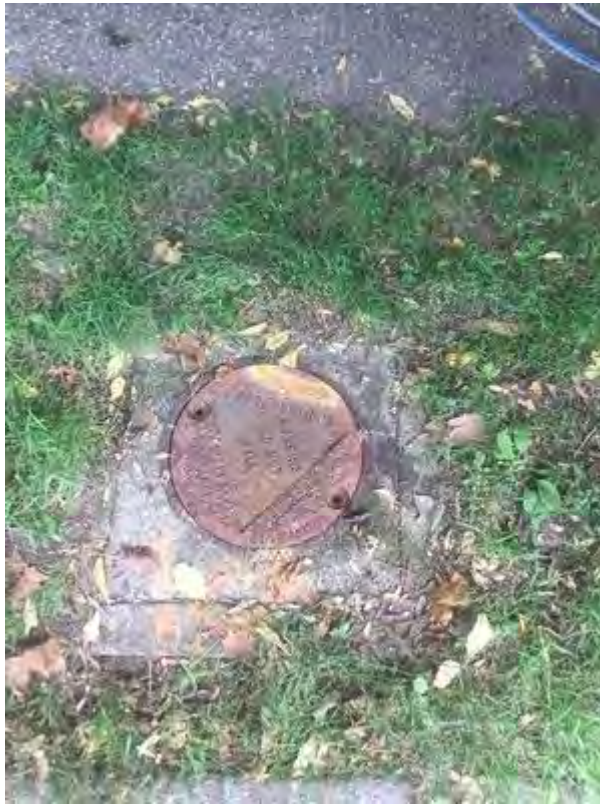
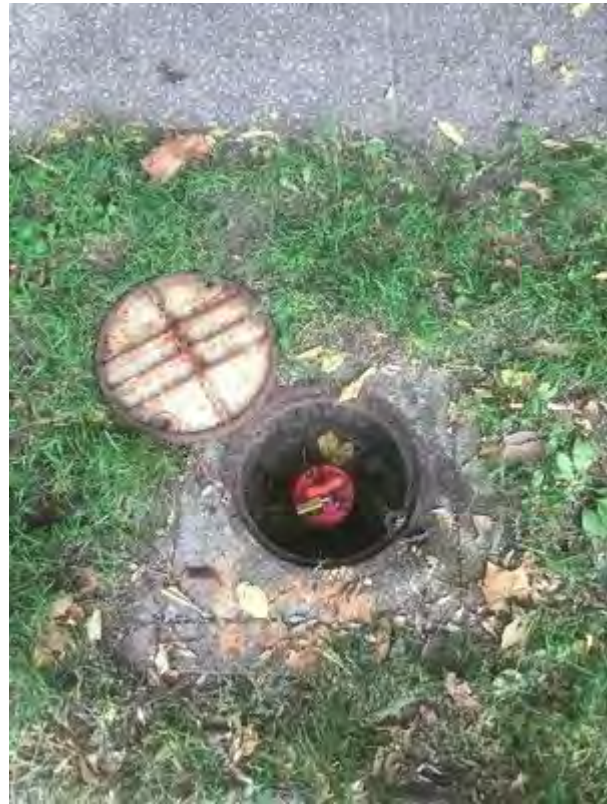
Client: Navy CLEAN	Facility: NWIRP Bethpage
Project Number: 112G08005-WE13	Location: Bethpage, New York
Date: September 21, 2021 14:56	Personnel: Noah Sprouse
Well ID: RE104D1	Well Location: 207037.186215 1127745.67815
Well Status: Other	Screen Interval: 350-370
WELL INVENTORY CONDITION	
Concrete pad in acceptable condition i.e. no cracks?	YES
Manhole cover present and in working condition?	YES
All bolts on manhole present and not stripped?	NO
Well plug present, locked and in good working condition?	YES
OVERALL CONDITION:	GOOD
Notes (Explain if answered No to any of the above) Missing two bolts, missing rubber gasket.

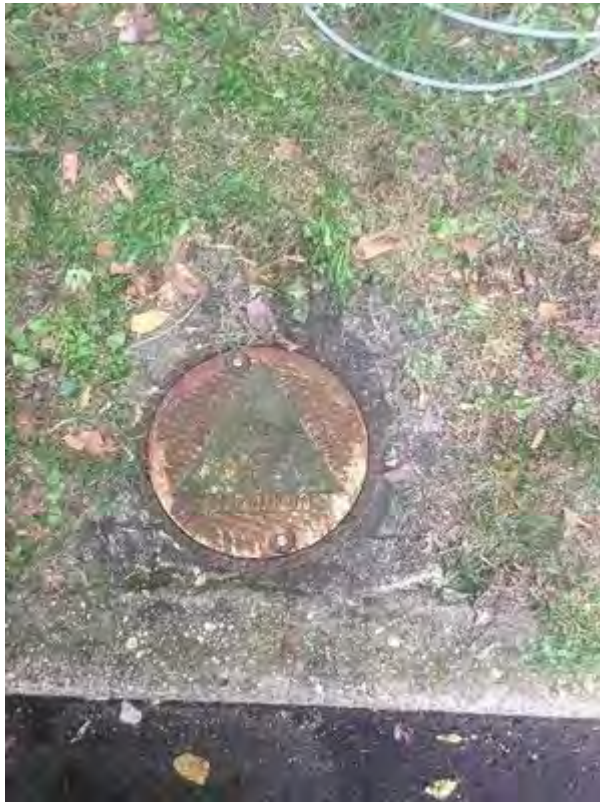
Client: Navy CLEAN	Facility: NWIRP Bethpage
Project Number: 112G08005-WE13	Location: Bethpage, New York
Date: September 21, 2021 14:51	Personnel: Noah Sprouse
Well ID: RE104D2	Well Location: 207000.03614 1127708.99093
Well Status: Other	Screen Interval: 710-730
WELL INVENTORY CONDITION	
Concrete pad in acceptable condition i.e. no cracks?	YES
Manhole cover present and in working condition?	YES
All bolts on manhole present and not stripped?	NO
Well plug present, locked and in good working condition?	YES
OVERALL CONDITION:	FAIR
Notes (Explain if answered No to any of the above) Both bolts stripped, missing rubber gasket.

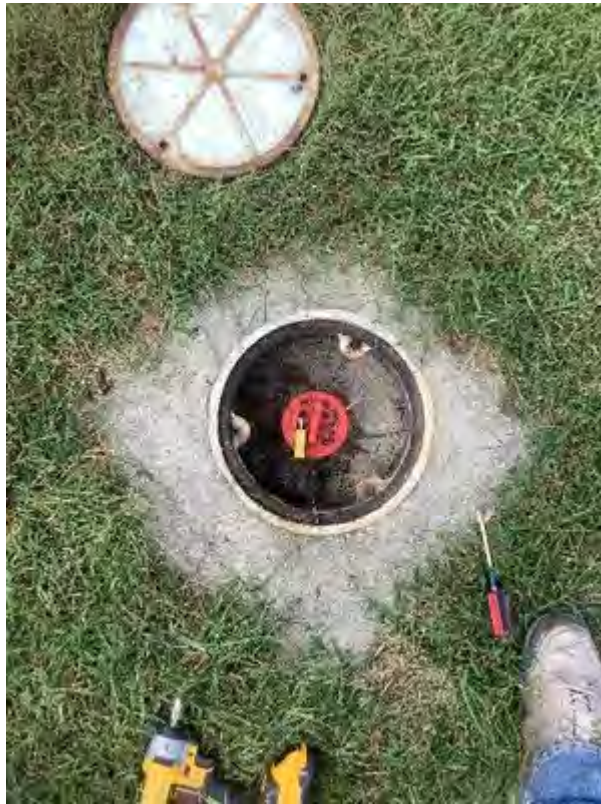
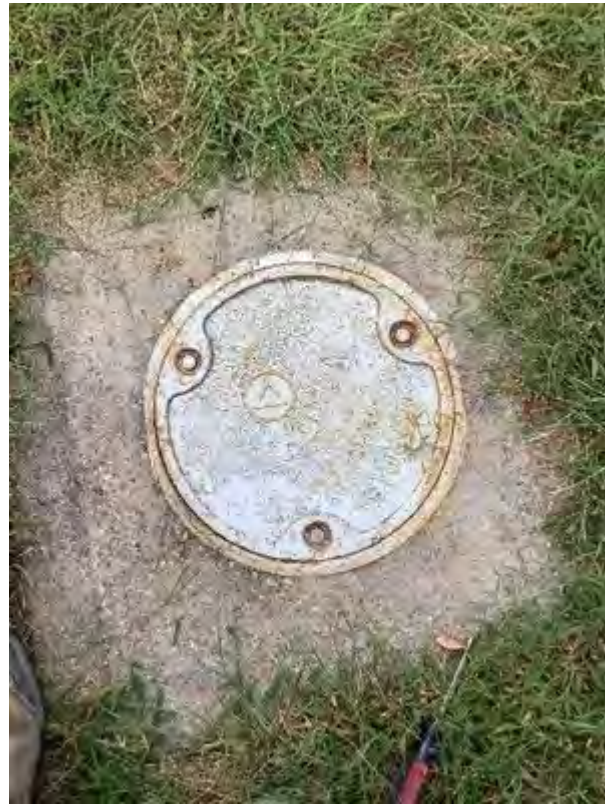
Client: Navy CLEAN	Facility: NWIRP Bethpage
Project Number: 112G08005-WE13	Location: Bethpage, New York
Date: September 21, 2021 13:20	Personnel: Beau Benfield
Well ID: RE124D1	Well Location: 202702.46 1122969.8
Well Status: Other	Screen Interval: 660-680
WELL INVENTORY CONDITION	
Concrete pad in acceptable condition i.e. no cracks?	YES
Manhole cover present and in working condition?	YES
All bolts on manhole present and not stripped?	NO
Well plug present, locked and in good working condition?	YES
OVERALL CONDITION:	GOOD
Notes (Explain if answered No to any of the above)
